Inspection Photos

Loc: 324795

Operator: WESTERN OPERATING COMPANY

Inspection Date: 10/5/2023

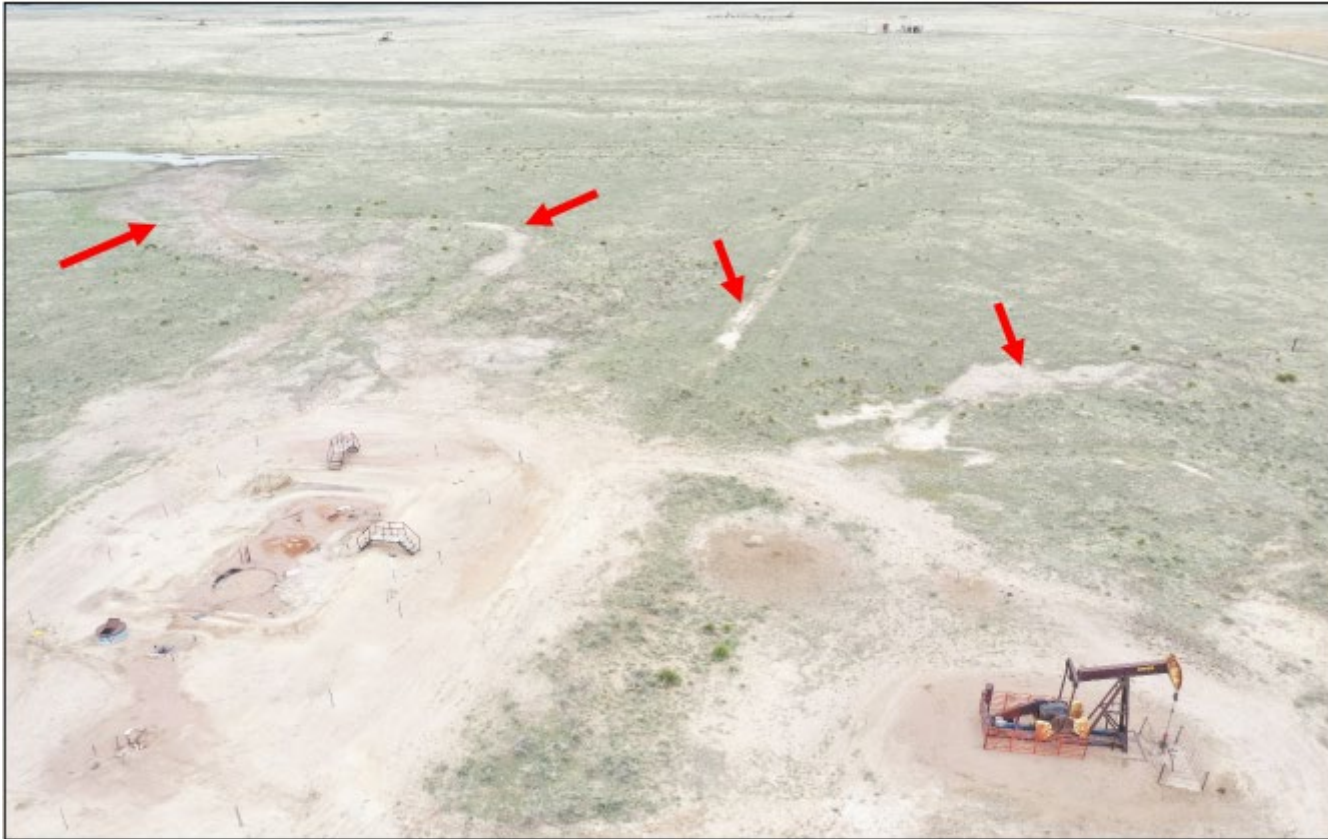
Photo 1. Drone aerial photo facing northwest from the Foster #1 wellsite. There are multiple impacted areas from previous spill. Site investigation and remediation will need to occur.

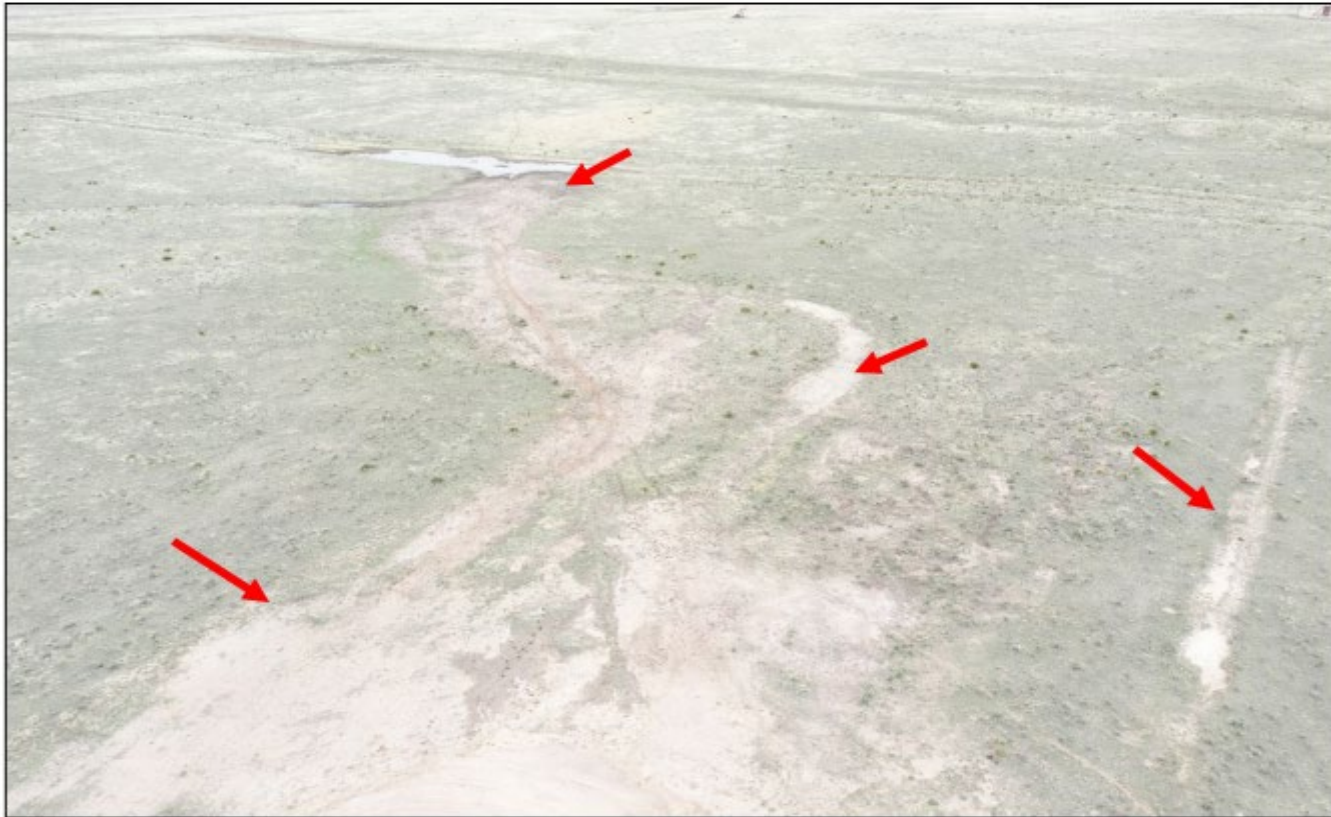
Photo 2. Drone aerial photo facing northwest from the Foster #1 wellsite. There is multiple impacted areas from previous spill. Site investigation and remediation will need to occur.

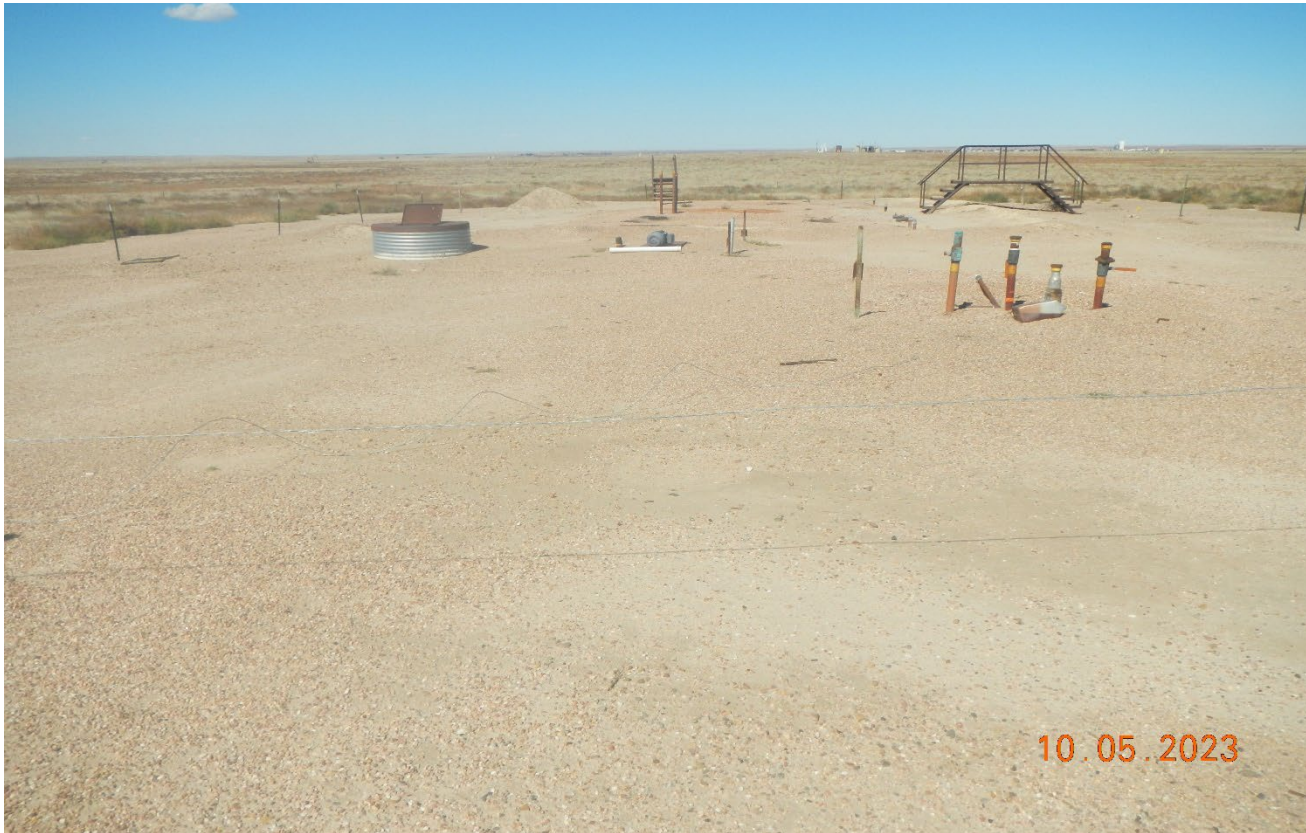
Photo 3. Facing toward the tank battery site. The tanks have been removed however, unused pipe risers and various equipment still remains.

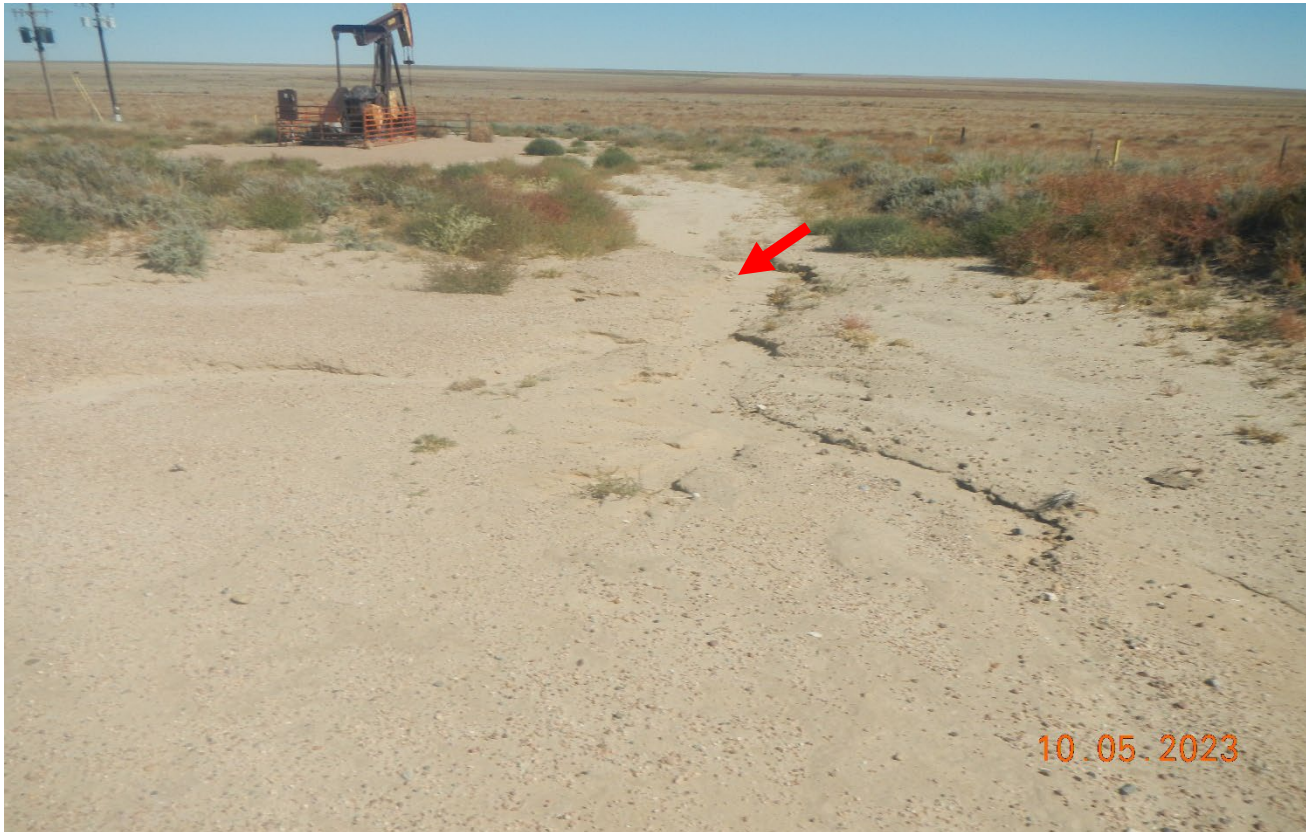
Photo 4. Facing northeast toward the wellsite. There is erosion occurring in this area shown at red arrow.

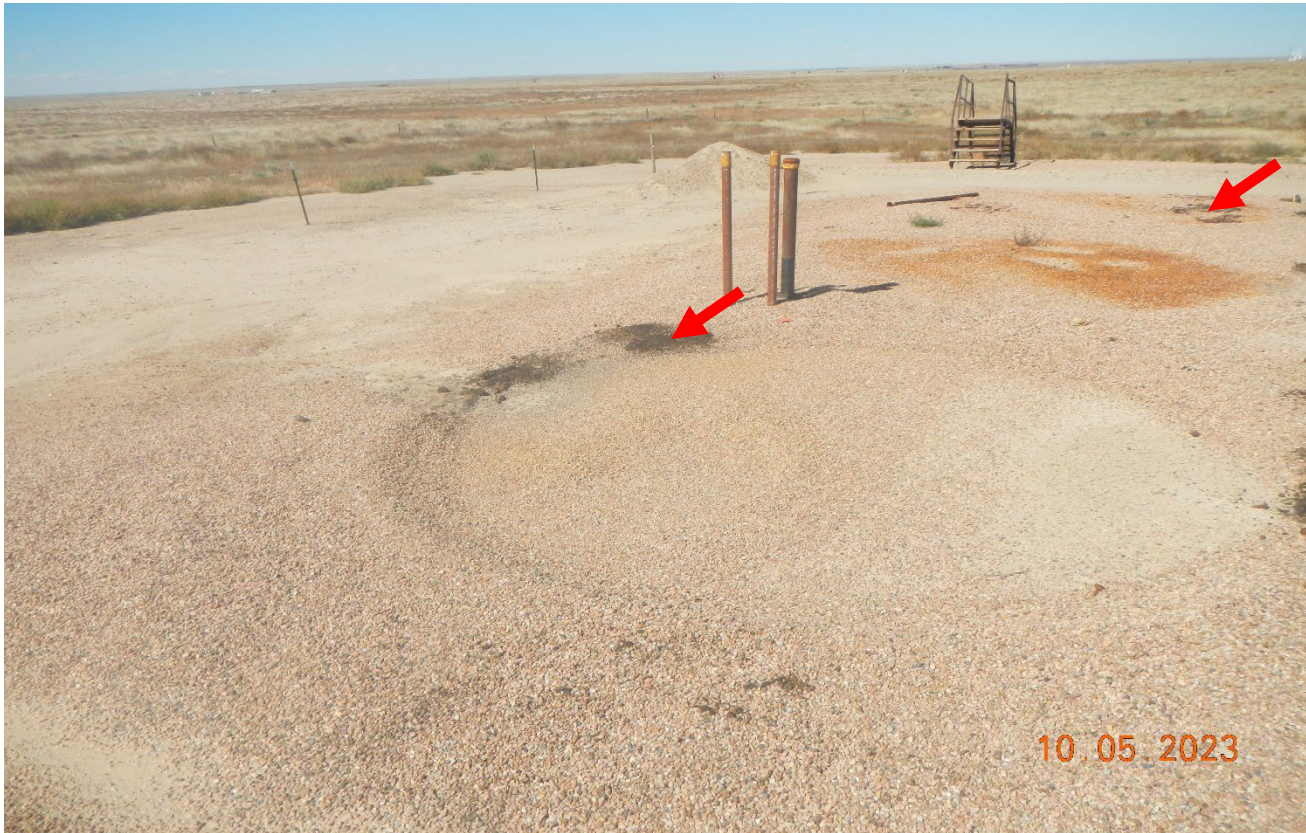
Photo 5. Facing northwest where tanks were located. There is oil impacted soils shown at red arrows.

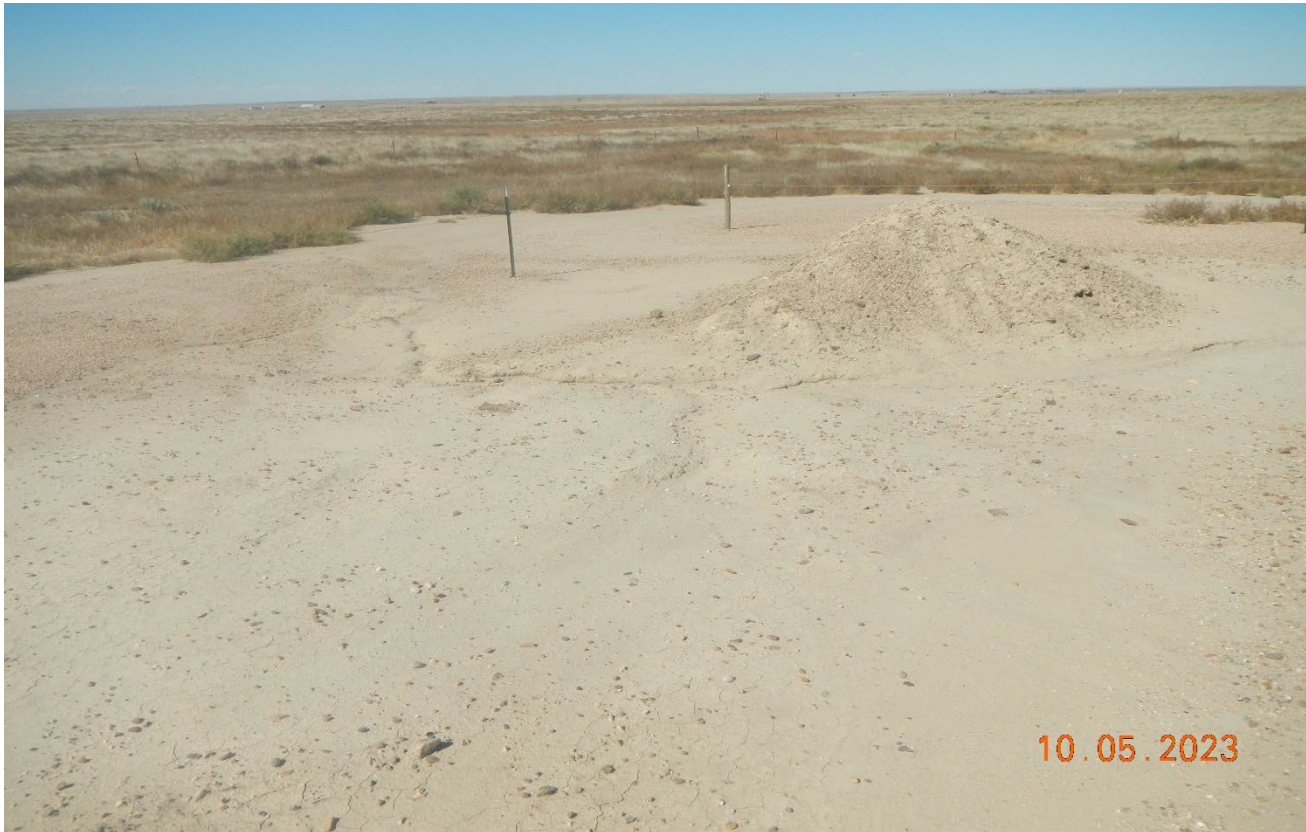
Photo 6. Facing toward the northwest side of the location. There is Stormwater erosion occurring off this area of the location. It appears impacted soils have been piled up and are not properly contained.

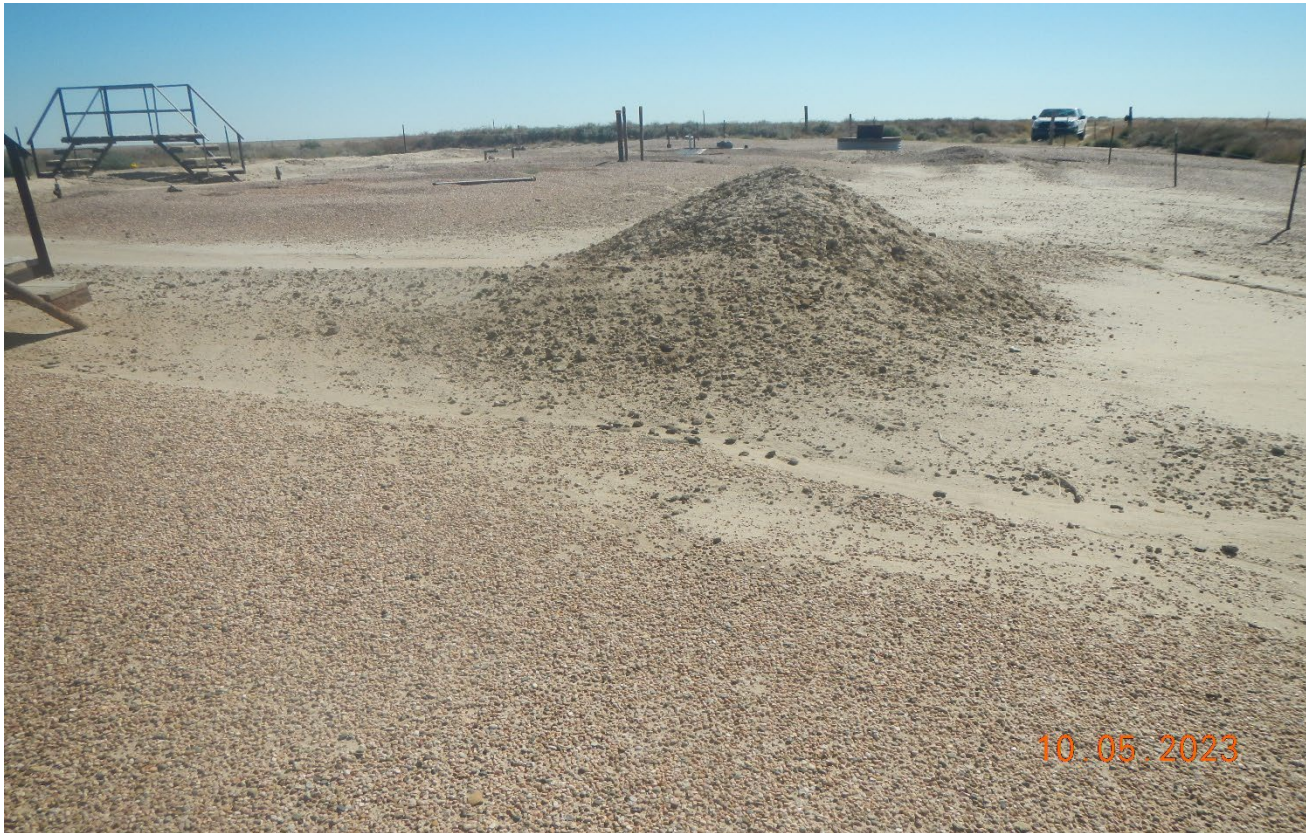
Photo 6. Facing toward the southeast. There is Stormwater erosion occurring off this area of the location. It appears impacted soils have been pled up and are not properly contained.
