Inspection Photos

Location Name: TEP ROCKY MOUNTAIN LLC, UNION ENERGY MINING DIV.-66S96W/33SWSE

Location ID: 334868

Date: 10/5/2023

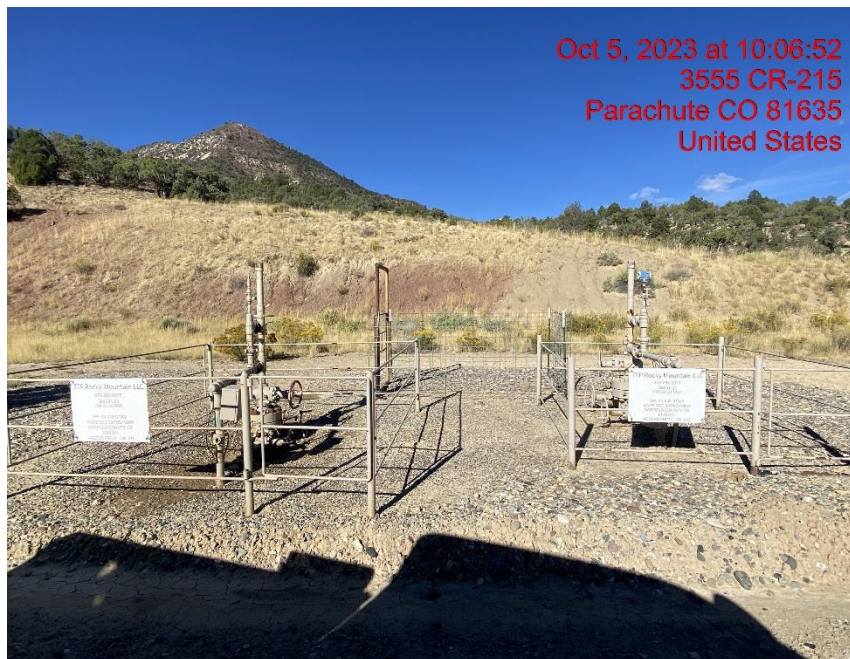
Wellheads – Photo #06814

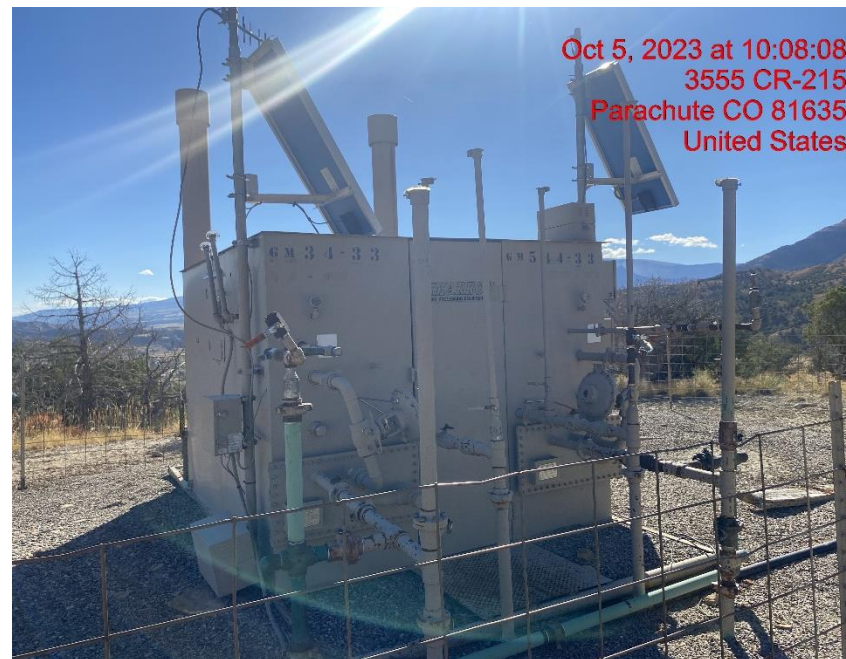
Separators – Photo #06816

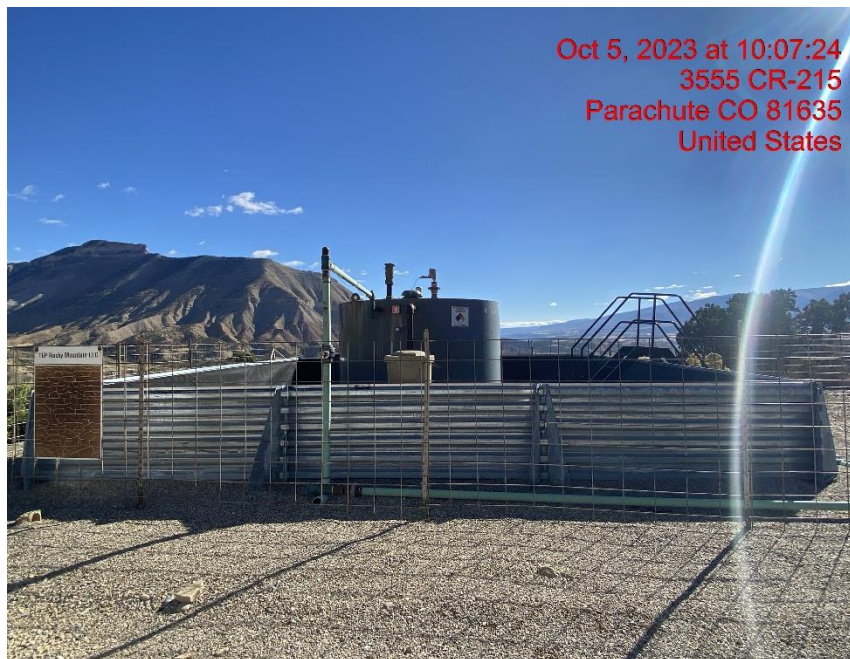
Tank Battery – Photo #06815

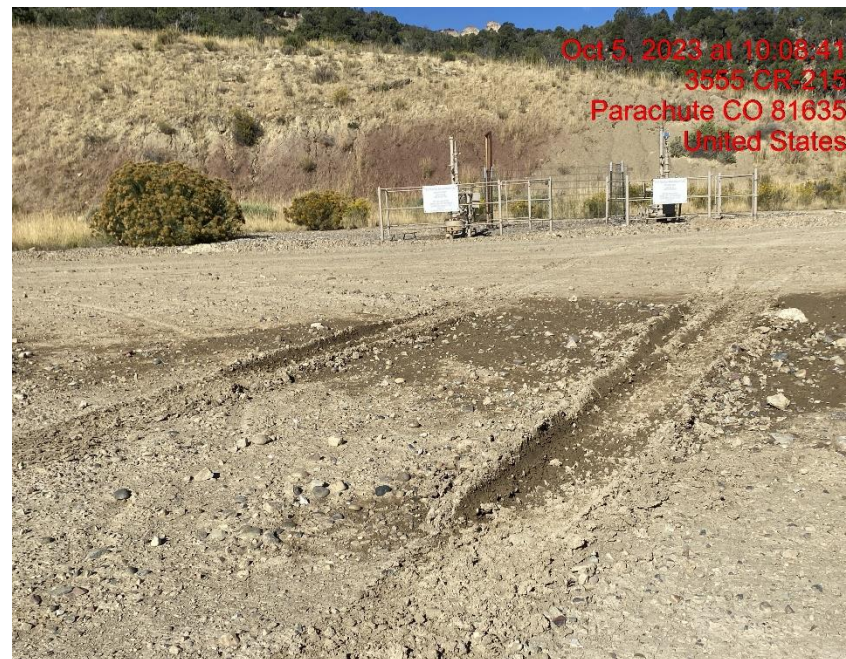
Location Lacks Stabilization – Photo #06817

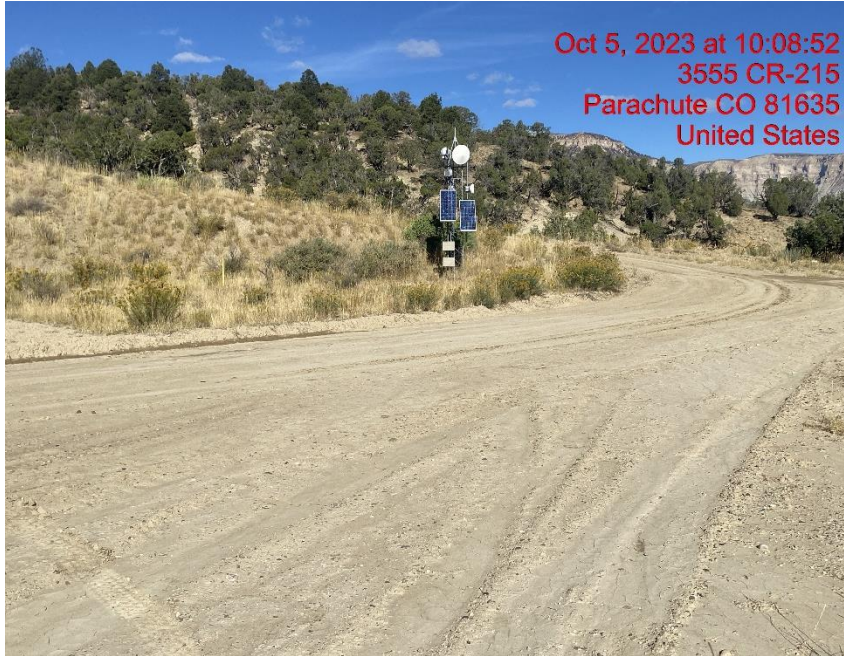
**Insufficient Vehicle Tracking BMPs at Location Entrance/Exit
– Photo #06818**

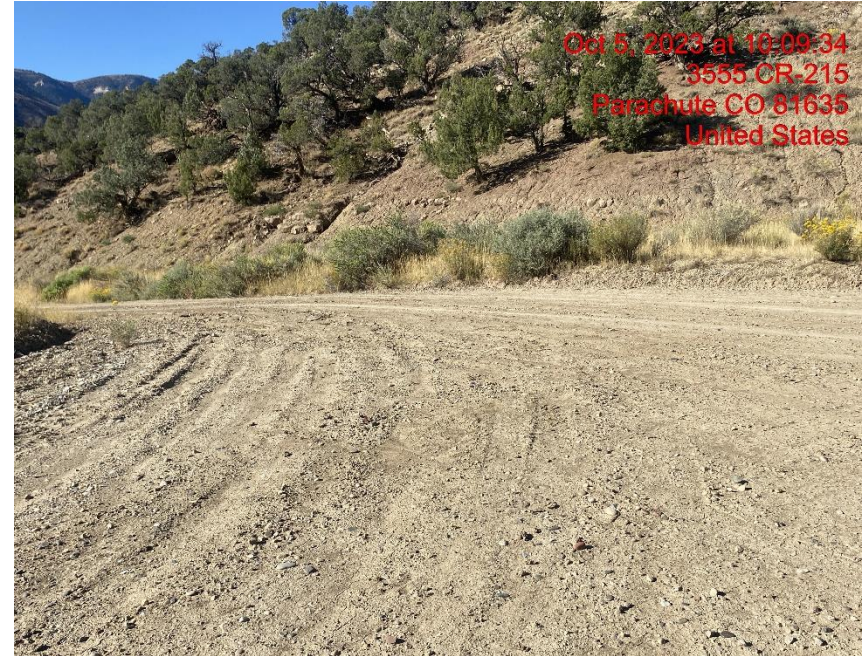
**Insufficient Vehicle Tracking BMPs at Location Entrance/Exit
– Photo #06819**
