Inspection Photos

Loc: 324836

Operator: CHEMCO INC

Inspection Date: 10/5/2023

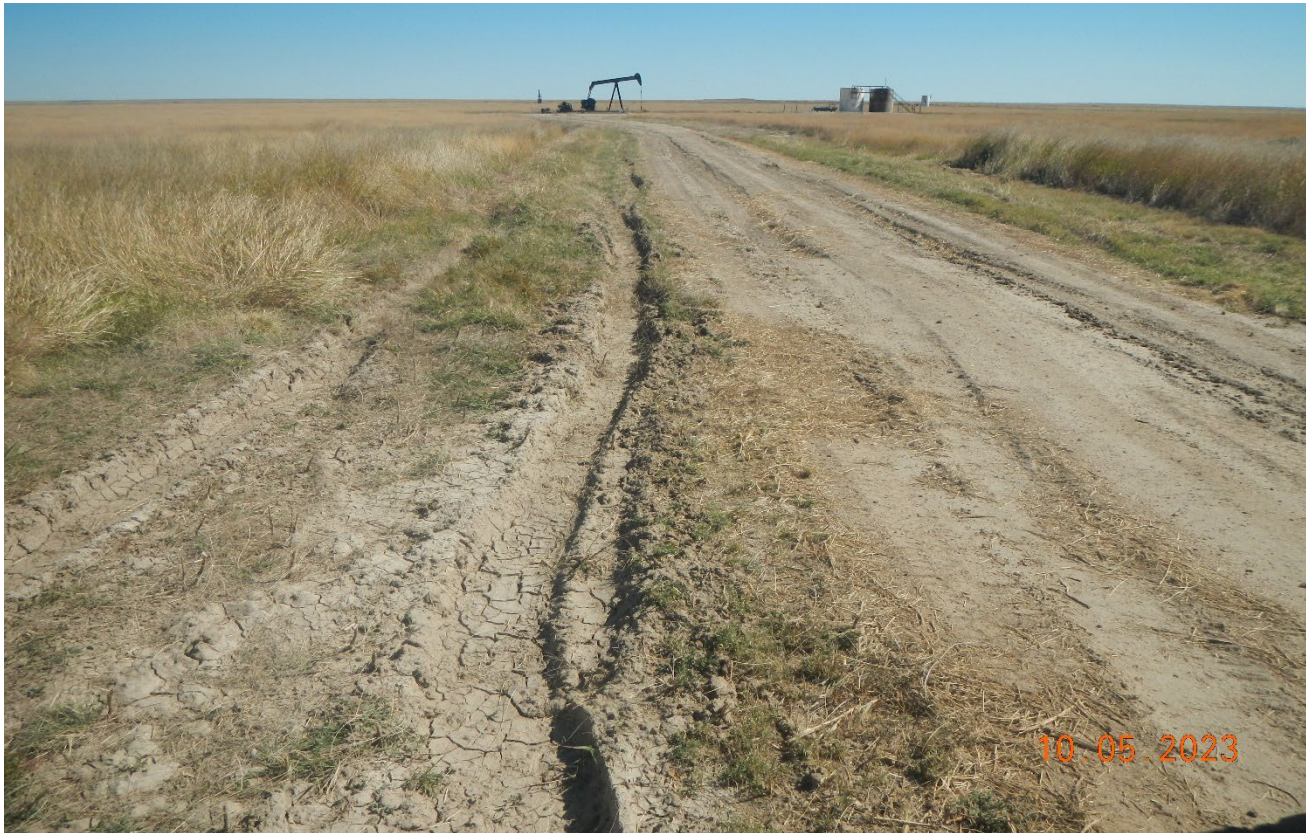
Photo 1. Facing east along the access road. Vehicle s have driven outside of the access road causing rutting and disturbance. This area needs to be repaired and the access road needs to be stabilized.

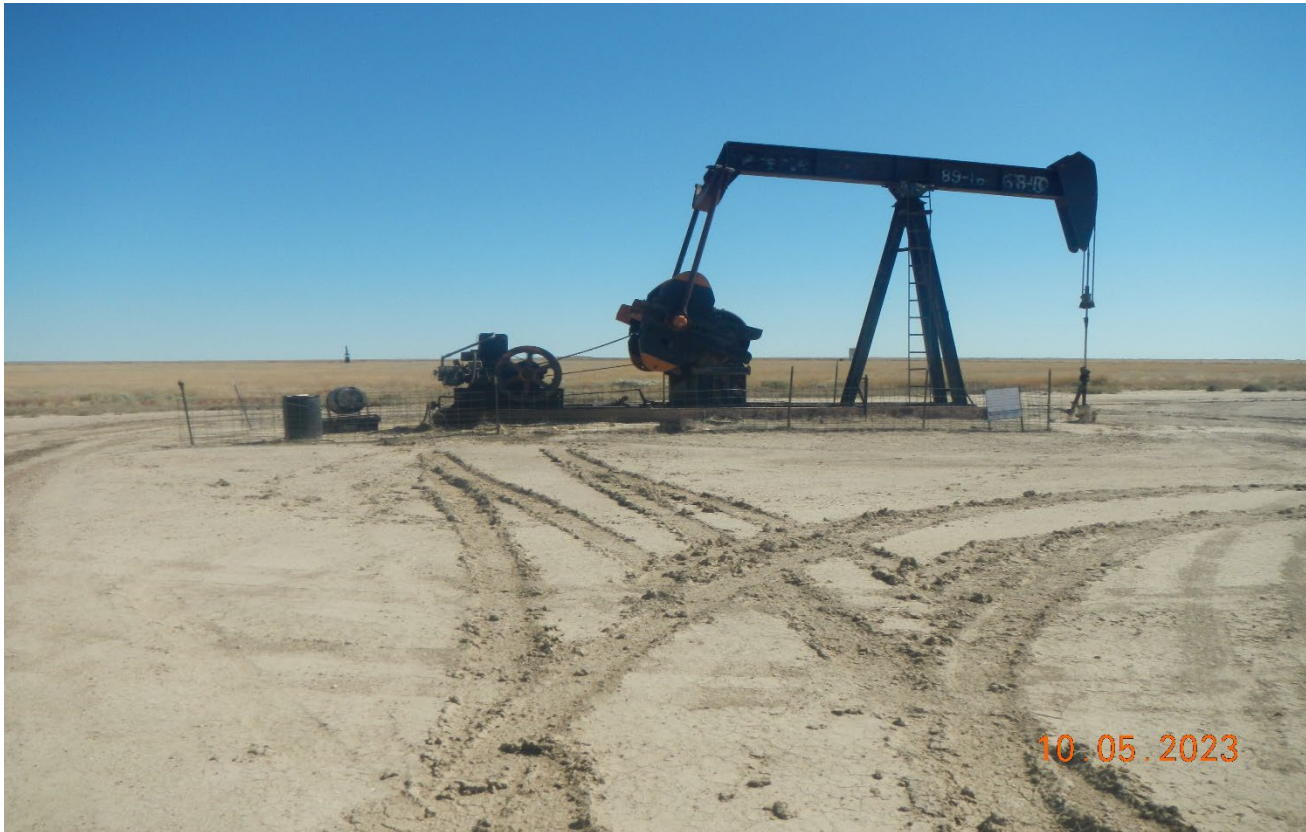
Photo 2. Facing east toward the wellsite.

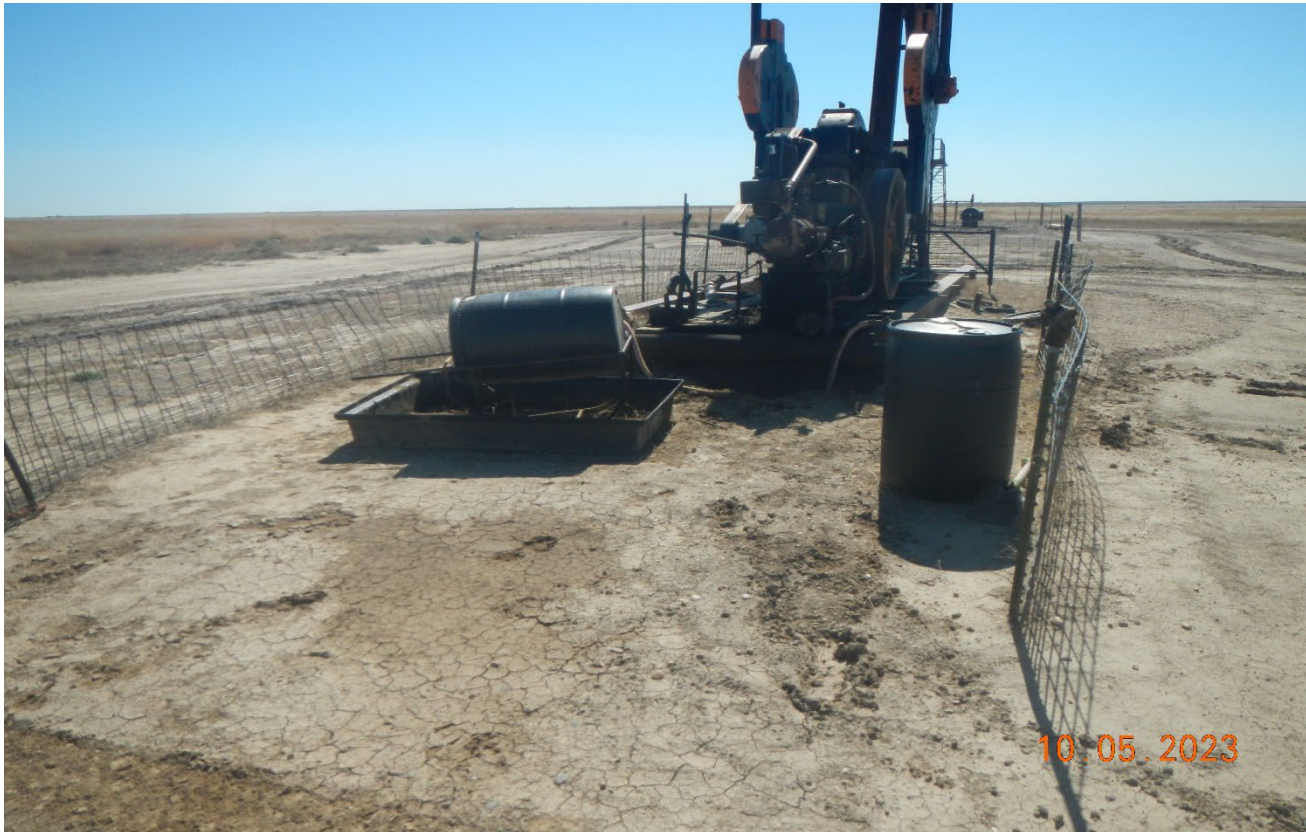
Photo 3. There is a barrel that is not in secondary containment and the fence is open on this side which is not preventing livestock entry.

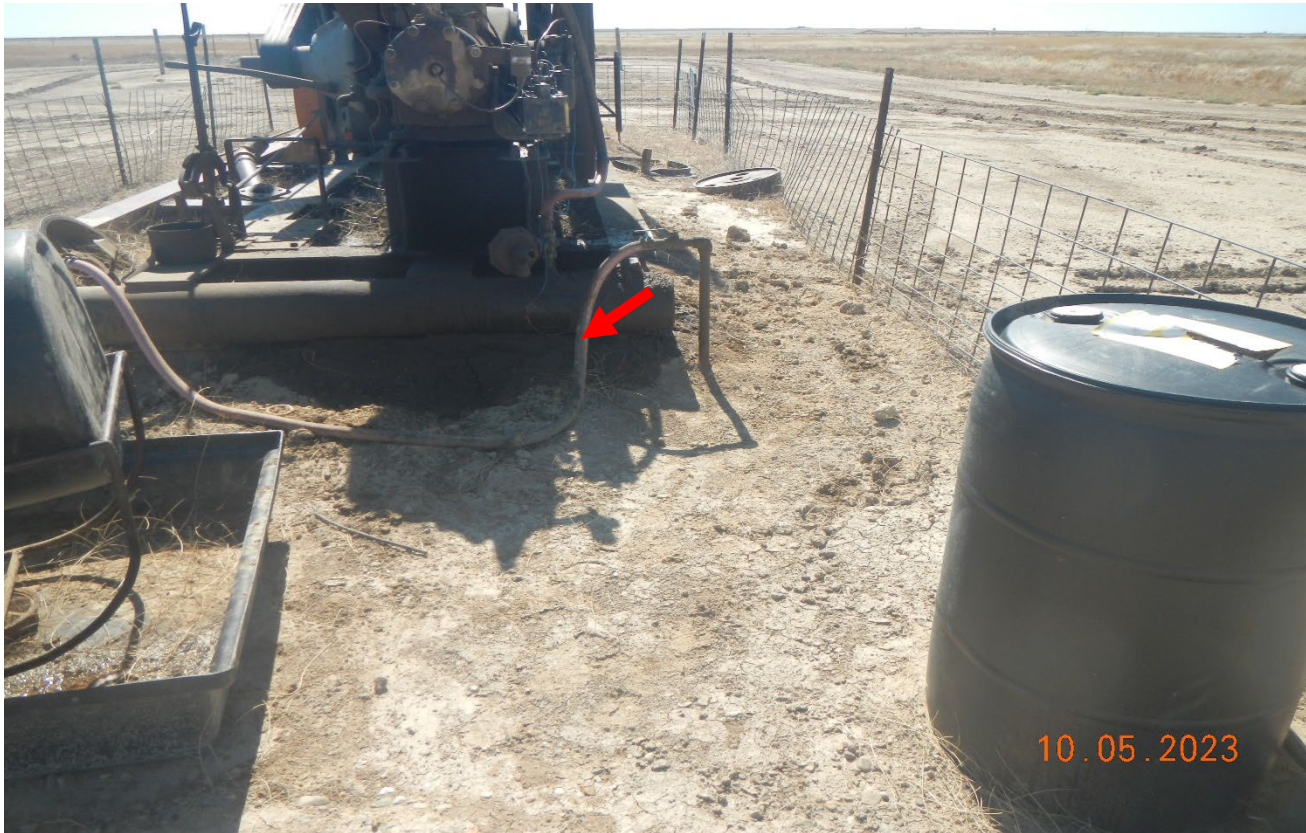
Photo 4. There is still oily soils at the base of the pumpjack. It appears some dirt was spread over the stained soils to cover it up in attempt to hide the spill. Previous corrective action was not completed.

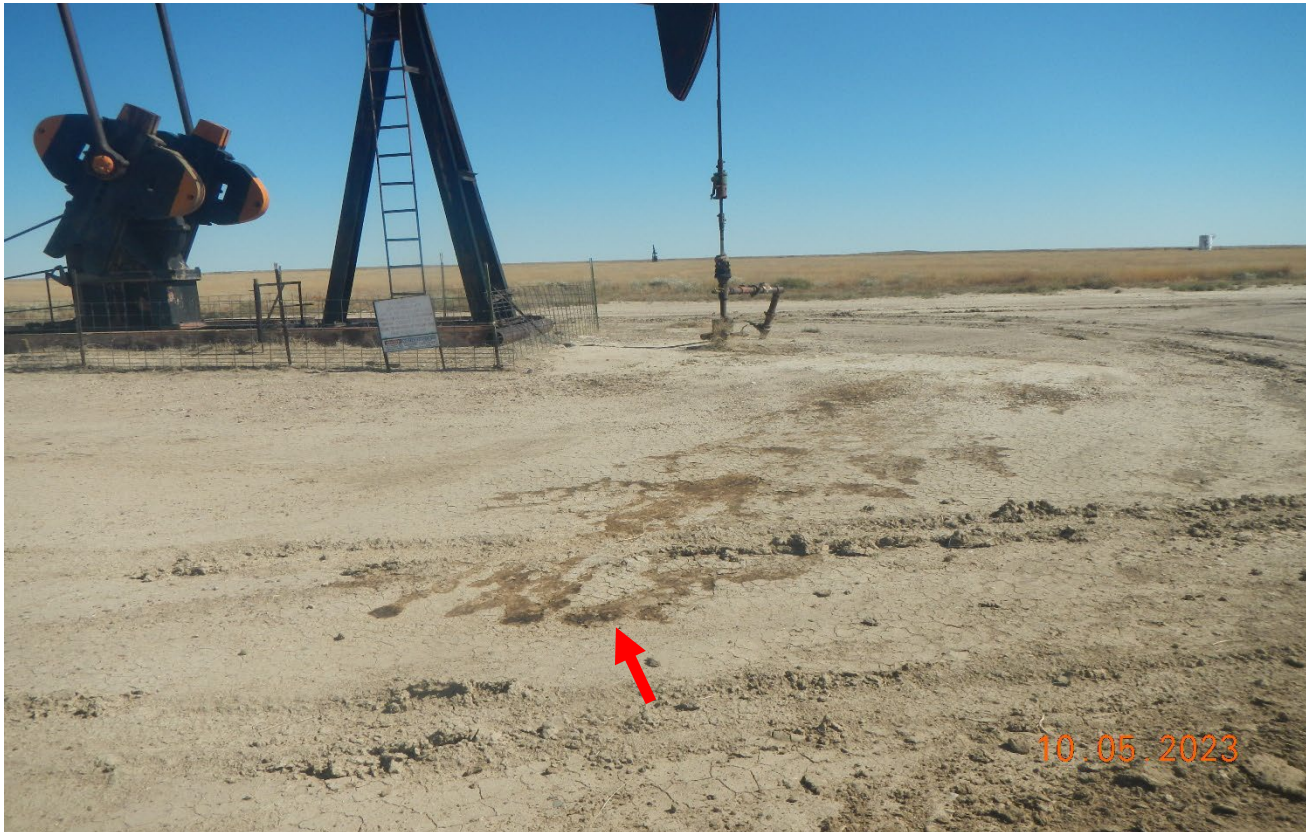
Photo 5. There is oil stained soils that leaked out of the wellhead all the way to where the red arrow is shown approx. 25'.

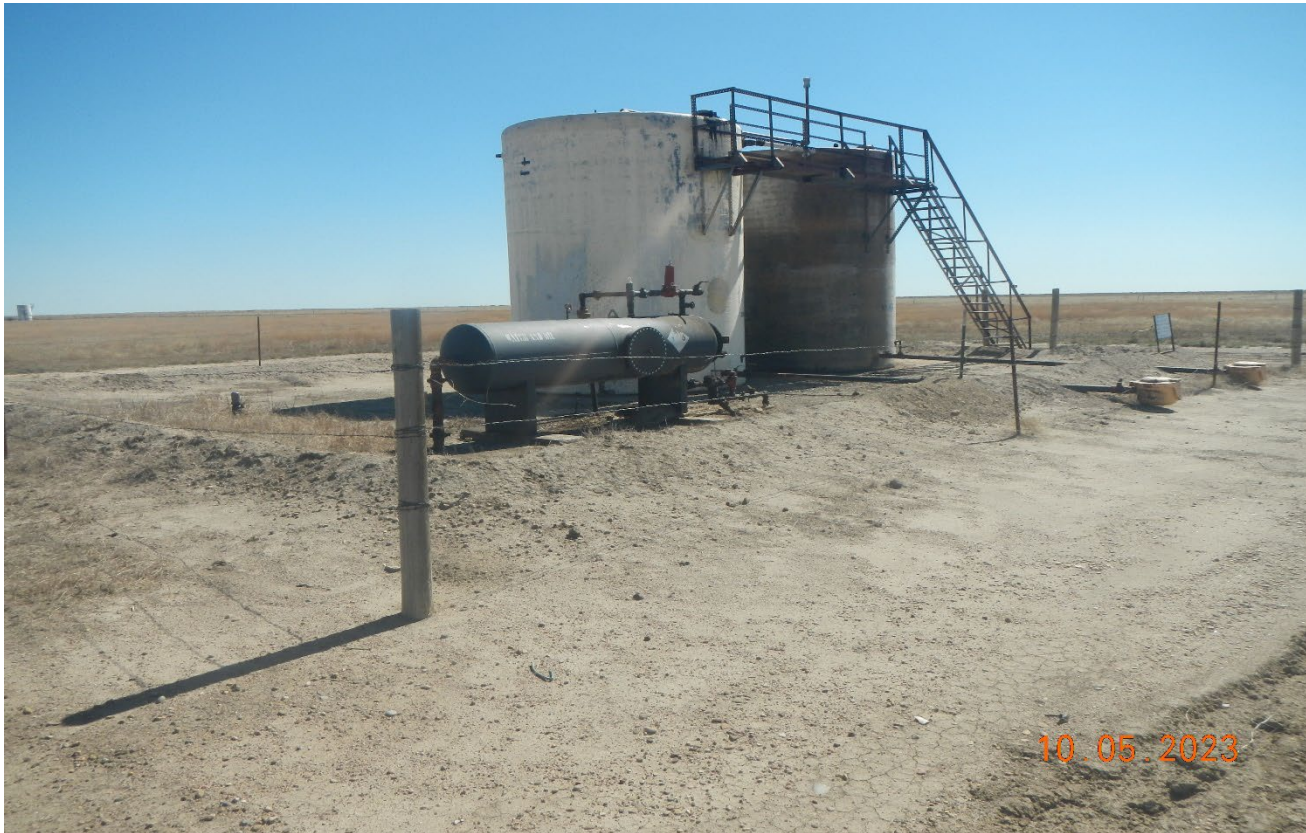
Photo 6. Facing toward the tank battery. Labeling on the tanks are faded.

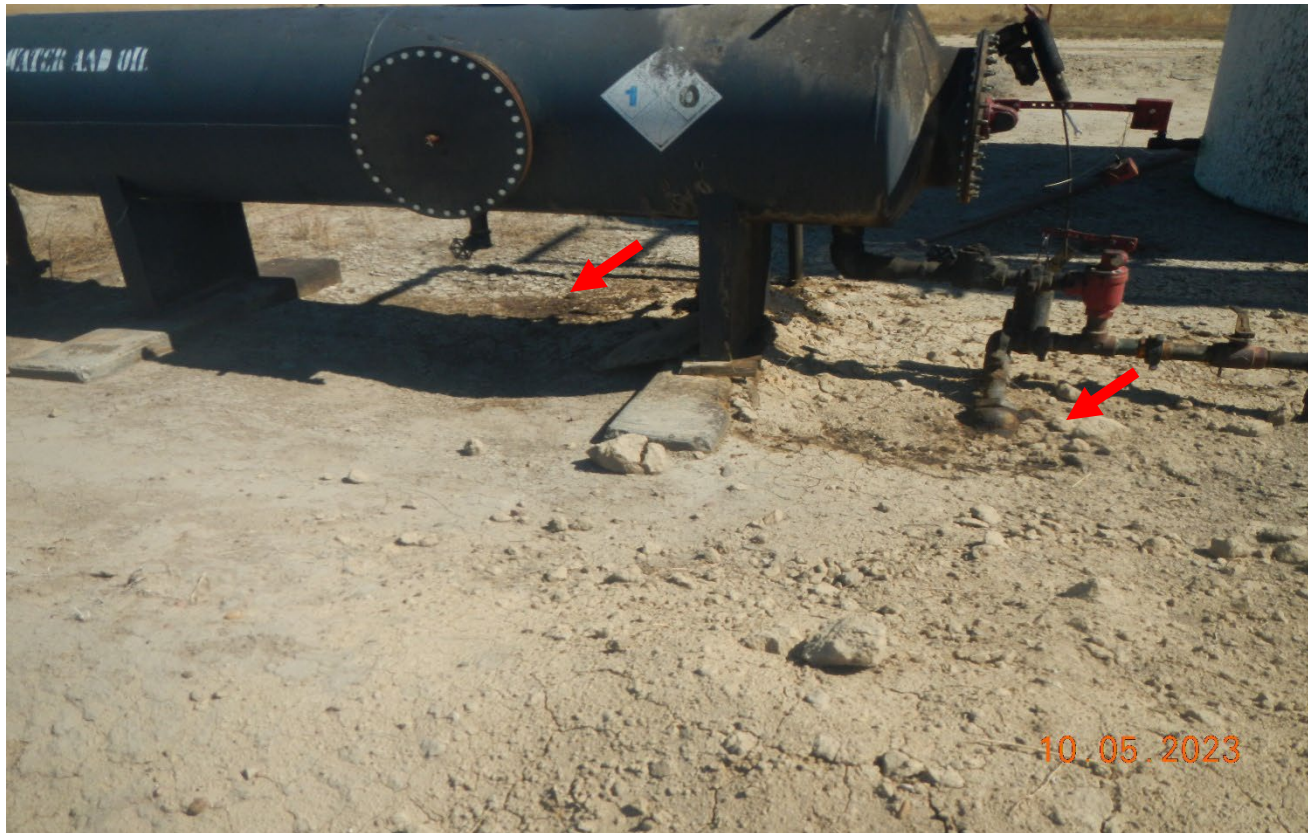
Photo 7. There is oily soils around the separator that must be cleaned up..
