Inspection Photos

Loc:324810

Operator: ENERVEST OPERATING LLC

Inspection Date: 10/5/2023

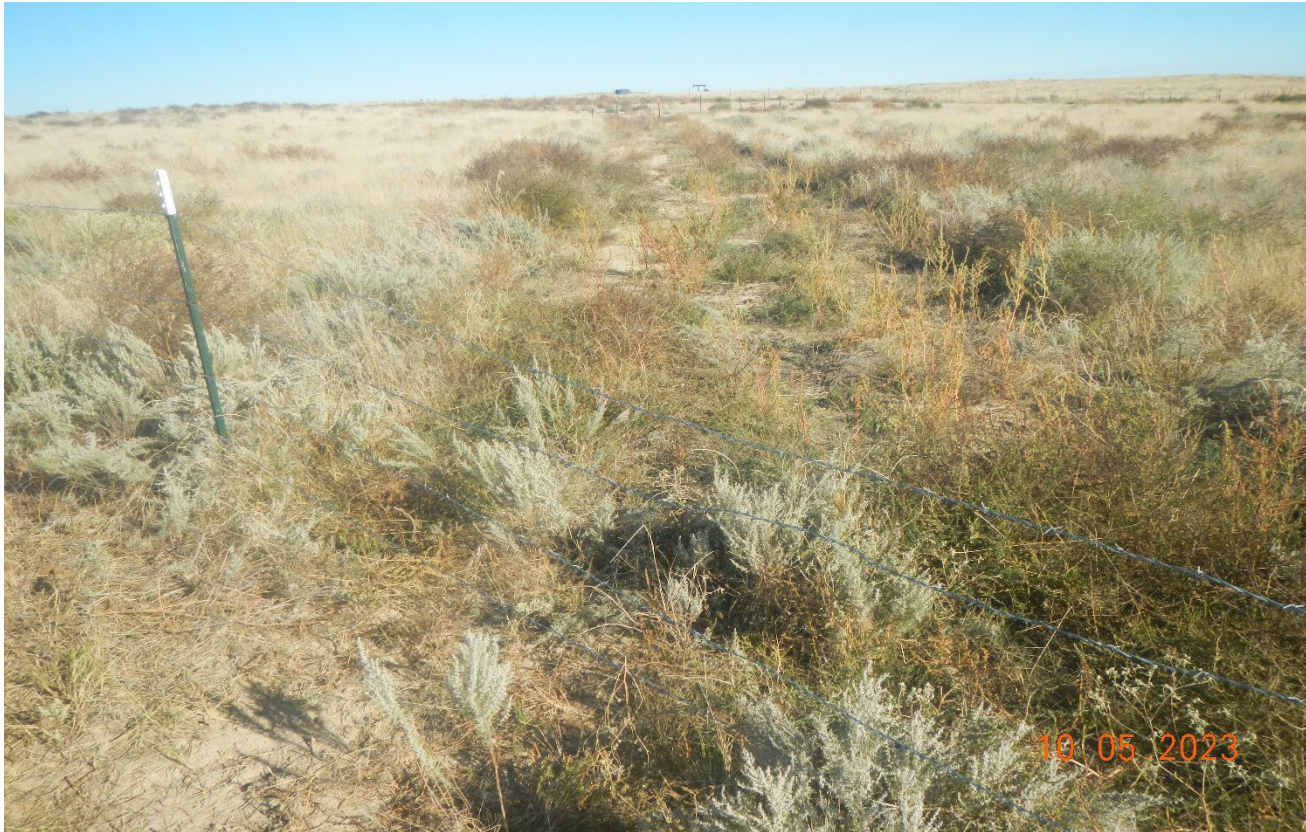
Photo 1. Facing northwest toward the reclaimed access road. There is vegetation establishing along with undesirable weeds that will need to be controlled.

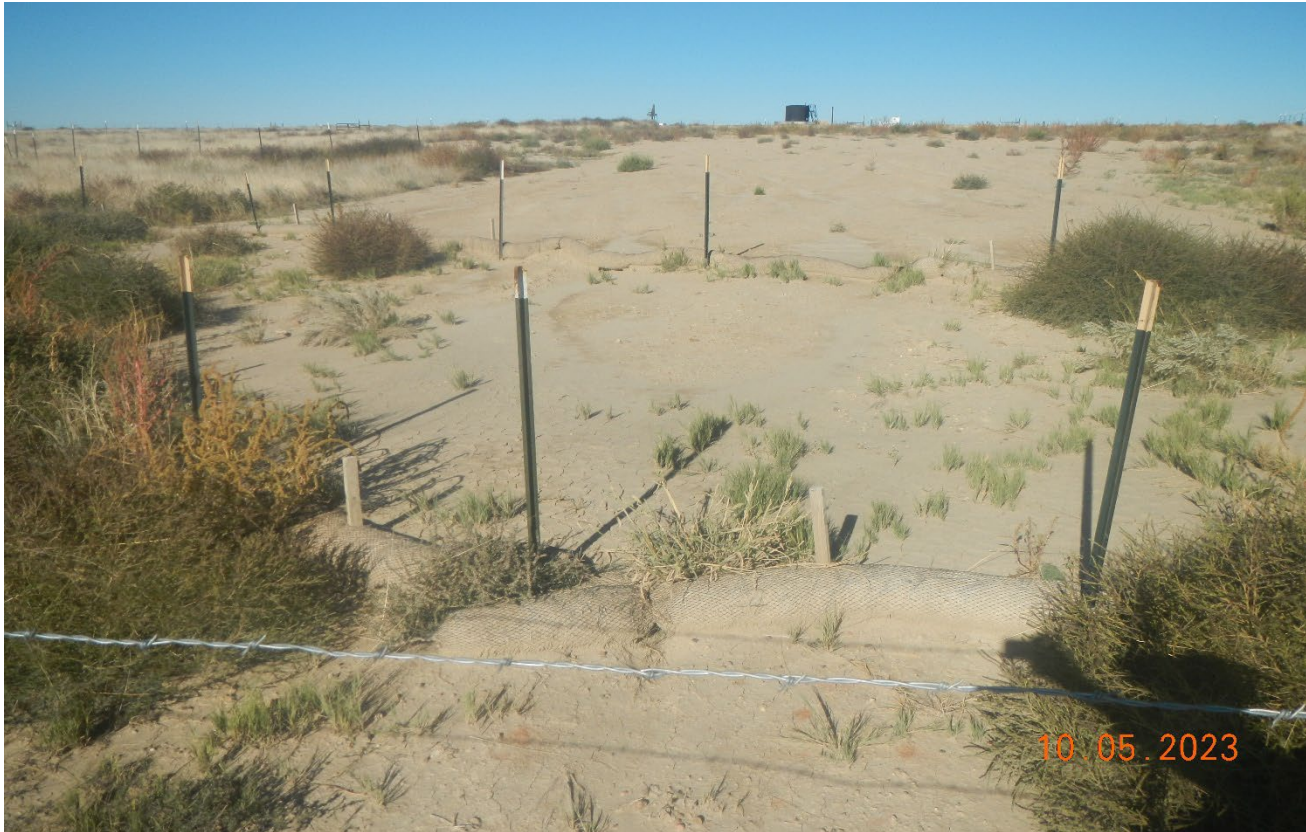
Photo 2. Facing west toward the location. Remediation Project #19874 is ongoing. Reclamation does not appear to be progressing.

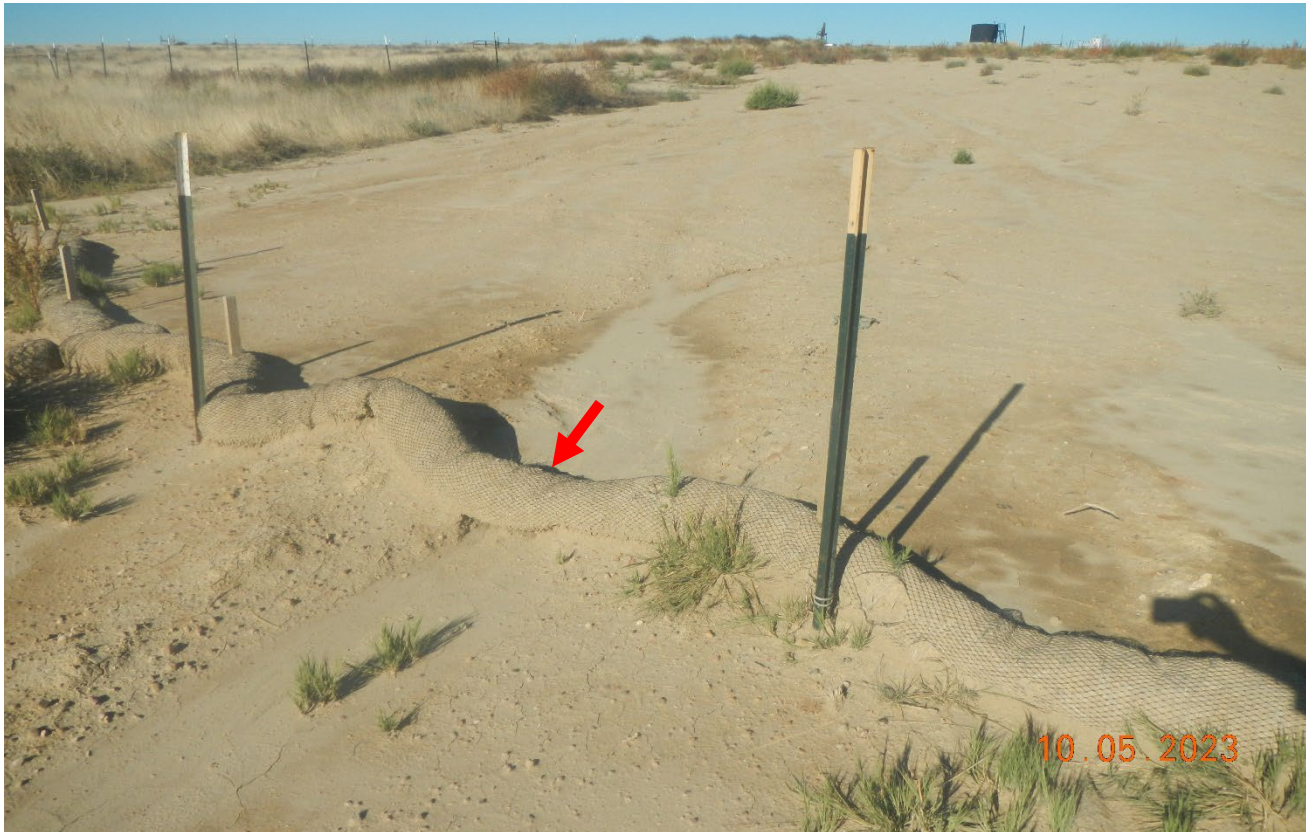
Photo 3. There is erosion occurring and stormwater controls are not maintained. Stormwater has eroded underneath the wattles.

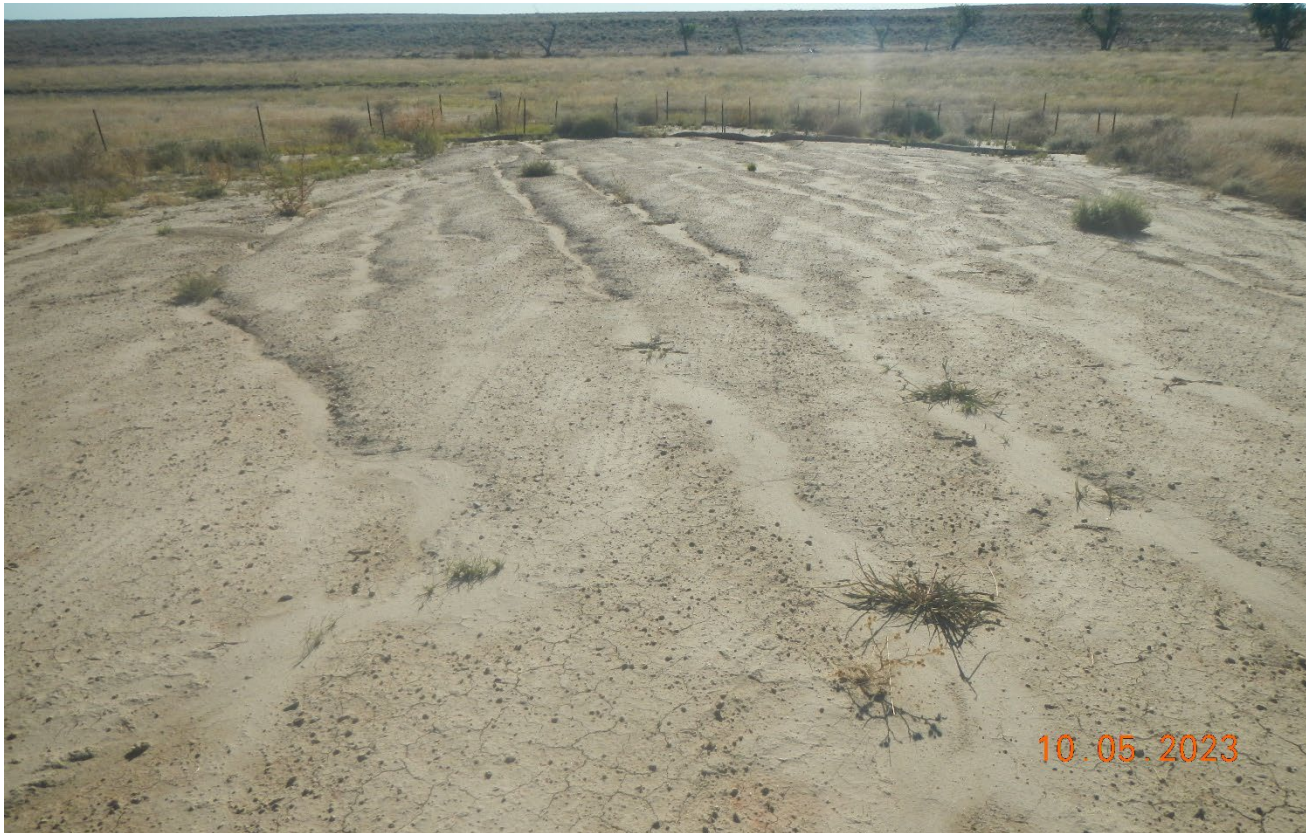
Photo 4. Facing east were excavated area was backfilled. Perennial vegetation does not appear to be establishing. A soil analysis needs to be performed

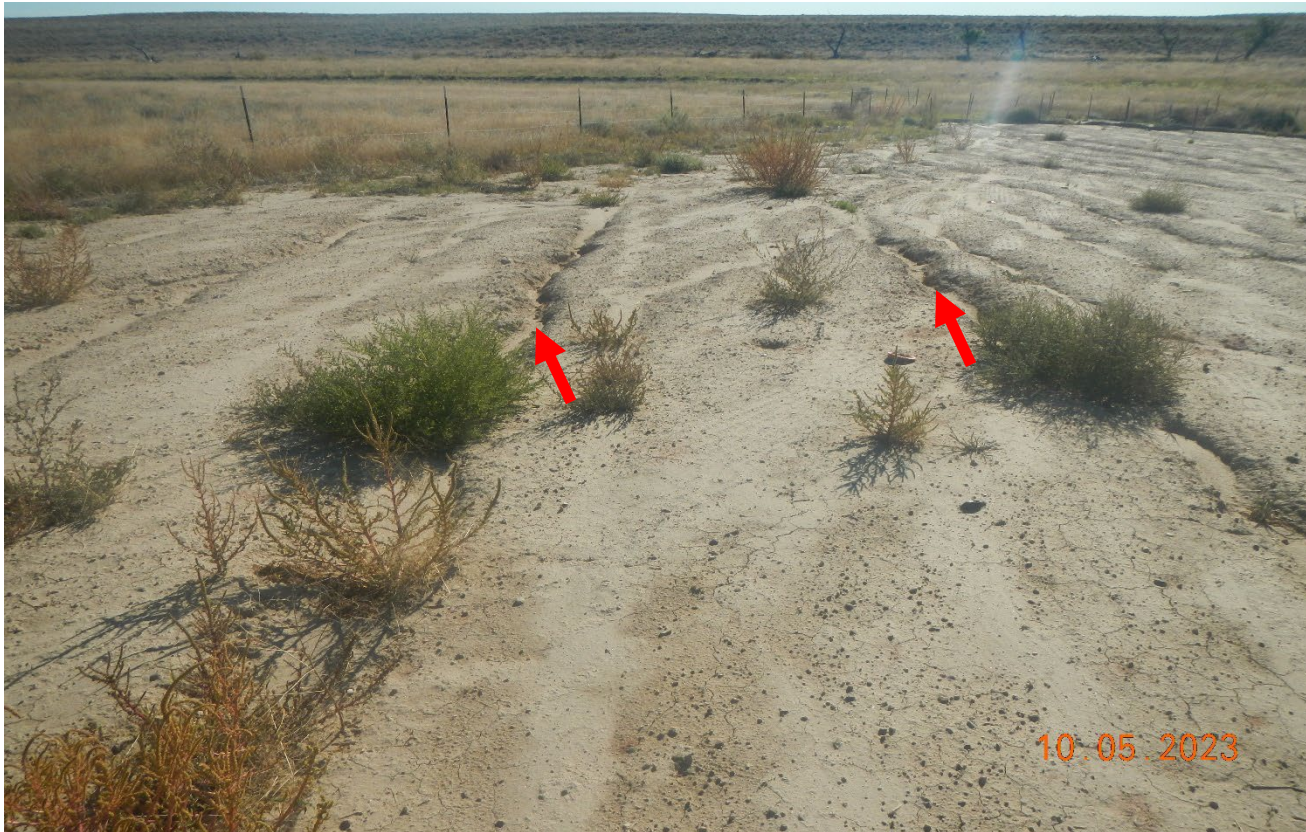
Photo 5. Facing northeast. There is erosion occurring at the location and soils are not stabilized.

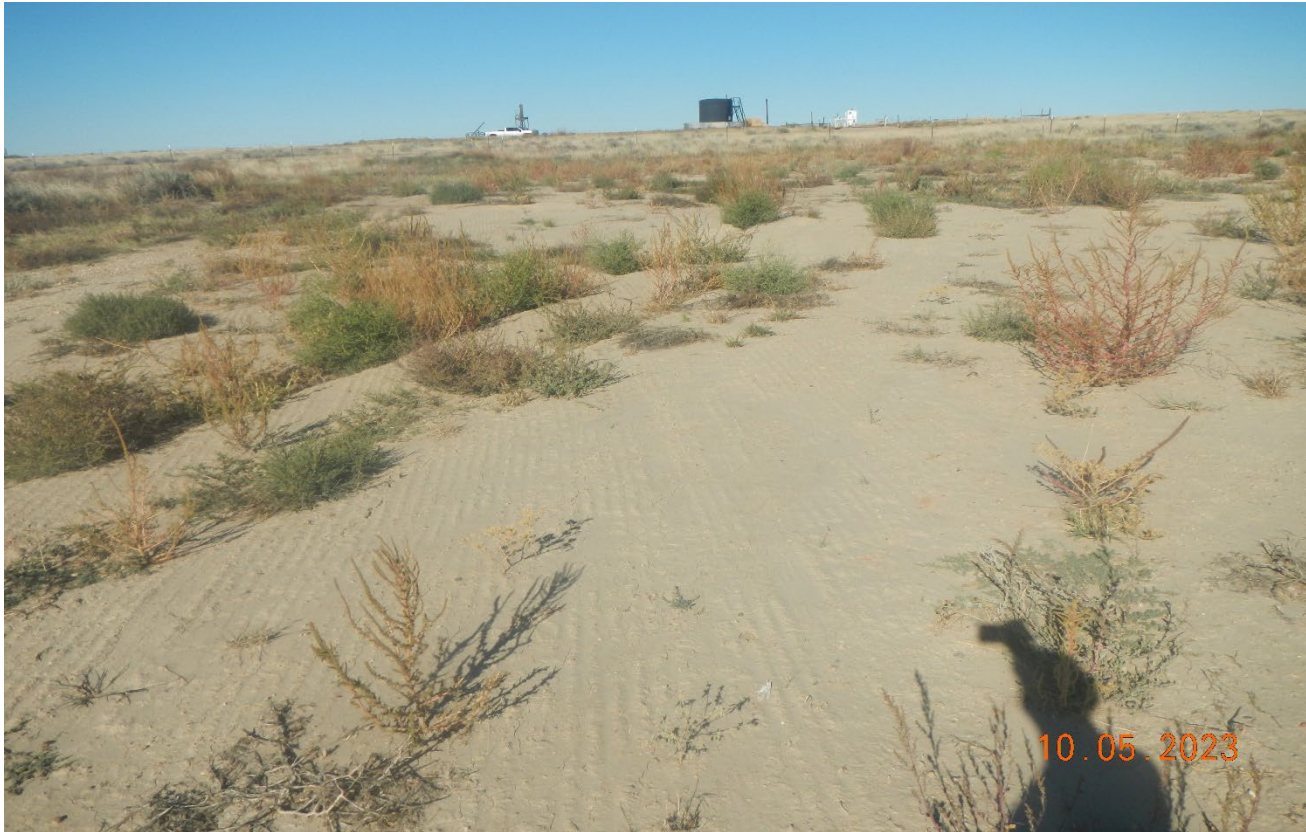
Photo 6. Facing west at the location. There is more vegetation establishment at the west side of the location however most is undesirable weeds.

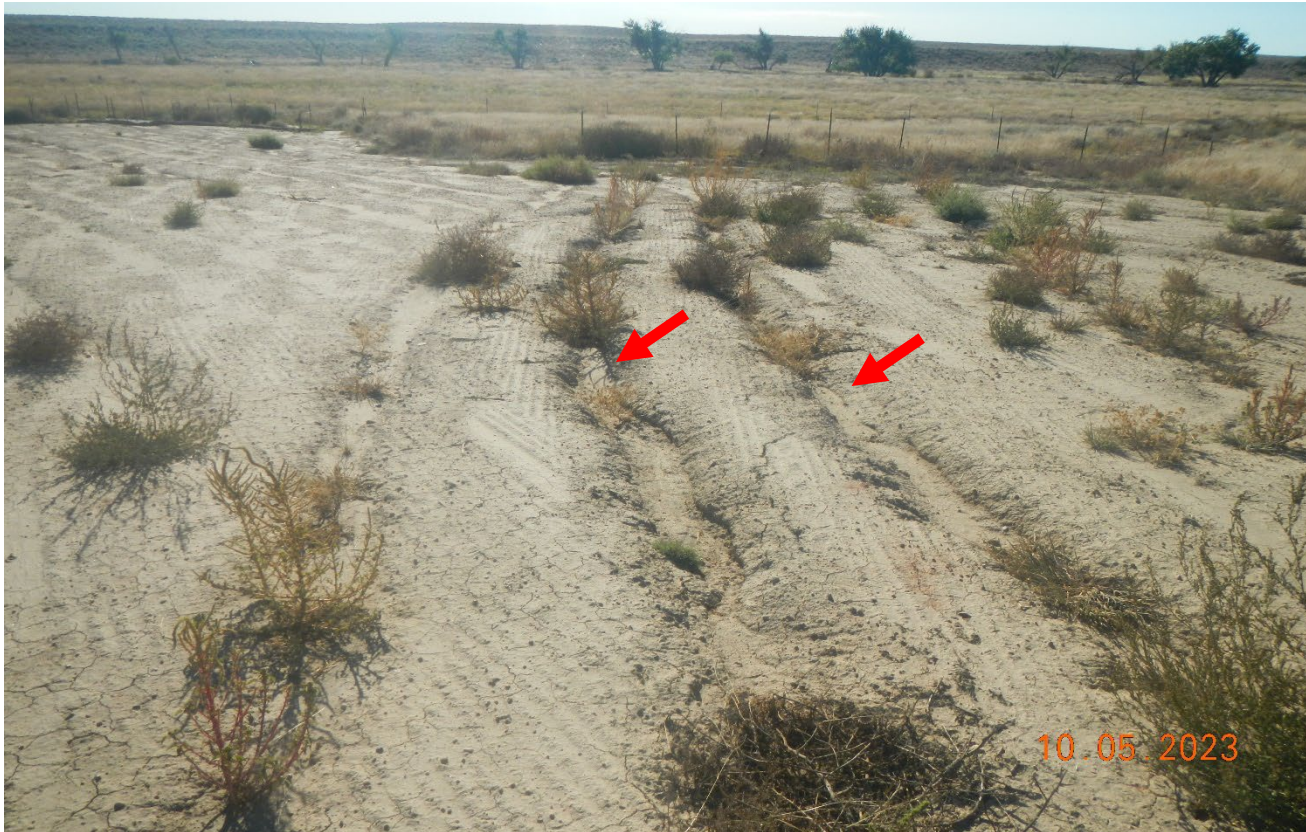
Photo 7. Facing southwest. There is erosion occurring at the location and soils are not stabilized.

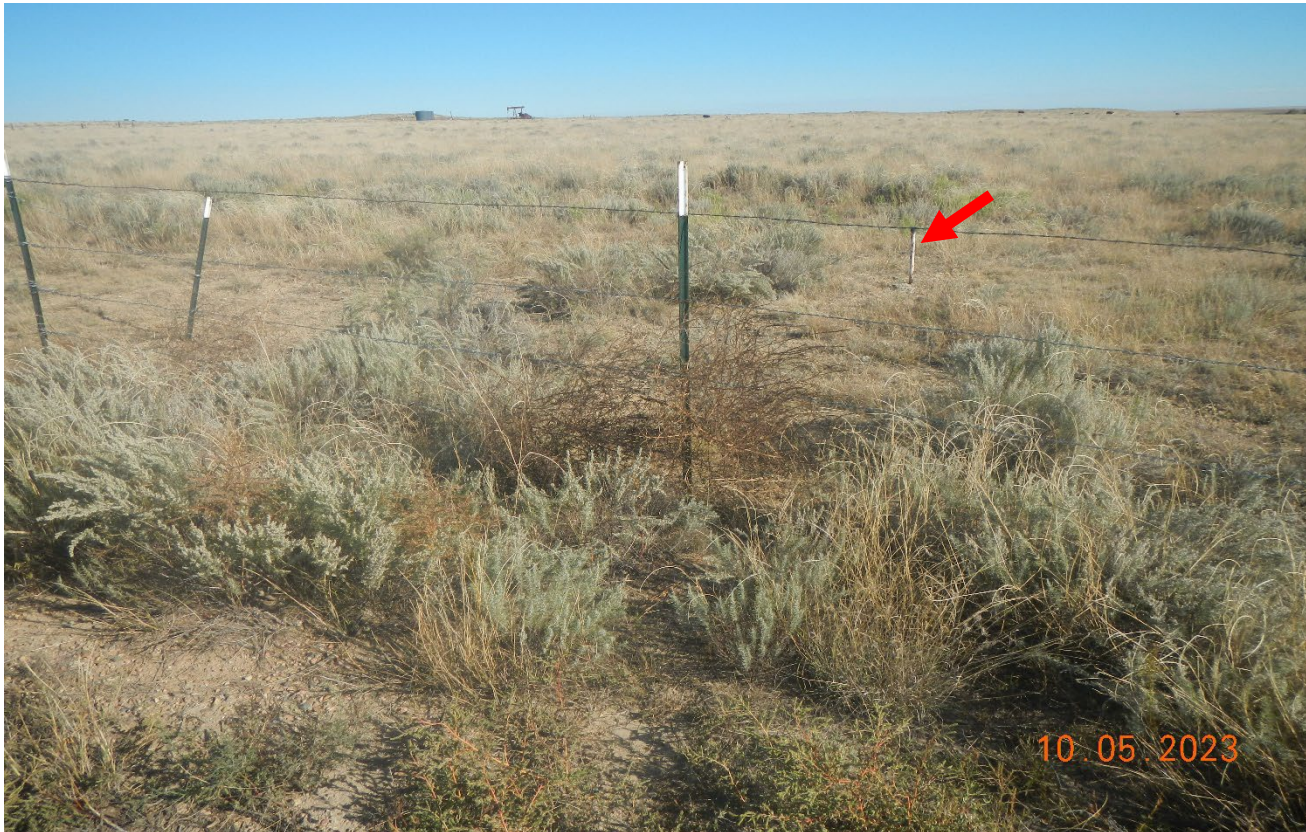
Photo 8. North side of the location outside of the fenced area is a pipe riser that needs to be removed.

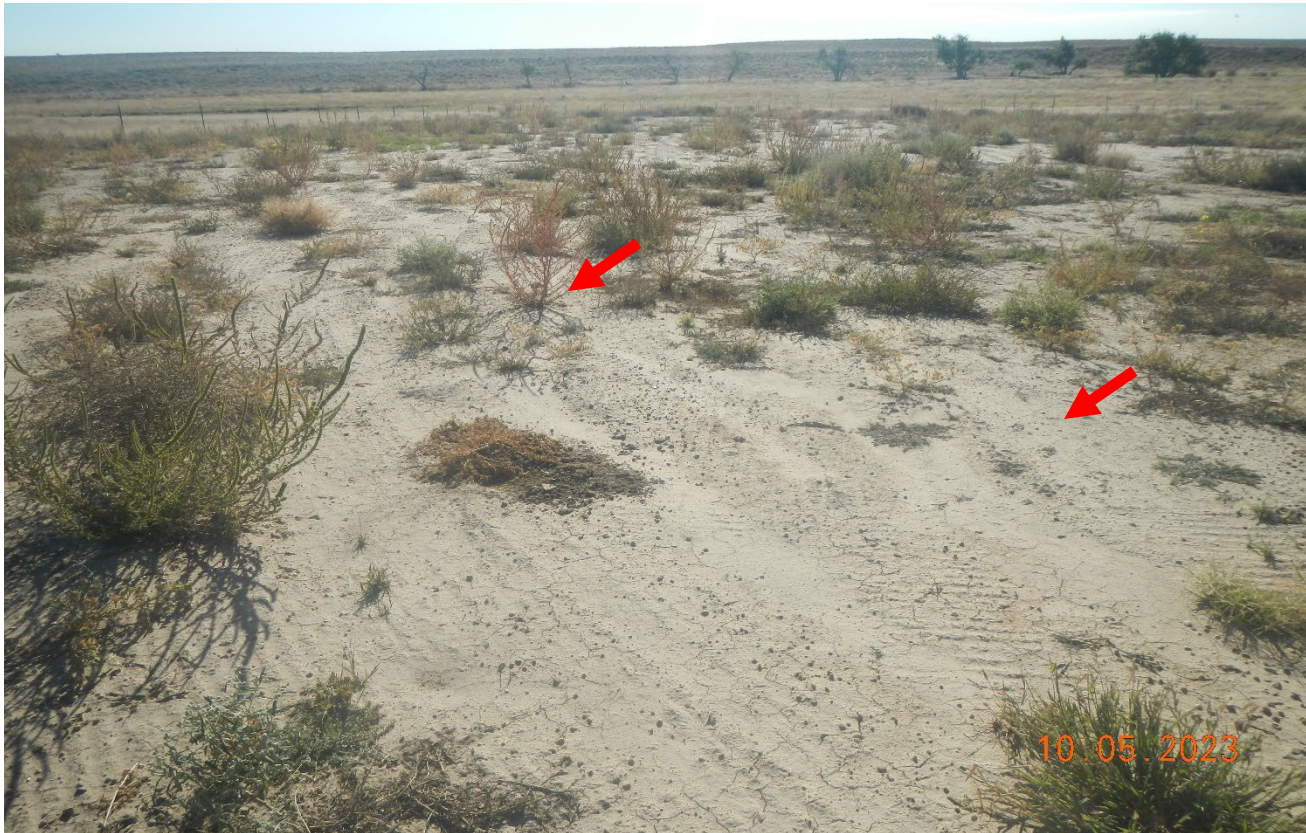
Photo 9. Facing east at the location. There is more vegetation establishment at the west side of the location however most is undesirable weeds.
