Inspection Photos
Location Name: Lesser PM J33 7
Location ID: 246209

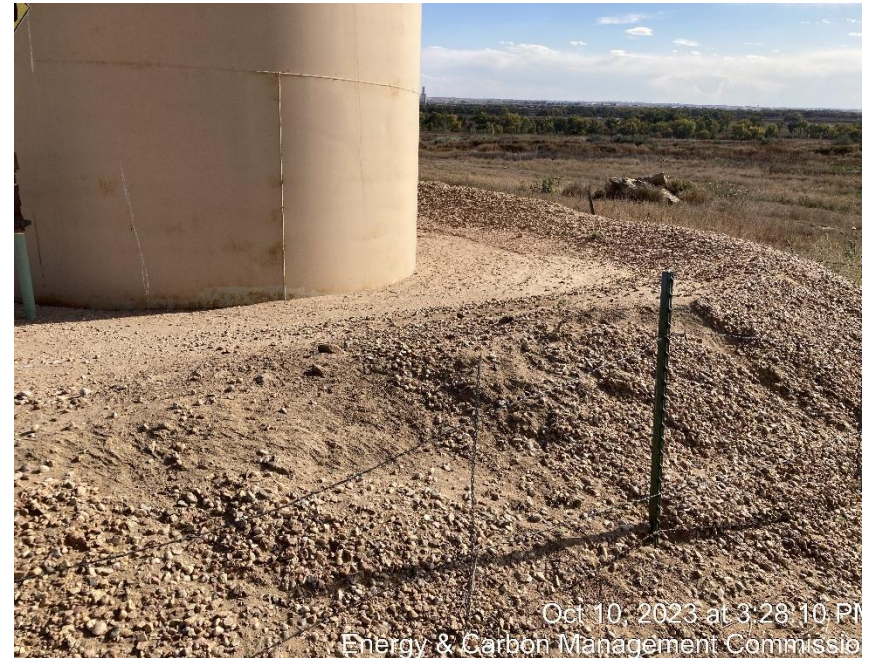
Berm Permeability no adequate ECMC rules

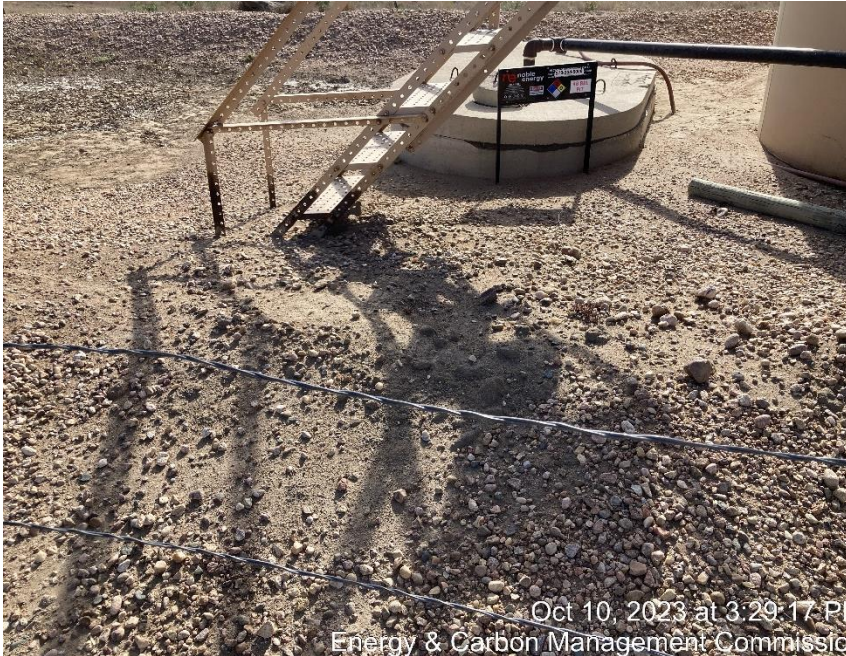
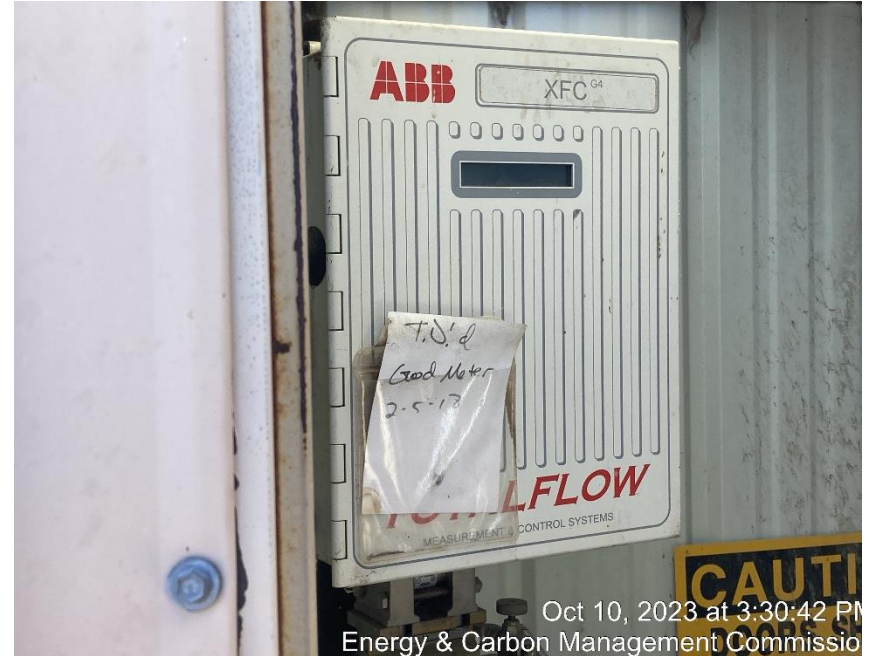
Meter run not calibrated since 2018

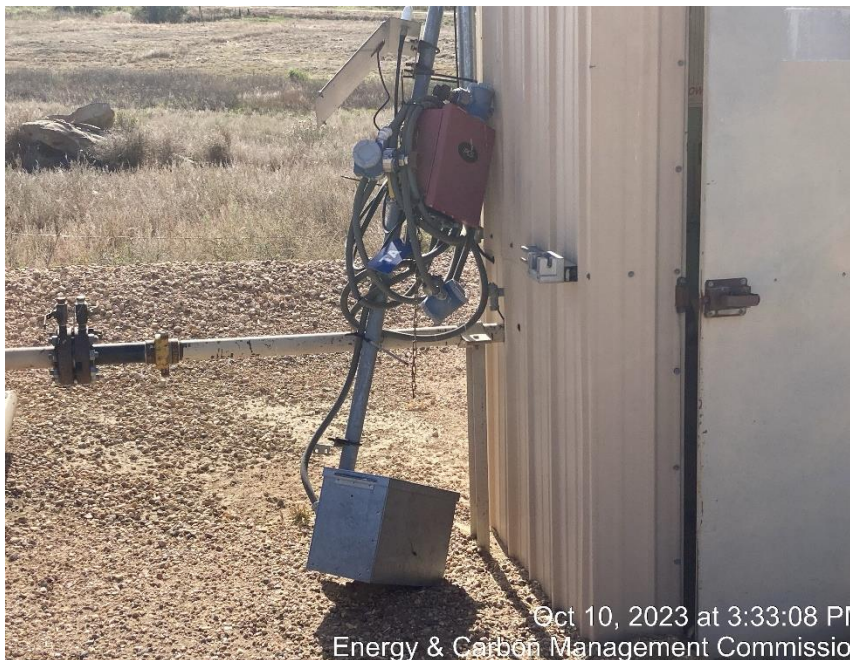
Unused equipment
