Caerus Piceance LLC
Piceance Creek Unit-62S97W 2NWNW
Location ID: 335894

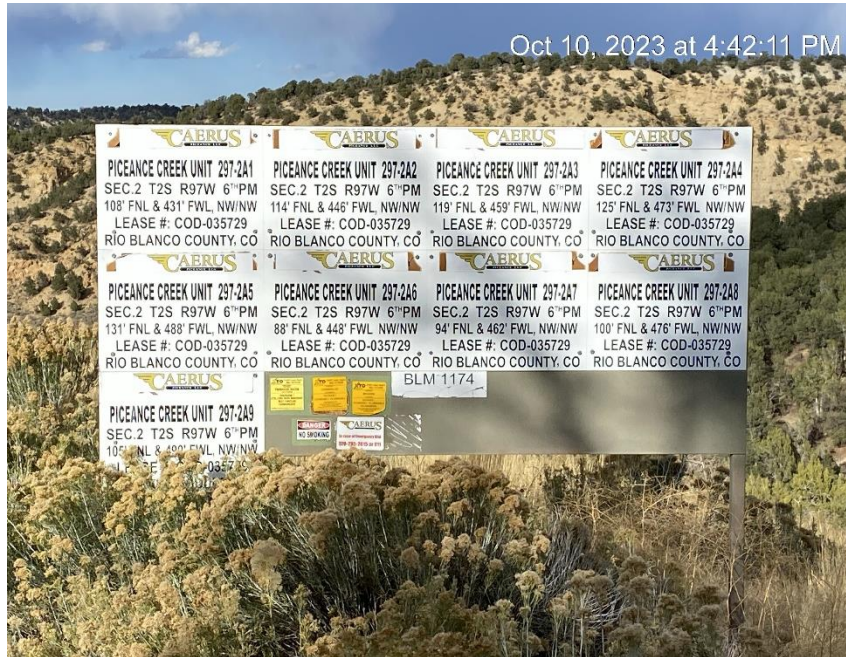
Entrance sign

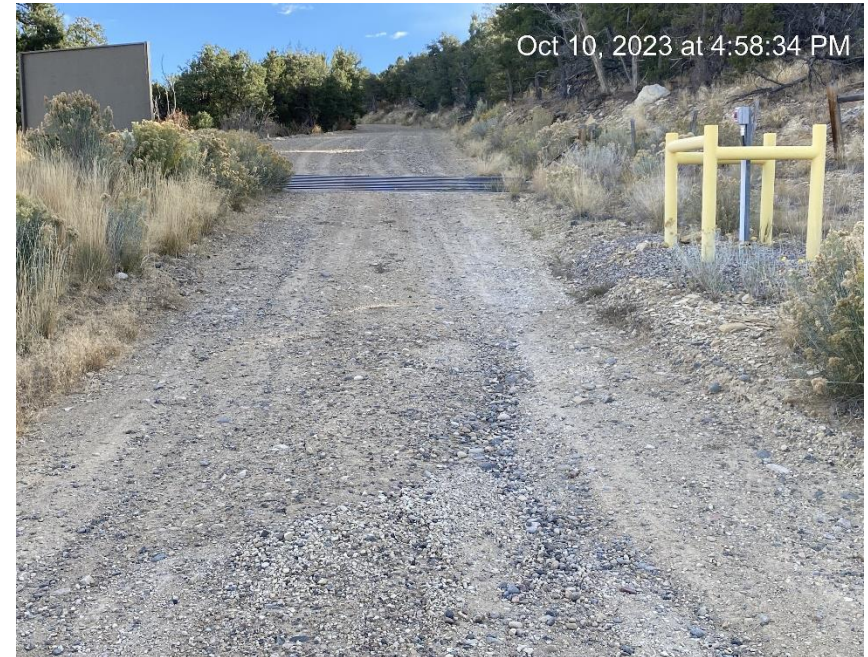
Access road to facility

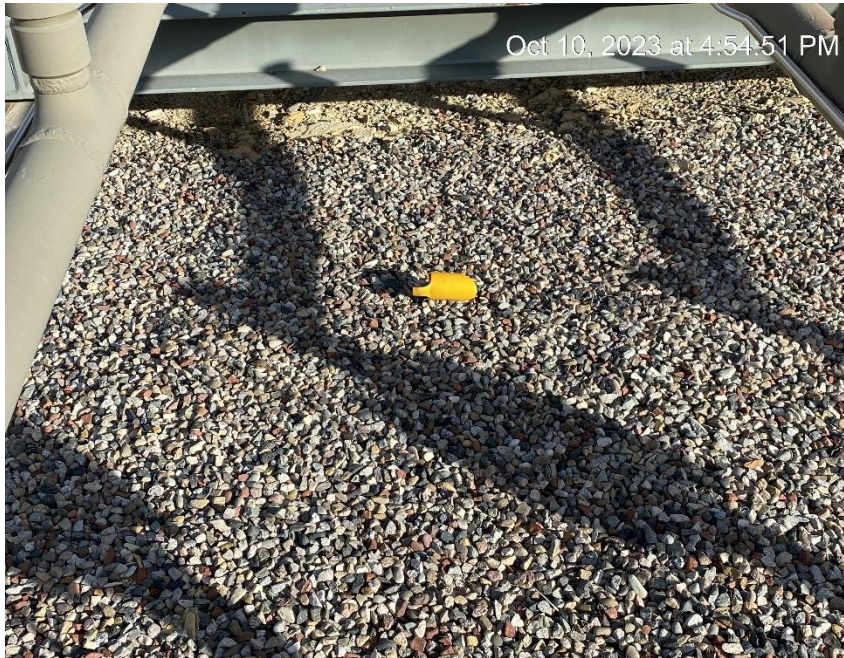
Debris

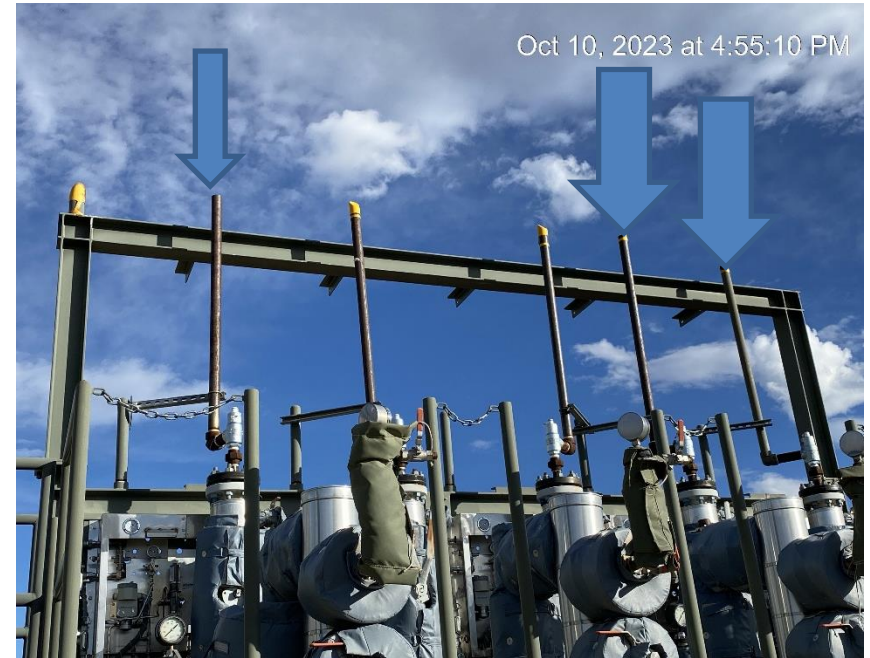
Rain caps missing from pop off risers

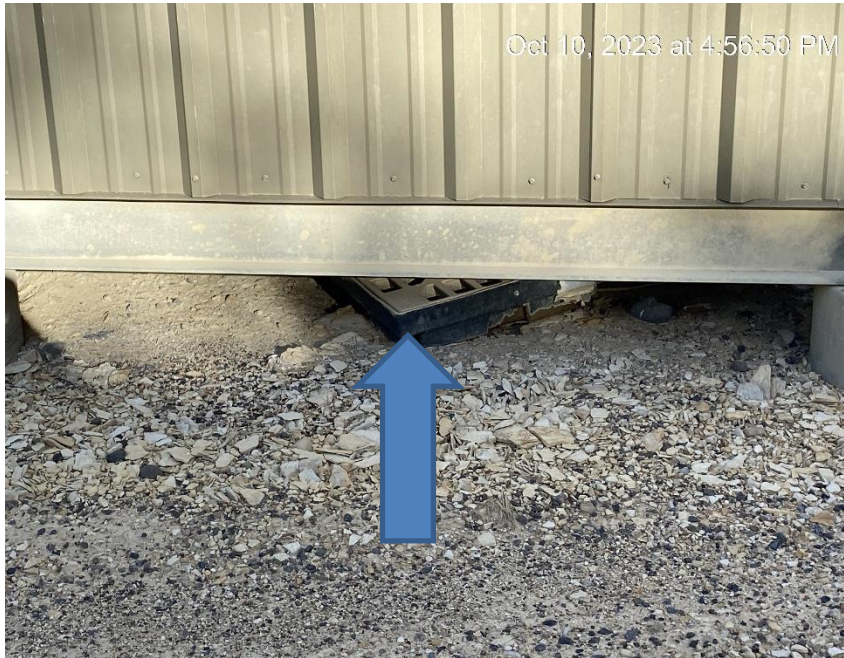
Debris

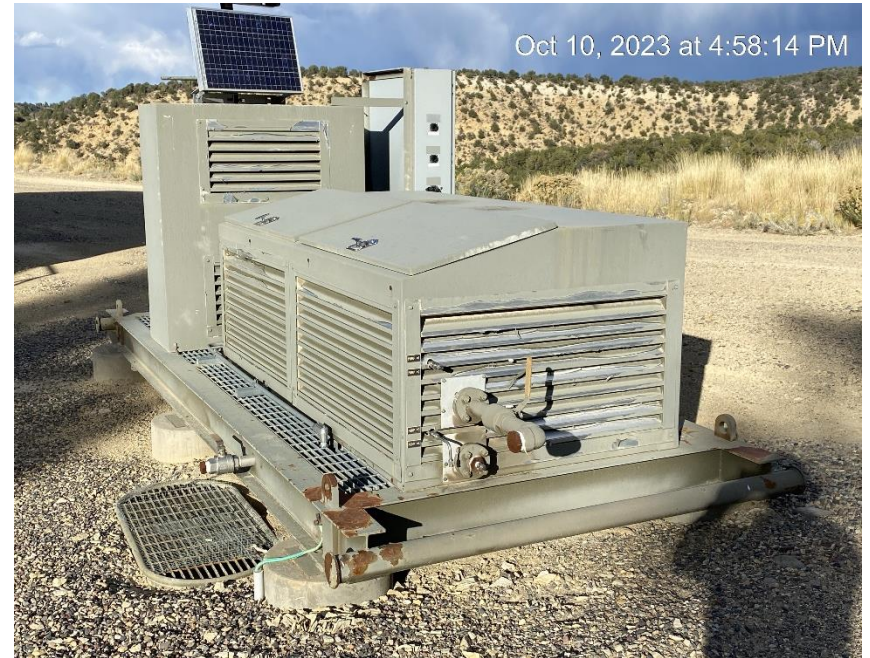
Equipment not in service

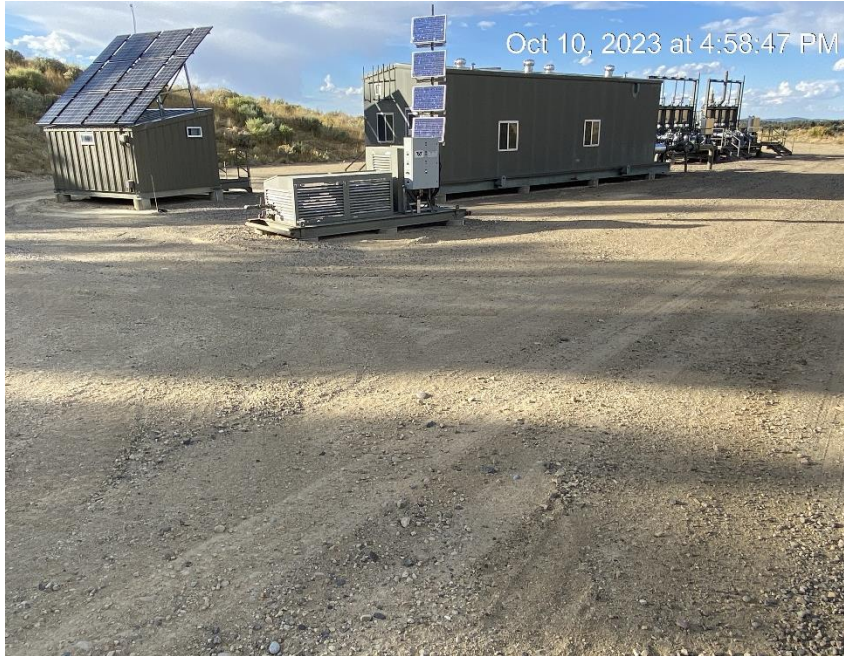
Production facility from Southeast corner

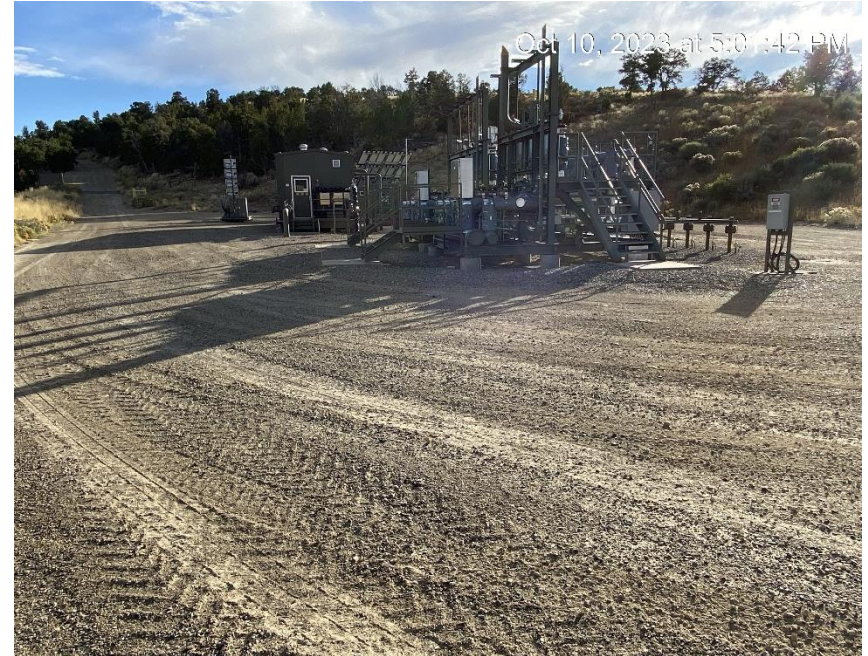
Production facility from Northeast corner

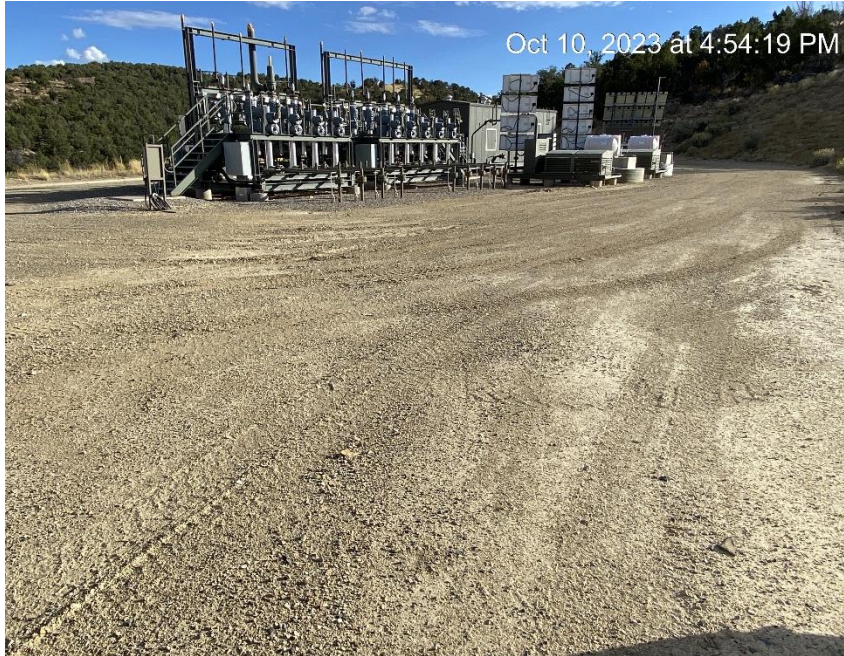
Production facility from Northwest corner

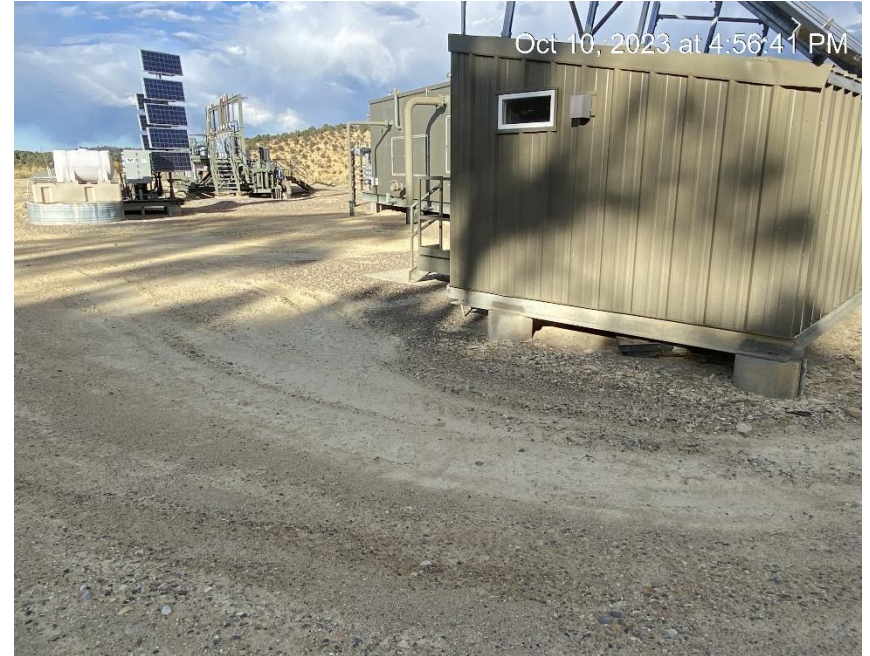
Production facility from Southwest corner

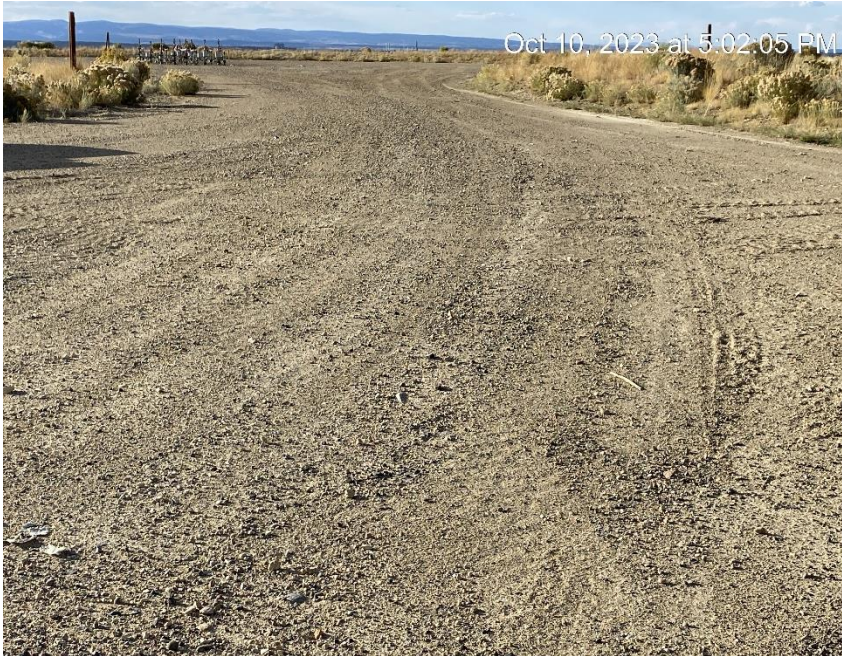
Access road to well pad from Production facility

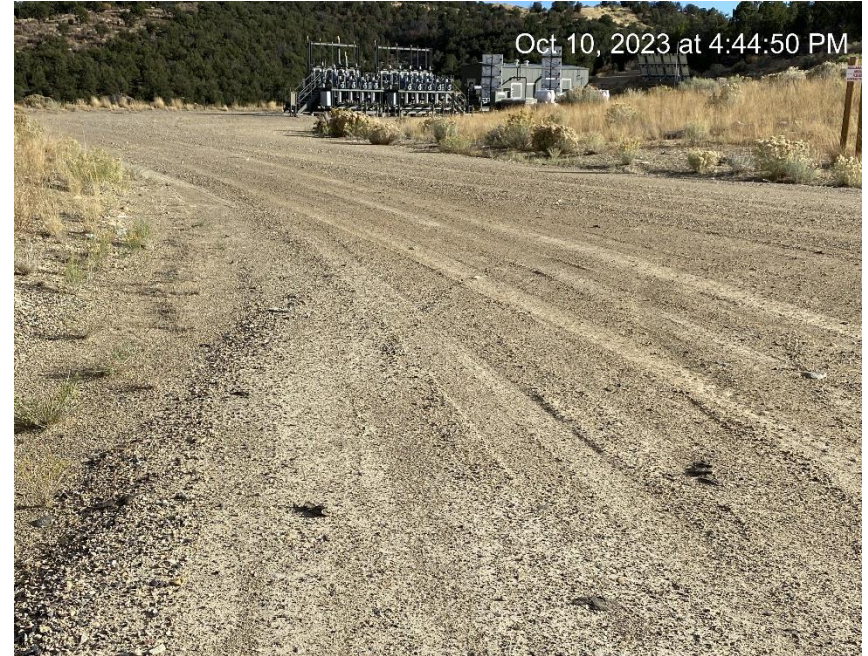
Well pad access road from Production facility

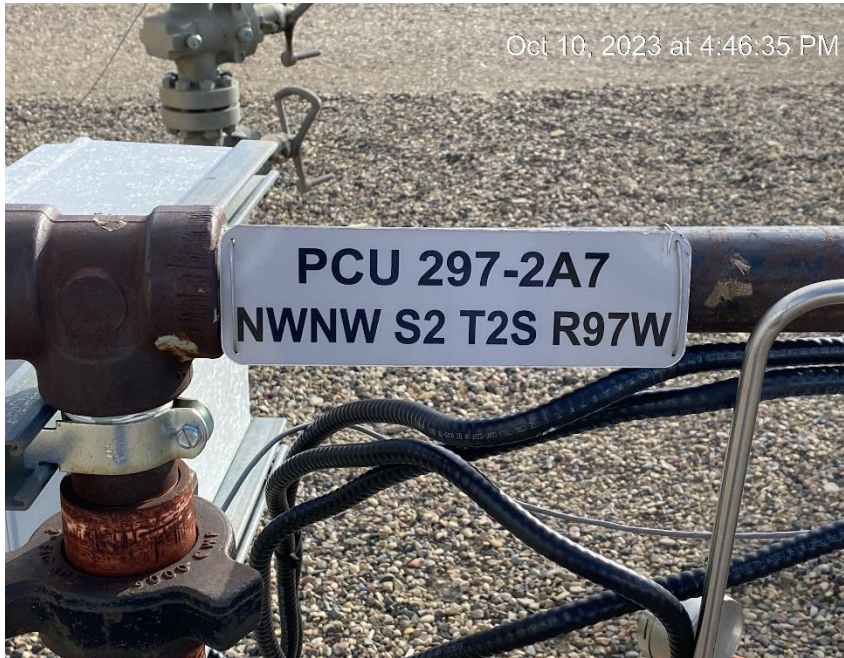
Wellhead signs missing required information

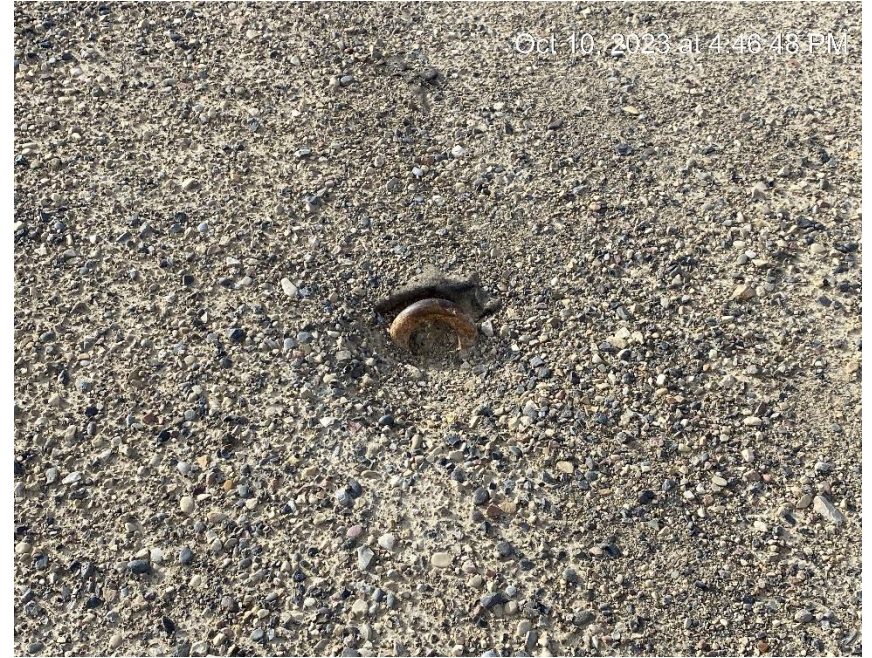
Unmarked anchor

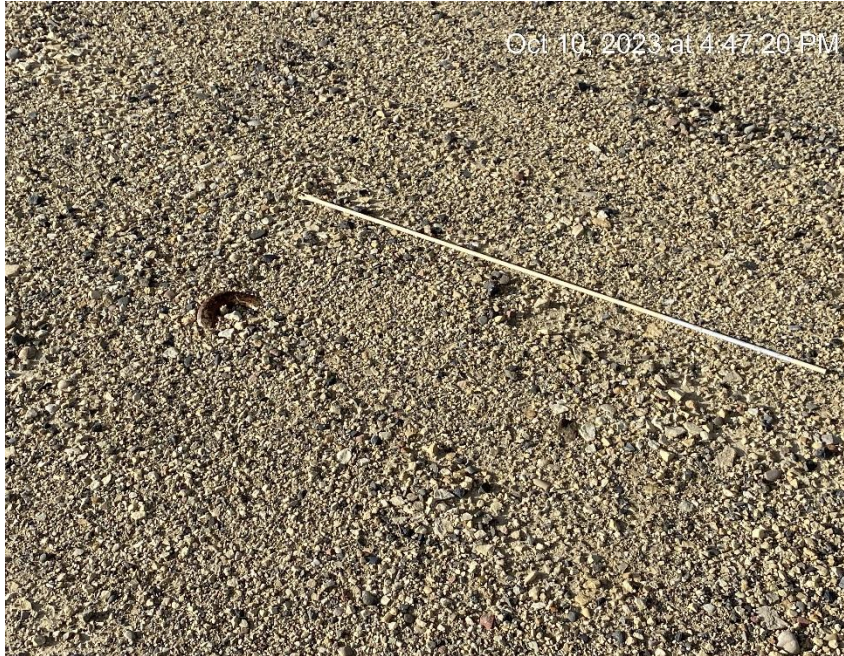
Unmarked anchor

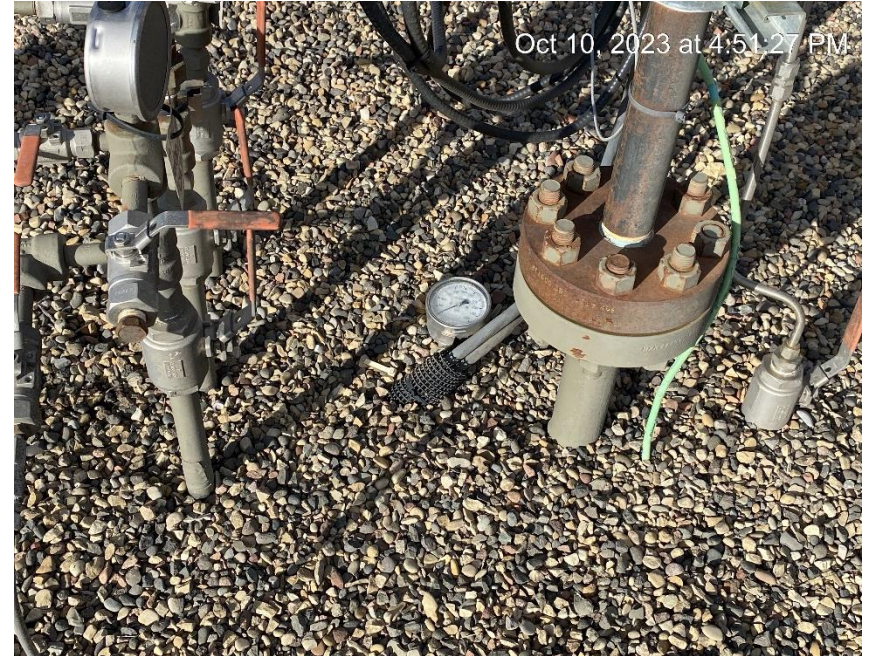
Debris

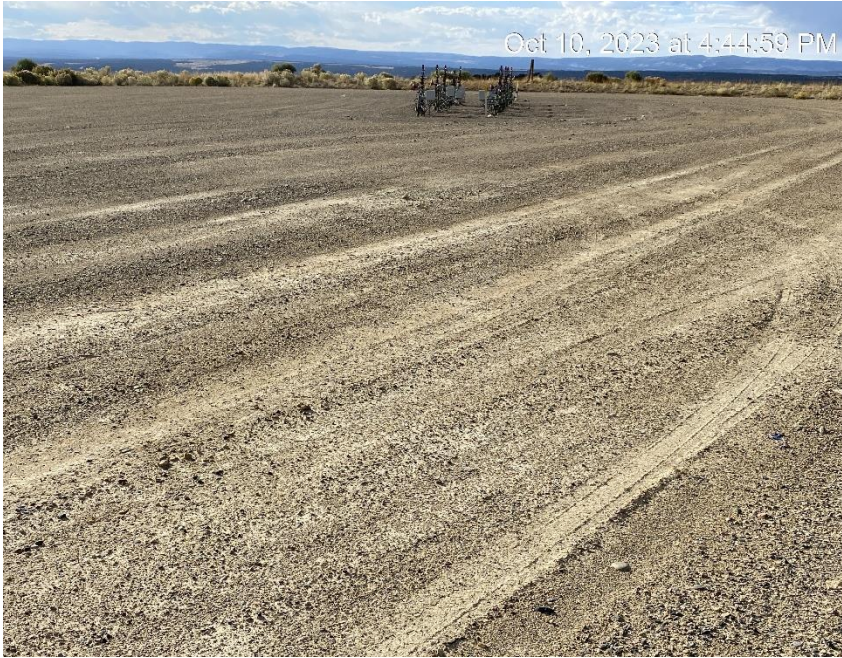
Well pad from Northeast corner

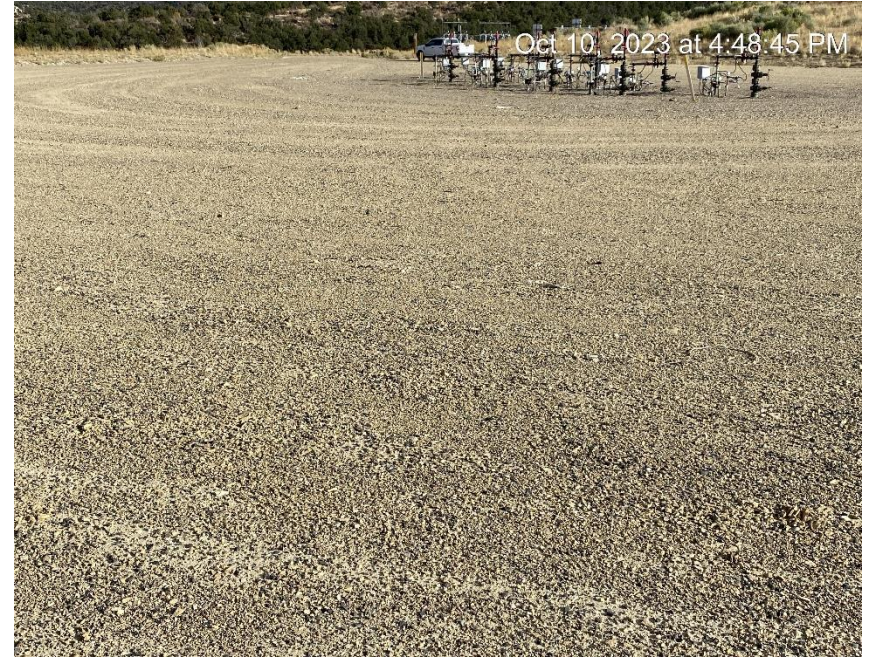
Well pad from Northwest corner

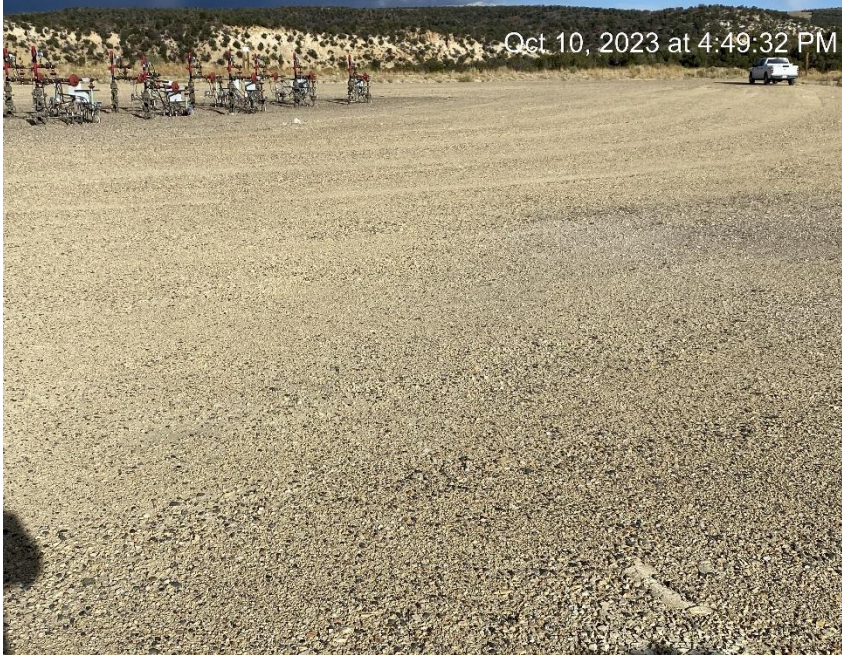
Well pad from Southwest corner

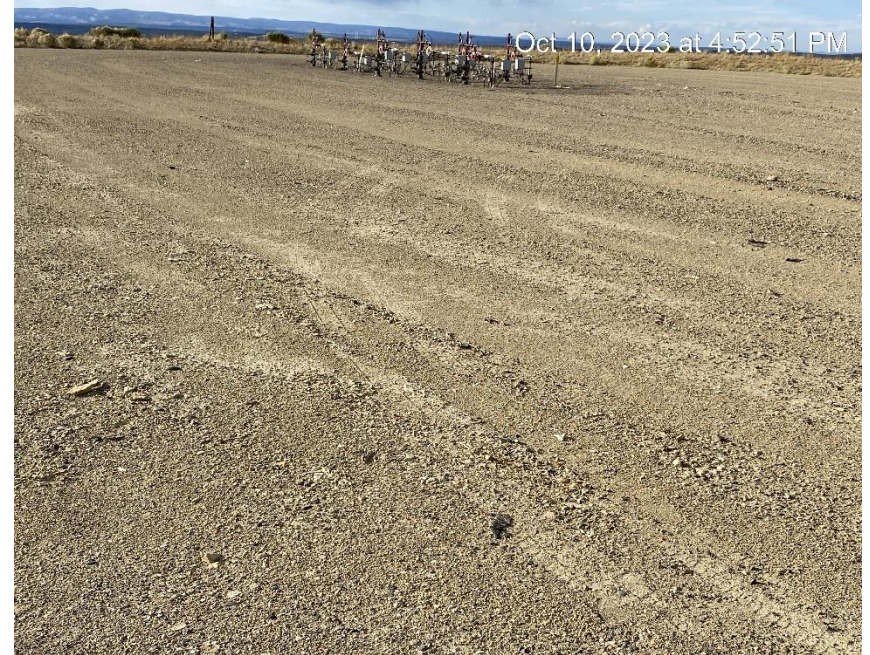
Well pad from Southeast corner
