Inspection Photos

Location Name: CAERUS PICEANCE LLC SCARBER (RN2) Pad

Location #: 334668

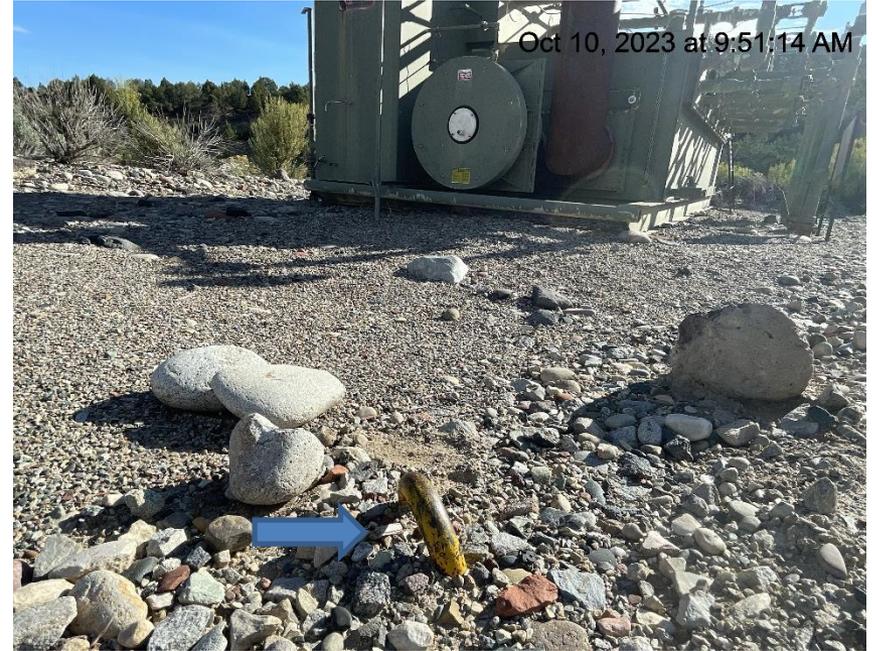
Photo # 2151 Unmarked deadman

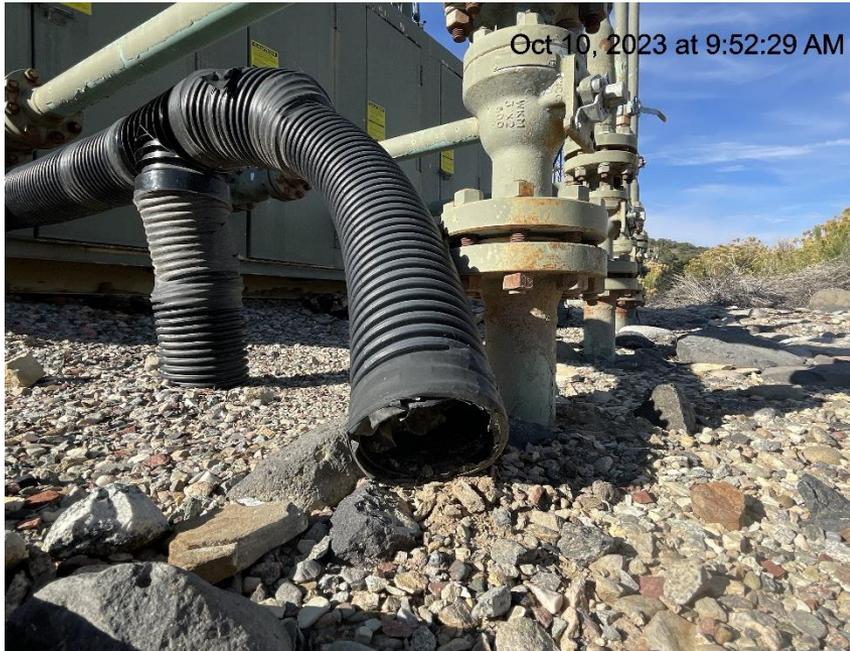
Photo # 2152 Flowline heating insulation open ended
