Inspection Photos

Location Name: CAERUS PICEANCE LLC SAVAGE RK1 Pad

Location #: 334638

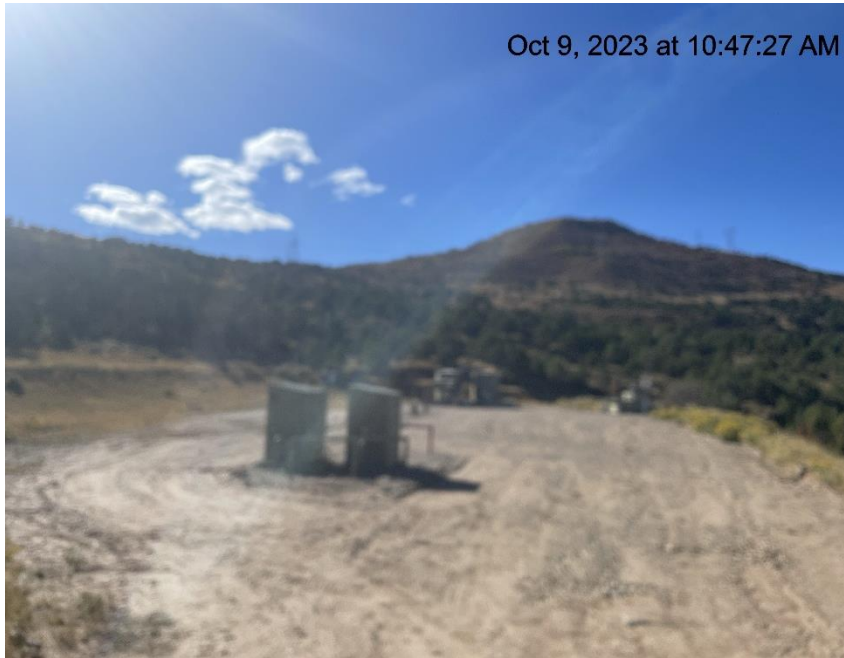
Photo # 1988 From entrance to location

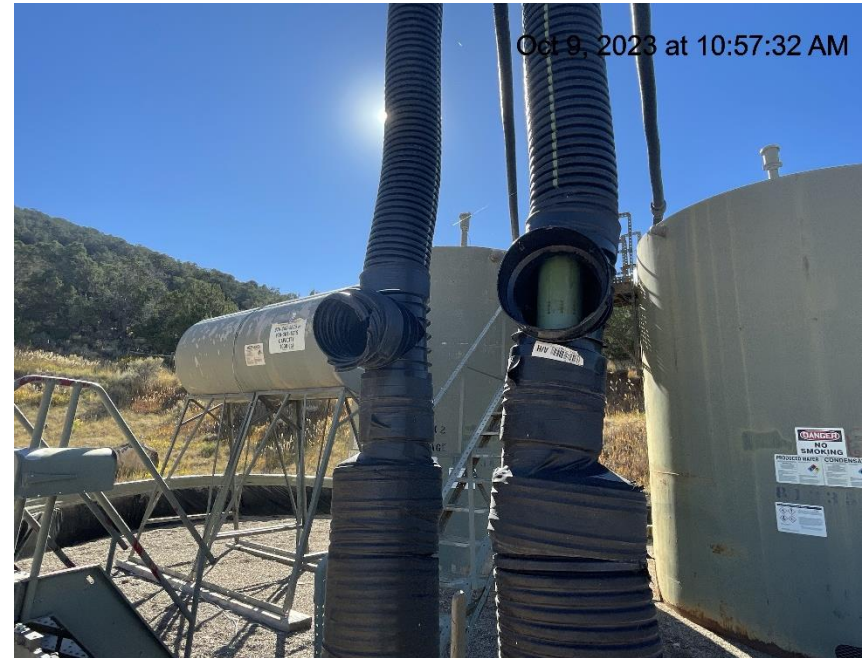
Photo # 1995 Flowline heating insulation open ended

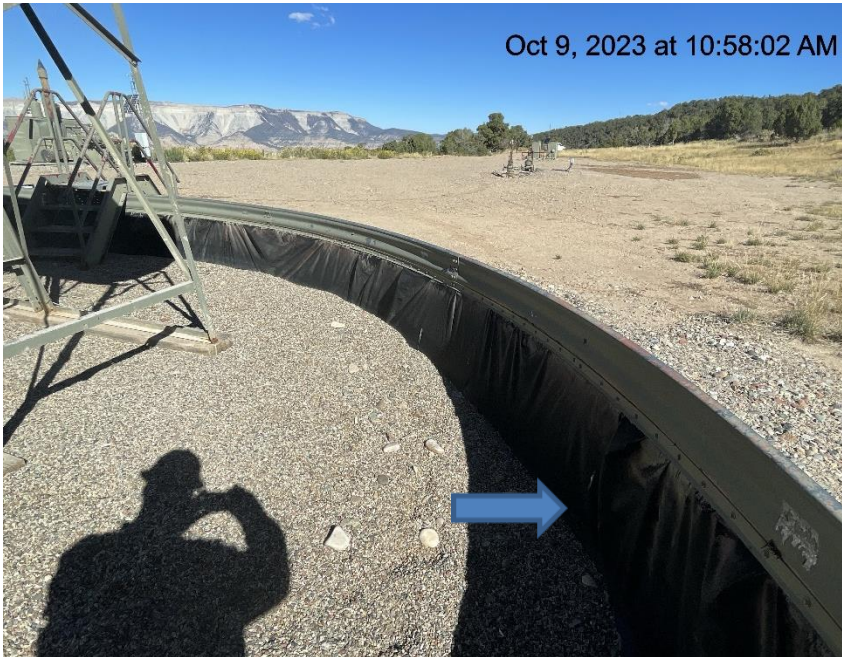
Photo # 1996 Hole in liner/liner needs maintenance

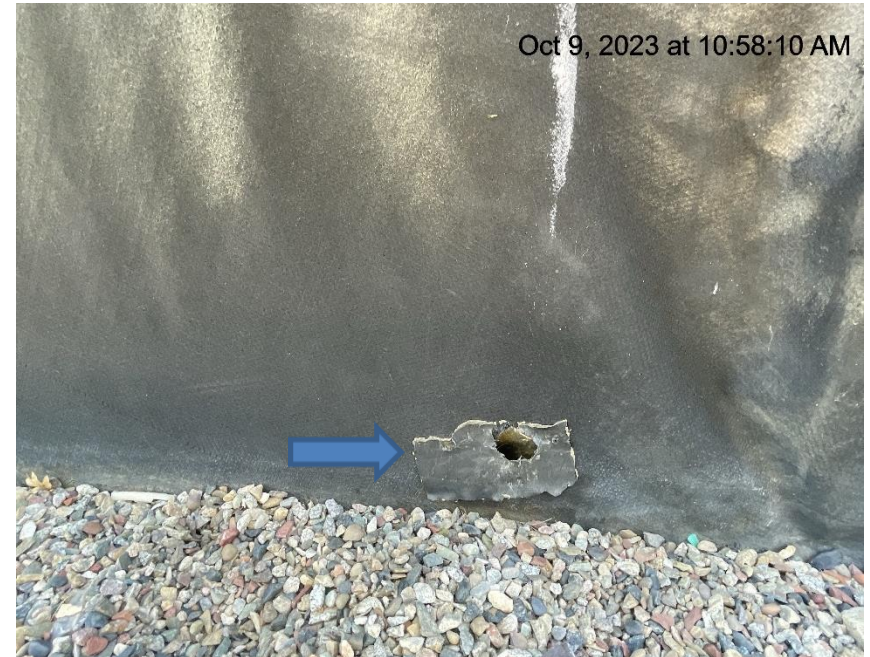
Photo # 1997 Hole in liner/liner needs maintenance

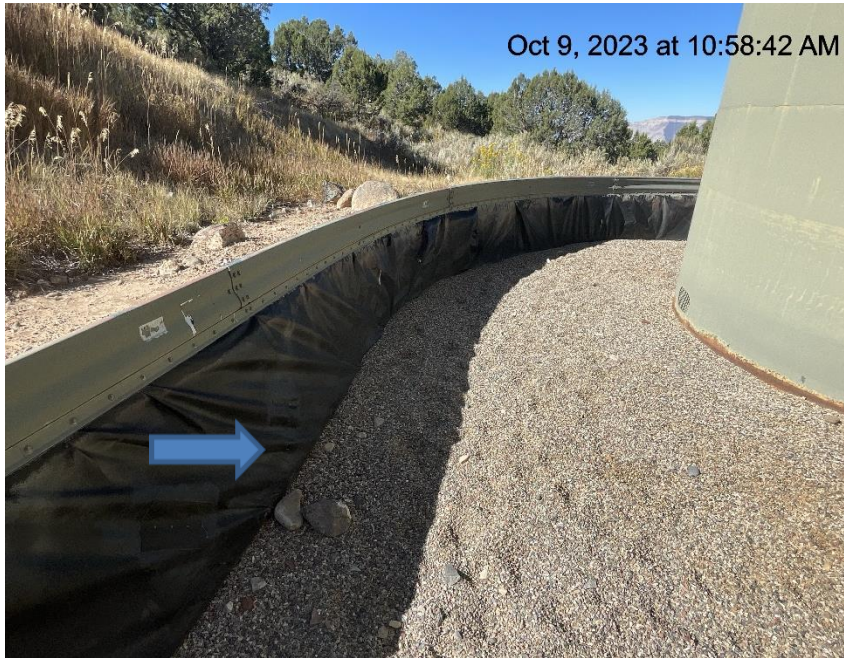
Photo # 1998 Hole in liner/liner needs maintenance

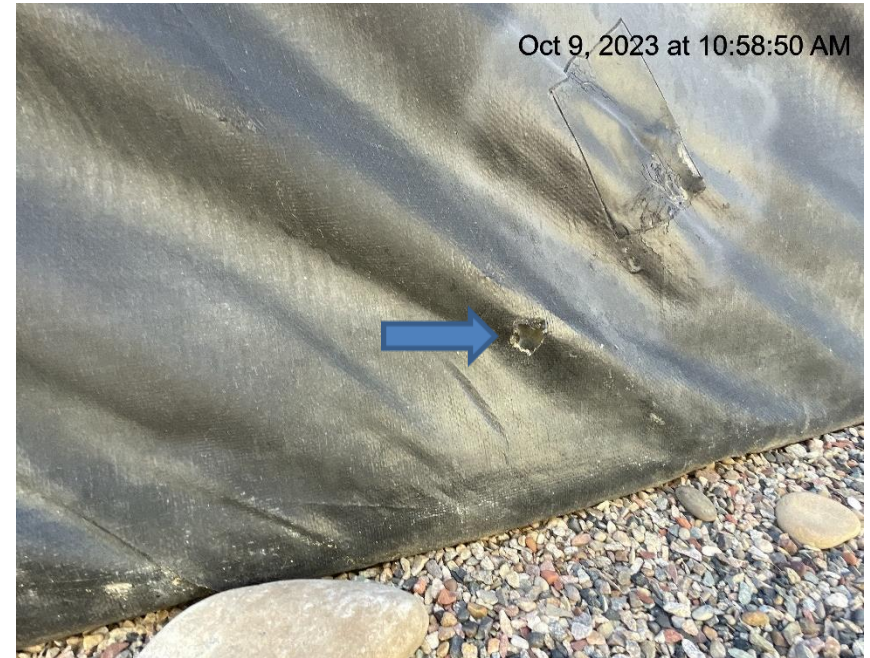
Photo # 1999 Hole in liner/liner needs maintenance
