Final Reclamation and Stormwater Inspection

Operator: H&M PETROLEUM CORPORATION - 10032

Location ID: 312318

Inspection Photos
Location Name: Catherine #3
Location ID: 312318

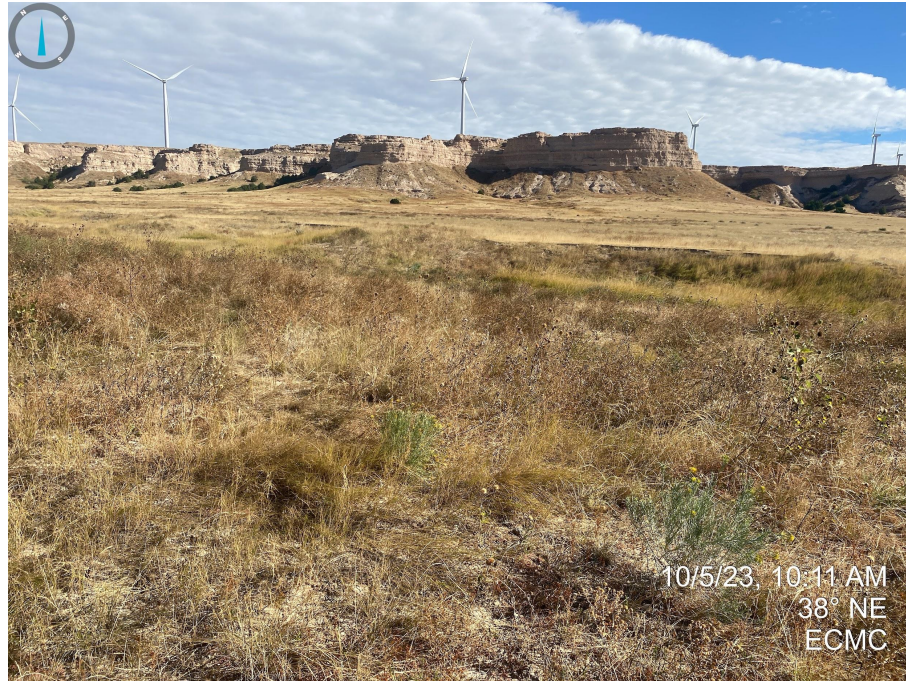
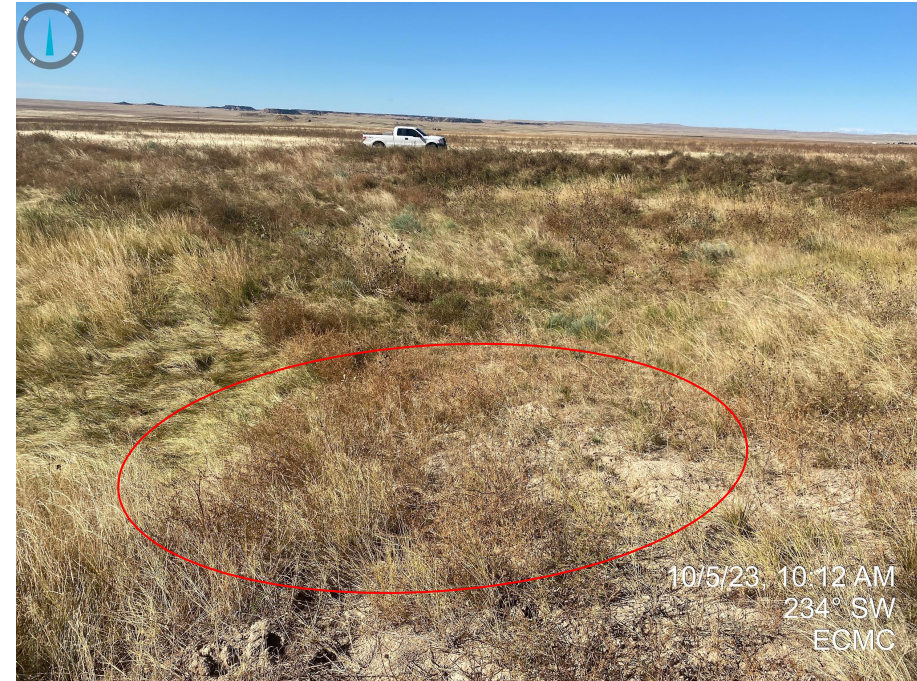
Photos 1 & 2. Taken from the former access road, near a natural drainage. It appears the Operator has recontoured and graded the drainage to reflect pre-disturbance features. Areas of non-uniform vegetative cover (bare/exposed soils) and undesirable vegetation (russian thistle) was observed in this area.

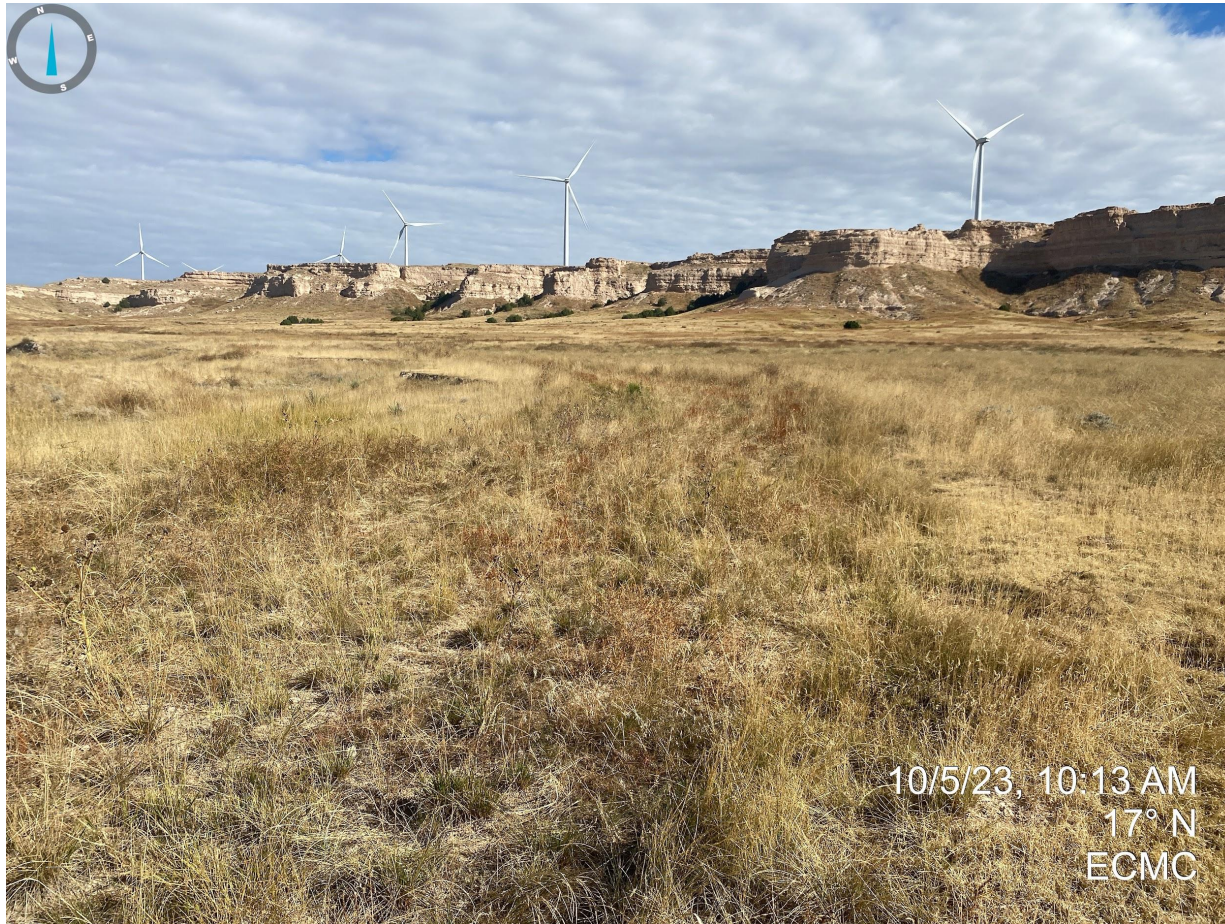
Photo 3. Taken east of the drainage, facing north along the access road. Portions of the access road are progressing towards reclamation standards with evidence of desirable vegetation observed (e.g. sand drop seed, blue grama, etc). However, some introduced species (e.g. crested wheatgrass) were also observed.

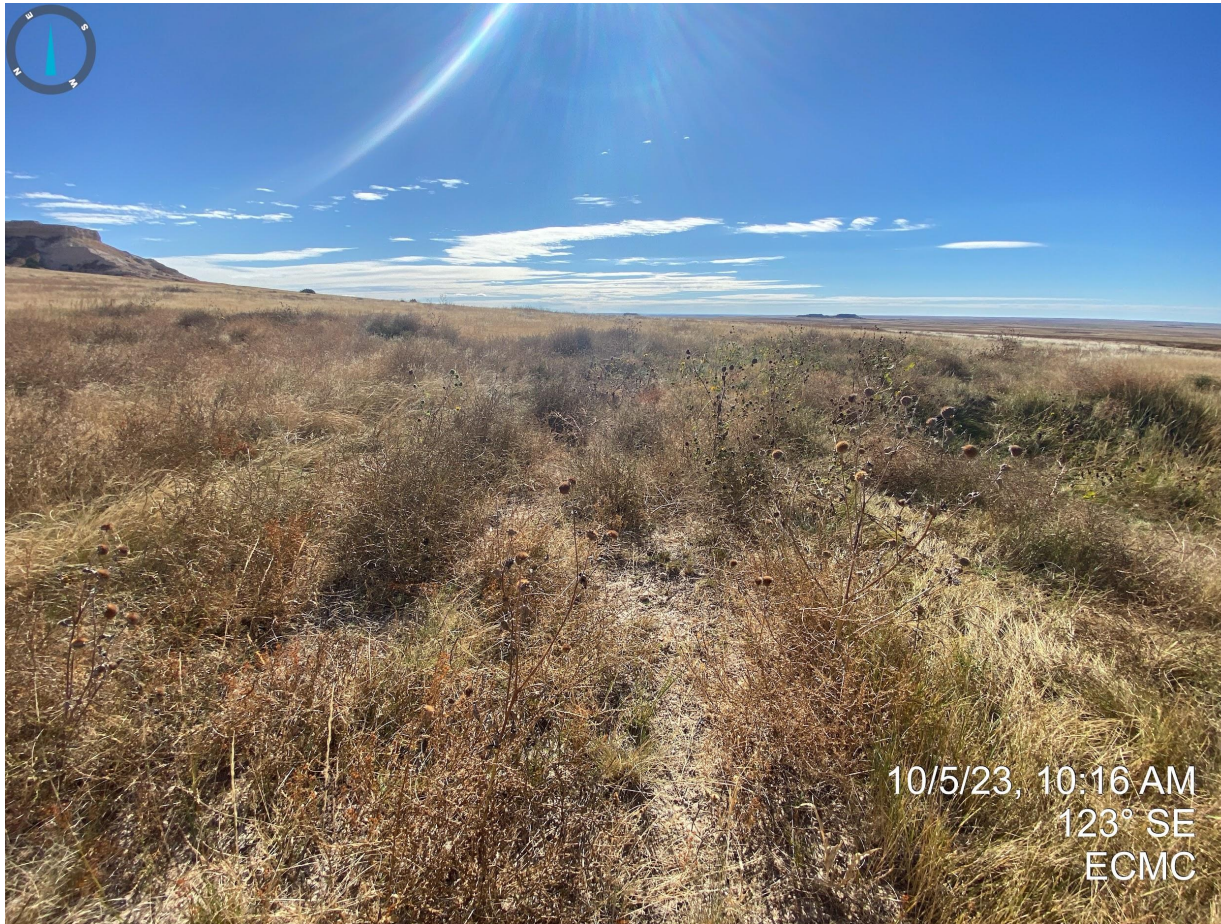
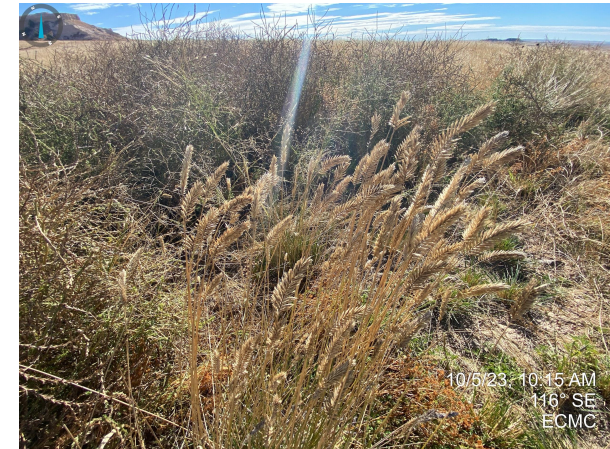
Photos 4 & 5. Taken south of the location along the access road. Photo illustrates undesirable vegetation (e.g. russian thistle and kochia) and introduced species (e.g. crested wheatgrass) growing along the reclaimed portions. Additional reclamation activities and management of undesirable vegetation is required.

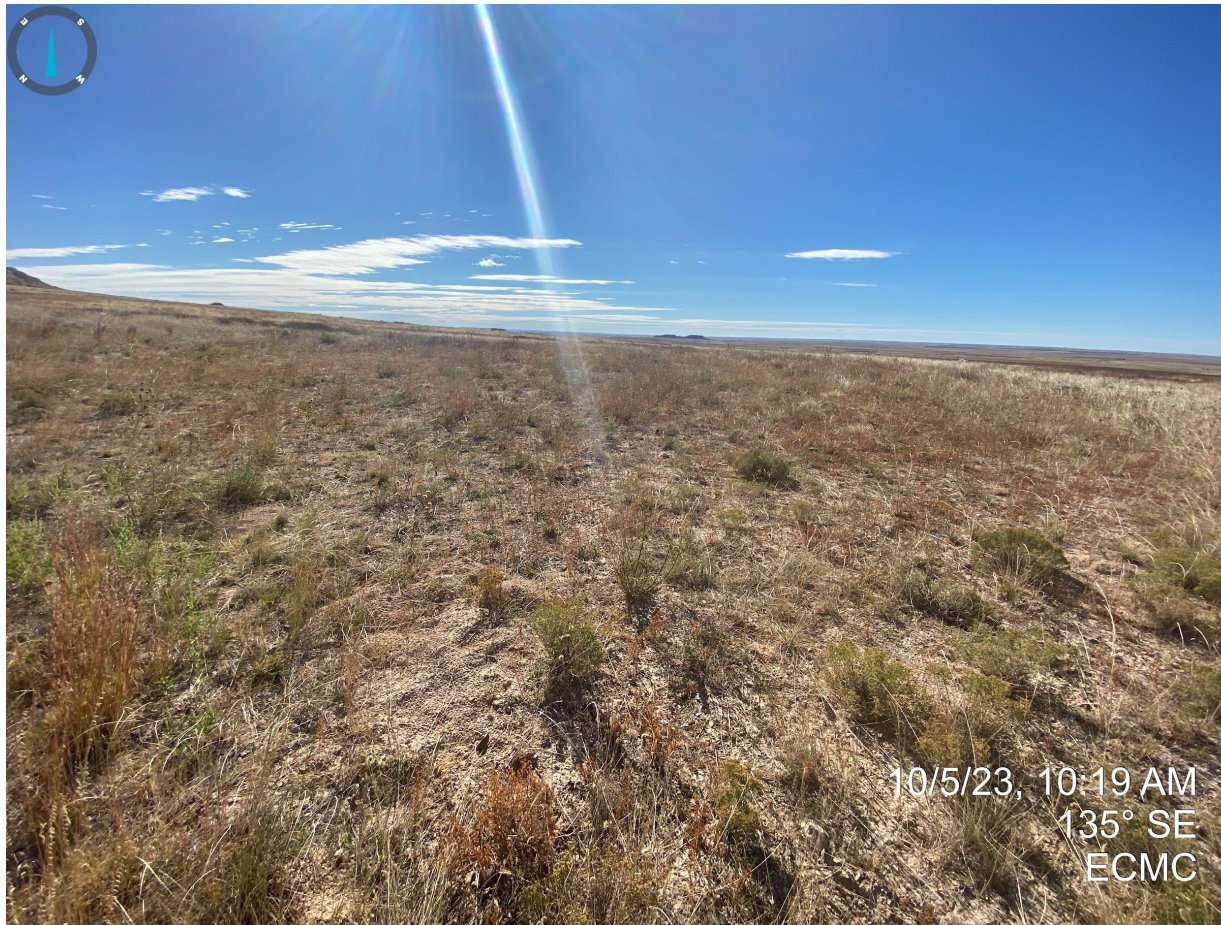
Photo 6. Taken from the northern portion of the location. Photo illustrates non-uniform vegetative cover resulting in areas of bare/exposed soil. Both desirable and undesirable species were observed throughout, however, the location does not appear to be progressing towards Rule 1004 regulations and standards.

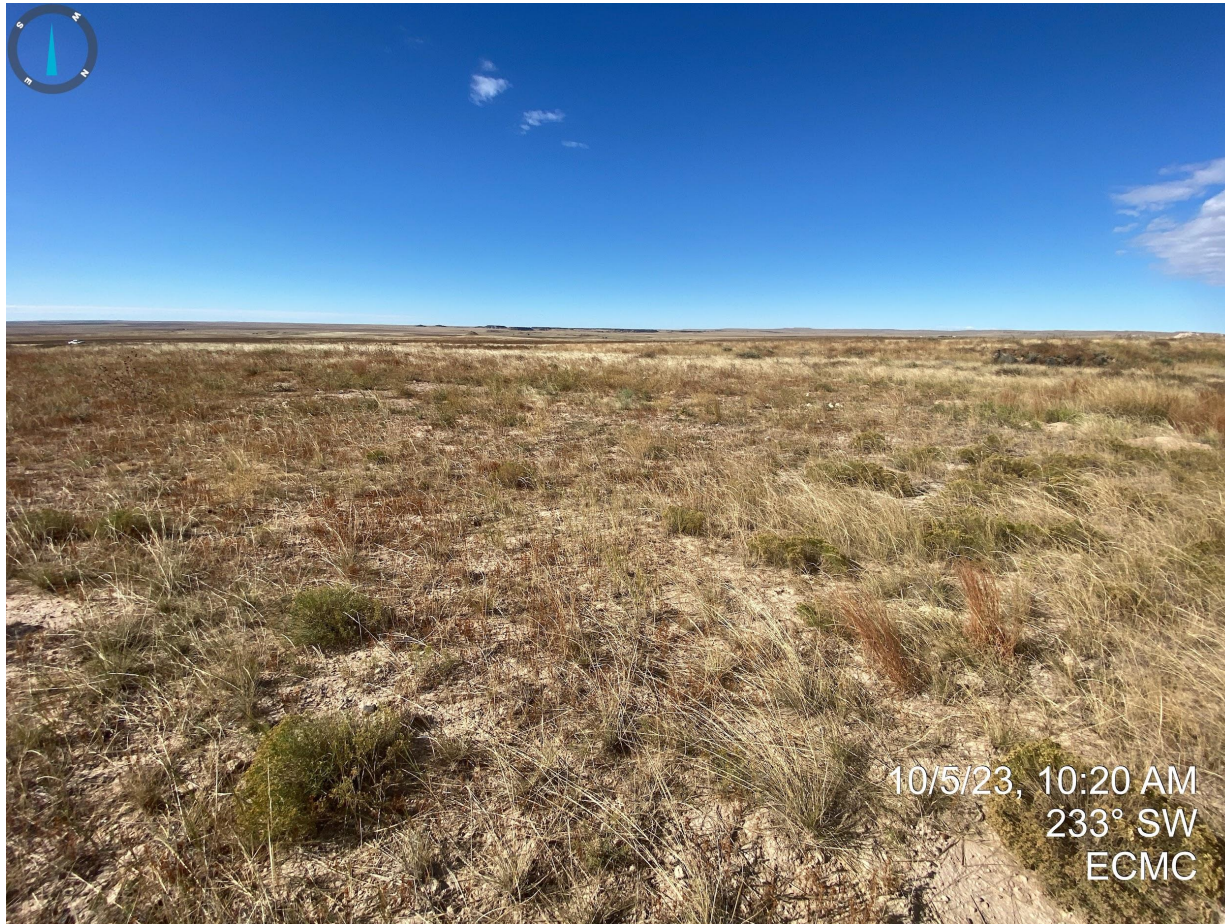
Photo 7. Taken from the northern end of the location; see comments in Photo 6.

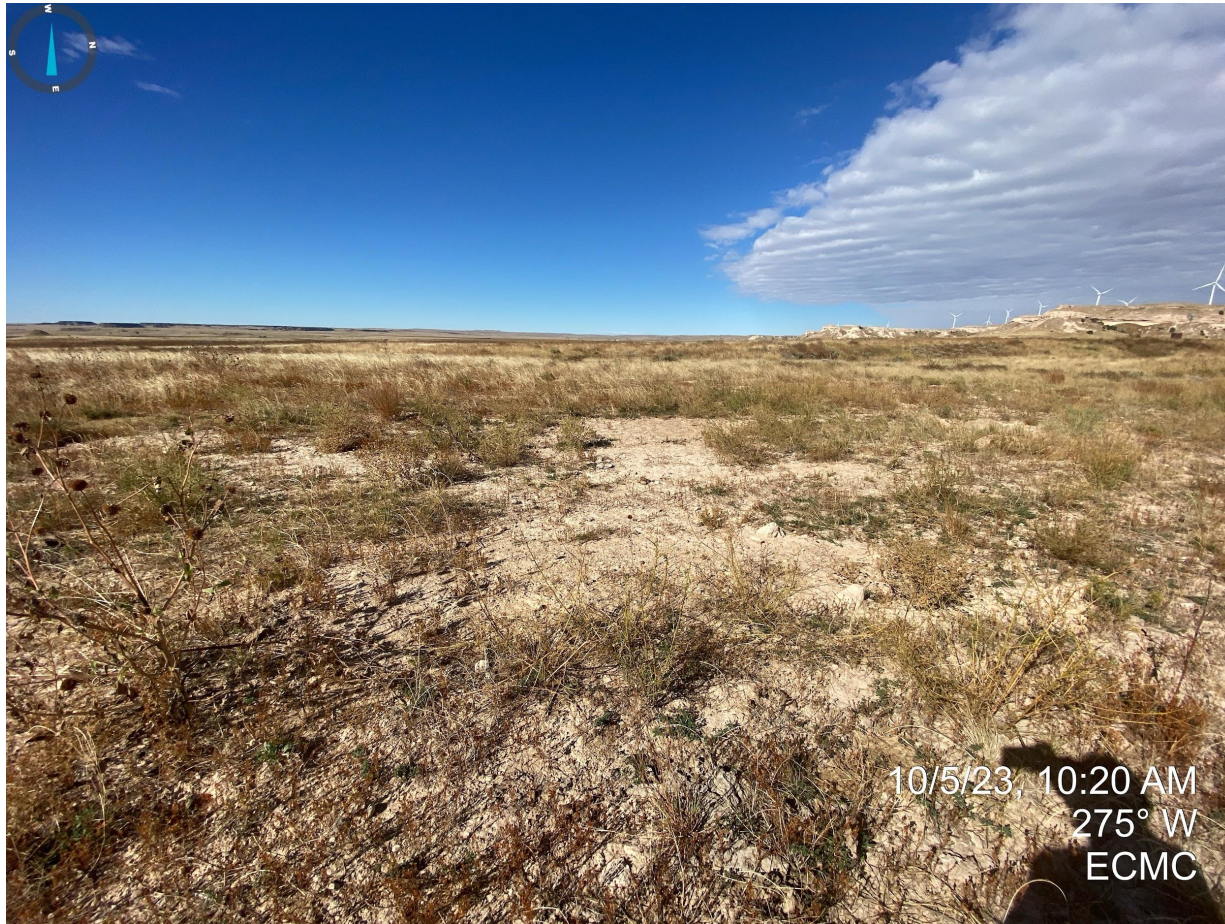
Photo 8. Taken from the eastern end of the location; see comments in Photo 6.

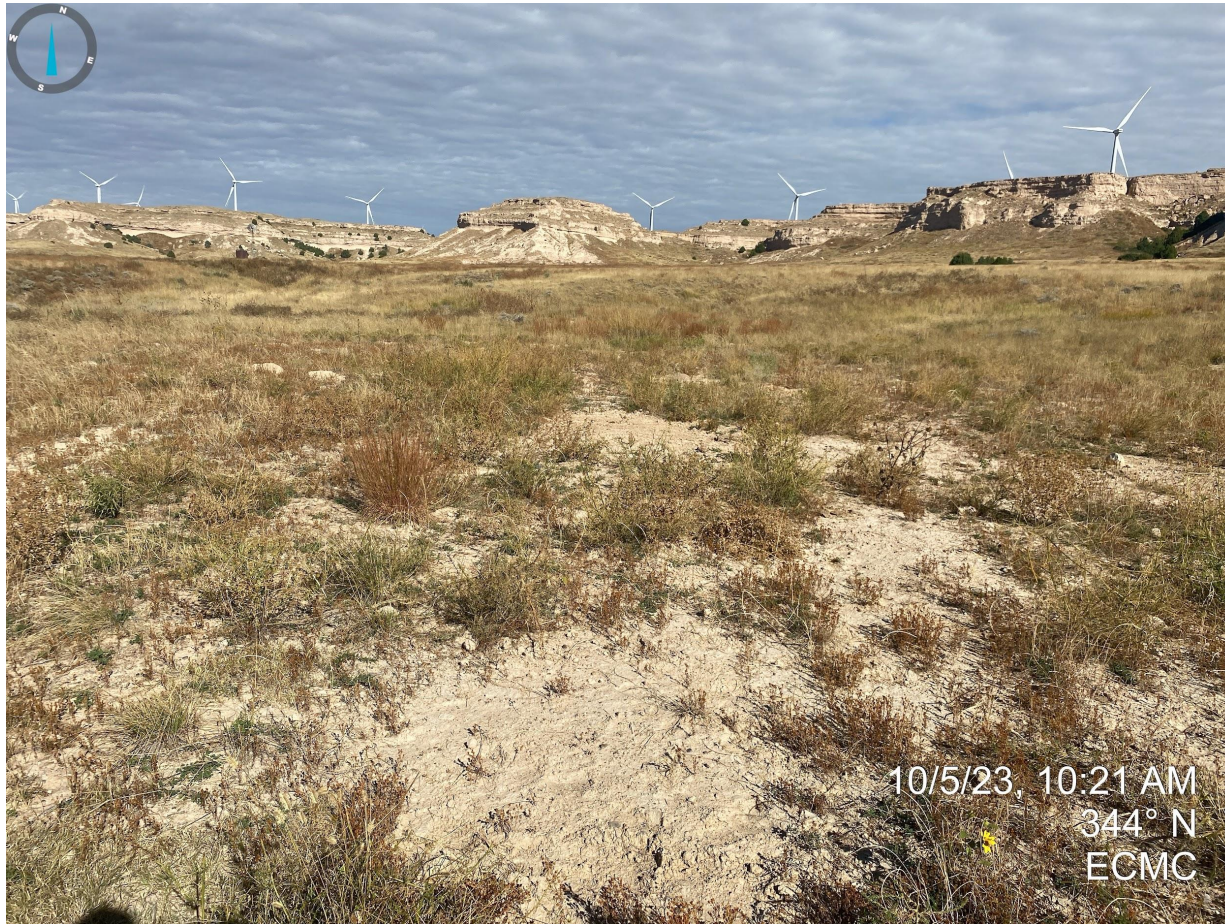
Photo 9. Taken from the southern end of the location; see comments in Photo 6.

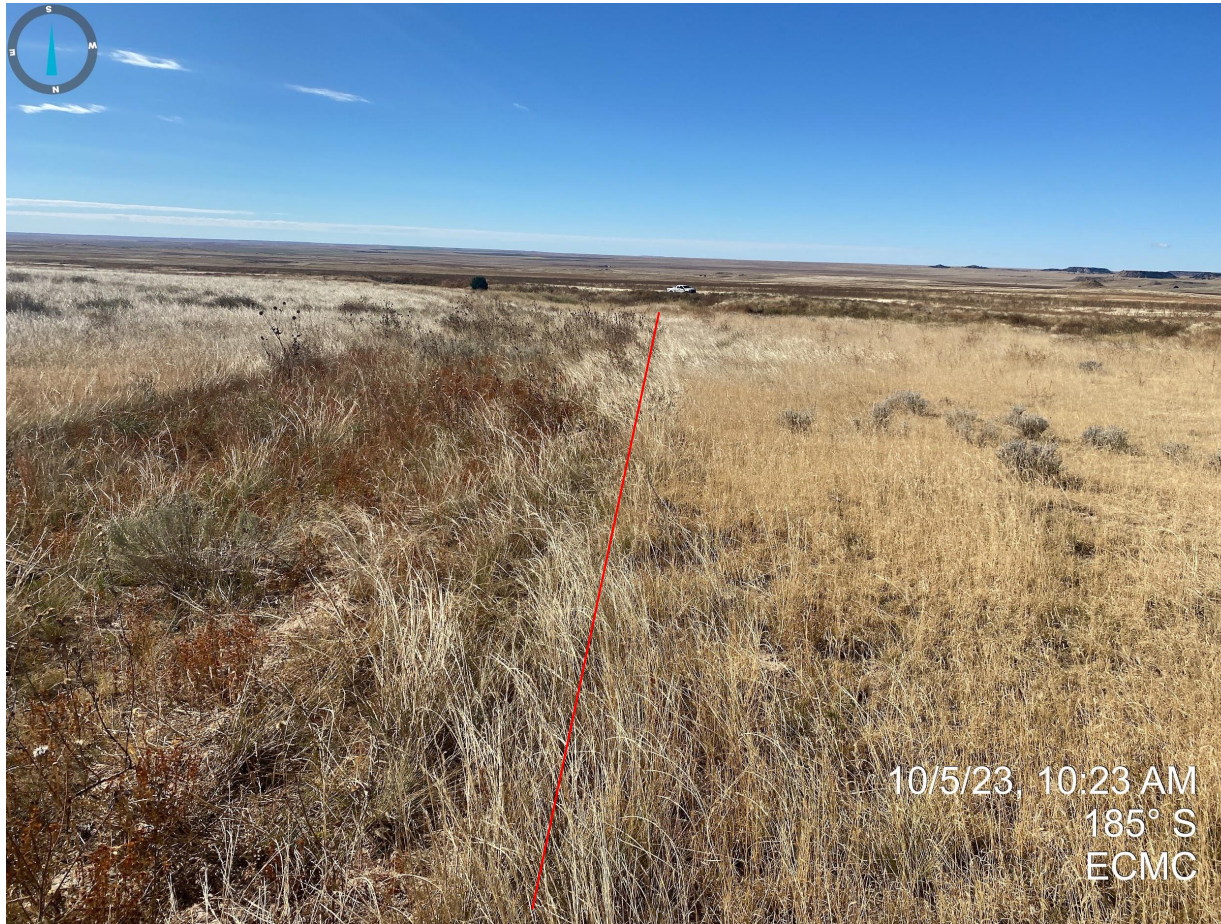
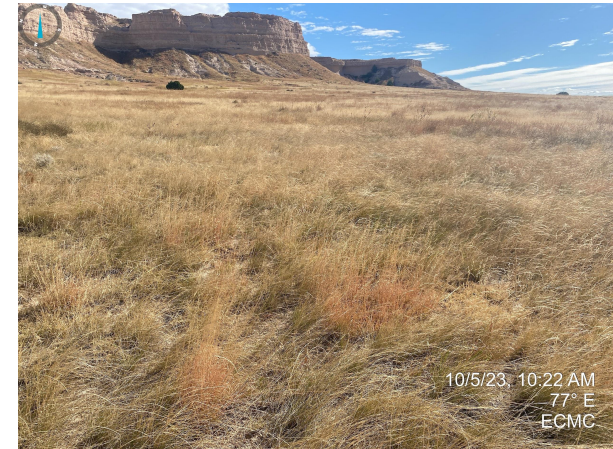
Photos 10 & 11. Taken south of the location. Photo illustrates the former access road, which is predominantly undesirable vegetation (e.g. russian thistle) and adjacent reference area on the right side of the left photo, delineated by red line. Right photo illustrates adjacent reference area (southeast of location) that is predominantly sideoats grama, blue grama, etc.
