Final Reclamation Inspection

Operator: Enduring LLC - 10663

Location ID: 326325

Inspection Photos
Location Name: Animas Wheeler 8-1
Location ID: 326325

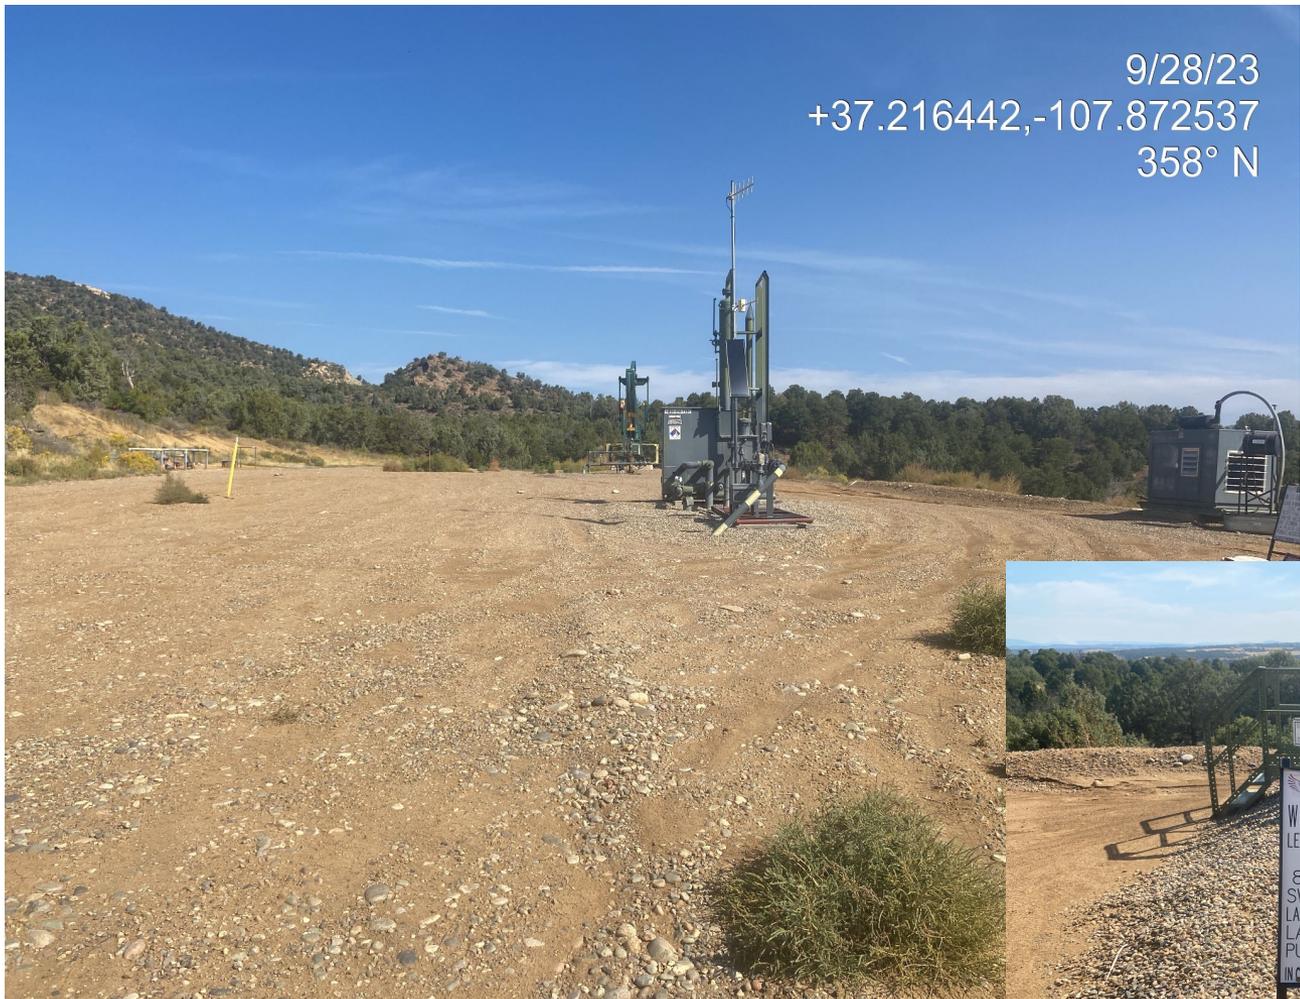
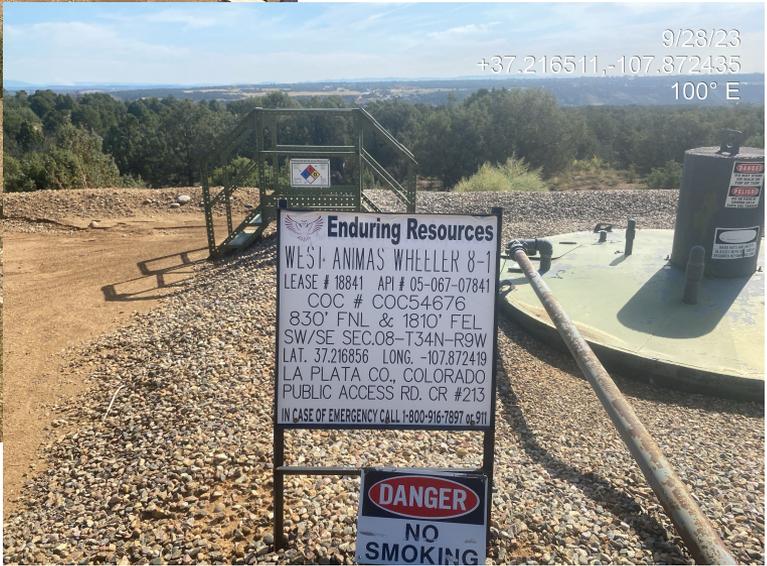
Photo 1. Overview photo of the disturbance taken from the access road entry point facing north.

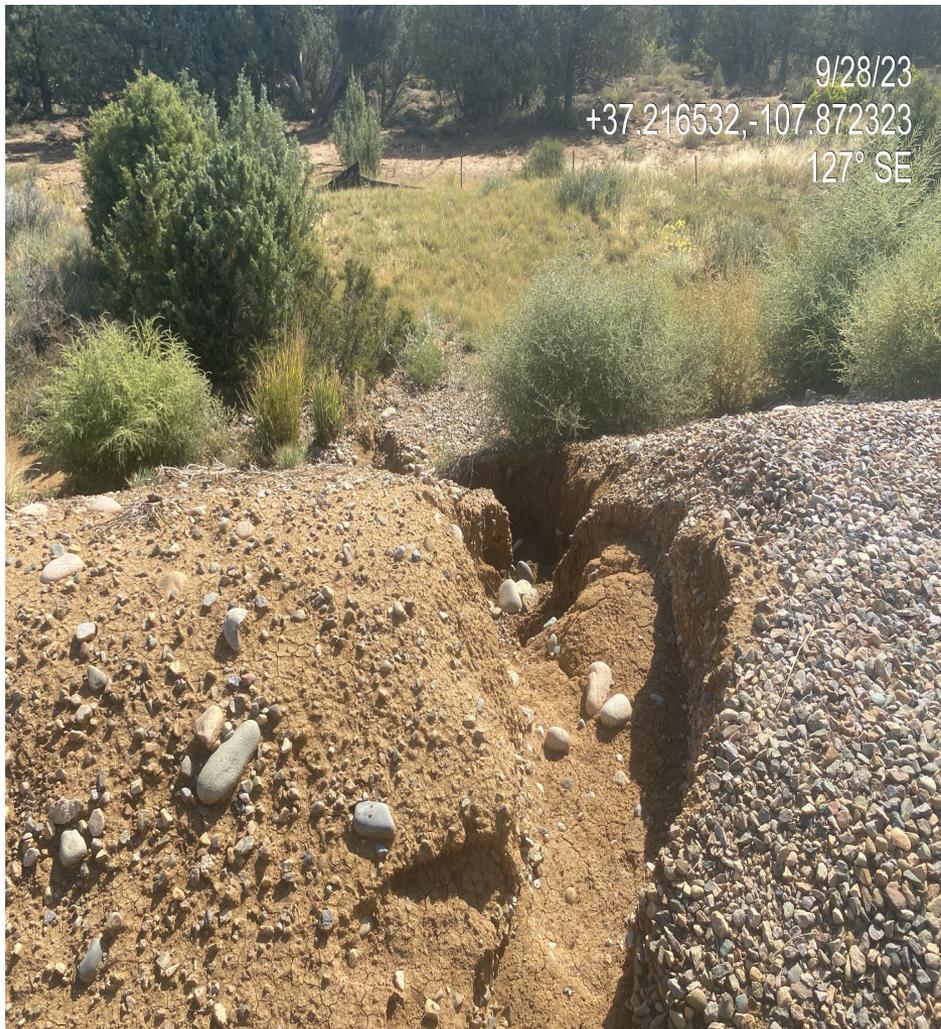
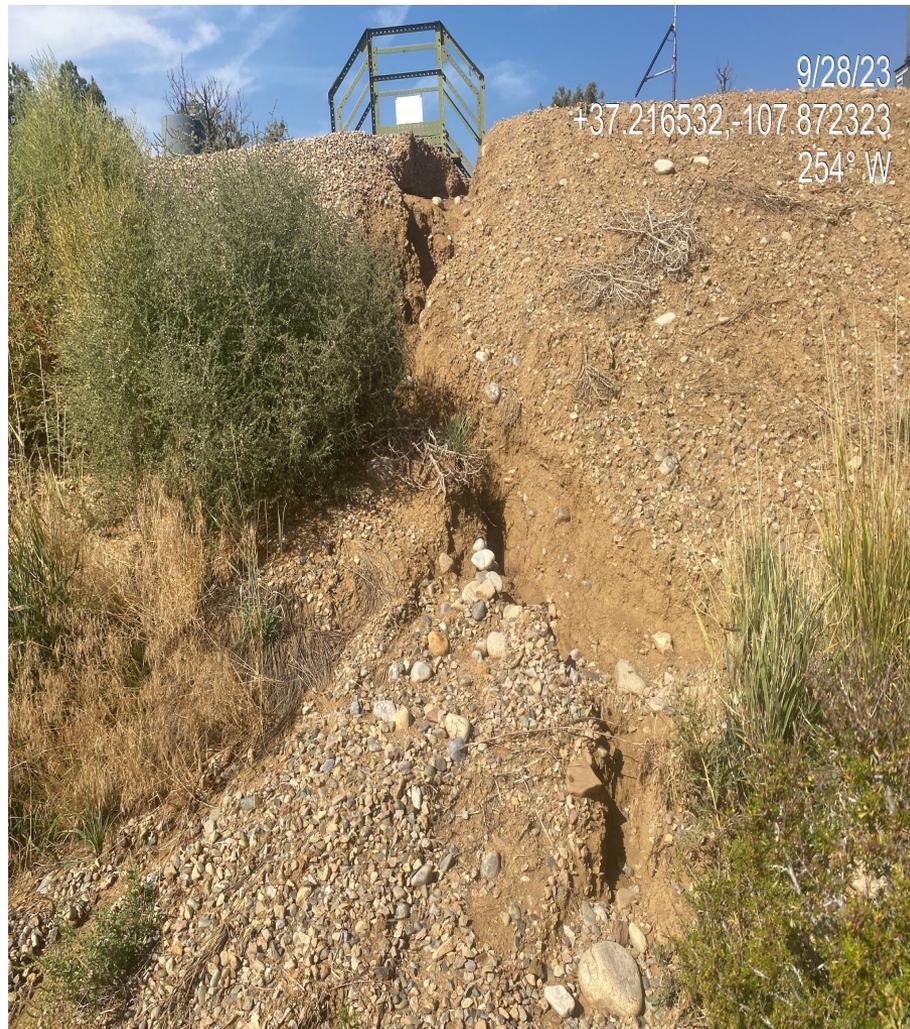
Photo 2. Photo of gully erosion observed on the fill slope, located on the eastern edge of the disturbance.

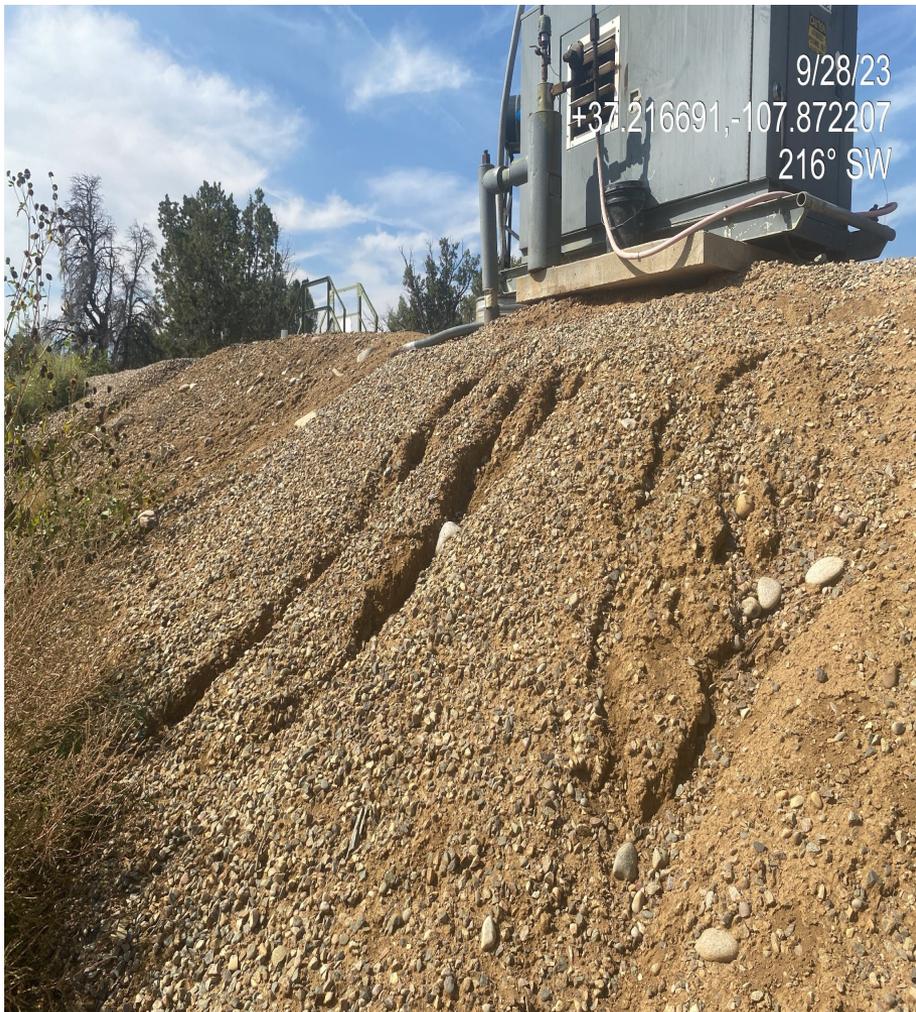
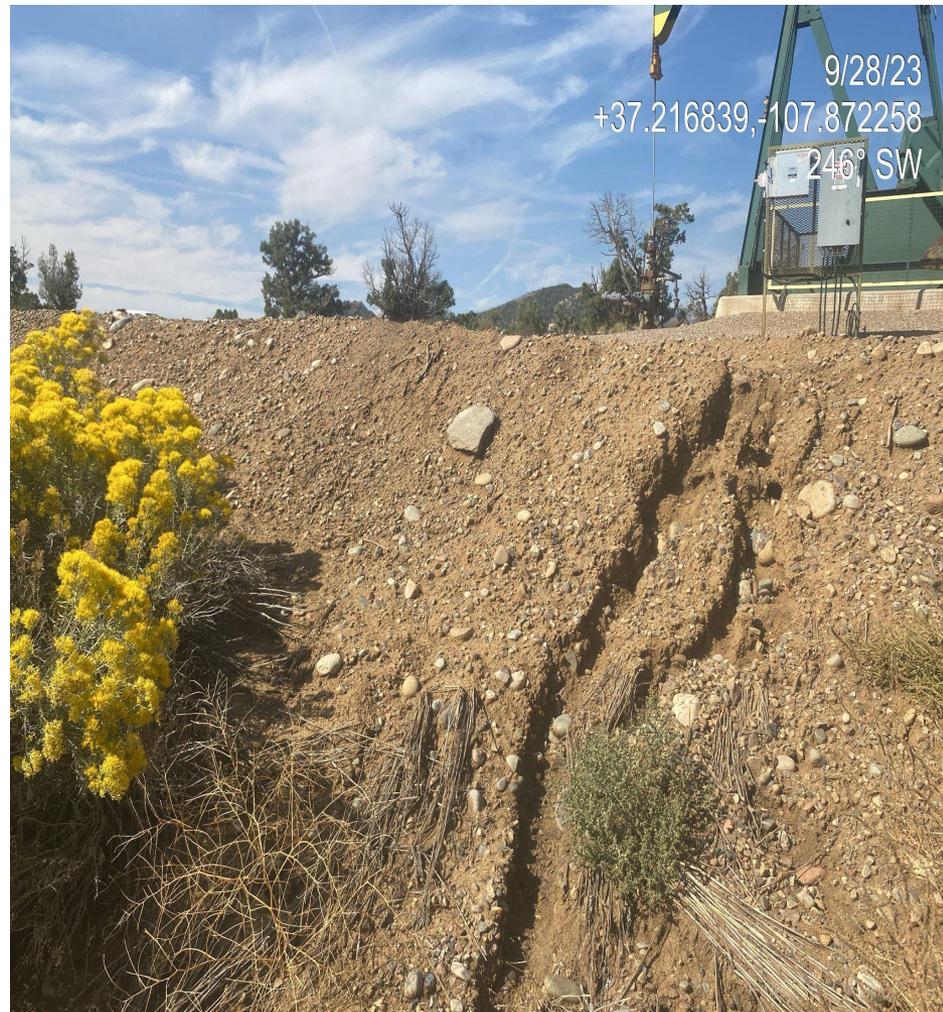
Photo 3. Rill erosion observed in several locations along the fill slope located on the eastern edge of the disturbance.

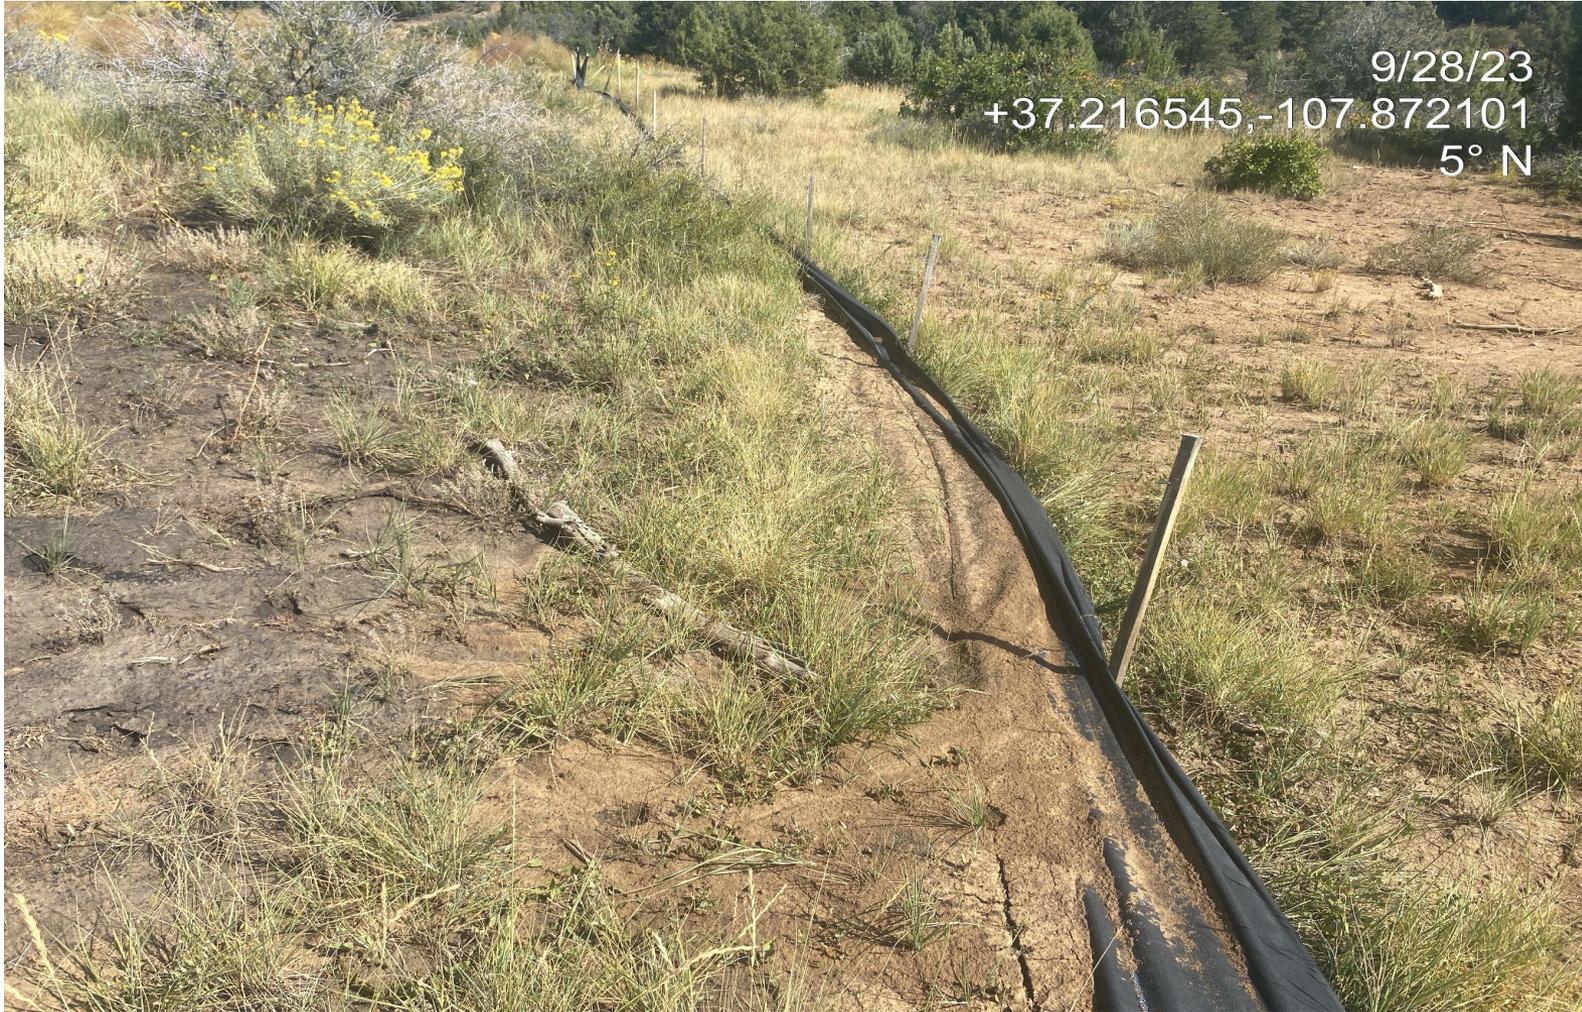
Photo 4. Silt fence along eastern edge of disturbance is in disrepair and is no longer functioning. BMP's used to minimize erosion and degradation of the location are inadequate.

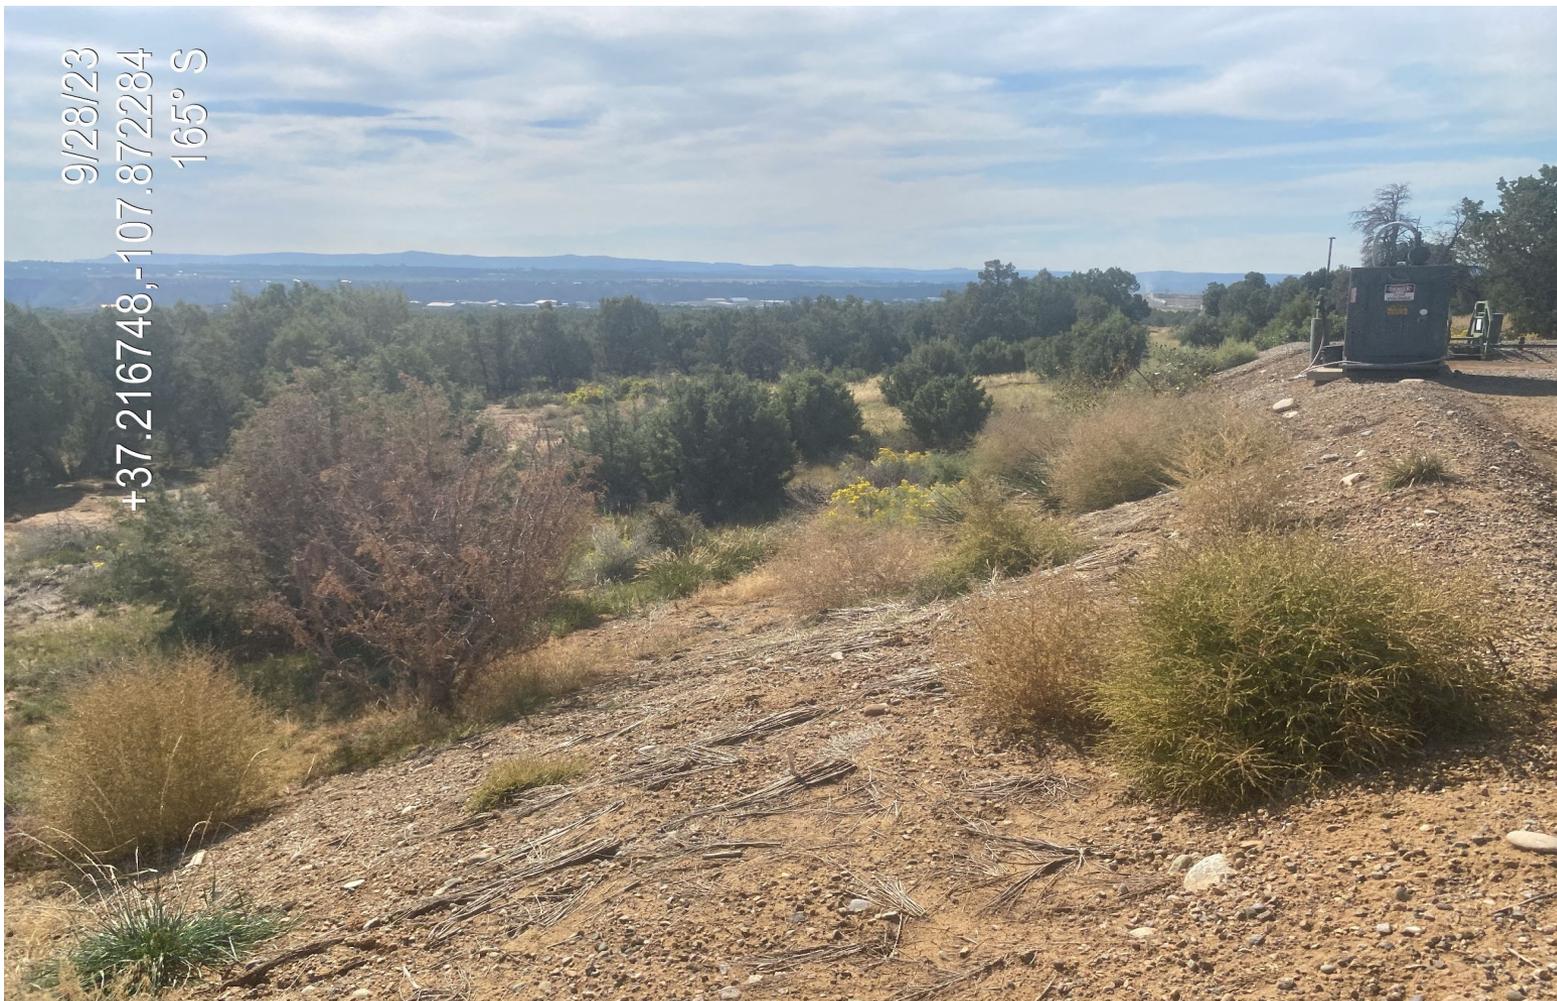
Photo 5. Eastern portion of disturbance is largely composed of annual, weedy vegetation including cheatgrass and kochia.

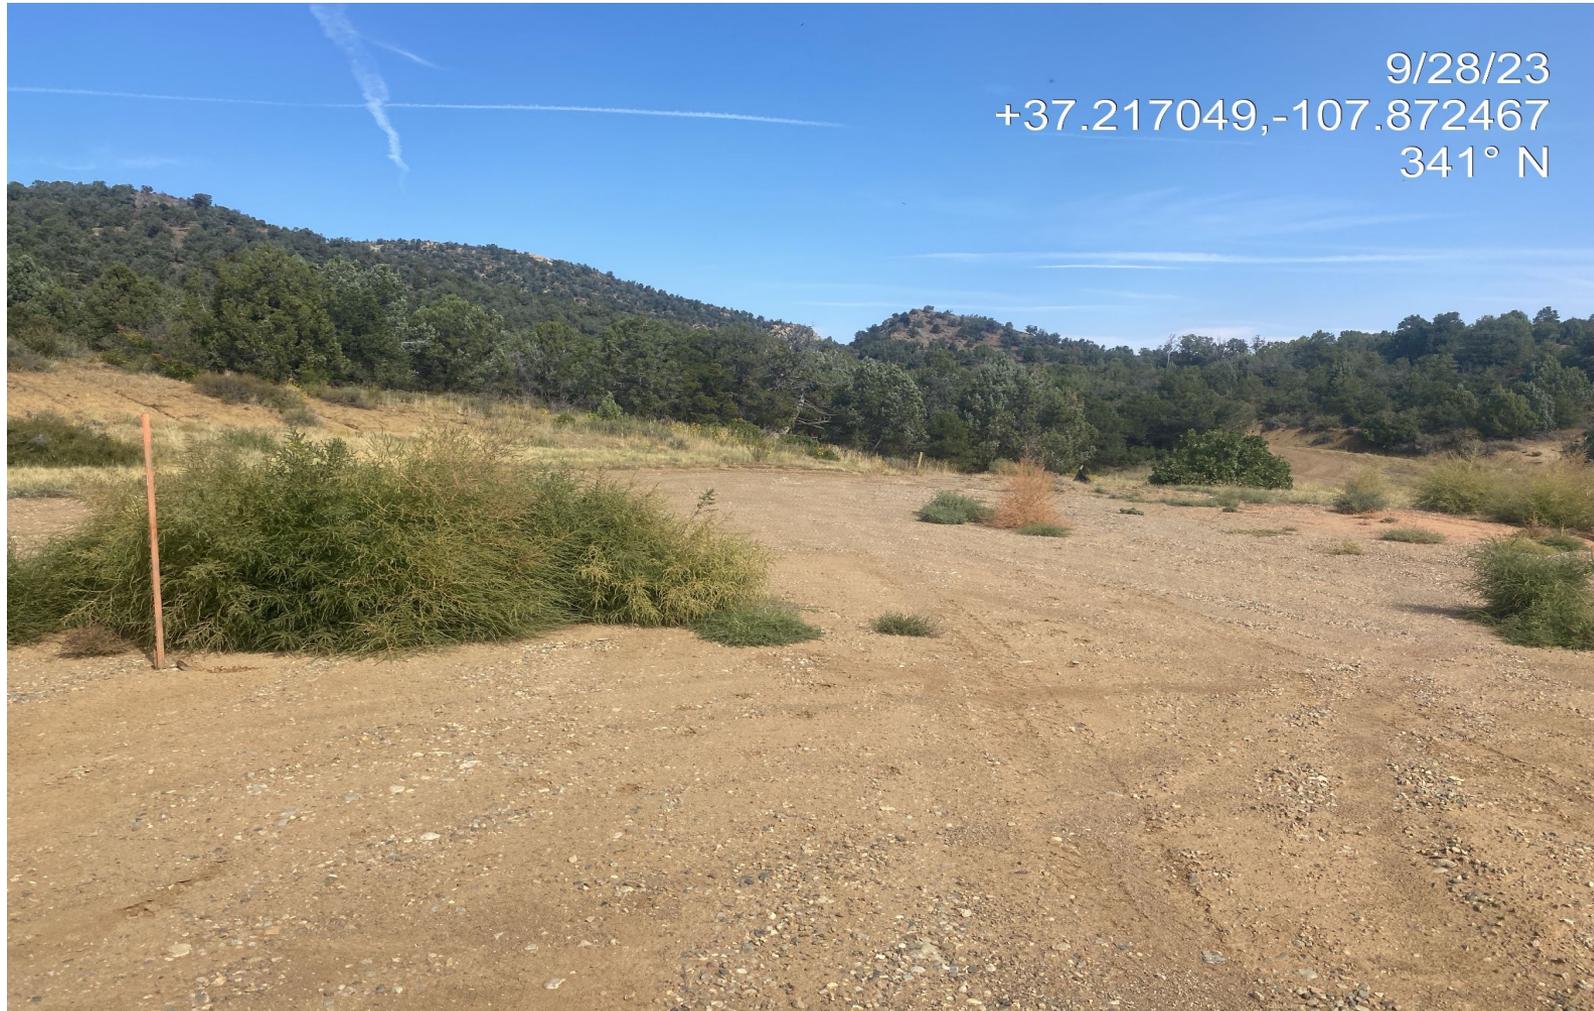
Photo 6. Kochia observed in various locations throughout the active disturbance.

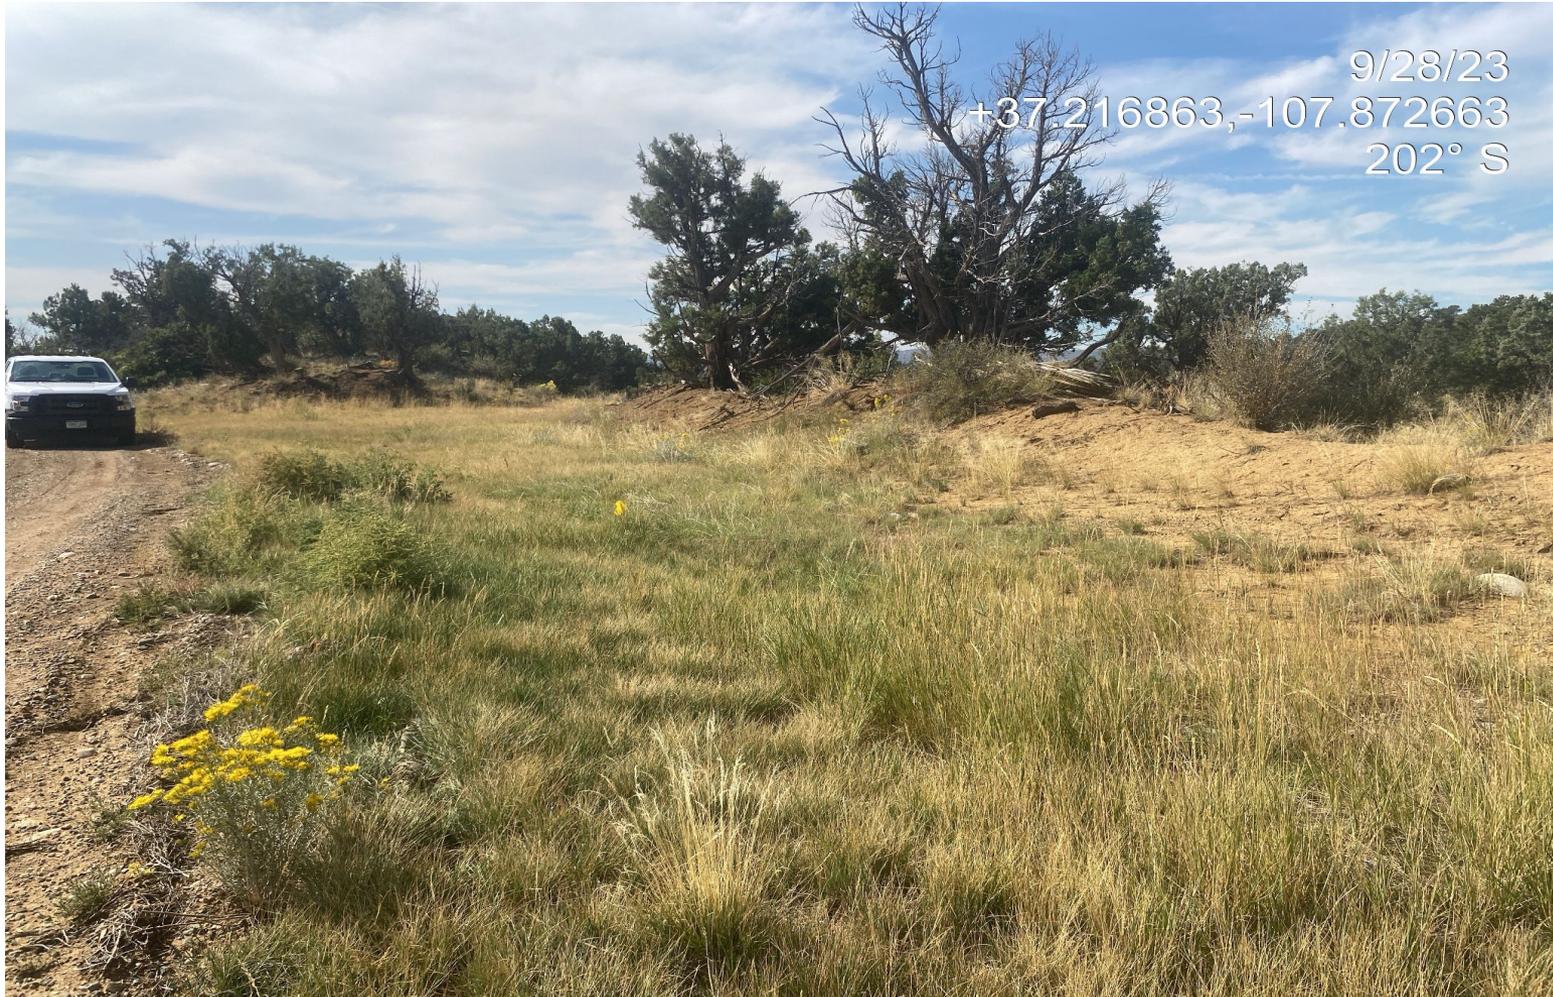
Photo 7. Western portion of the disturbance meets 80% vegetation threshold standards and appears reflective of reference areas.

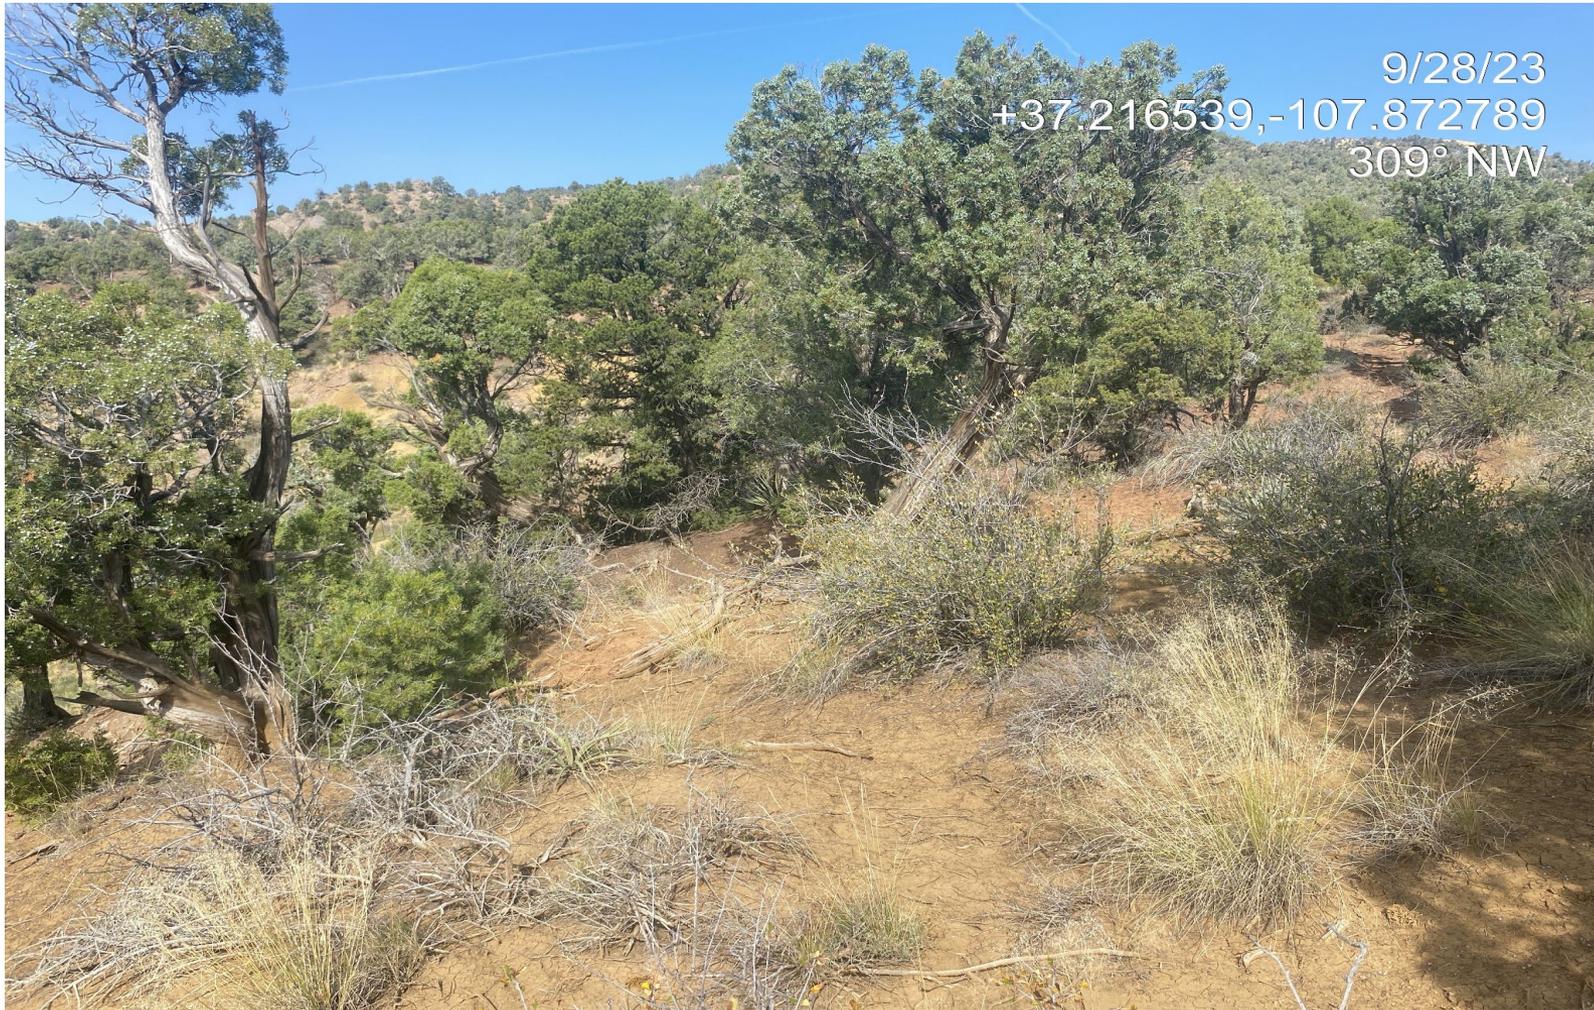
Photo 8. Reference area comprised of Juniper, antelope bitterbrush and indian rice grass.
