Inspection Photos

10/09/2023

Operator: CAERUS PICEANCE LLC #10456

Location ID: 335886

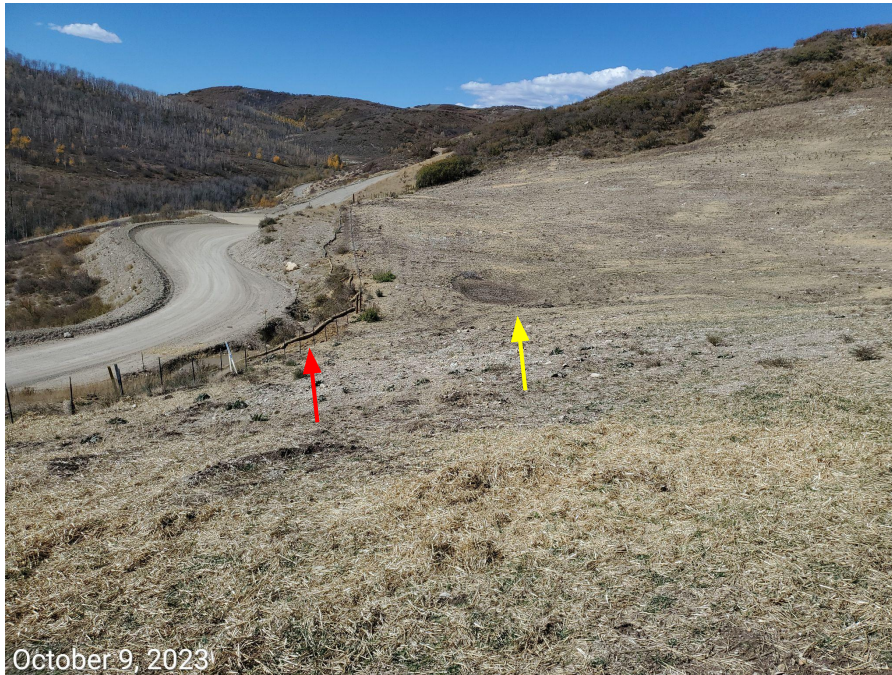
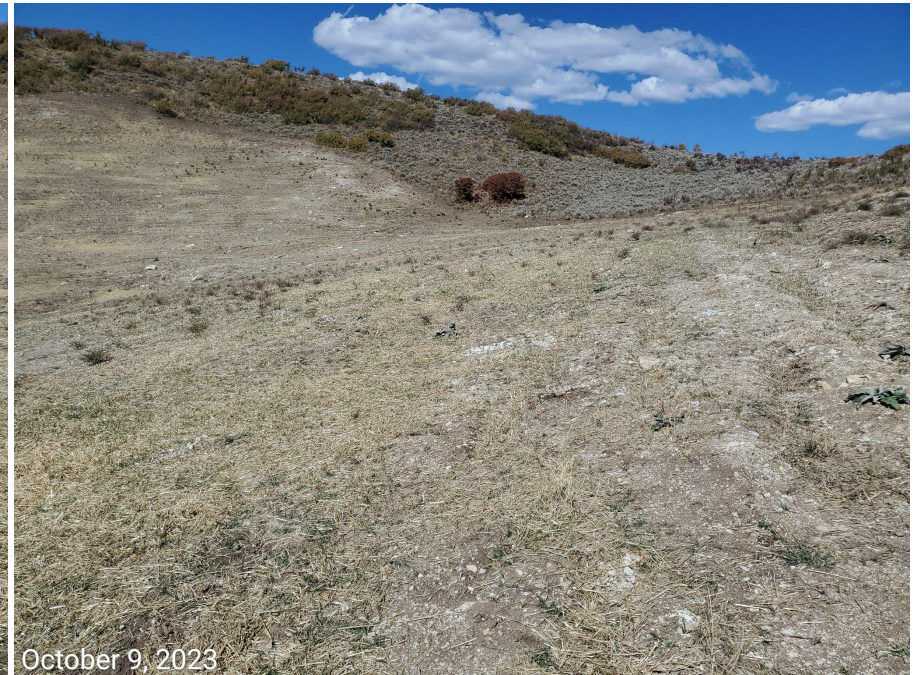
Photo 1: Photos taken from the southeast end of the Location. Photos provide an overview of the Location (as well as the reclamation work conducted) from west to northwest. Location has been recontoured/regraded and revegetation activities are apparent. Straw mulch has been blown over the reclamation area. Erosion logs (wattles, red arrow) implemented along the southern perimeter (left of photo left). A shallow swale (yellow arrow) has been constructed during contouring work to act as a retention pond to capture runoff.

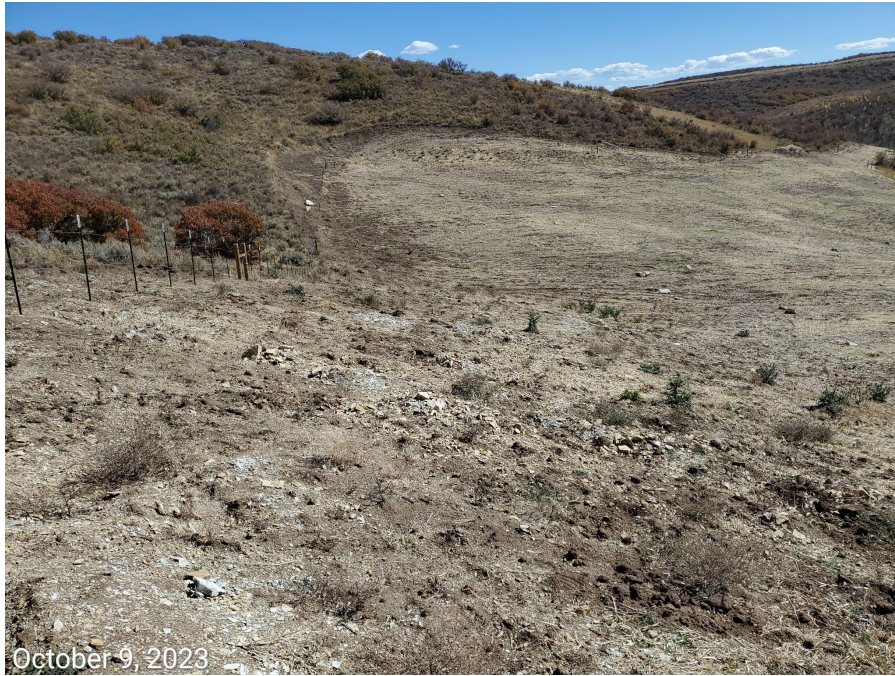
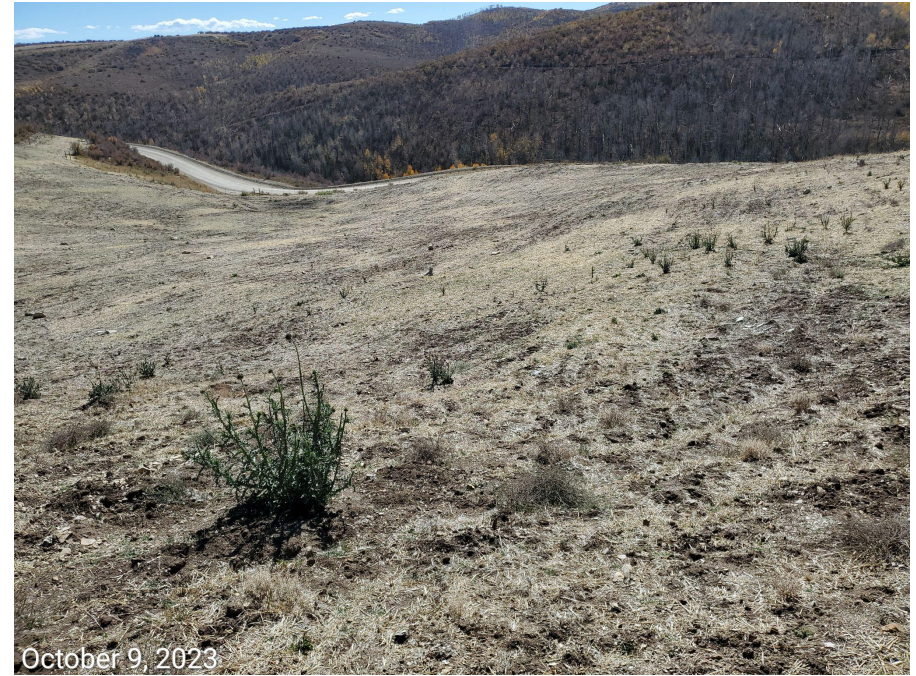
Photo 2: Photos 2-3 taken from the north end of the Location. Photos provide an overview of the Location (as well as the reclamation work conducted) from east, southeast southwest to west. ECMC Staff commends Caerus for the contour work conducted on the Location.

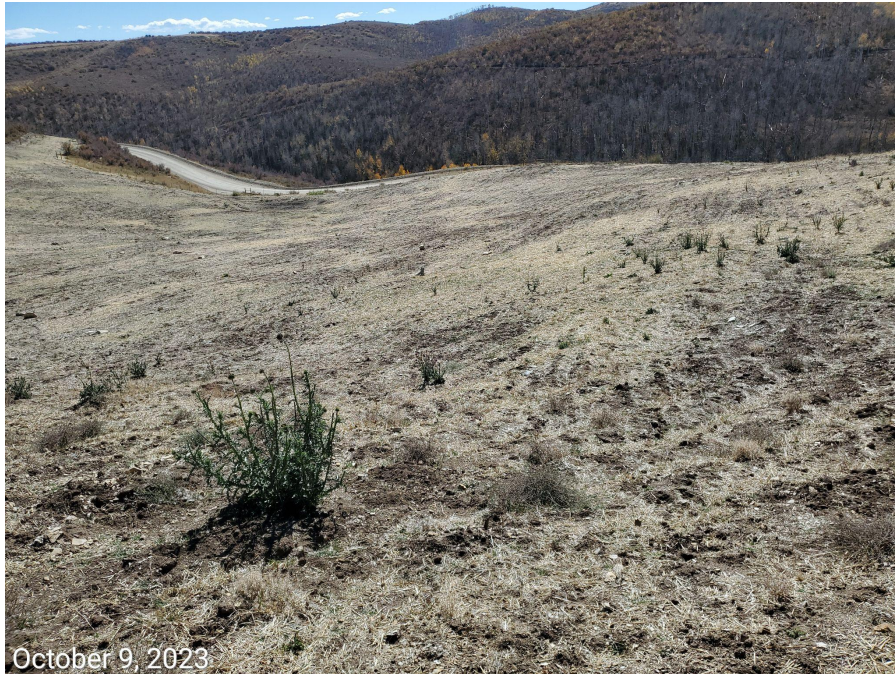
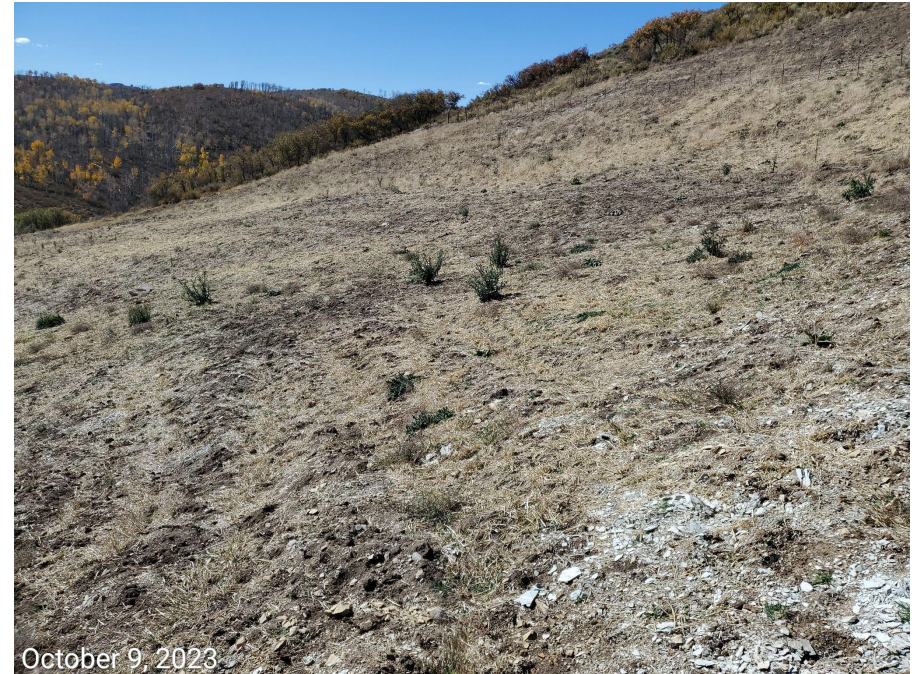
Photo 3: See comments under photo 2.

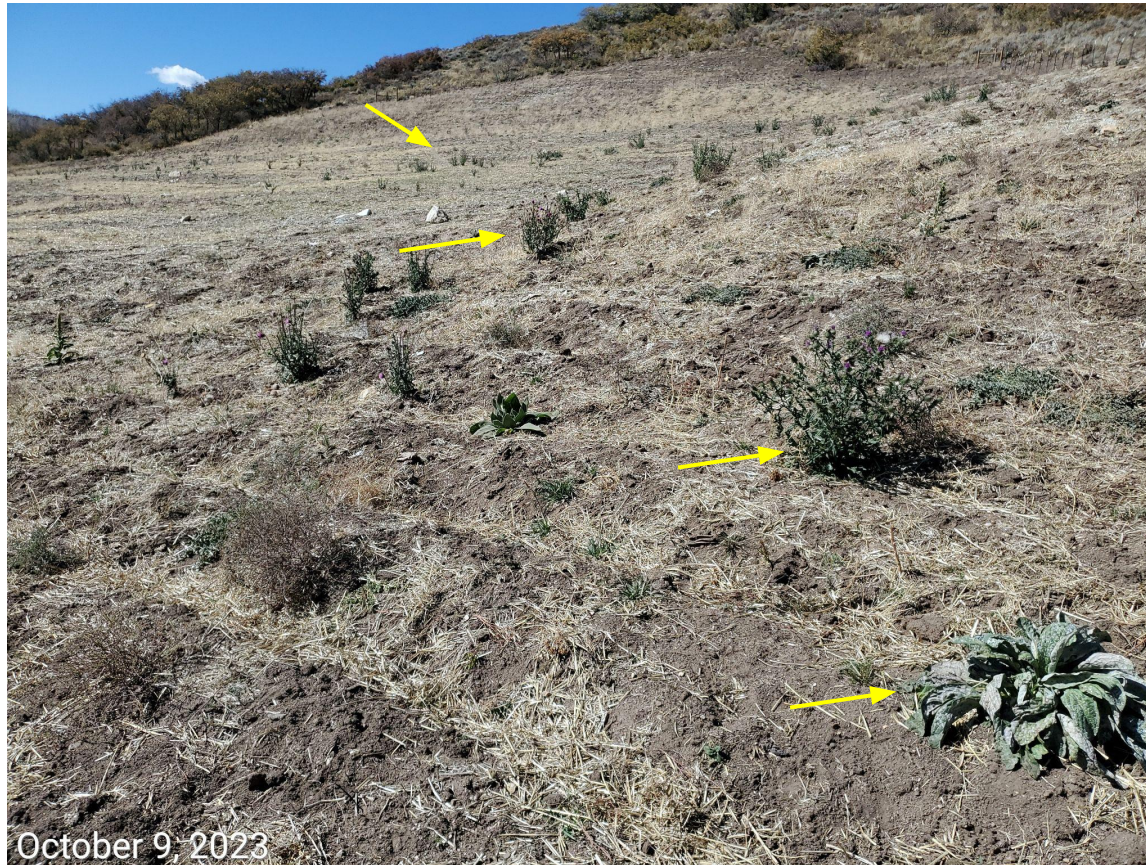
Photo 4: Photo provides an example of Noxious weeds observed established on the Location; species observed include Musk thistle and Houndstongue. All tall and green vegetation observed within this photo (as well as within photos 2-3) are noxious weeds.

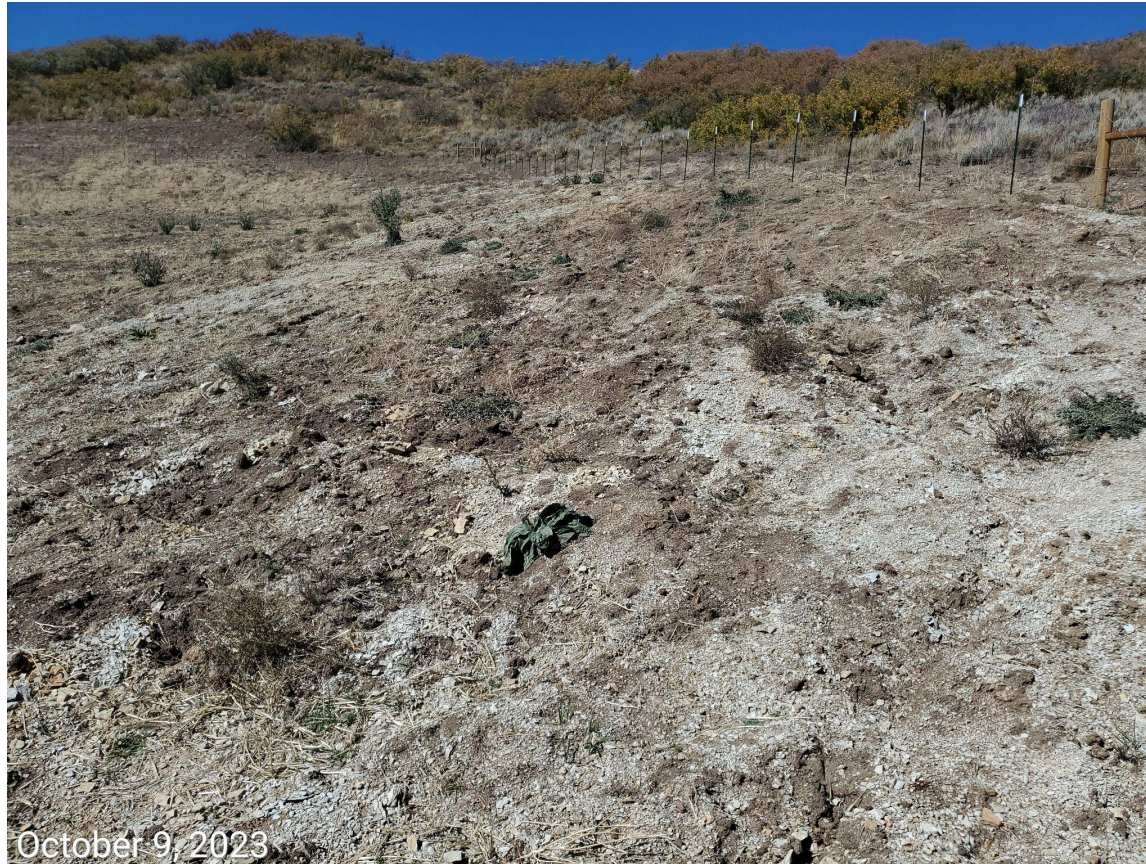
Photo 5: Photo taken from the northwest end of the Location, facing west. Photo example showing areas where mulch had not been uniformly applied and/or anchored; mulch on Location has been blown onto the soil surface, and was not observed to be anchored mechanically (such as crimping or a tackifier).

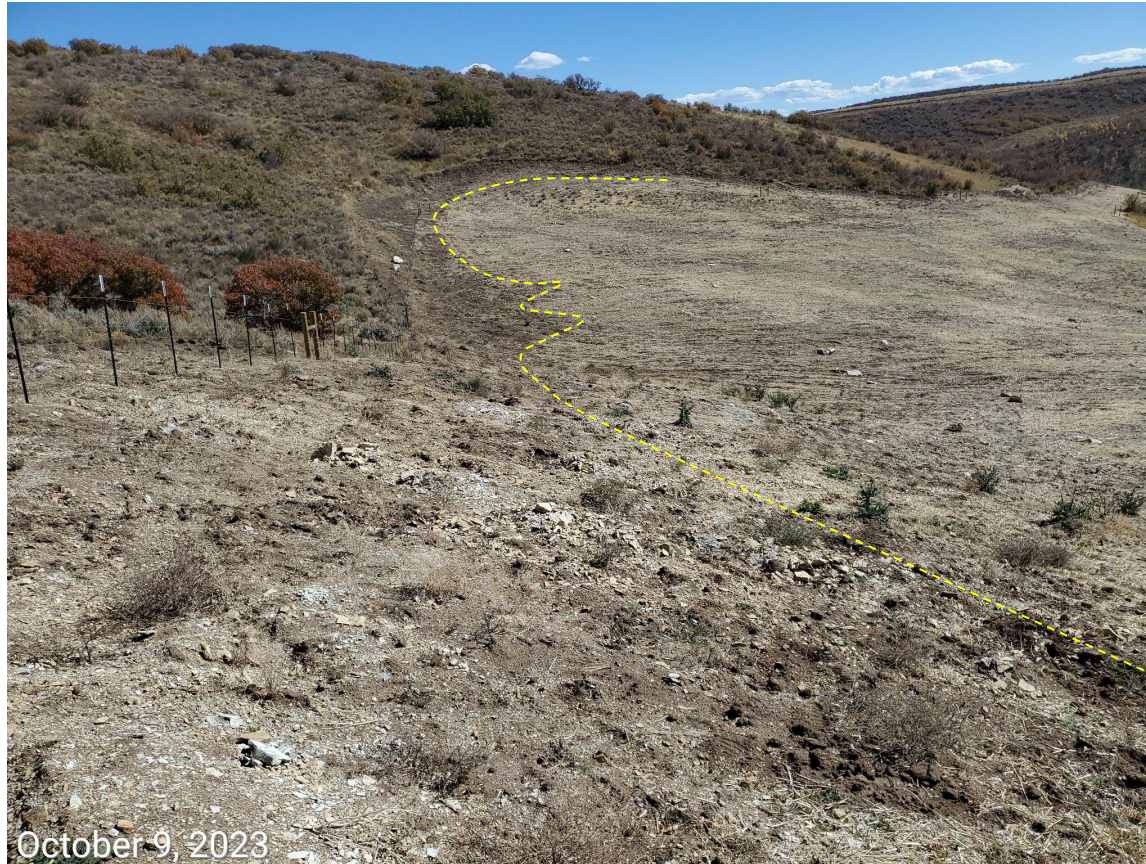
Photo 6: Photo taken from the north end of the Location, facing east. Photo example showing areas where mulch had not been uniformly applied (left of line) and/or anchored; mulch on Location has been blown, and was not observed to be anchored mechanically (such as crimping or a tackifier). Photo also shows stormwater and erosion control measures to manage runoff along the northern perimeter of the Location have not been implemented.

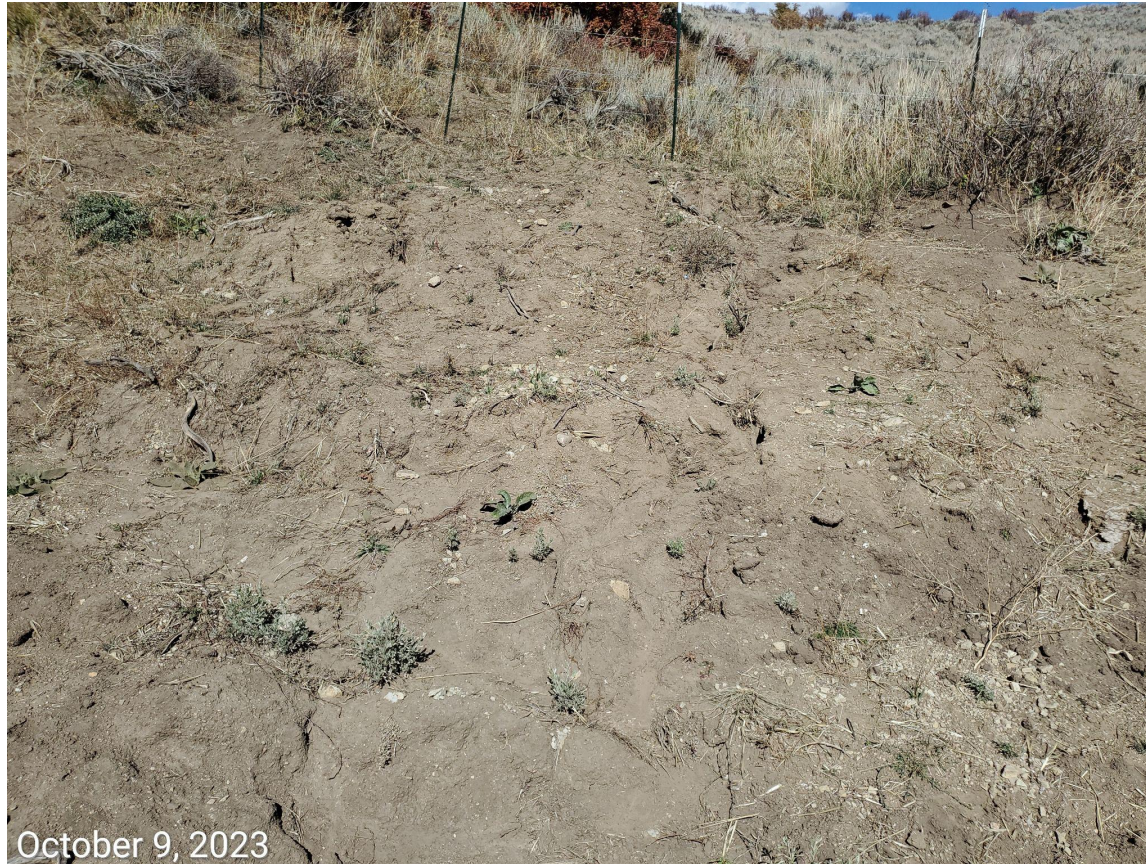
Photo 7: Photo taken from the north end of the Location. Photo example showing erosion degradation is becoming apparent; soils within photo are bare and at risk to wind, water and weeds. Perimeter control measures to manage runoff have not been implemented.

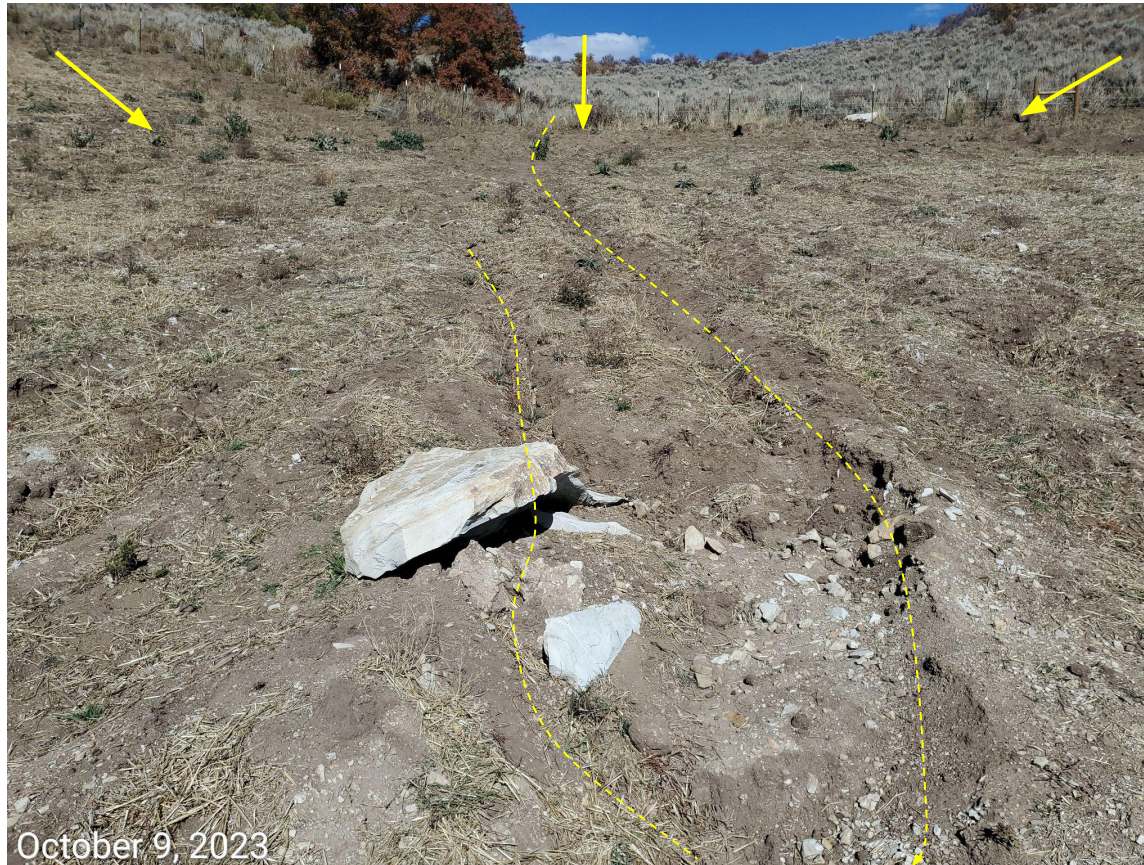
Photo 8: Photo taken ~50 south/downhill of photo 7. Photo shows areas where stormwater is becoming concentrated flows on the Location, resulting in degradation. Yellow arrows represent flow direction; lines outline erosion.

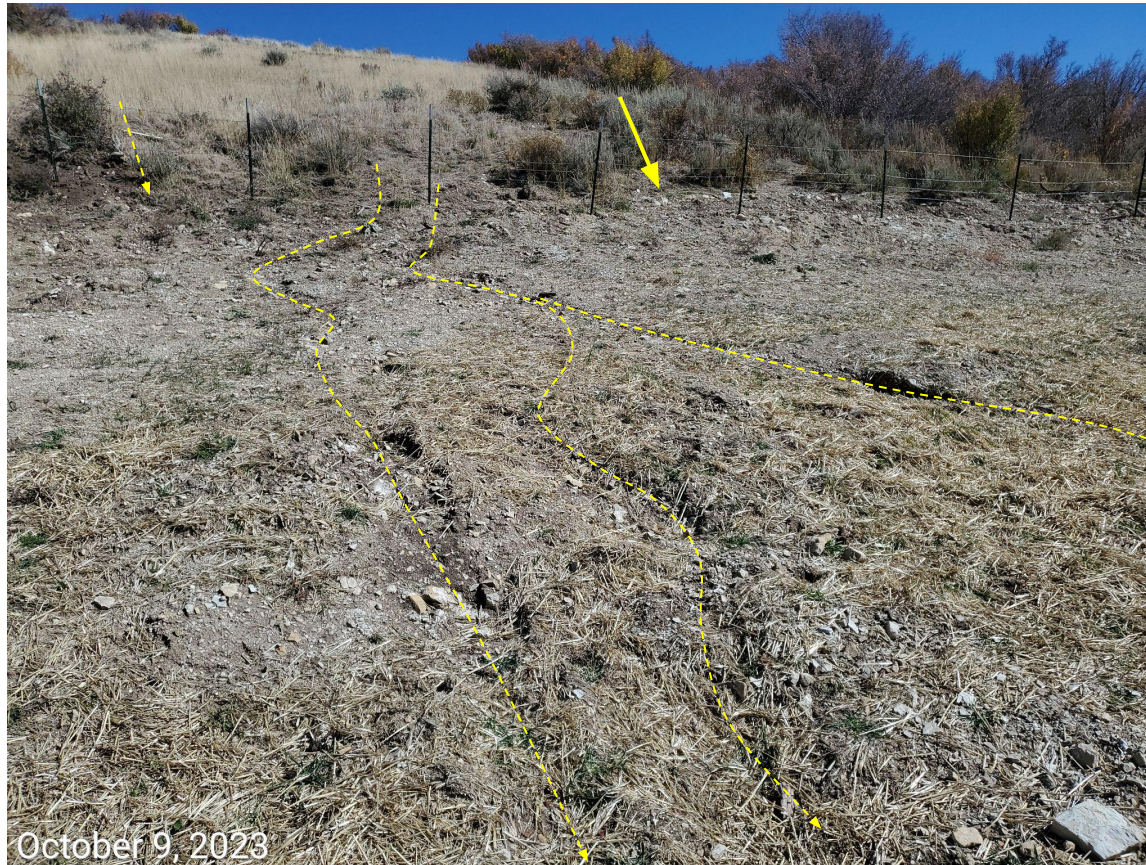
Photo 9: Photo example showing erosion degradation is becoming apparent. Perimeter control measures to manage runon have not been implemented. Yellow arrows represent flow direction; lines outline erosion.

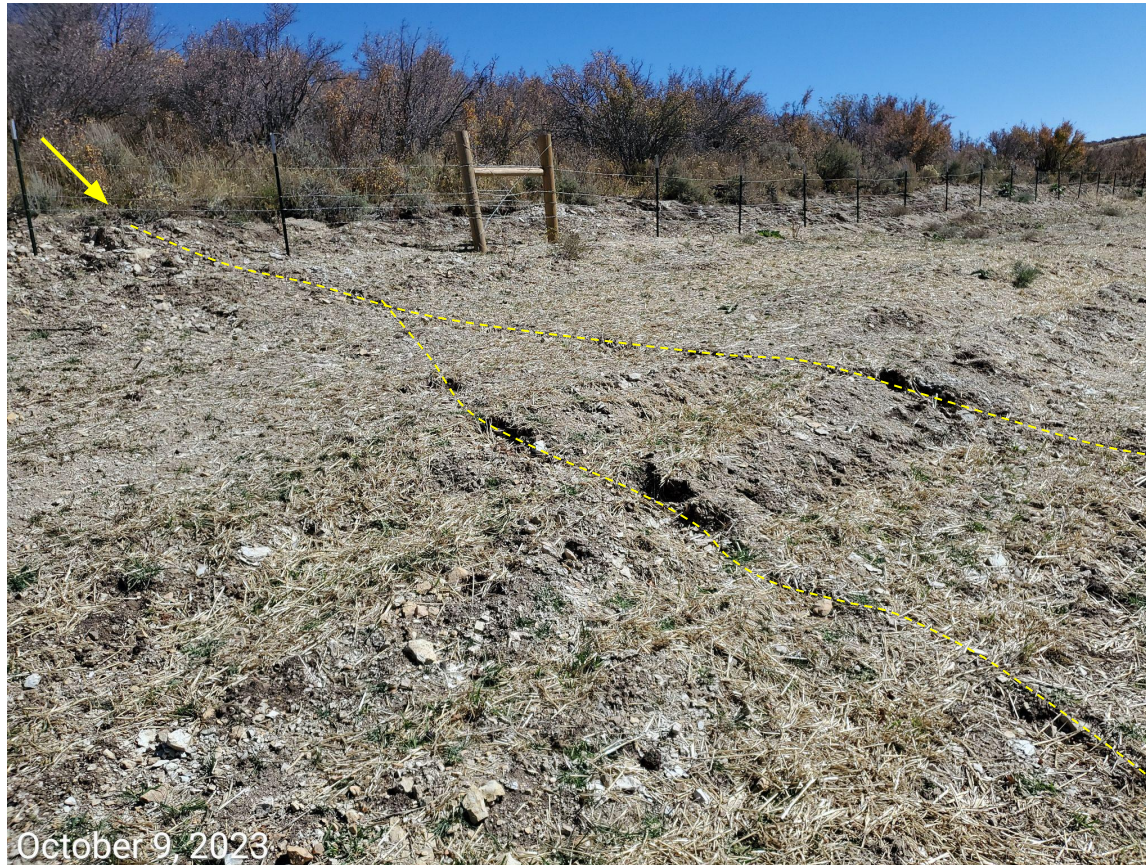
Photo 10: Photo example showing erosion degradation is becoming apparent. Perimeter control measures to manage runon have not been implemented. Yellow arrows represent flow direction; lines outline erosion.

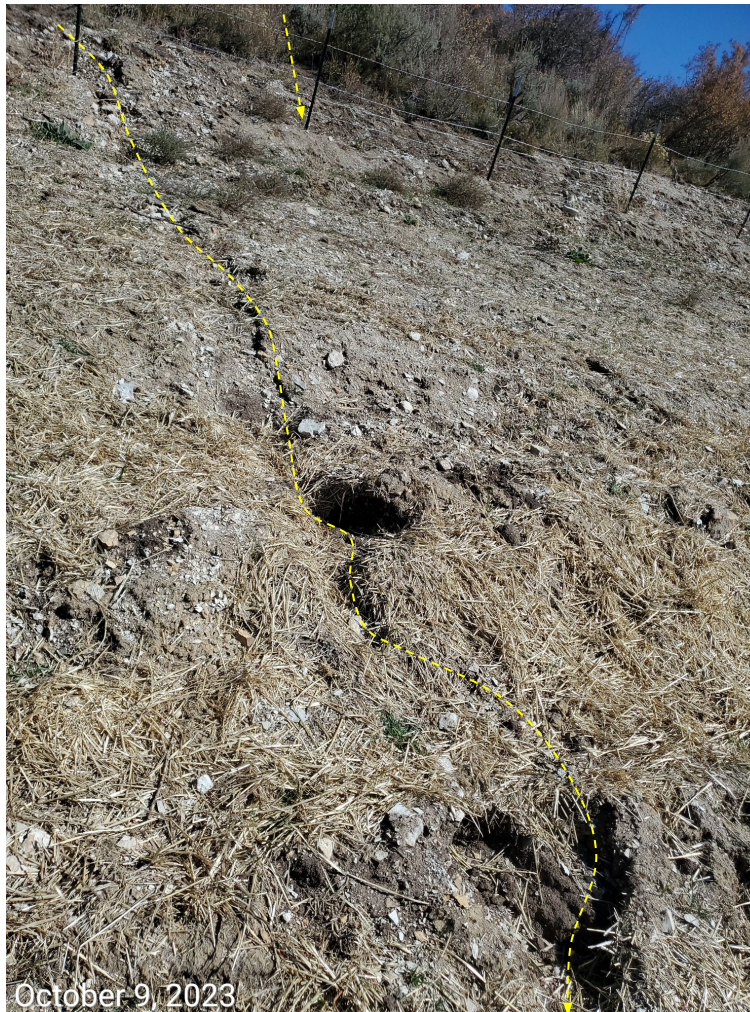
Photo 11: Photo example showing erosion degradation is becoming apparent. Perimeter control measures to manage runoff have not been implemented. Yellow arrows represent flow direction; lines outline erosion.

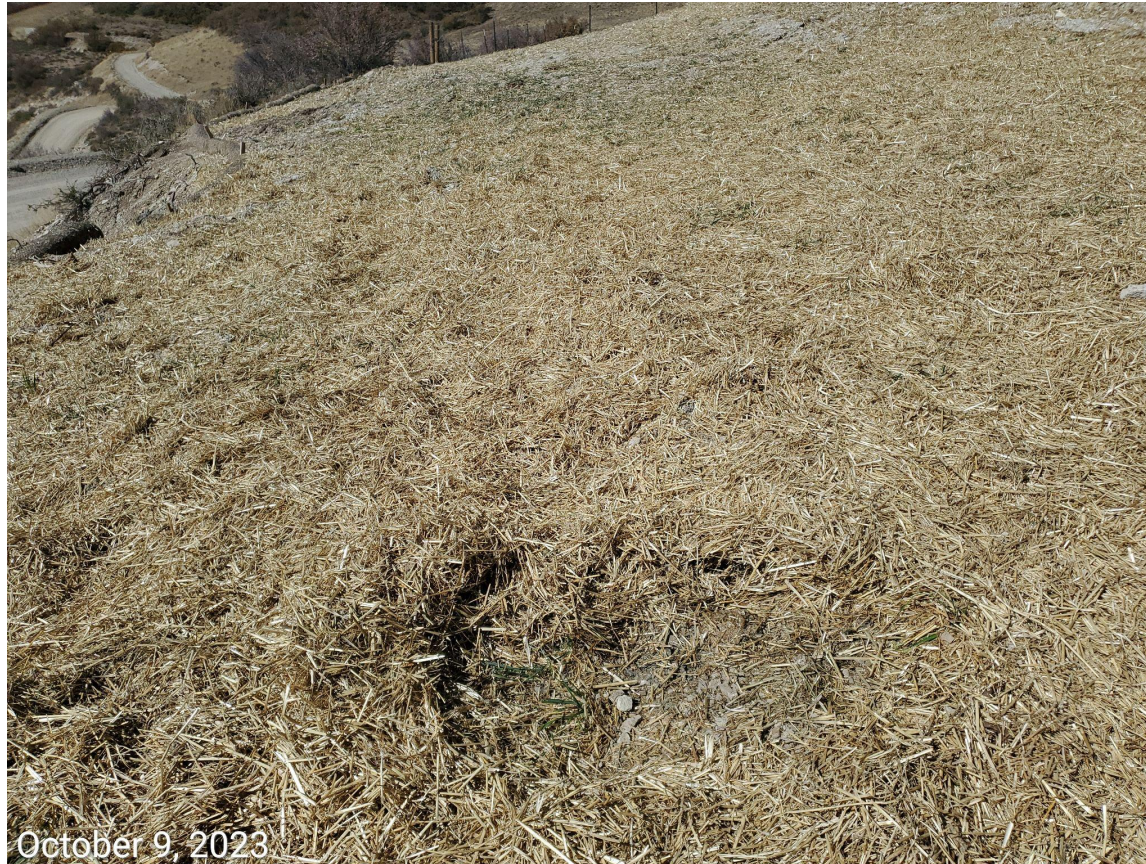
Photo 14: Photos example showing downslope areas where mulch has either been applied too thickly, or is accumulating due to lack of anchoring in conjunction with wind/water/gravity. Mulch was ~6 inches thick in such areas.
