Inspection Photos

Loc: 324494

Operator: **OXY USA INC**

Inspection Date: 10/11/2023

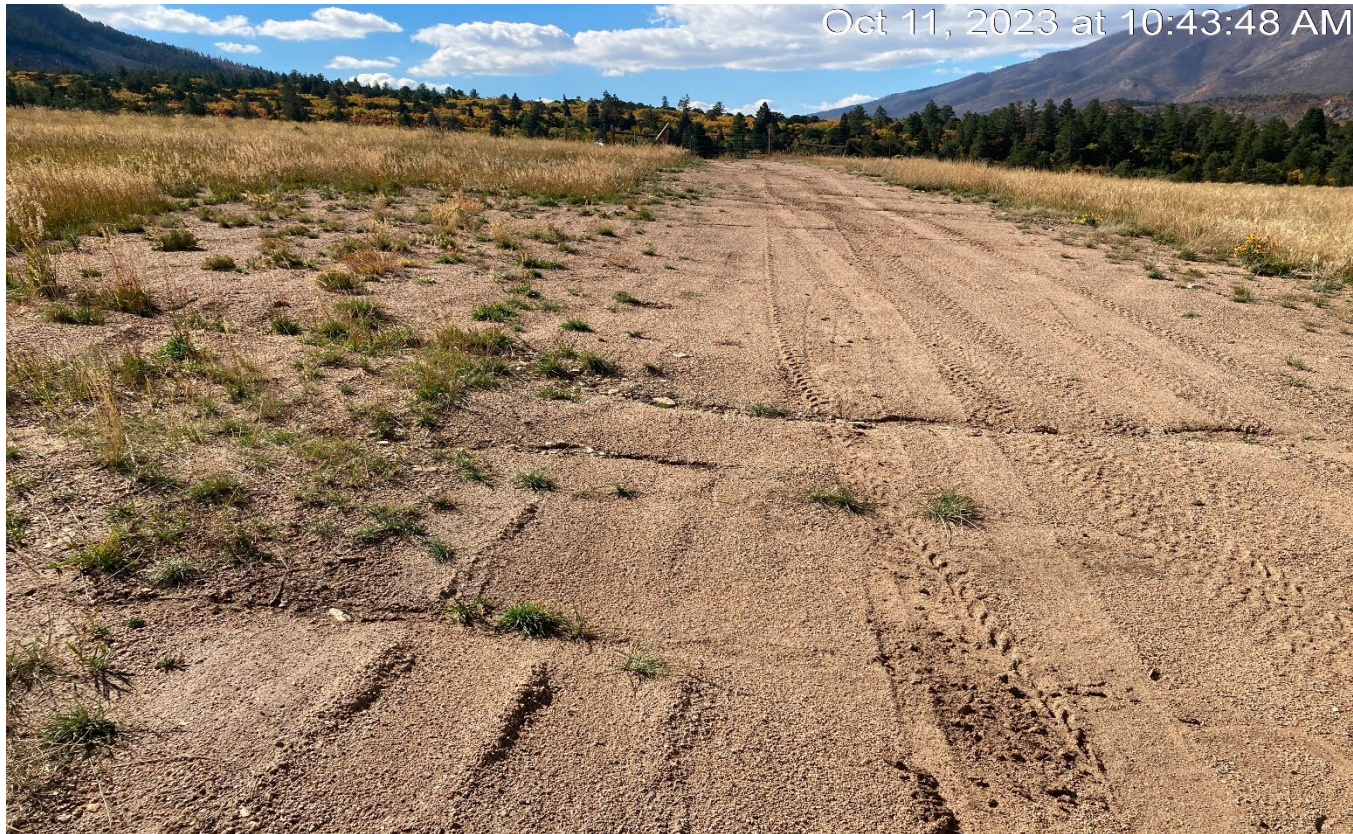
Photo 1. Facing south toward the access road. There is erosion occurring across the road and no BMP's were installed. The access road will need to be decompacted and reclaimed. Previous corrective action has not been completed.

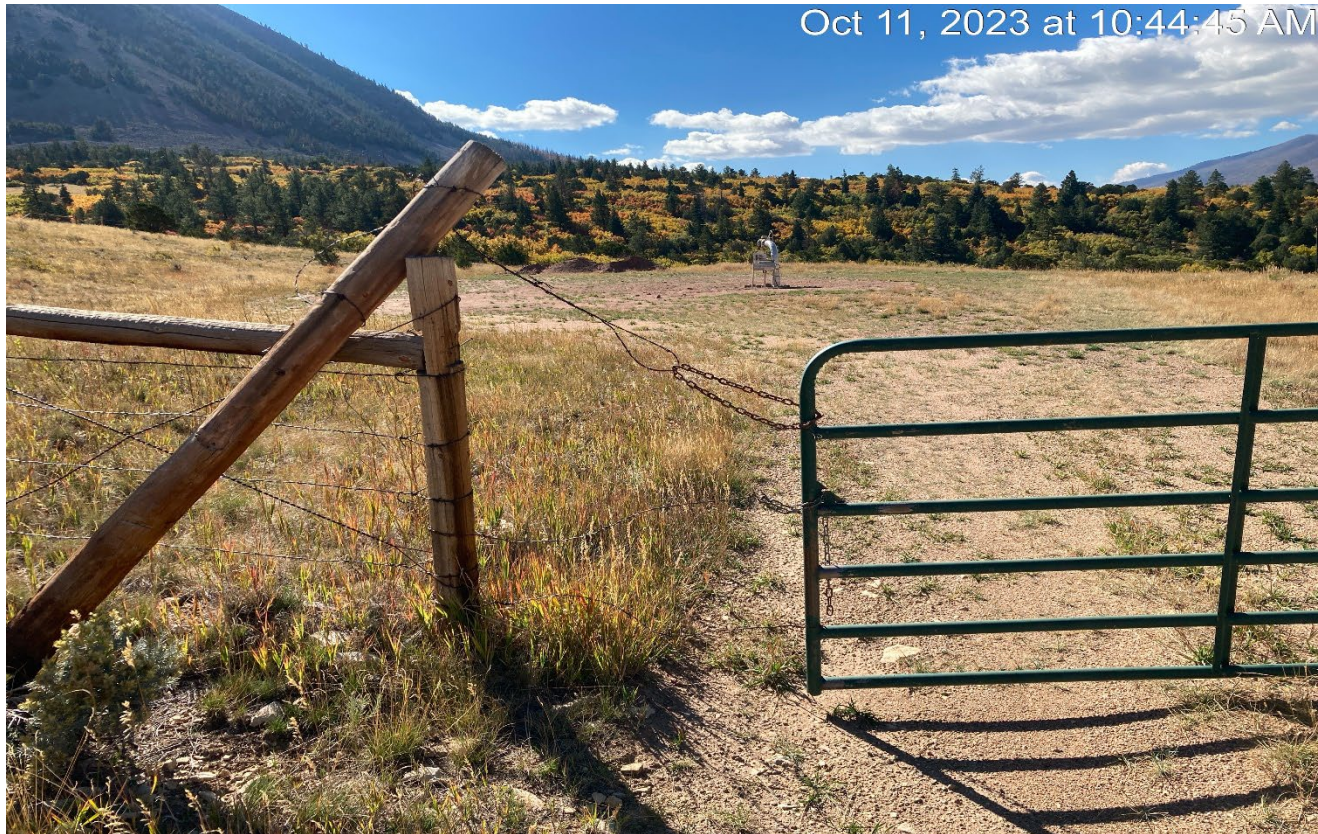
Photo 2. Facing south toward the location. The well has been plugged and abandoned . The location will need to be recontoured back to the original contours and reclaimed. This gate does not prevent livestock entry..

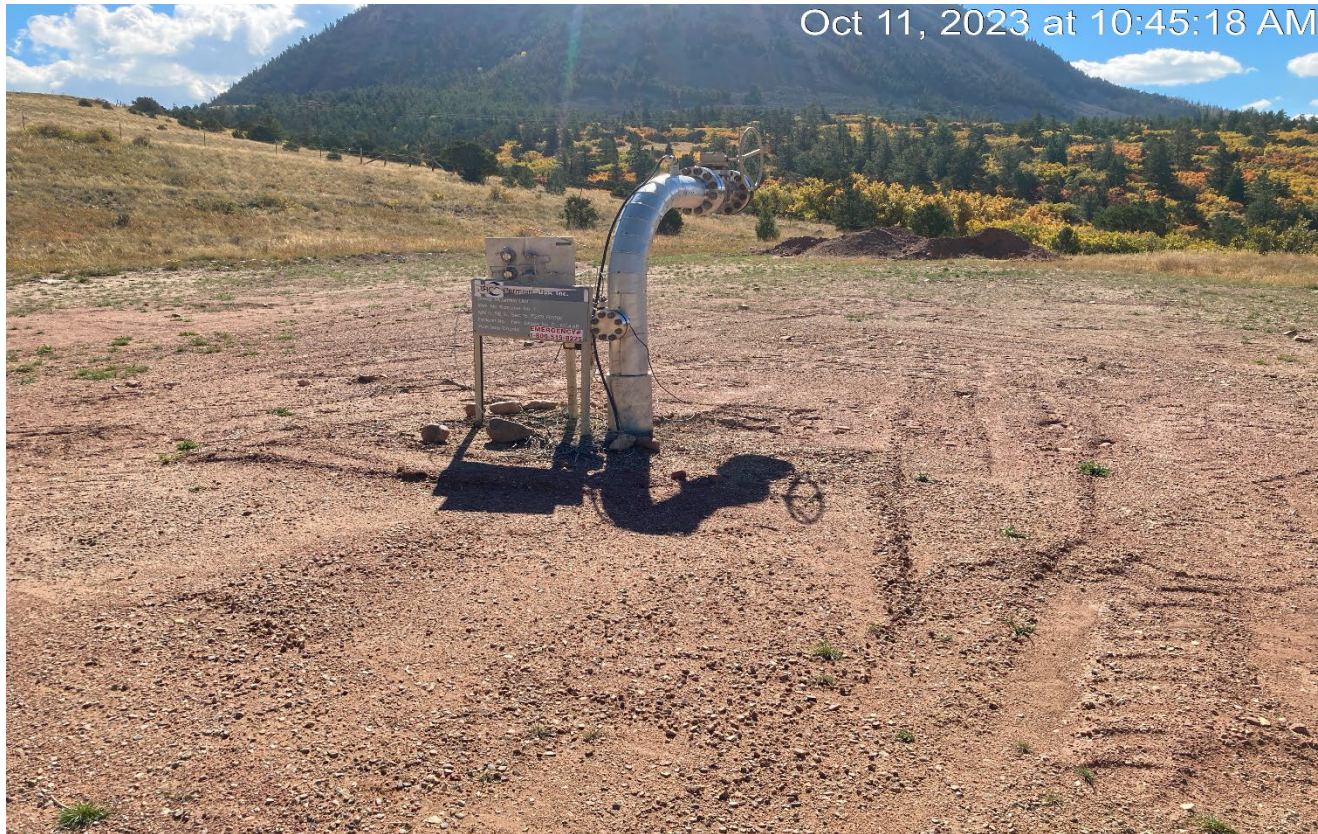
Photo 3. Facing toward the wellsite. The wellhead has been covered up and backfilled. This pipe riser must be removed. All equipment must be removed with 3 months of abandonment.

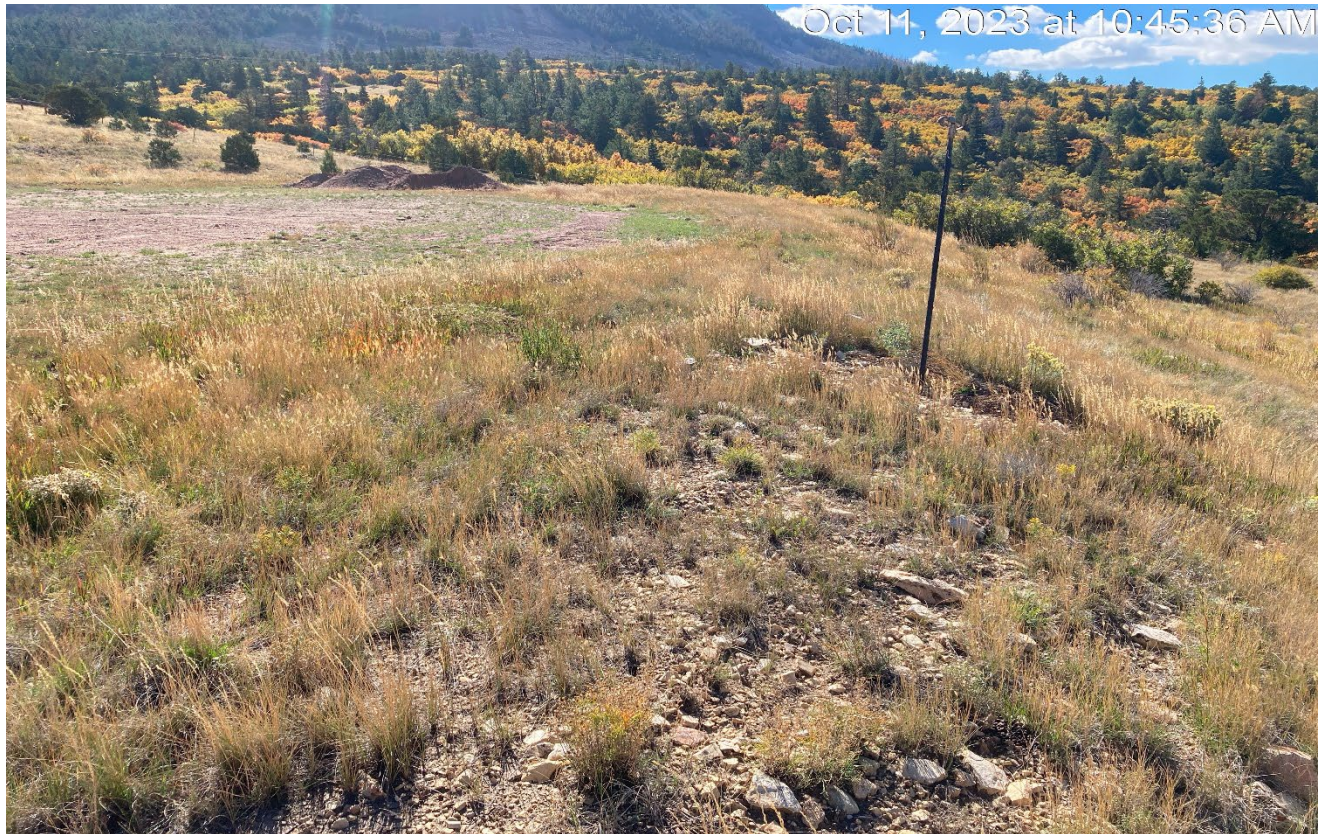
Photo 4. Facing south toward the fill slope which must be recontoured back to the original condition.

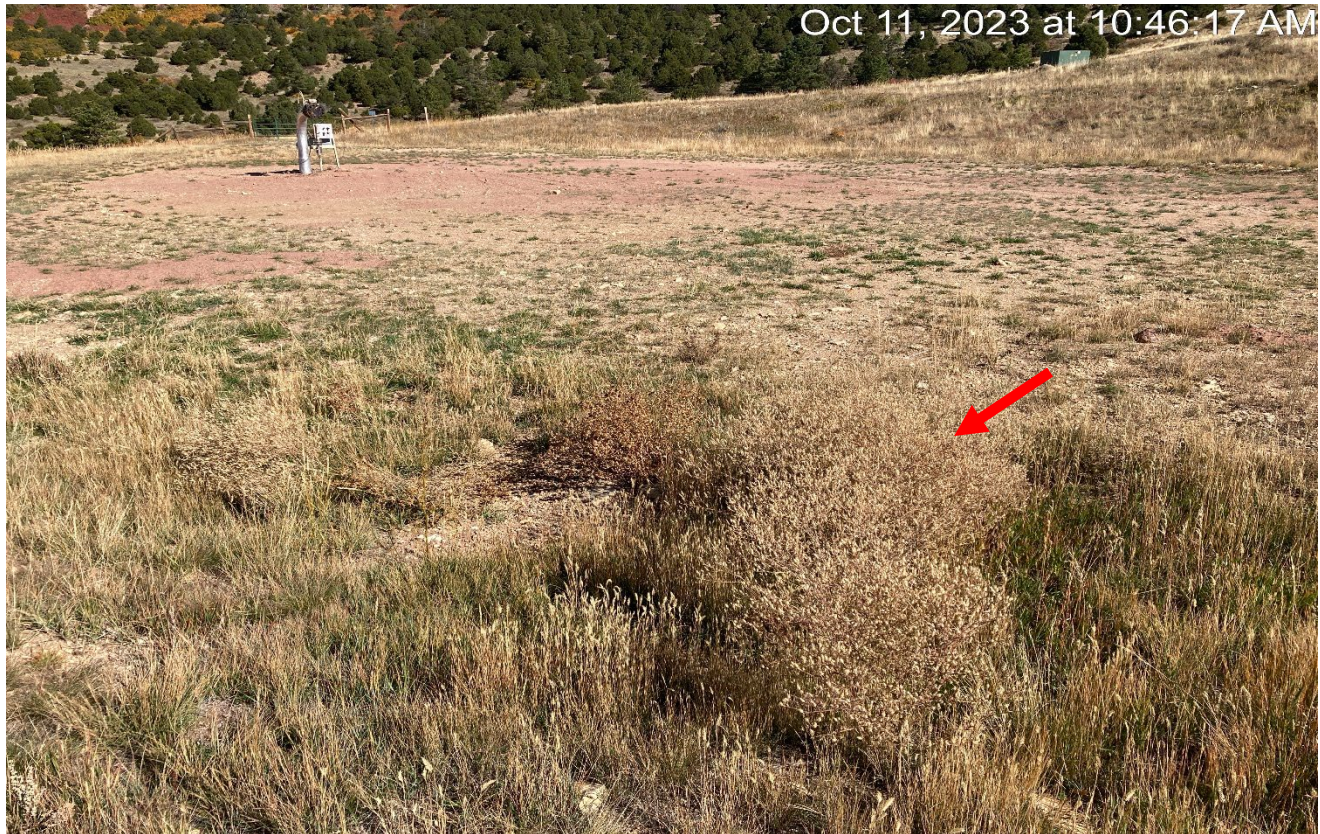
Photo 4. Facing northeast at the location. There are noxious weeds that remains hat have seed heads that must be bagged and removed. Red arrow points to Diffuse knapweed.
