# Interim Reclamation and Stormwater Inspection

Operator: TIMKA RESOURCES LTD - 88370

Location ID: 322914

Inspection Document #: 708200605

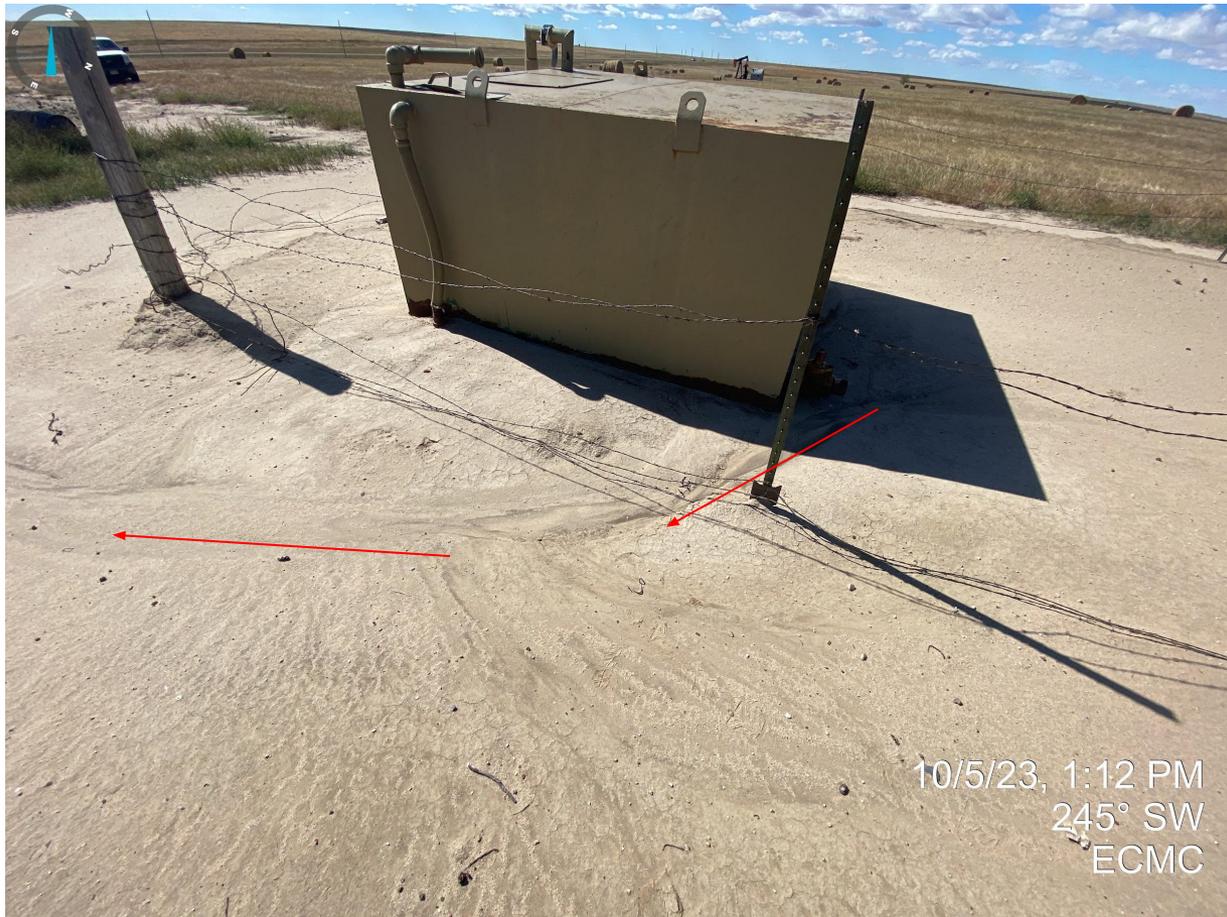
**Photo 1.** This location does not comply with Rule 1002.f. During this inspection, Staff observed rill erosion degradation occurring along the access road; originating near the produced water tank and traveling south along the access road towards HWY 14. Implementation of additional stormwater controls measures/BMPs and/or maintenance is required.

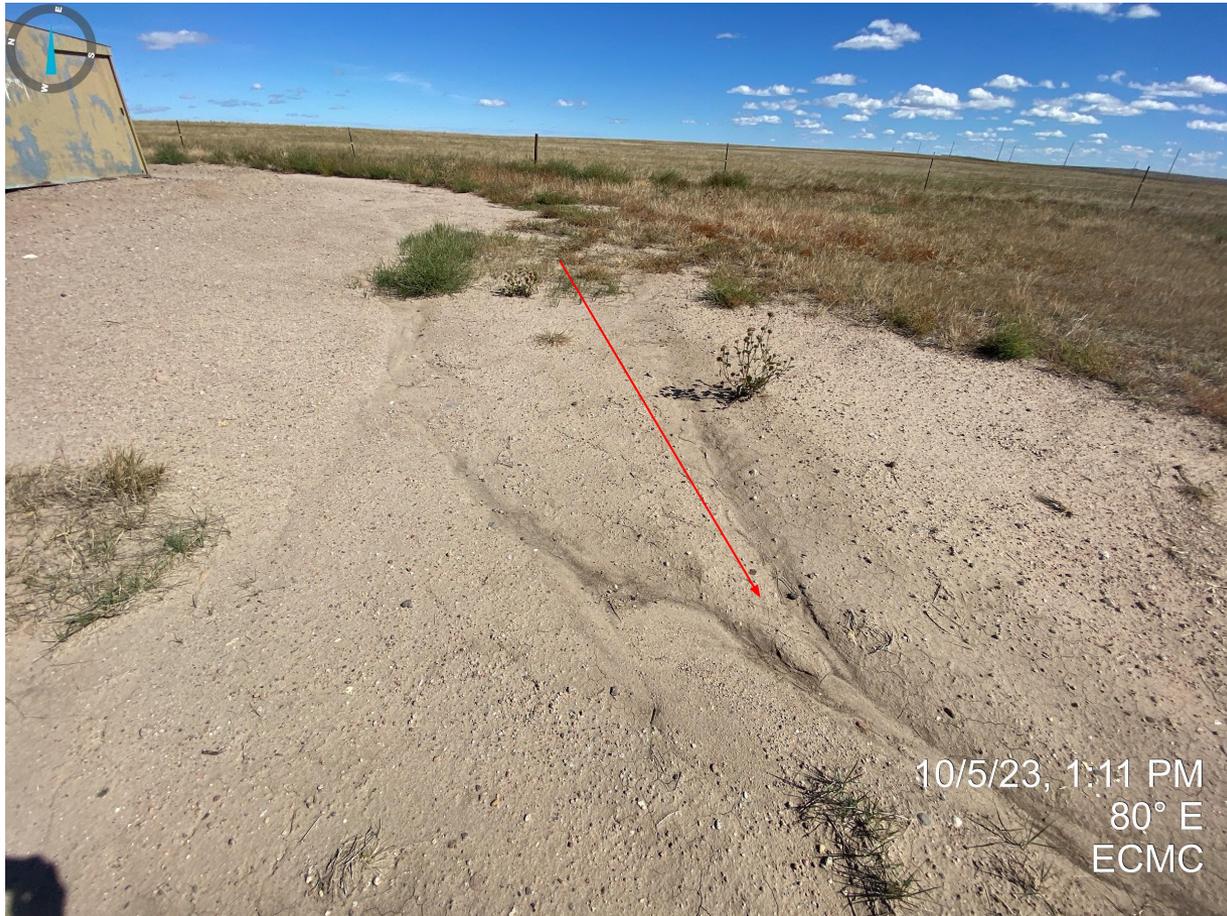
**Photo 2.** See comments in Photo 1.

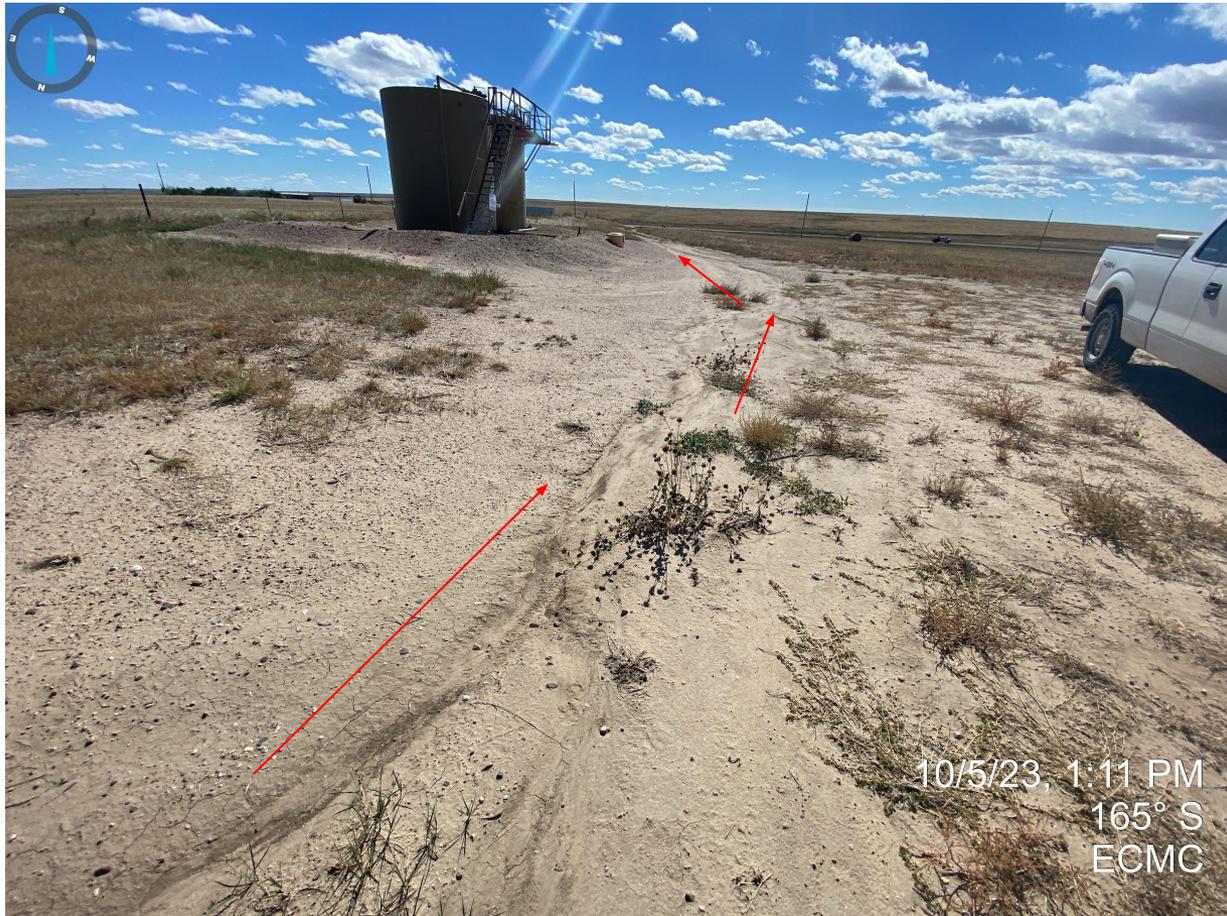
**Photo 3.** See comments in Photo 1.

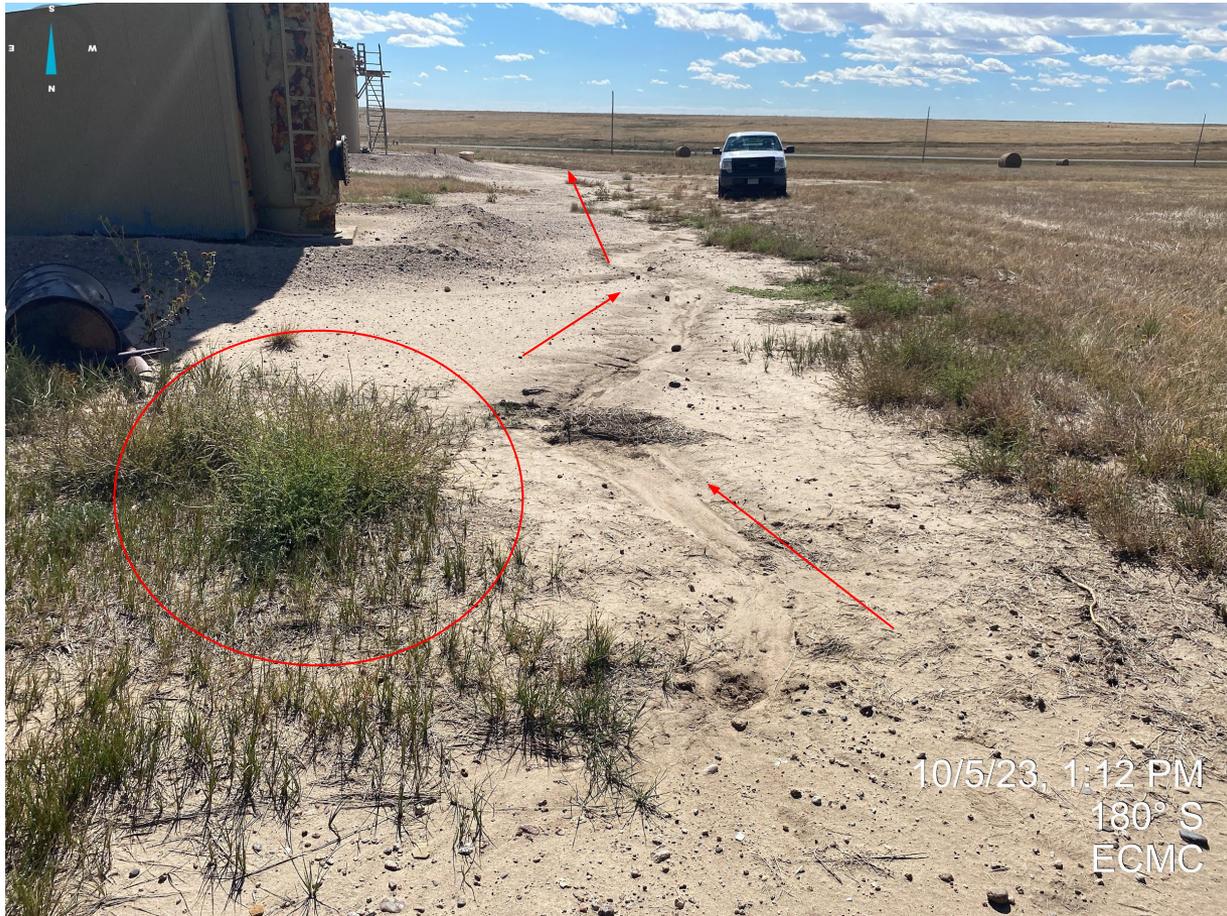
**Photo 4.** See comments in Photo 1. Russian thistle also observed (red circle)

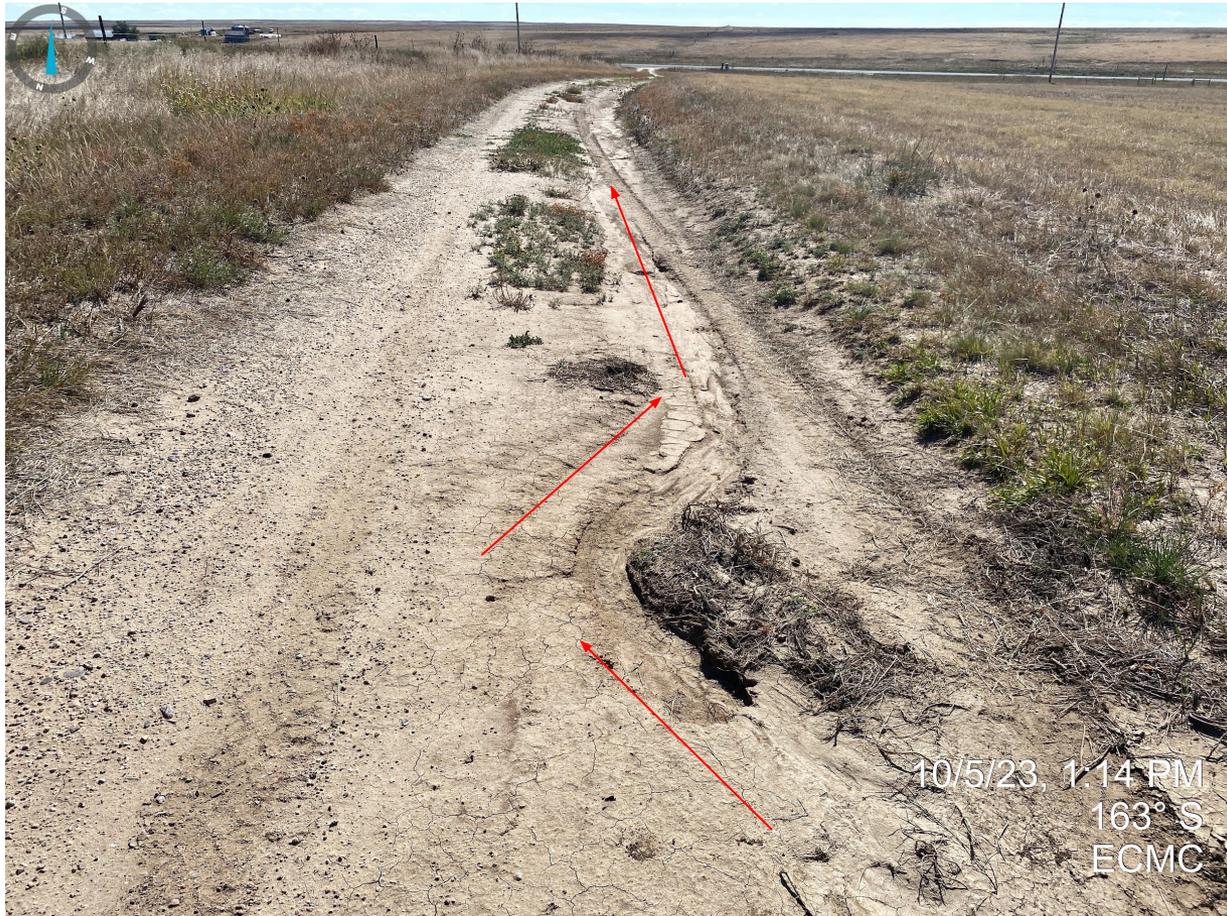
**Photo 5.** See comments in Photo 1.

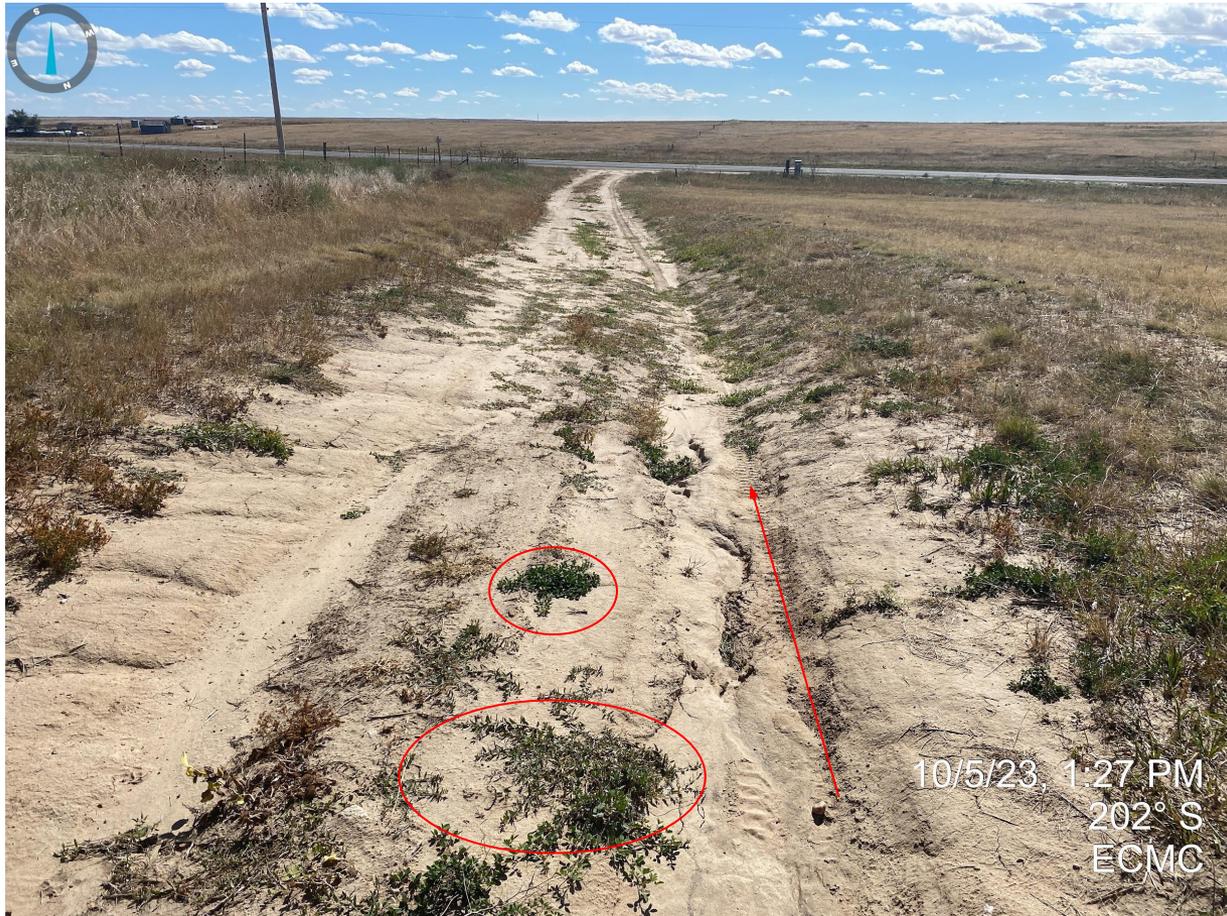
**Photo 6.** See comments in Photo 1. Colorado List C Noxious Weed- Field Bindweed- observed to be growing throughout the access road (example in red circle).

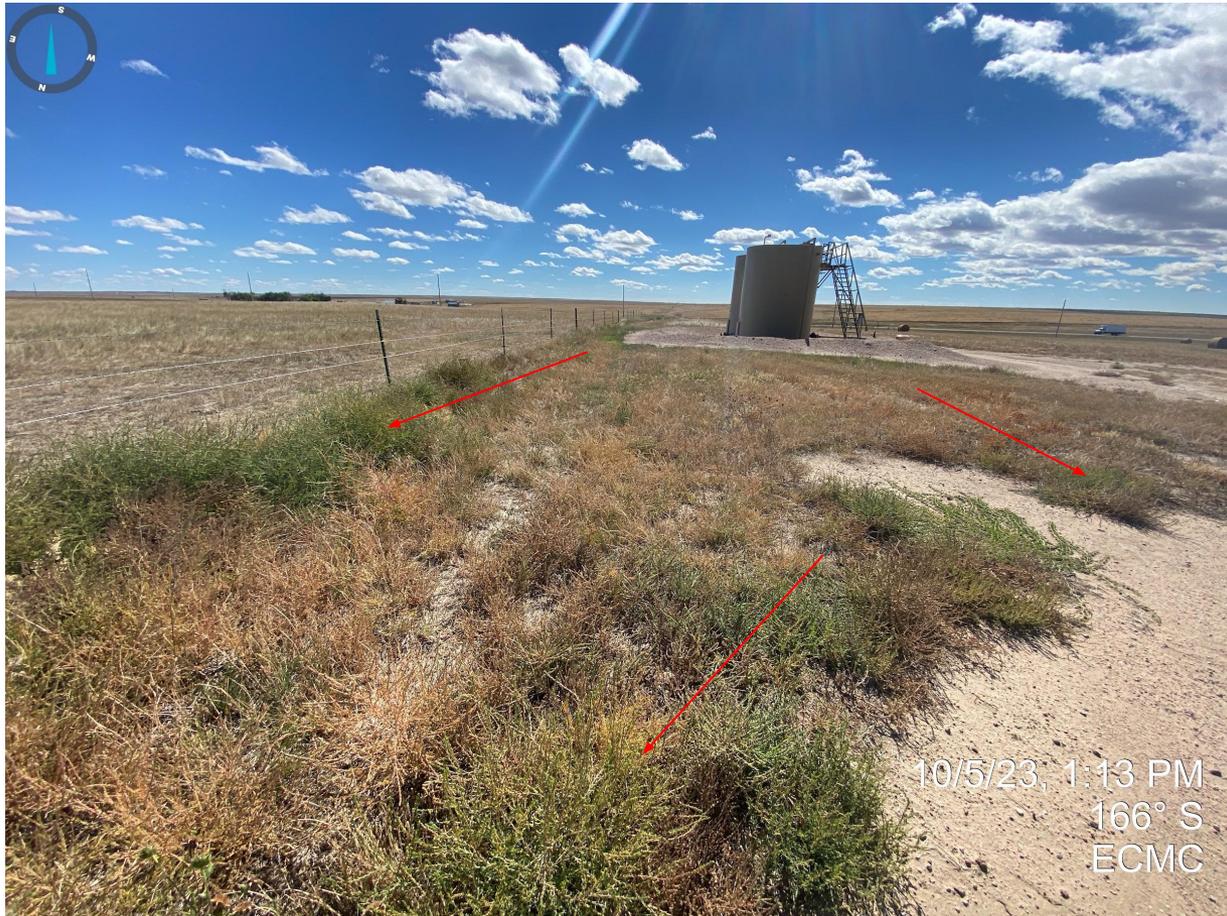
**Photo 7.** Russian thistle observed to be growing near the produced water tank and tank battery.
