# Inspection Photos

**Operator:** CAERUS PICEANCE LLC #10456

**Location ID:** 335455

**Inspection Doc:** 696205336

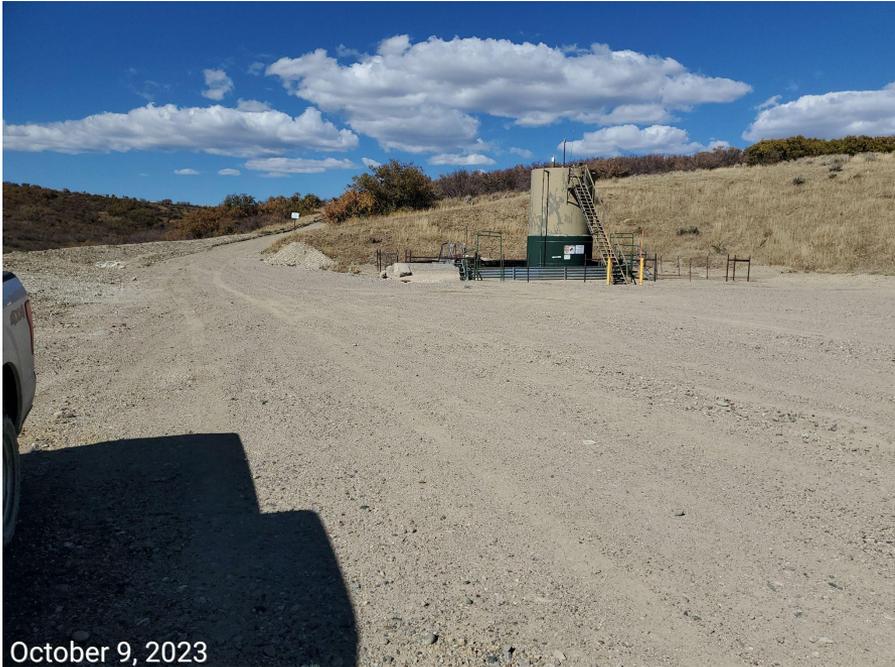
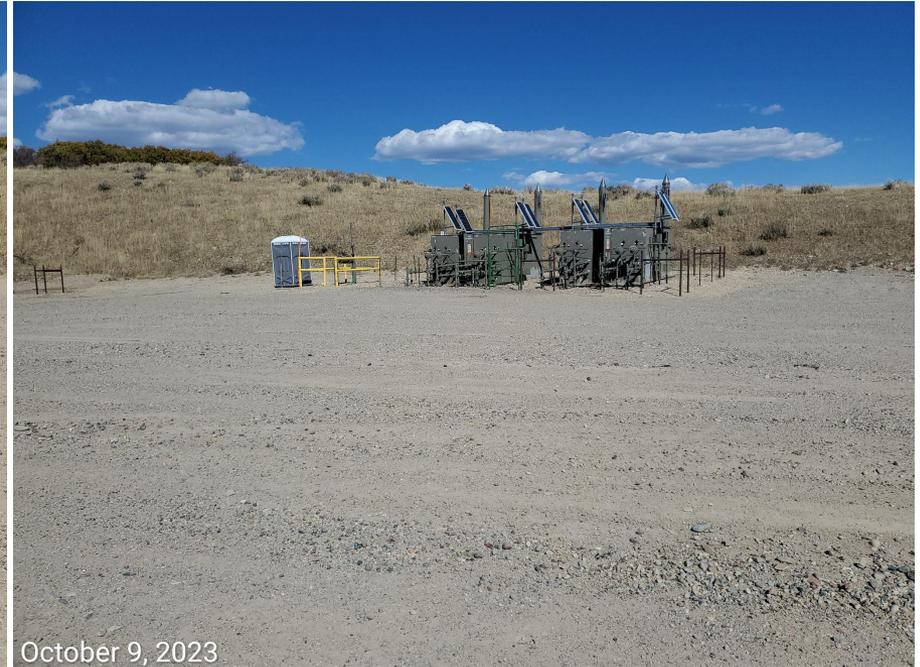
**Photo 1:** Photos 1-2 taken from west end of the working pad surface. Photos provide an overview of the pad from north, northeast, southeast to south.

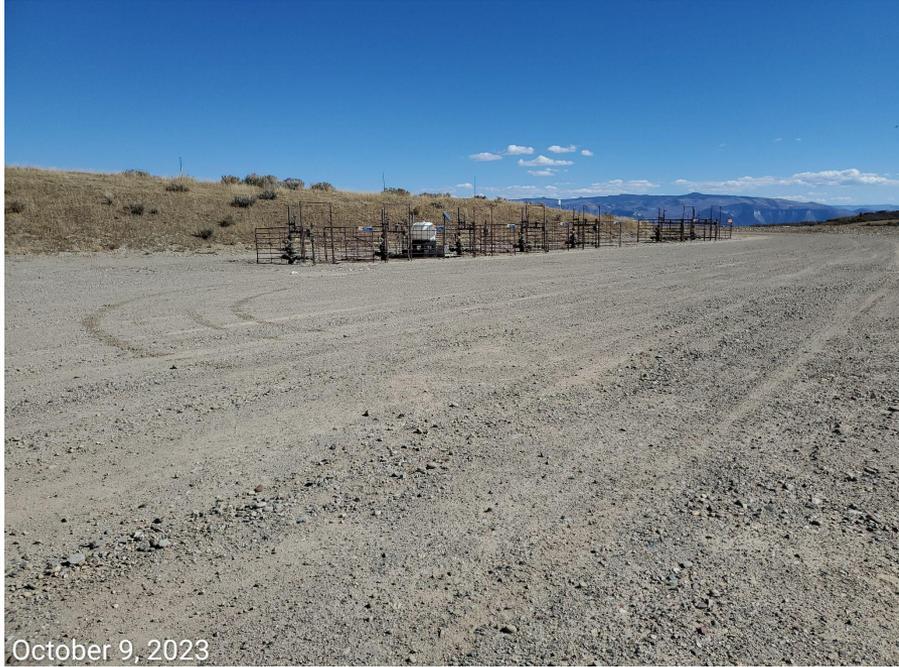
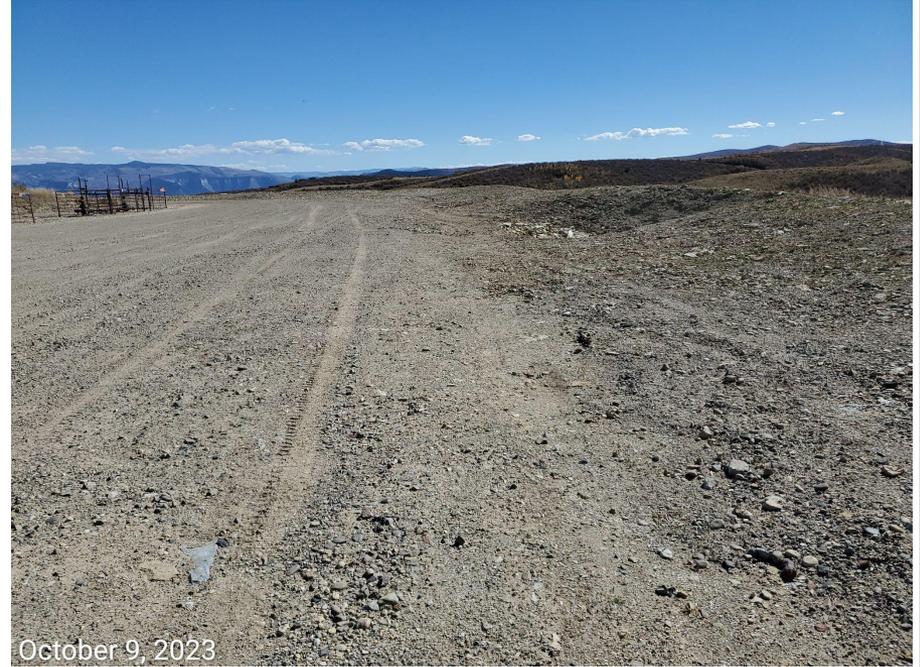
**Photo 2:** See comments under photo 1.

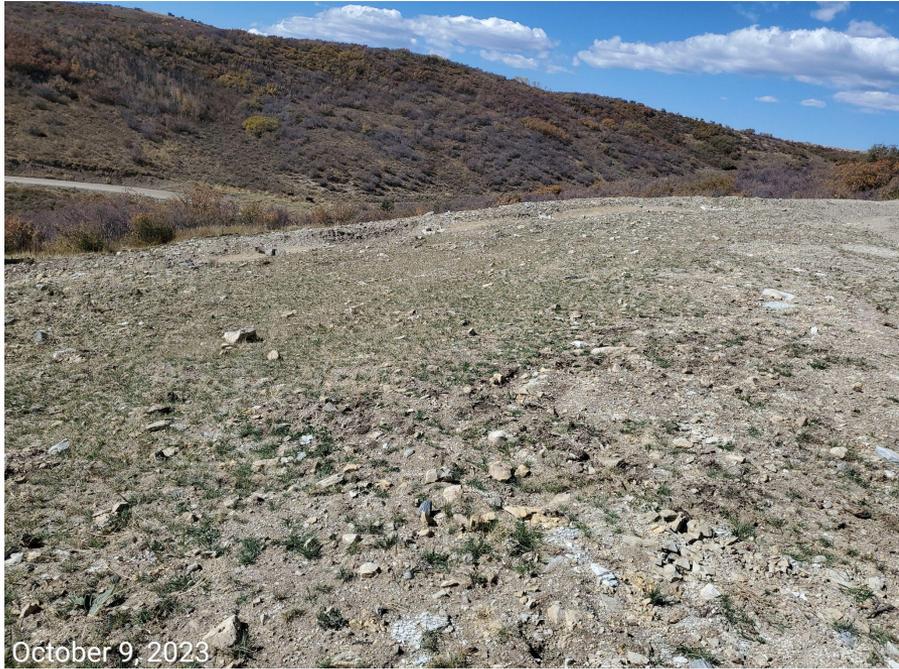
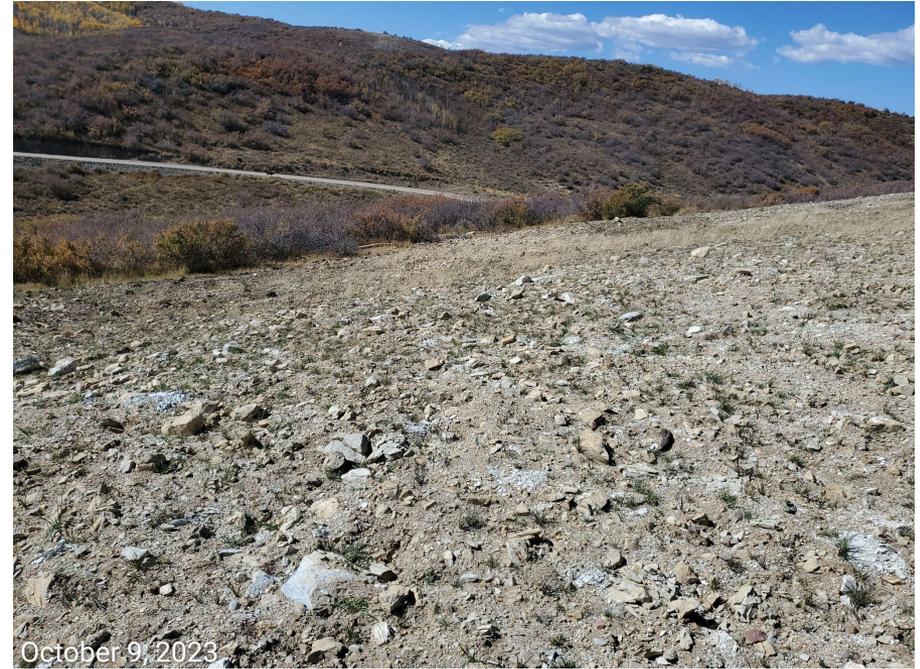
**Photo 3:** Photos taken from the interim areas on the west end of the Location. Photos show reclamation, including recontouring/regrading and revegetation work has been performed on areas not needed for production.

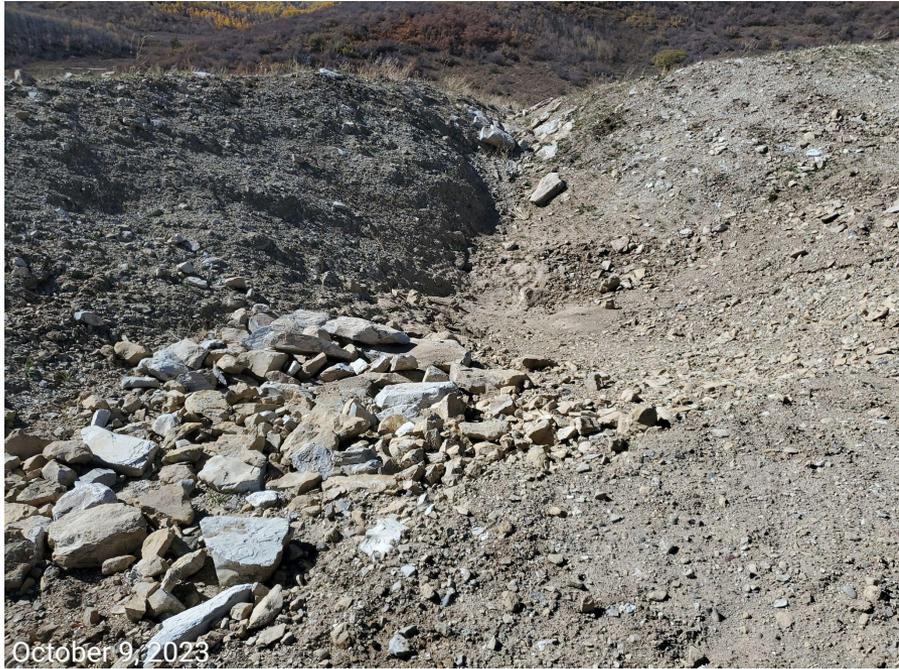
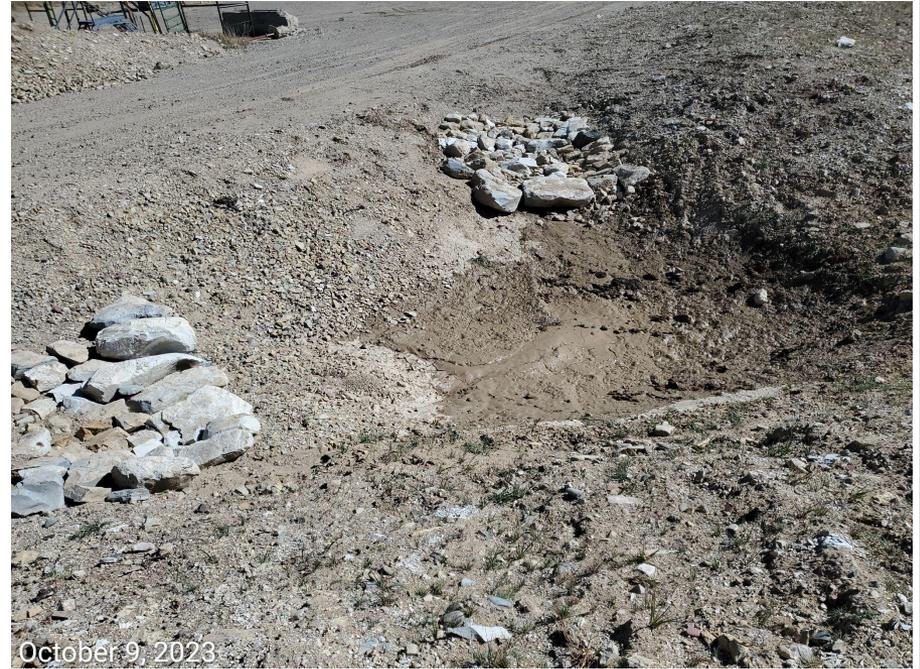
**Photo 4:** Photos show the two sediment traps constructed along the western working pad surface.

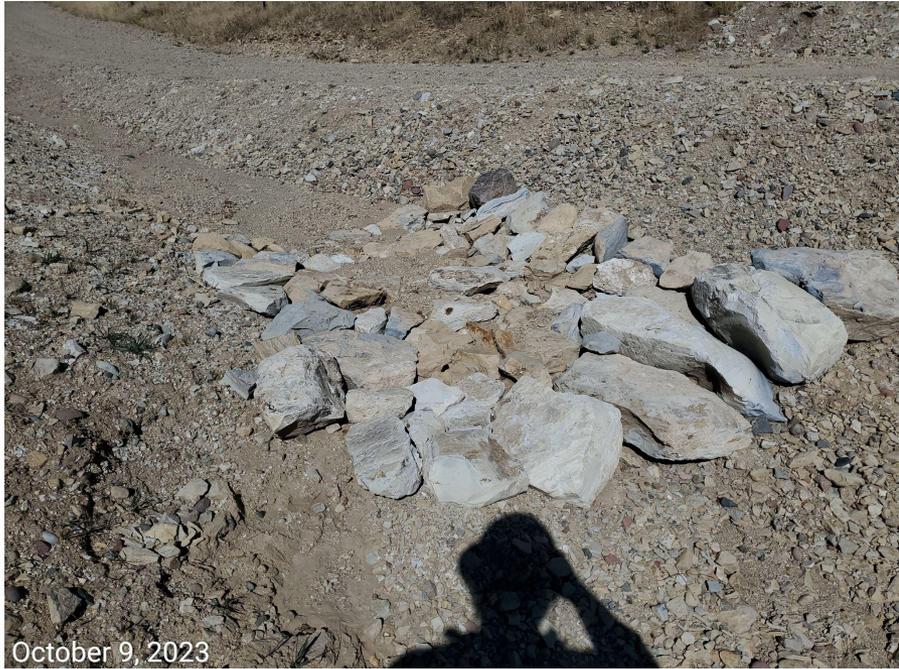
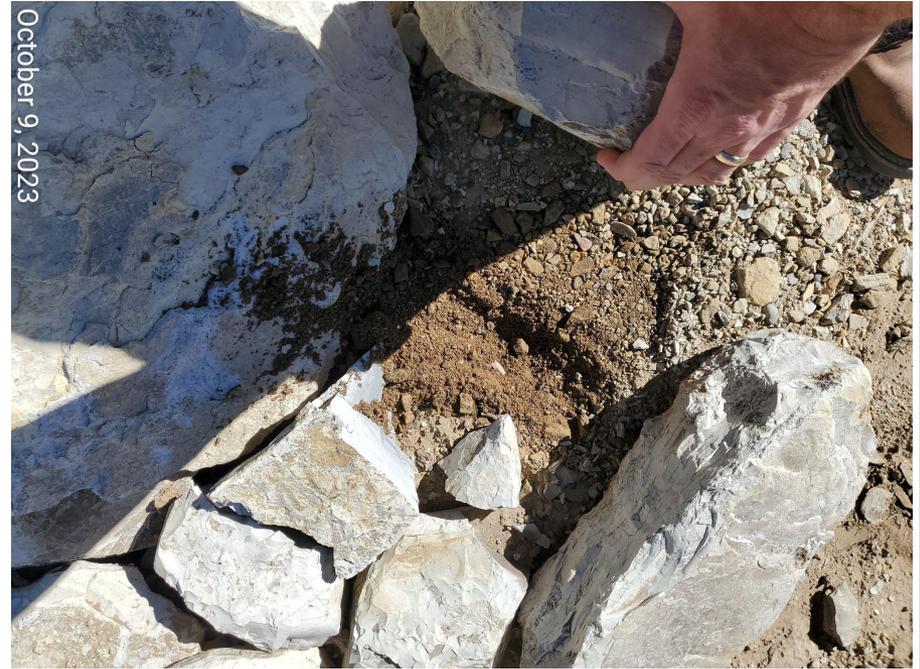
**Photo 5:** Photo taken from the sediment trap on the western working pad surface. Photo example showing inlet/outlet armoring has not been constructed in conjunction with geotextile lining per good engineering practices.

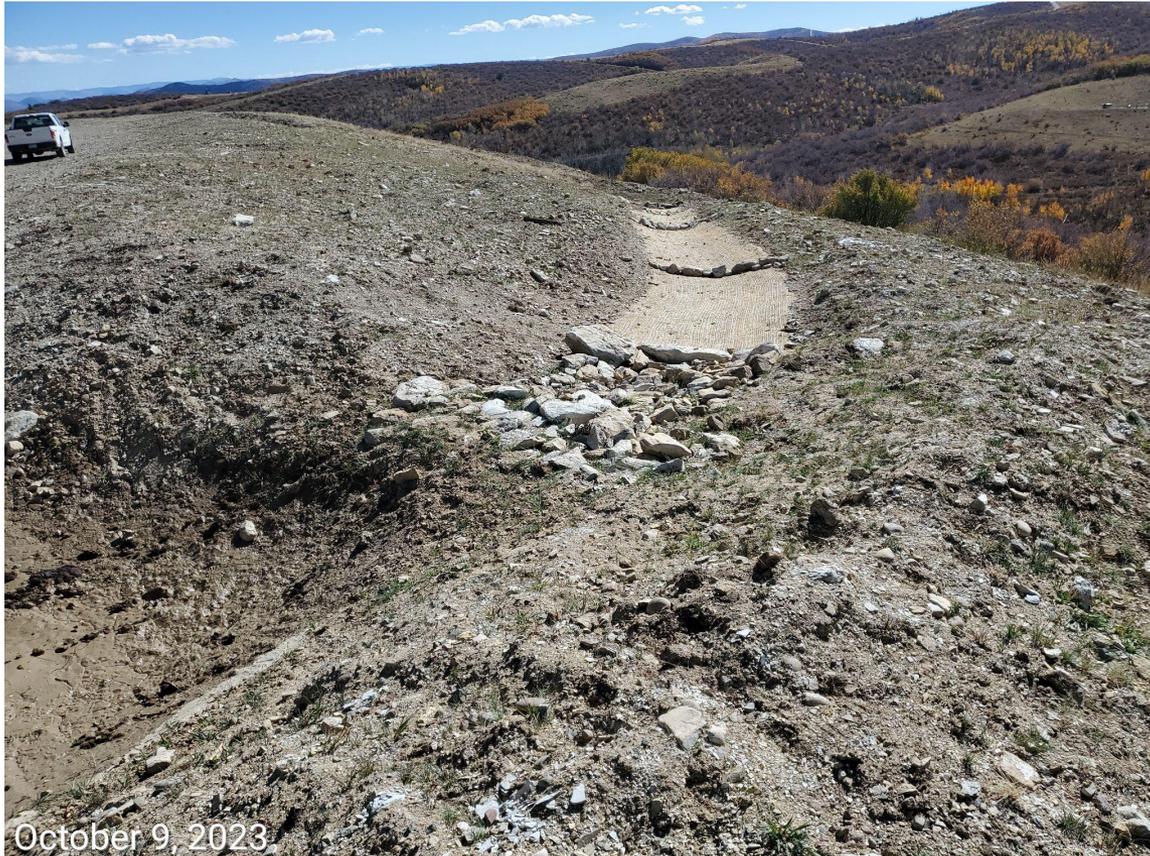
**Photo 6:** Photo taken from the northwestern end of the working pad, facing south. Photo example showing a diversion ditch leading from the sediment trap. Ditch has been lined with erosion blankets in conjunction with rock checks to mitigate stormwater velocity.

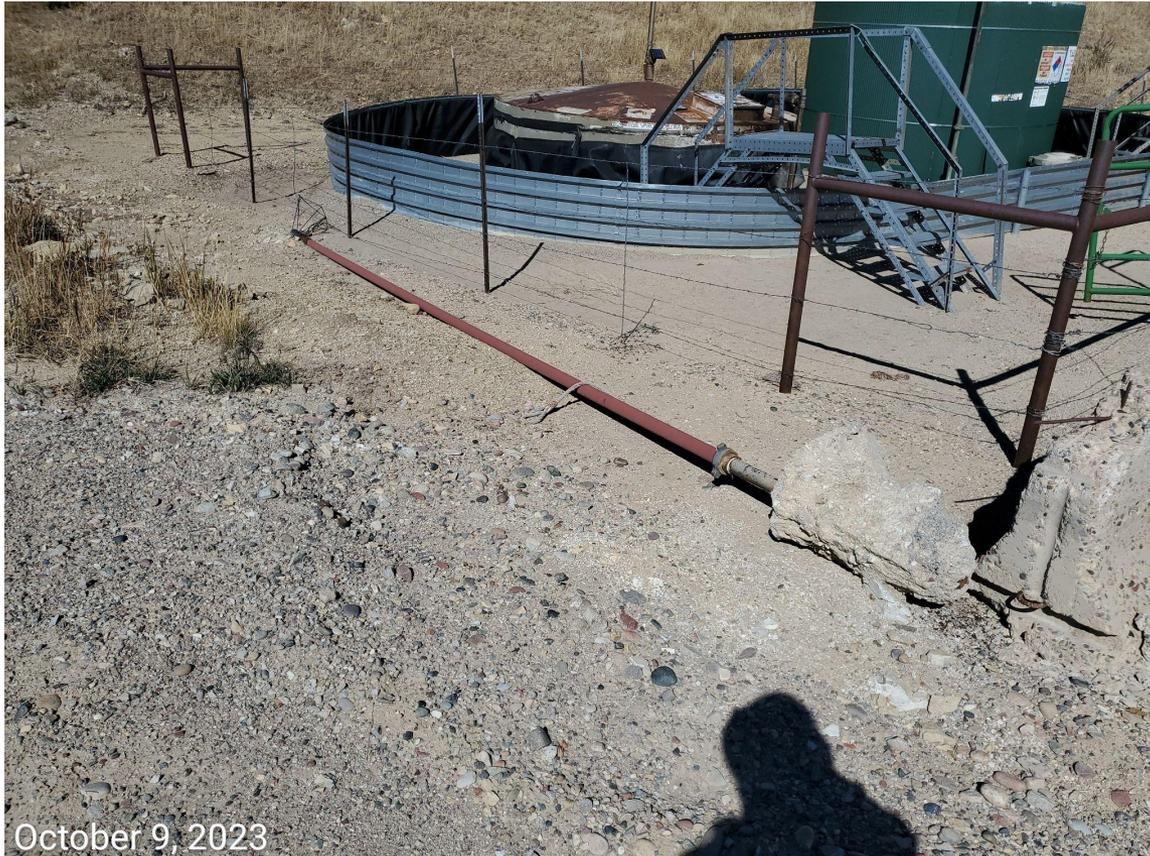
**Photo 7:** Photo shows unused flagpole stored next to the tank battery, on the north end of the Location.

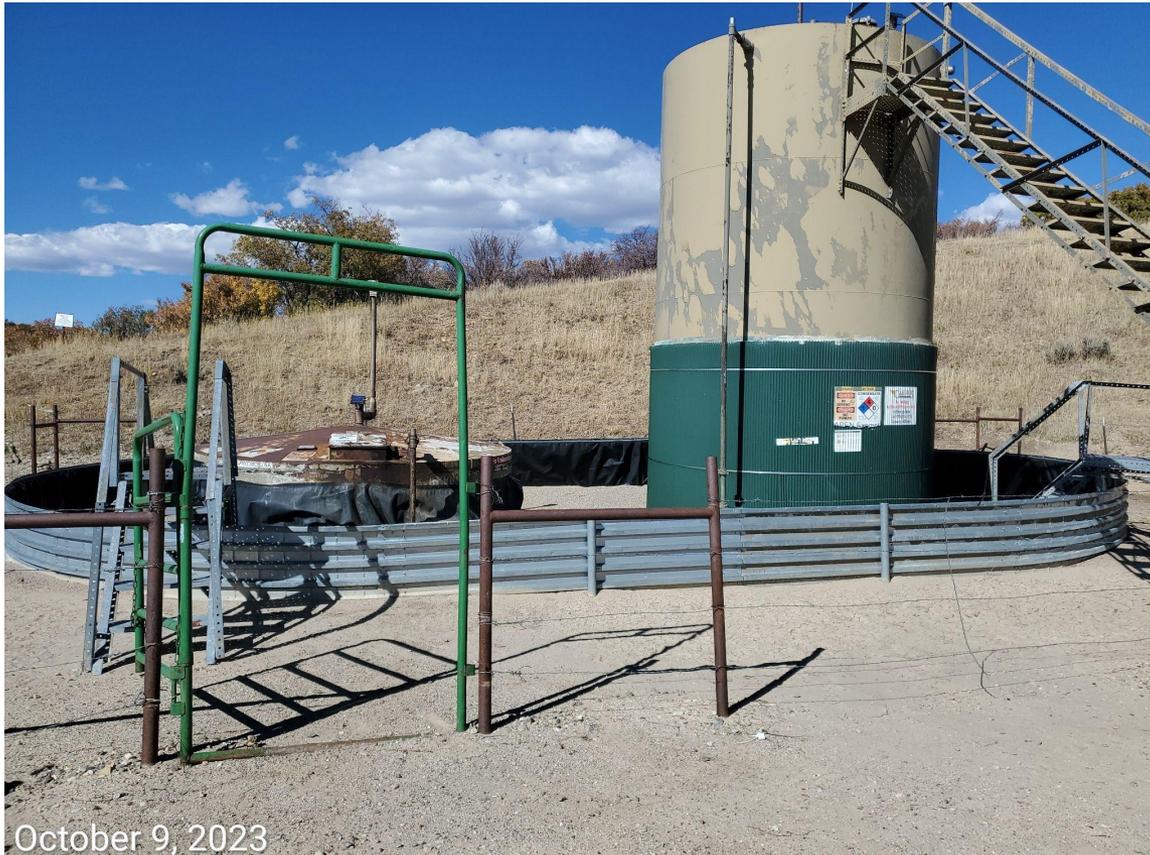
**Photo 8:** Tank battery facility, north end of the Location. Tank battery signage not posted pursuant to Rule 605.e

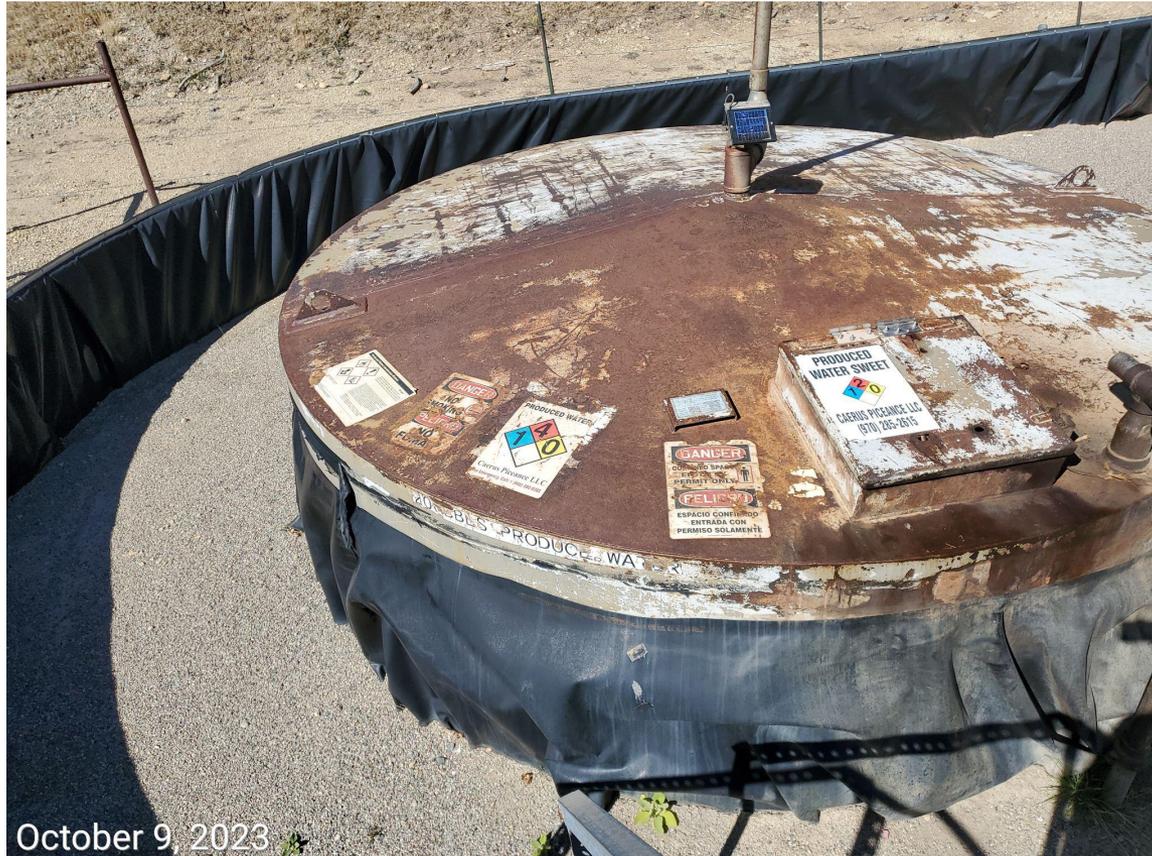
**Photo 9:** Photo taken from the tank battery facility. Capacity labeling on tank no longer legible.

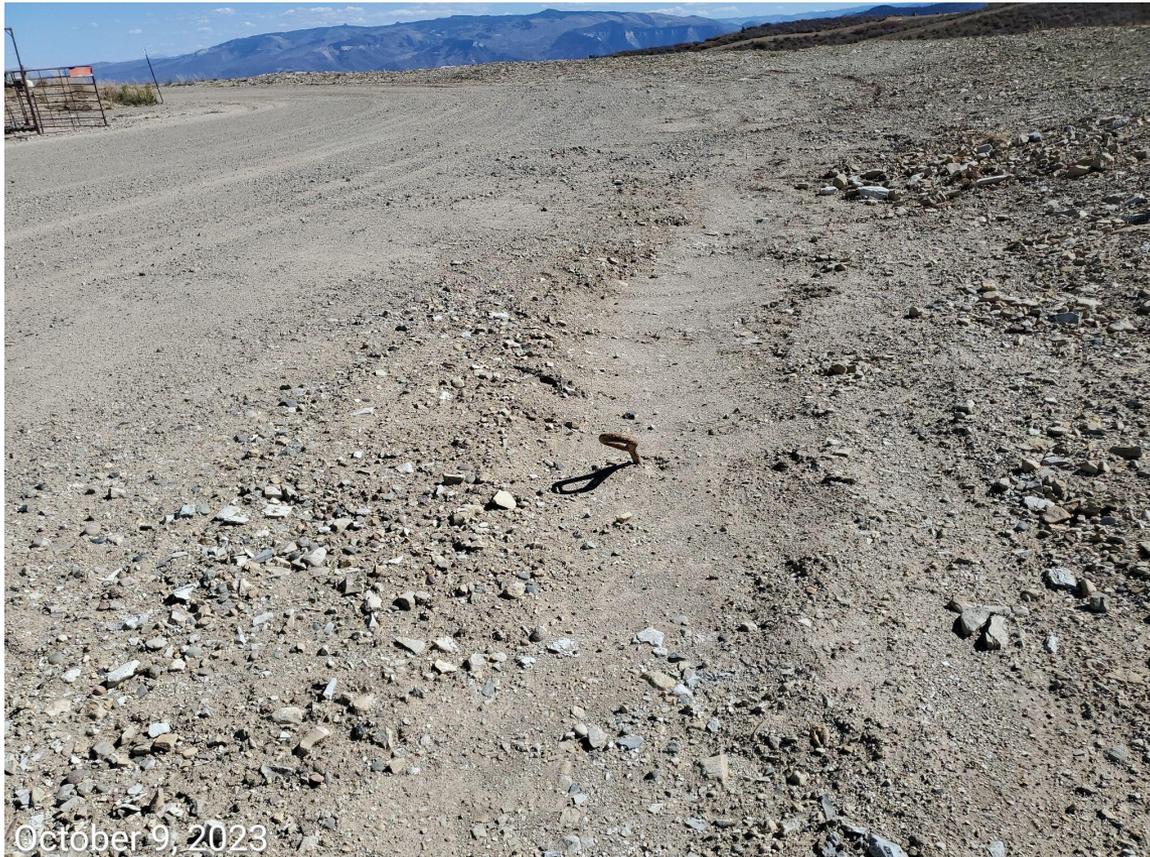
**Photo 10:** Photo taken from the southwest end of the working pad. Photo shows unmarked anchor.
