Inspection Photos

Location Name: TEP Rocky Mountain LLC SAVAGE SR 12-9 Pad

Location # 335043

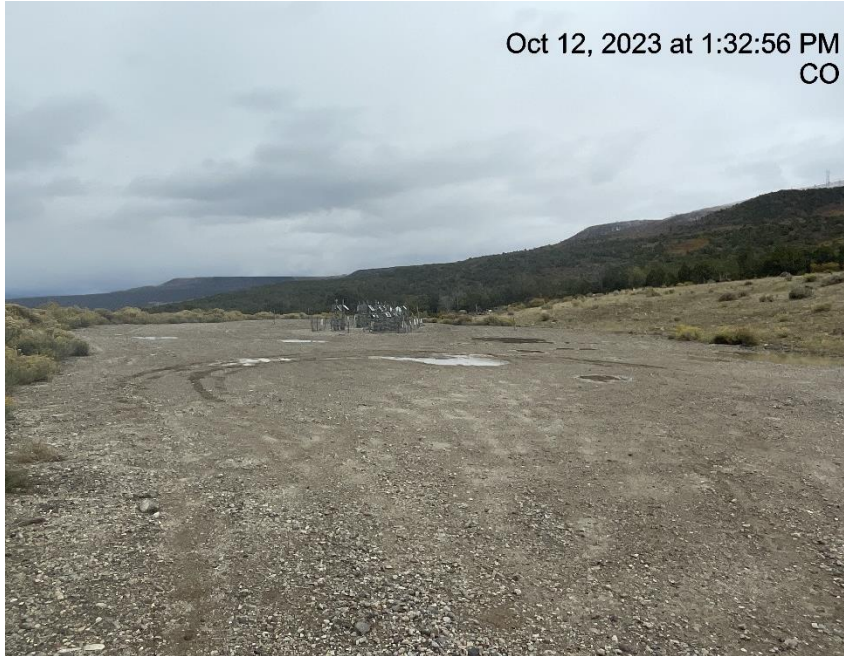
Photo # 2693 From entrance to location

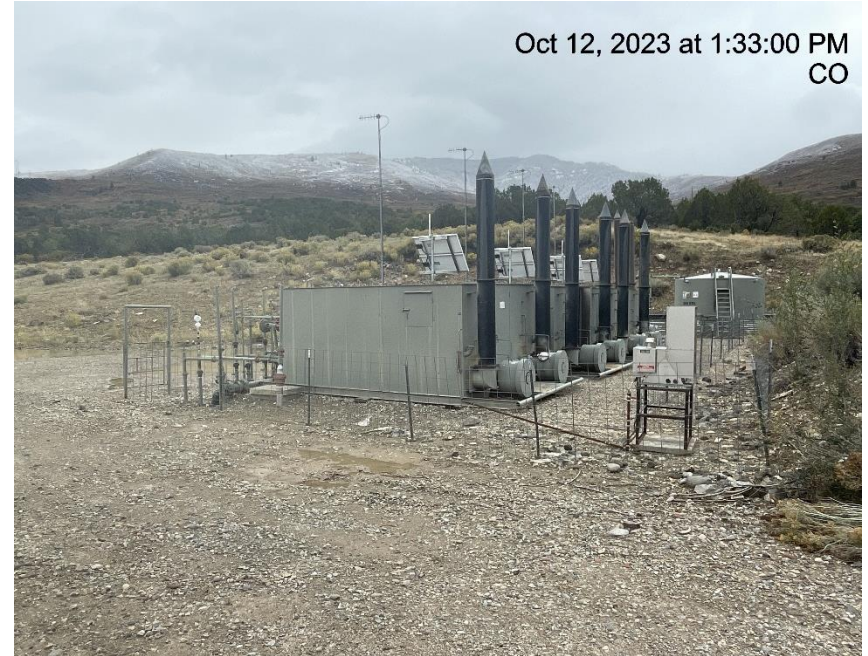
Photo # 2694 From entrance to location

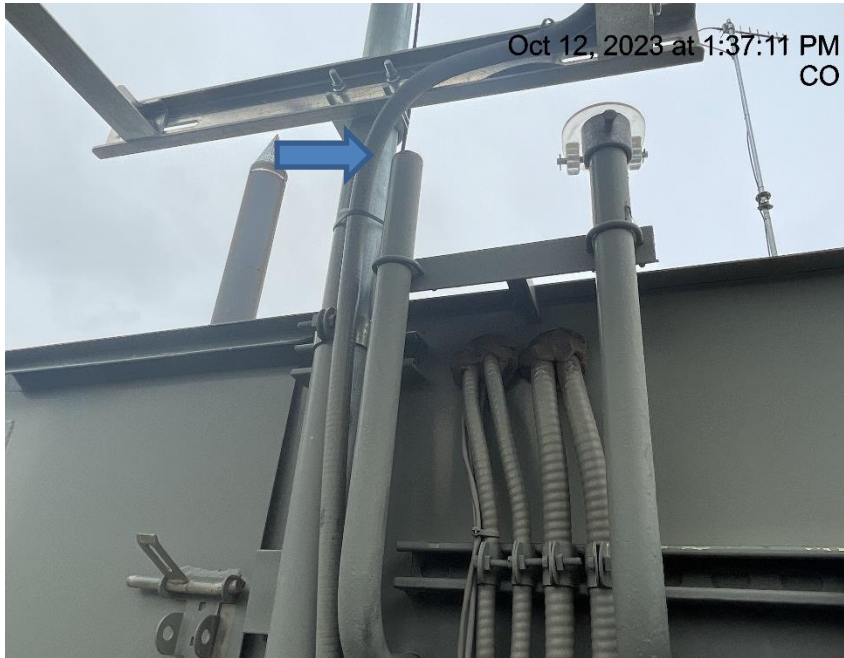
Photo # 2701 SR 411-9 rupture disk vent line lacks cap

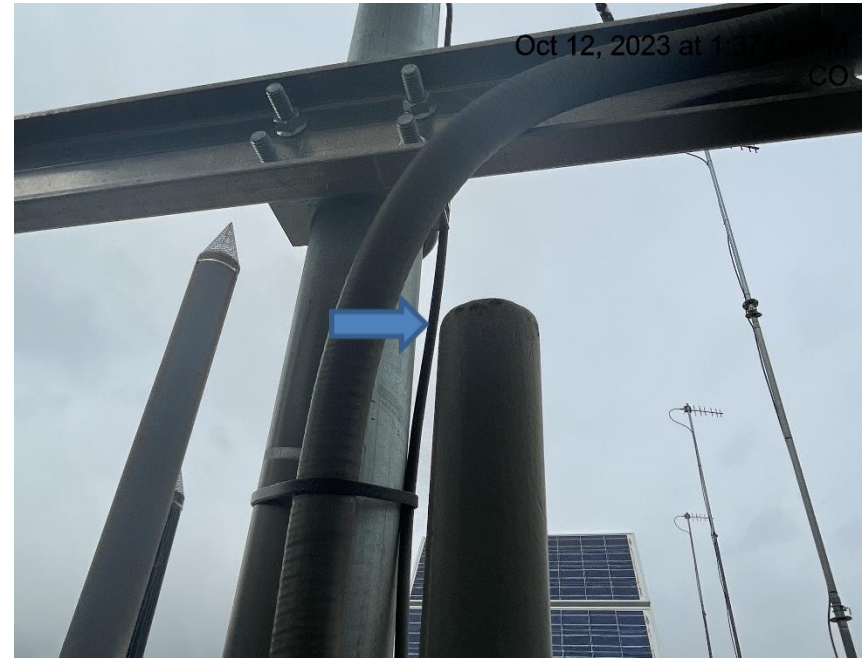
Photo # 2702 SR 411-9 rupture disk vent line lacks cap

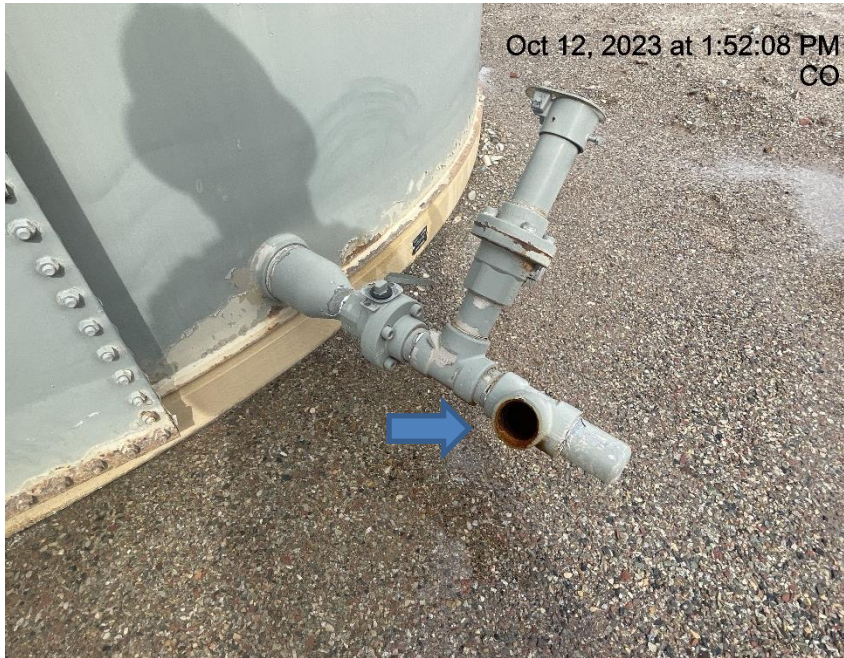
Photo # 2703 Open ended load line
