Interim Reclamation and Stormwater Inspection

October 4 and 11, 2023

Location ID: 456651

Inspection Document #: 697504884

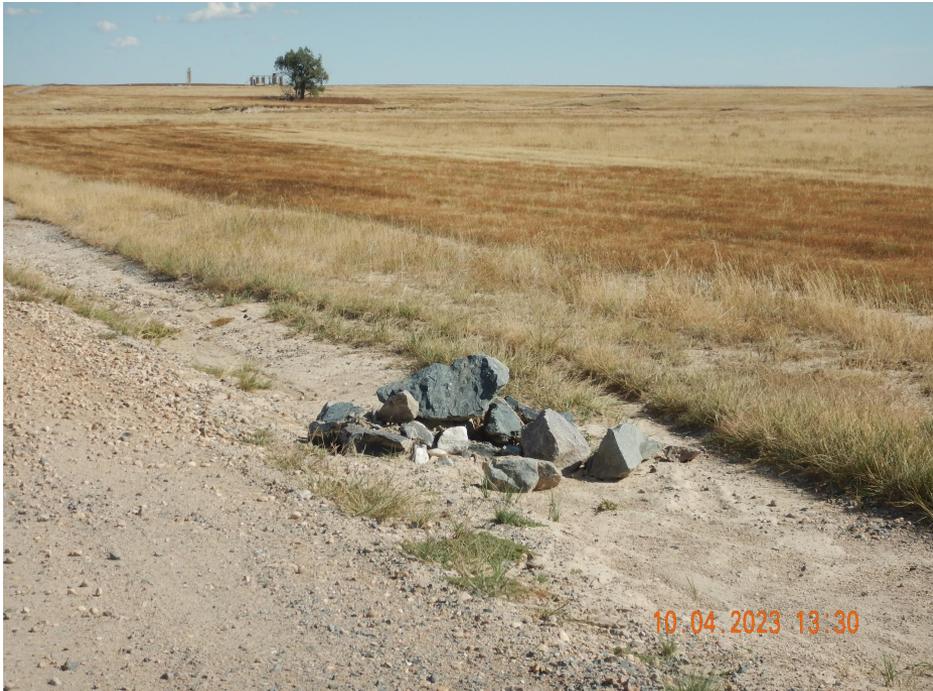
Photo 1. Photo taken from a portion of the access road, facing East. Photo illustrates a check dam BMP that has not been installed per good engineering practices. It appears rocks were dumped in the ditch without being properly keyed in, which means the crest and weir are not to specifications. Also, there does not appear to be any geotextile under the check dam.

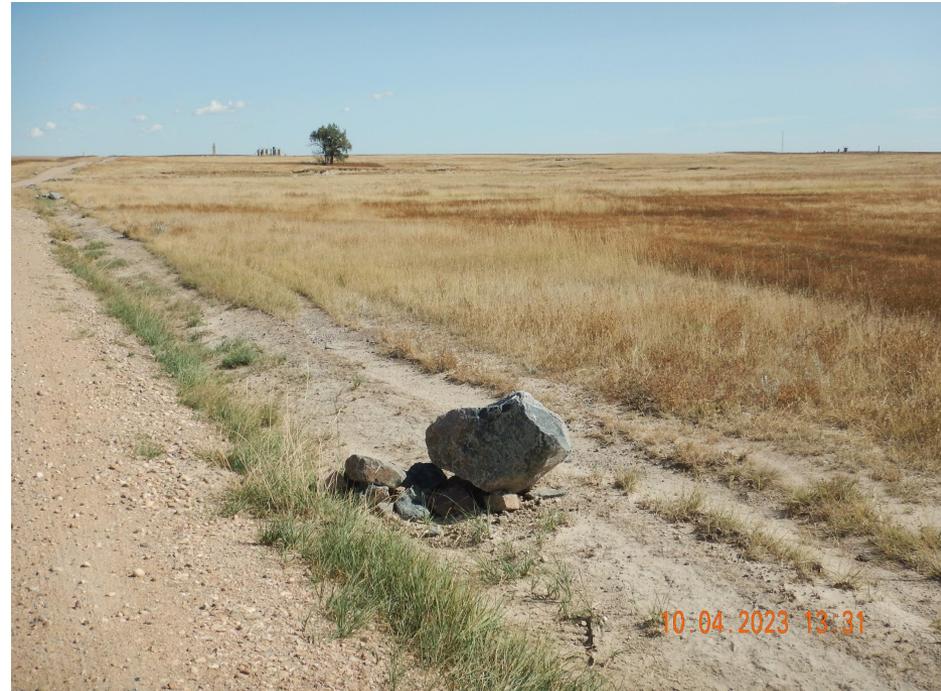
Photo 2. Photo taken from a portion of the access road, facing East. See comments under Photo 1.

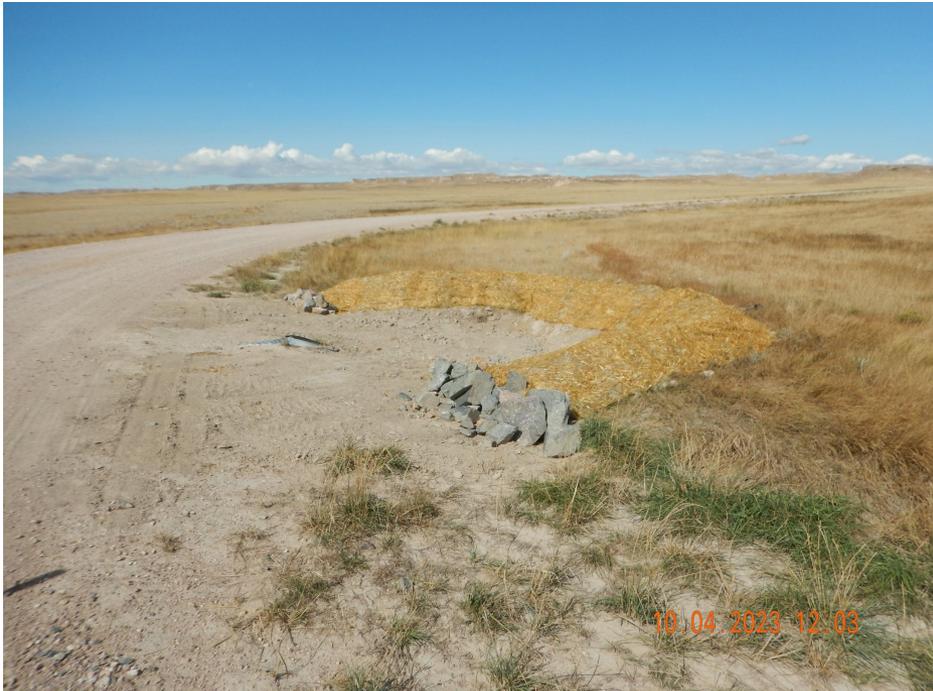
Photo 3. Photo taken from a portion of the access road, facing Northwest. Photo illustrates stormwater BMP repairs along the inlet area of a culvert crossing. The BMP is an improvement from the previous condition but there are additional engineering practices that shall be implemented- see Photo 4.

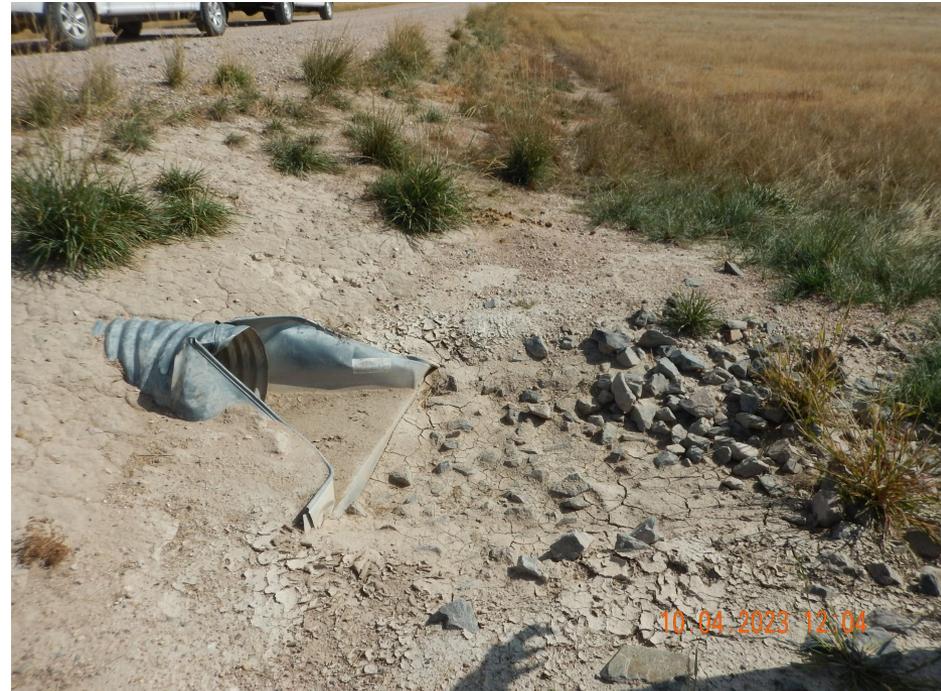
Photo 4. Photo taken from the outlet of the culvert, facing South. The outlet area of the culvert lacks sufficient stabilization. Sediment discharge was observed out into the adjacent areas beyond the outlet area.

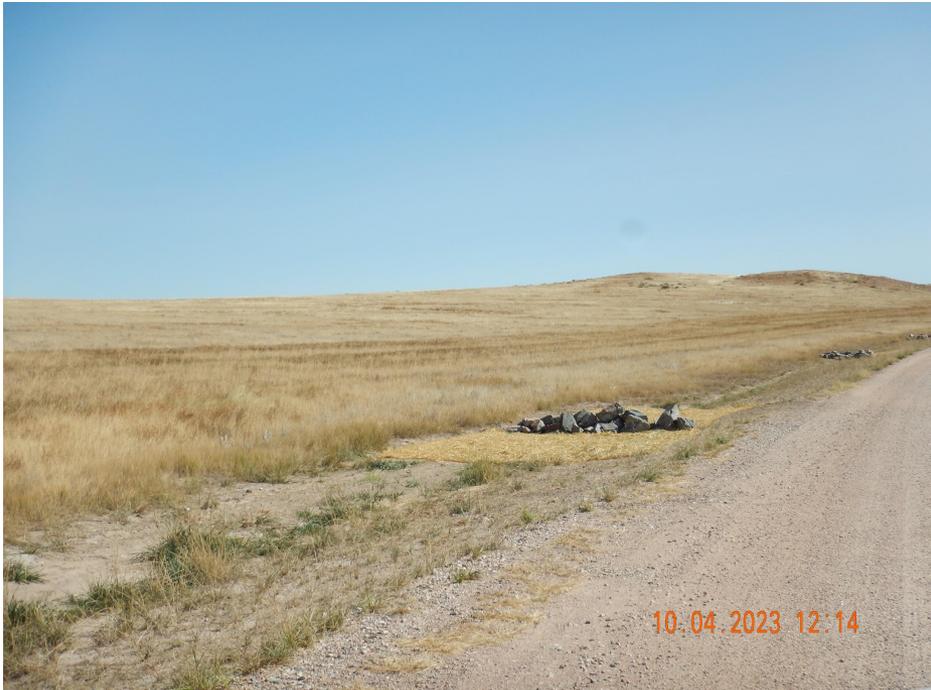
Photo 5. Photo taken from a portion of the access road, facing South. Photo illustrates stormwater BMP repairs for check dams but the check dam is not installed properly- specifically the crest and weir are not to specification. Also, it does not appear that geotextile was installed under the check dams.

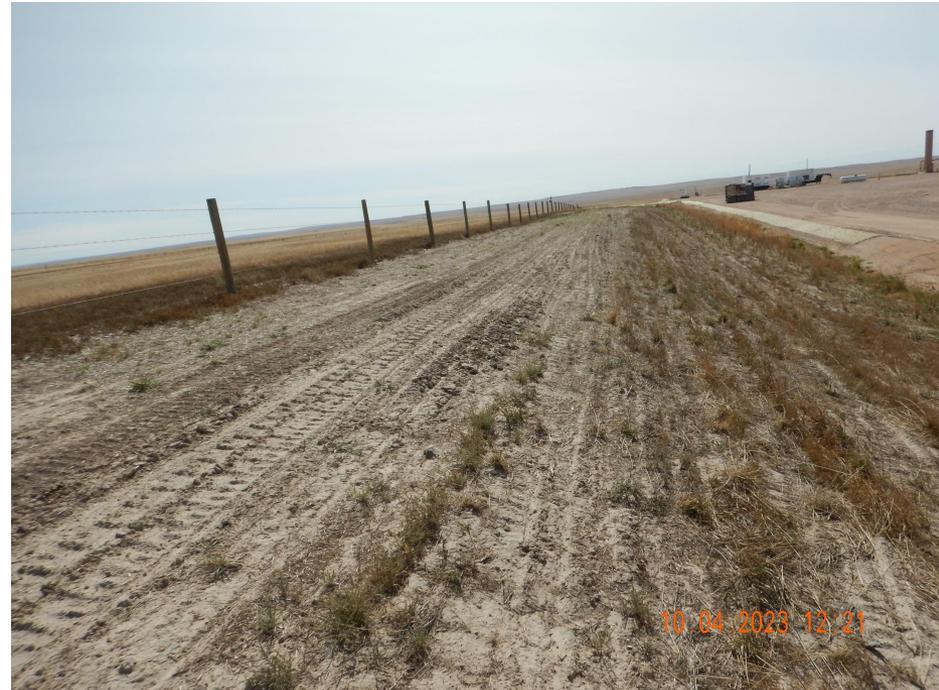
Photo 6. Photo taken from the eastern perimeter of location, facing South. Photo illustrates the cut slope has been seeded. Germination of desirable species was observed but remains in-process.

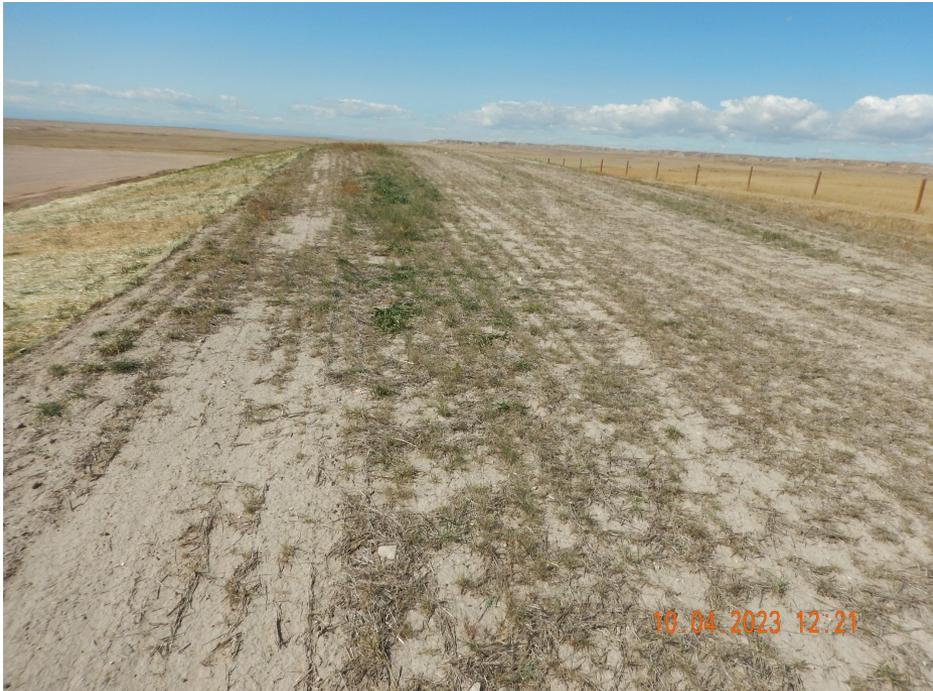
Photo 7. Photo taken from the topsoil stockpile, facing West. Photo illustrates germination of desirable species was observed but remains in-process.

Note- erosion control blankets were not properly trenched along the southern slope.

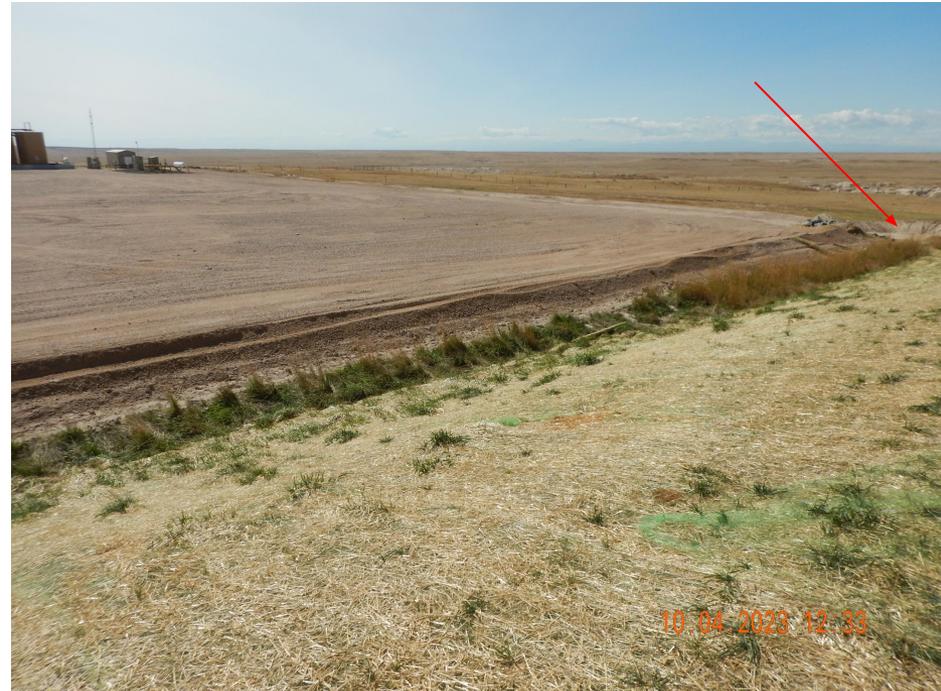
Photo 8. Photo taken from the topsoil stockpile, facing Southwest. Photo illustrates the Operator has installed another sediment trap. Specification on the design are pending per the engineered stamped Stormwater Management Plan.

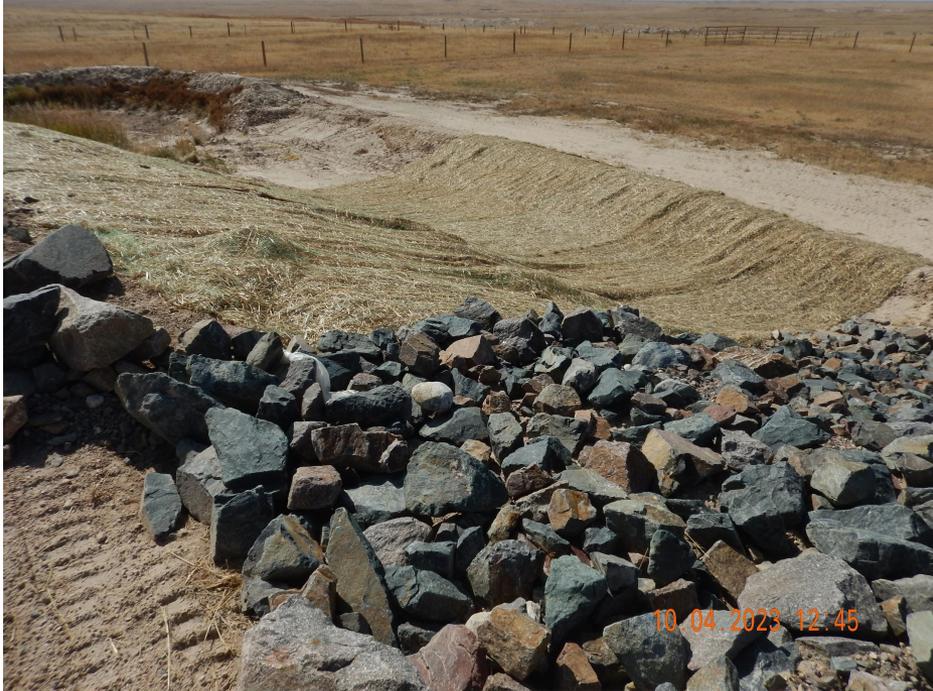
Photo 9. Photo taken from the southwestern well pad, facing Southwest. Photo illustrates erosion control blankets have been installed but were not properly trenched- see Photo 10.

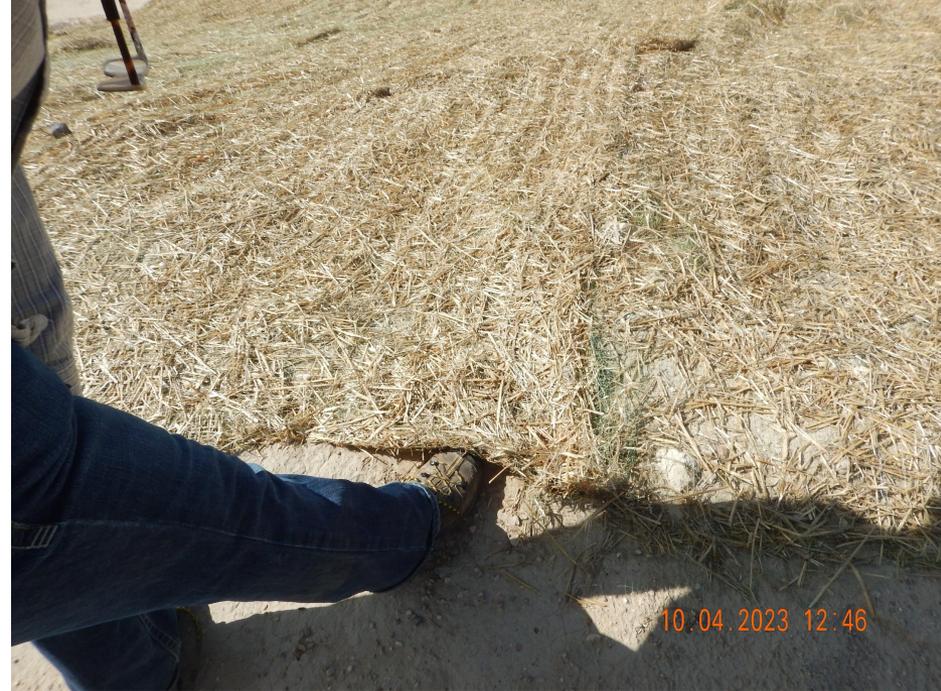
Photo 10. Photo of erosion control blanket that has not been properly trenched.

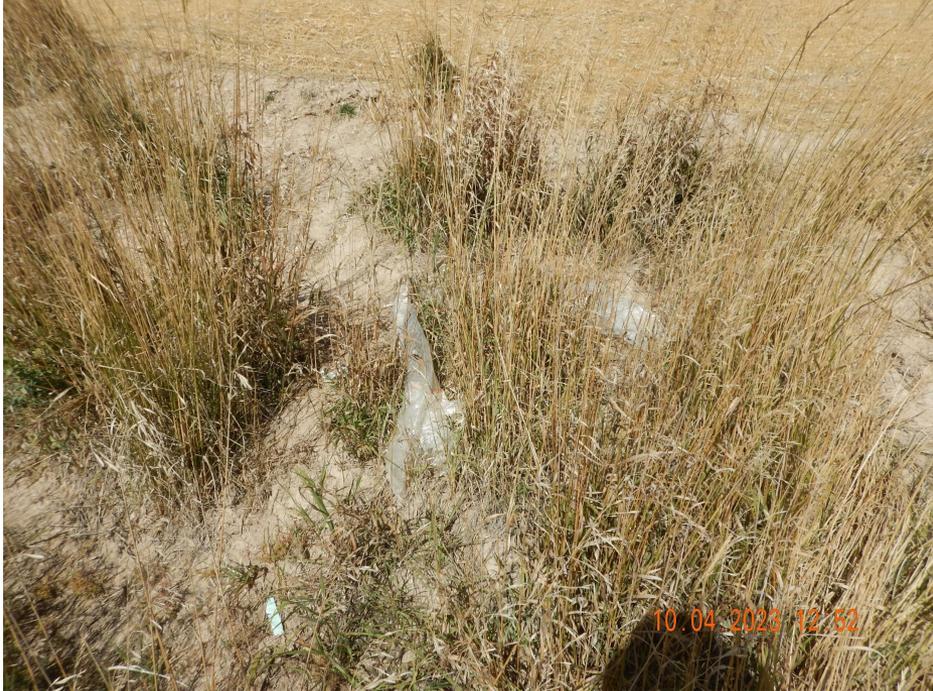
Photo 11. Photo taken from the southeastern fill slope. Photo illustrates trash from plastic bags used for erosion control blankets. Trash was picked up and put into a proper disposal bin.

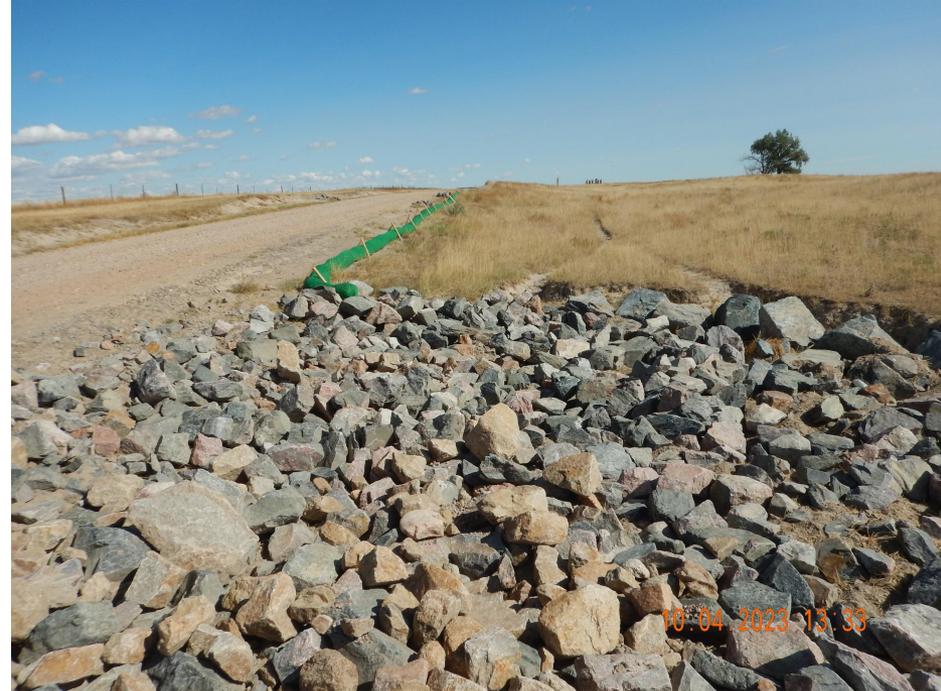
Photo 12. Photo taken from Geary Creek, facing East. Photo illustrates the Operator has installed riprap into the eastern channel and added filtrex wattles.

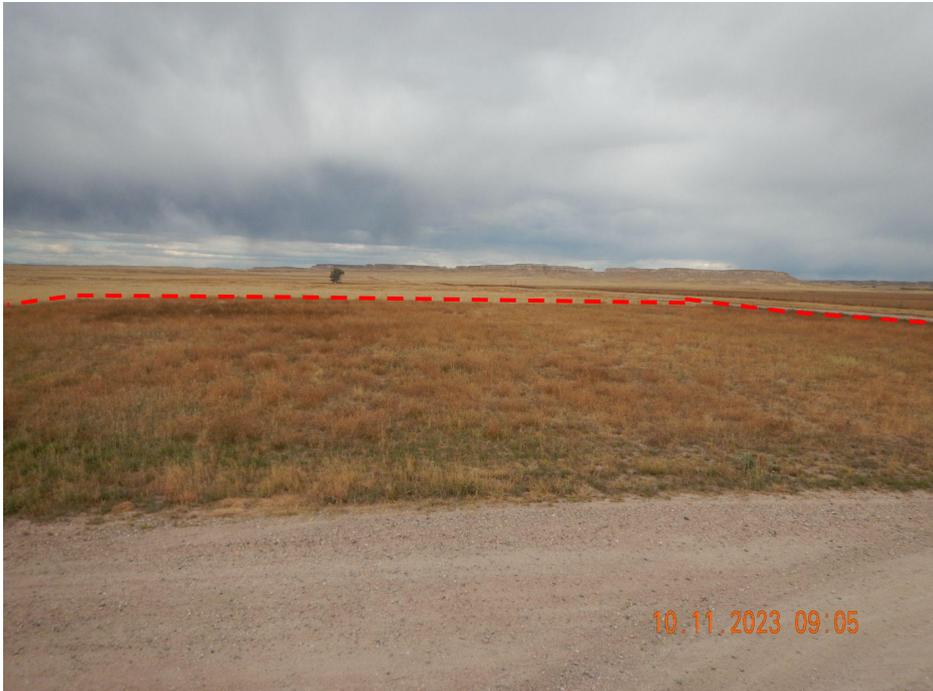
Photo 13. Photo taken from the MLVT area, facing West. Photo illustrates much of the MLVT area consisting of Russian thistle. Some germination of desirable plant species was observed but additional seeding is required.

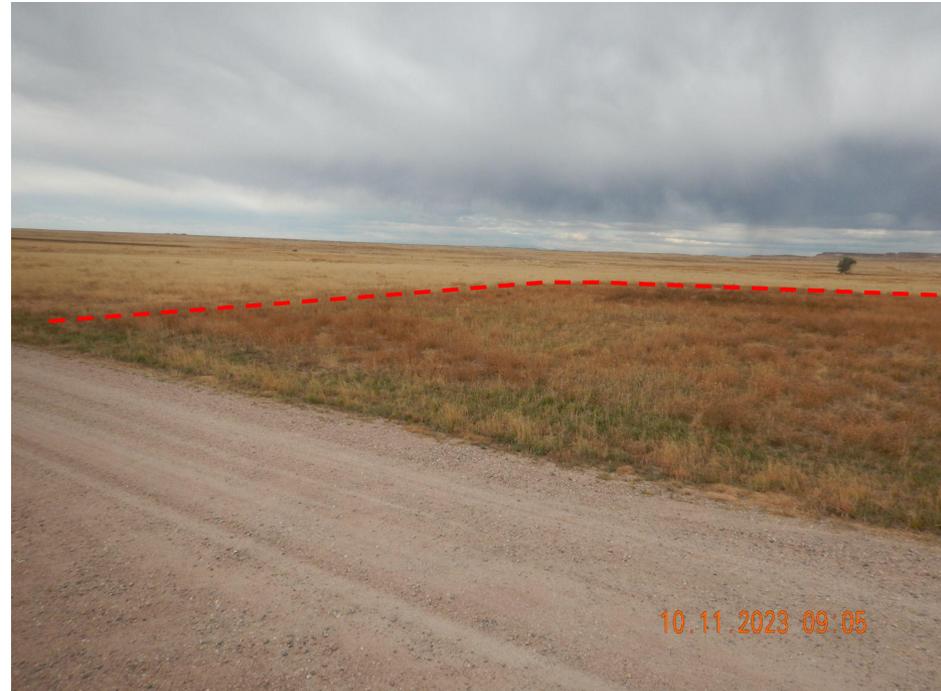
Photo 14. Photo taken from the MLVT area, facing Southwest. See comments under Photo 13.

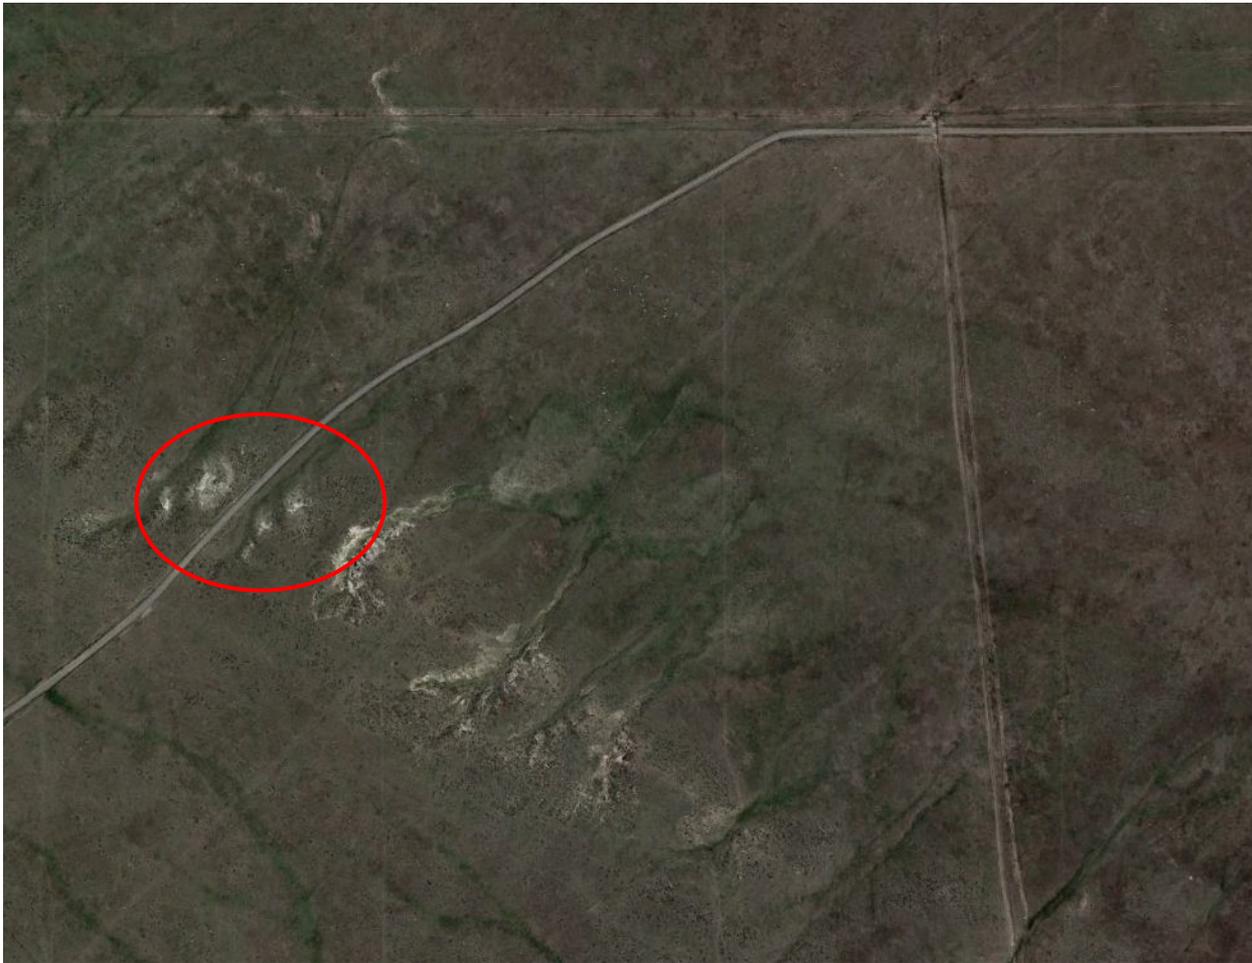
Photo 15. Google Earth aerial imagery from 7/17/2019 illustrates an area along the lease road where a BMP has not been properly installed and is not sufficient to control stormwater erosion off the lease road. Both Upland and CCRP will have to coordinate on the corrective action.
