Storm Water Management and Erosion control
Location Name: TEP ROCKY MOUNTAIN LLC GOAD RMV 73-34 Pad
Location ID: 324007

Location Overview: Location is within High Priority/Density/NSO/Black Bear Habitat areas. Location is approximately 163 yards from Spruce Creek.

Section/Township/Range: 34 6S94W

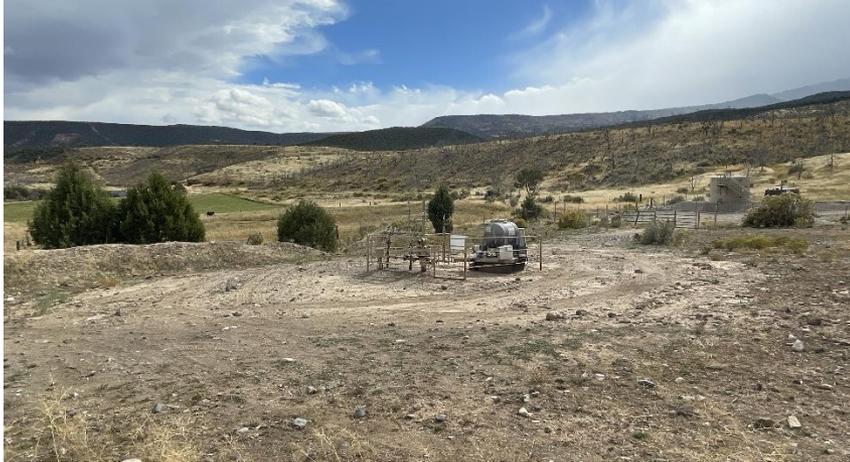
North West corner of location.

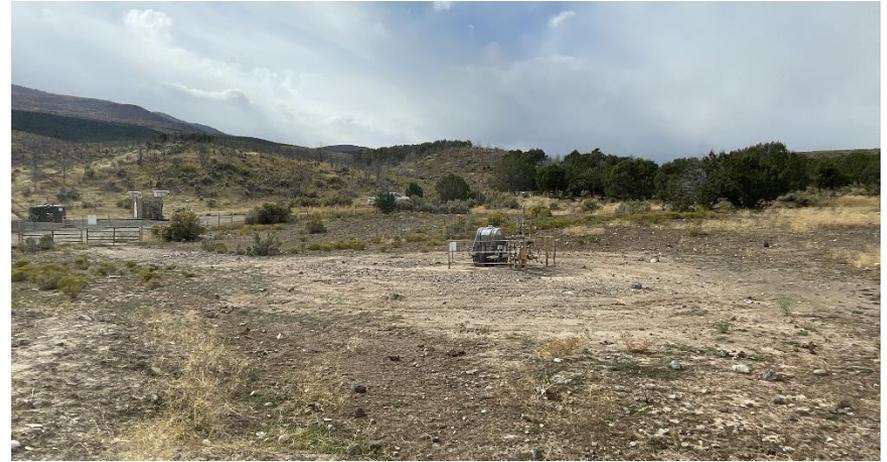
North East corner of location.

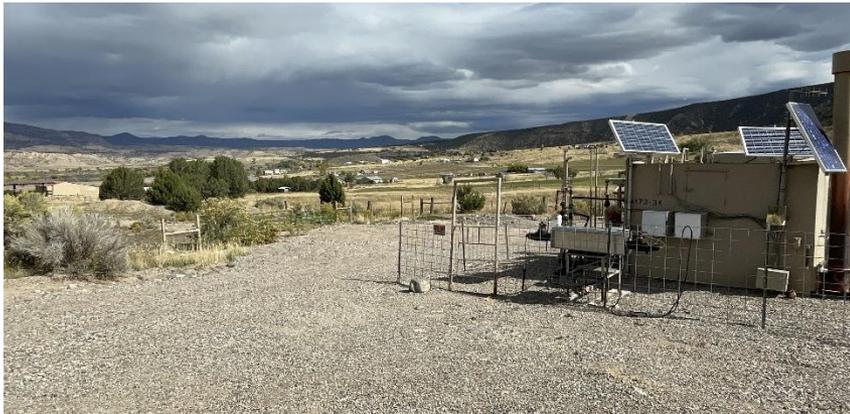
South West corner of location.

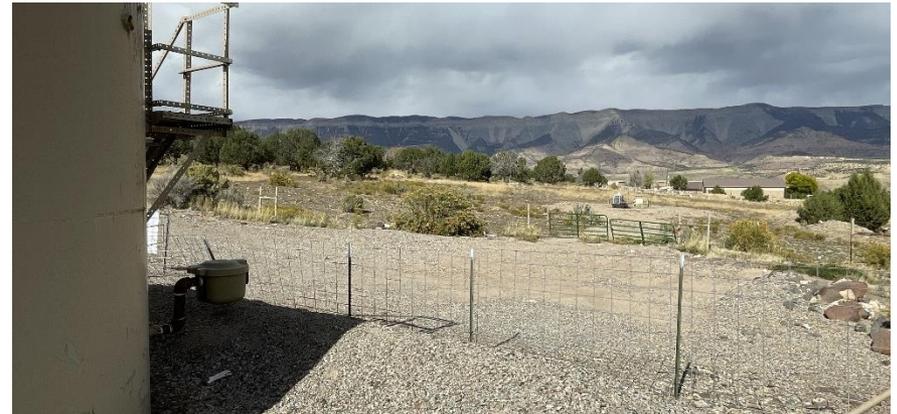
South East corner of location.

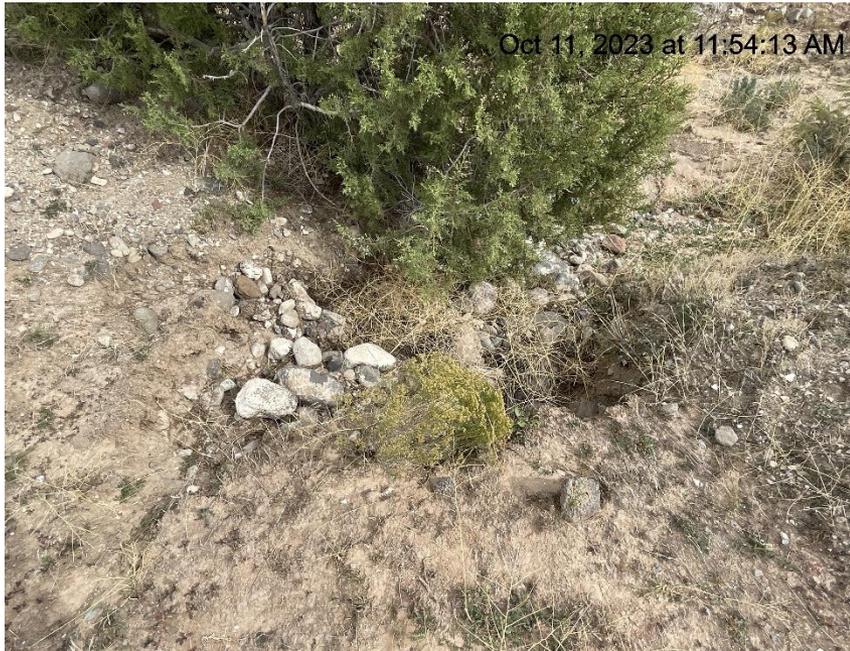
Photo # 2421 Rip Rap/BMP needs maintenance

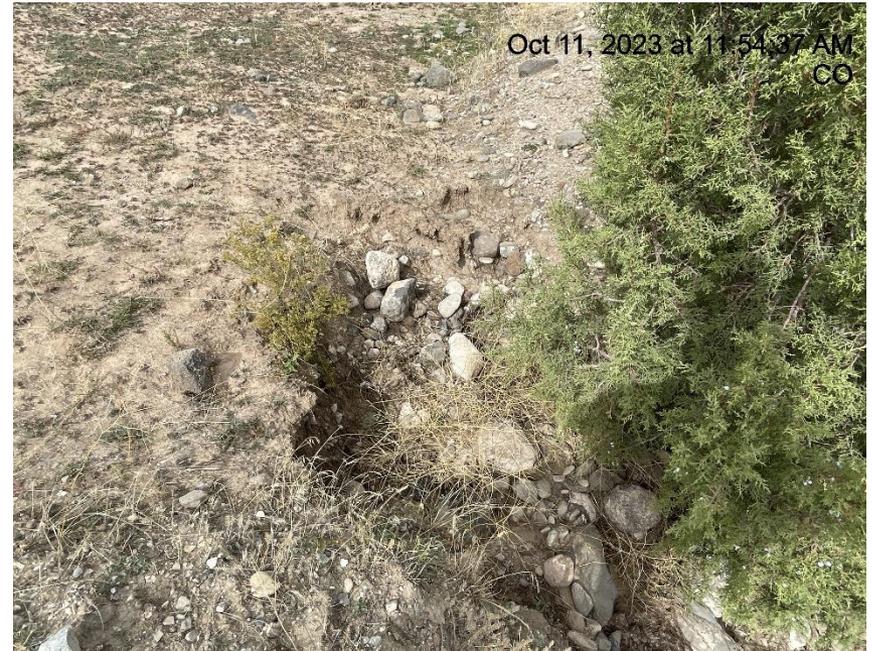
Photo # 2422 Rip Rap/BMP needs maintenance

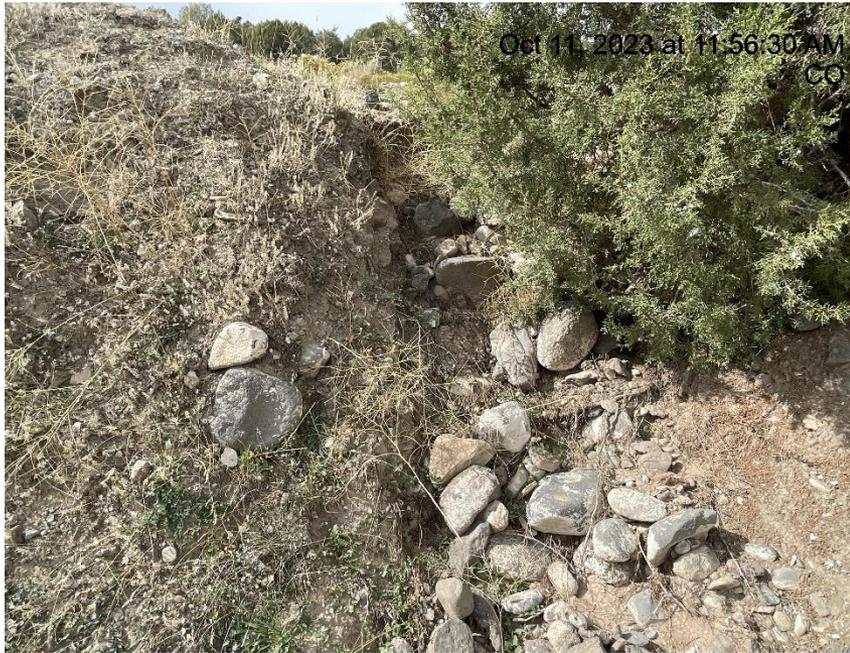
Photo # 2423 Rip Rap/BMP needs maintenance

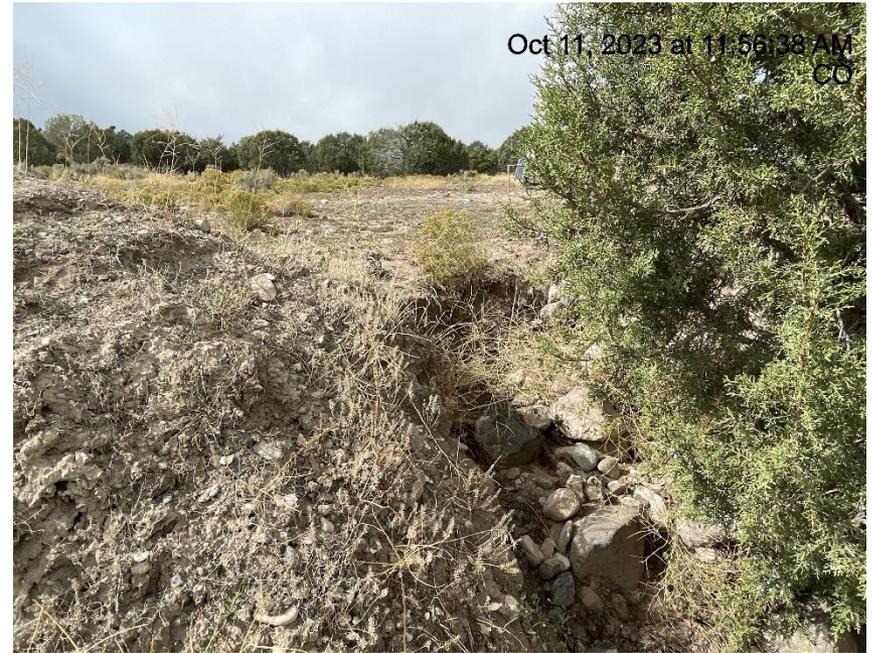
Photo # 2424 Rip Rap/BMP needs maintenance

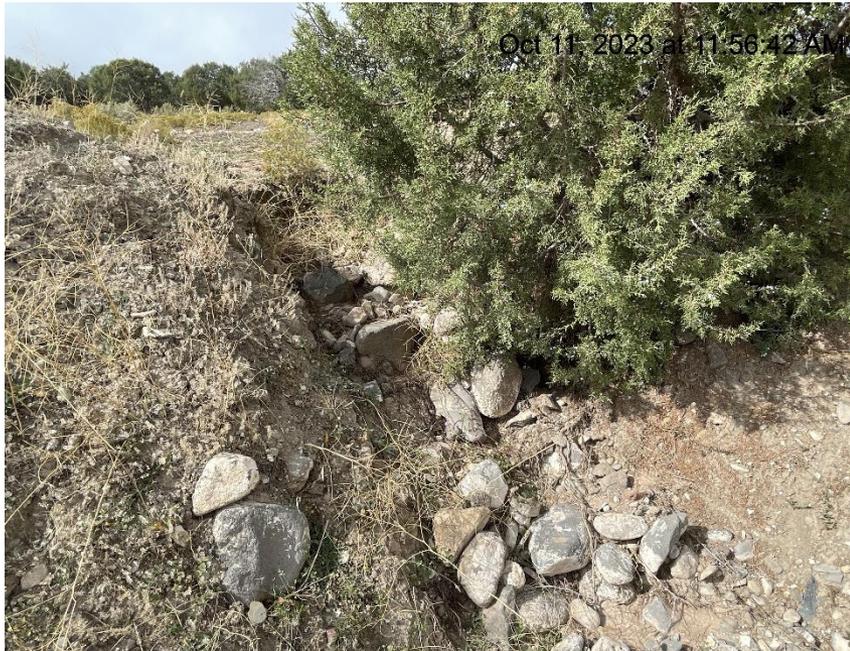
Photo # 2425 Rip Rap/BMP needs maintenance

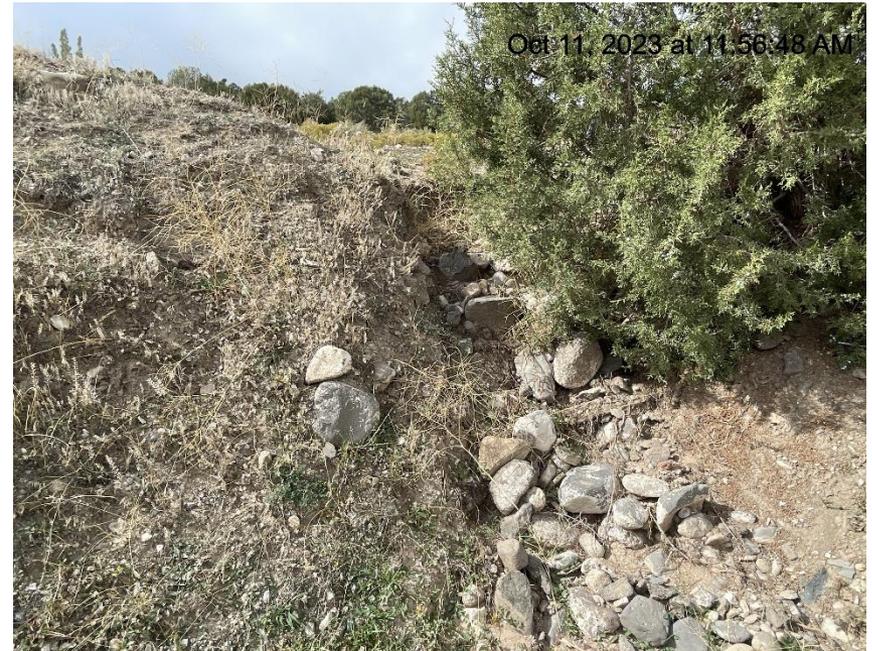
Photo # 2426 Rip Rap/BMP needs maintenance

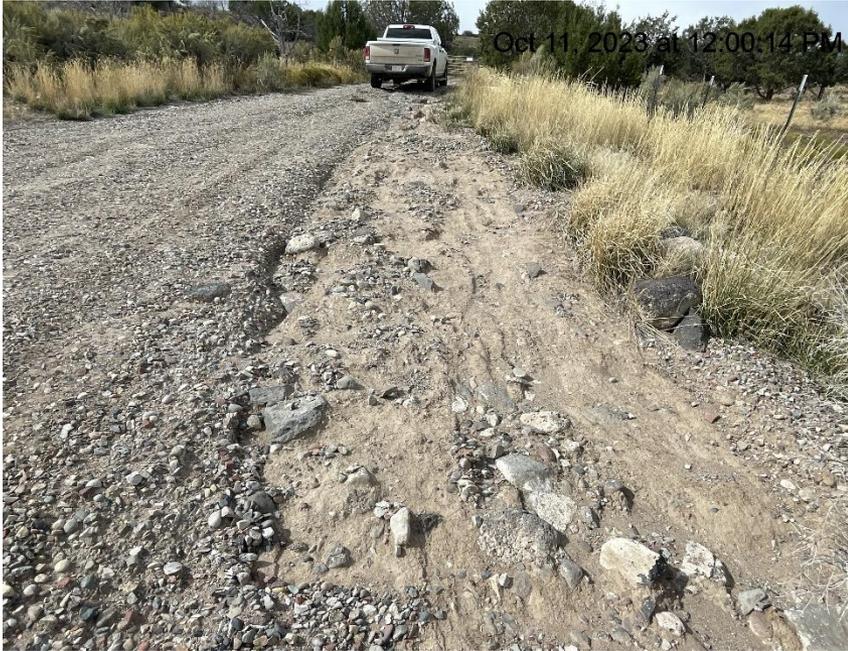
Photo # 2427 Erosion & transport of sediment on lease road near entrance to location

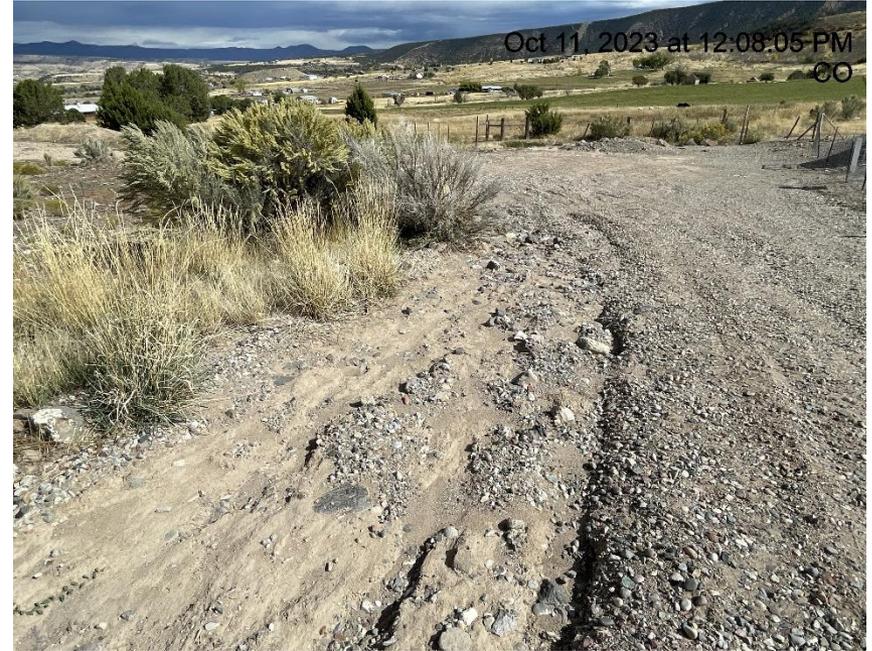
Photo # 2428 Erosion & transport of sediment on lease road near entrance to location

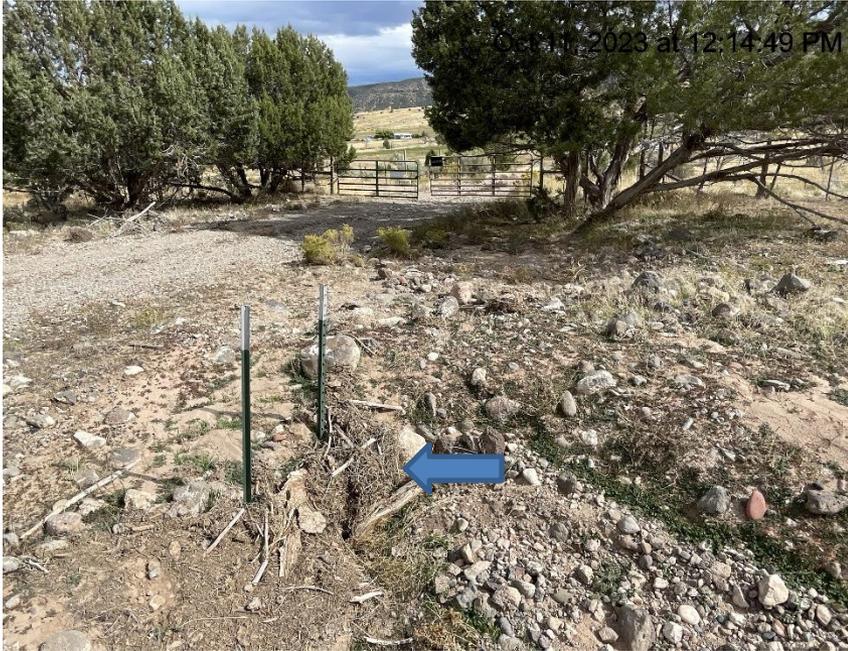
Photo # 2429 Culvert on lease road needs maintenance

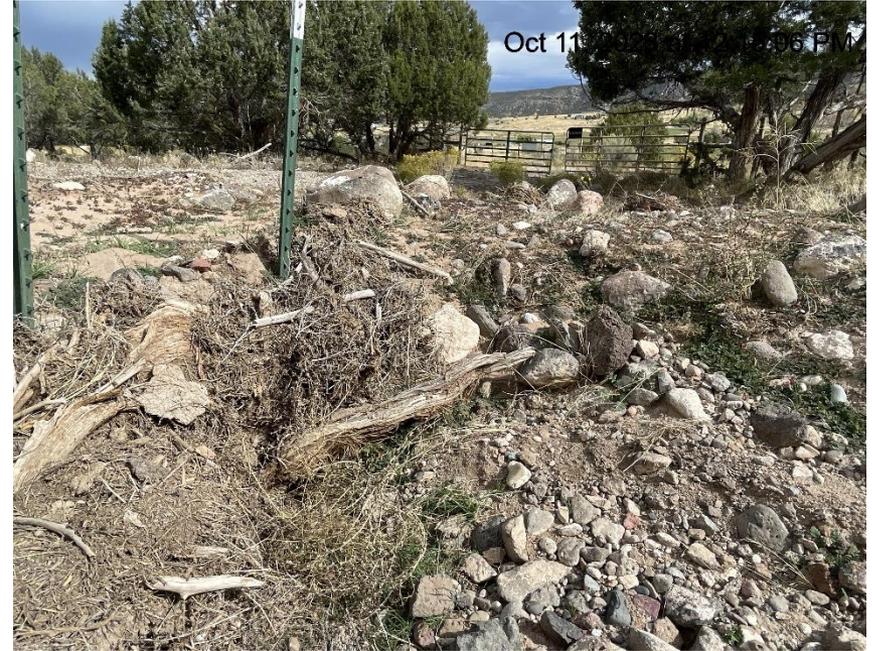
Photo # 2430 Culvert on lease road needs maintenance

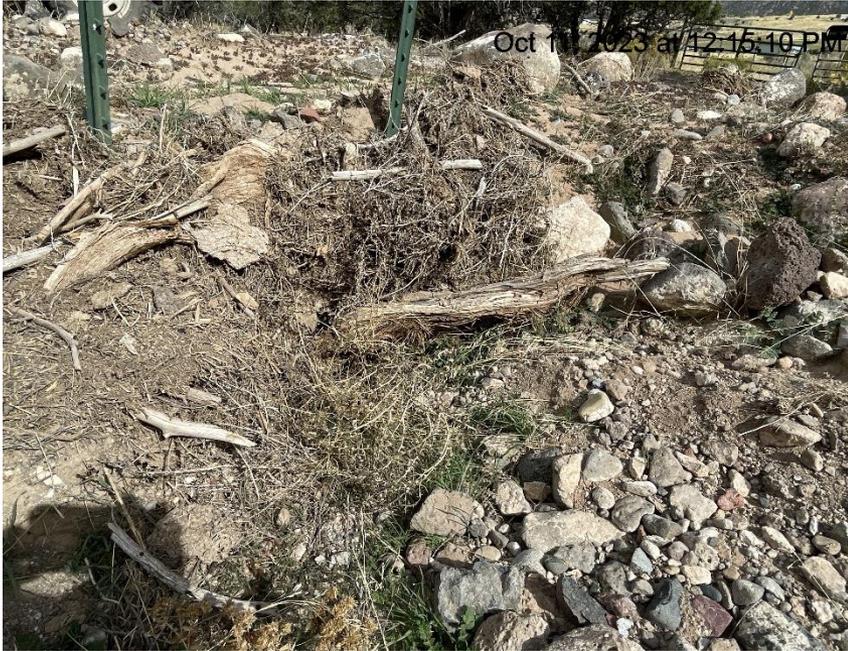
Photo # 2431 Culvert on lease road needs maintenance

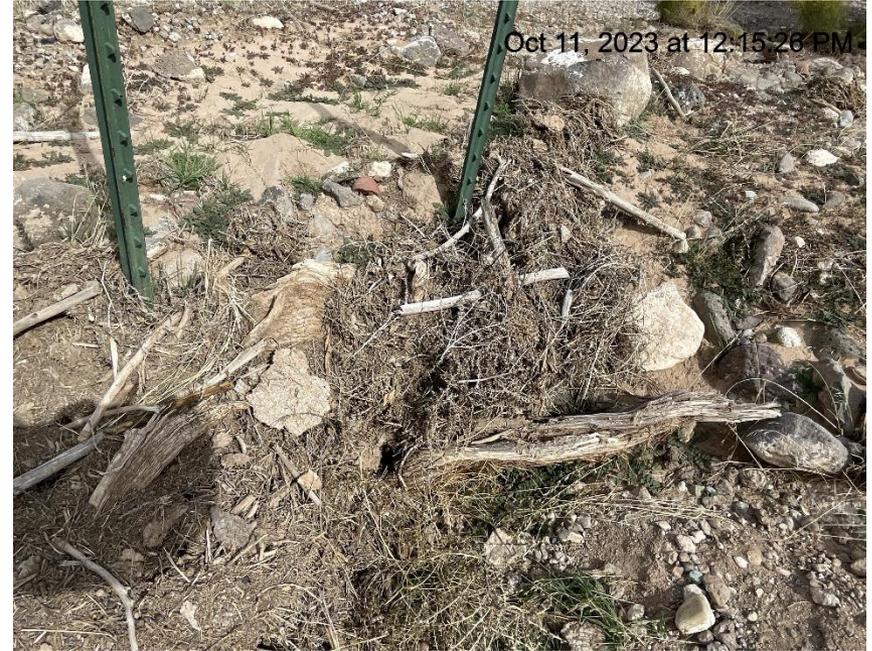
Photo # 2432 Culvert on lease road needs maintenance
