Inspection Photos
Location Name: Melbon 12C-8HZ
Location ID: 431712

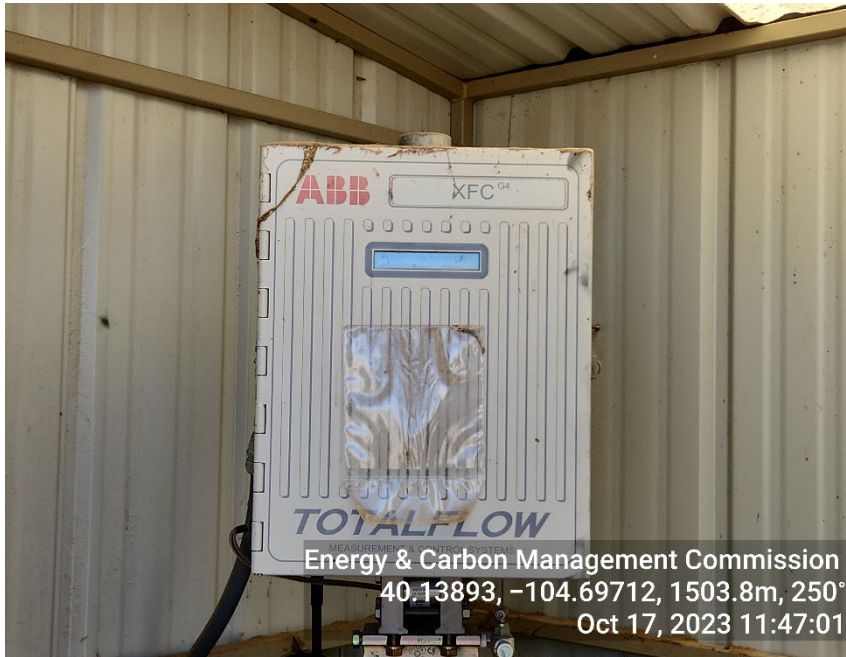
Photo 17: Gas meter disconnected

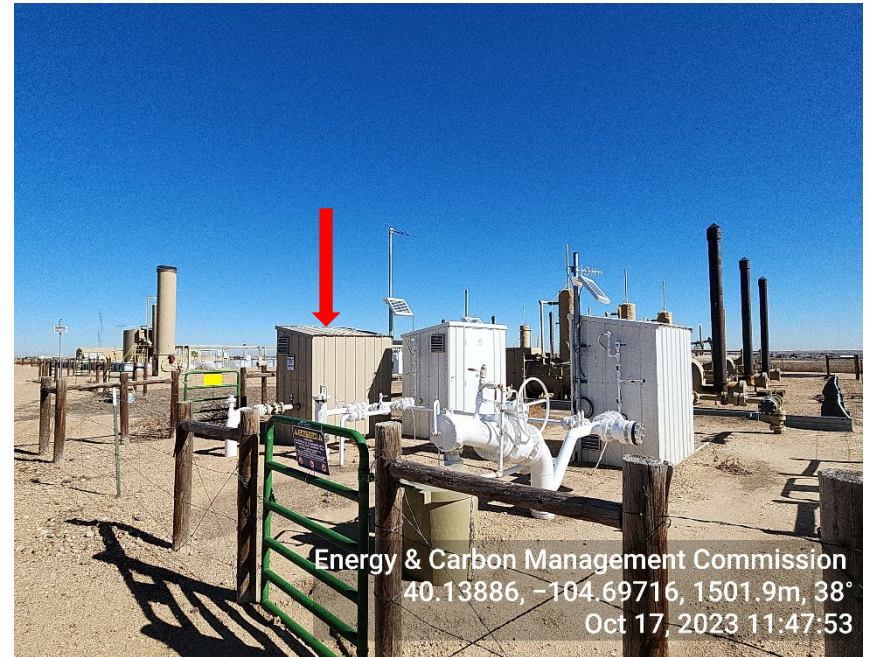
Photo 18: Gas meter disconnected
