Storm Water Management and Erosion control
Location Name: TEP ROCKY MOUNTAIN LLC CLOUGH 136 Pad
Location ID: 322444

**Location Overview: Location is within High Priority/Density
Habitat areas. Location is approximately 22 yards from a
drainage that contributes to the Colorado River.**

Section/Township/Range: 20 6S94W

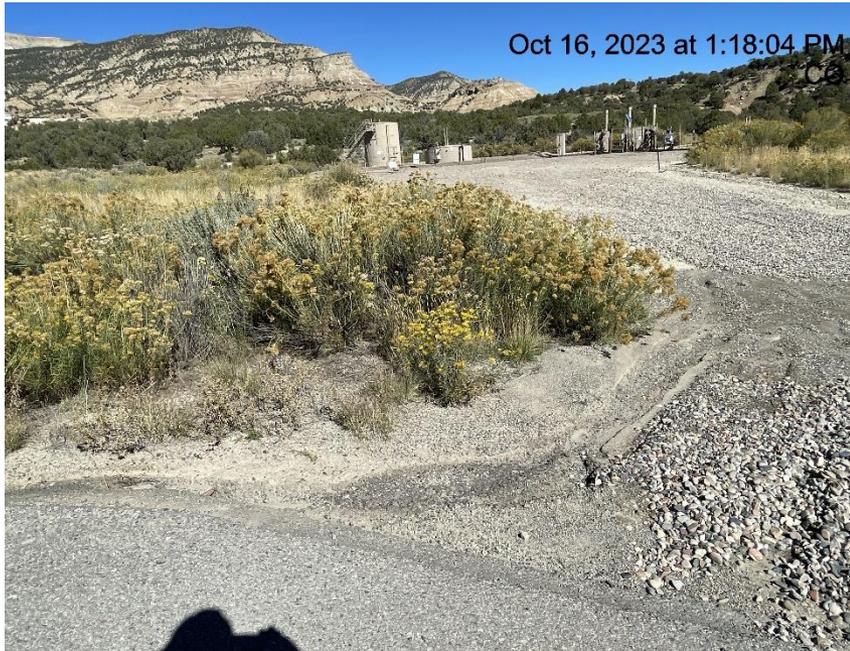
Photo # 2884 Sediment migrating onto gravel track pad/BMP needs maintenance

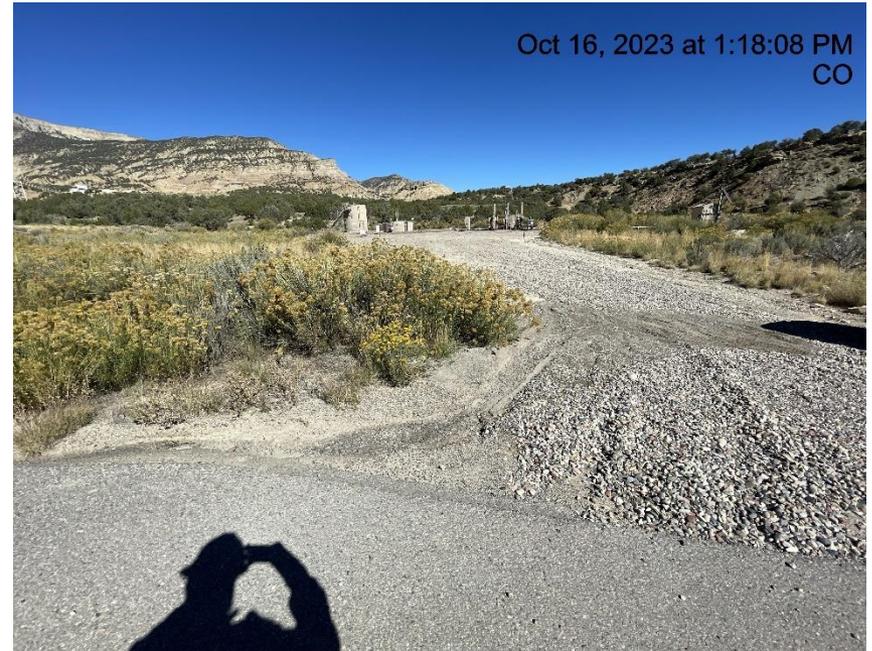
Photo # 2885 Sediment migrating onto gravel track pad/BMP needs maintenance

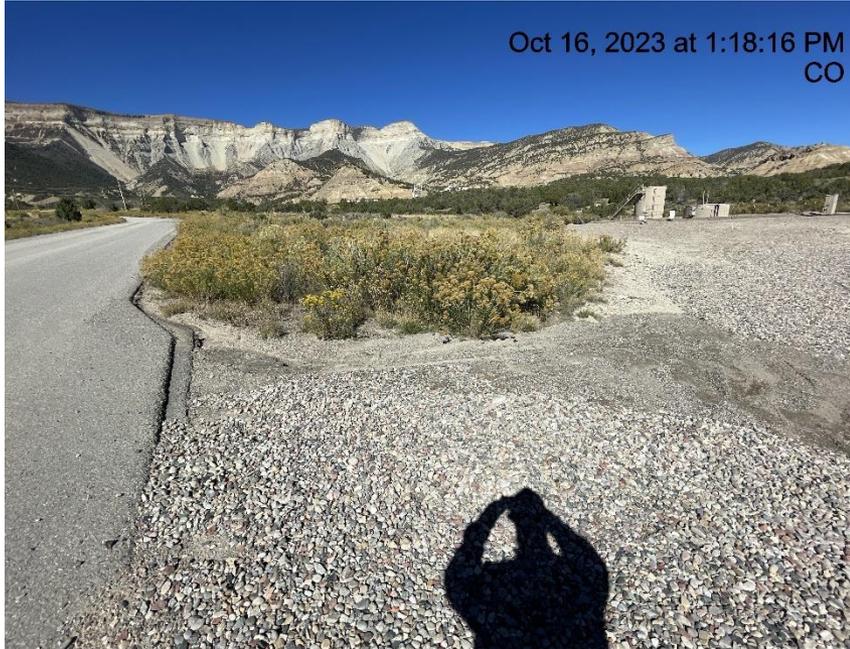
Photo # 2886 Sediment migrating onto gravel track pad/BMP needs maintenance

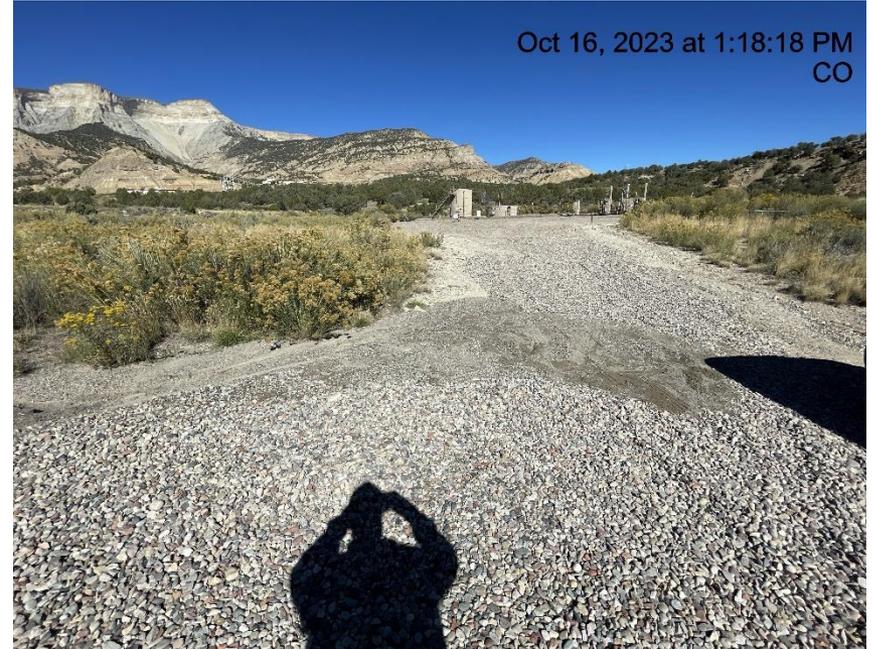
Photo # 2887 Sediment migrating onto gravel track pad/BMP needs maintenance

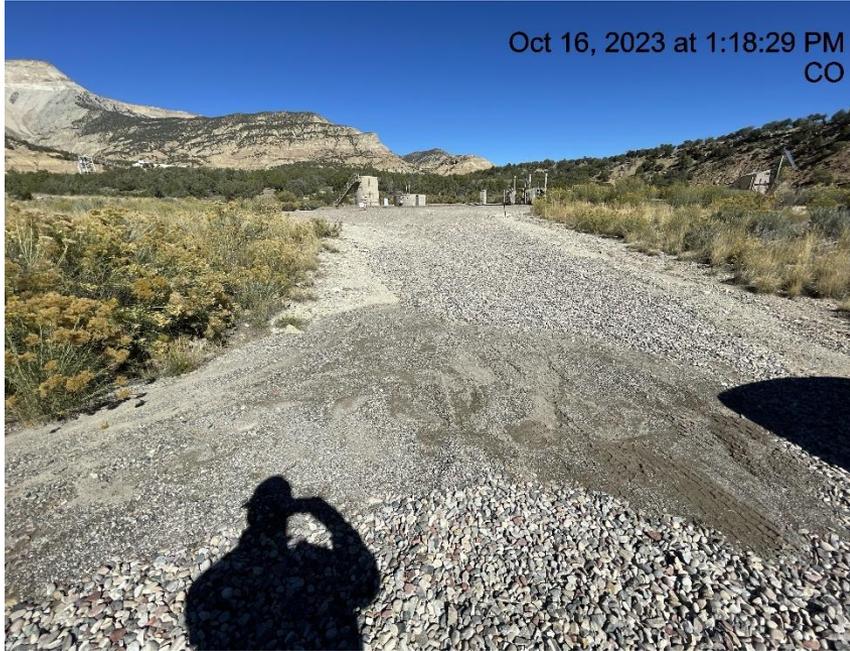
Photo # 2888 Sediment migrating onto gravel track pad/BMP needs maintenance

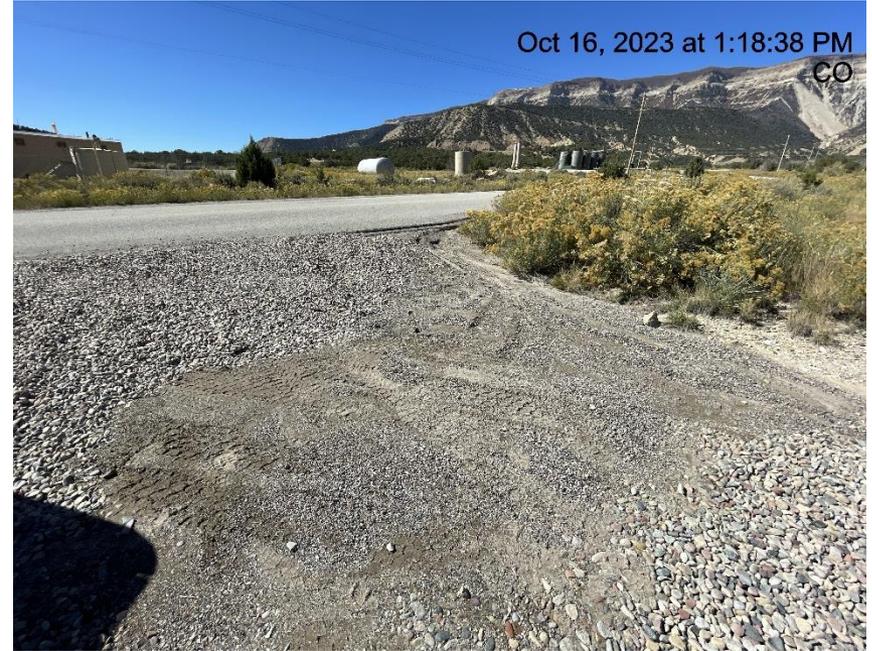
Photo # 2889 Sediment migrating onto gravel track pad/BMP needs maintenance

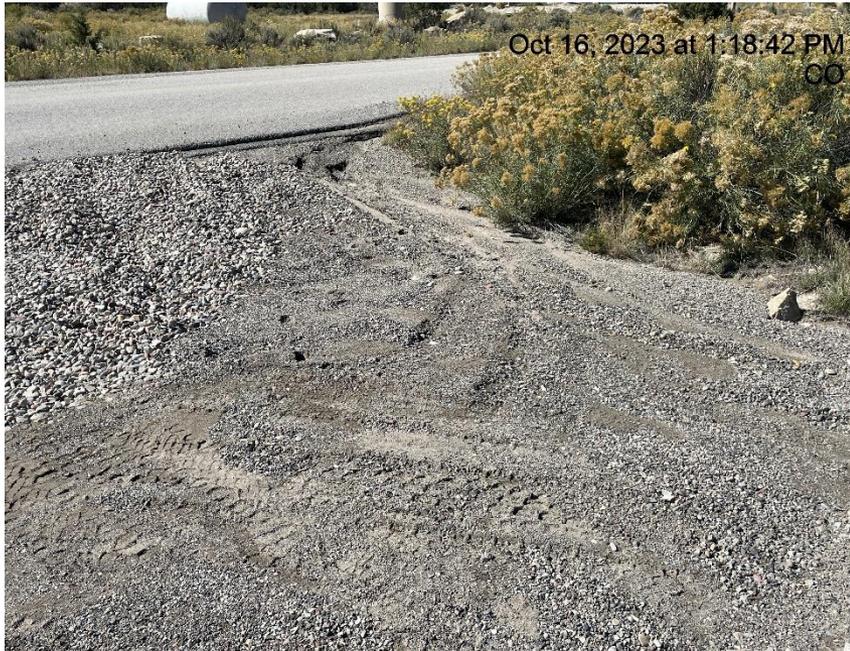
Photo # 2890 Sediment migrating onto gravel track pad/BMP needs maintenance

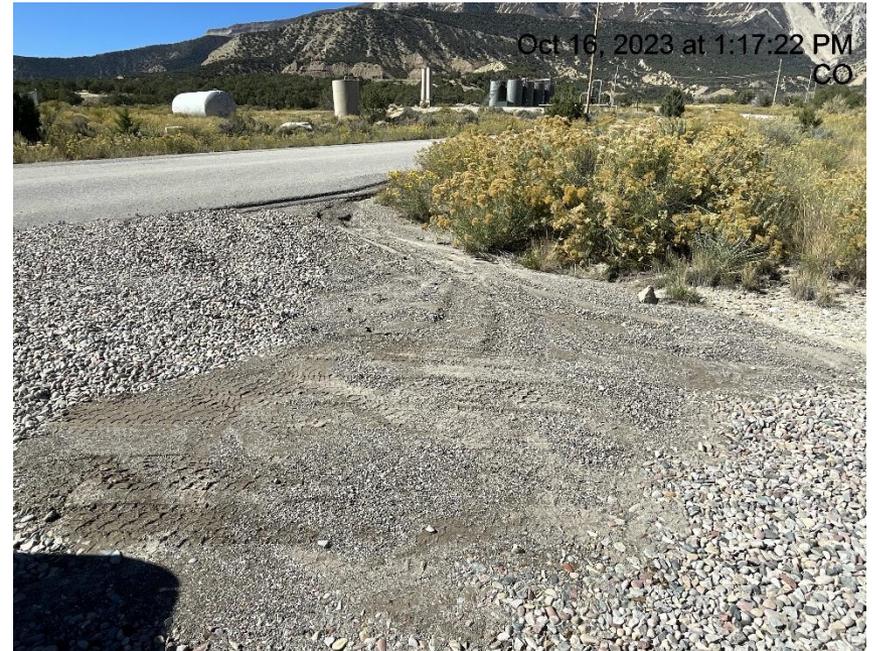
Photo # 2891 Sediment migrating onto gravel track pad/BMP needs maintenance

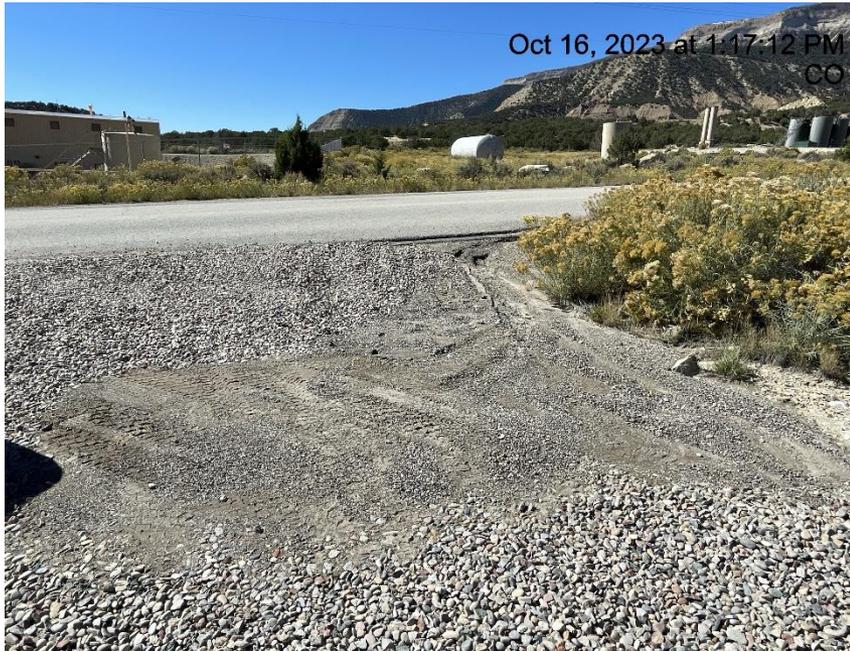
Photo # 2892 Sediment migrating onto gravel track pad/BMP needs maintenance
