WELL NAME: YANKOVICK #1, API #: 043-40037, INSP. # 695108710

COLORADO
Energy & Carbon Management
Commission
Department of Natural Resources

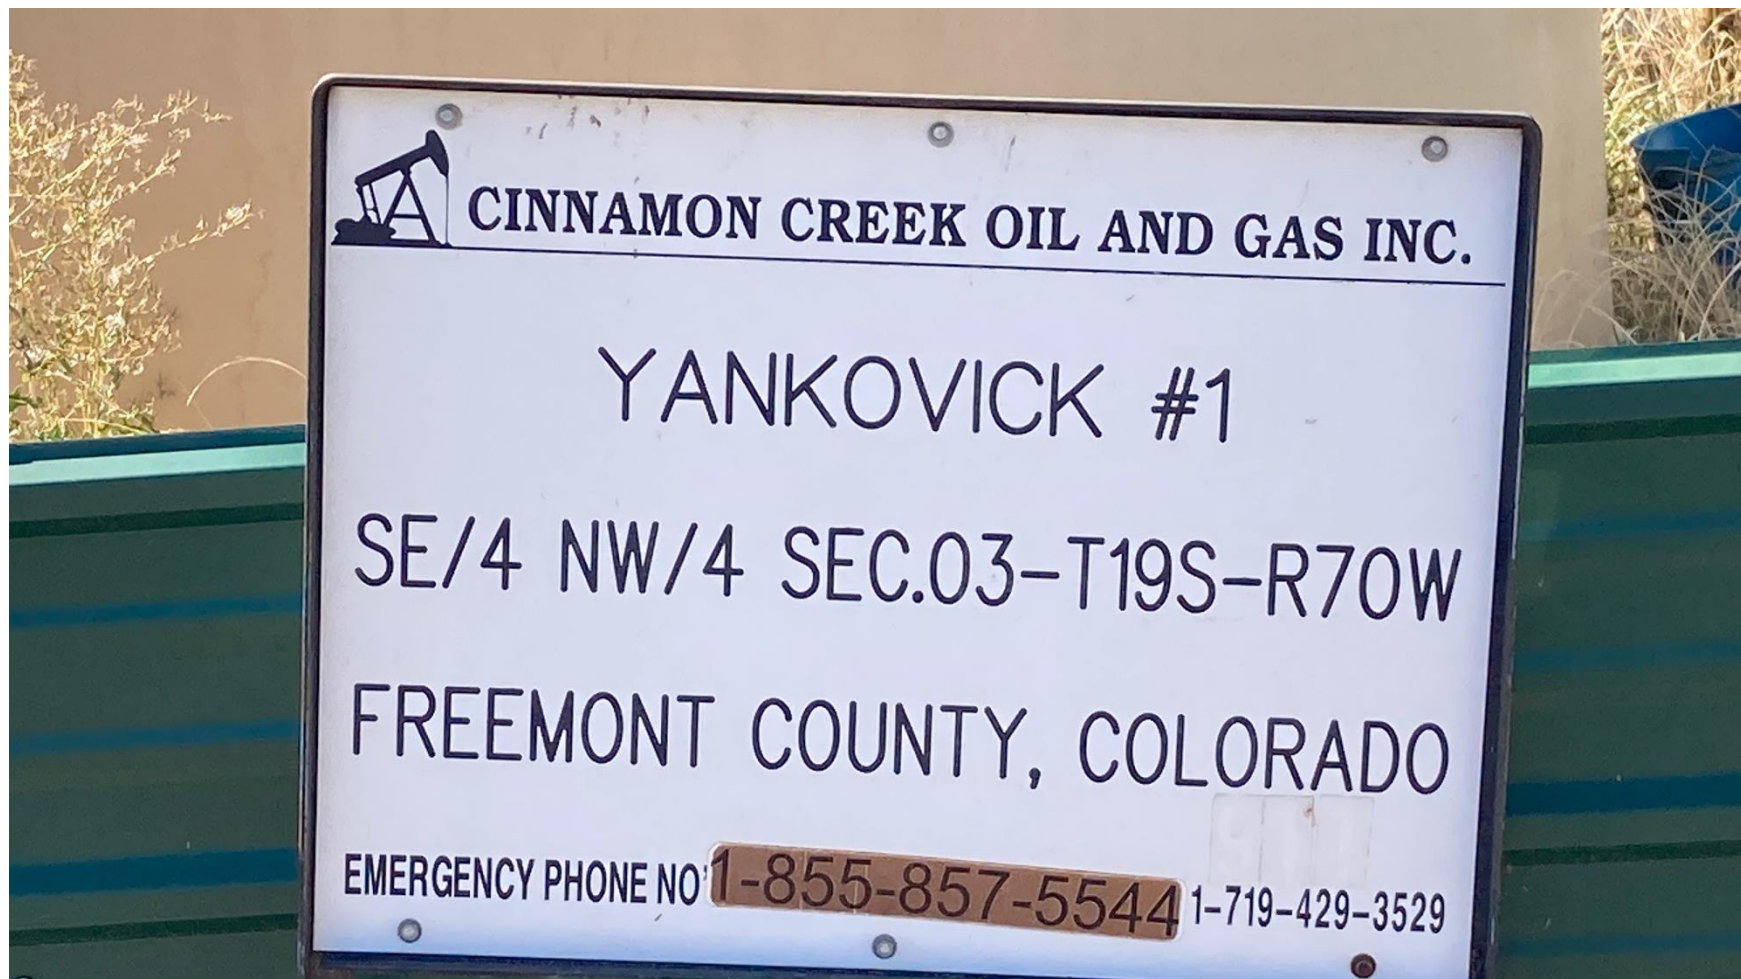
PHOTO 1: WELL SIGN

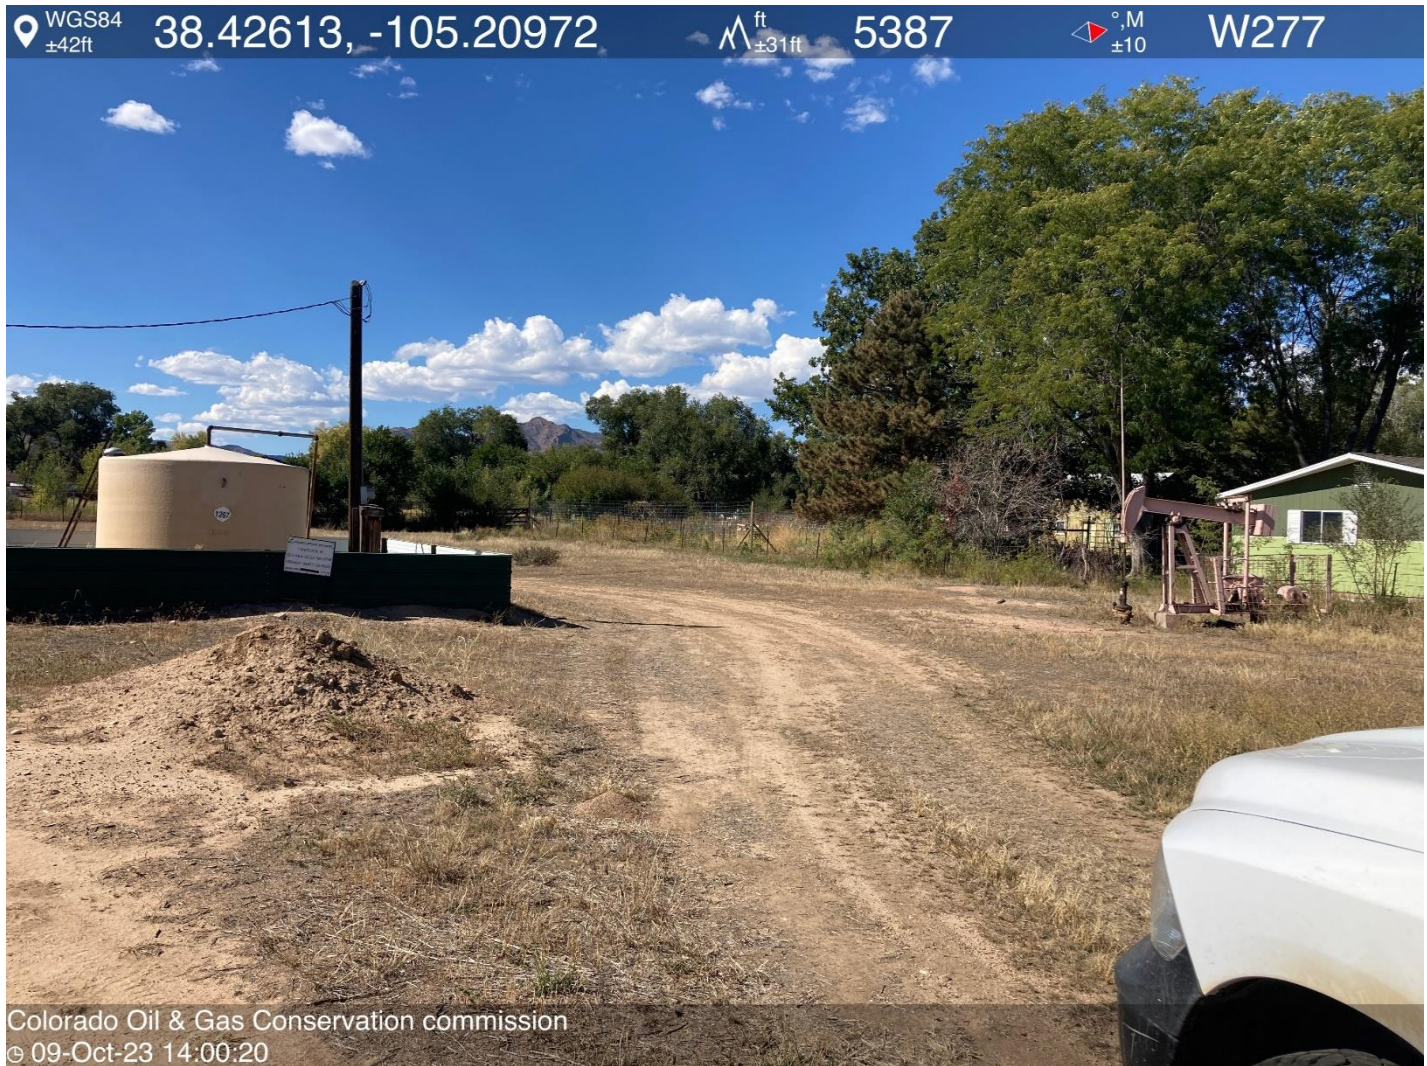
PHOTO 2: LOCATION

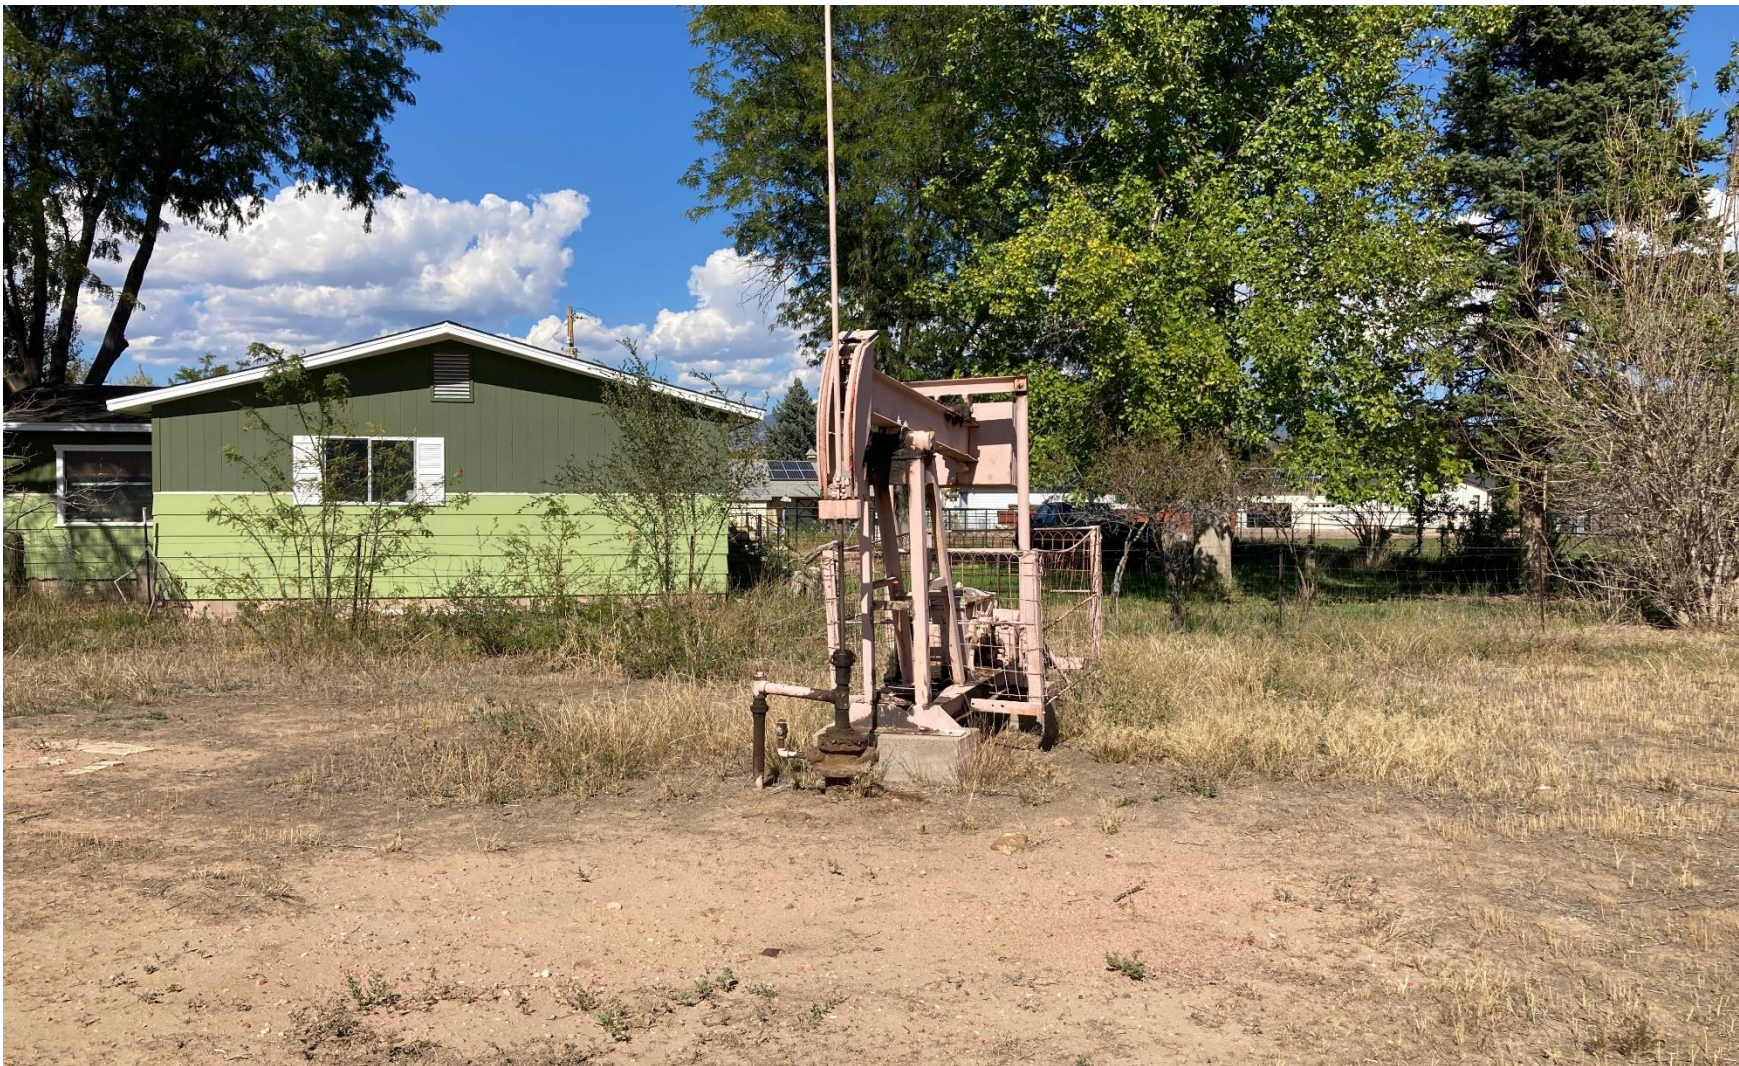
PHOTO 3: WELLHEAD AND EQUIPMENT

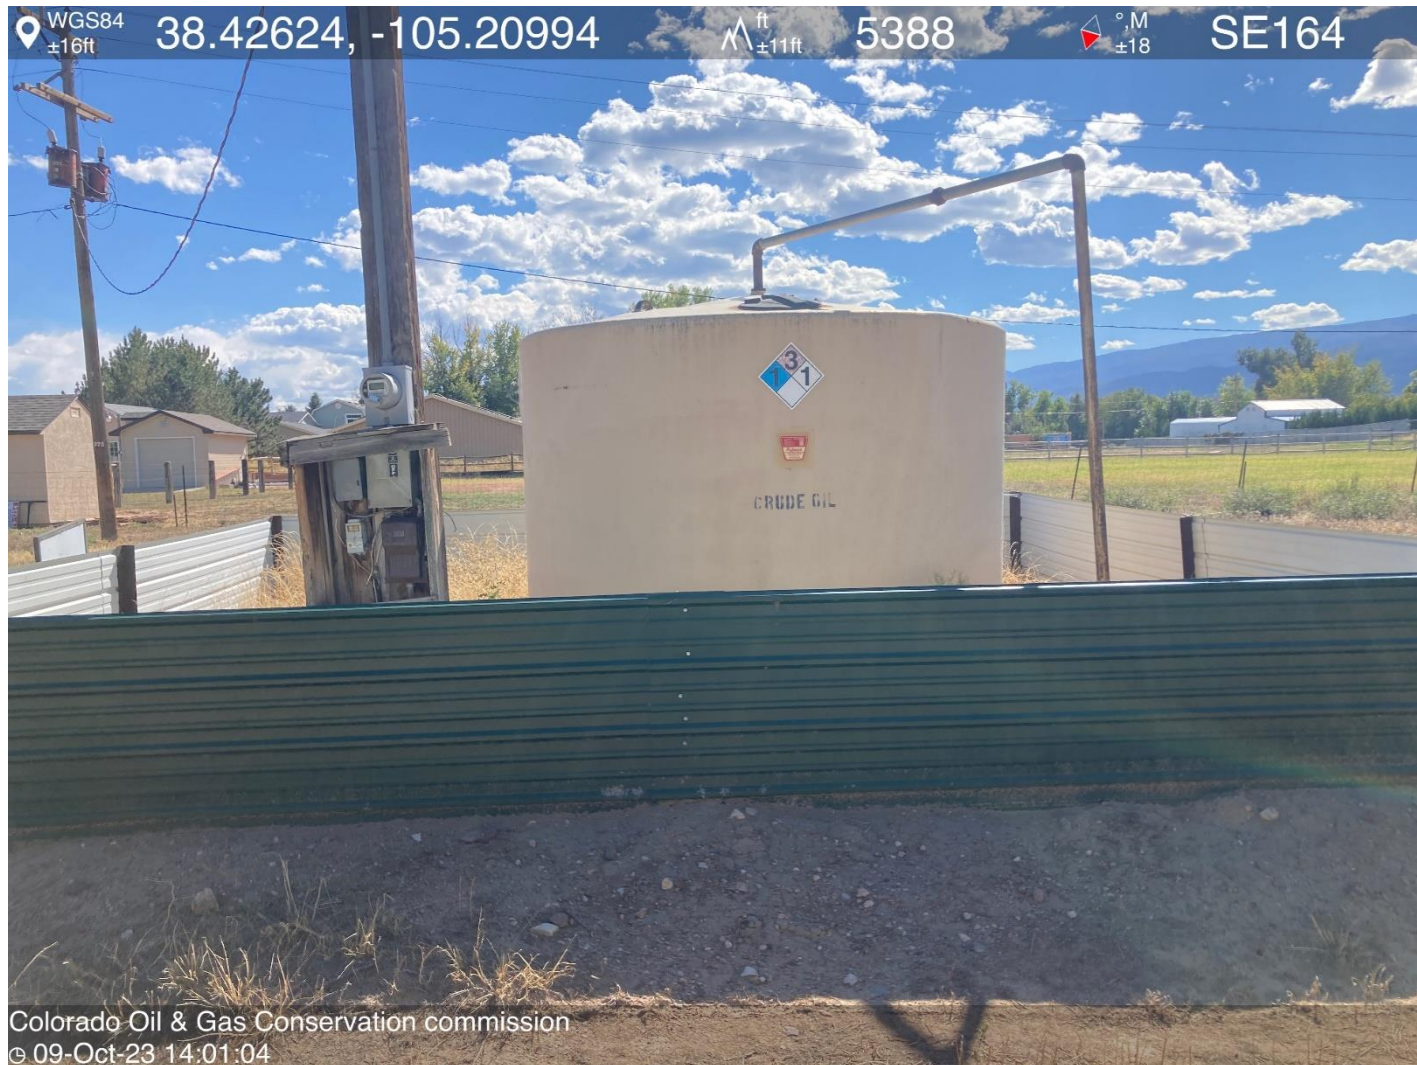
PHOTO 4: TANK BATTERY/ NO TANK BAPACITY POST ON OR AT TANK BATTERY. POST CAPACITY PER RULE 605. CA DATE 11-19-2023.

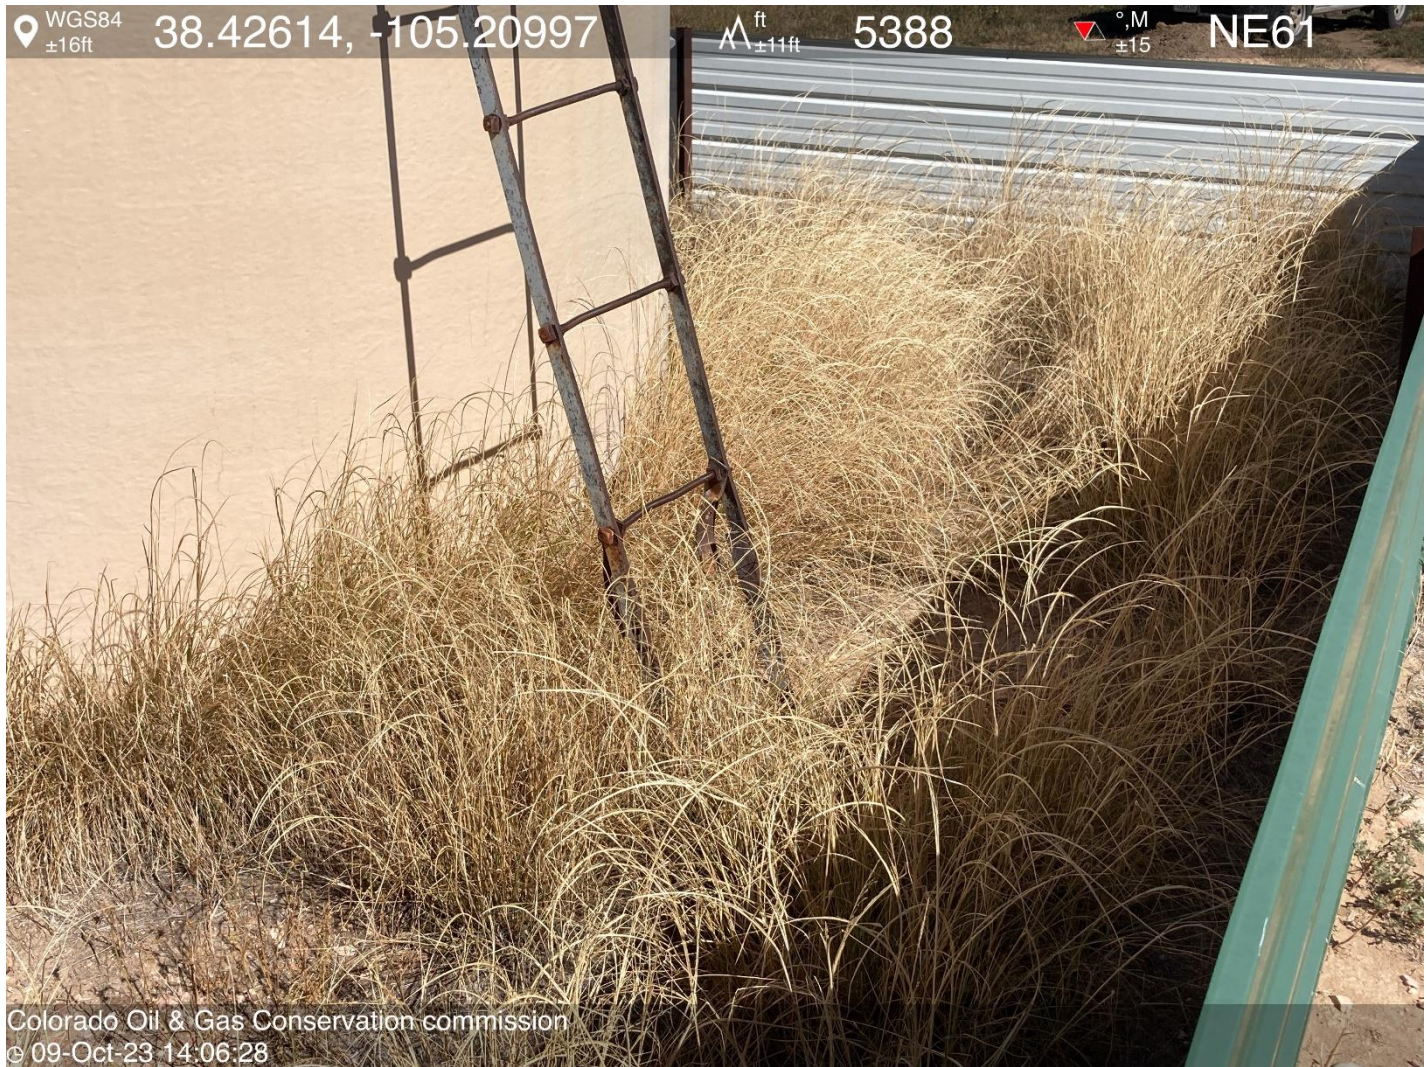
PHOTO 5: WEEDS INSIDE TANK BATTERY BERM. MAINTAIN WEEDS PER RULE 606. CA DATE 11-19-2023.

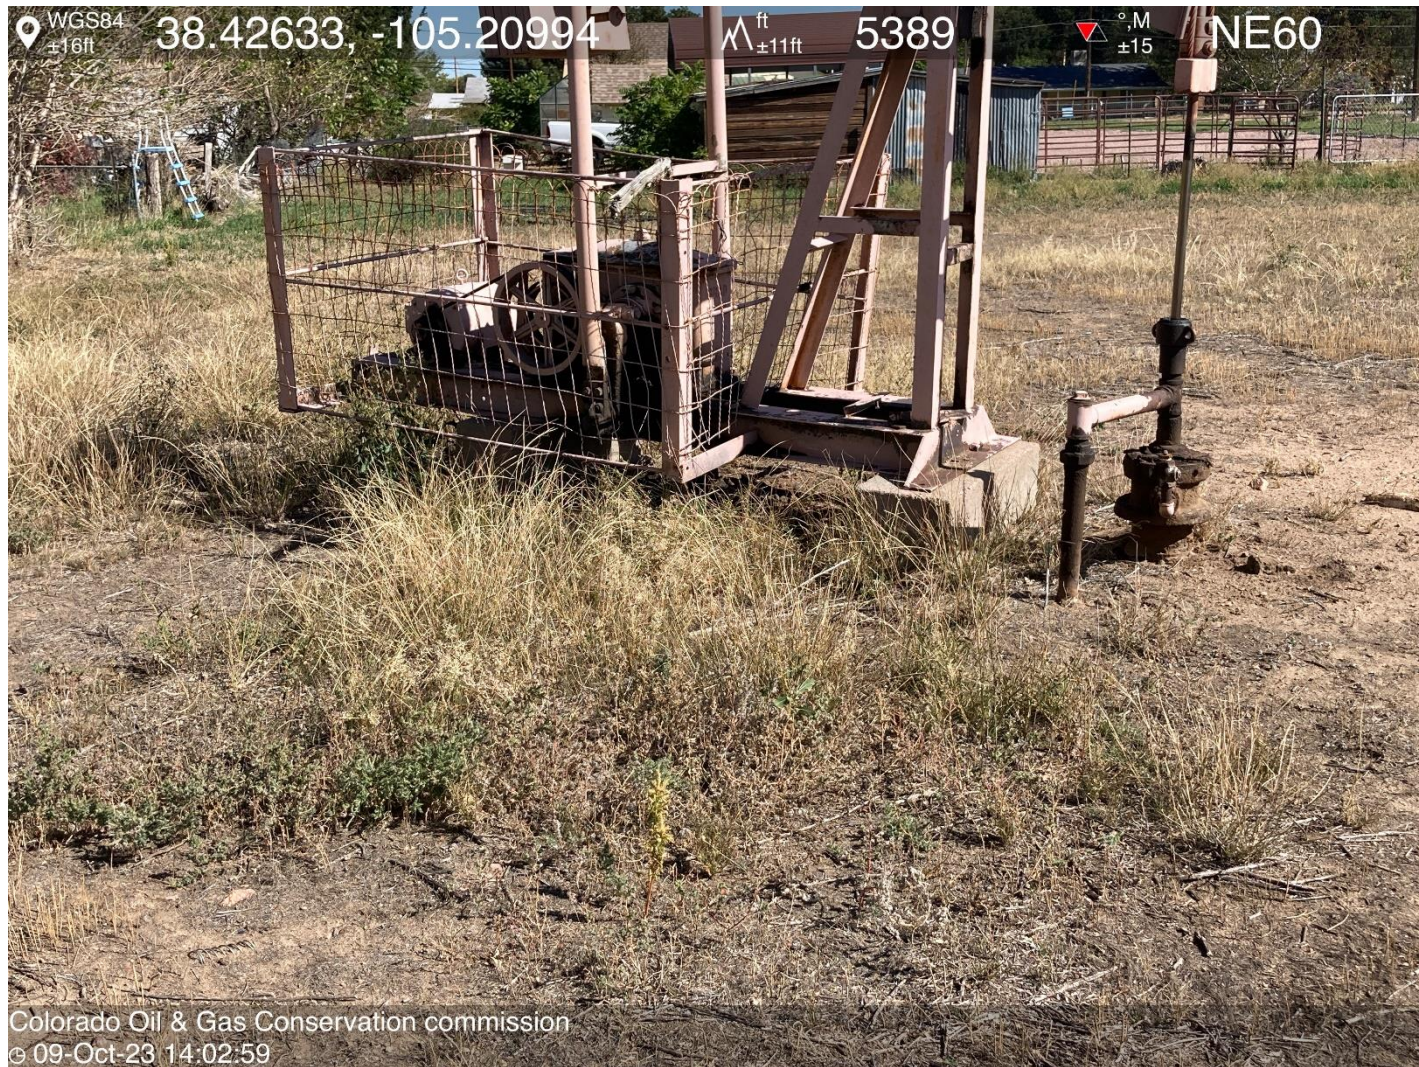
PHOTO 6: WEEDS AROUND WELLHEAD/PUMPJACK. MAINTAIN WEEDS PER RULE 606. CA DATE 11-19-2023.

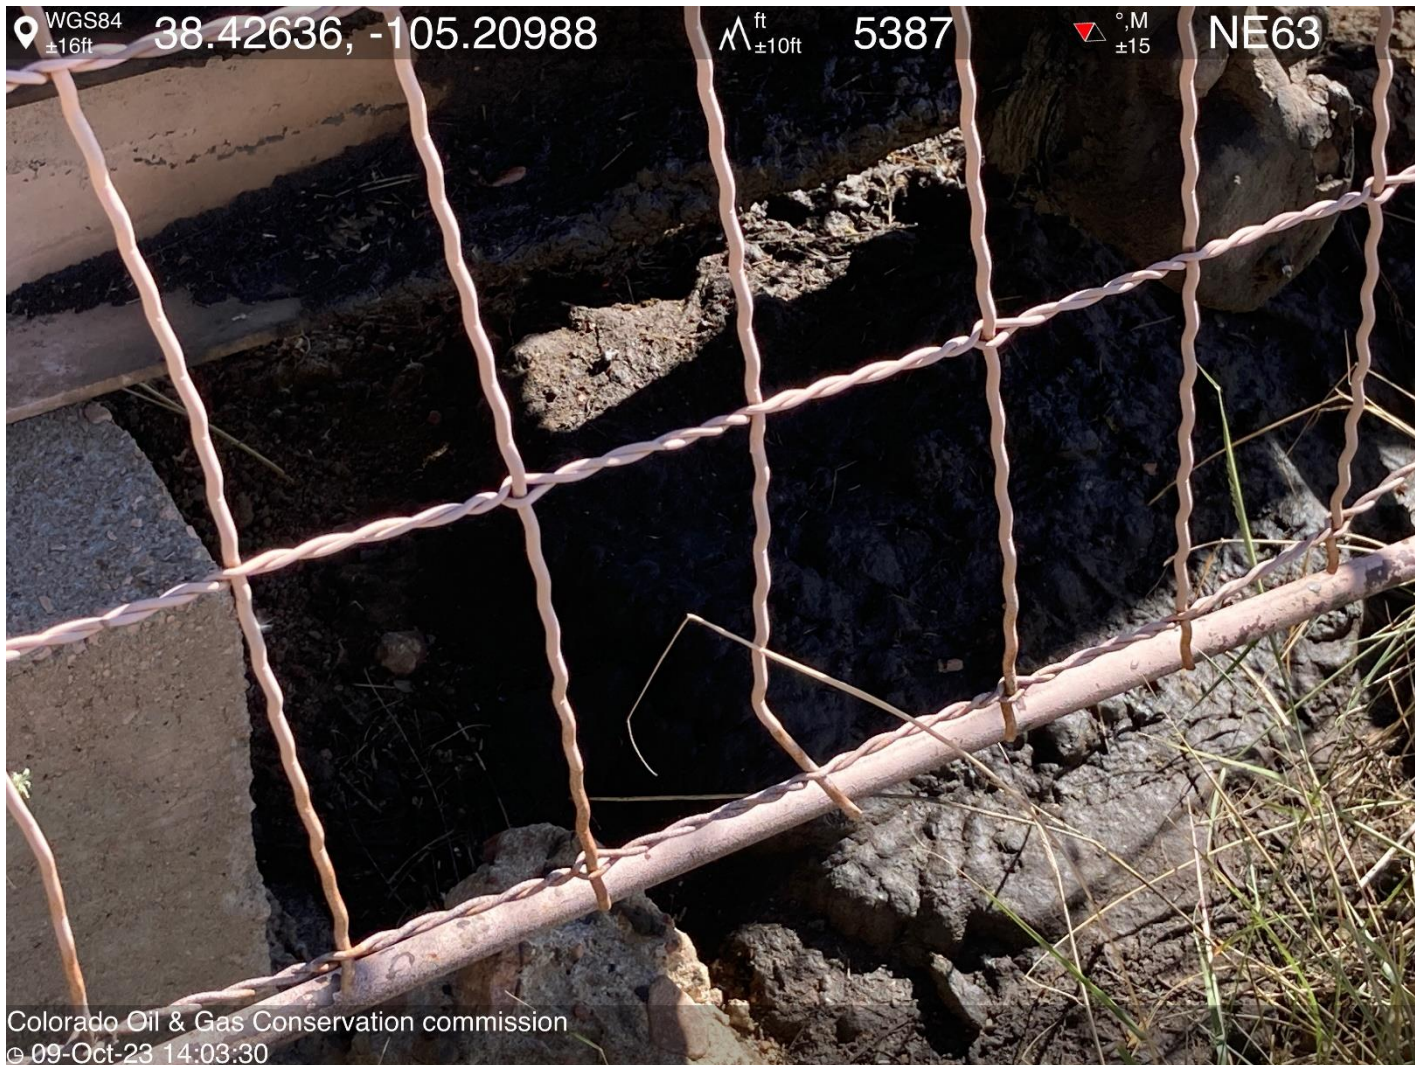
PHOTO 7: AREA OF IMPACTED SOIL UNDER PUMPJACK GEAR BOX. Conduct maintenance on equipment, cleanup stained material and review self inspection processes. COMPLY WITH RULE 1002,(2).D CA DATE 11-19-2023.

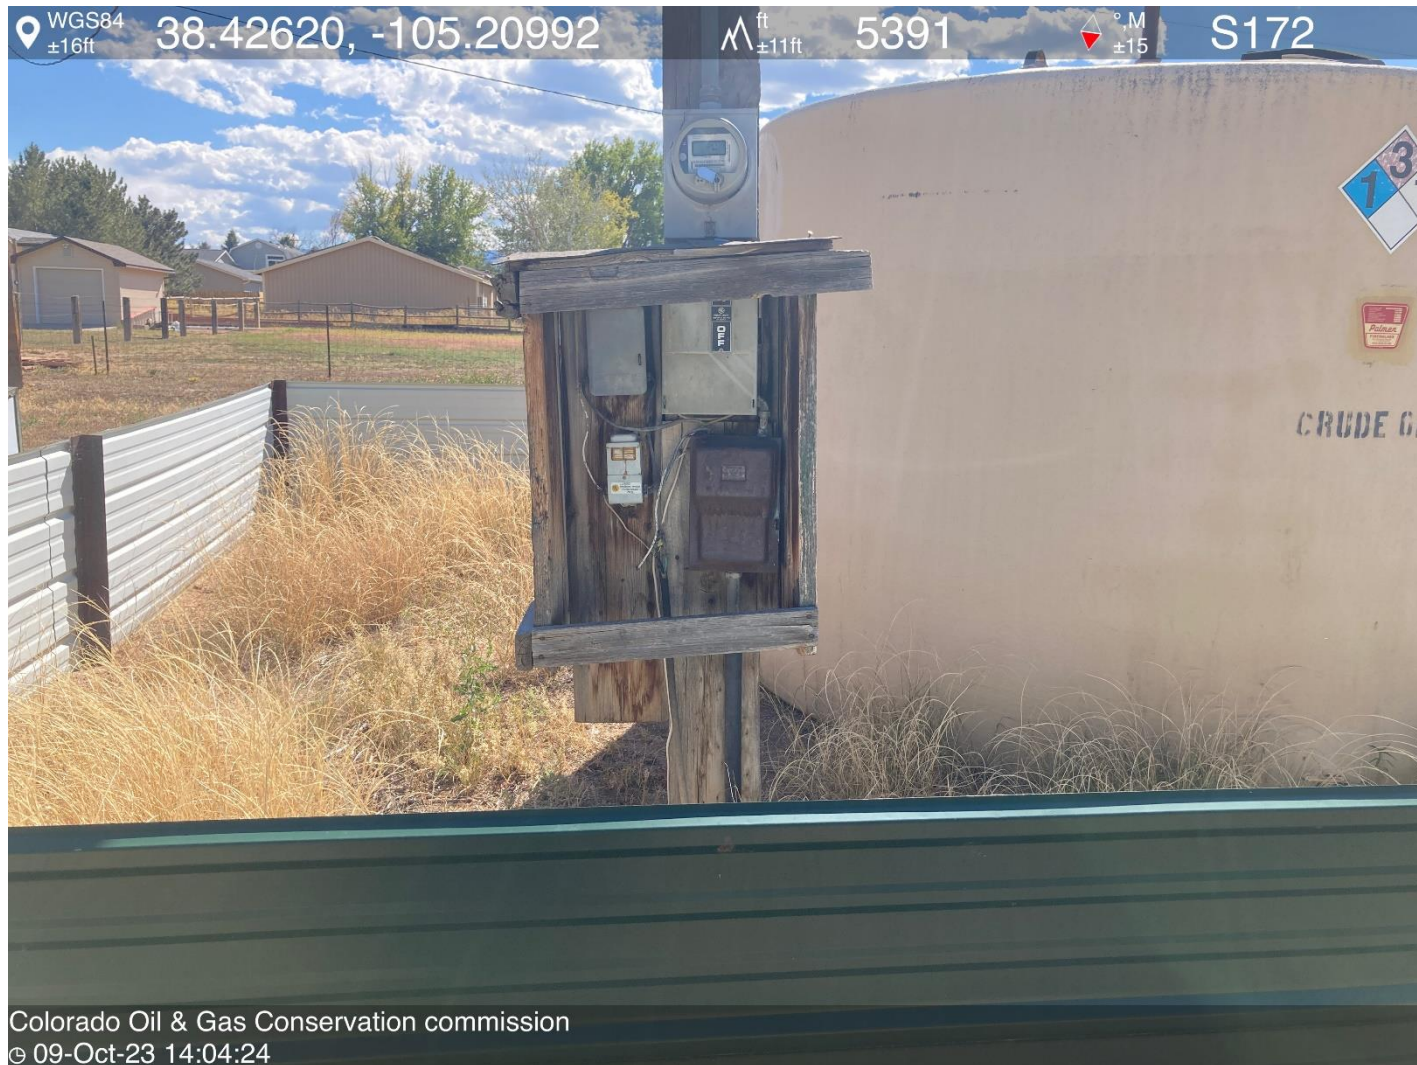
PHOTO 8: THERE ARE EXPOSED WIRE CONNECTIONS INSIDE WOOD ELECTRIC PANEL BOX. Securely fasten all valves, pipes, fittings, electric equipment and Production Facilities to ensure good mechanical condition, inspect at regular intervals and maintain in good mechanical condition per Rule 603.O(6) CA DATE 11-19-2023.

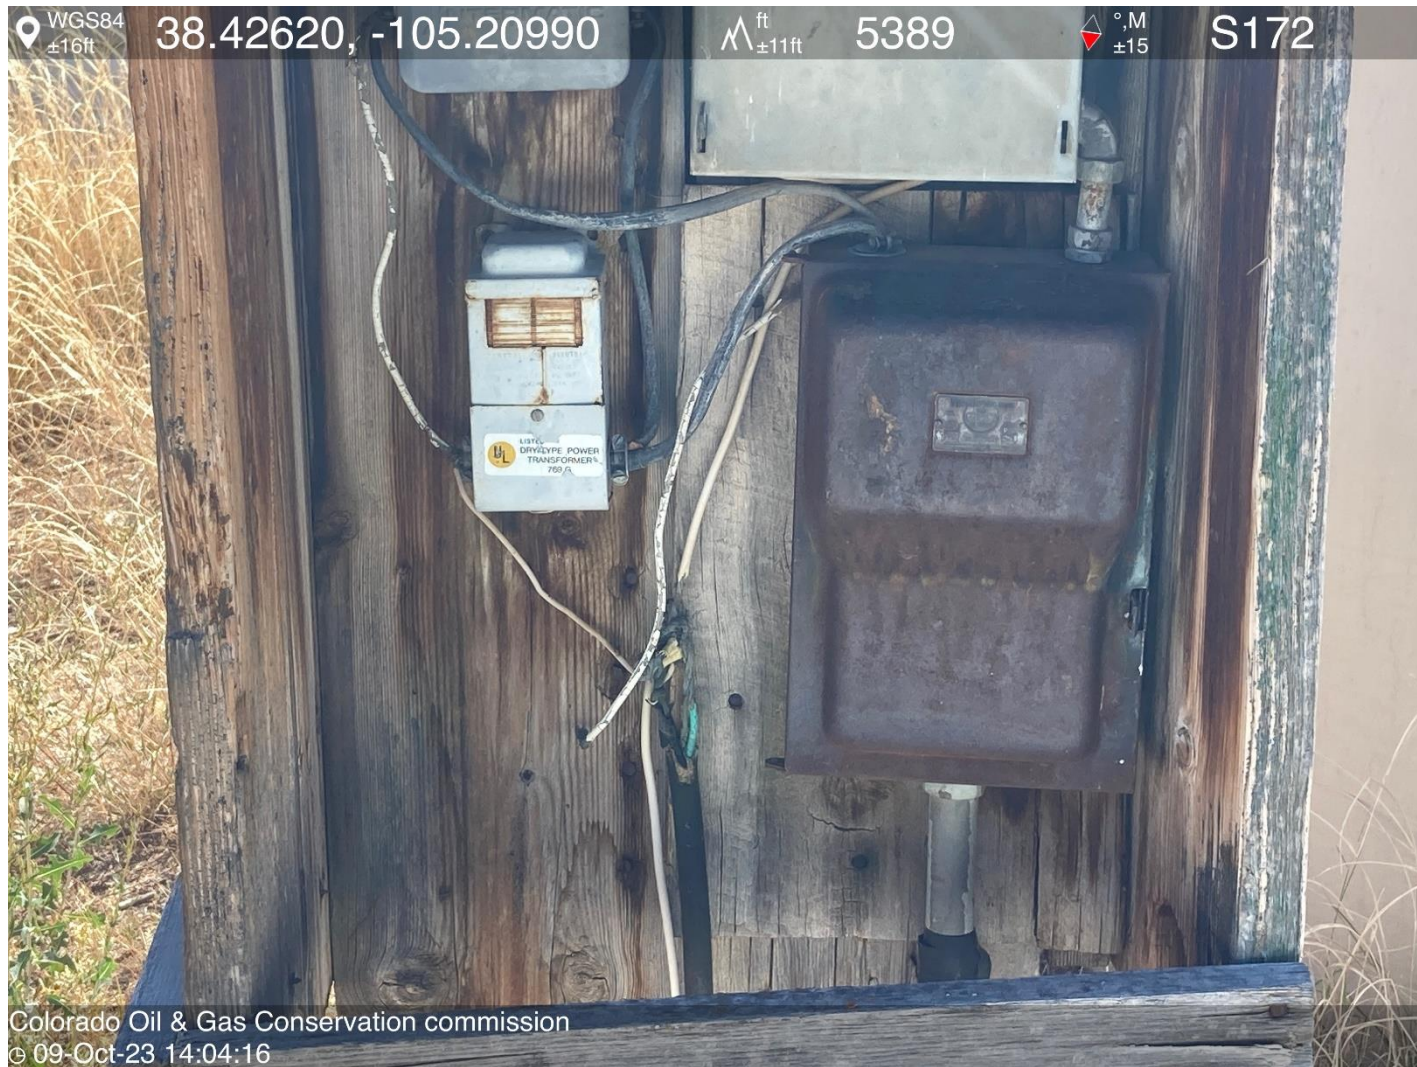
PHOTO 9: THERE ARE EXPOSED WIRE CONNECTIONS INSIDE WOOD ELECTRIC PANEL BOX. Securely fasten all valves, pipes, fittings, electric equipment and Production Facilities to ensure good mechanical condition, inspect at regular intervals and maintain in good mechanical condition per Rule 608.e. CA DATE 11-19-2023.

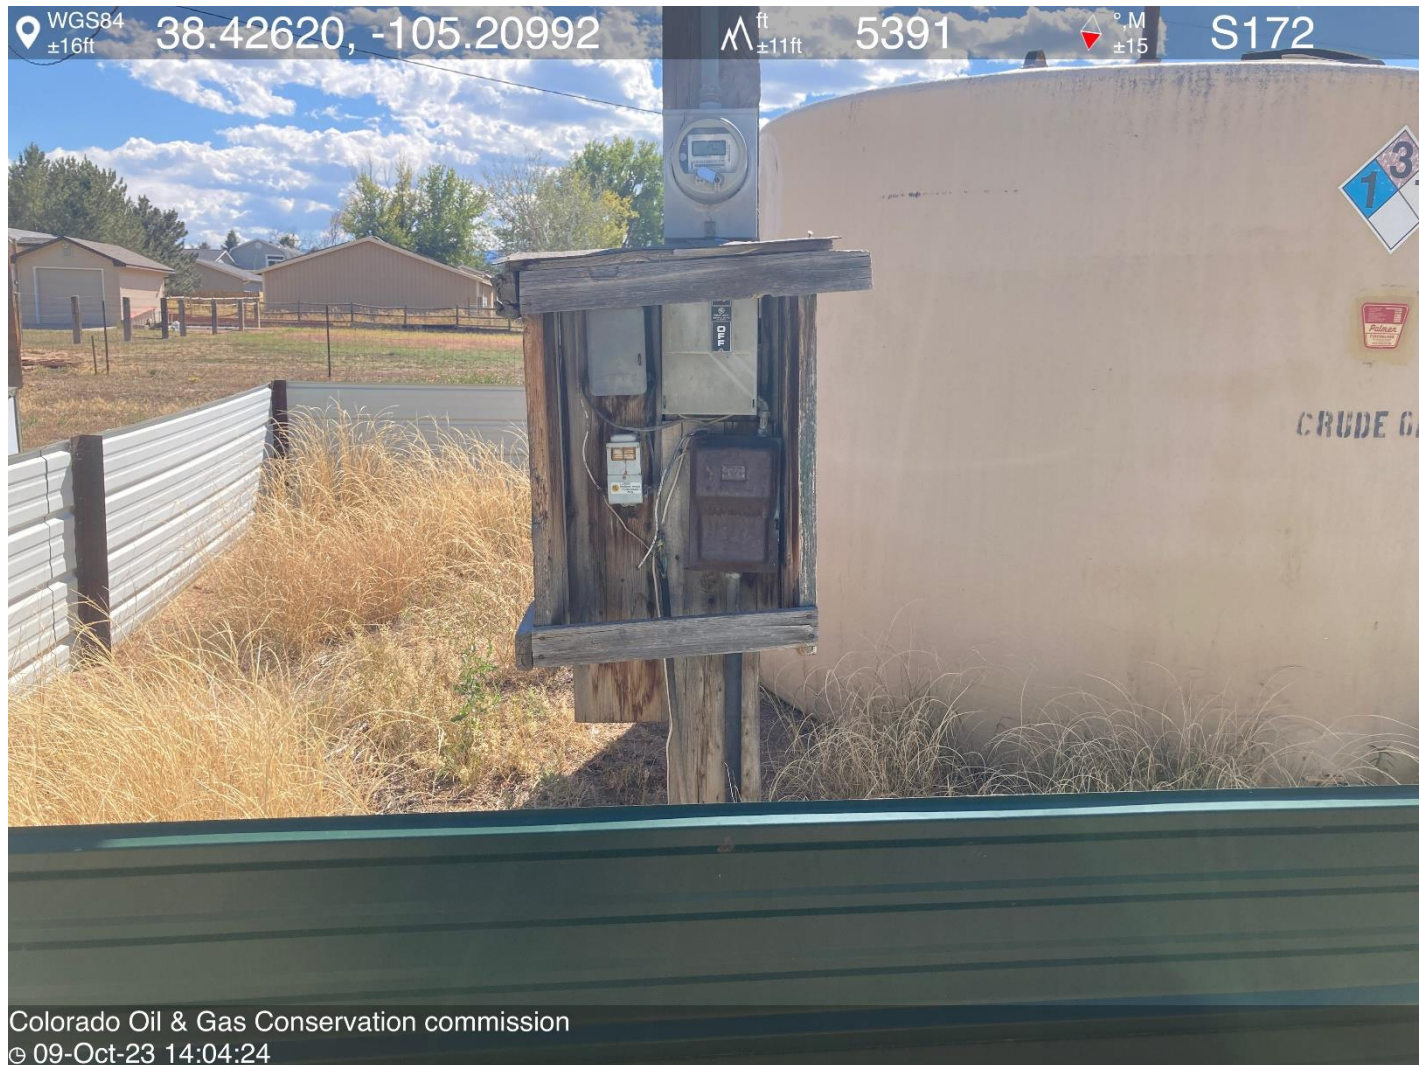
PHOTO 10: ELECTRIC PANEL IS APP. 3' FROM CRUDE OIL TANK BATTERY.

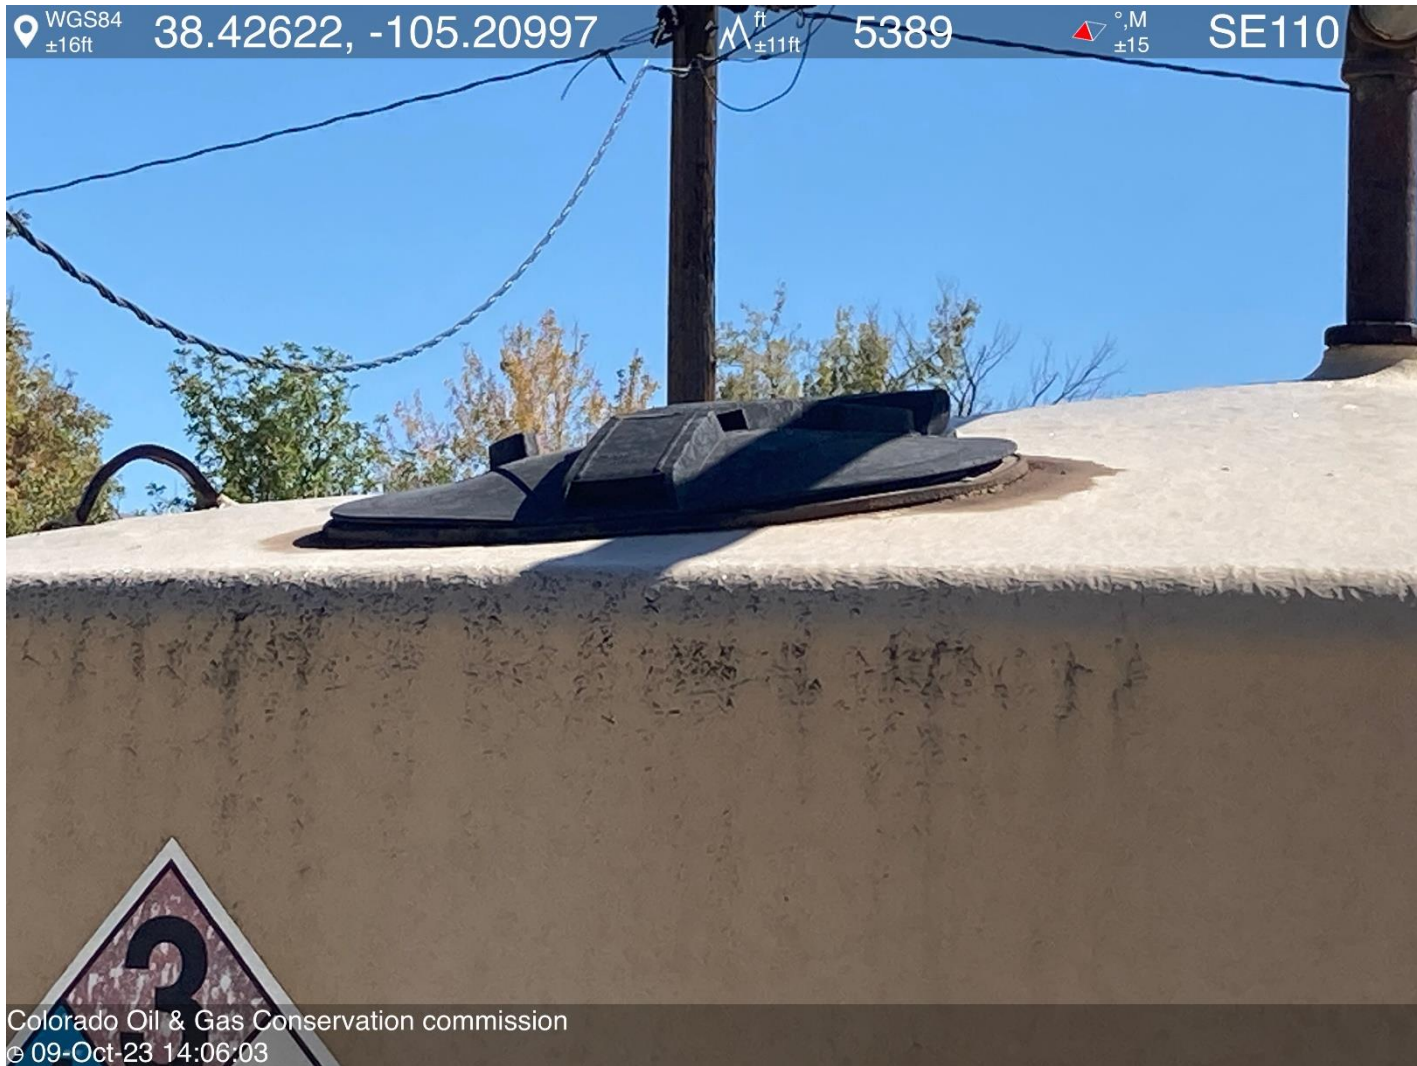
PHOTO 11: THERE APPEARS TO BE A RUBBER FLAP COVER ON TANK BATTERY WITH NO SAFETY VALVE INSTALLED ON TANK. Tanks will function as sealed and ventless with gas released only through a vapor control system or properly sized pressure relief valve. per Rule 608.a.(9). CA DATE 10-21-2023.

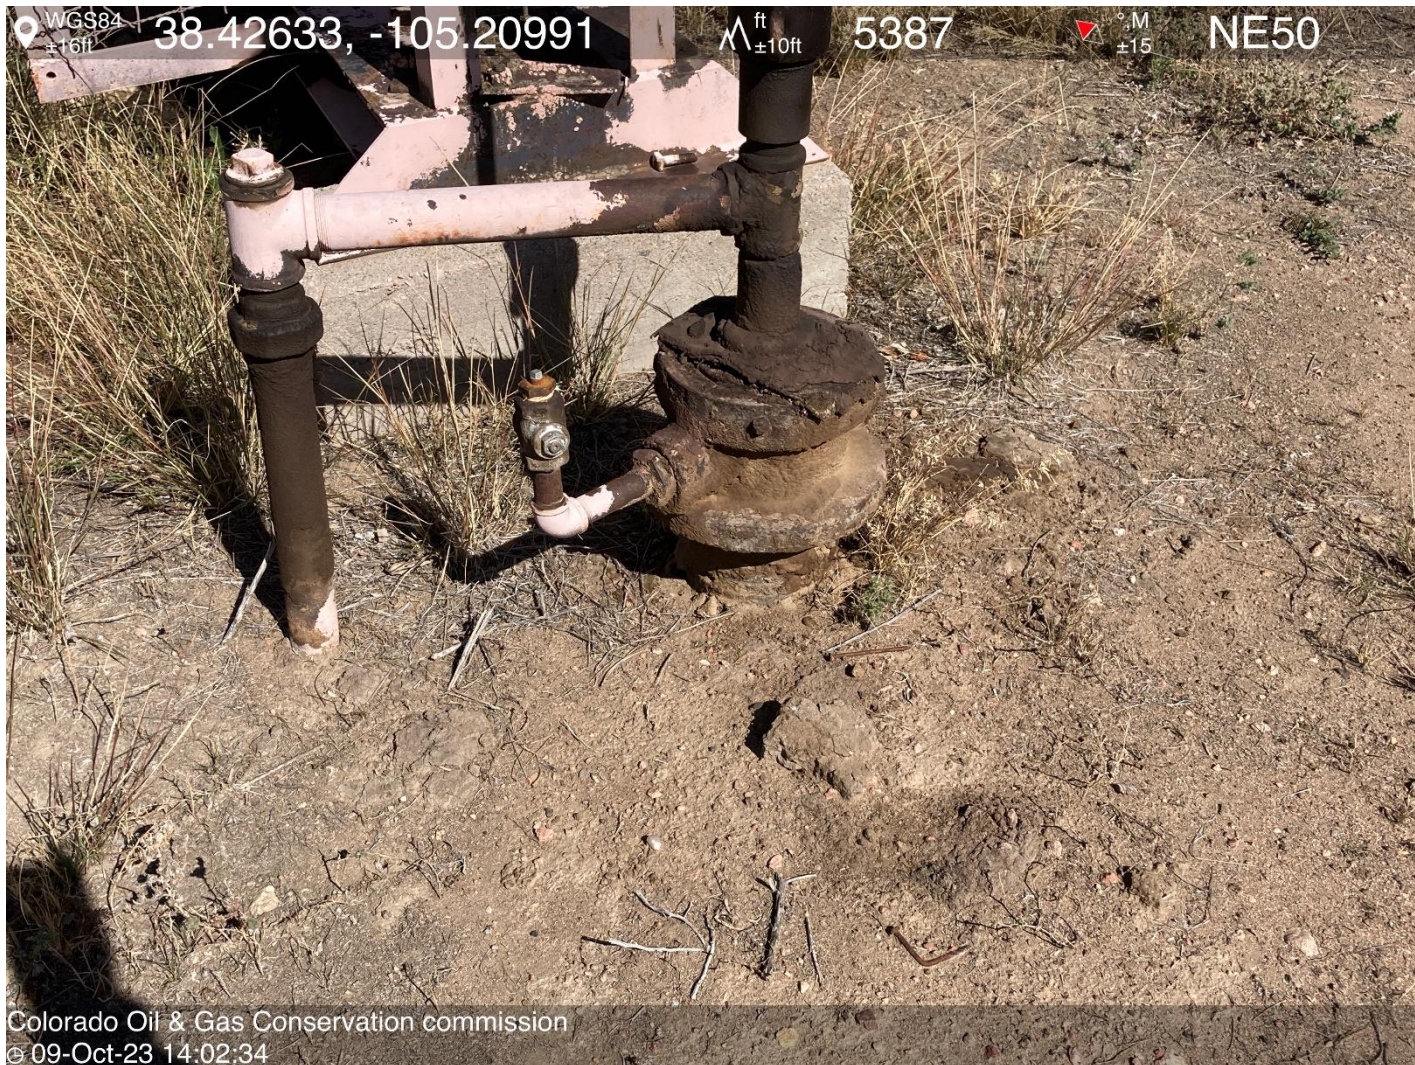
**PHOTO 12: BRADENHEAD IS NOT ACCESSABLE. Install appropriate fittings to allow bradenhead visual inspection as per Rule 419.a.(1), (2).
CA DATE 11-19-2023.**

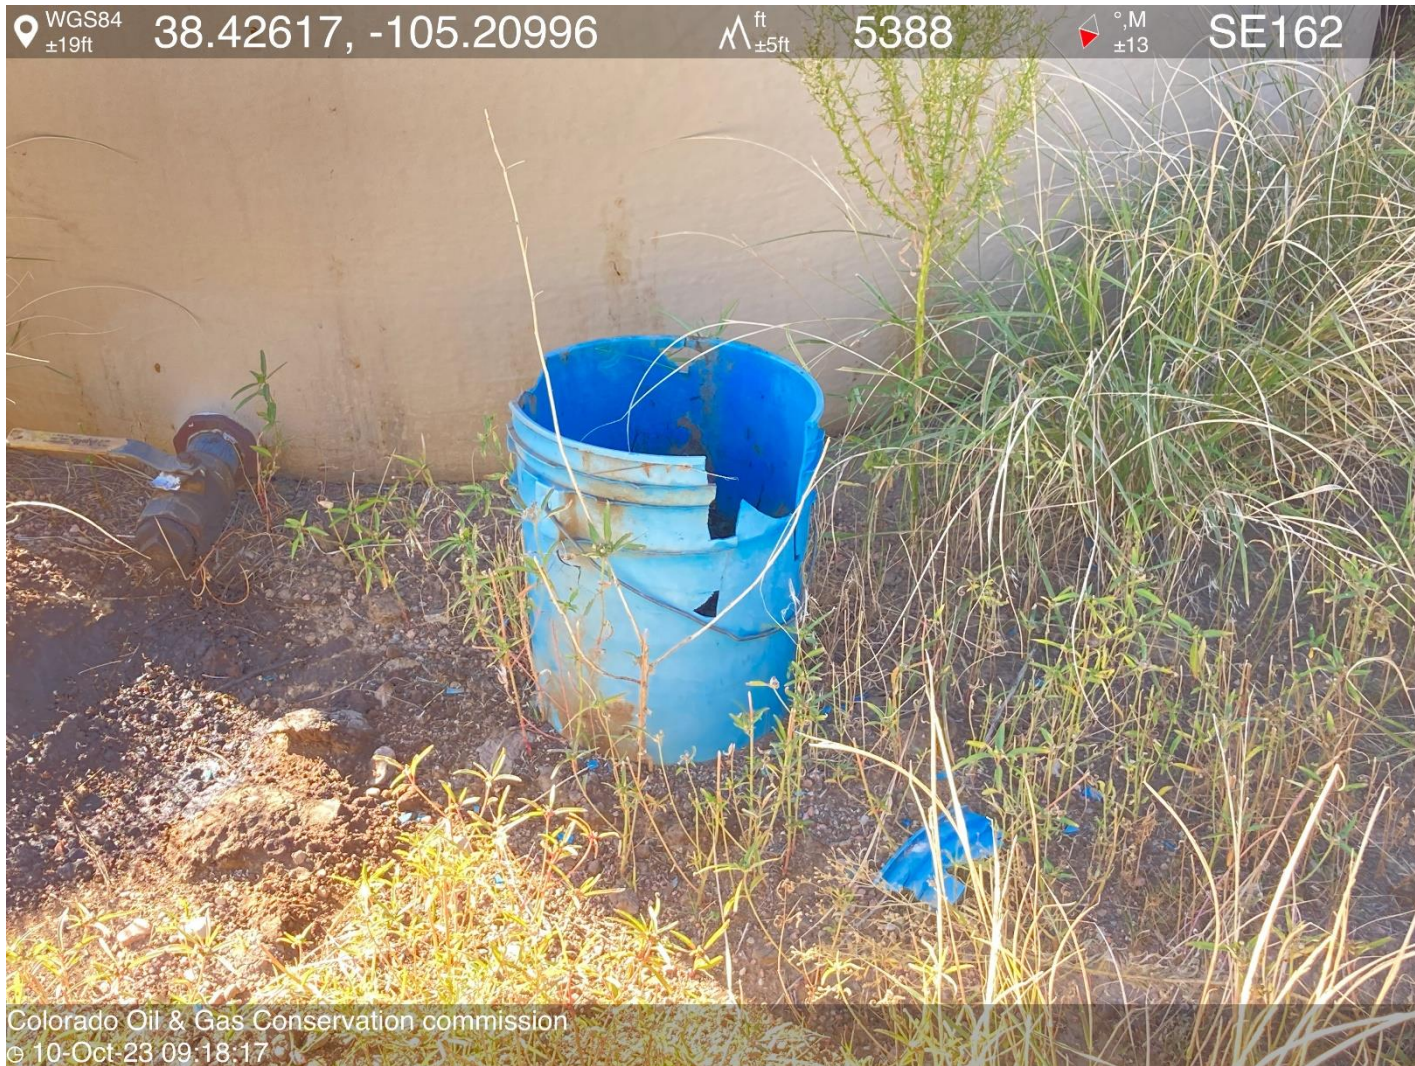
PHOTO 13: TRASH INSIDE TANK BATTERY CONTAINMENT (BLUE 5 GAL. BUCKET. REMOVE TRASH PER RULE 606. CA DATE 11-19-2023.
