Interim Reclamation and Stormwater Inspection

Date:10/17/2023

Operator: Fundare Resources Operating Company
LLC - 10773

Location ID: 436724

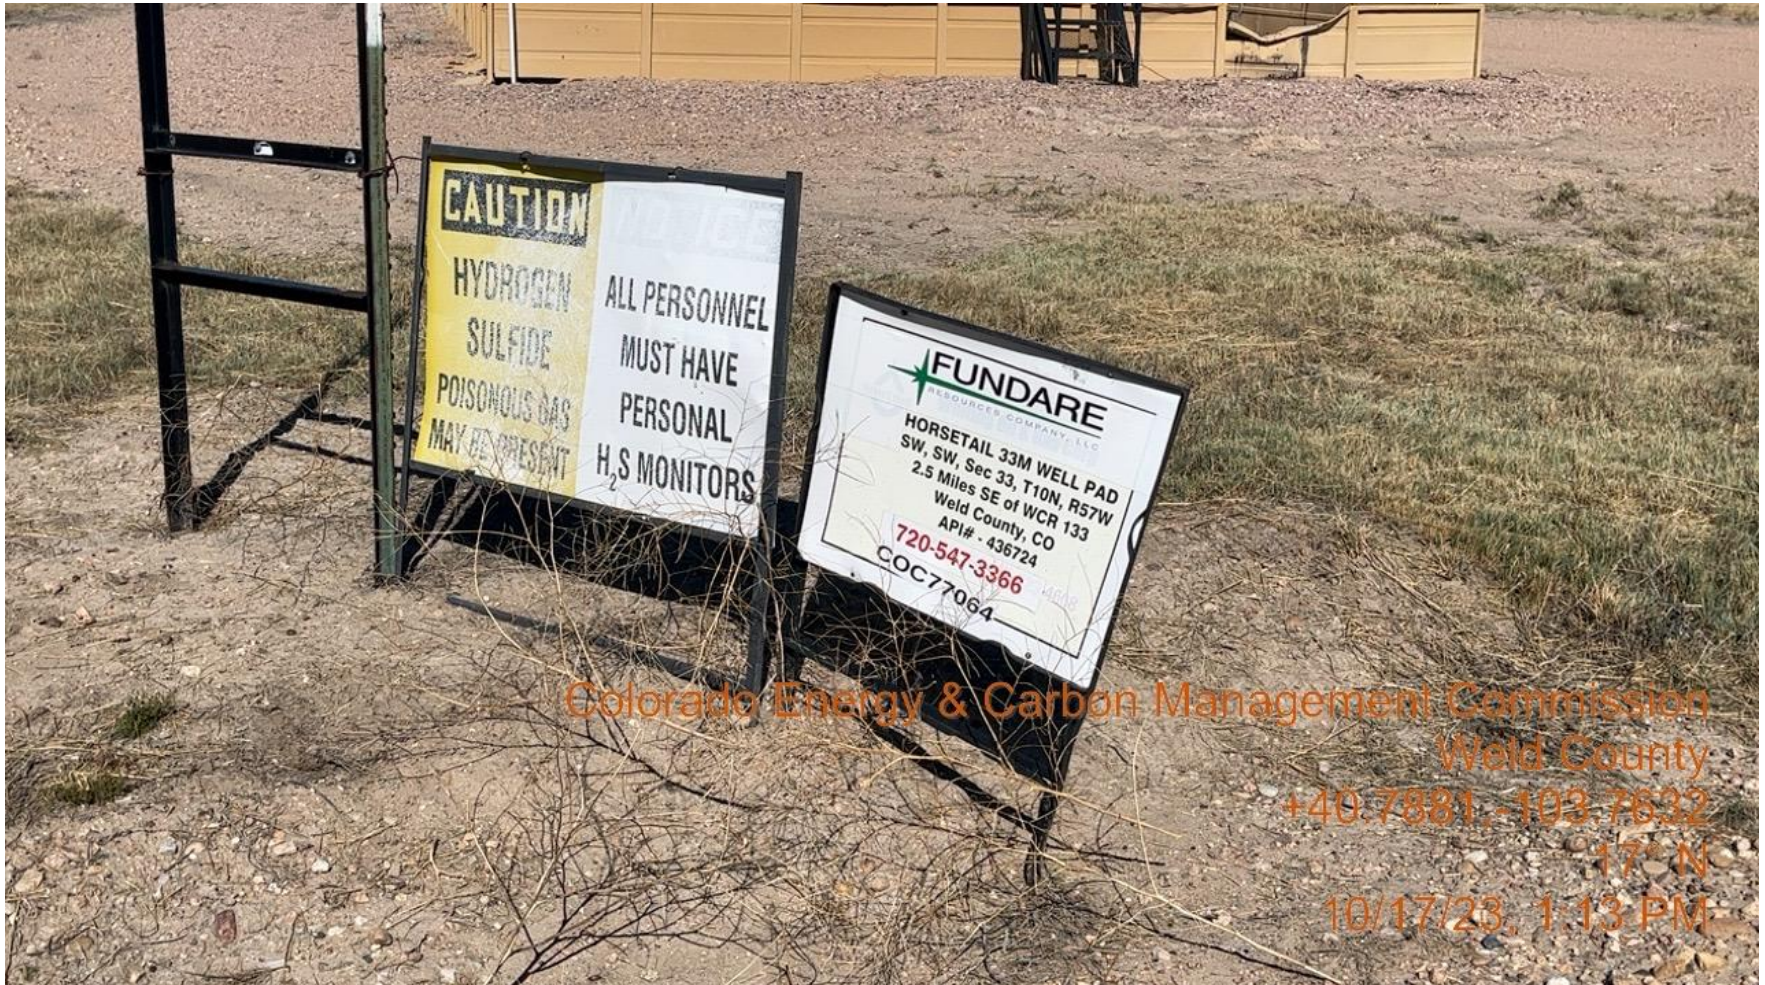
Photo 1. Photo taken from the well location entrance facing North. The photo illustrates the operator sign.

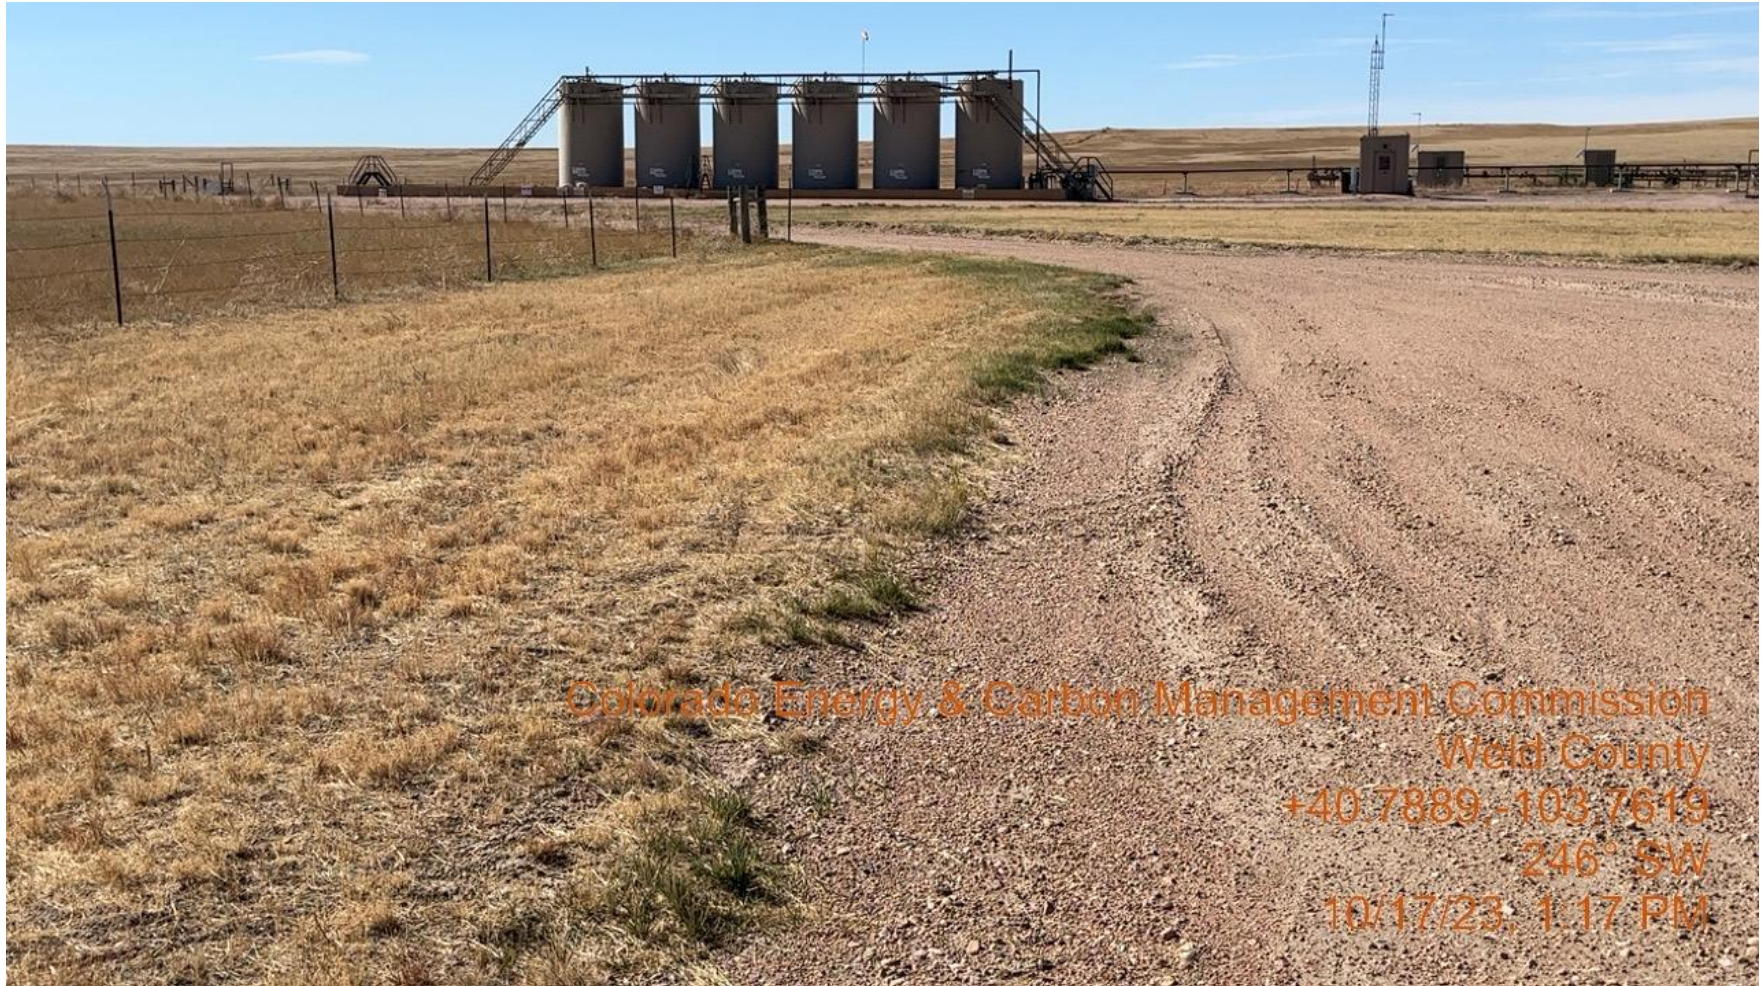
Photo 2. Photo taken from the location entrance facing Northeast. The photo illustrates that the interim areas on location have been mowed.

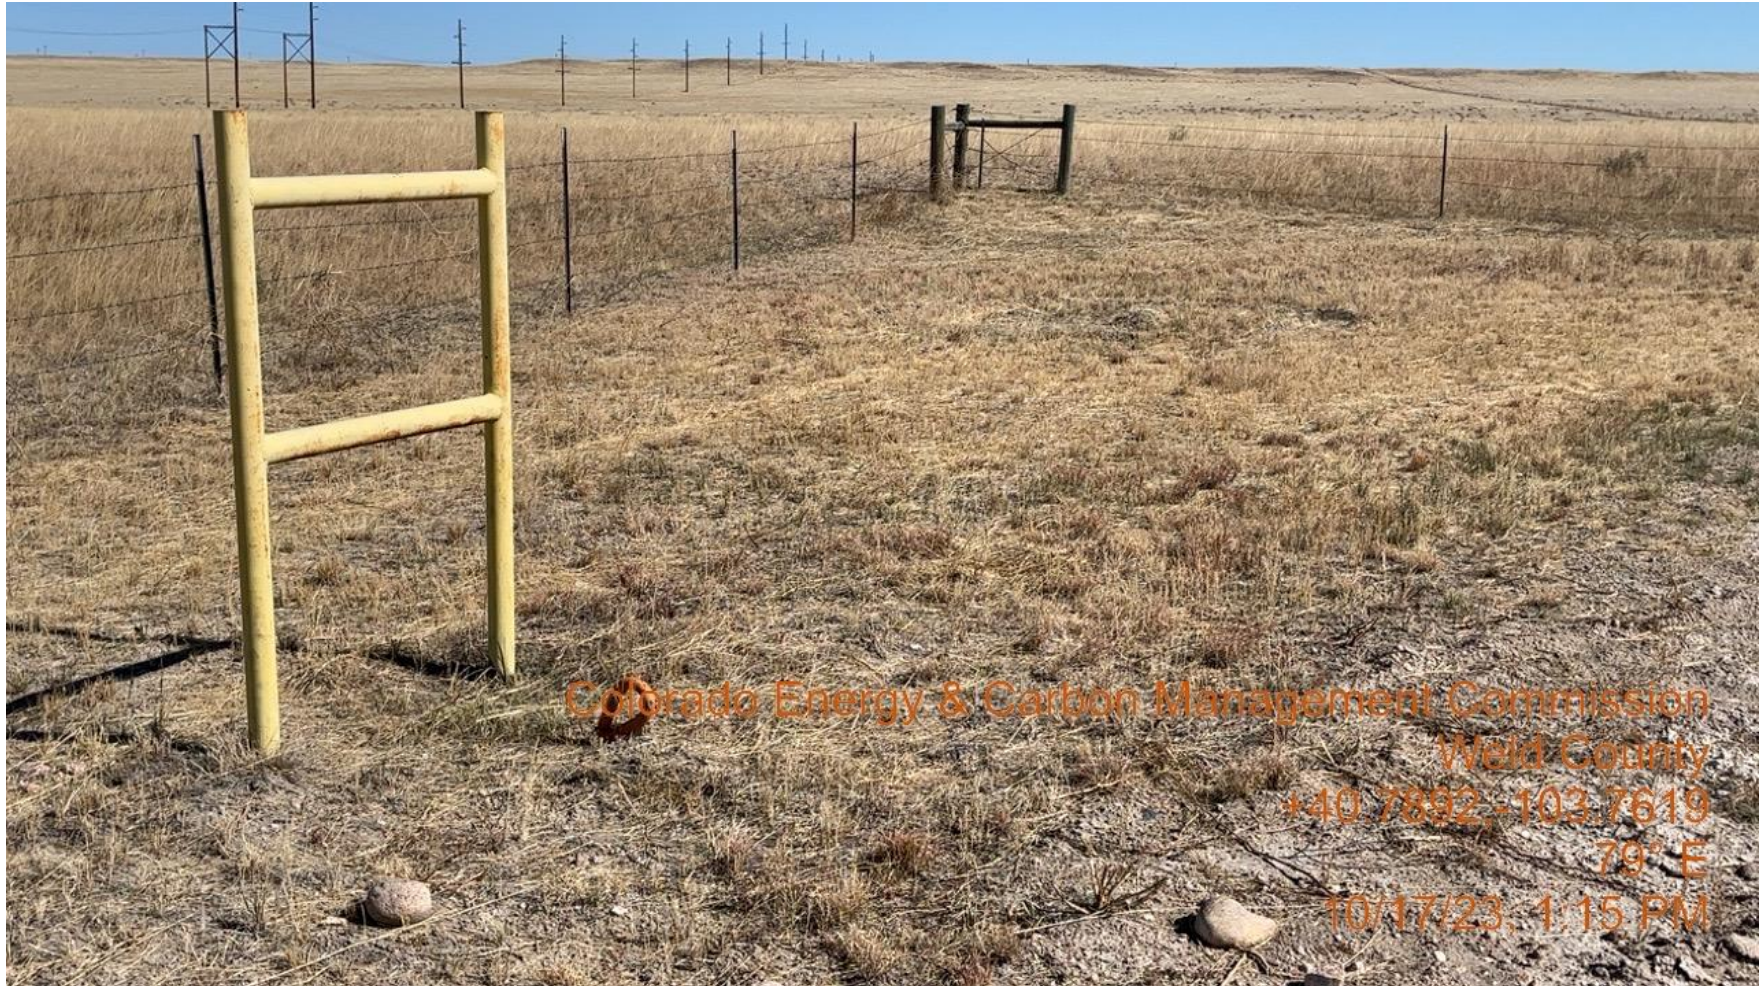
Photo 3. Photo on location facing East. The photo illustrates the guy line anchors are visibly marked by yellow painted steel uprights. The photo also illustrates there has been good recruitment of vegetation in the interim but that it has been mowed.

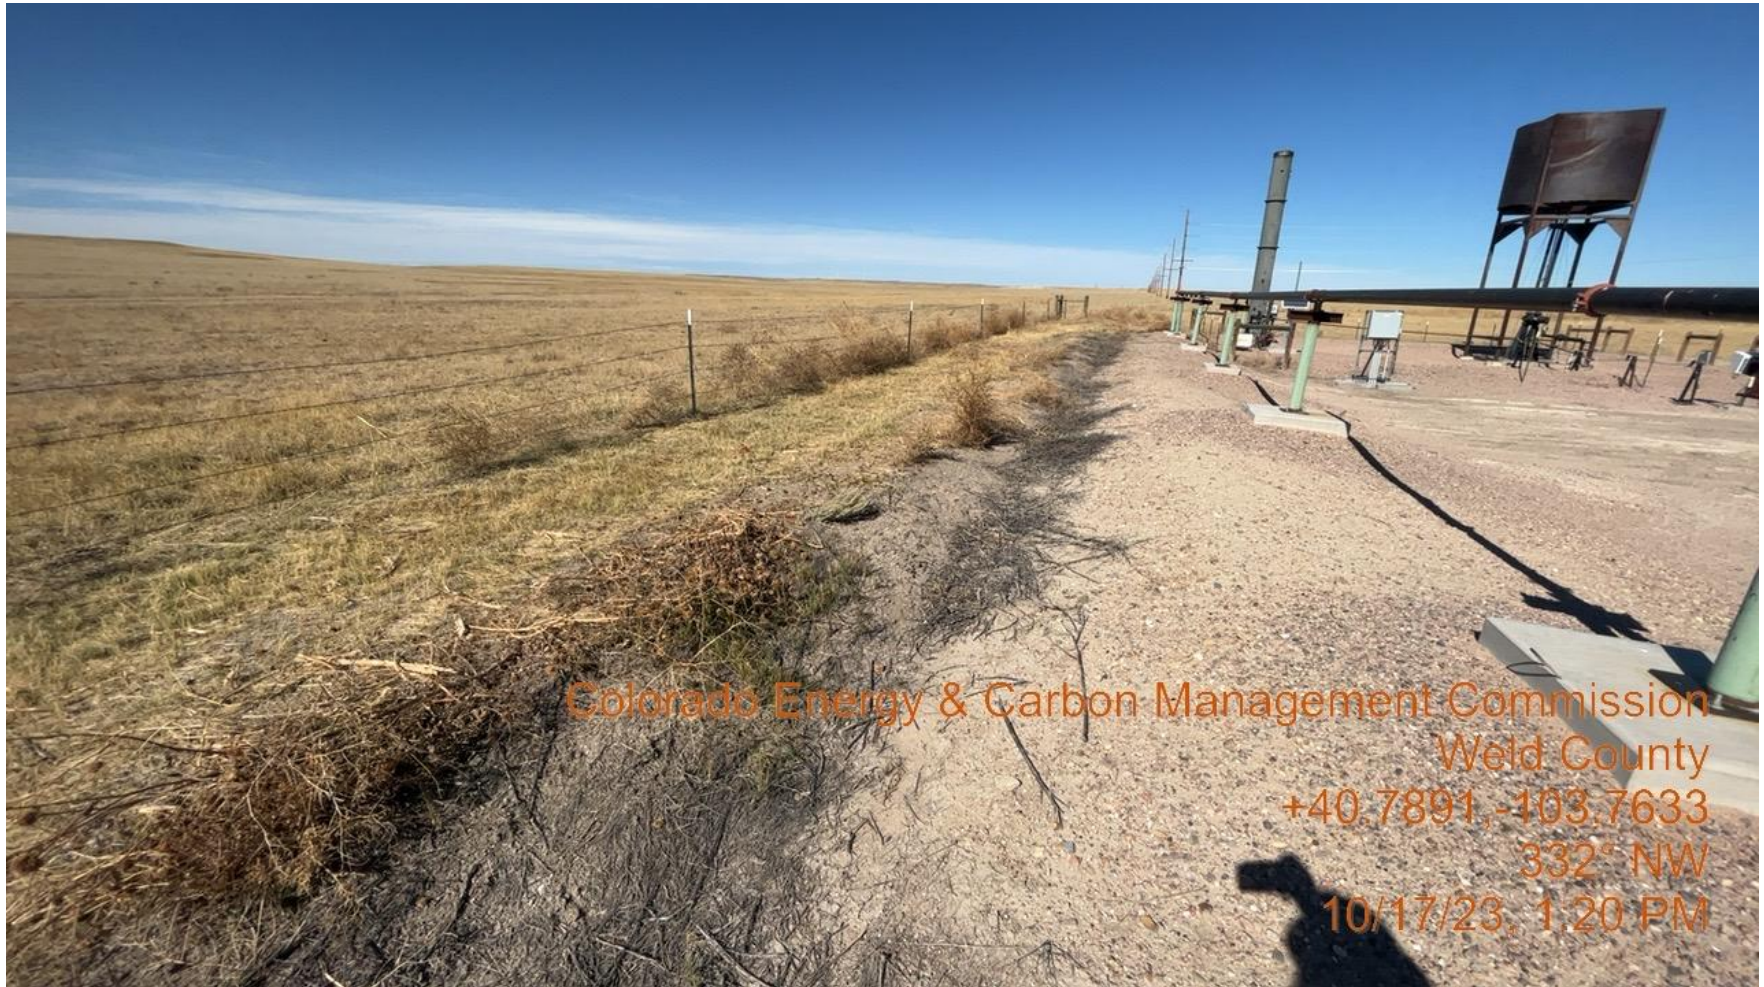
Photo 4. The photo was taken from the West side of the location facing South. The photo illustrates tumbleweeds (kochia and russian thistle) up against the fence inside the location.

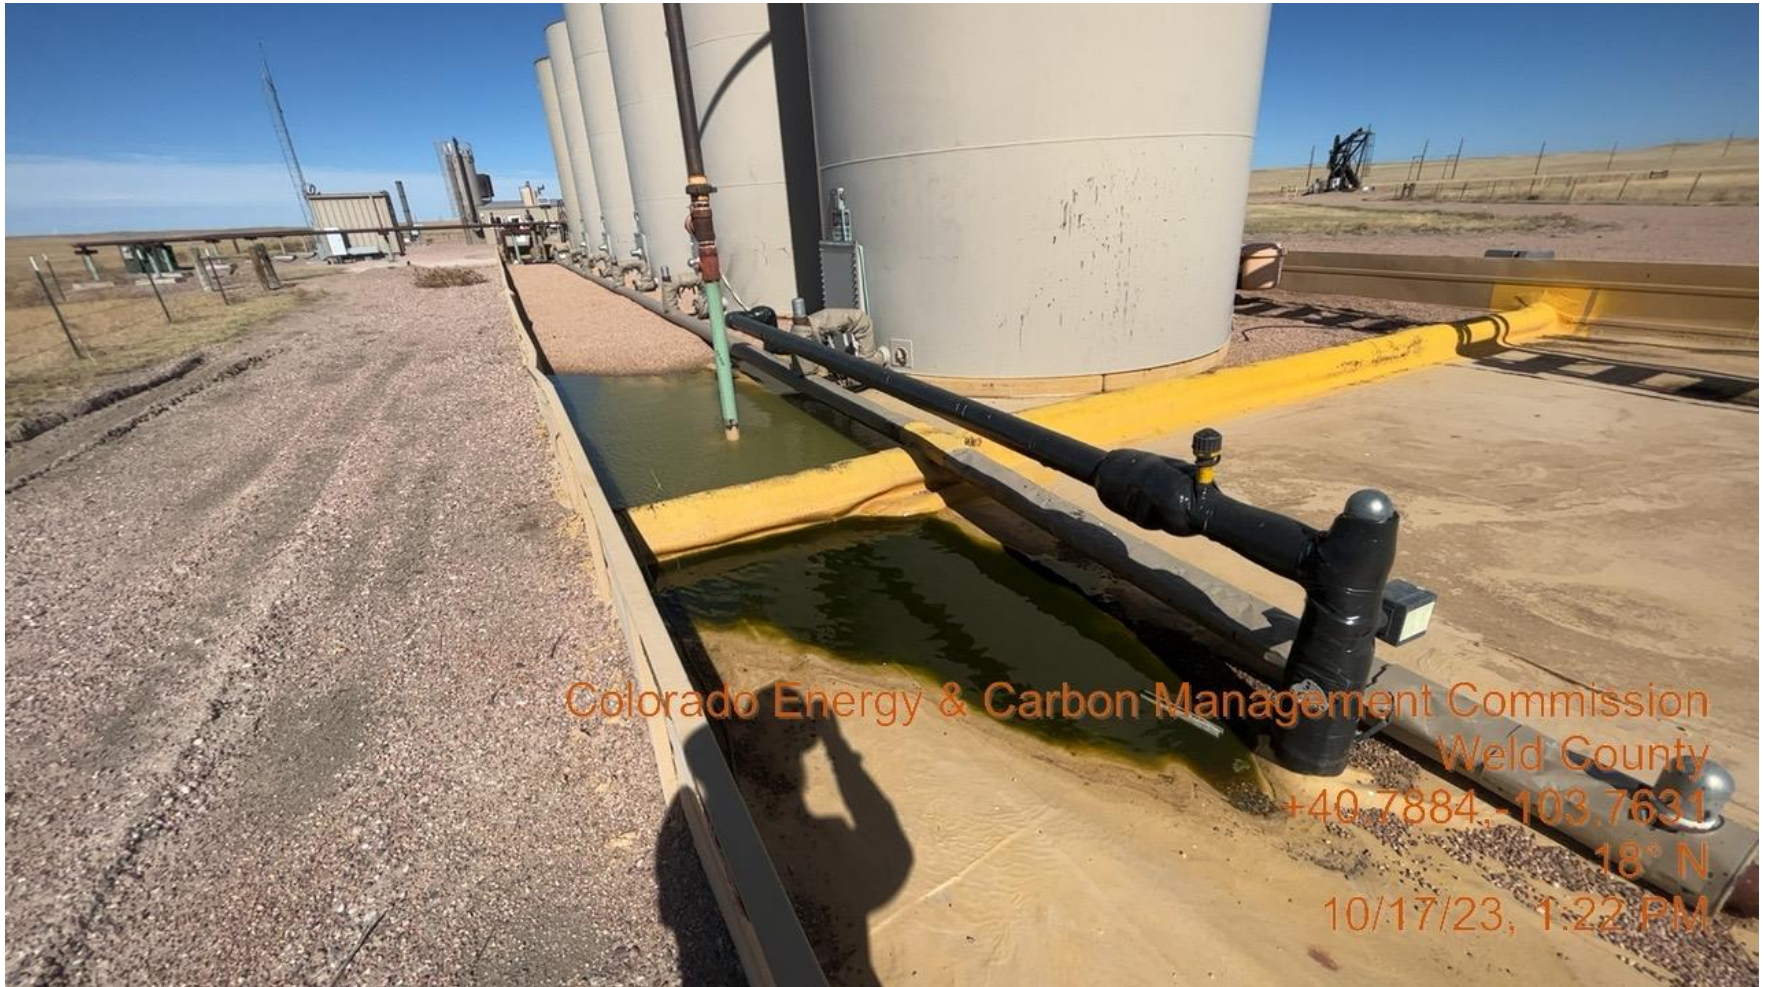
Photo 5. The photo was taken from the West side of the location facing North. The photo illustrates produced water inside the secondary containment.
