WELL NAME: APACHE CANYON 20-11, API #: 071-09868, INSP. # 695108681

COLORADO  
Energy & Carbon Management  
Commission  
Department of Natural Resources

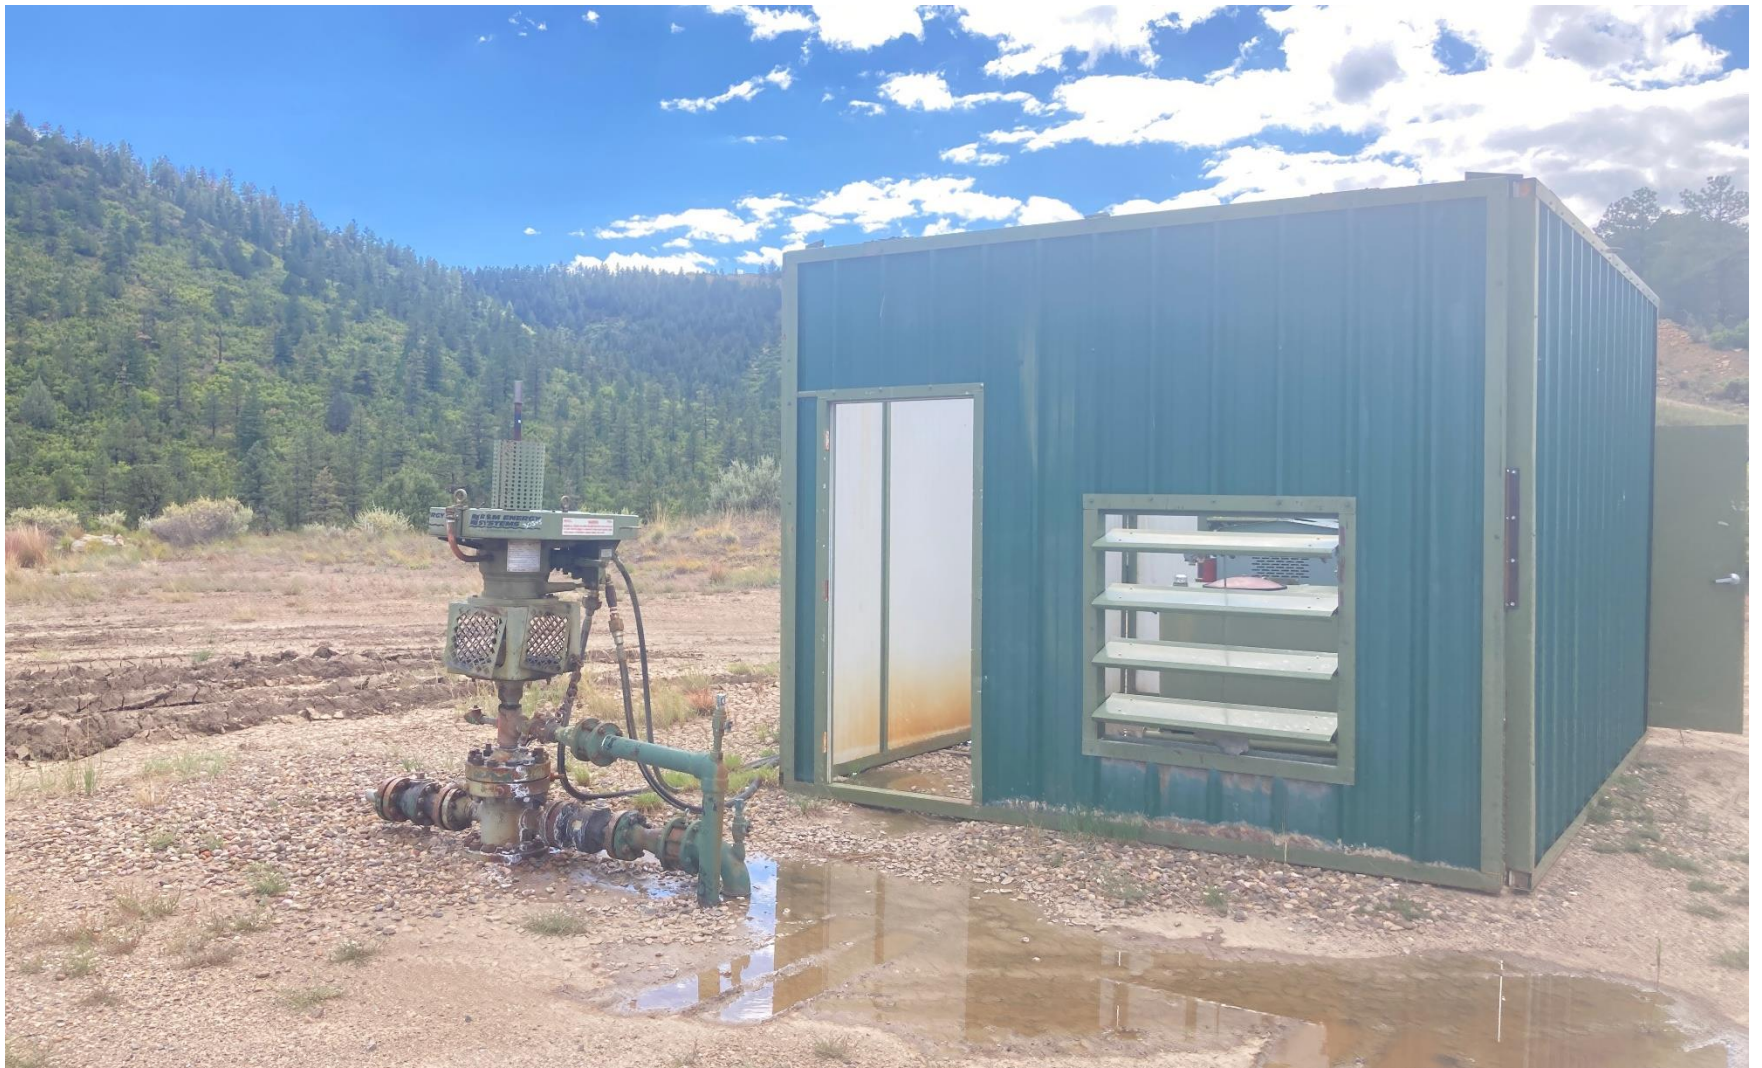
**PHOTO 3: WELLHEAD AND EQUIPMENT, WELLHEAD WAS NOT LEAKING AT TIME OF INSPECTION.**

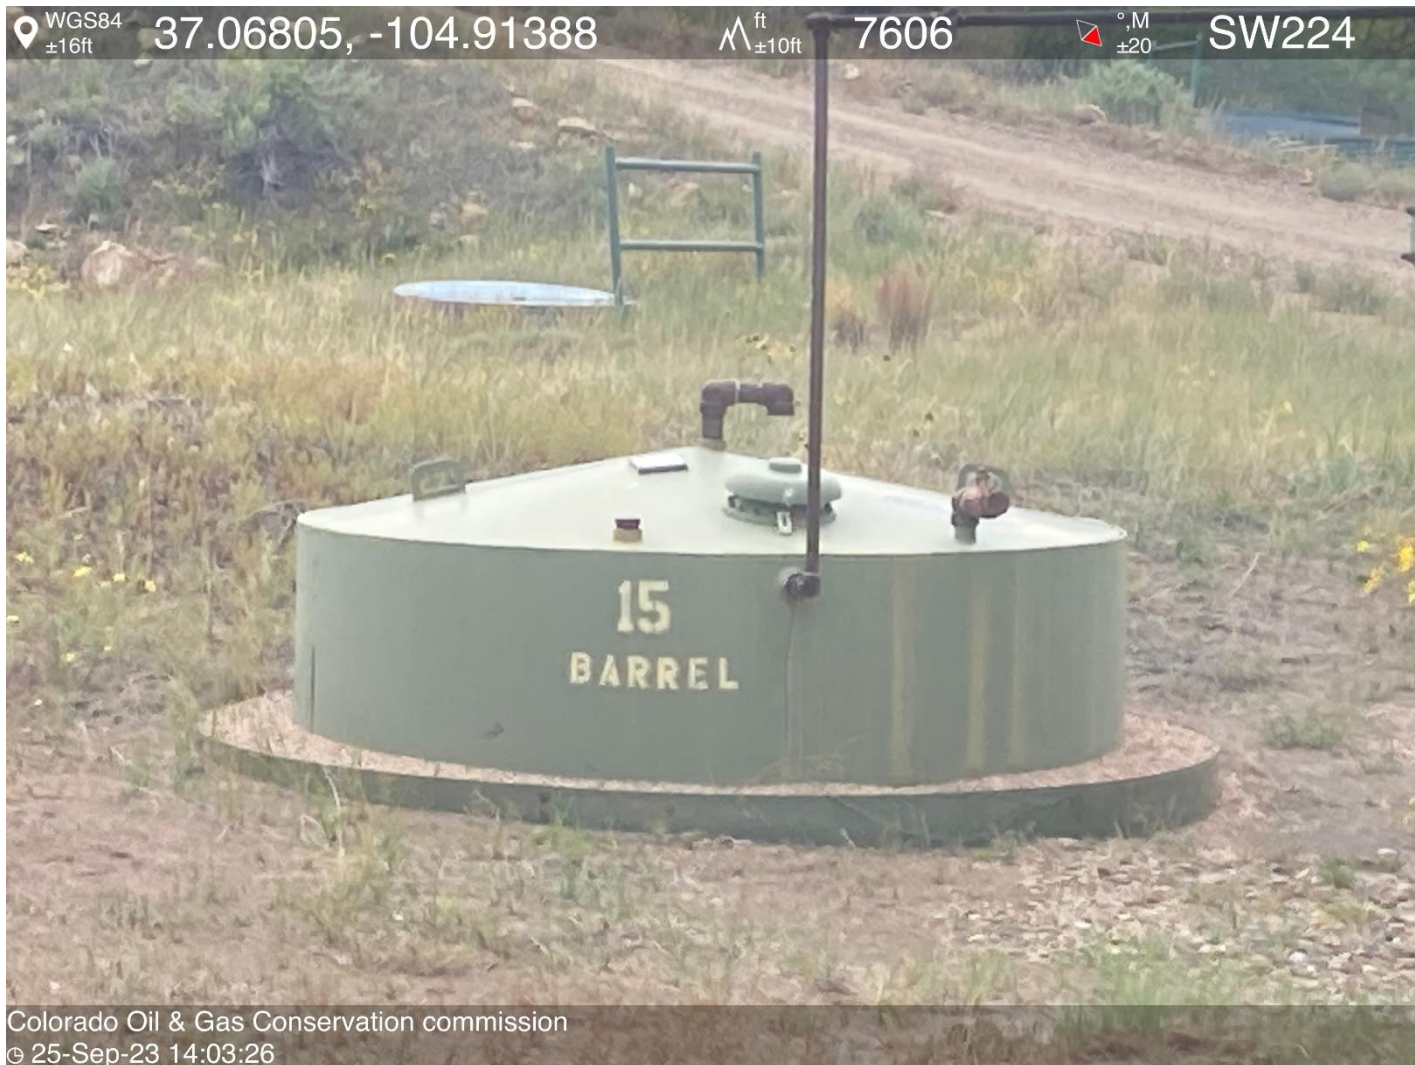
**PHOTO 4: 15 BBL PRODUCED WATER TANK.**

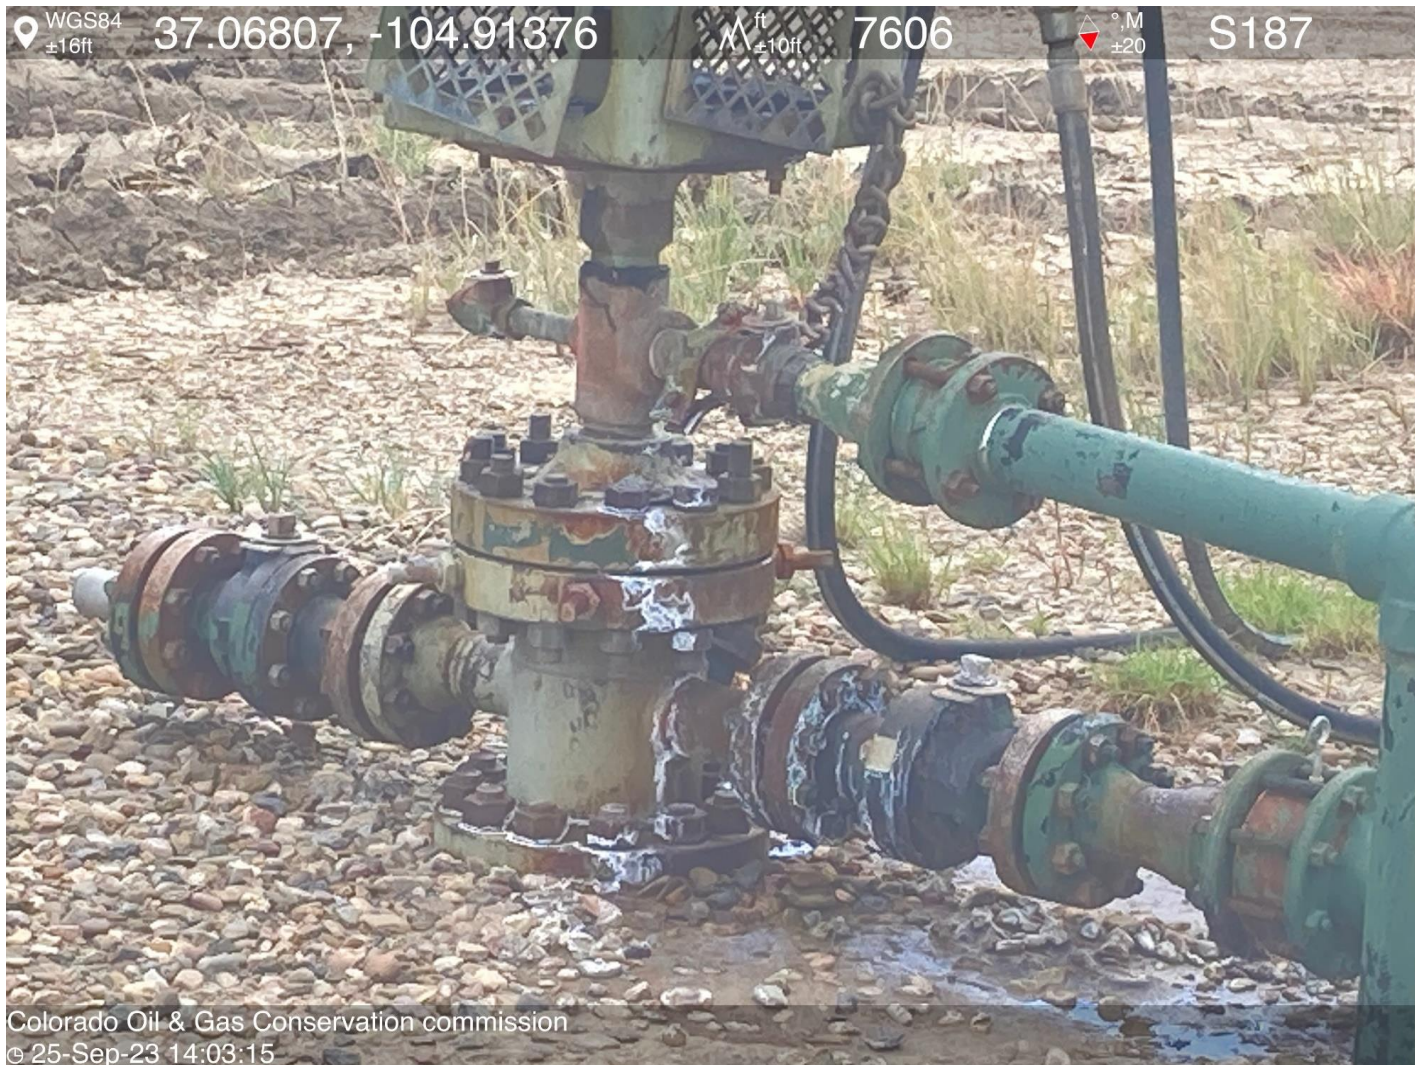
**PHOTO 5: Signs of recent slow leak from wellhead. Salt/mineral buildup is evident on the wellhead. Securely fasten all valves, pipes, fittings, and Production Facilities to ensure good mechanical condition, remove salt/mineral buildup, inspect at regular intervals and maintain in good mechanical condition per Rule 608.e. CA DATE 11-19-2023.**

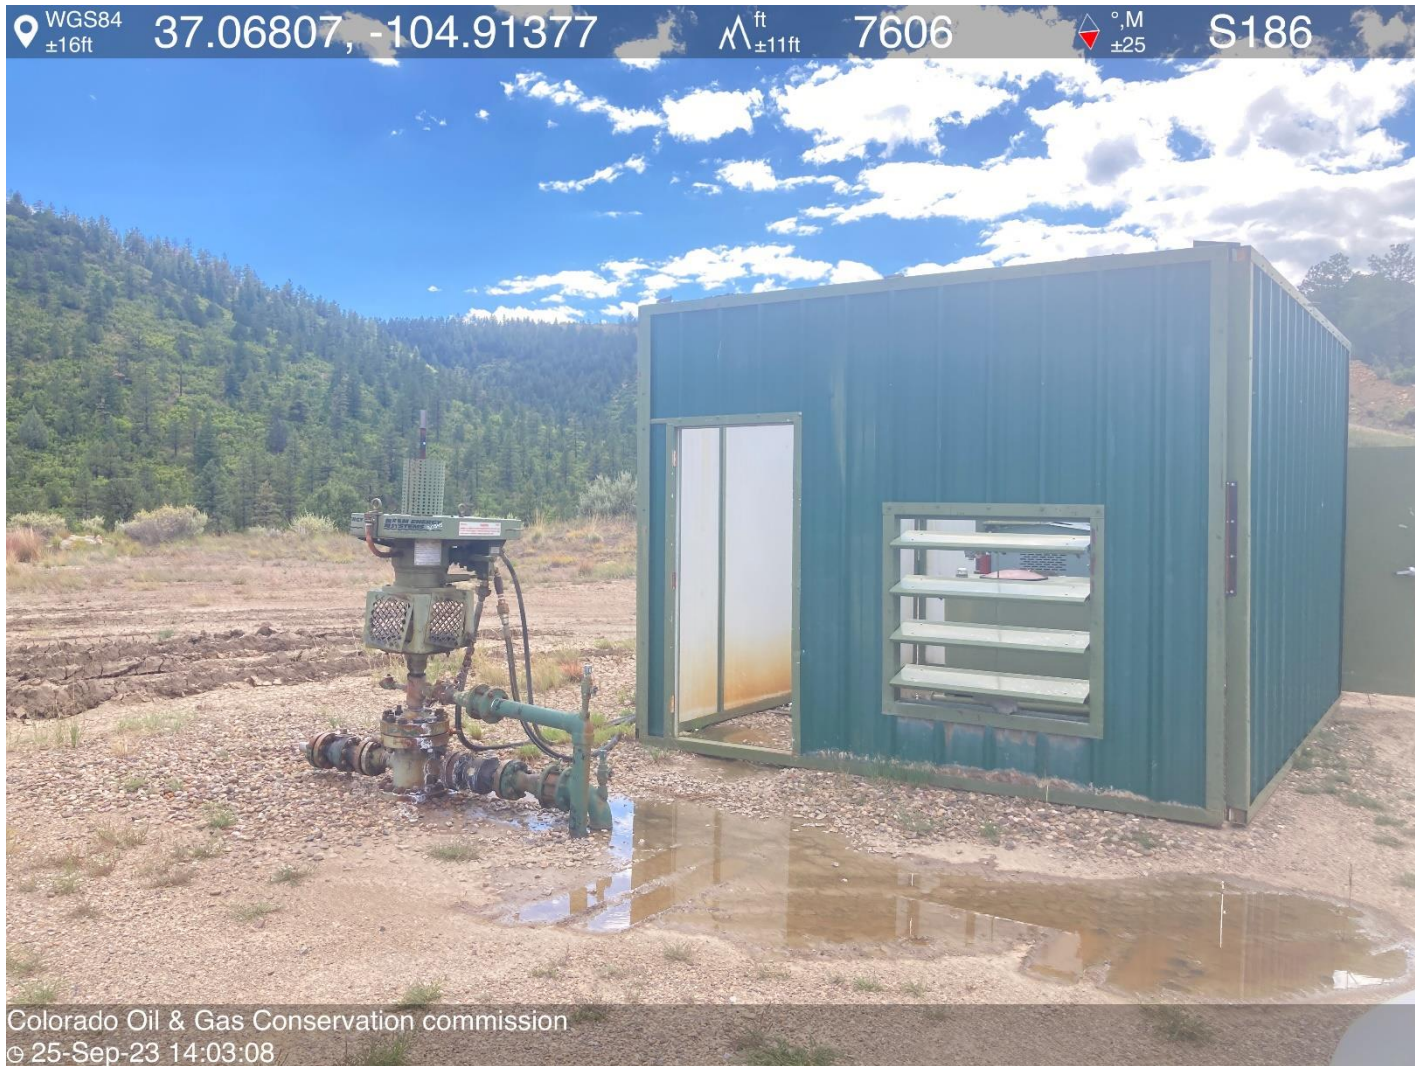
**PHOTO 6:** Produced water spill from the wellhead has left a salt impacted area around the wellhead. **Securely fasten all valves, pipes, fittings, and Production Facilities to ensure good mechanical condition, inspect at regular intervals, remove salts/mineral impacted soils, and maintain in good mechanical condition per Rule 608.e. CA DATE 11-19-2023.**

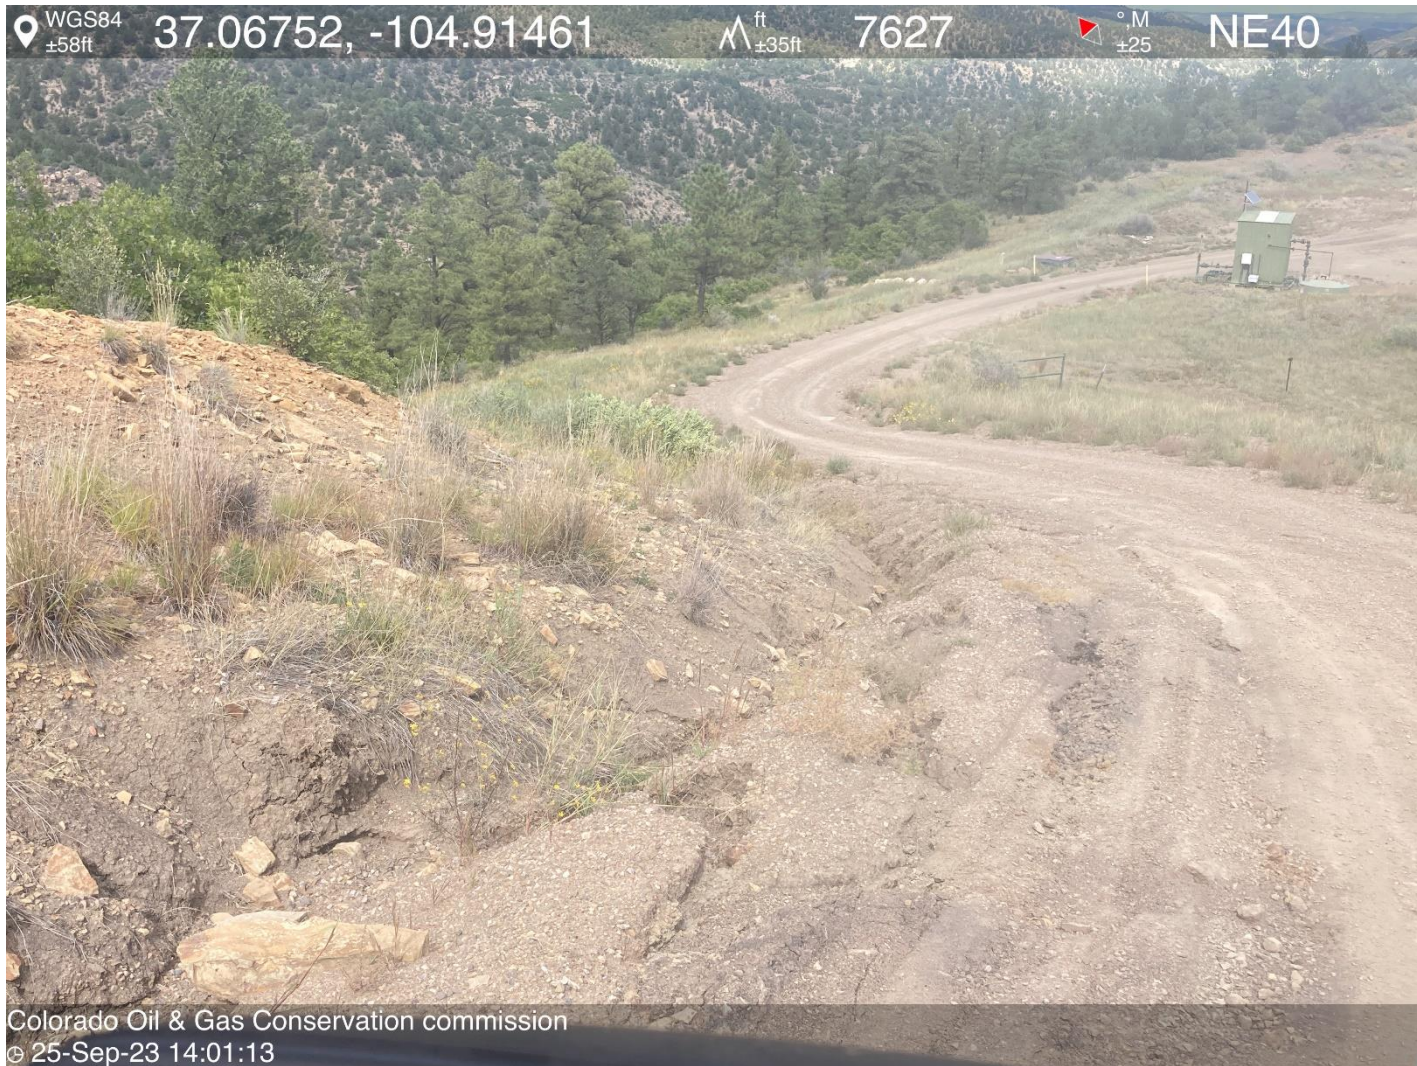
**PHOTO 7: NO STORM WATER BMP'S INSTALLED OR BMP'S ON ROW DRAINAGE DITCH JUST SOUTH OF LOCATION HAS CAUSED EROSION ON AND ALONG SIDE ROW. Install or repair required BMPs per Rule 1002.f.(2)C CA DATE 11-19-2023.**

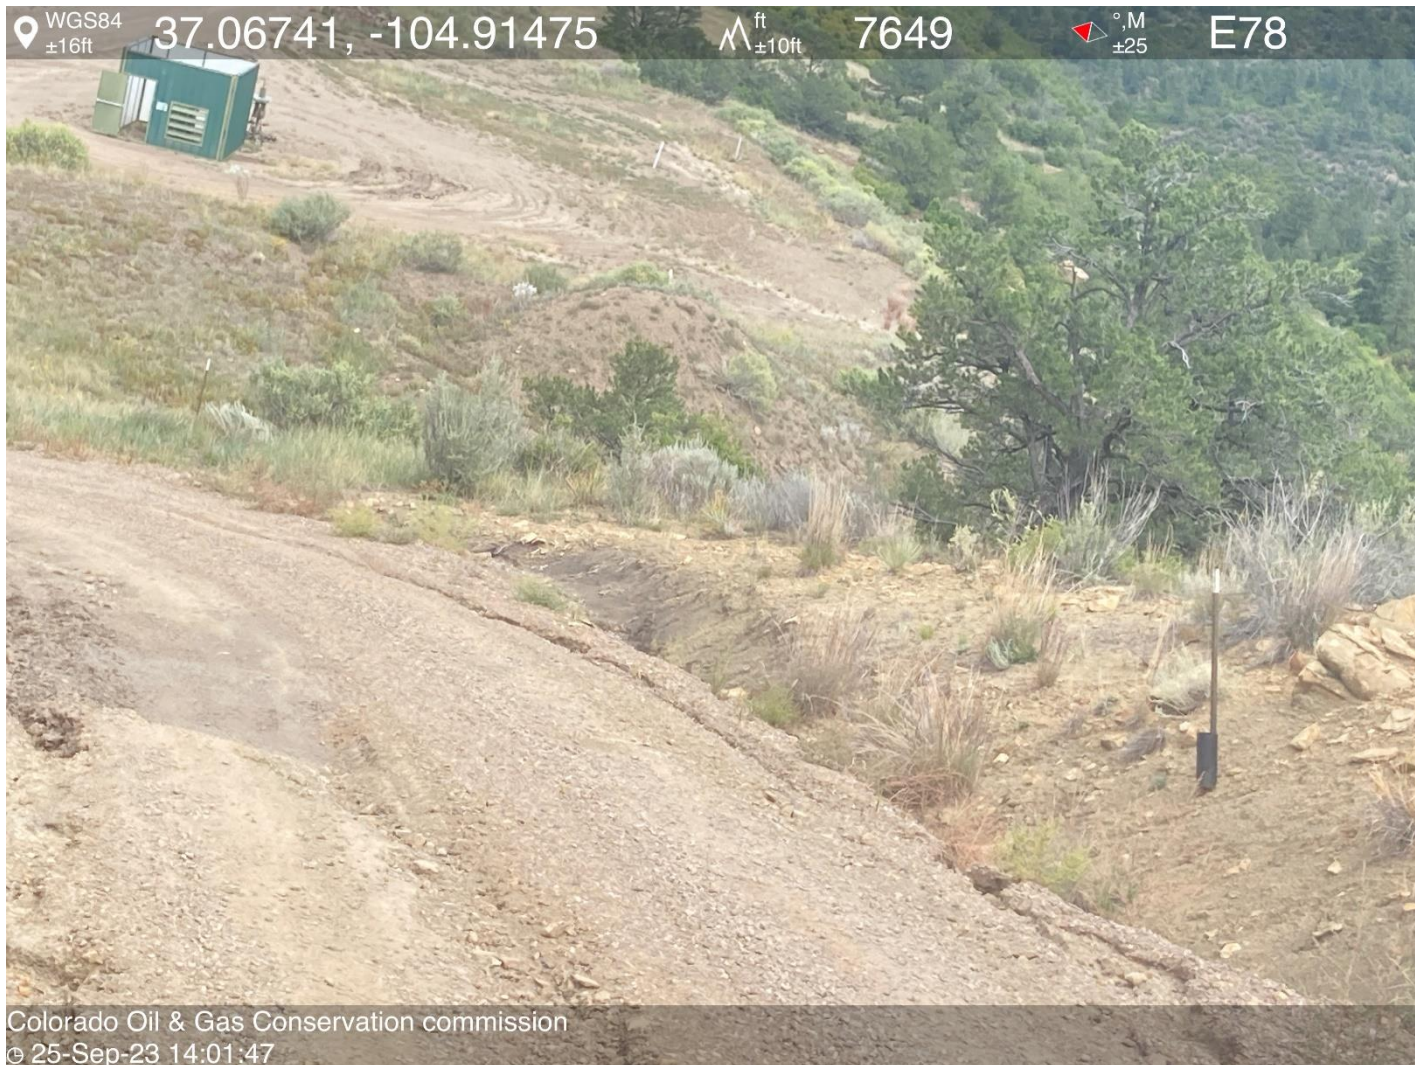
**PHOTO 8: NO STORM WATER BMP'S INSTALLED OR BMP'S ON ROW DRAINAGE DITCH JUST SOUTH OF LOCATION HAS CAUSED EROSION ON AND ALONG SIDE ROW. Install or repair required BMPs per Rule 1002.f.(2)C CA DATE 11-19-2023.**

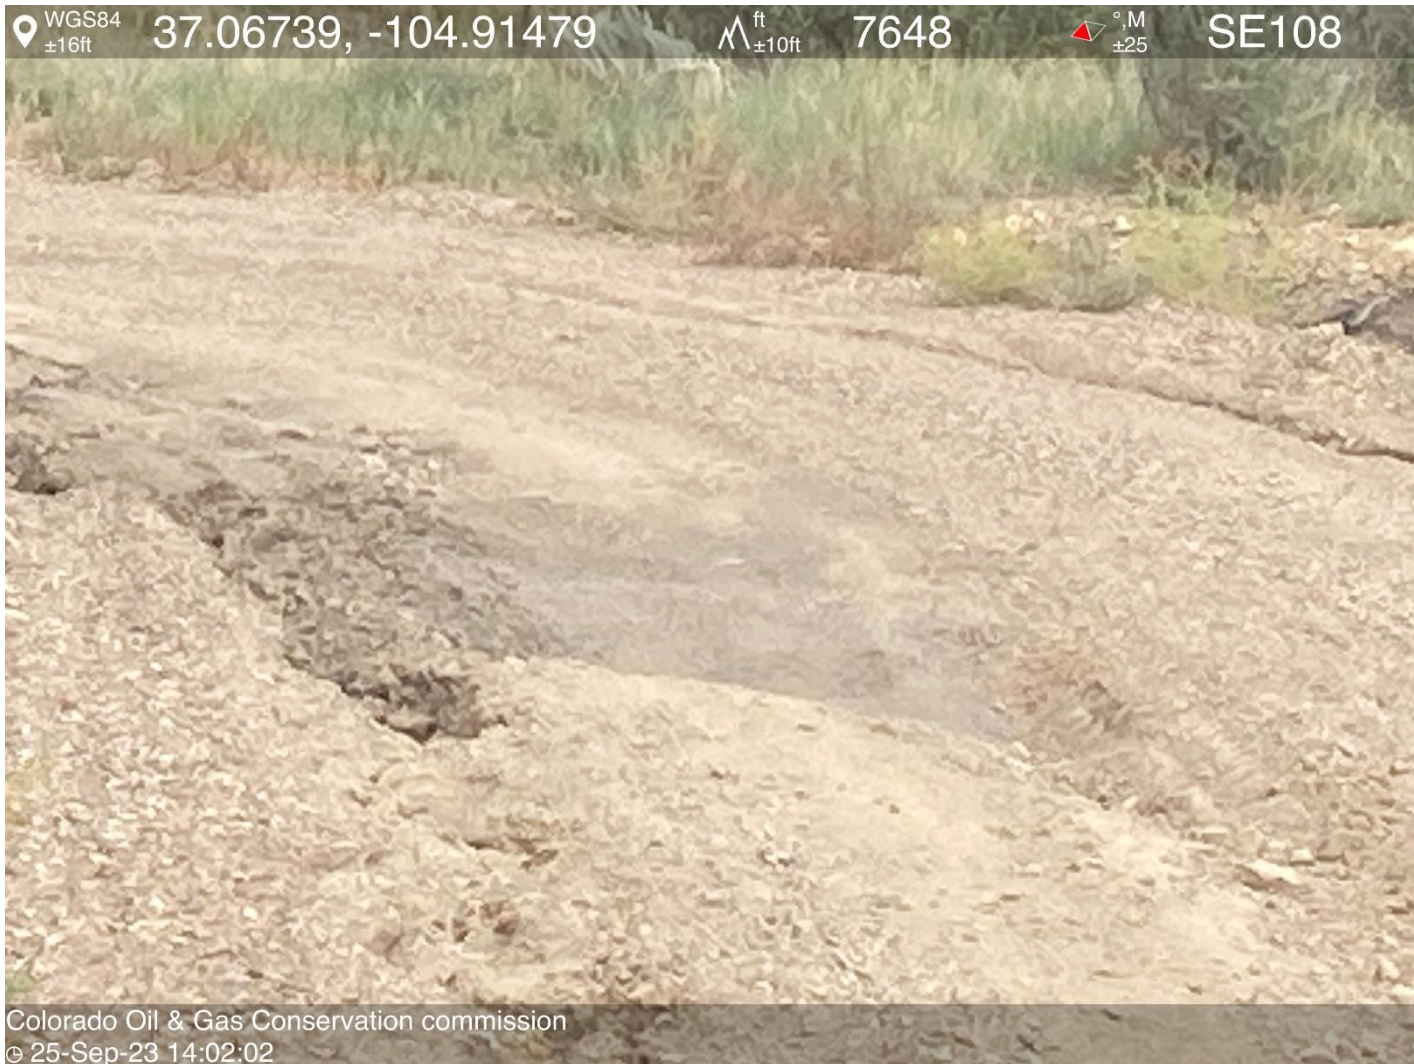
**PHOTO 9: NO STORM WATER BMP'S INSTALLED OR BMP'S ON ROW DRAINAGE DITCH JUST SOUTH OF LOCATION HAS CAUSED EROSION ON AND ALONG SIDE ROW. Install or repair required BMPs per Rule 1002.f.(2)C CA DATE 11-19-2023.**
