WELL NAME: HILL RANCH 29-15, API #: 071-06458, INSP. # 695108684

COLORADO
Energy & Carbon Management
Commission
Department of Natural Resources

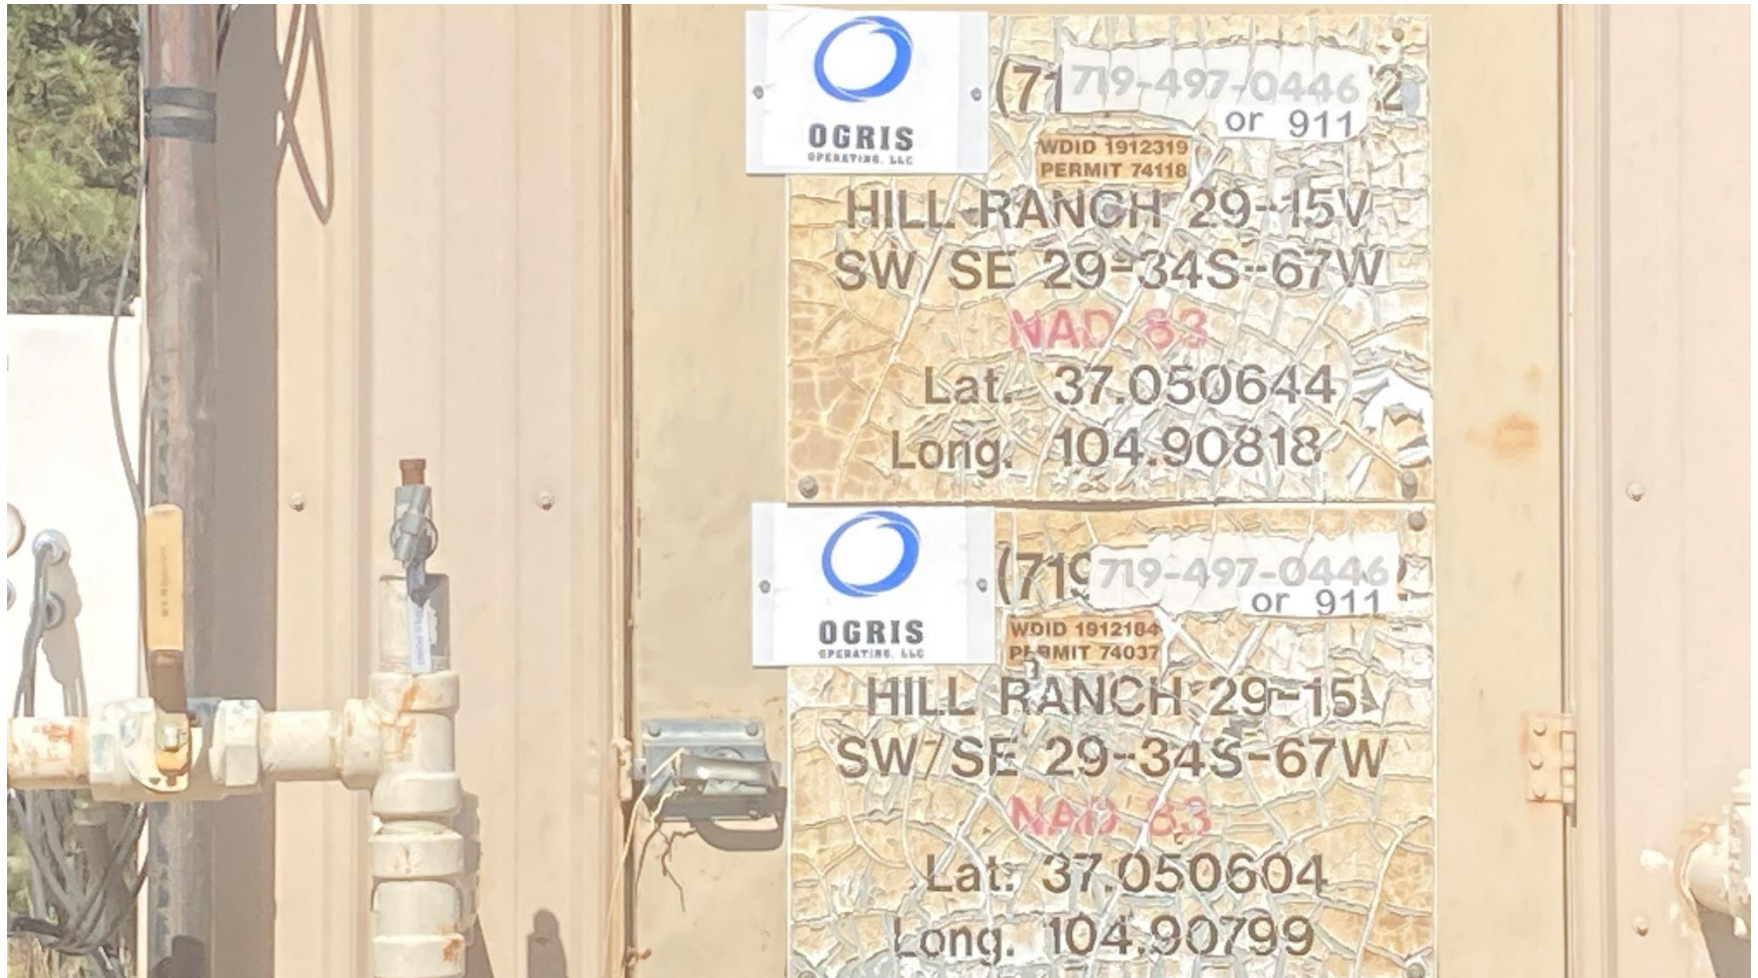
PHOTO 1: WELL SIGN

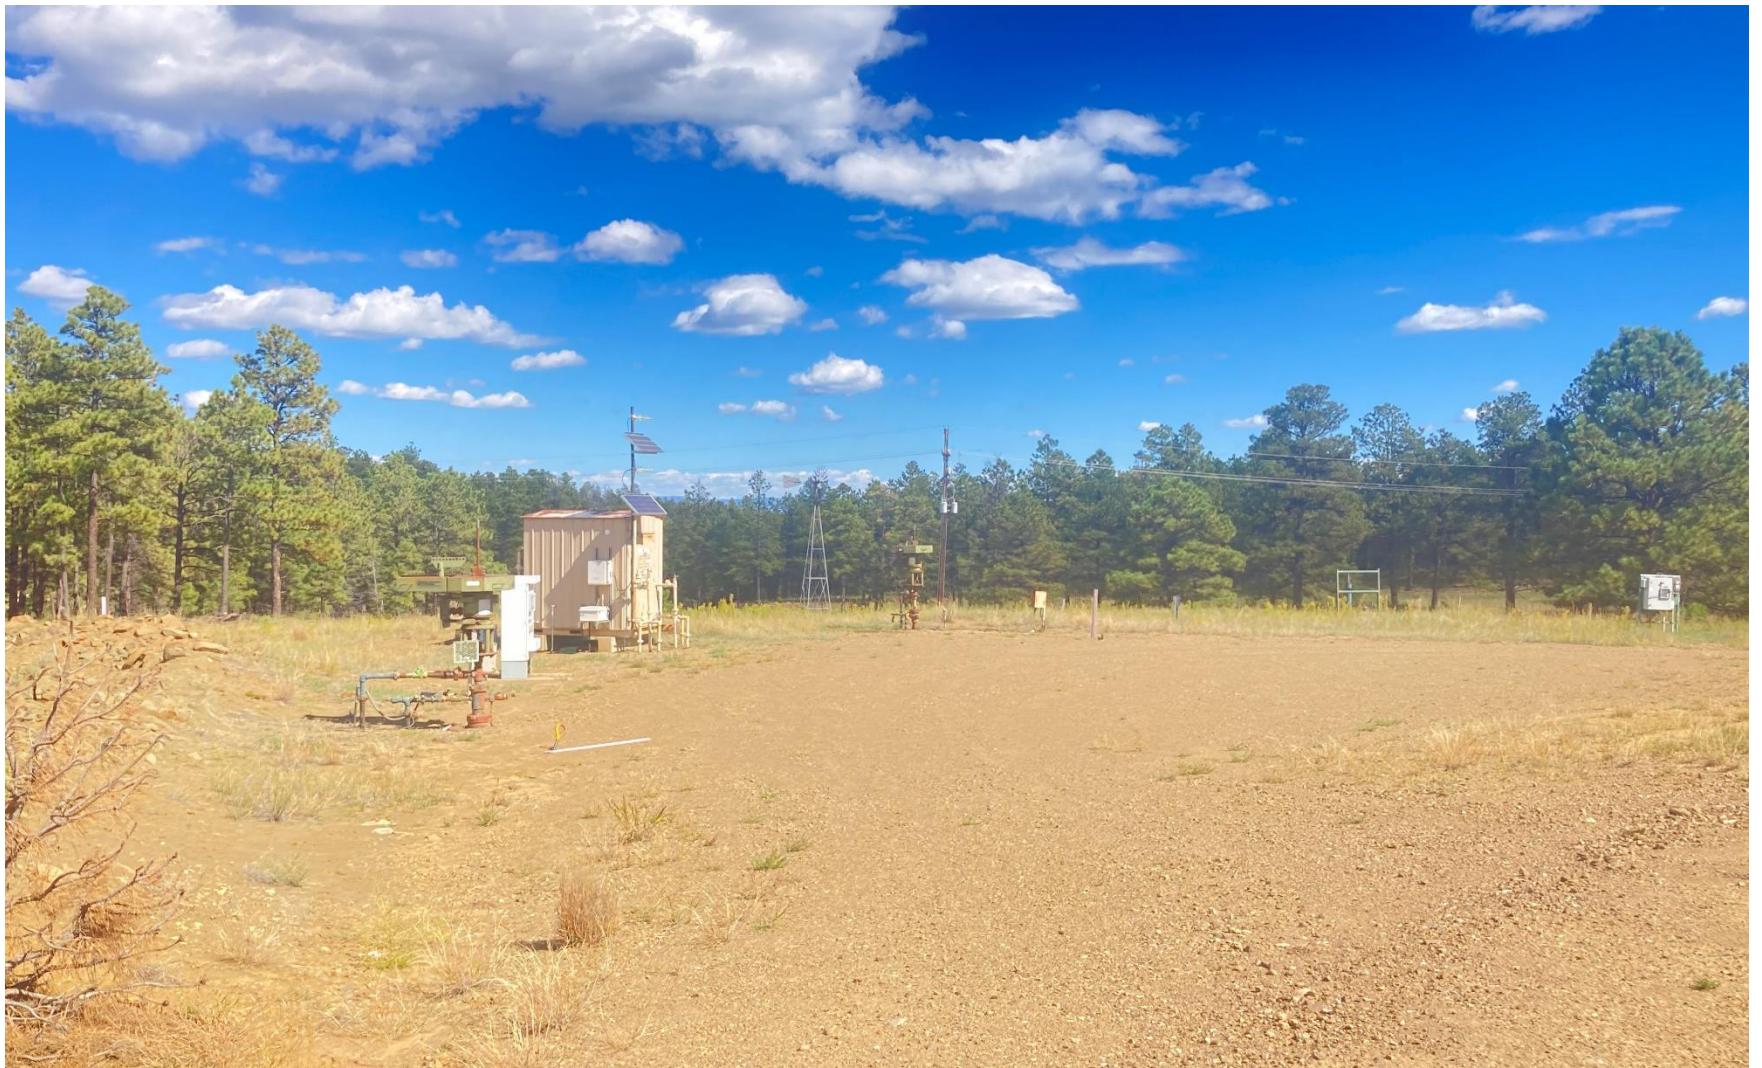
PHOTO 2: LOCATION

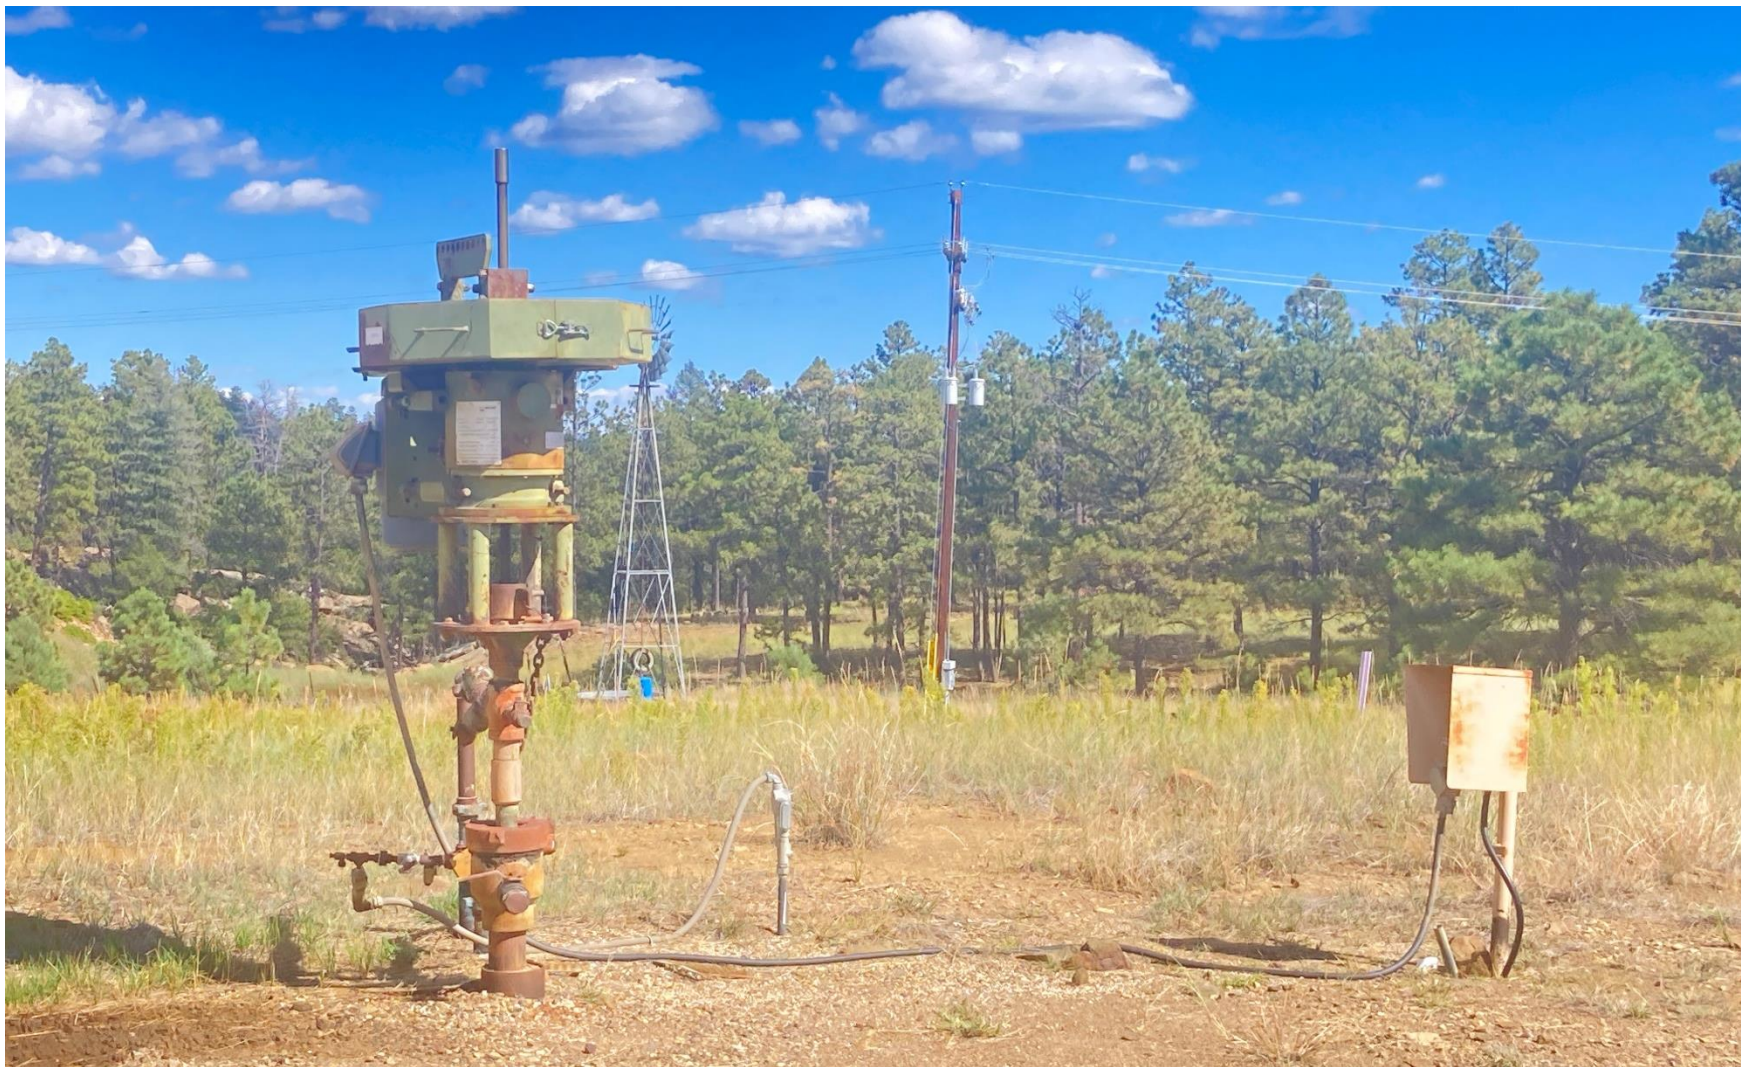
PHOTO 3: V WELLHEAD AND EQUIPMENT

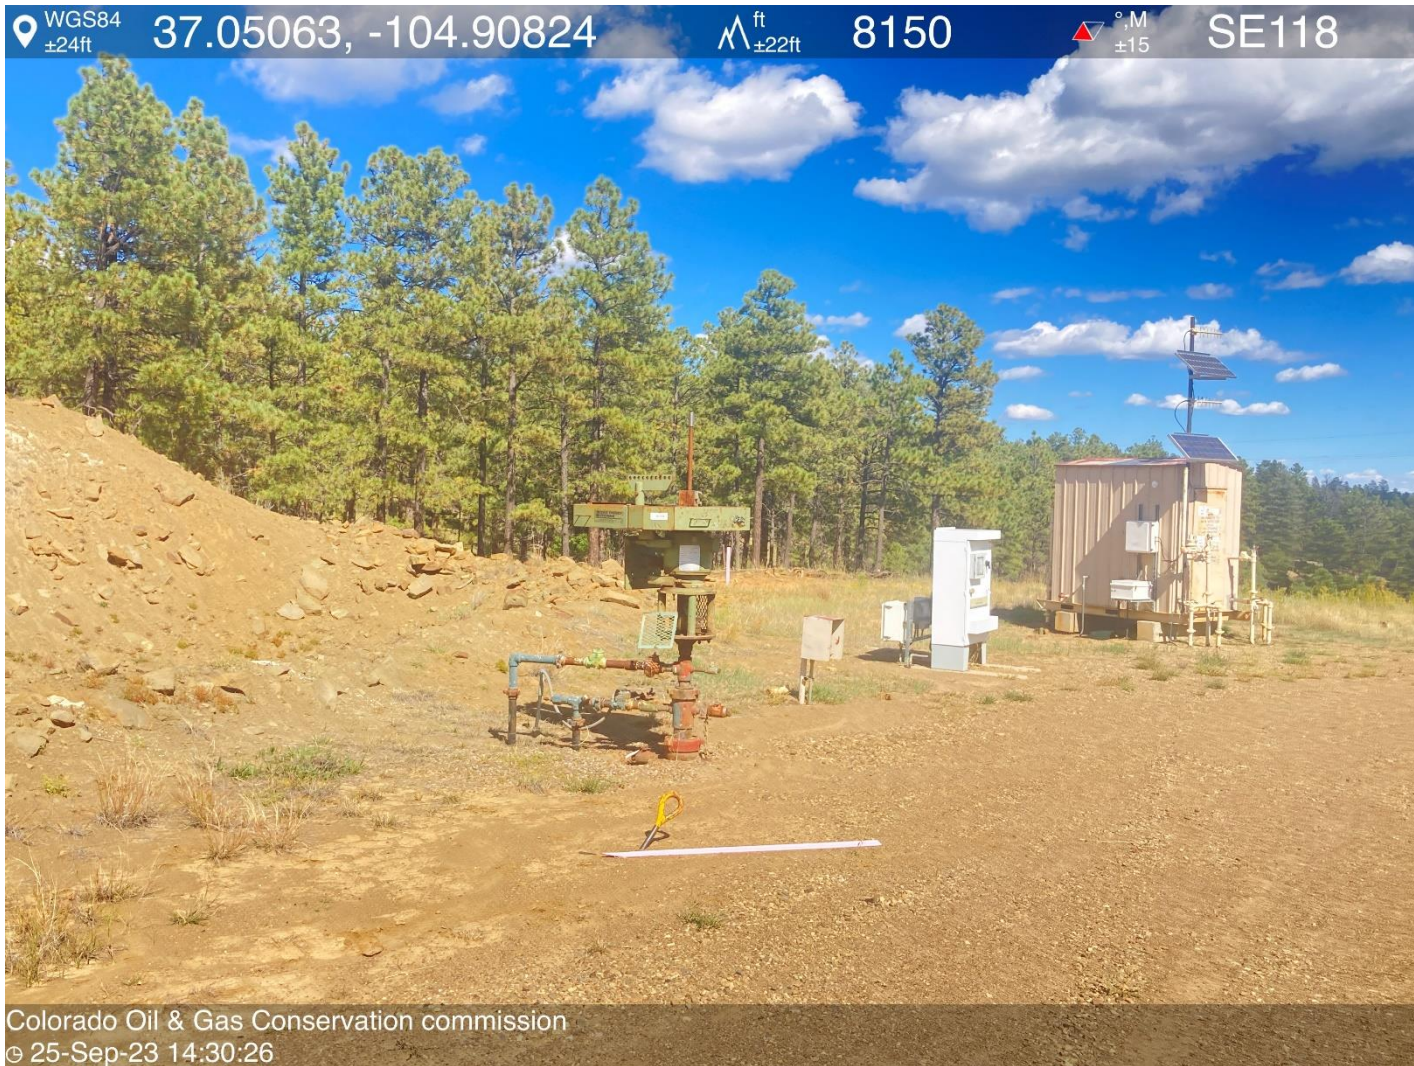
PHOTO 4: R WELLHEAD AND EQUIPMENT

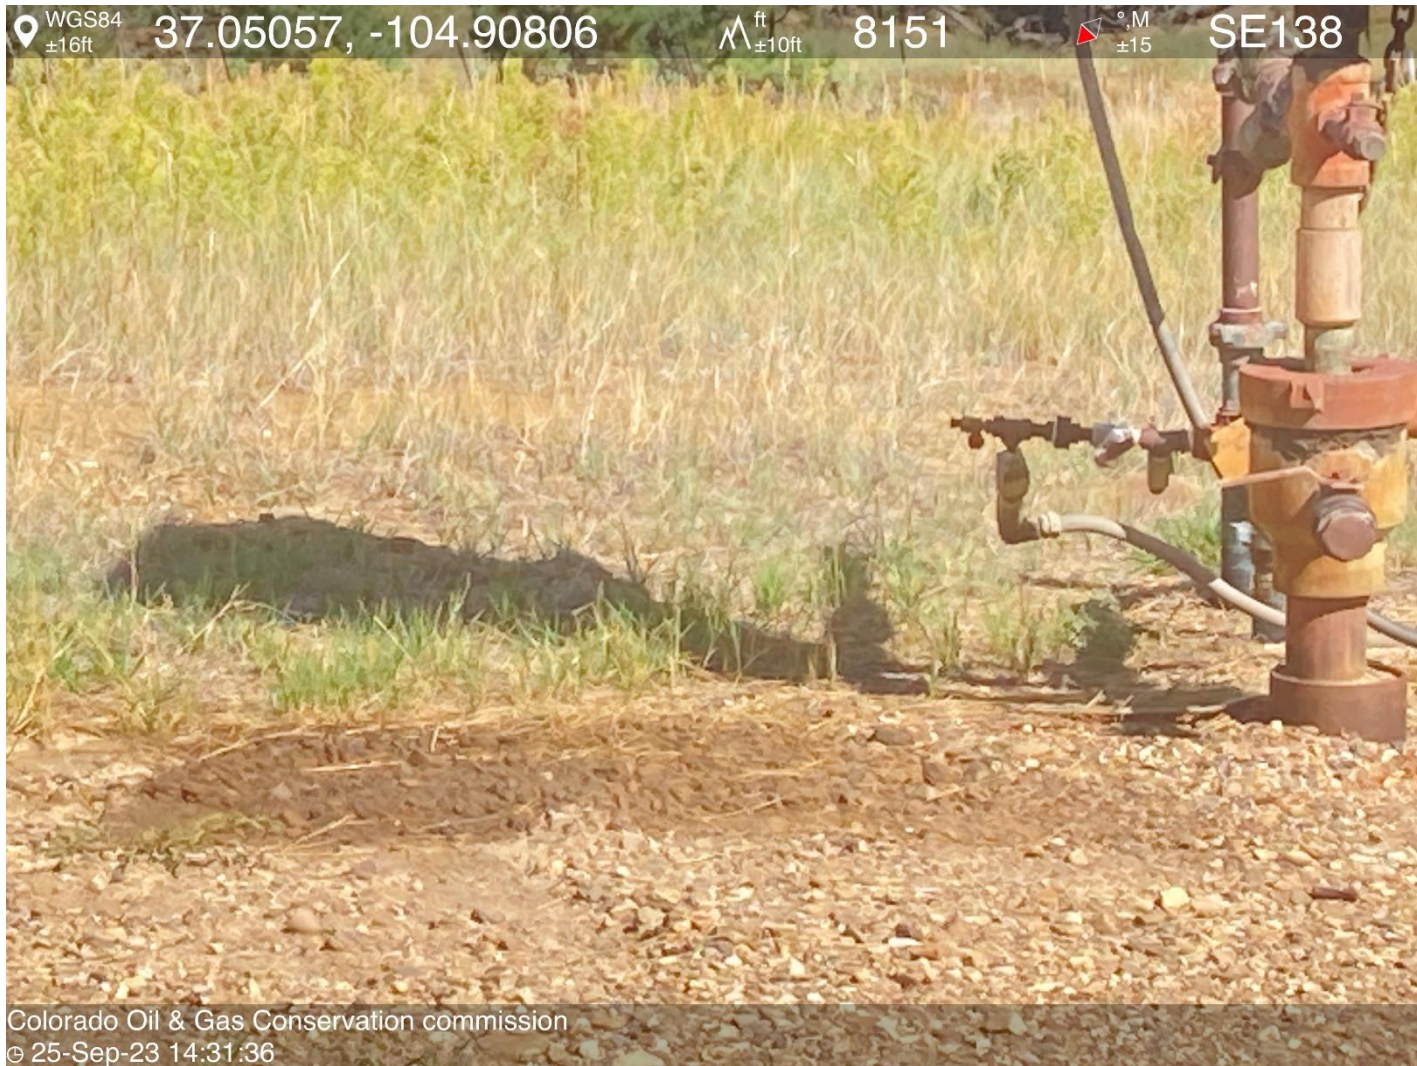
PHOTO 5: AREA OF IMPACTED SOIL APPEARS TO BE FROM A PREVIOUS HYDRAULIC HOSE LEAK (NO LEAK AT TIME OF INSPECTION). Conduct maintenance on equipment, cleanup stained material and review self inspection processes. COMPLY WITH RULE 1002,(2).D. CA DATE 11-19-2023.
