Inspection Photos

10/18/2023

Operator: PETROLEUM RESOURCE
MANAGEMENT CORP - 10421

Location ID: 436485

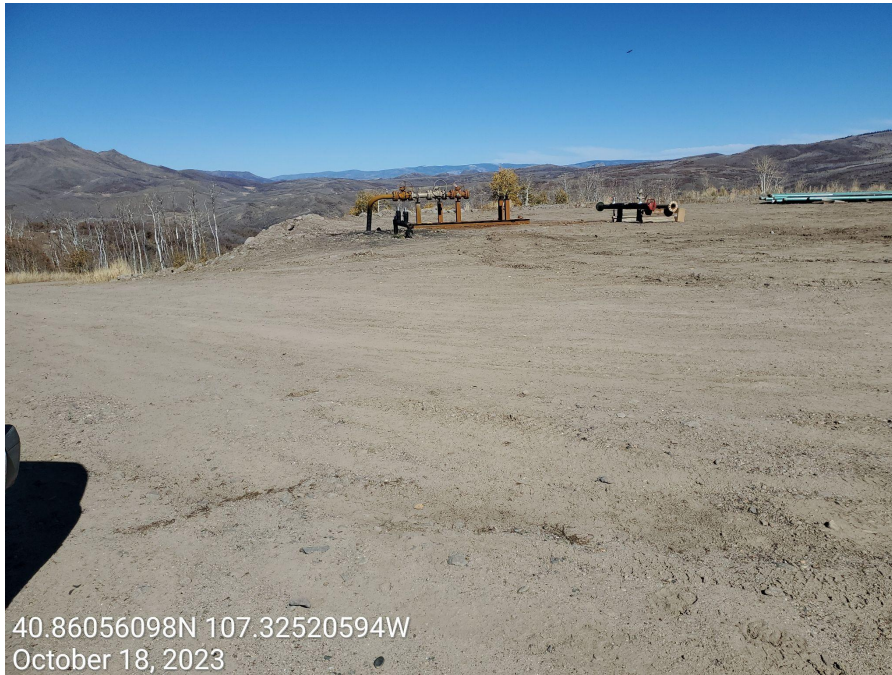
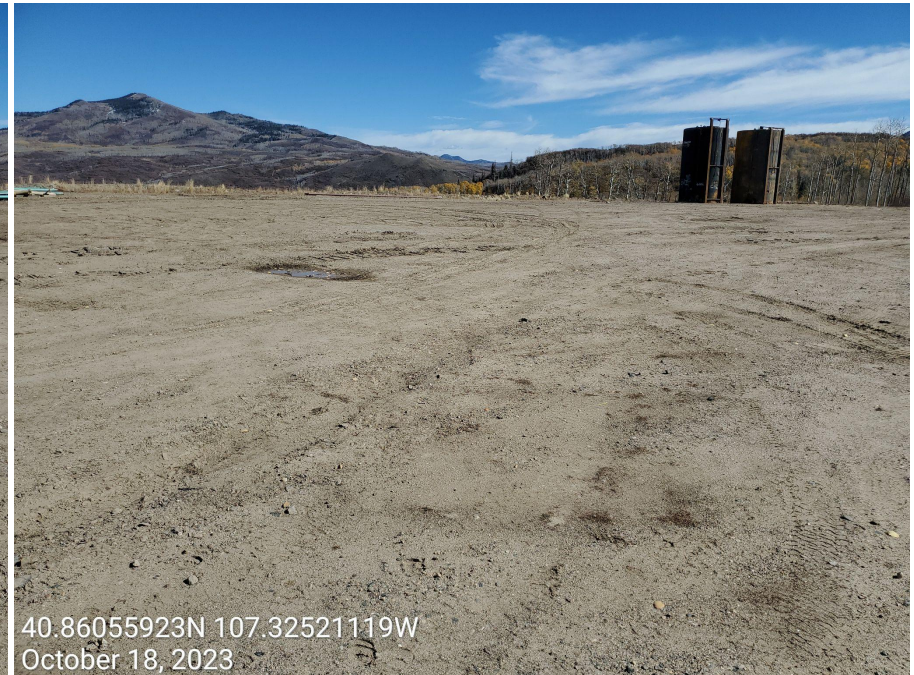
Photo 1: Photos 1-2 taken from the entrance on the northwest end of the Location. Photos provide an overview of the working pad surface from north, northeast, southeast to south.

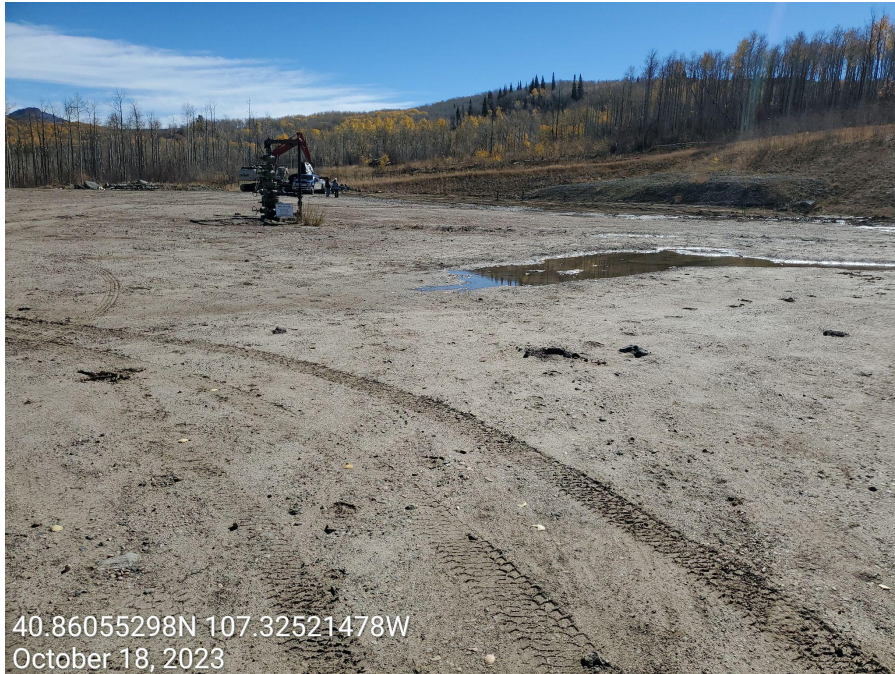
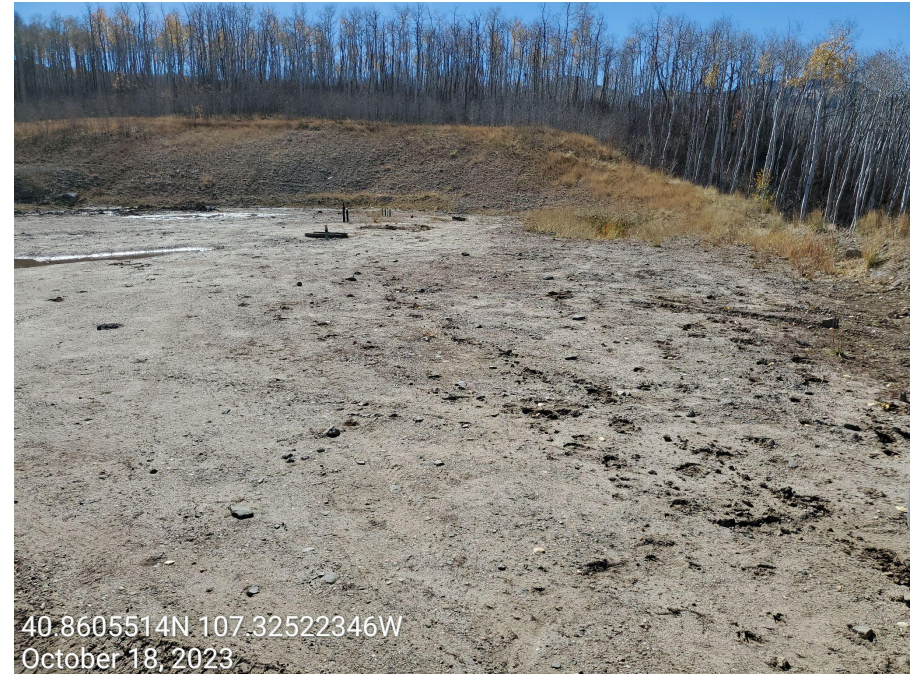
Photo 2: See comments under photo 1.

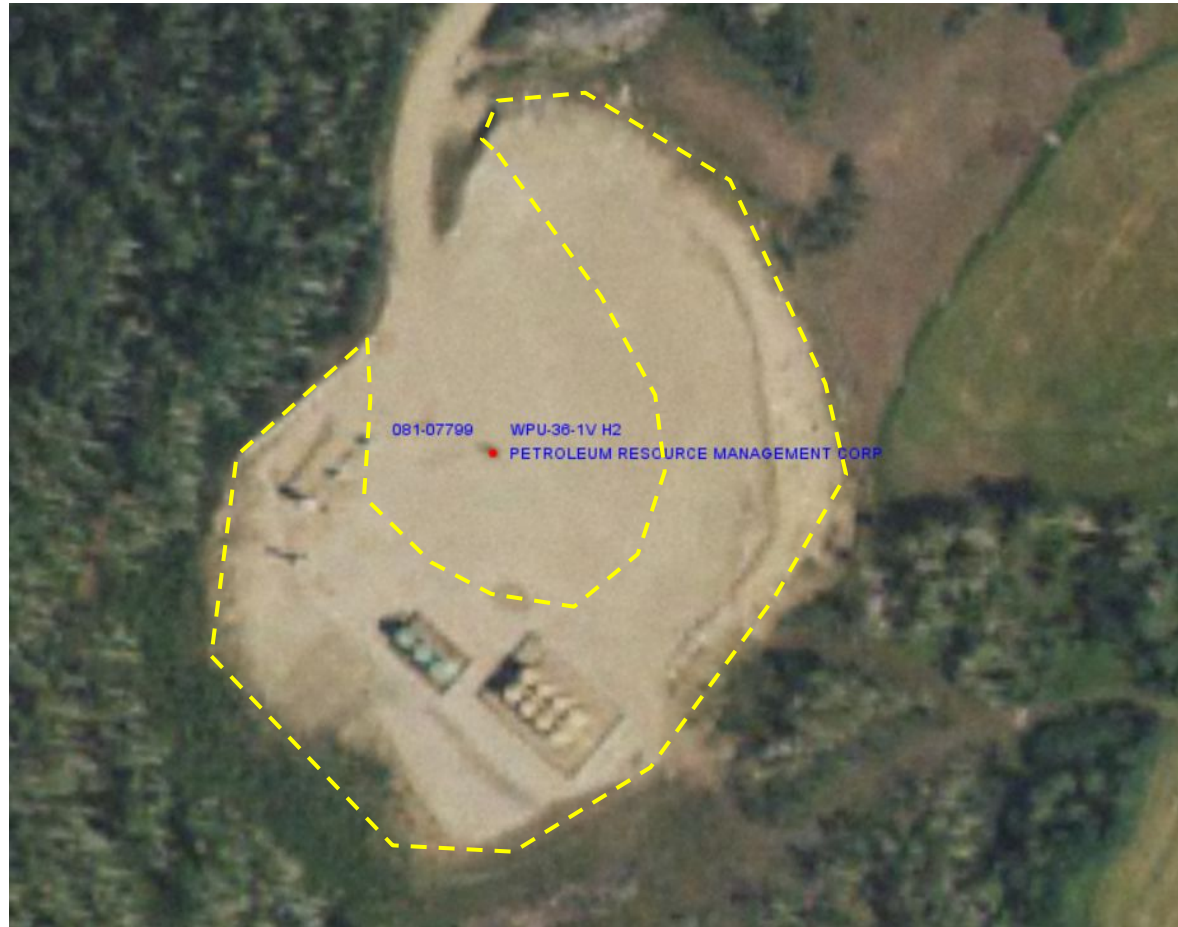
Photo 3: 2021 COGIC Aerial imagery of the Location. With exception to the well, all production equipment has been removed from the Location. Yellow polygon represents approximate areas of the Location (~75 foot buffer around the well) that are no longer necessary for production, and are subject to 1003 reclamation requirements.

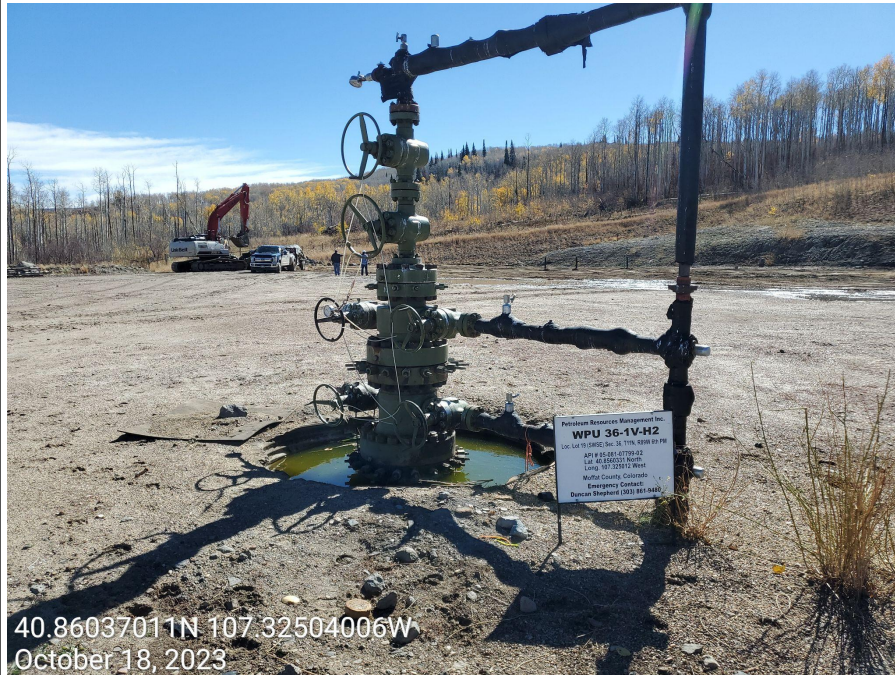
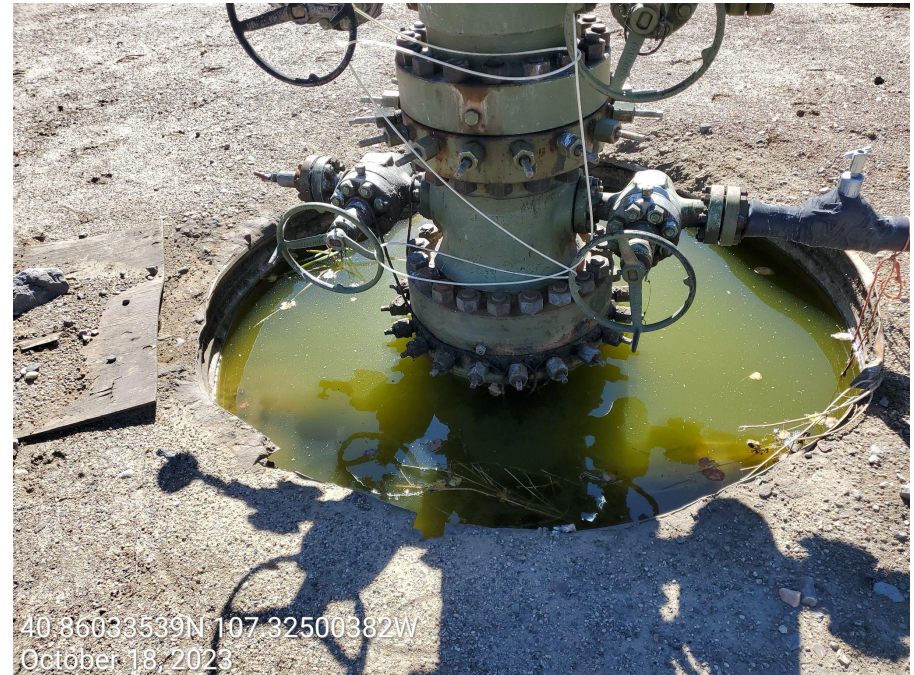
Photo 4: Photos show well on Location. Cellar has not been covered; BMPs to prevent wildlife access, or egress, have not been implemented. Cellar and has also filled with fluids

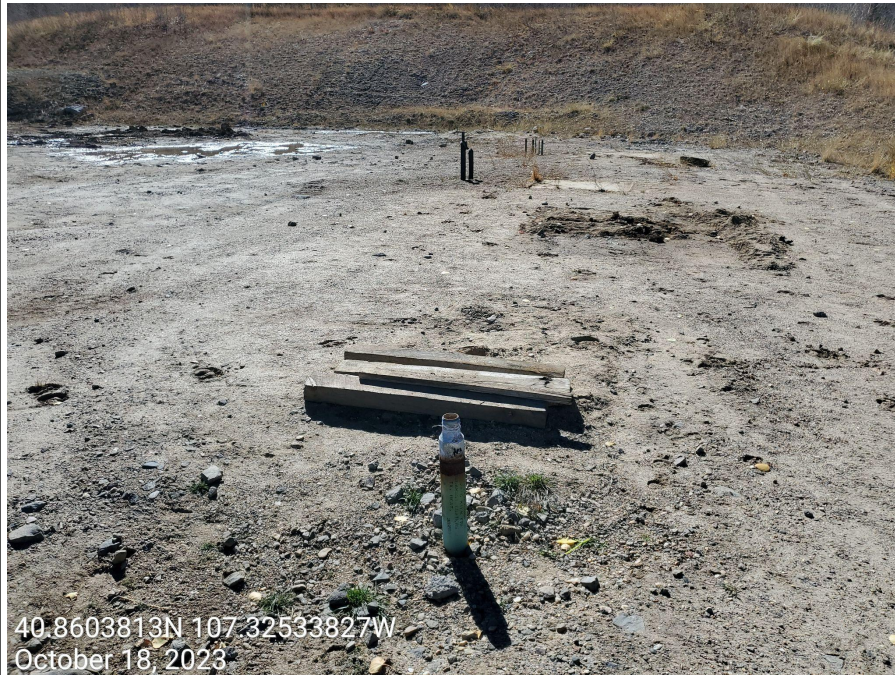
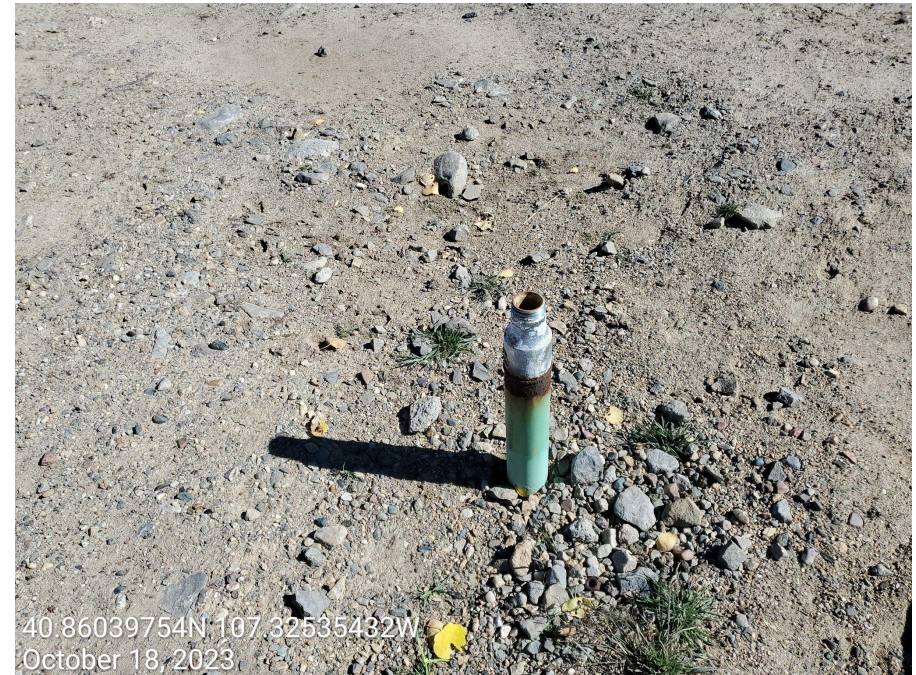
Photo 5: Photos 5-6 examples showing 15 risers observed on the southern and western areas of the location. Risers were associated with production equipment that has since been removed from the Location. Flowlines/risers have not been properly capped/OOSLAT, abandoned and removed.

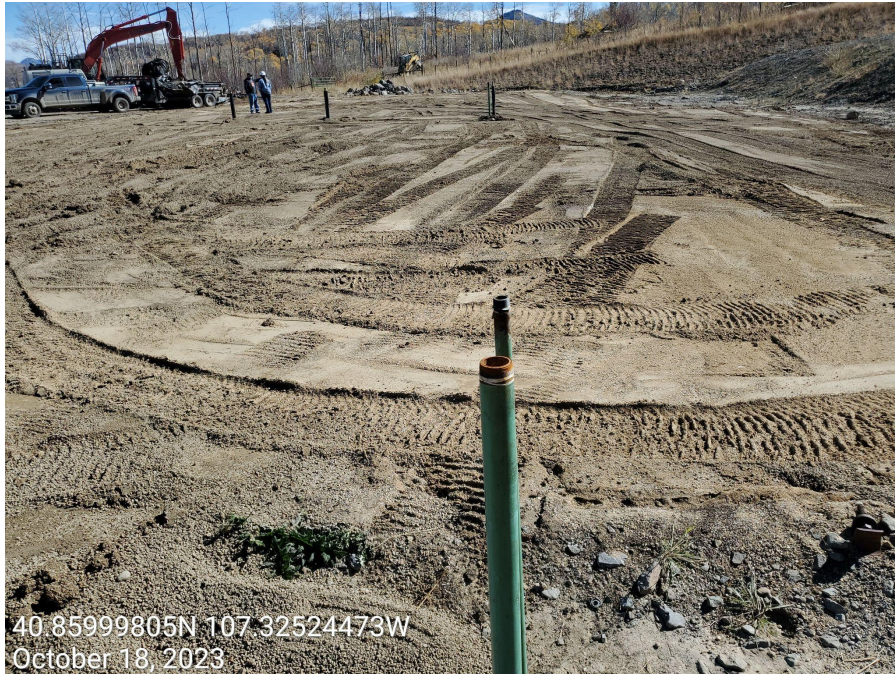
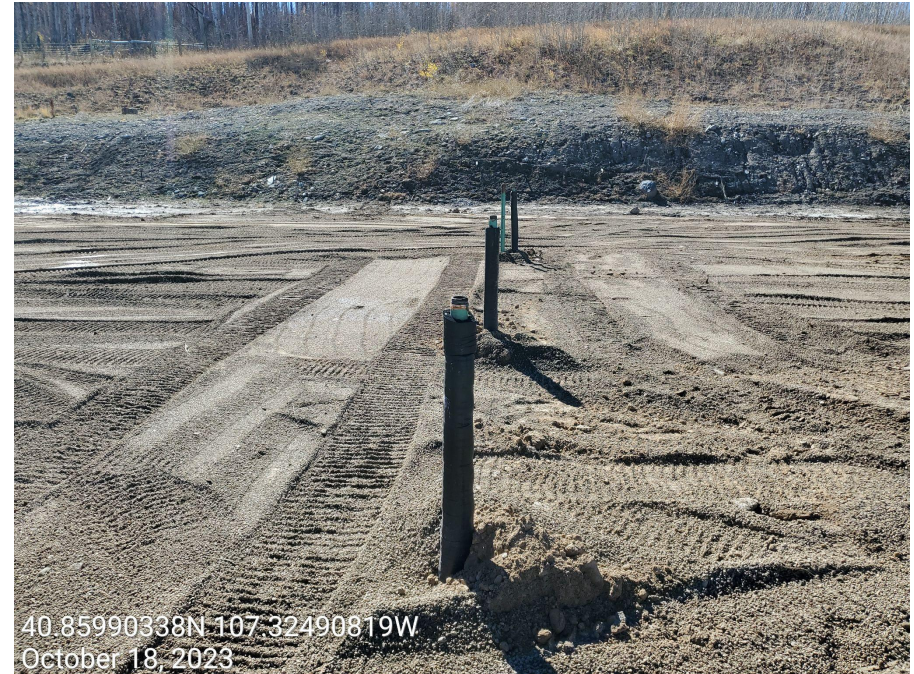
Photo 6: See comments under photo 5.

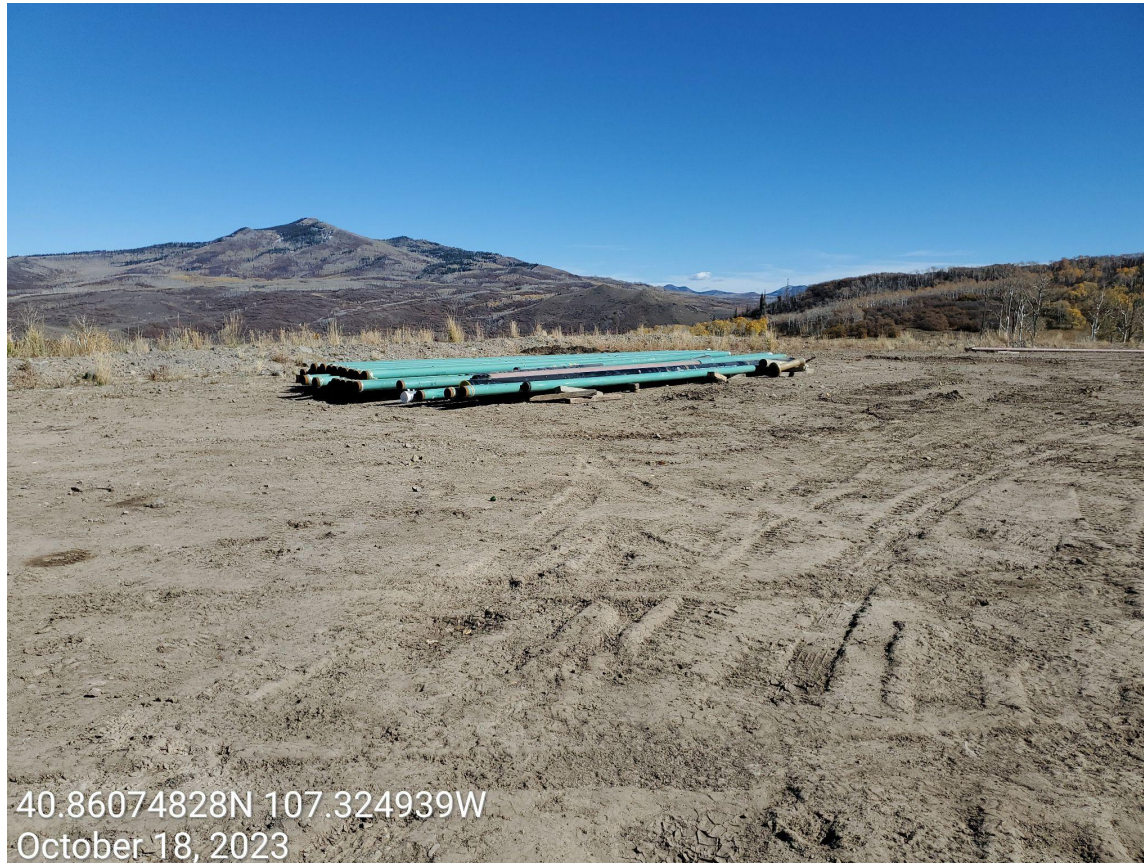
Photo 7: Photo example of unused pipe equipment stored on the north end of the Location.

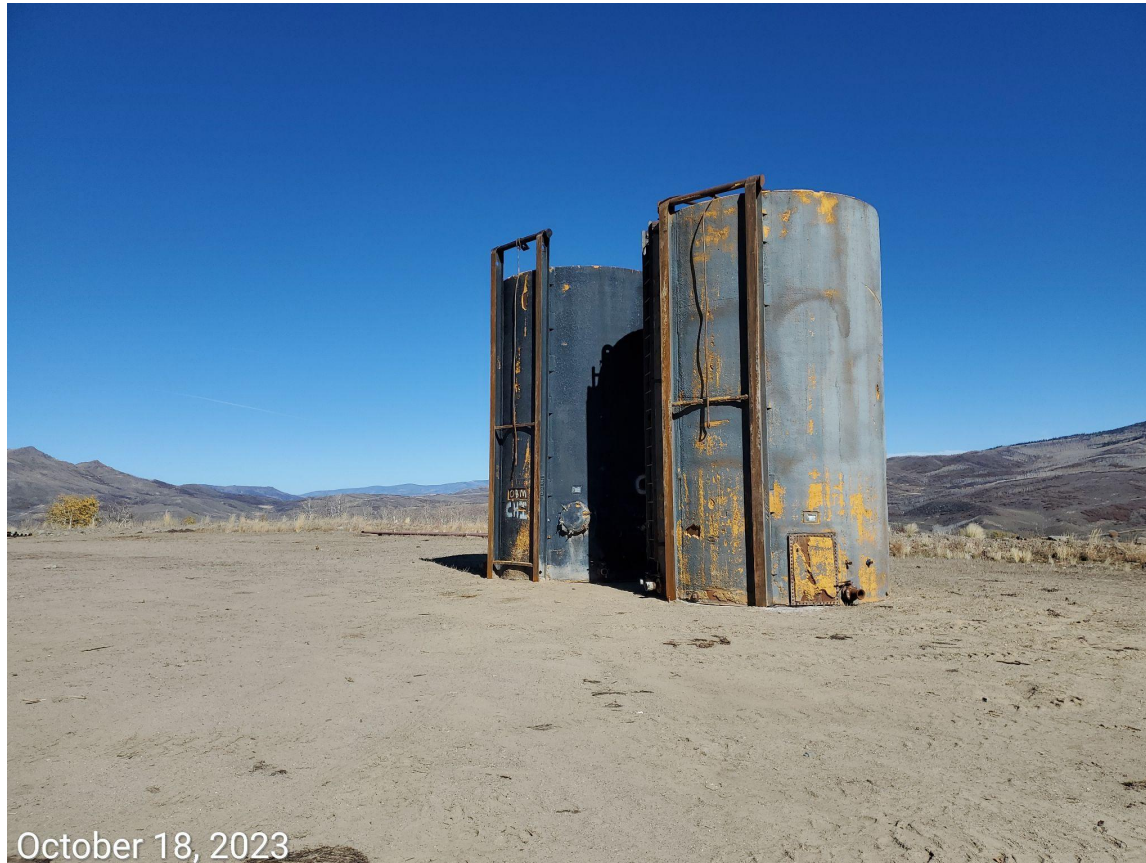
Photo 8: Photo taken from the east end of the Location. Photo shows two tanks; tanks lack required signage pursuant to 605 Rules. Tanks are not necessary and require removal pursuant to 606 rules.

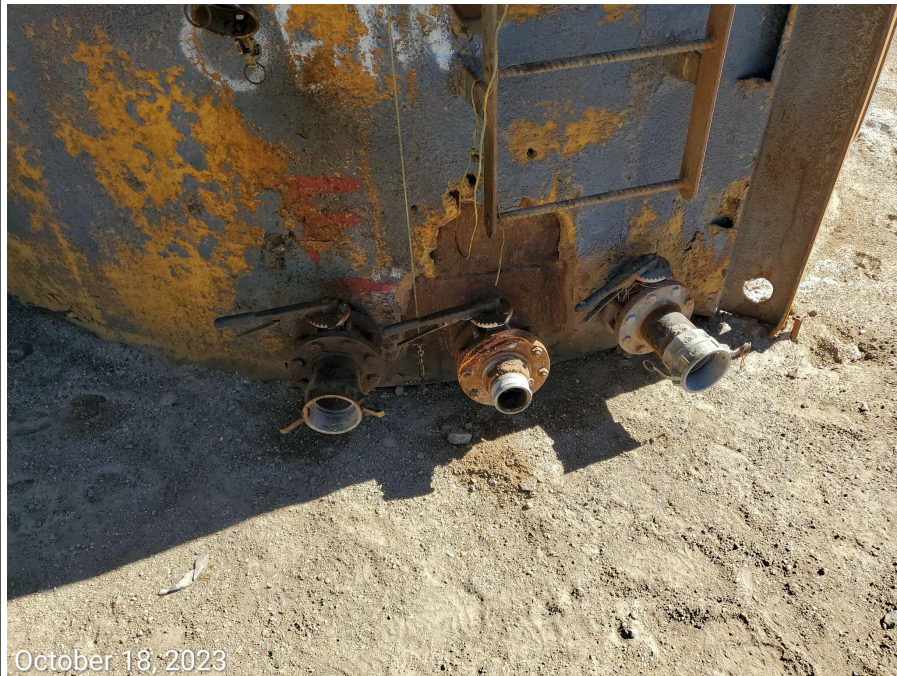
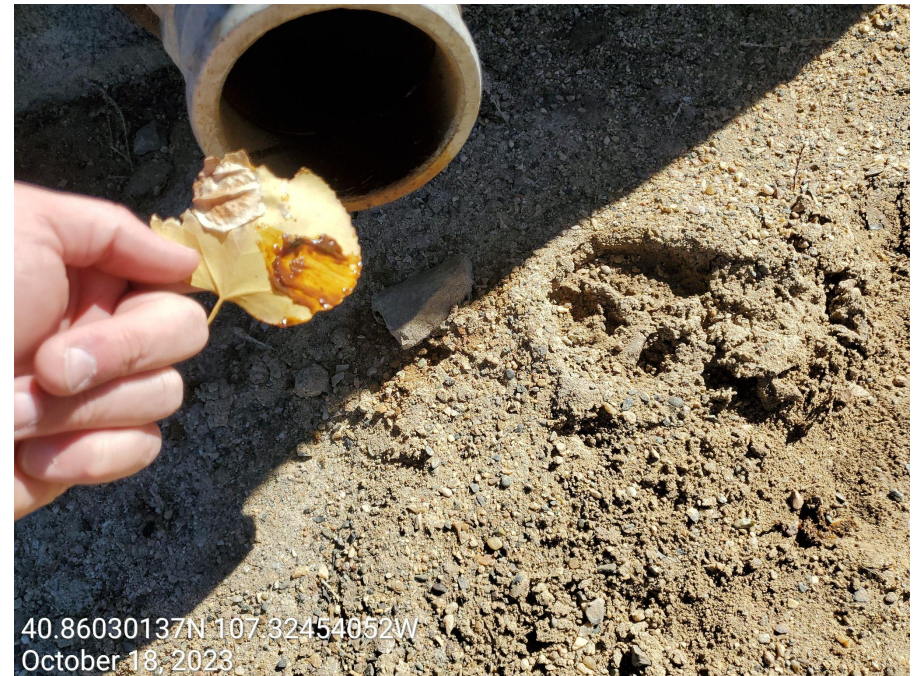
Photo 9: Photo taken from the two tanks on the east end of the Location. Loadout lines have not been properly plugged or capped. Fluids apparent at lines and stained soils were observed at the base of the tanks.

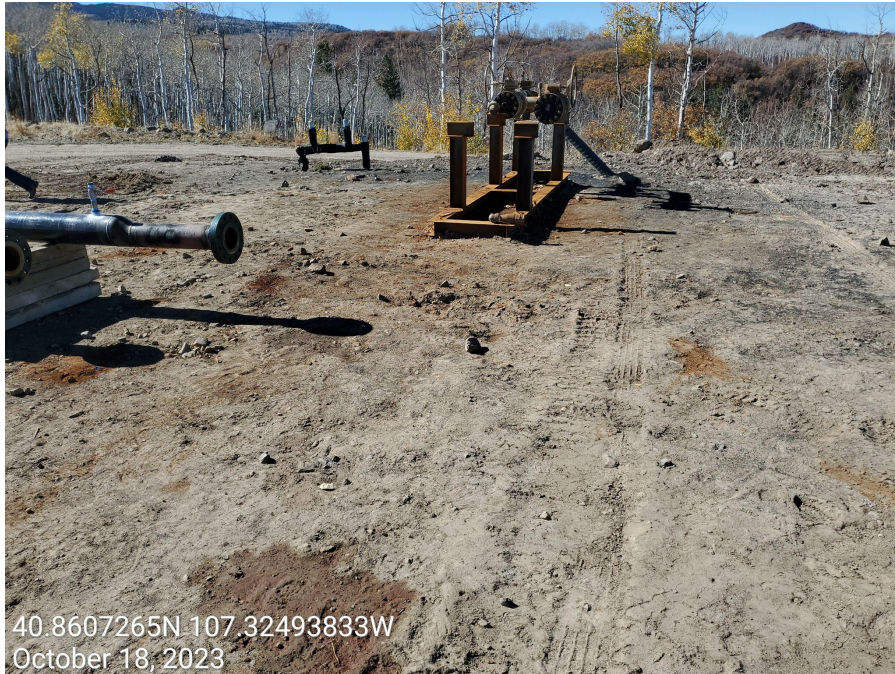
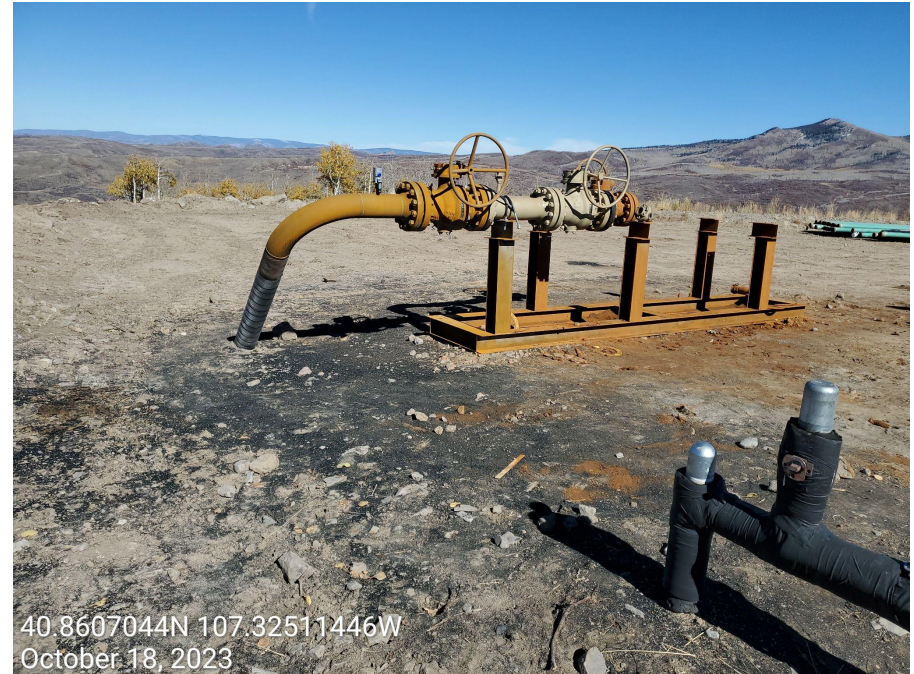
Photo 10: Photos examples showing stained soils observed on the north end of the Location; including the black and brown material spilled onto the working pad surface.

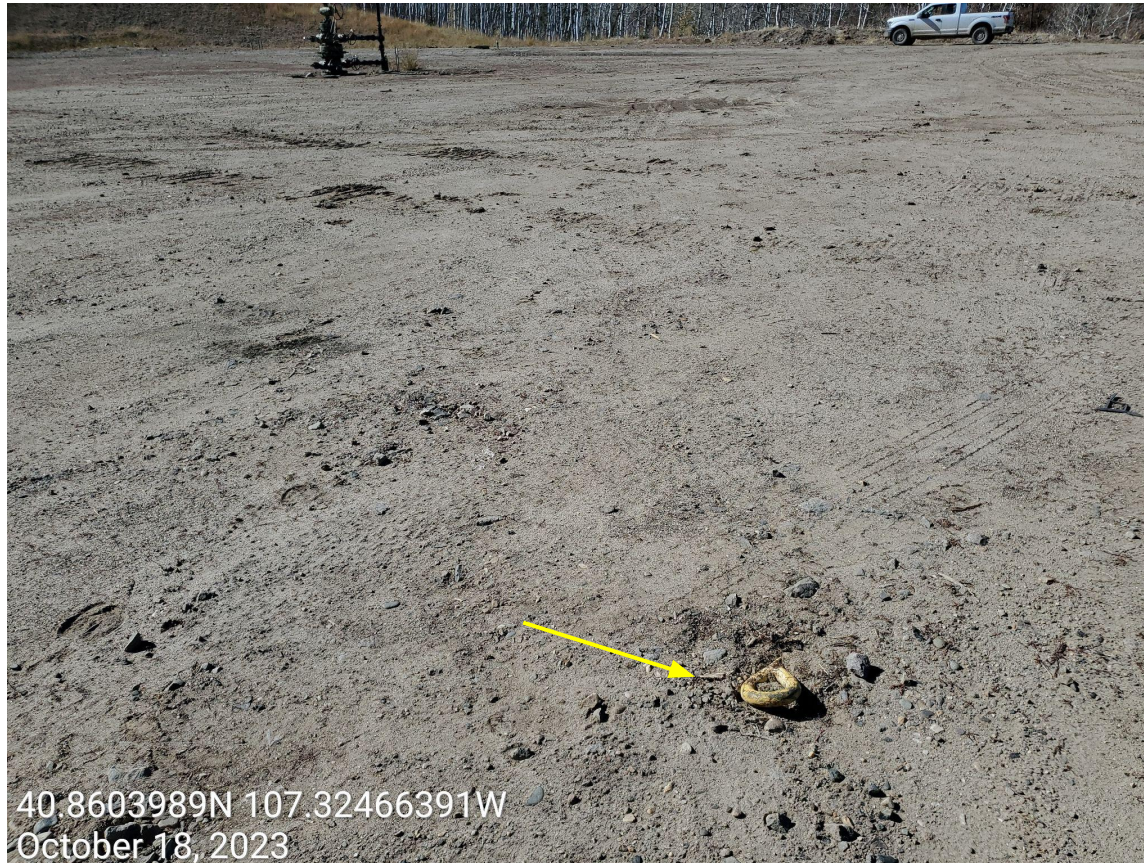
Photo 11: Photo example showing anchors on location missing required marking.

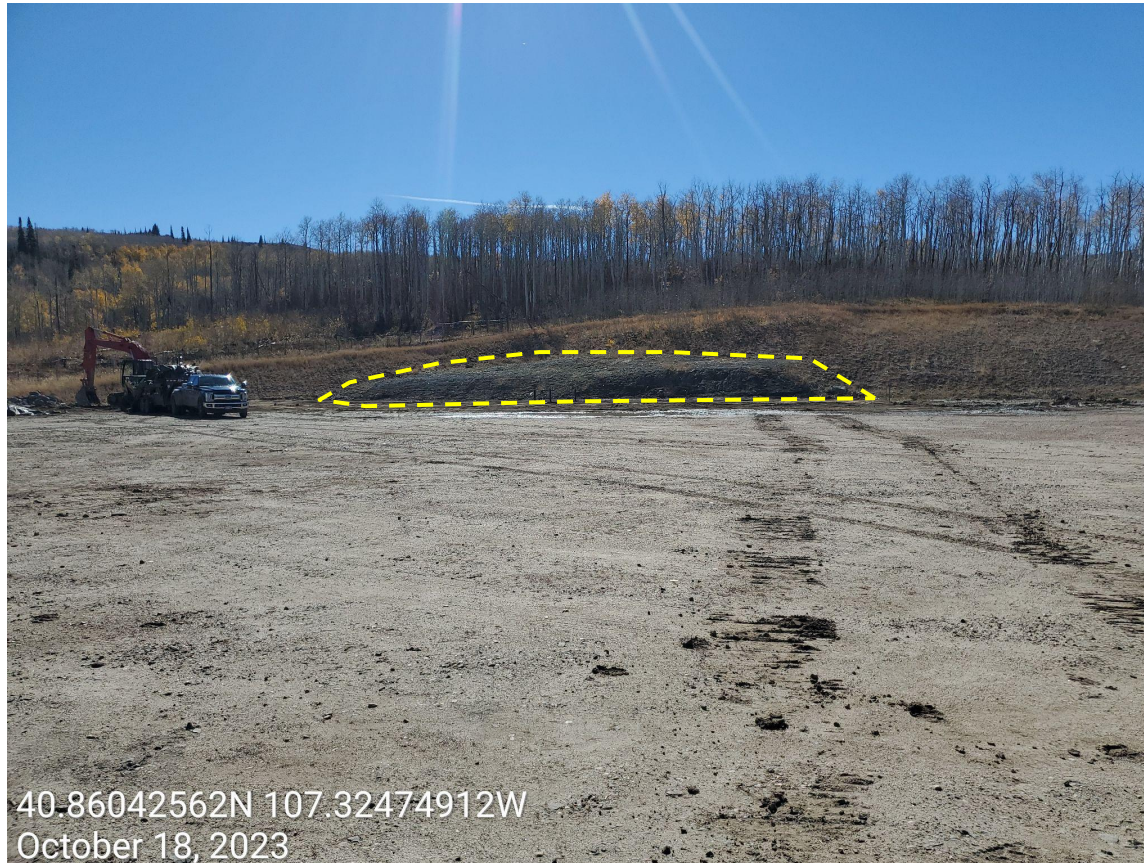
Photo 12: Photo taken from the south end of the Location, facing south. Photo shows drill cuttings (yellow polygon) stored along the cut slope.

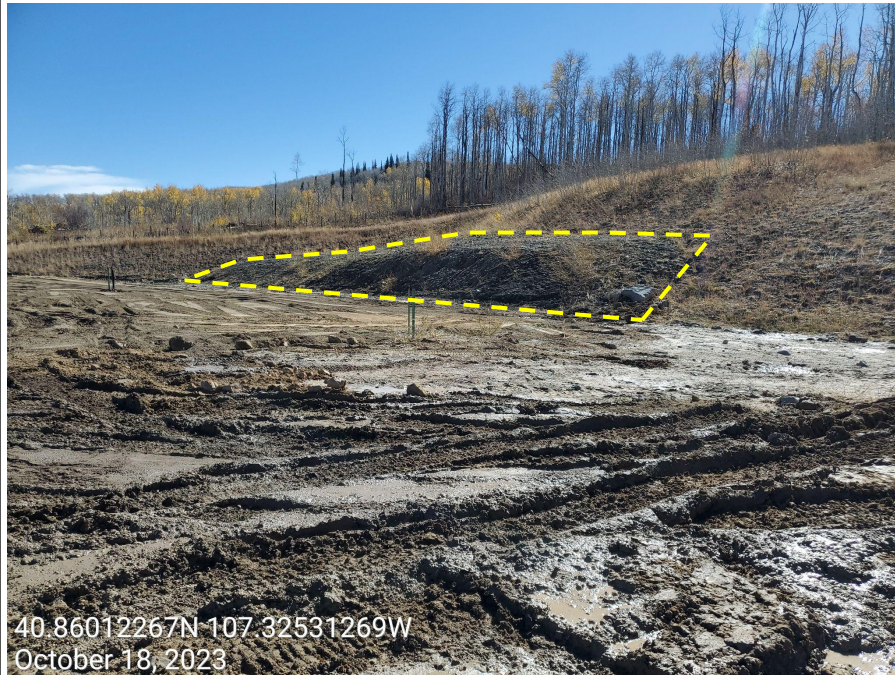
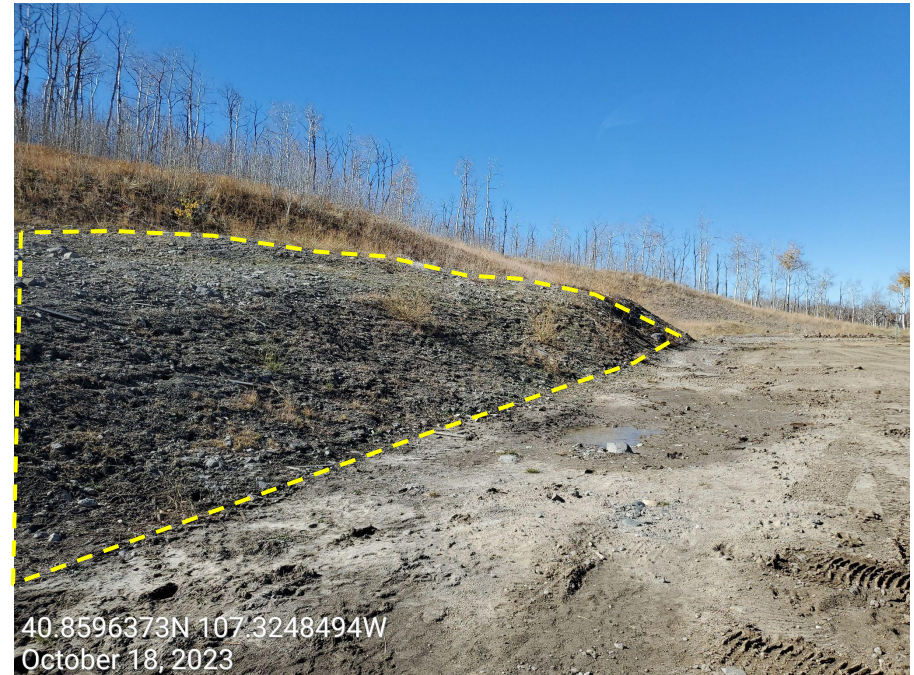
Photo 13: Continued from photo 12. Photos show drill cuttings stored along the cut slope.

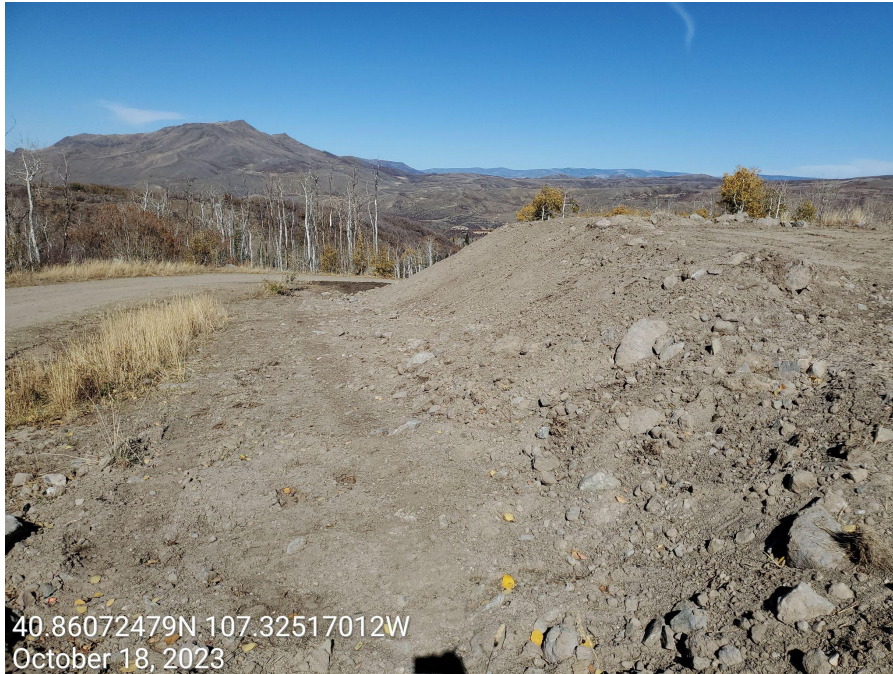
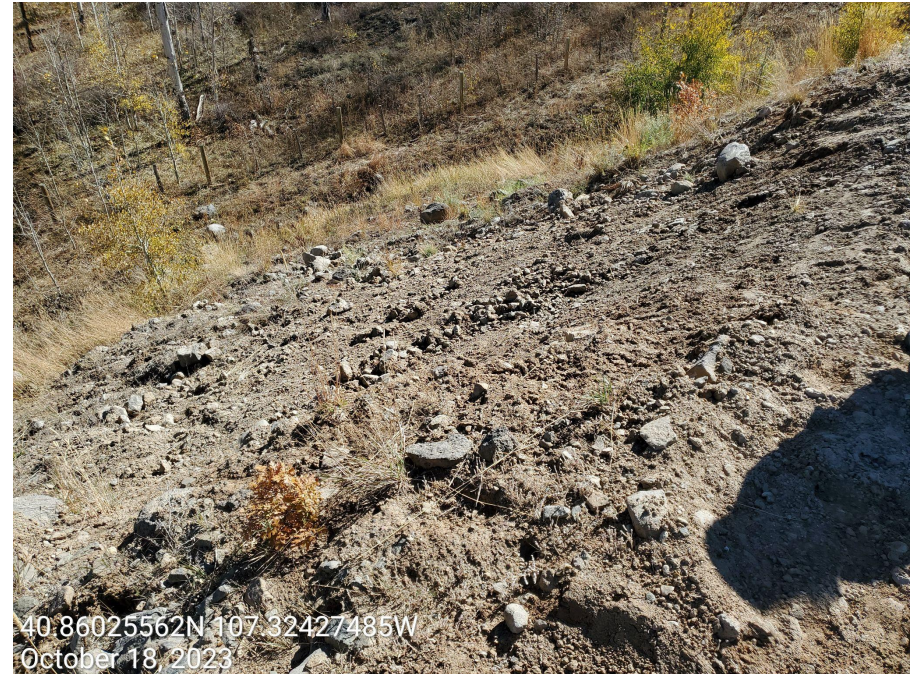
Photo 14: Photo left taken from the fill slopes on the north end of the Location; photo right taken from the fill slopes on the east end of the Location. Slopes are bare and lack stabilization; BMPs to stabilize the slopes, as well as to minimize erosion and degradation have not been implemented per good engineering practices.

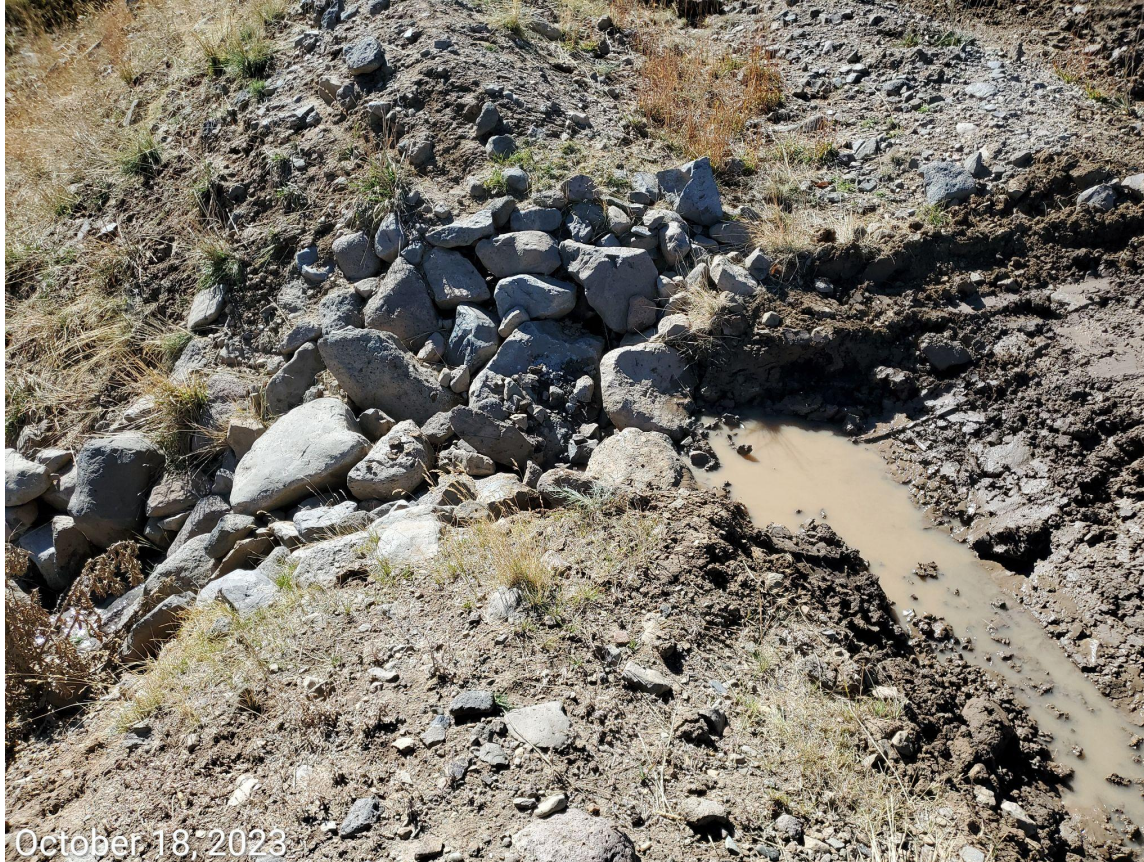
Photo 15: Photo taken from the east end of the Location. Photo shows stormwater outlet from the working pad surface. Control measures to allow for sediment laden-free stormwater discharge have not been implemented in conjunction with the outlet on the east end of the location; sediment laden stormwater was observed discharging from the working pad surface. Outlet does not appear to have been lined with geotextile material in conjunction with the rip-rap armoring. Stormwater degradation to the walls of the outlet observed.

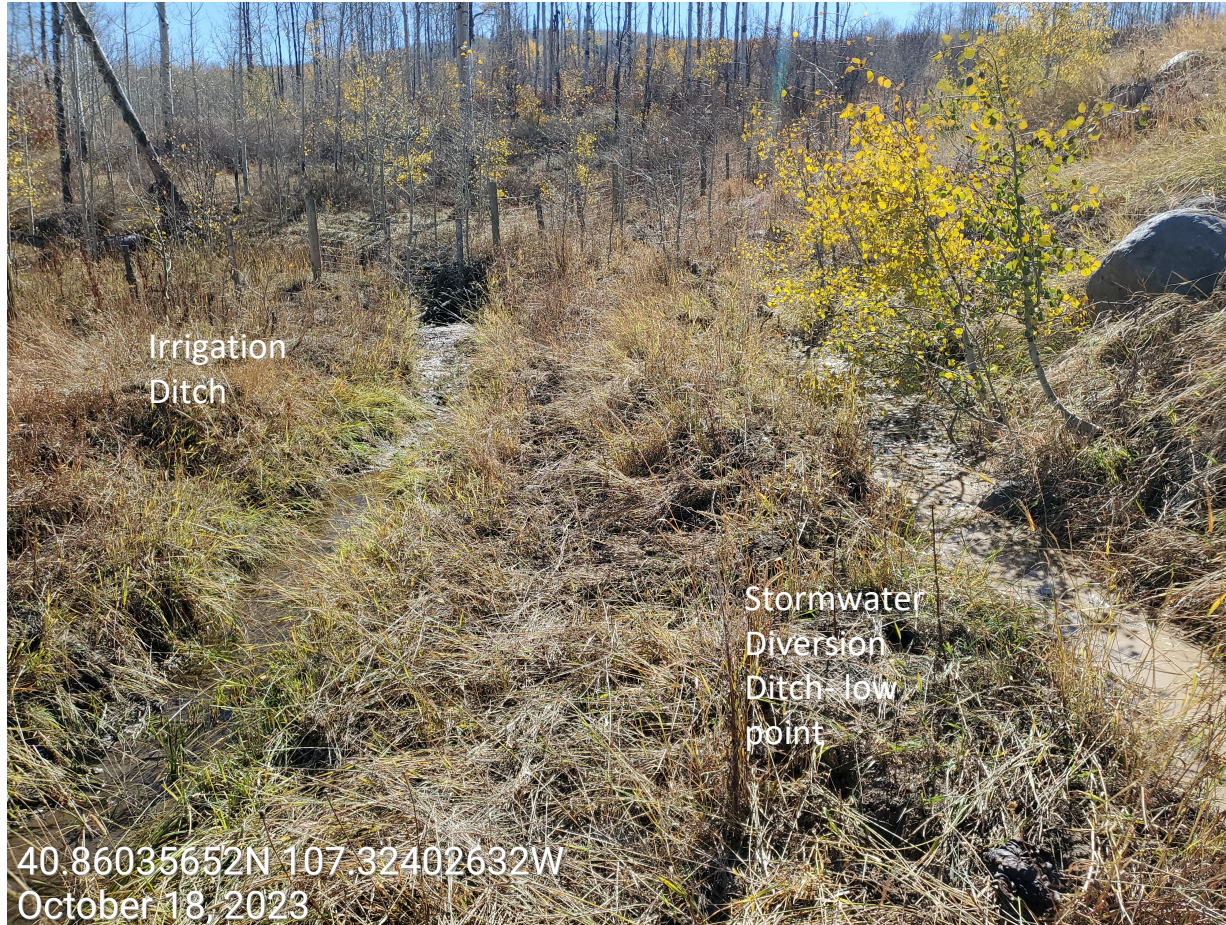
Photo 16: Photo taken from the east perimeter of the Location. Photo shows the low point of the stormwater diversion ditch; stormwater runoff from the Location will discharge from this point and enter the irrigation ditch (waters of the state)

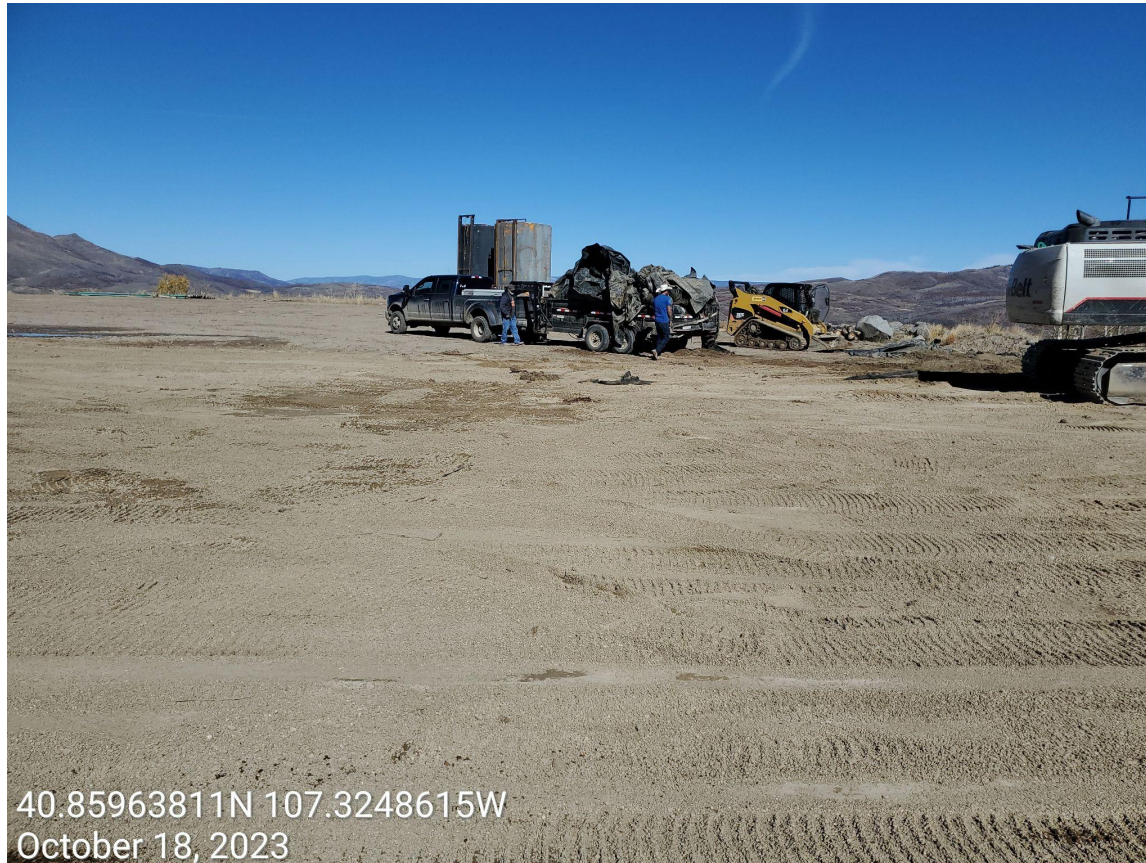
Photo 17: Photo shows Operator on site in the process of removing remaining liner material.

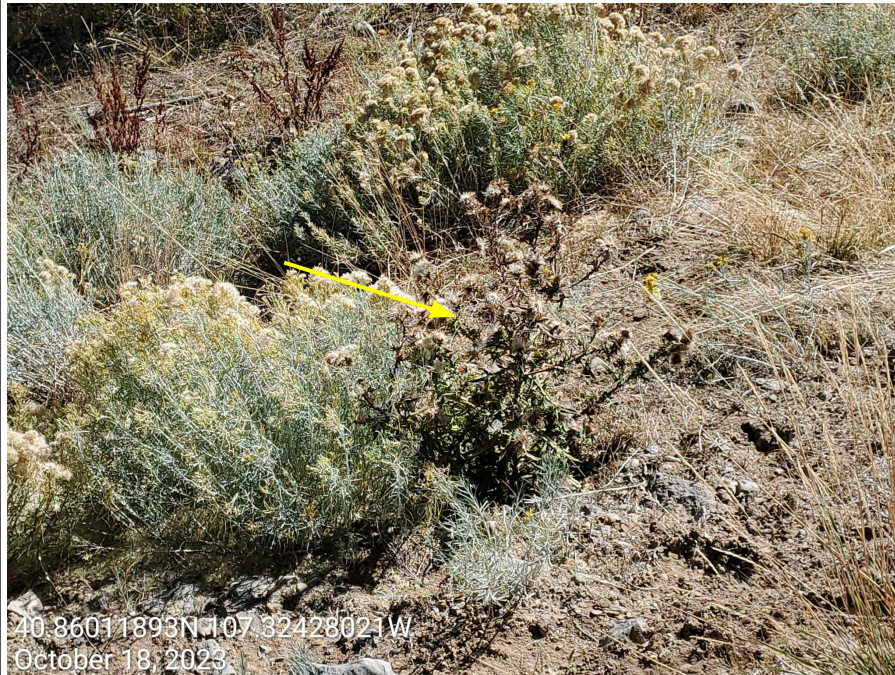
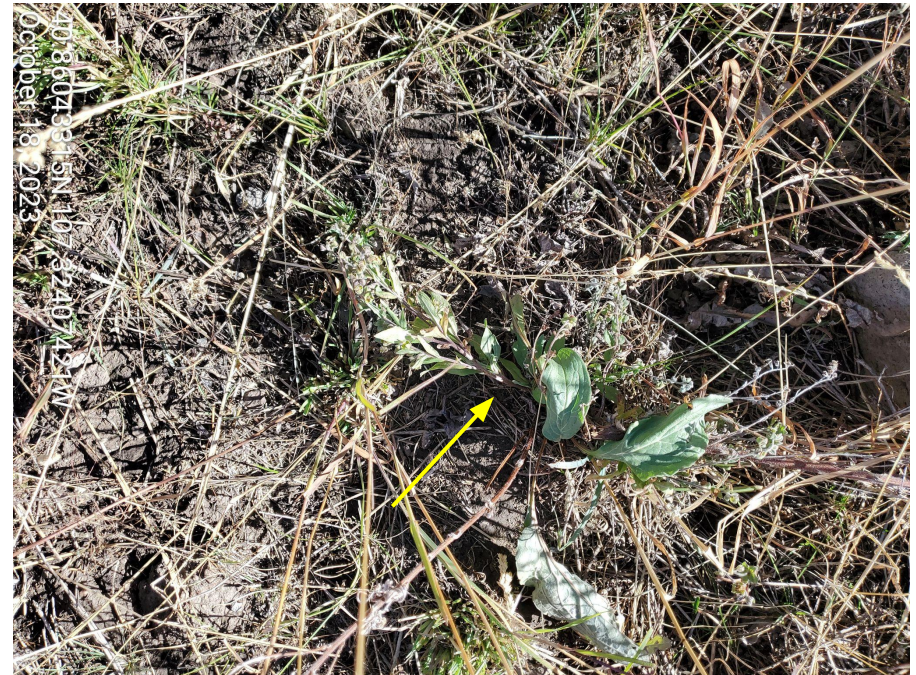
Photo 18: Photo examples showing Undesirable Plant Species observed on the fill slopes of the Location. Undesirable Species include Bull thistle, Canada thistle and Houndstongue- Colorado State List B noxious weeds.
