Inspection Photos

Loc: 426591

Operator: **ULTRA RESOURCES INC**

Inspection Date: 10/19/2023

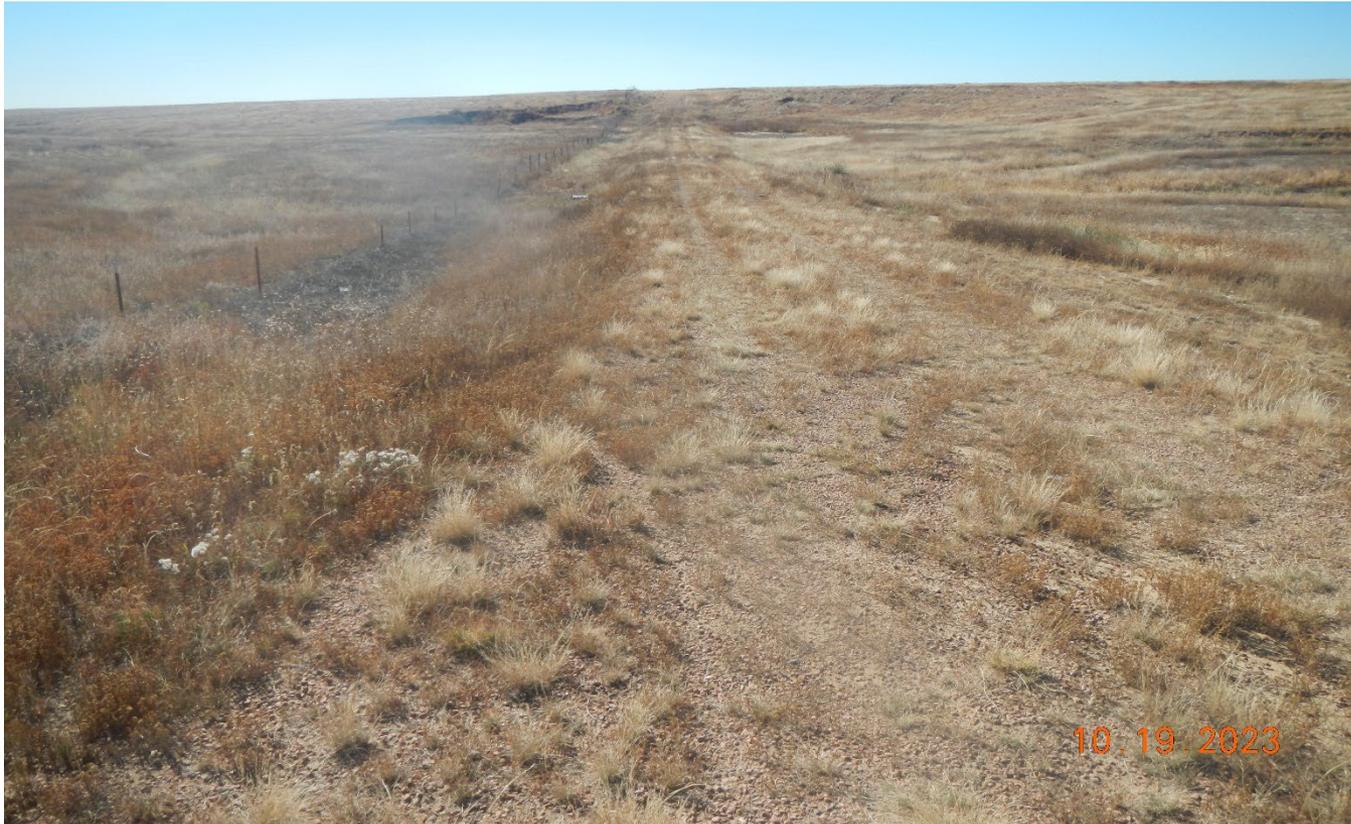
Photo 1. Facing south at the beginning of the access road. There is a wire gate not shown in the photo that requires maintenance. Lat/Long:38.75165,-104.55224.

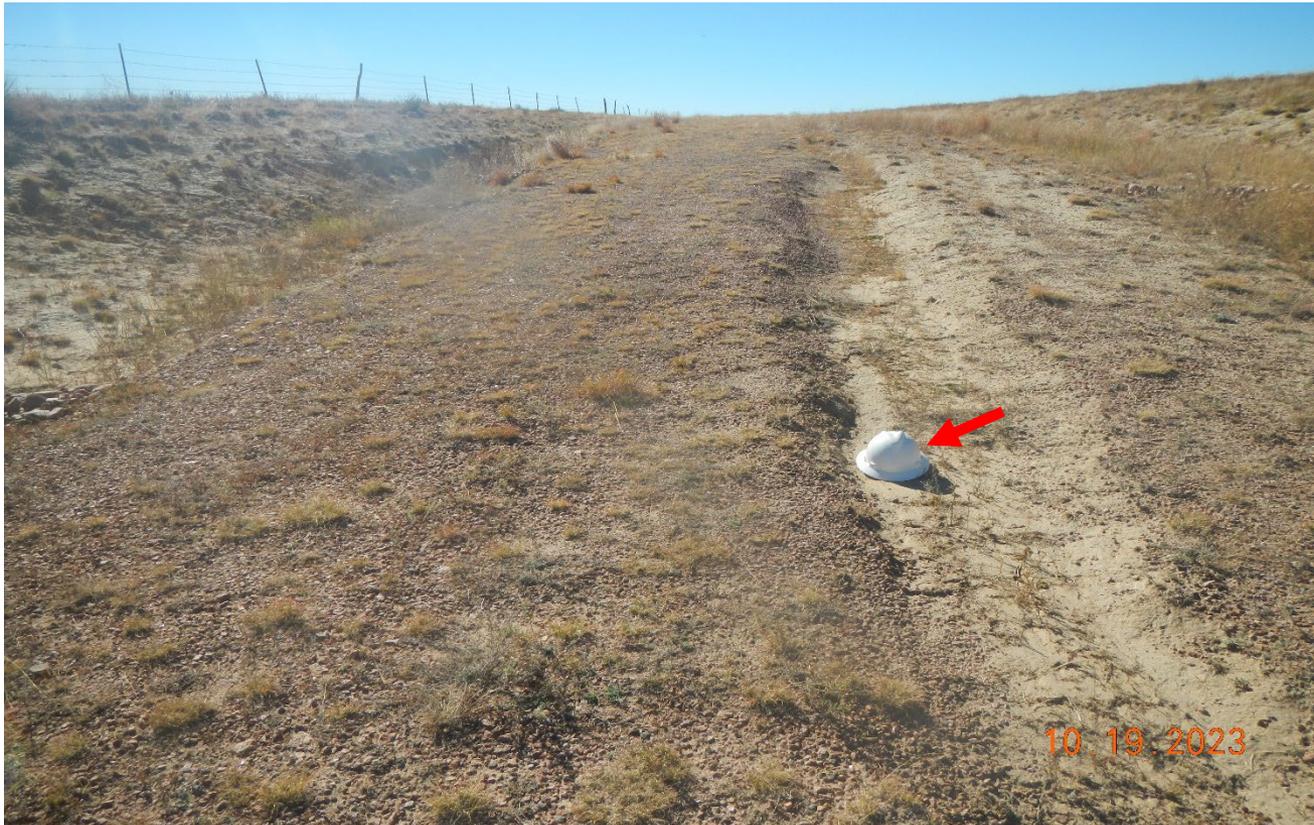
Photo 2. There is an erosion channel along the road at LatLong:38.74925,-104.55225. This area needs to be repaired and stabilized. Red arrow points to hard hat in the erosion channel.

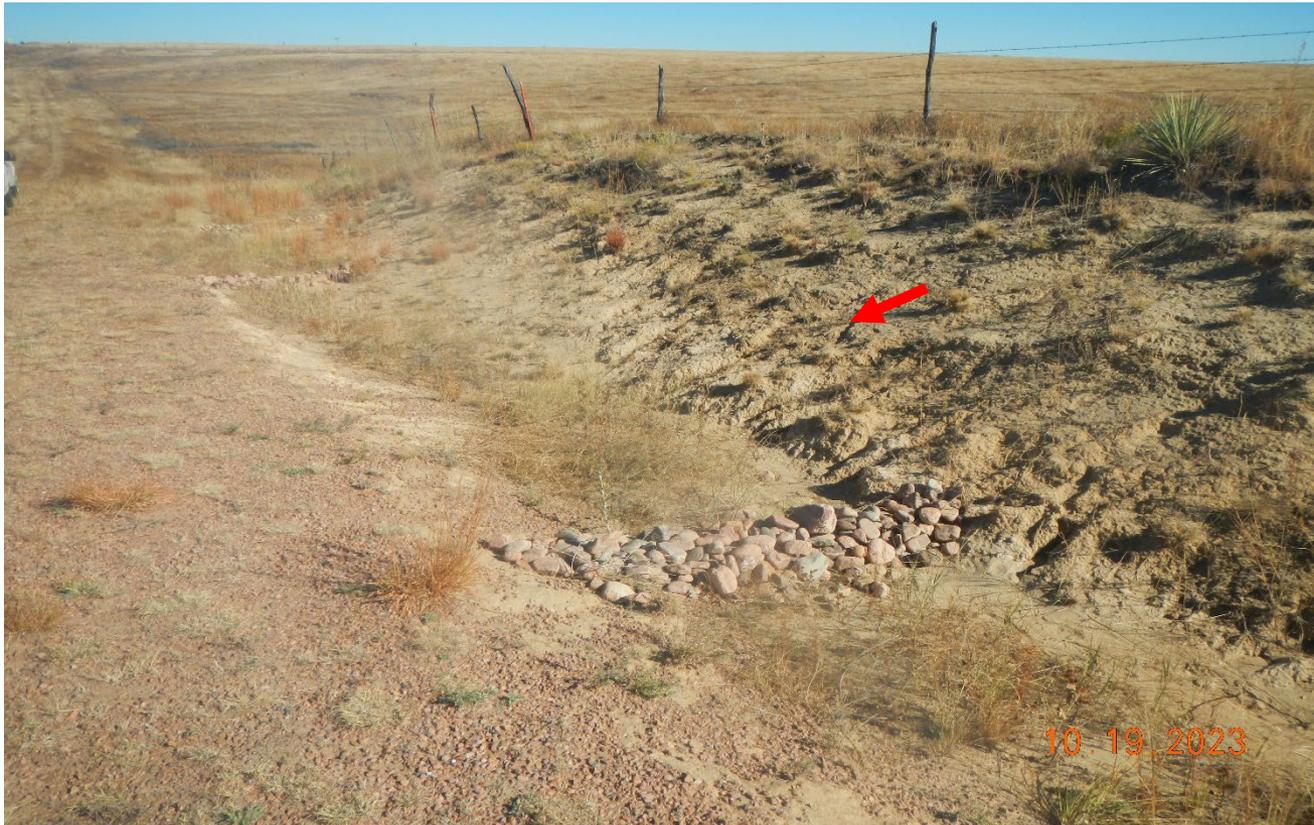
Photo 4. Facing northeast along the road toward the erosion along the roadside. There has been additional rock check dams installed however there is erosion at red arrow that needs to be stabilized and seeded.

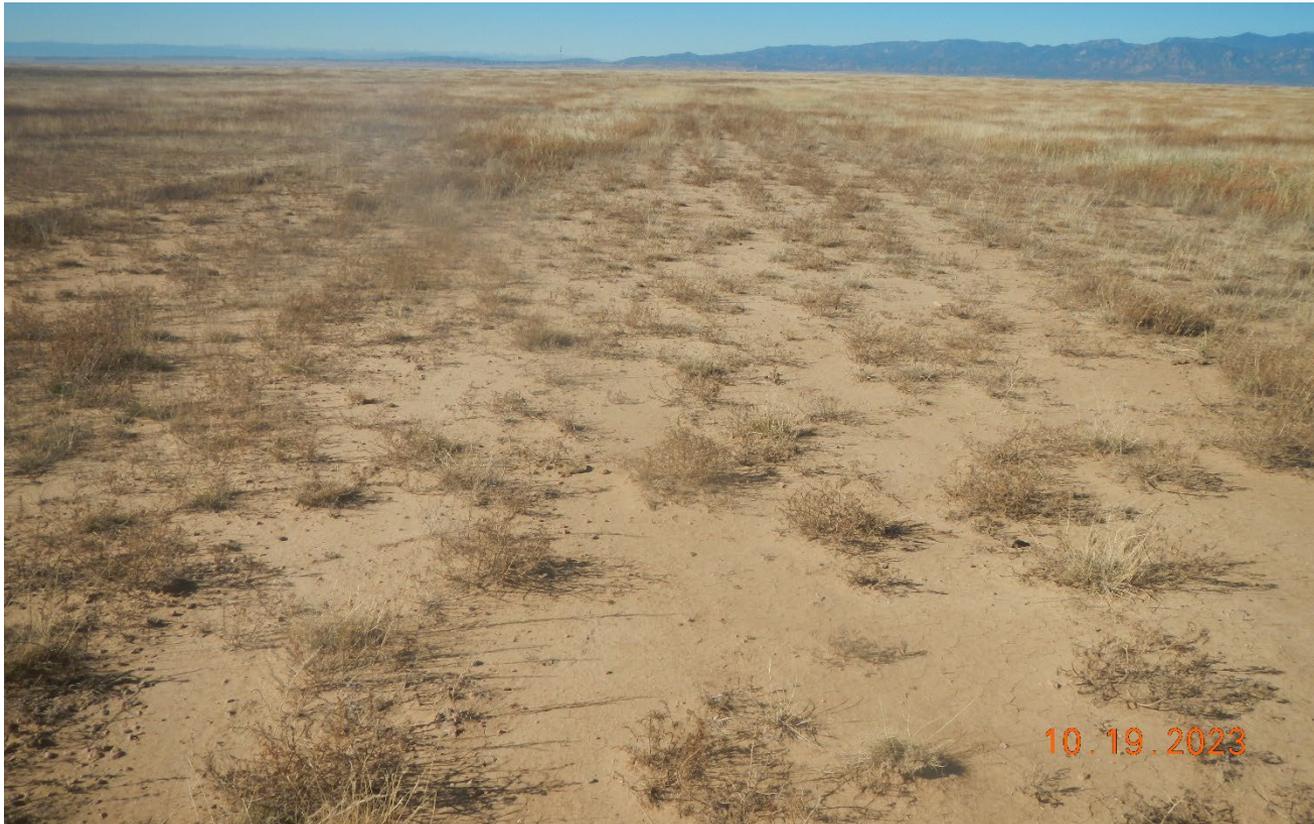
Photo 5. Facing northwest along the access road. This area of the road has not established sufficient vegetation cover approximately 150'x75' in size.
Lat/Long:38.74022,-104.55316.

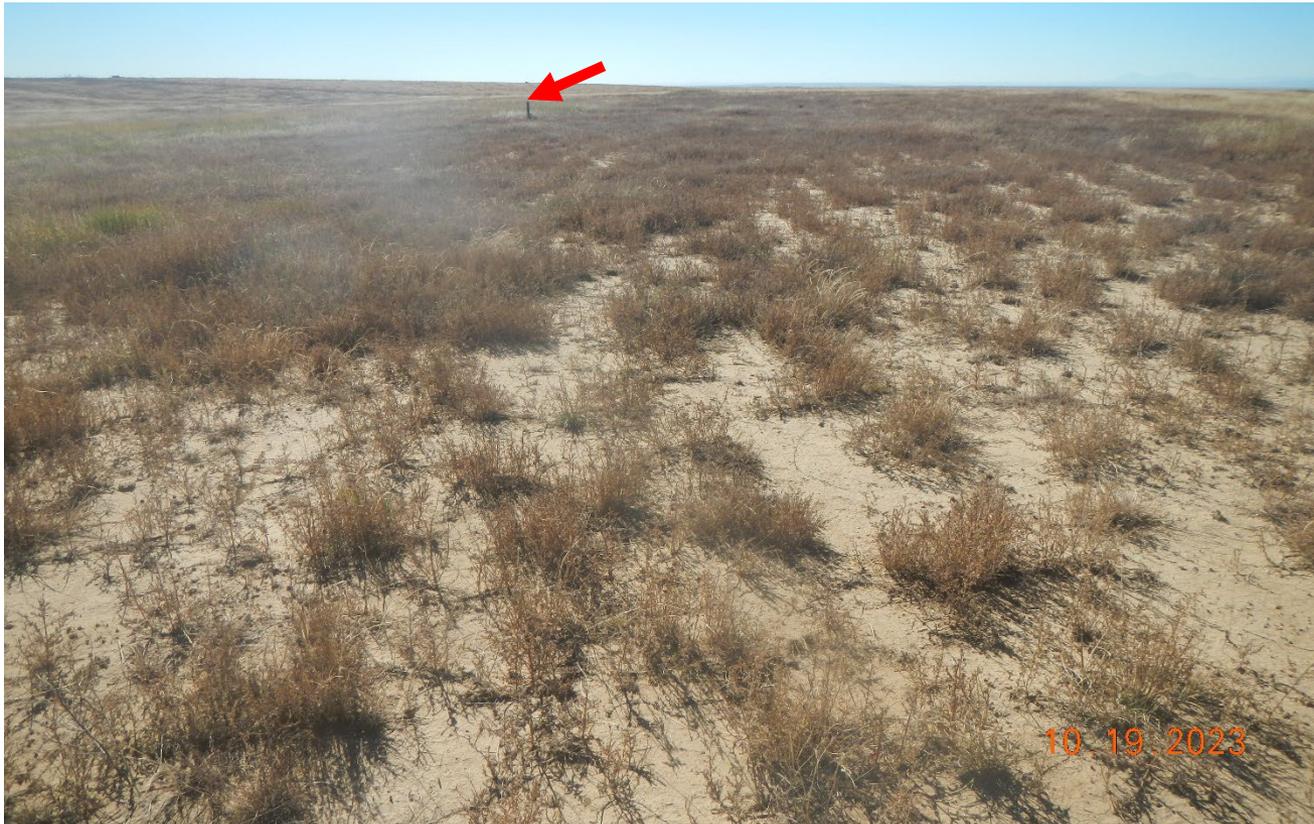
Photo 6. Facing south toward the location. The west side of the location has not established perennial vegetation and there are undesirable weeds. Red arrow points to the well marker at center of the location.

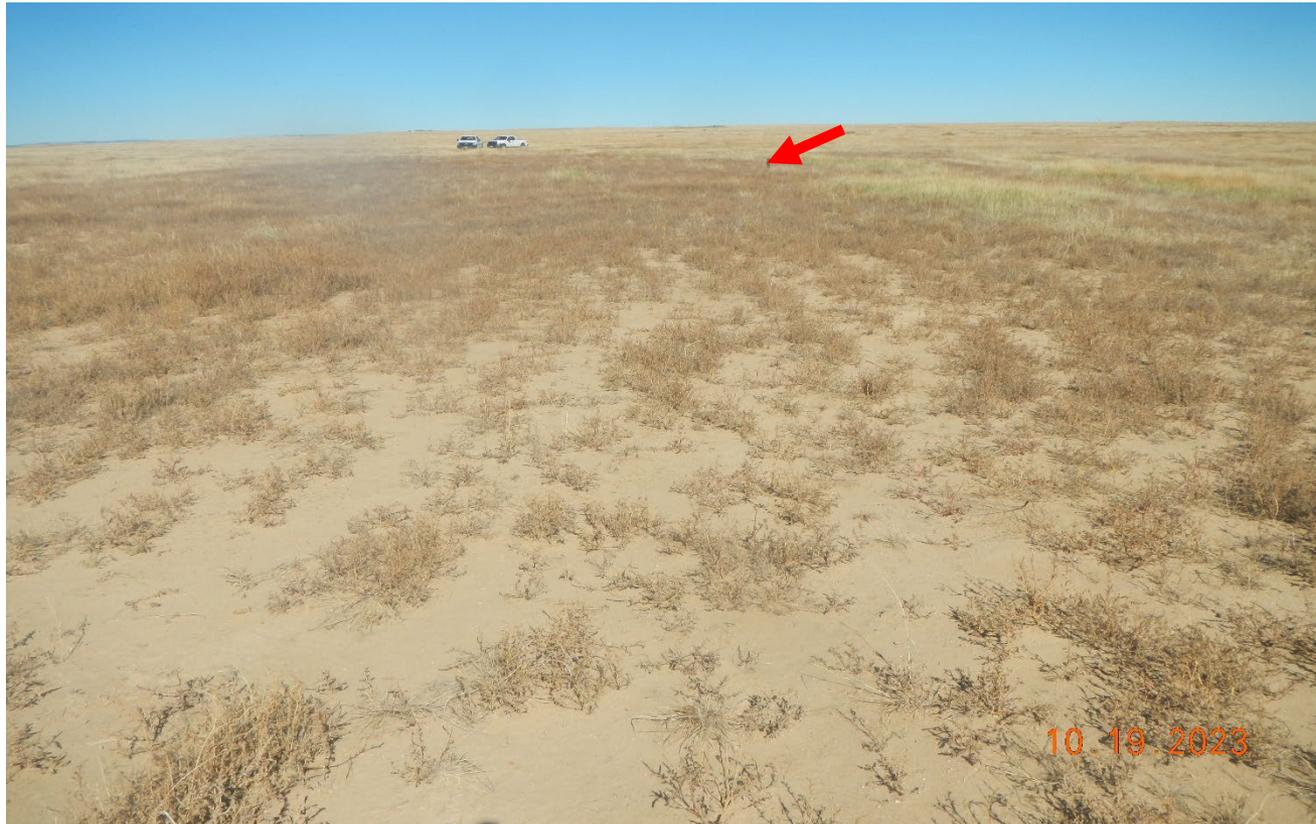
Photo 7. Facing north toward the location. The west side of the location has not established perennial vegetation and there are undesirable weeds. Red arrow points to the well marker at center of the location.

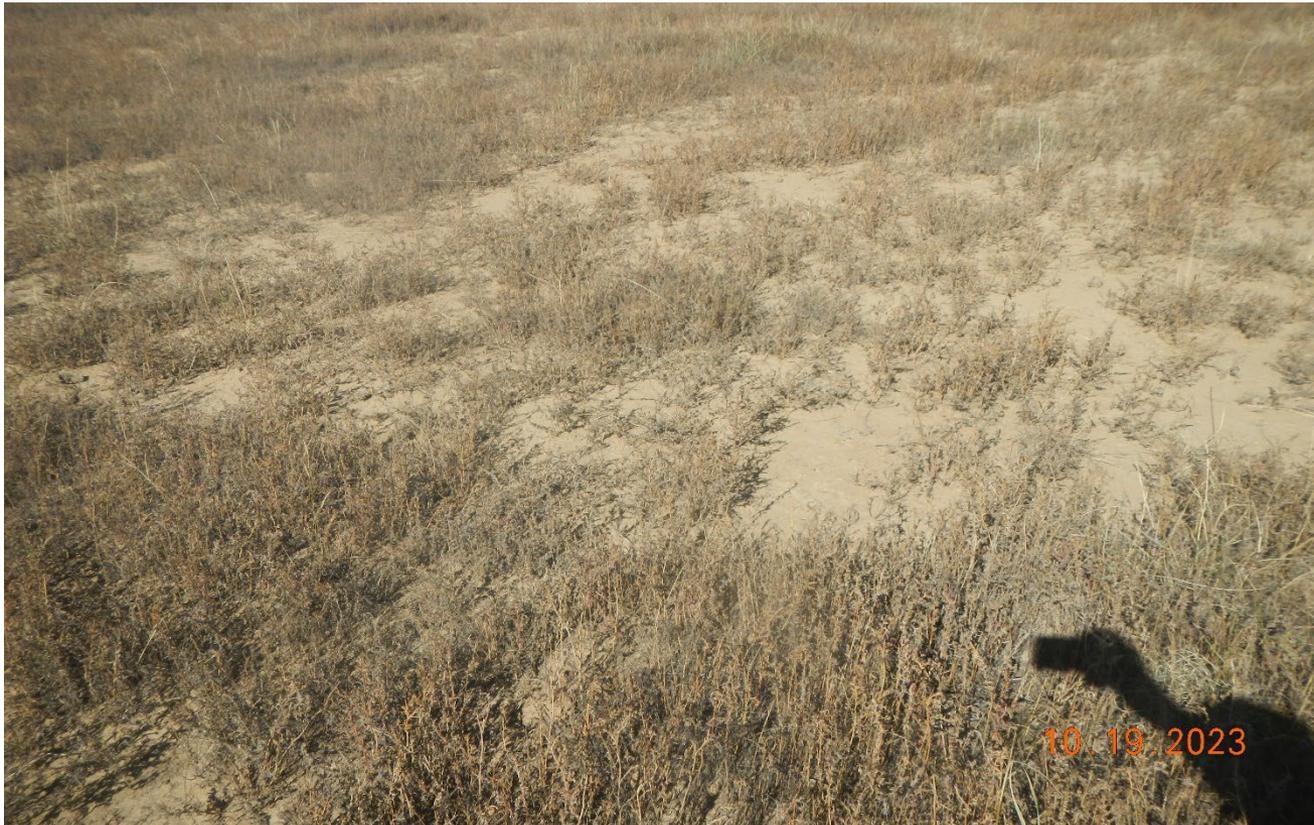
Photo 8. View of ground cover at west side of the location shows most entirely undesirable weeds (Kochia).
