Inspection Photos
Location Name: CHAMPLIN_HER_2-8
Location ID: 320245

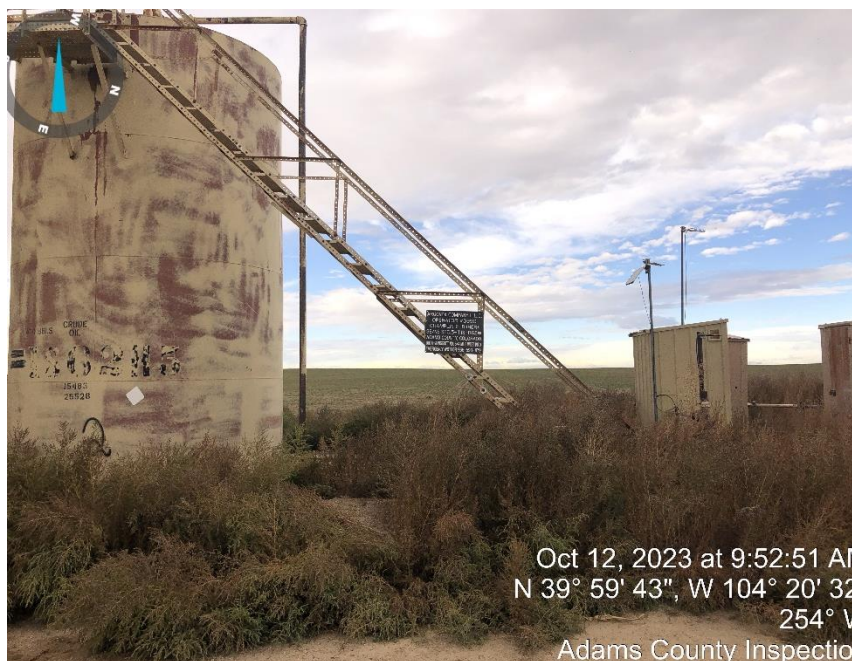
Photo #1 Well sign.

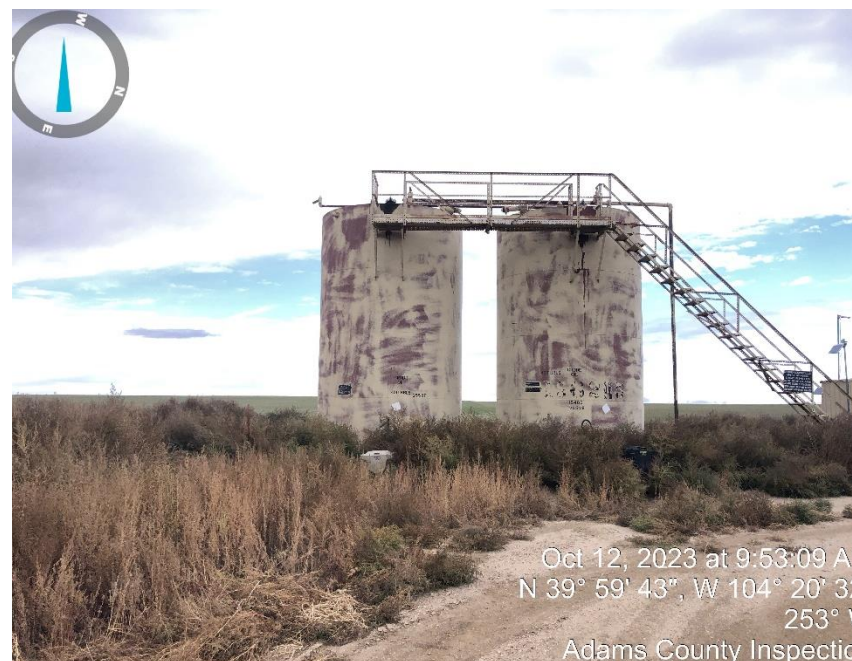
Photo #2 Crude tanks.

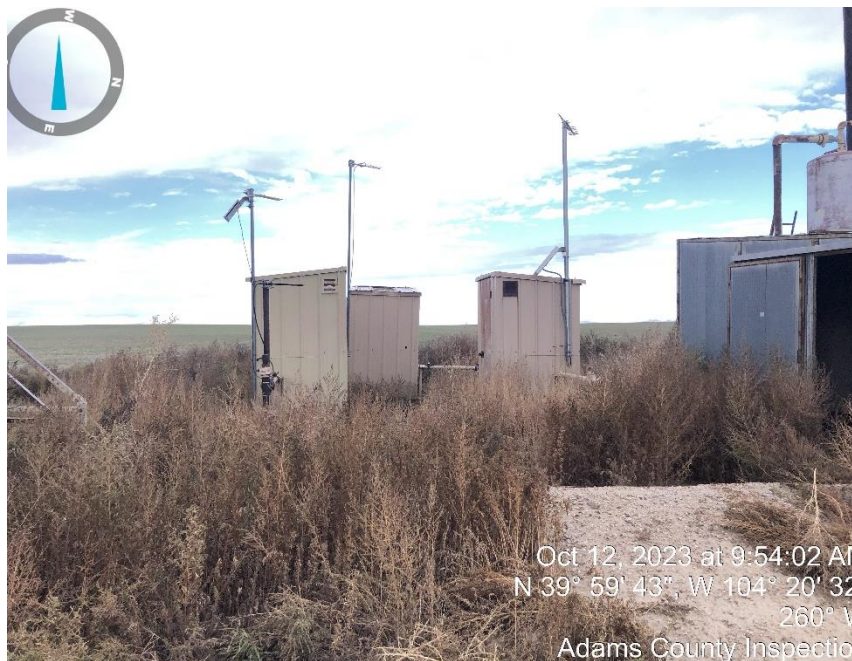
Photo #3 Meters.

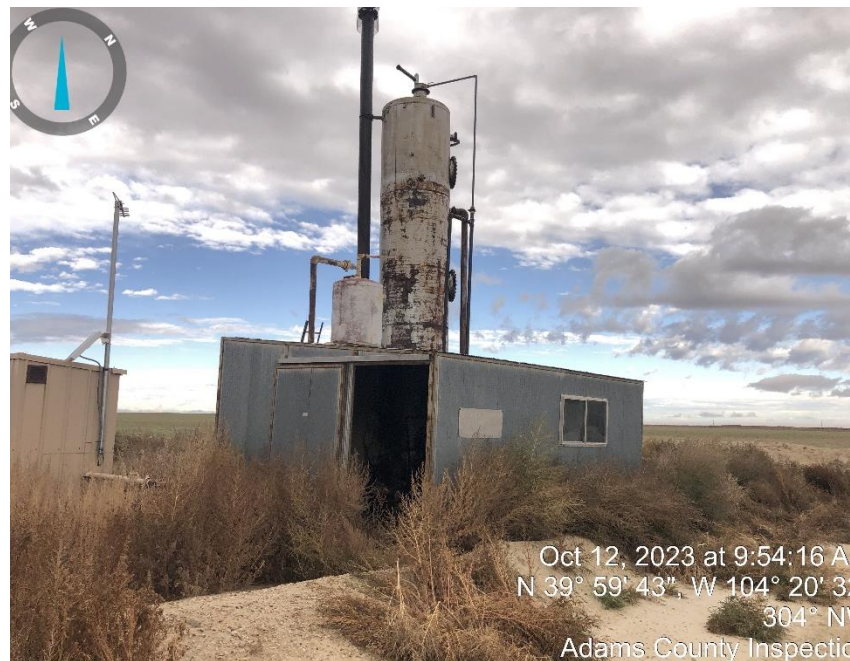
Photo #4 Separator house.

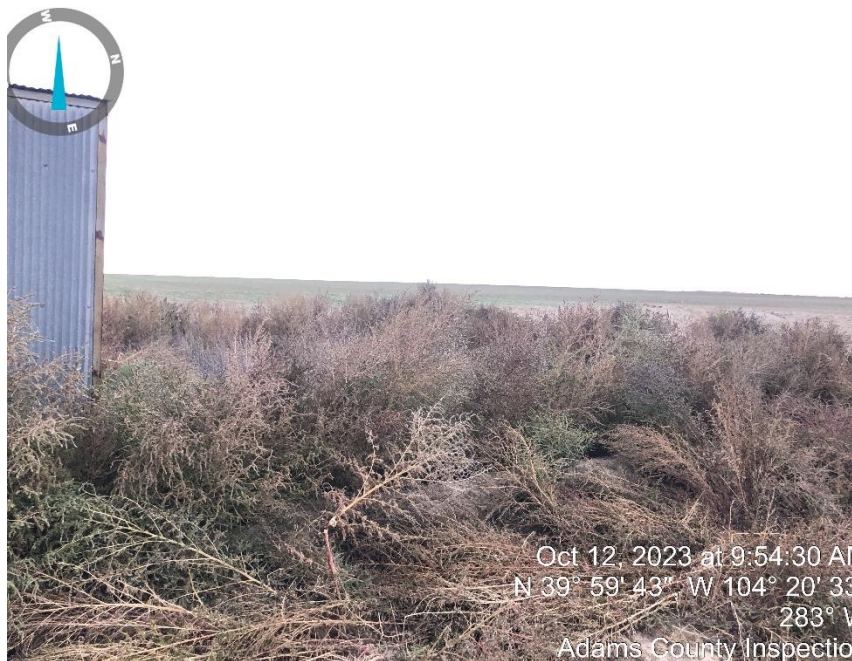
Photo #5 weeds in vault berm.

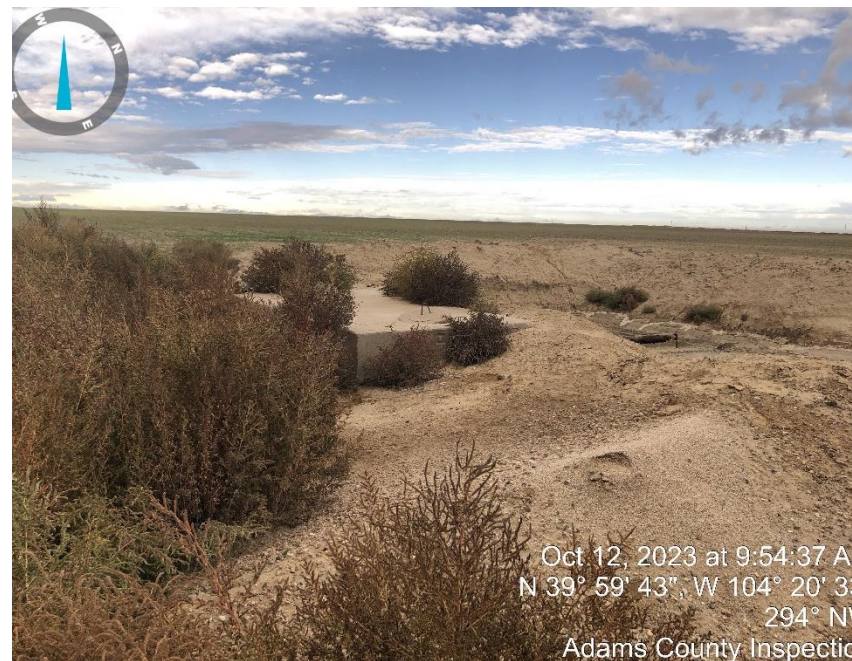
Photo #6 P/W vault.

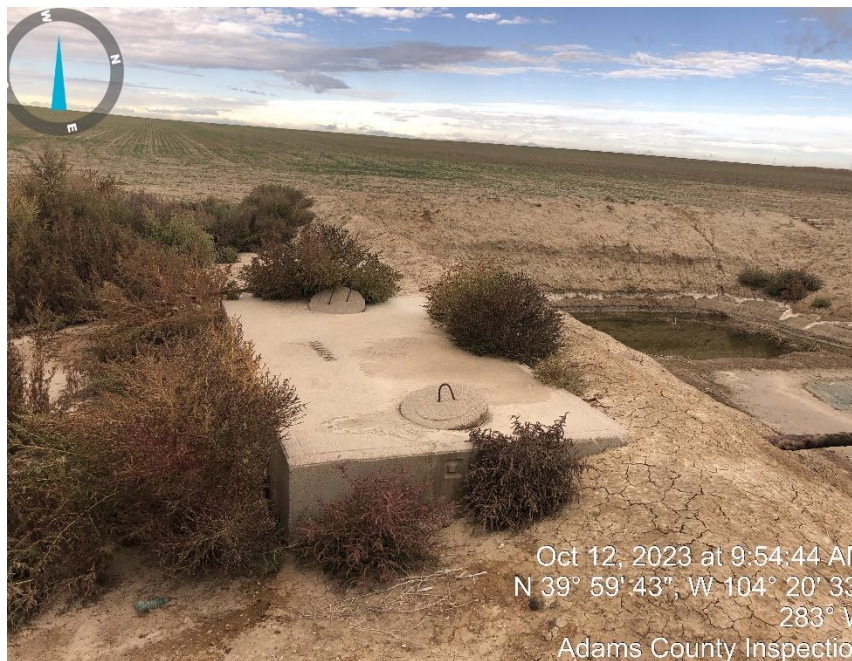
Photo #7 P/W vault.

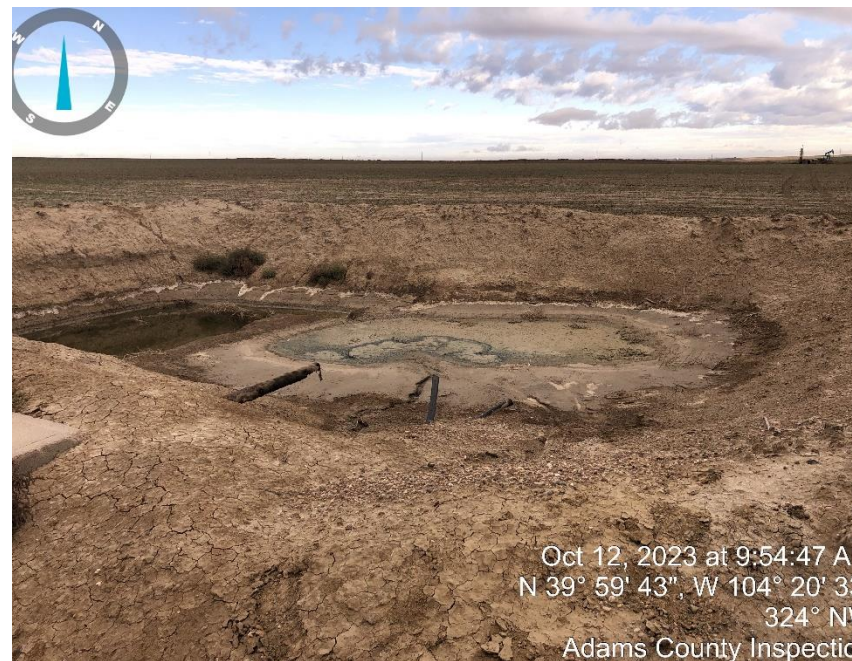
Photo #8 Open pit.

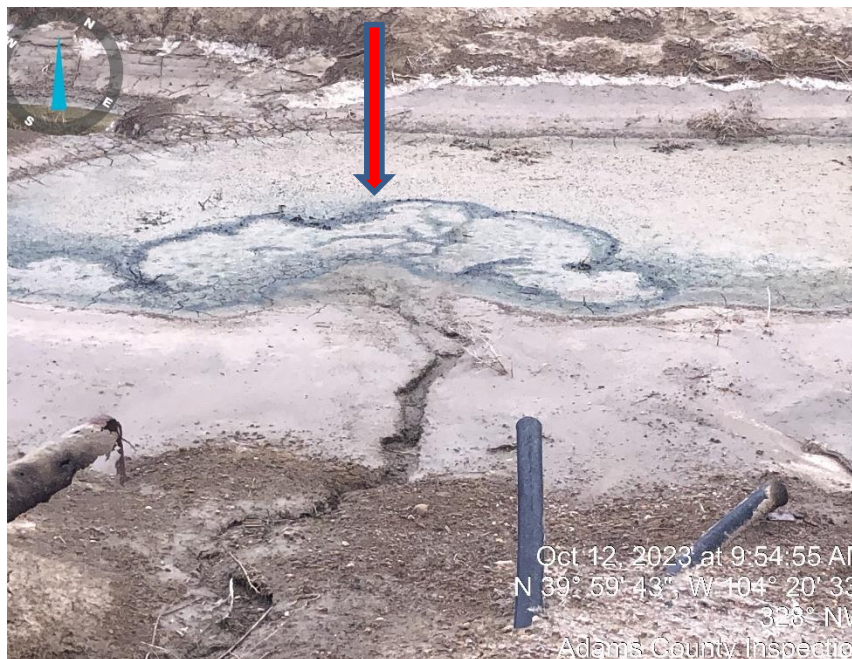
Photo #9 Hydrocarbons in the bottom of open pit.

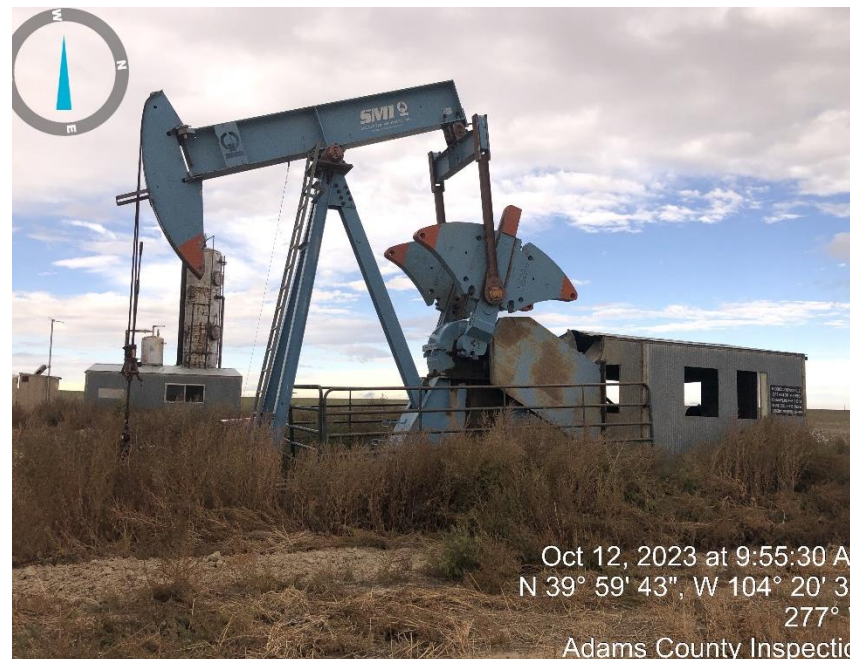
Photo #10 Pump jack.

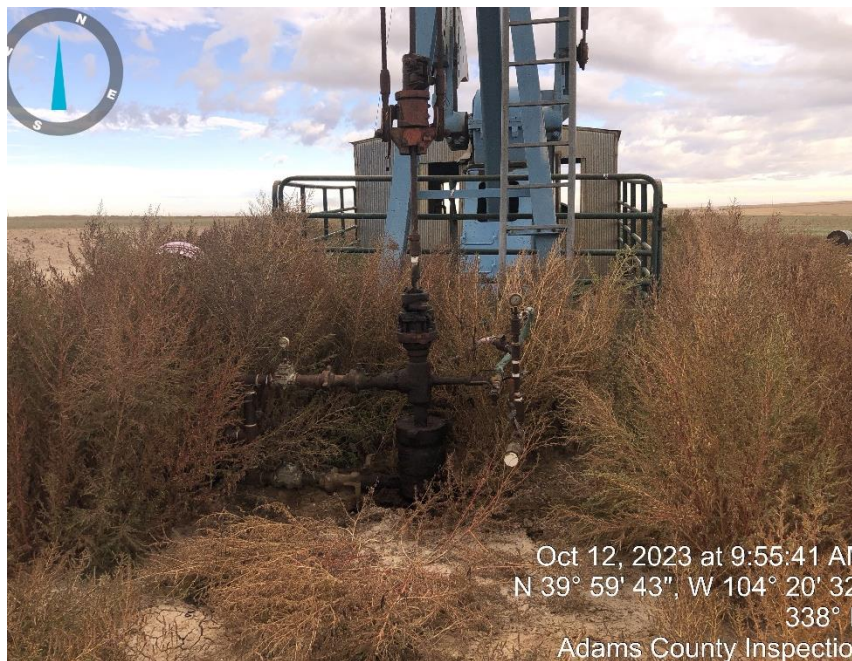
Photo #11 Well head.

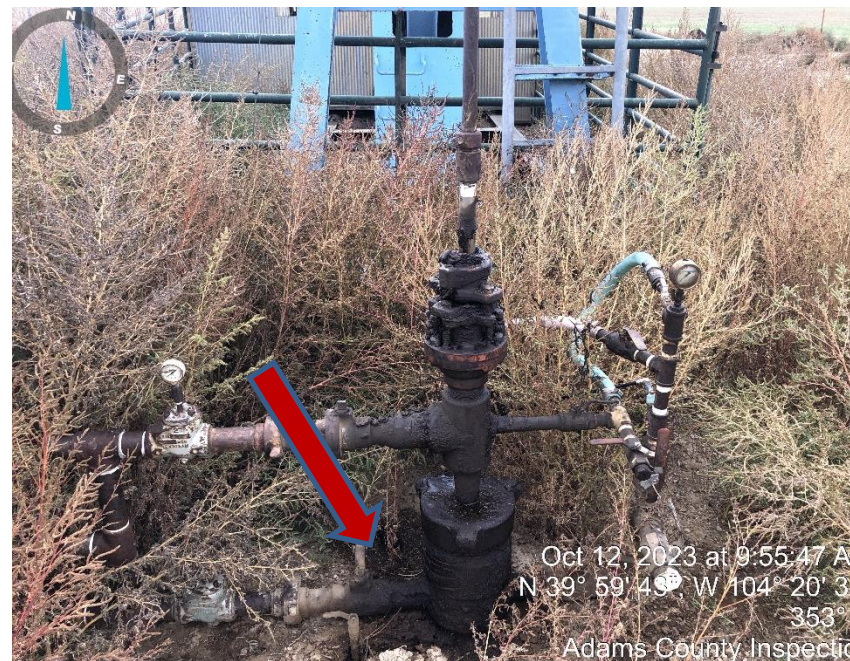
Photo #12 Stained soil around well head.

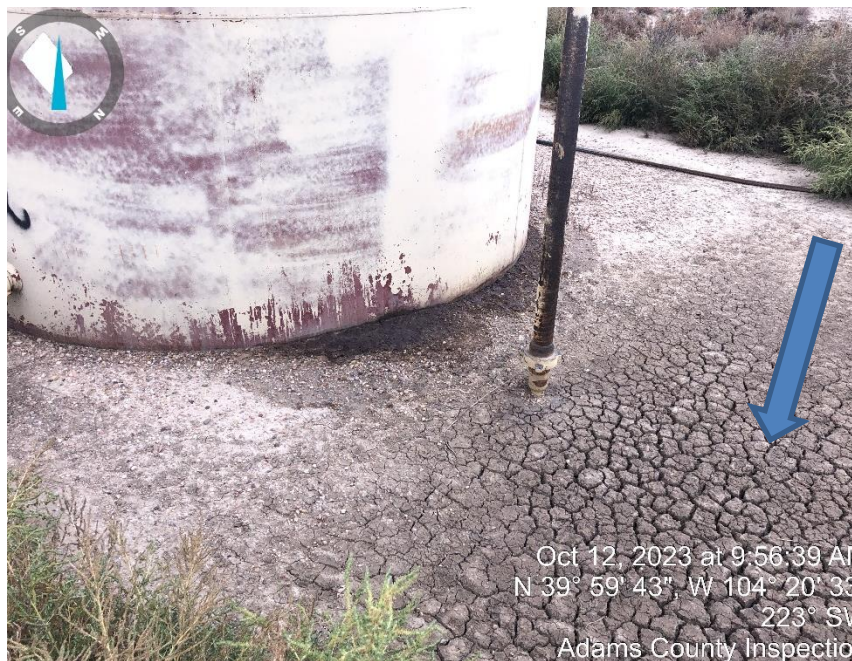
Photo #13 stained soil in berm around crude tanks.

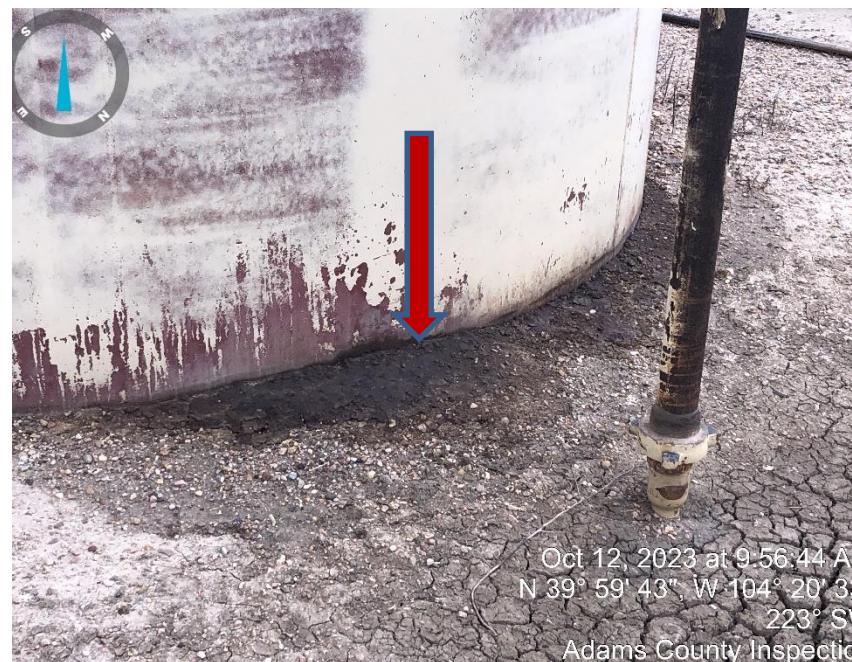
Photo #14 Stained soil under Crude tank.

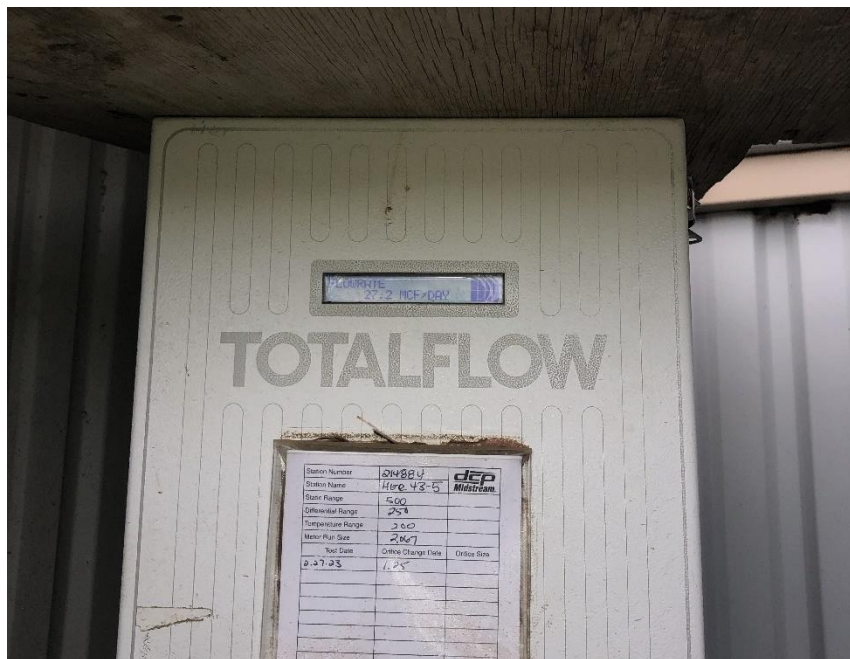
Photo #15 Meter for well site

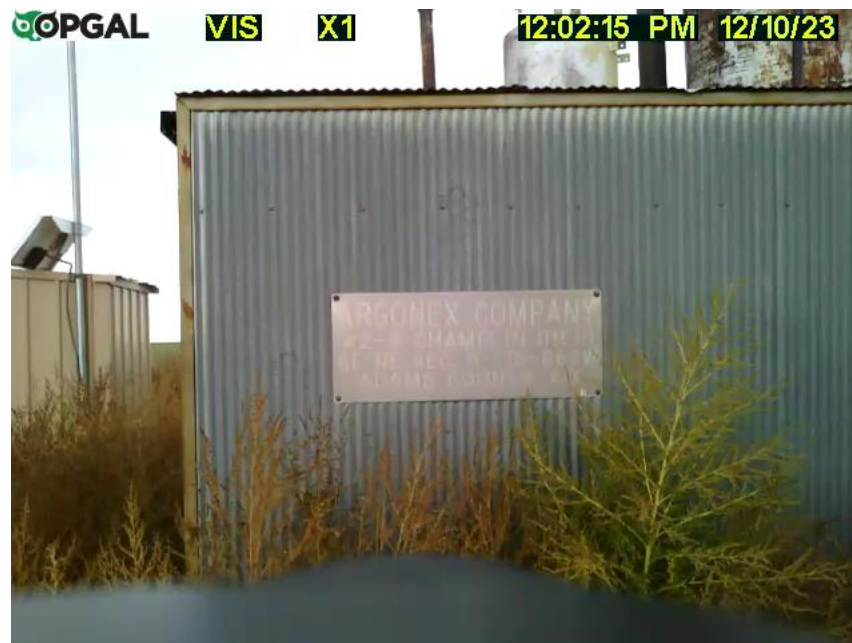
Video #1 of well active venting.
