Inspection Photos

Location Name: TEP ROCKY MOUNTAIN LLC, CHEVRON-66S96W/20SESW

Location ID: 335183

Date: 10/17/2023

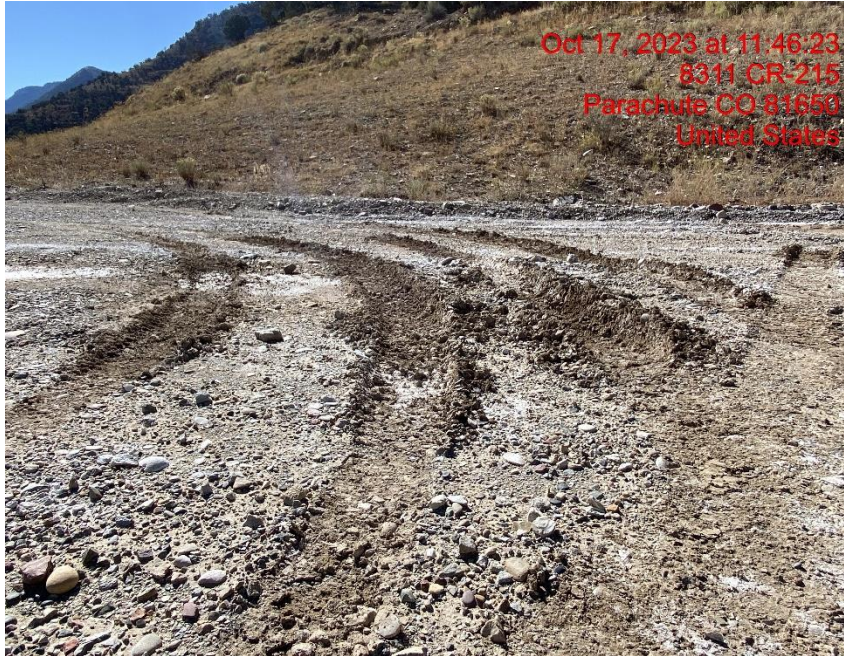
Location Lacks Stabilization – Photo #07014

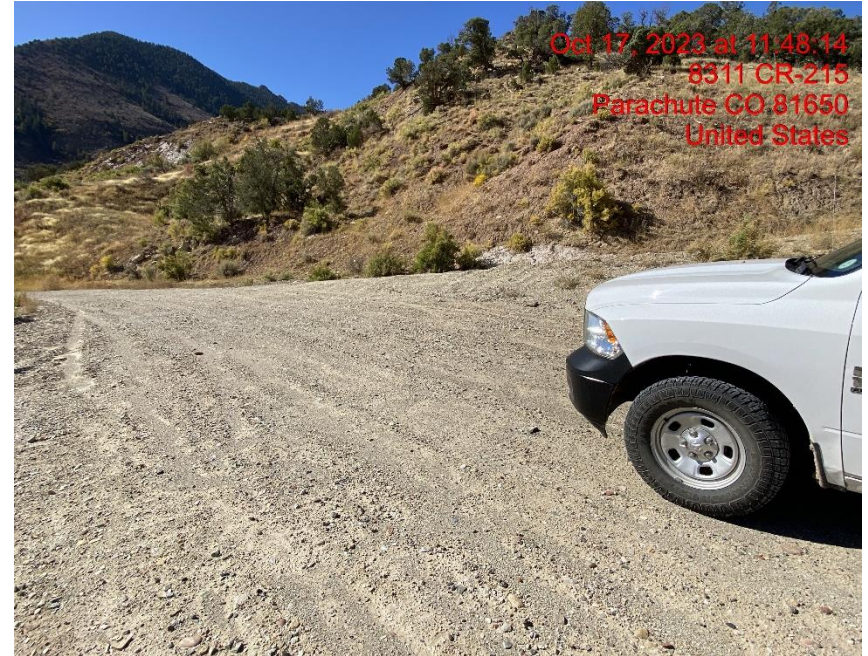
Insufficient Vehicle Tracking BMPs at Location Entrance/Exit
– Photo #07019
