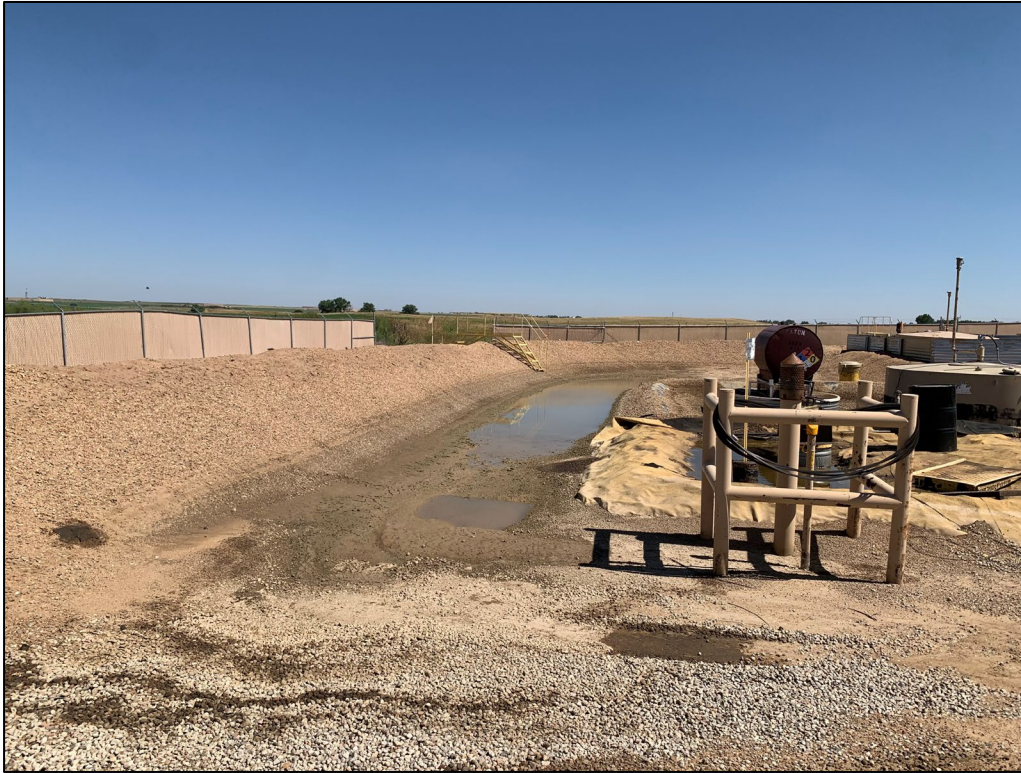
Photograph 1: Stormwater outside secondary containment area. Staining in foreground. East corner of the facility facing southeast.

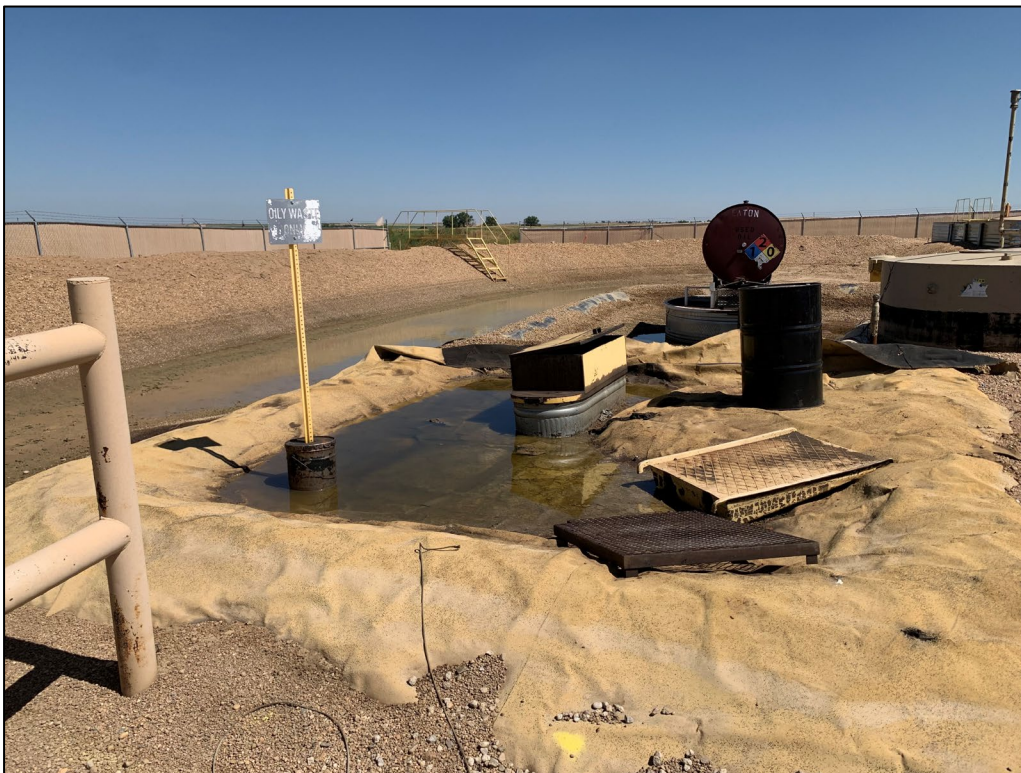
Photograph 2: Stormwater inside and outside secondary containment area. East corner of the facility facing southeast.

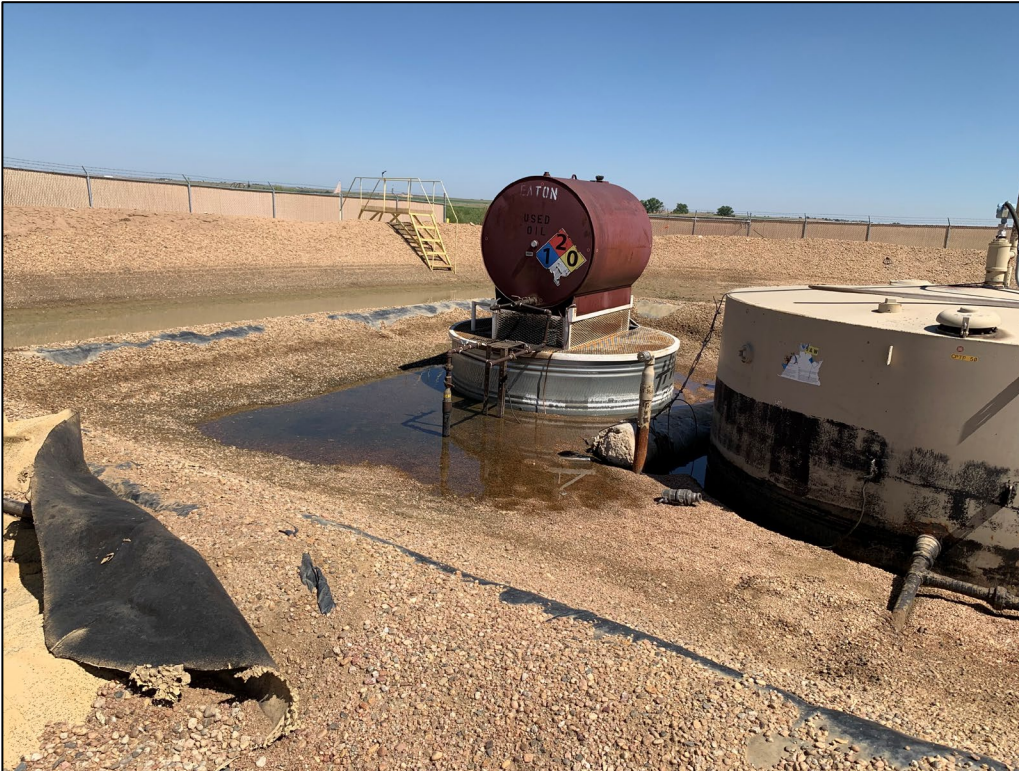
Photograph 3: Stormwater inside and outside secondary containment area. East corner of the facility facing east. Staining present on sides of secondary berm.

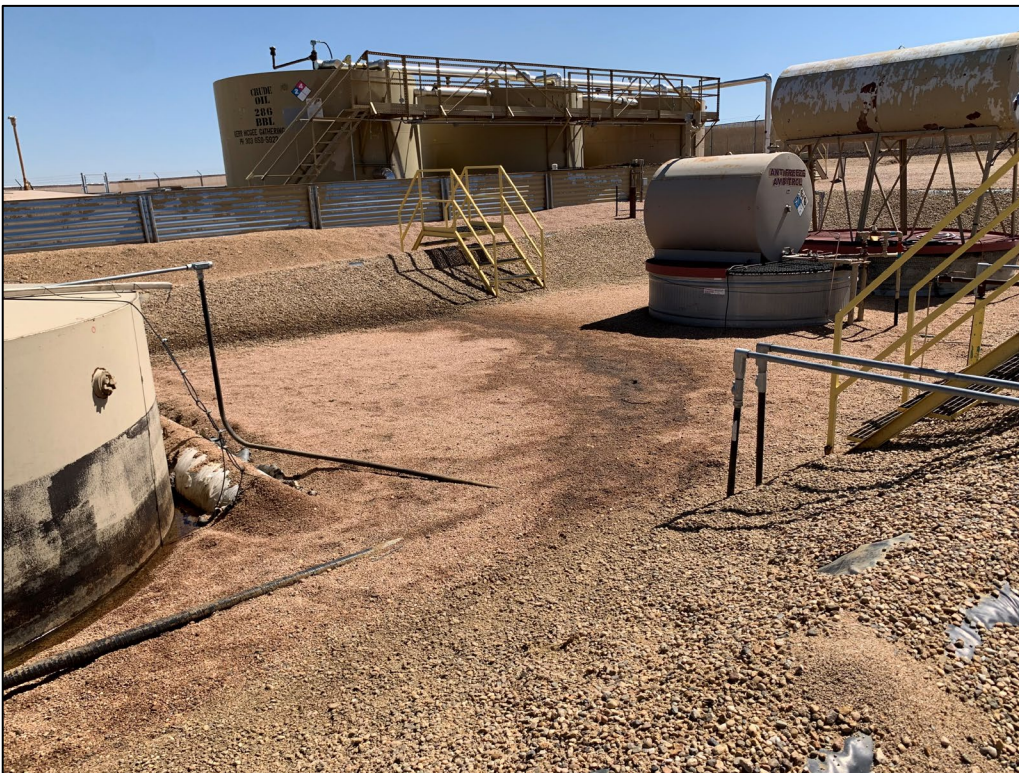
Photograph 4: Dry area inside secondary containment. Staining along evaporation line. East corner of the facility facing south.

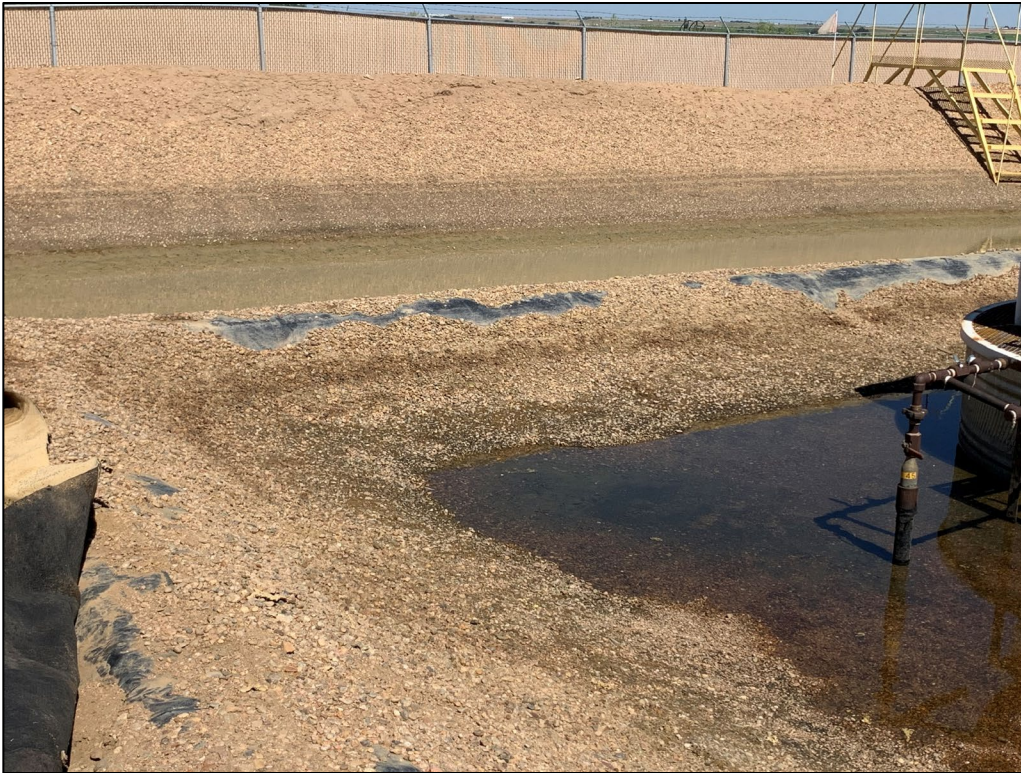
Photograph 5: Close up of staining inside secondary containment. No visible sheen on stormwater at time of discovery. East corner of the facility facing east.

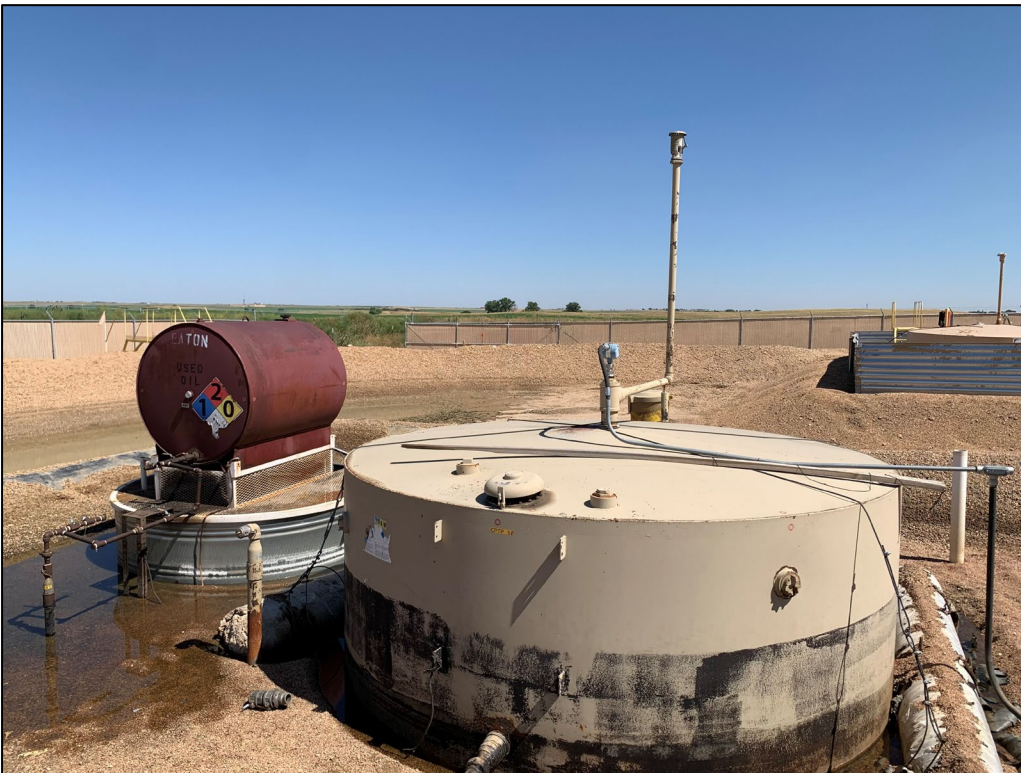
Photograph 6: Tanks within secondary containment. East corner of the facility facing east.

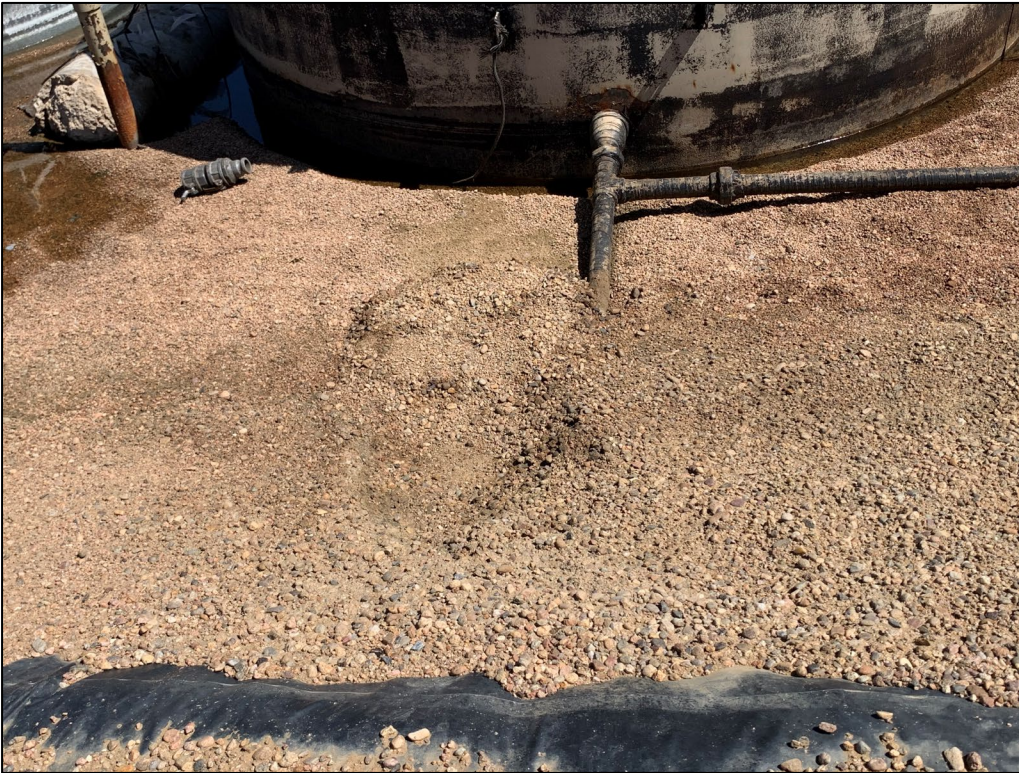
Photograph 7: Close up of piping at tank base. No staining or evidence of leakage from piping.

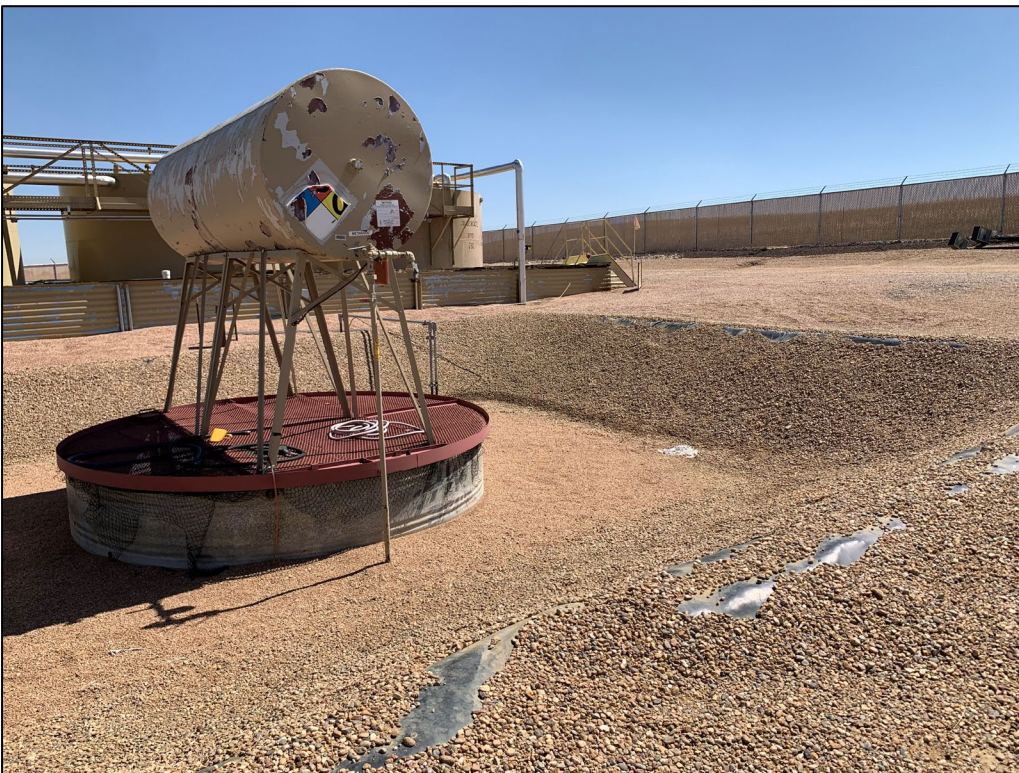
Photograph 8: South end of secondary containment. No staining or evidence of impacts from excess stormwater. East corner of facility, facing southwest.
