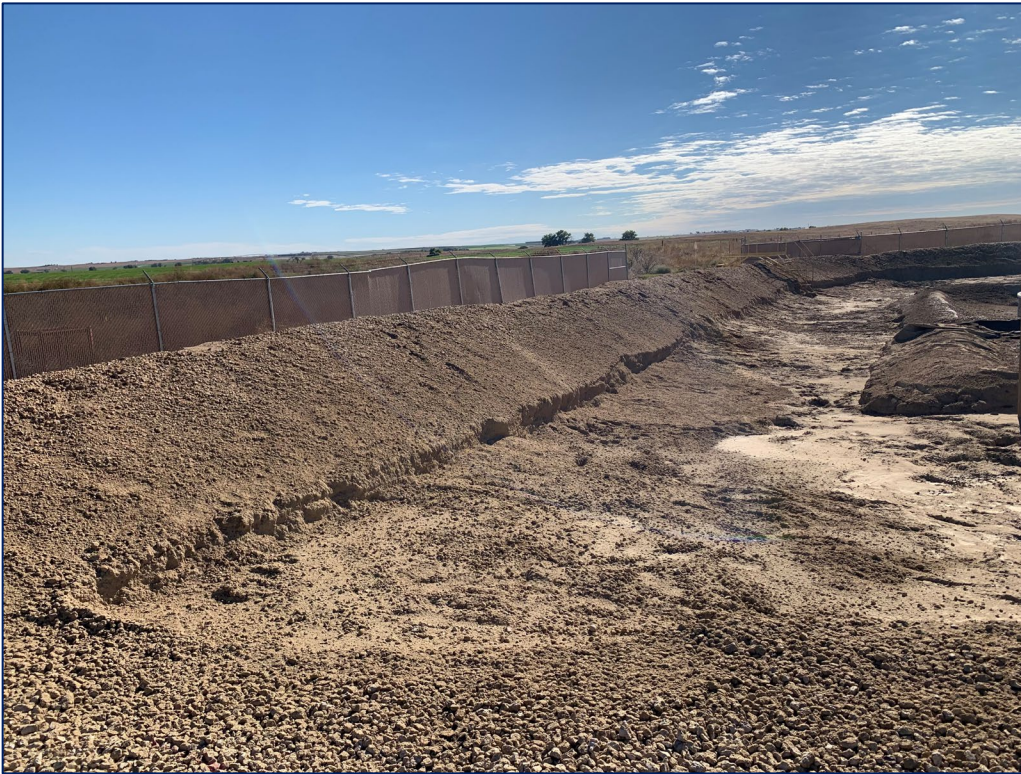
Photograph 1: Area of hydrovaced soil removal. Northwest corner facing southeast.

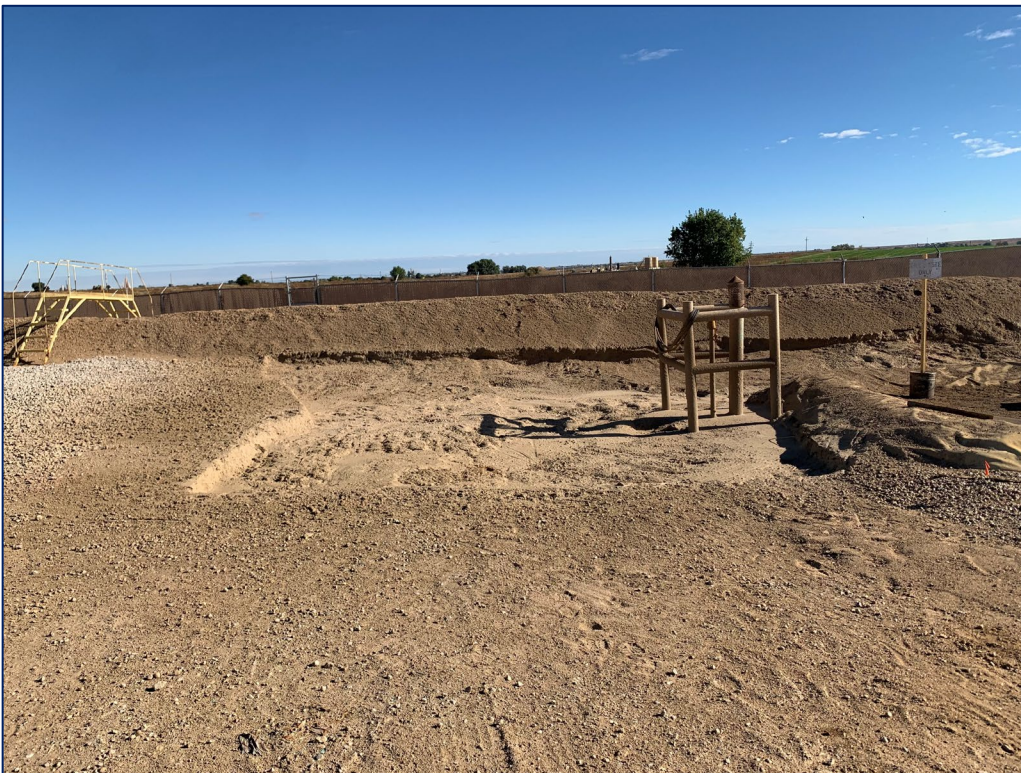
Photograph 2: Area of hydrovaced soil removal. South of northwest corner facing northeast.

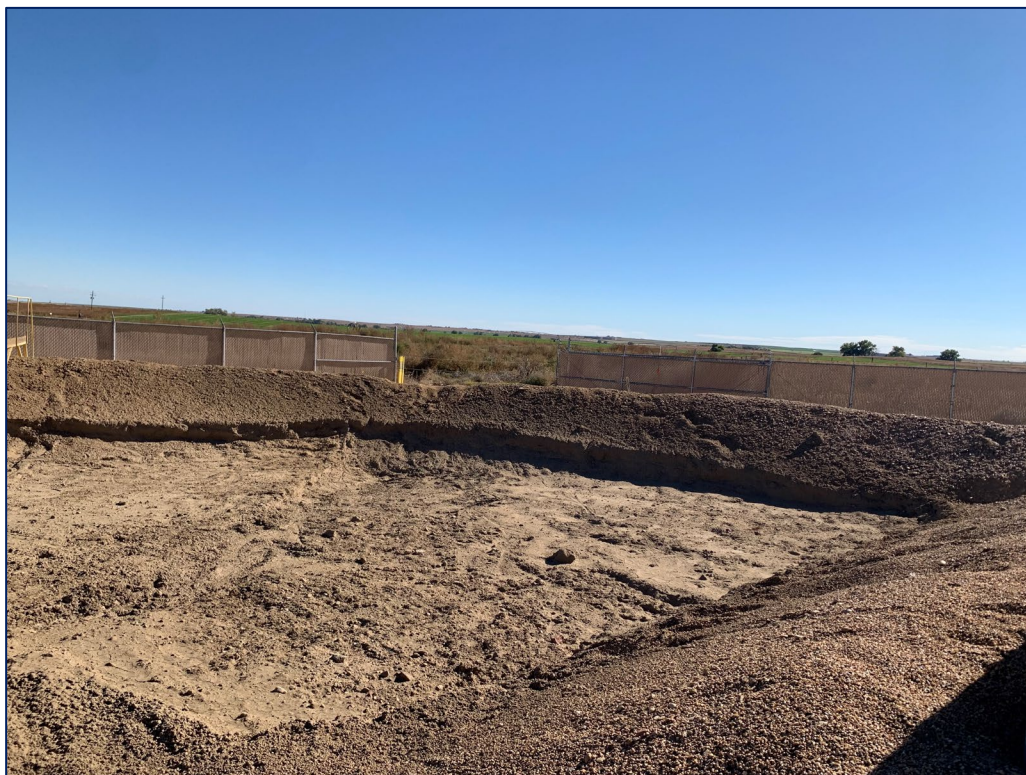
Photograph 3: Area of hydrovaced soil removal. South of east corner facing east.

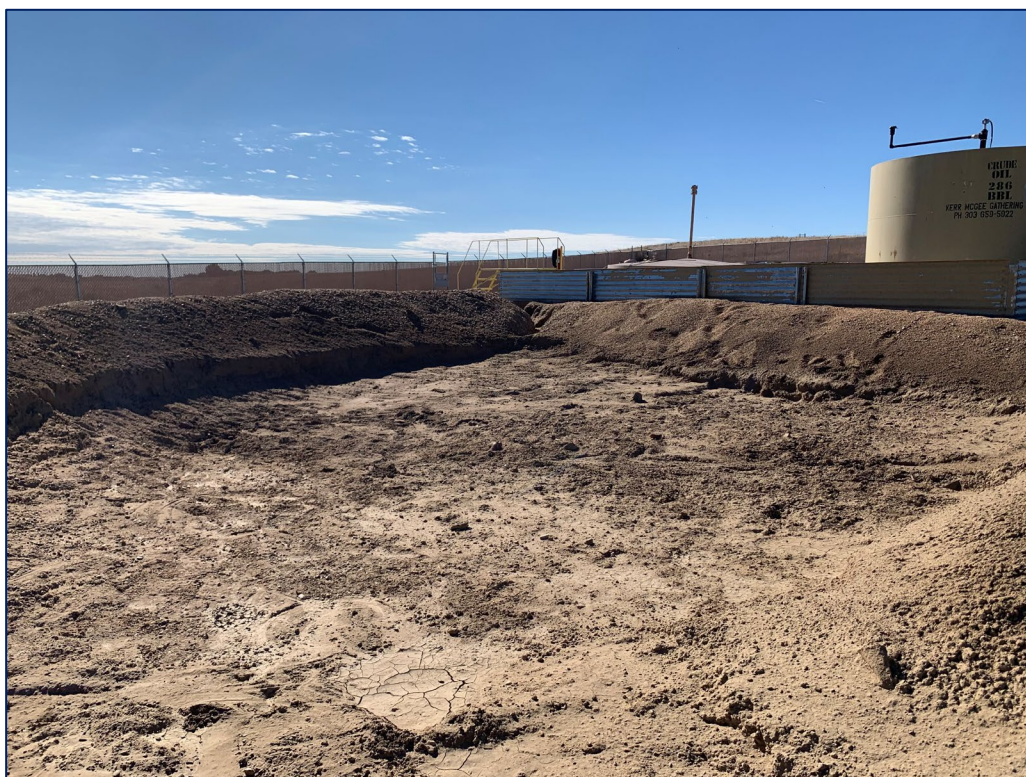
Photograph 4: Area of hydrovaced soil removal. Southeast corner, facing south.

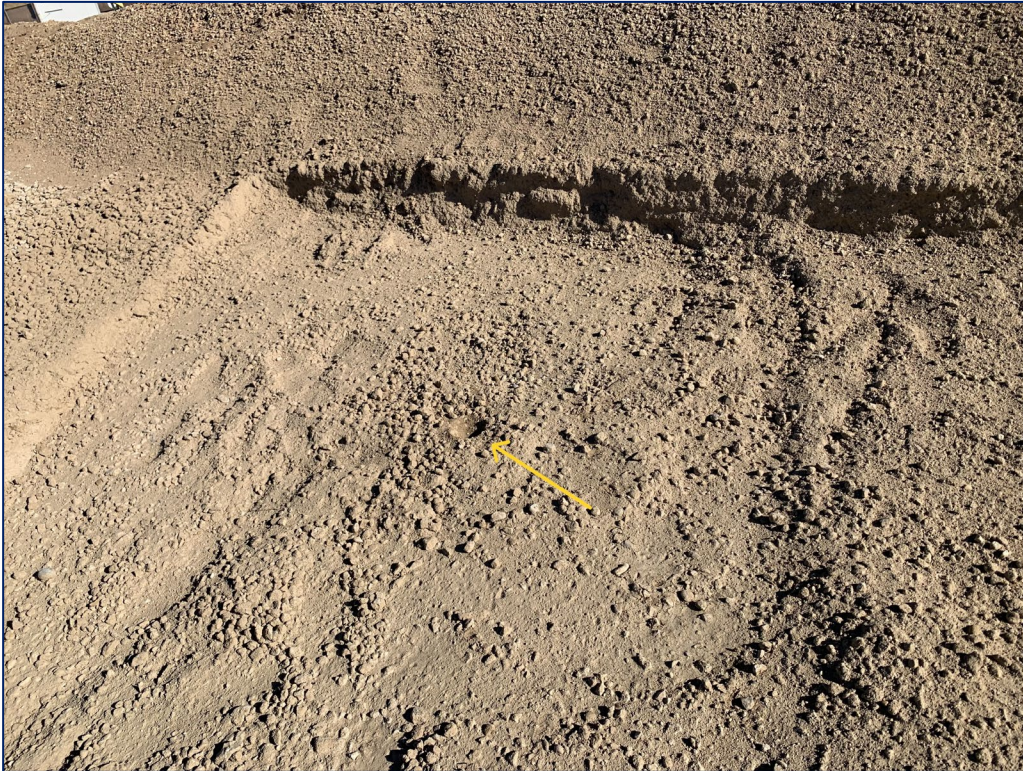
Photograph 5: Sample location TOF-N01. Northwest corner. Location of diesel range total petroleum hydrocarbon exceedance.
