Storm Water Management and Erosion control
Location Name: TEP ROCKY MOUNTAIN LLC RMV 200-20 Pad
Location ID: 335263

Location Overview: Location is within High Priority/Density Habitat areas. Location is approximately 138 yards from a creek/drainage that contributes to the Colorado River.

Section/Township/Range: 20 6S94W

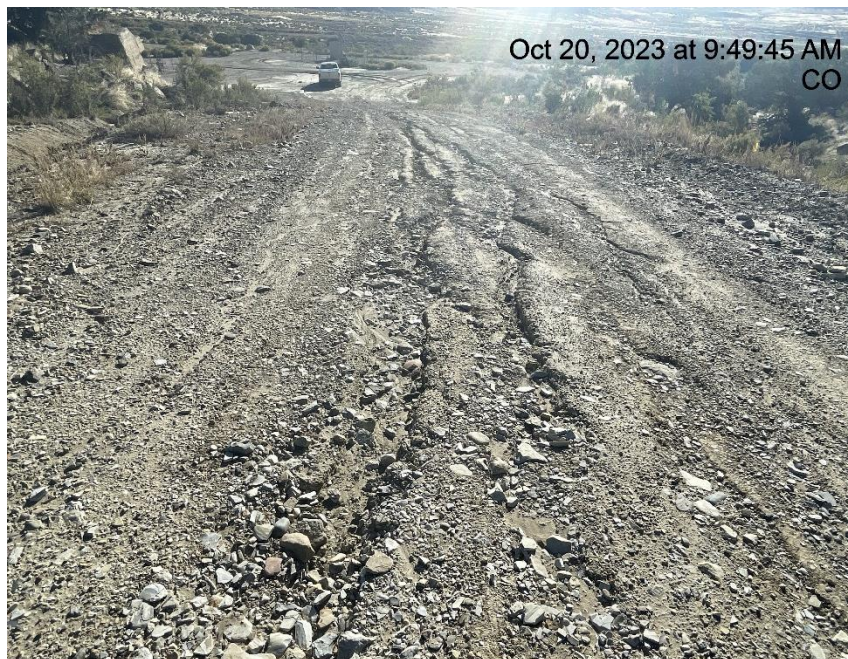
Photo # 3440 Erosion & transport of sediment on lease road /insufficient BMP's

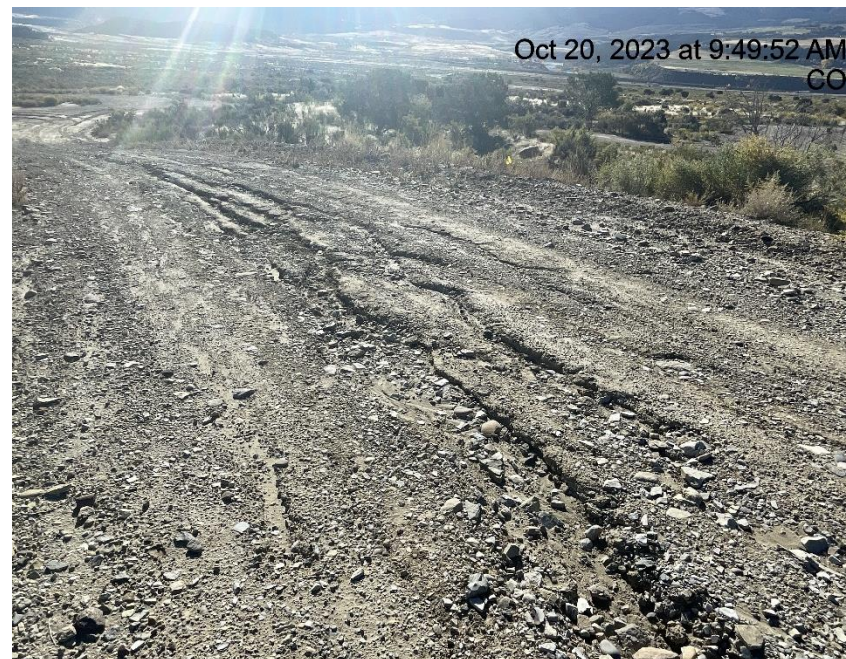
Photo # 3441 Erosion & transport of sediment on lease road /insufficient BMP's

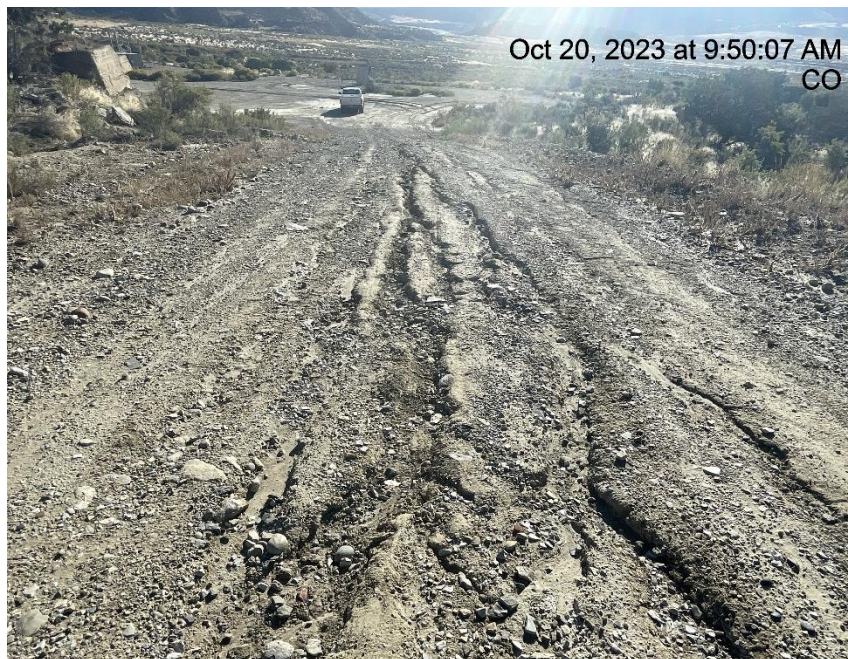
Photo # 3442 Erosion & transport of sediment off lease road into a vegetated area choking off vegetation/insufficient BMP's

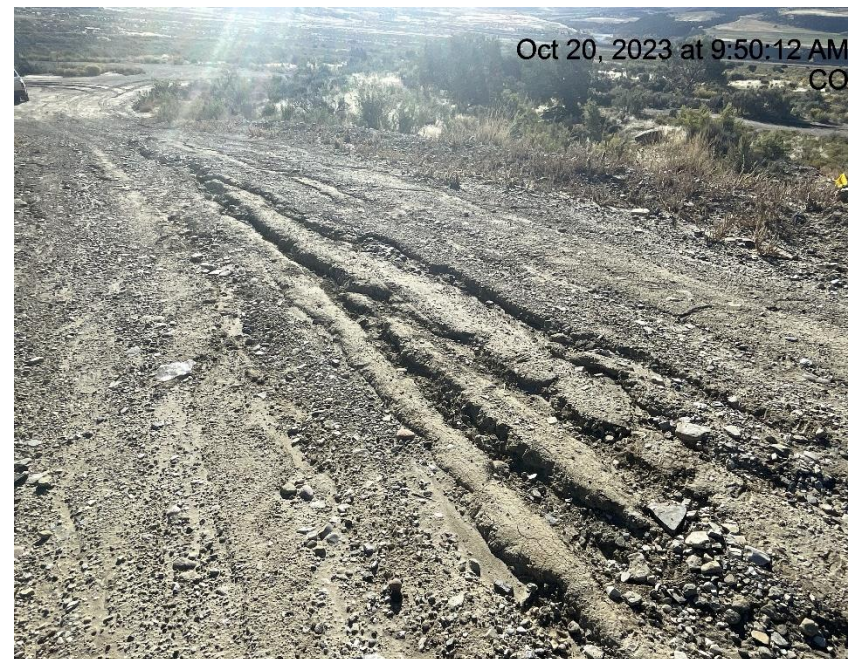
Photo # 3443 Erosion & transport of sediment off lease road into a vegetated area choking off vegetation/insufficient BMP's

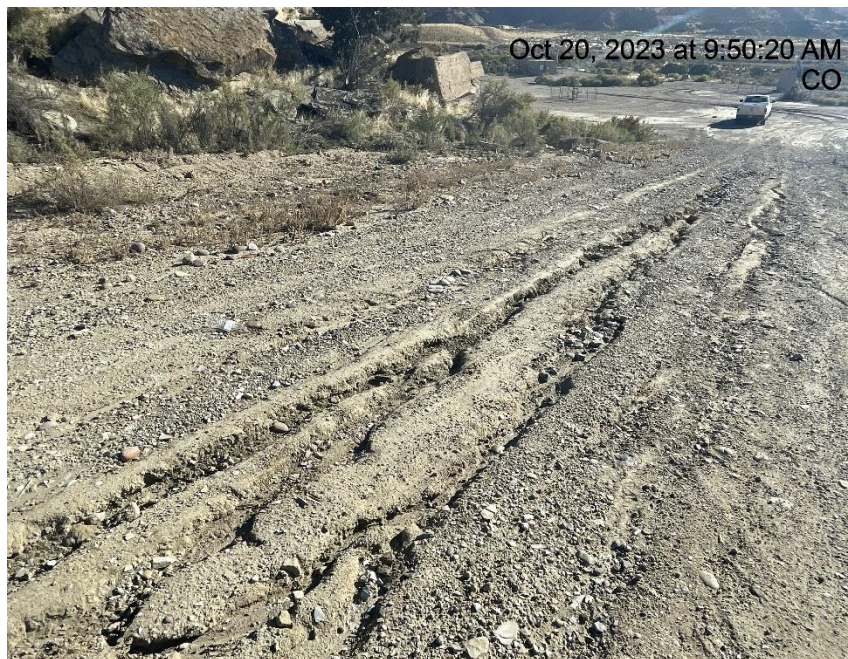
Photo # 3444 Erosion & transport of sediment on lease road /insufficient BMP's

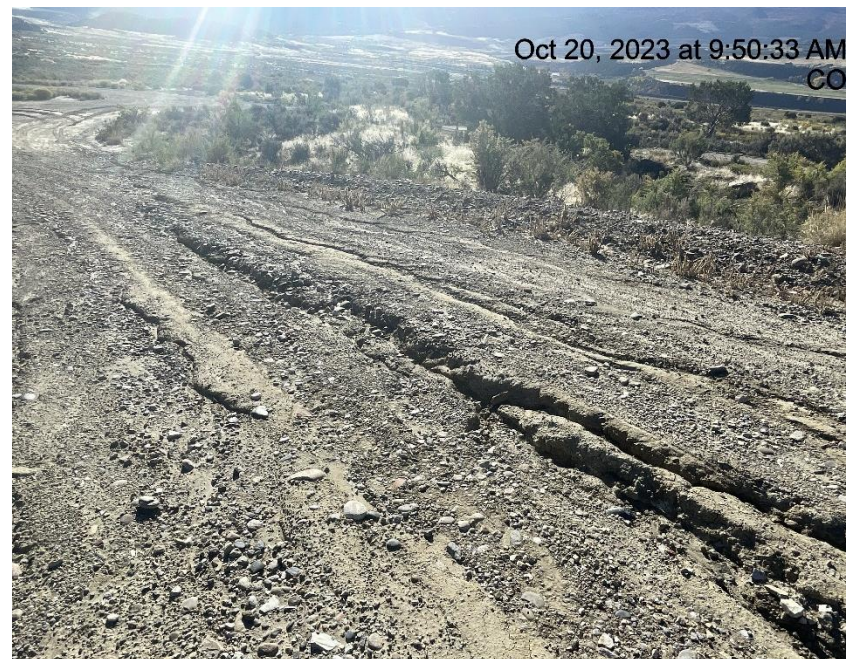
Photo # 3445 Erosion & transport of sediment on lease road /insufficient BMP's

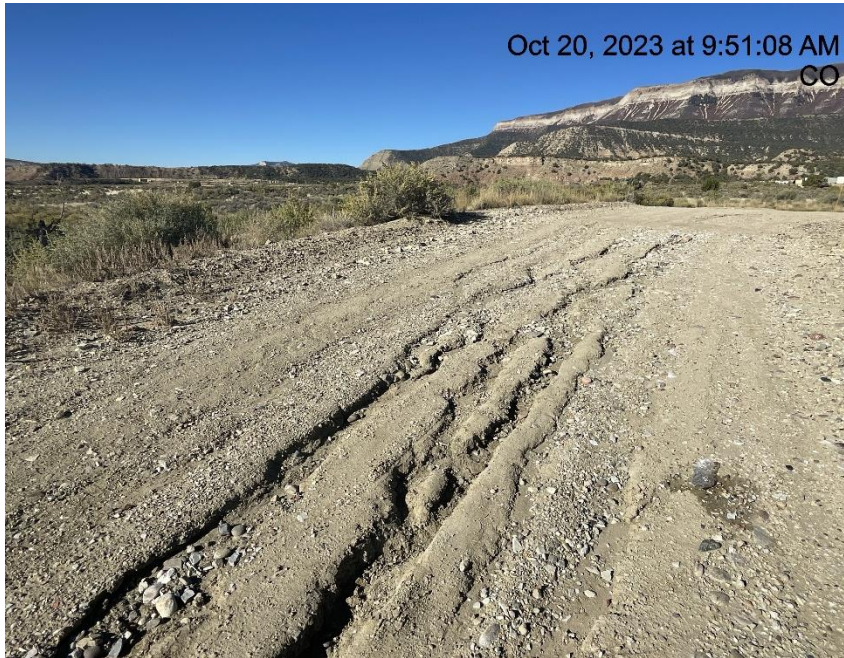
**Photo # 3446 Erosion & transport of sediment on lease road
/insufficient BMP's**

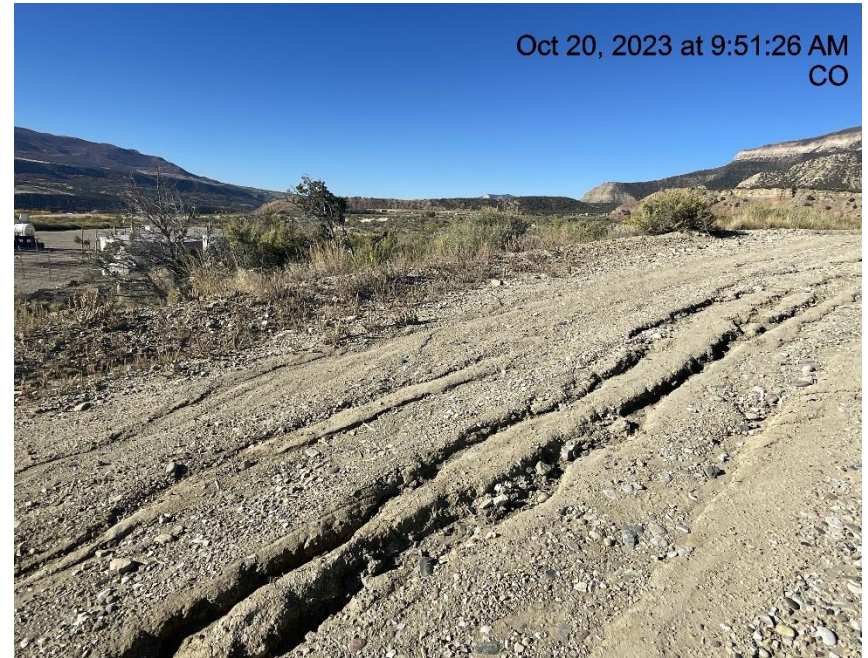
**Photo # 3447 Erosion & transport of sediment on lease road
/insufficient BMP's**

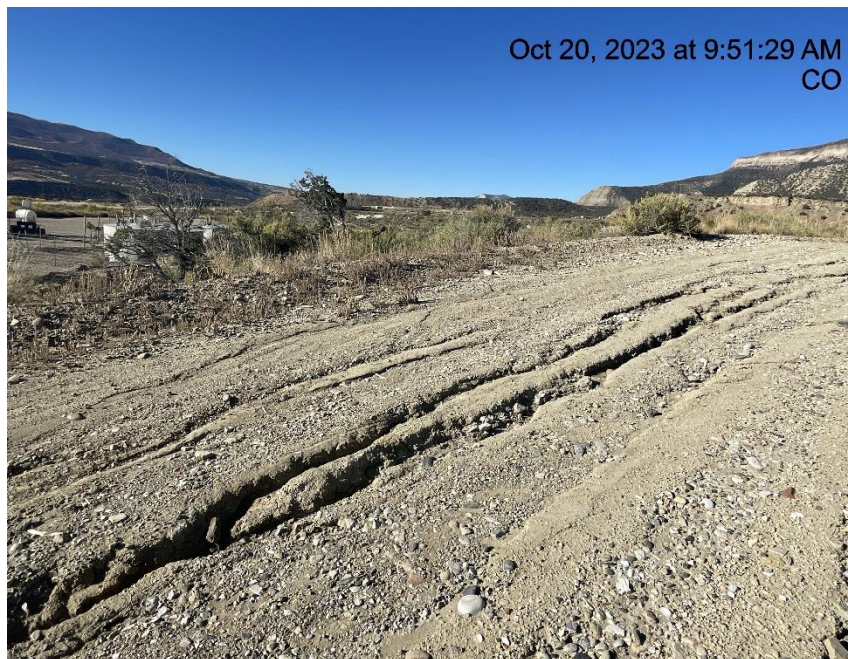
Photo # 3448 Erosion & transport of sediment on lease road /insufficient BMP's

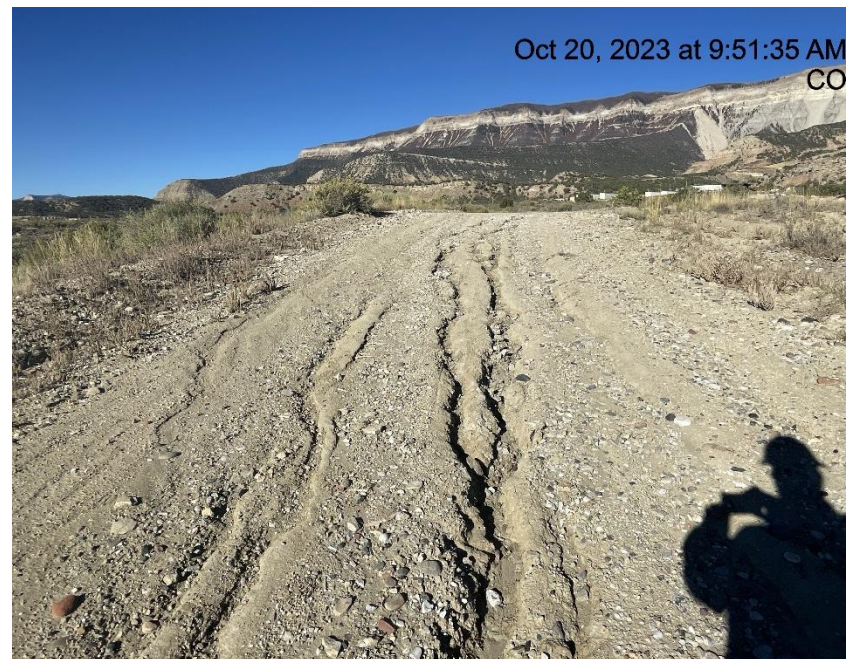
Photo # 3449 Erosion & transport of sediment on lease road /insufficient BMP's

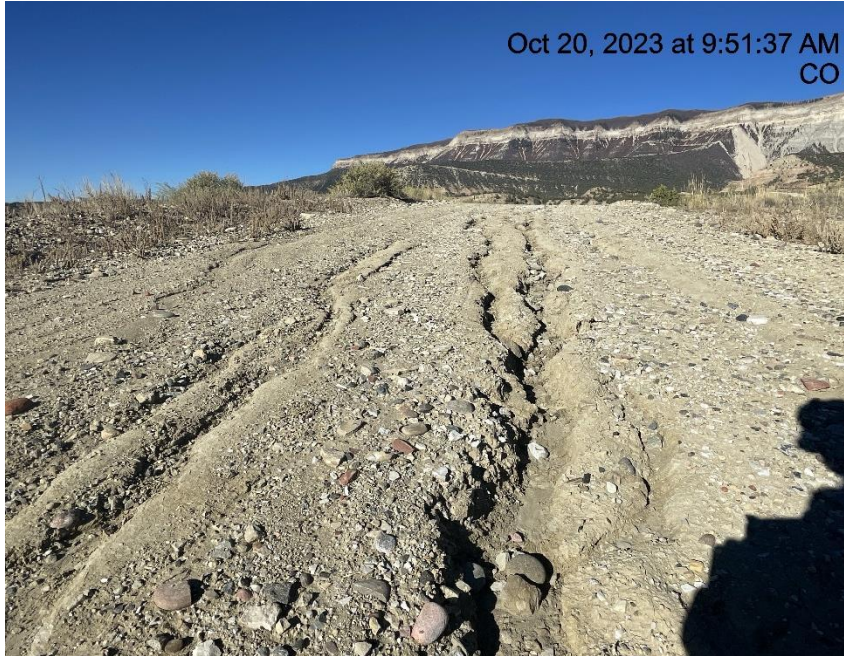
**Photo # 3450 Erosion & transport of sediment on lease road
/insufficient BMP's**

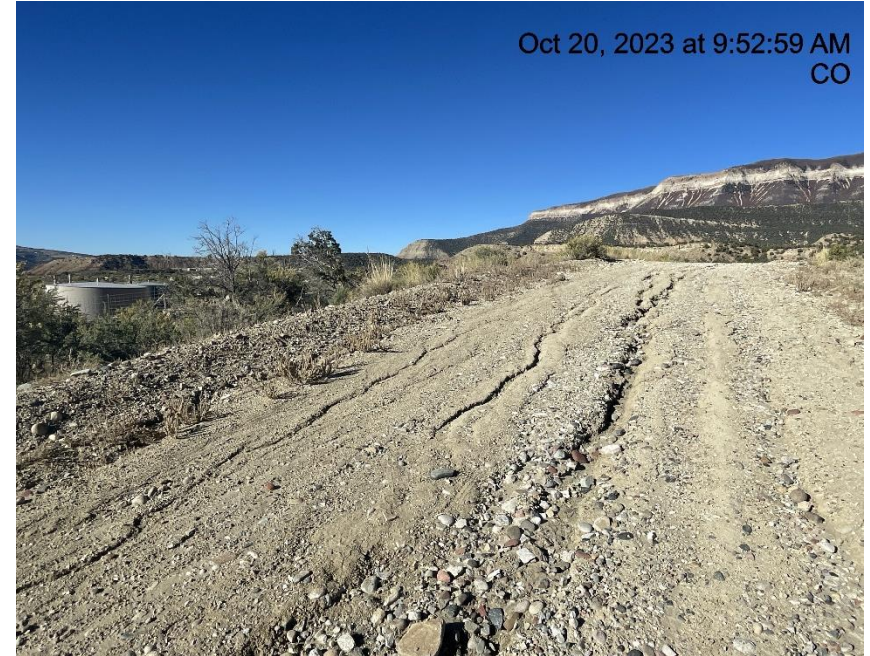
**Photo # 3451 Erosion & transport of sediment on lease road
/insufficient BMP's**

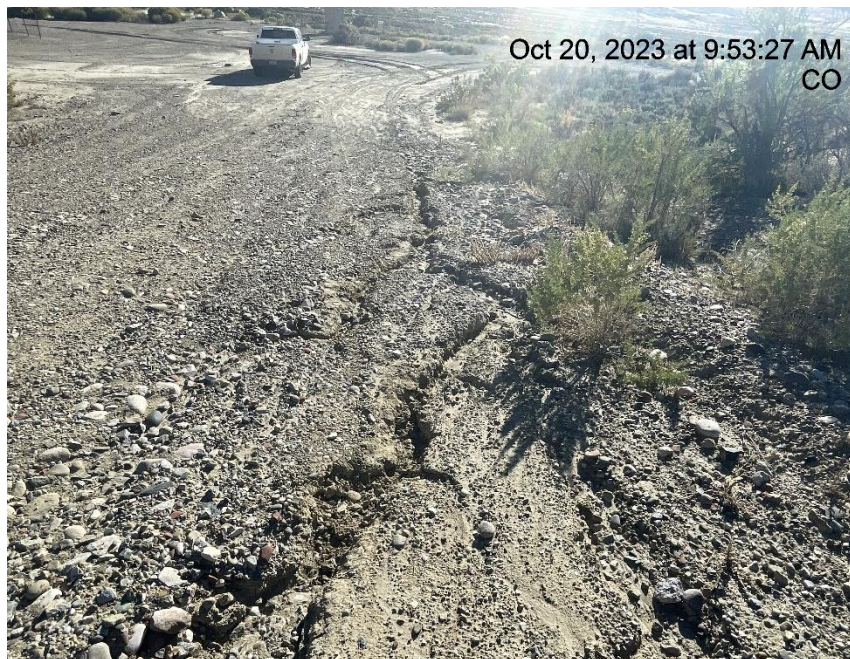
Photo # 3452 Erosion & transport of sediment off lease road into a vegetated area choking off vegetation/insufficient BMP's

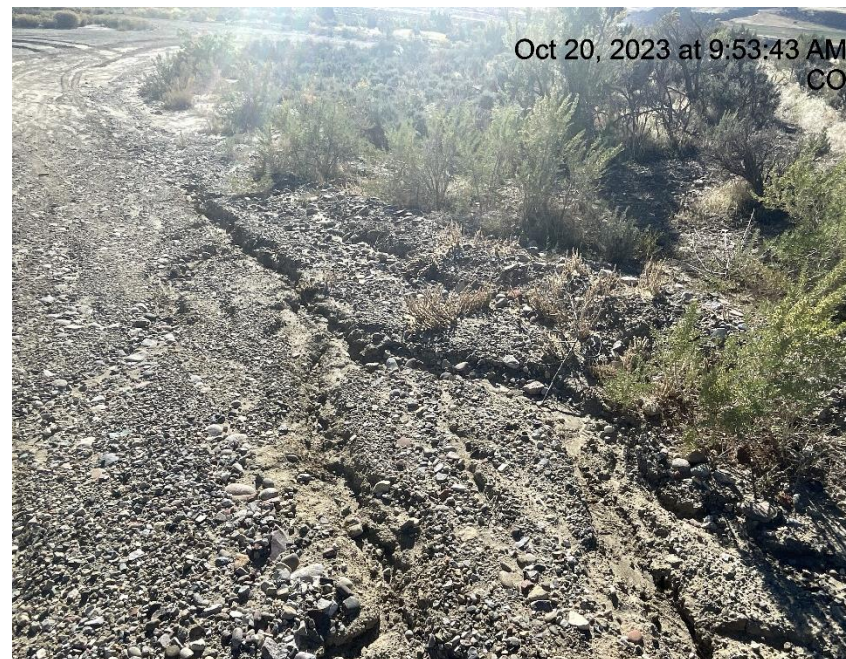
Photo # 3453 Erosion & transport of sediment off lease road into a vegetated area choking off vegetation/insufficient BMP's

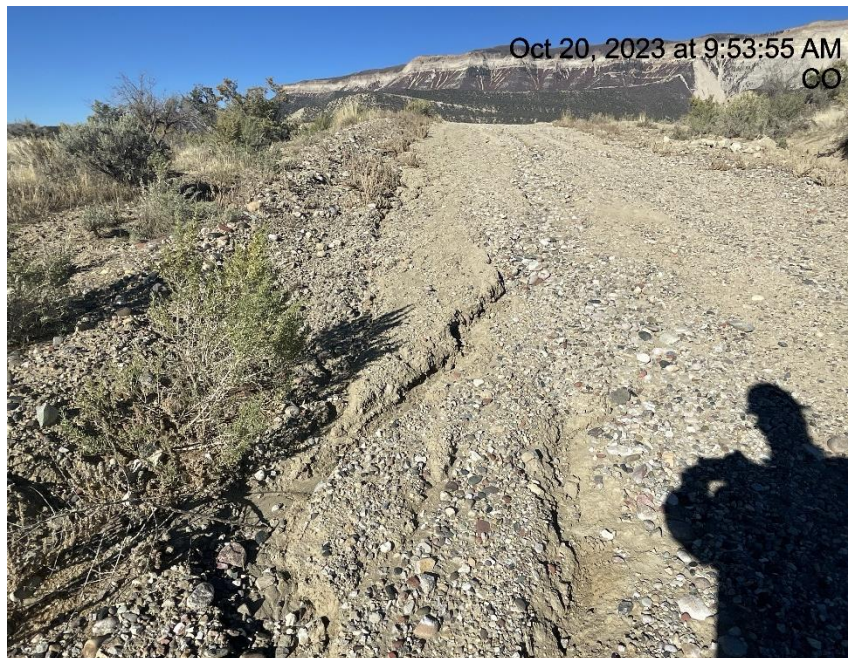
Photo # 3454 Erosion & transport of sediment off lease road into a vegetated area choking off vegetation/insufficient BMP's

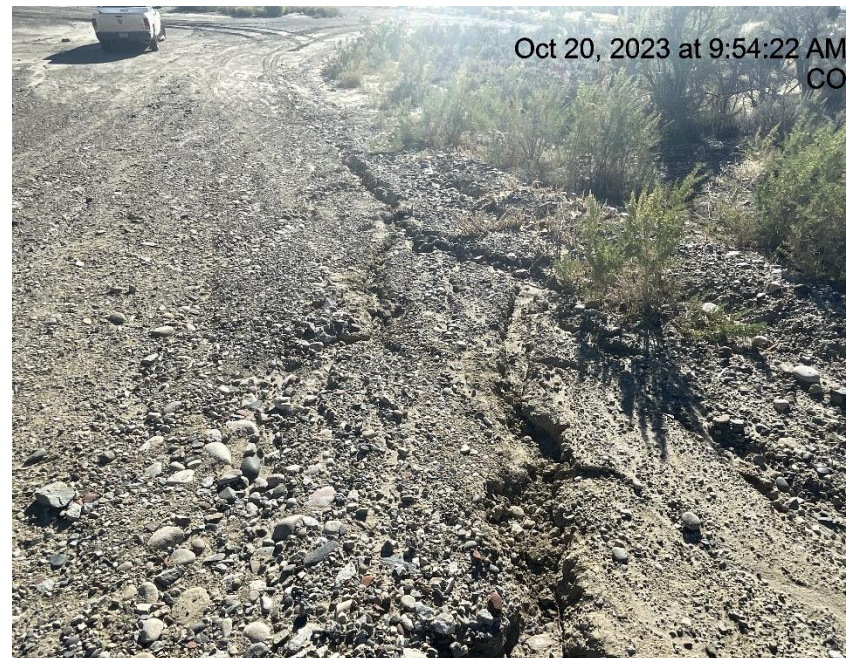
Photo # 3455 Erosion & transport of sediment off lease road into a vegetated area choking off vegetation/insufficient BMP's

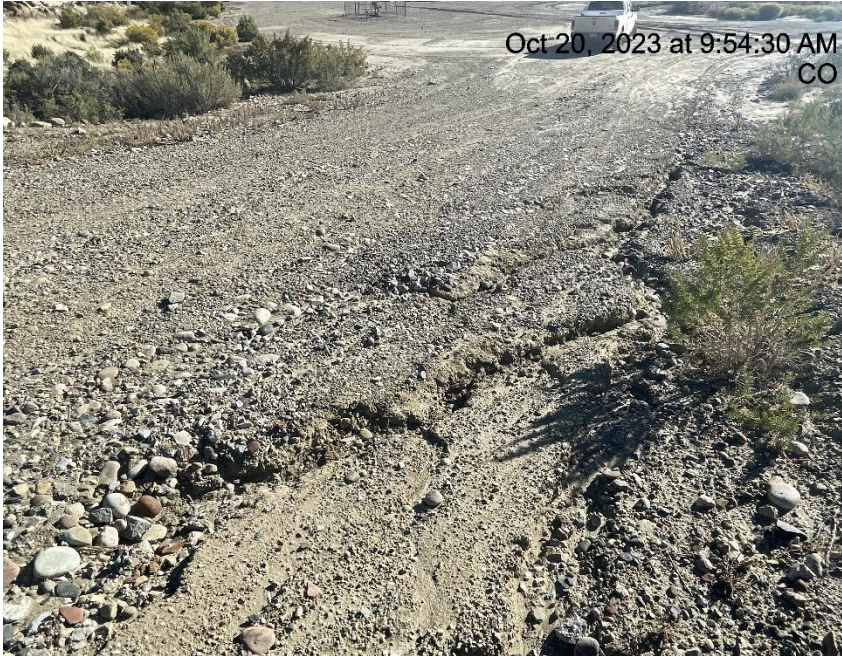
Photo # 3456 Erosion & transport of sediment off lease road into a vegetated area choking off vegetation/insufficient BMP's

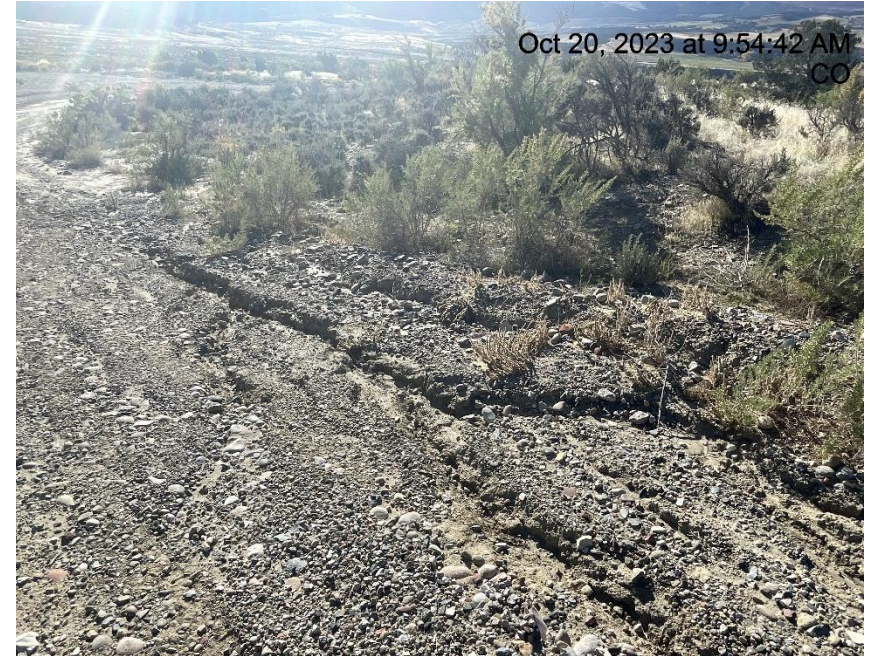
Photo # 3457 Erosion & transport of sediment off lease road into a vegetated area choking off vegetation/insufficient BMP's

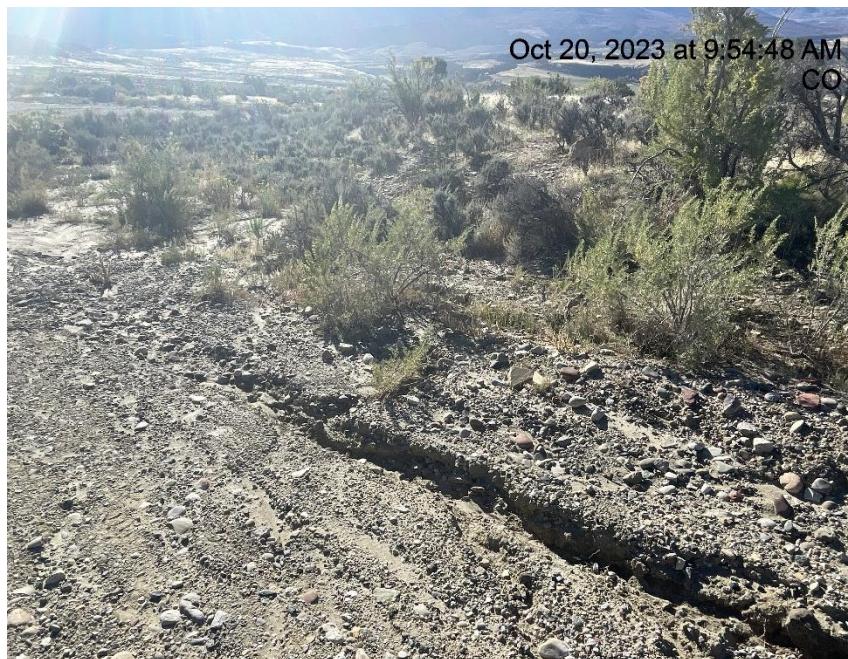
Photo # 3458 Erosion & transport of sediment off lease road into a vegetated area choking off vegetation/insufficient BMP's

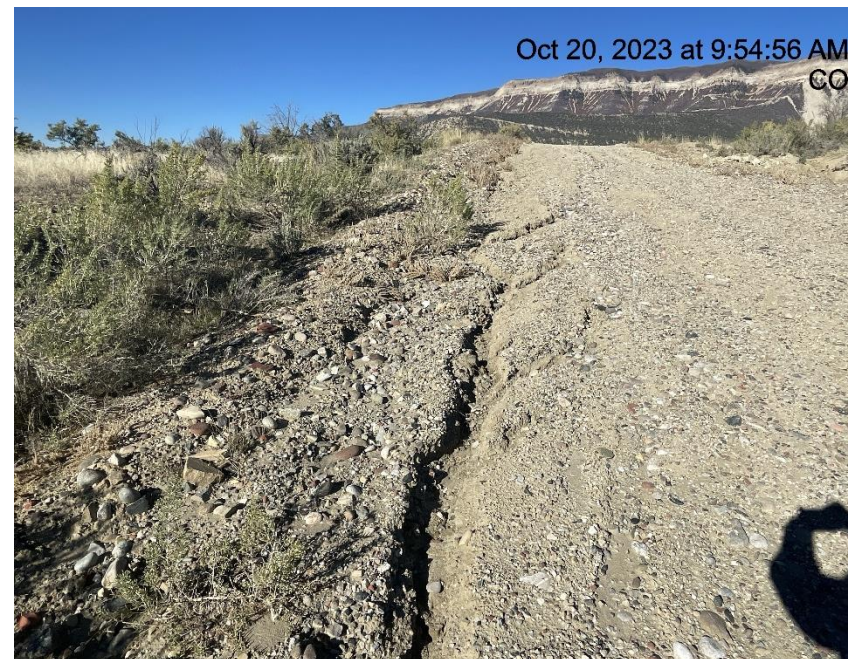
Photo # 3459 Erosion & transport of sediment off lease road into a vegetated area choking off vegetation/insufficient BMP's

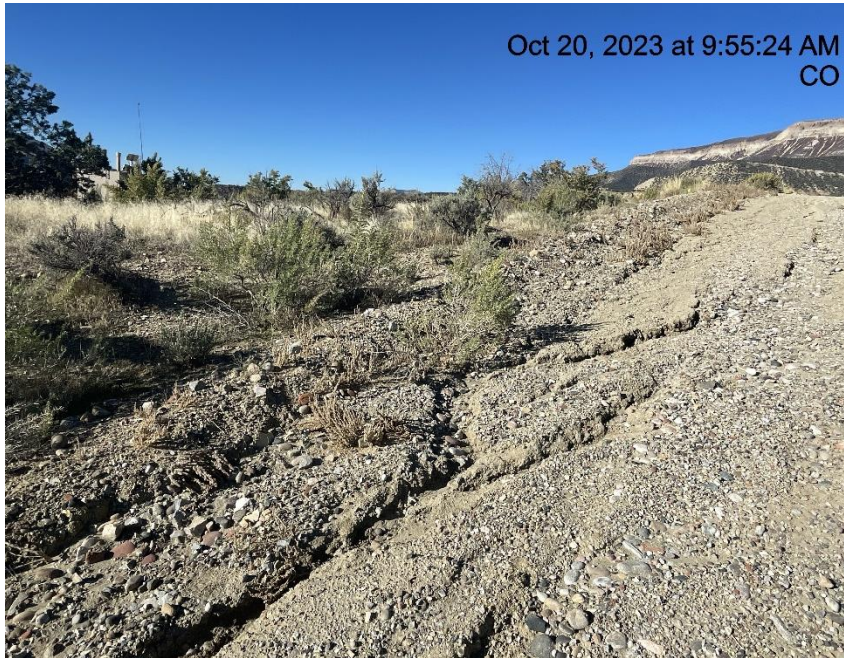
Photo # 3460 Erosion & transport of sediment off lease road into a vegetated area choking off vegetation/insufficient BMP's

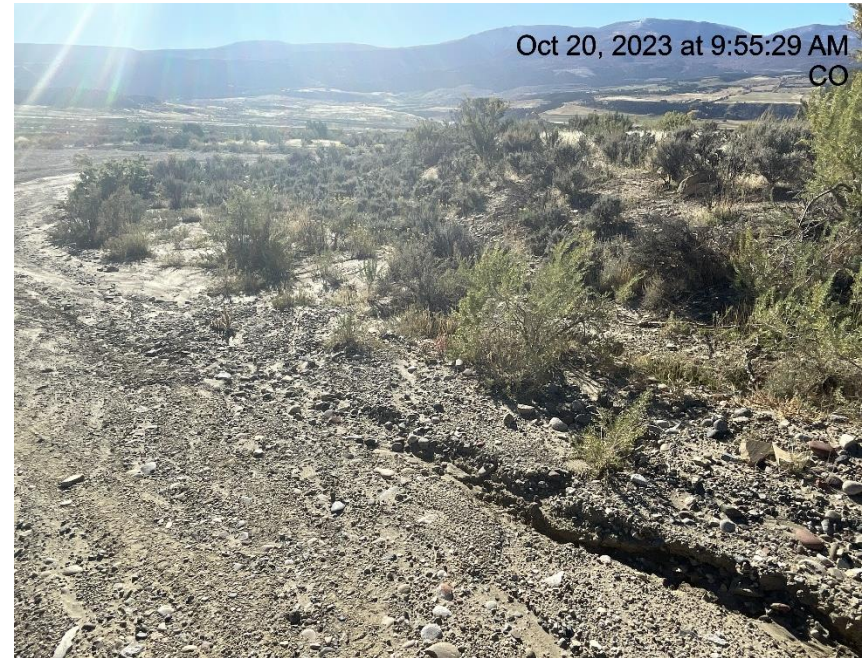
Photo # 3461 Erosion & transport of sediment off lease road into a vegetated area choking off vegetation/insufficient BMP's

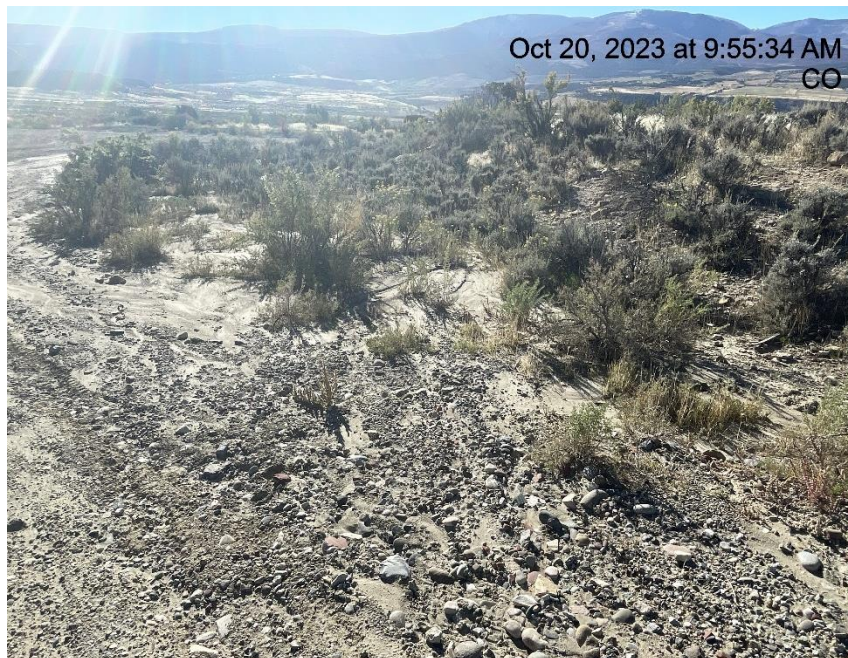
Photo # 3462 Erosion & transport of sediment off lease road into a vegetated area choking off vegetation/insufficient BMP's

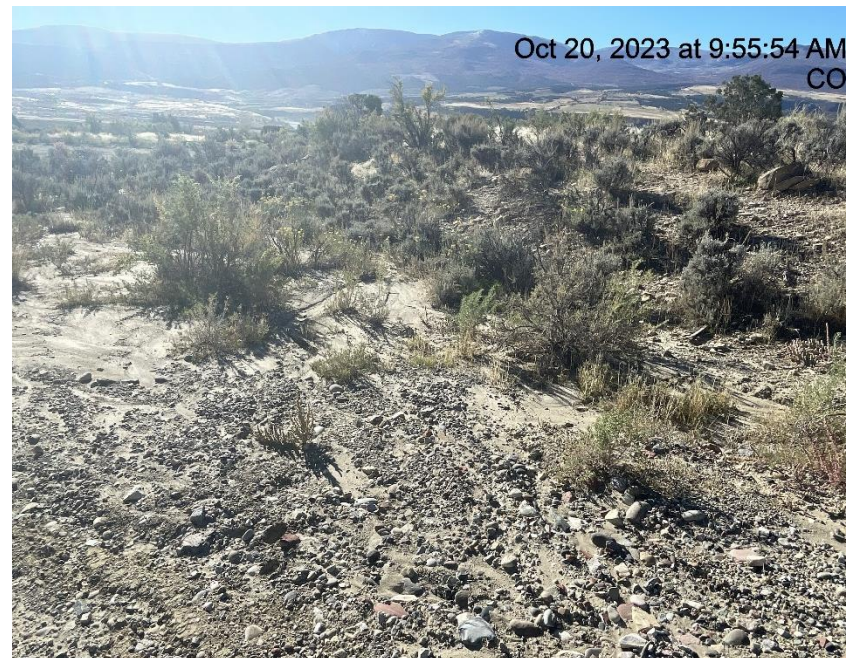
Photo # 3463 Erosion & transport of sediment off lease road into a vegetated area choking off vegetation/insufficient BMP's

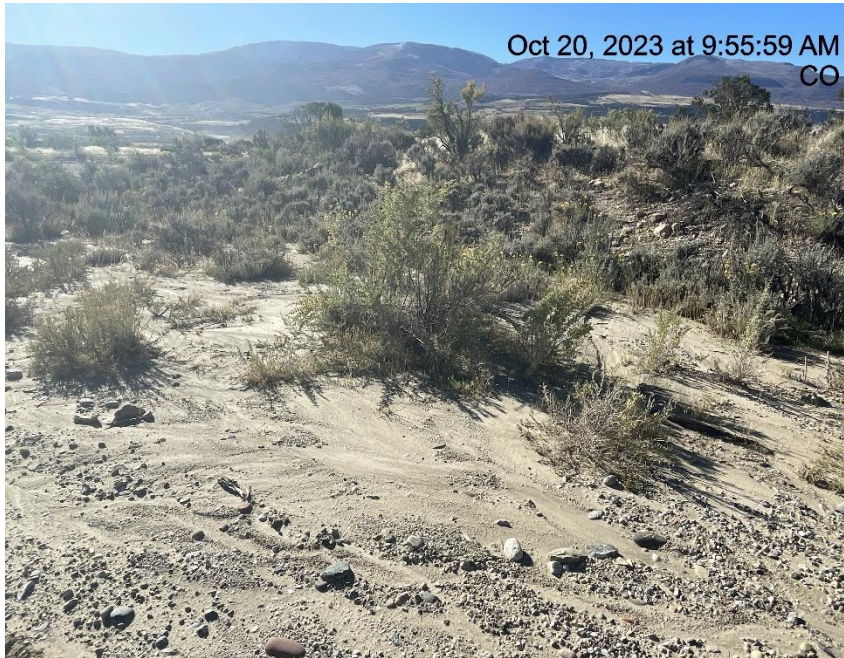
Photo # 3464 Erosion & transport of sediment off lease road into a vegetated area choking off vegetation/insufficient BMP's

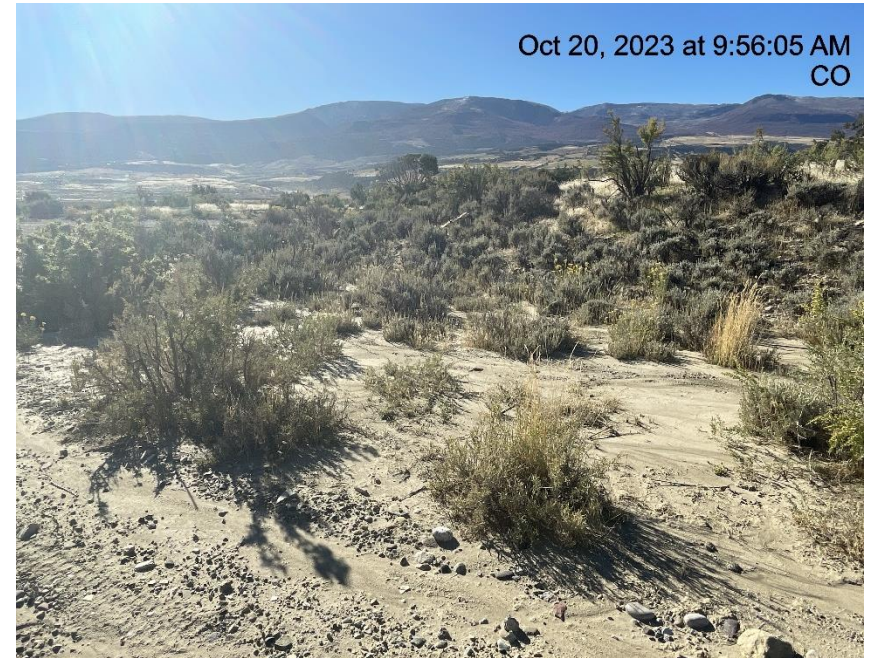
Photo # 3465 Erosion & transport of sediment off lease road into a vegetated area choking off vegetation/insufficient BMP's

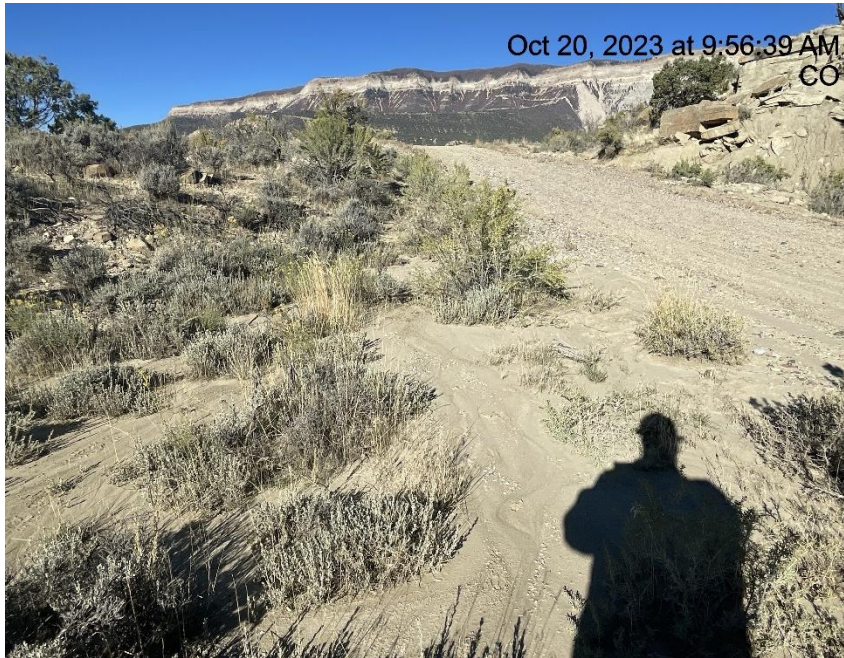
Photo # 3466 Erosion & transport of sediment off lease road into a vegetated area choking off vegetation/insufficient BMP's

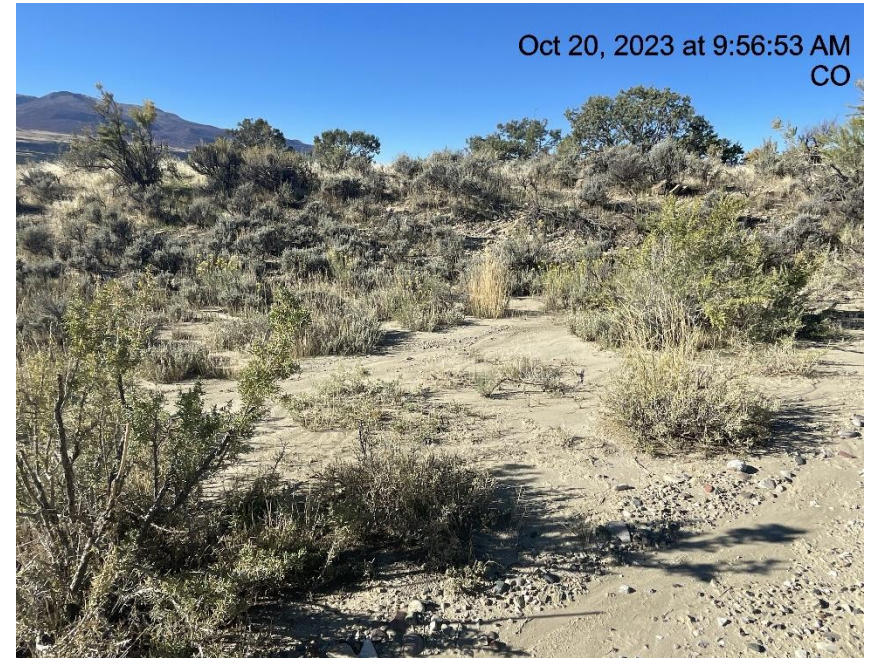
Photo # 3467 Erosion & transport of sediment off lease road into a vegetated area choking off vegetation/insufficient BMP's

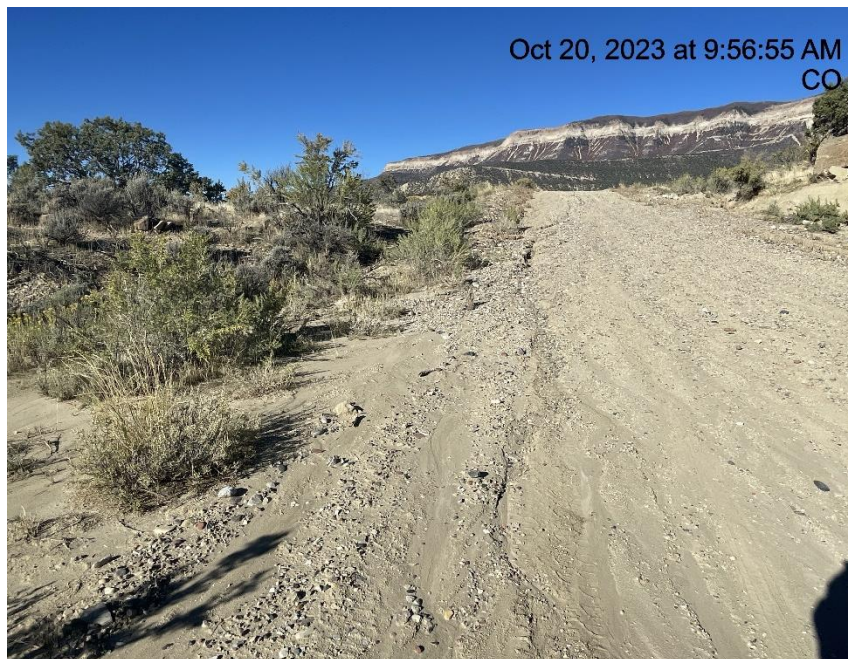
Photo # 3468 Erosion & transport of sediment off lease road into a vegetated area choking off vegetation/insufficient BMP's

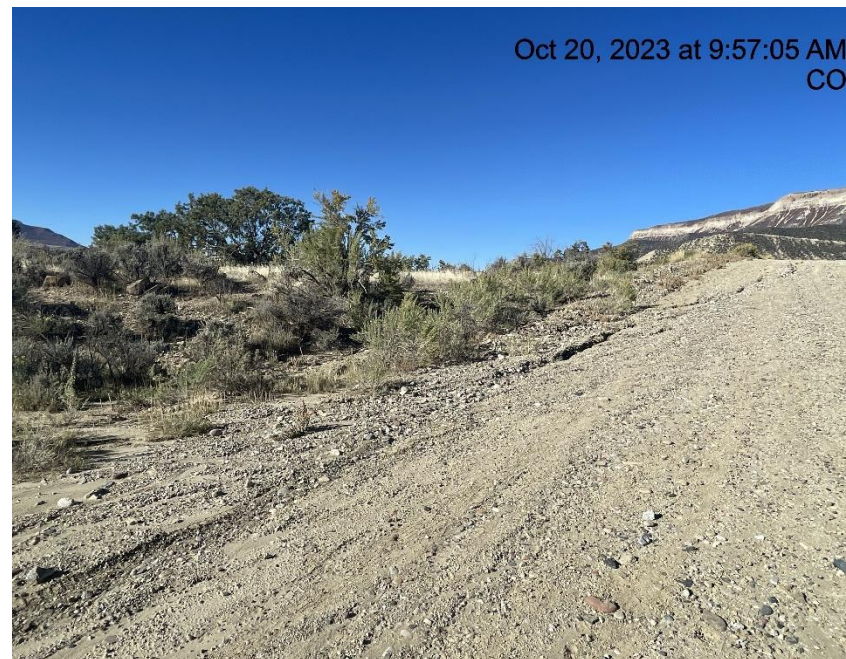
Photo # 3469 Erosion & transport of sediment off lease road into a vegetated area choking off vegetation/insufficient BMP's

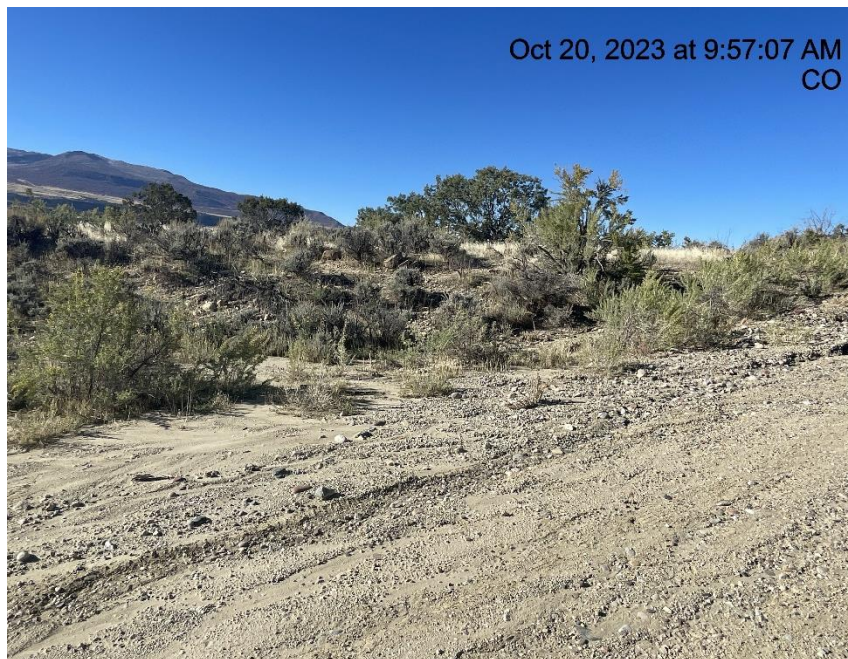
Photo # 3470 Erosion & transport of sediment off lease road into a vegetated area choking off vegetation/insufficient BMP's

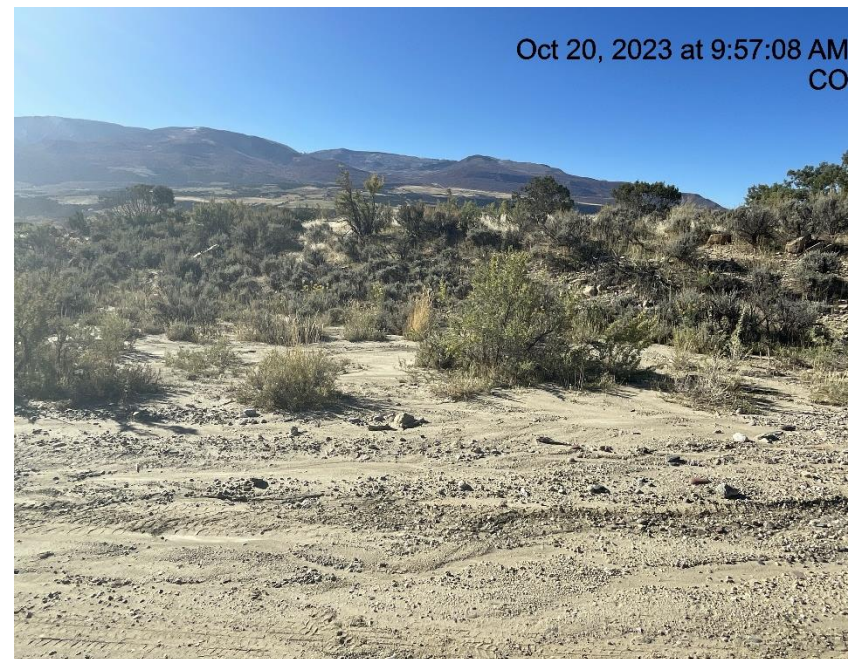
Photo # 3471 Erosion & transport of sediment off lease road into a vegetated area choking off vegetation/insufficient BMP's

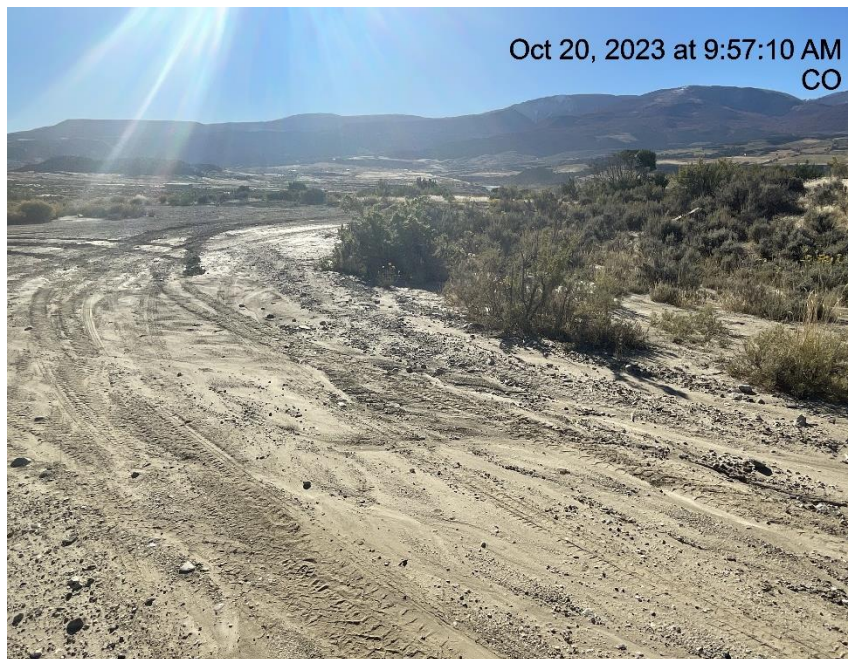
Photo # 3472 Erosion & transport of sediment off lease road into a vegetated area choking off vegetation/insufficient BMP's

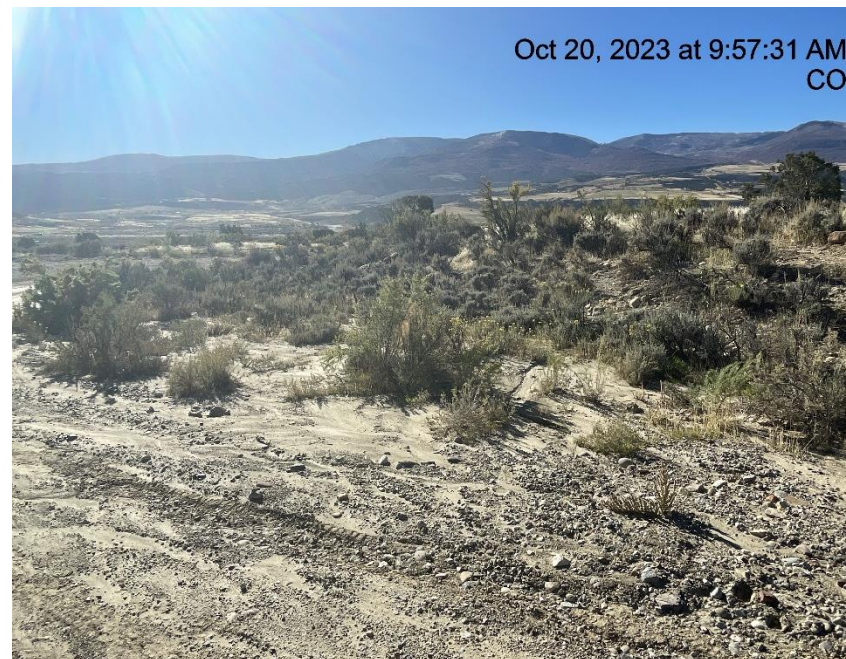
Photo # 3473 Erosion & transport of sediment off lease road into a vegetated area choking off vegetation/insufficient BMP's

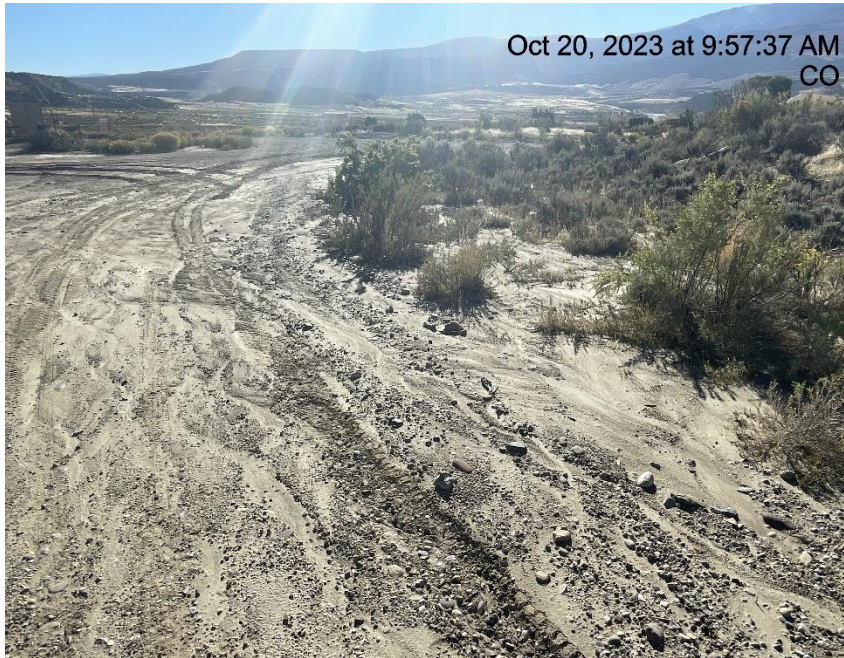
Photo # 3474 Erosion & transport of sediment off lease road into a vegetated area choking off vegetation/insufficient BMP's

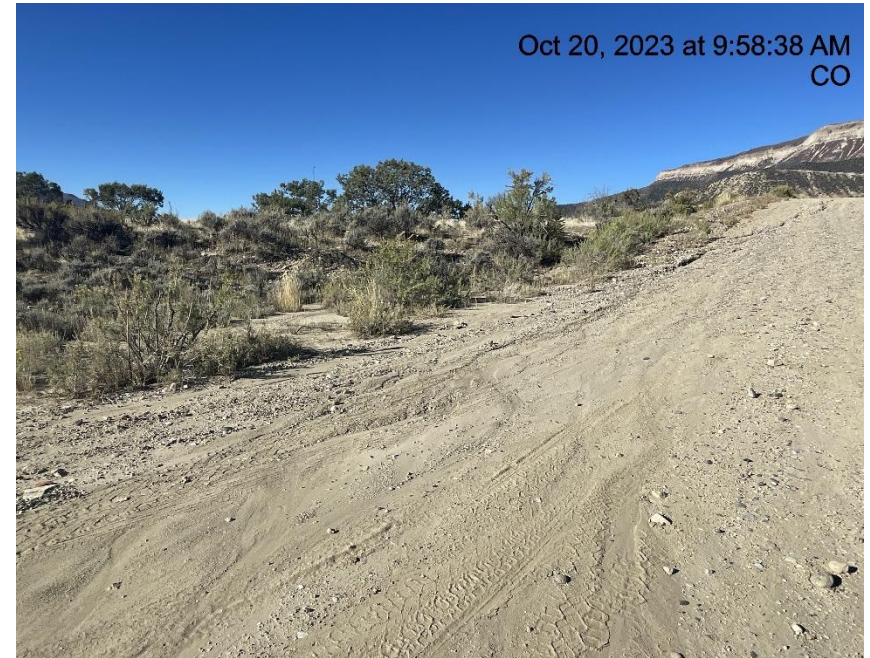
Photo # 3475 Erosion & transport of sediment off lease road into a vegetated area choking off vegetation/insufficient BMP's
