## Inspection Photos

Location Name: CAERUS PICEANCE LLC CLEM 15-14 (PA15) Pad

Location #: 324017

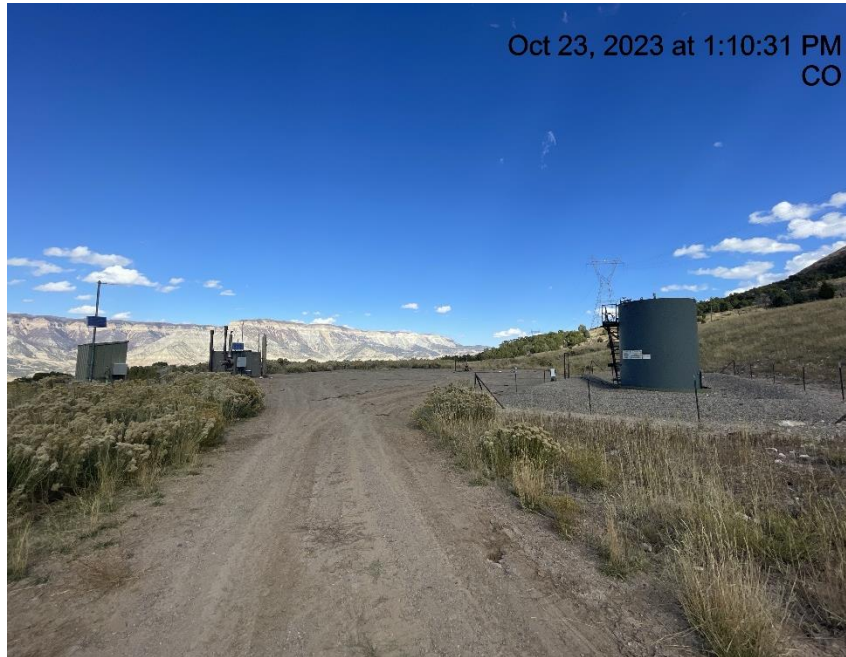
Photo # 3803 From entrance to location

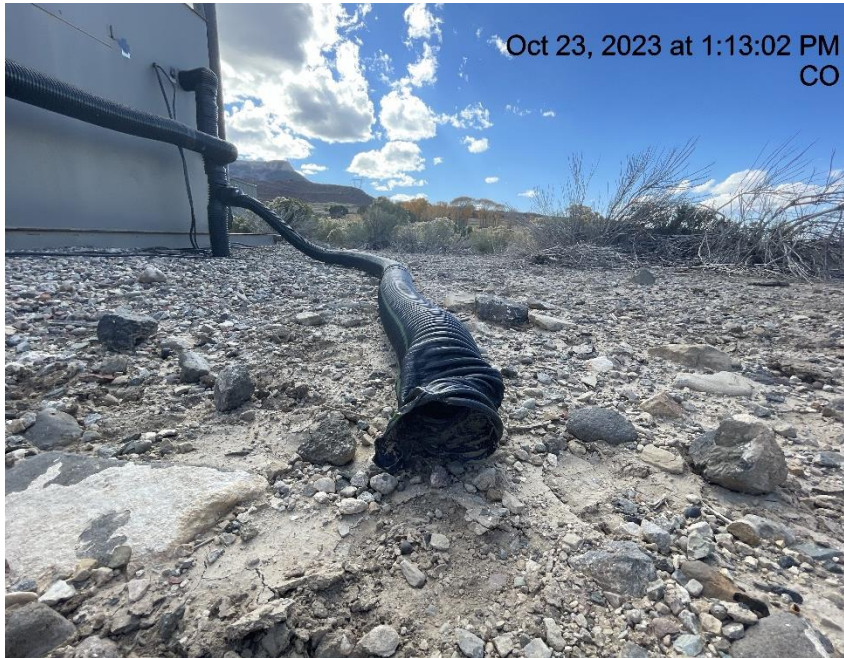
**Photo # 3809 Flowline heating insulation open ended**

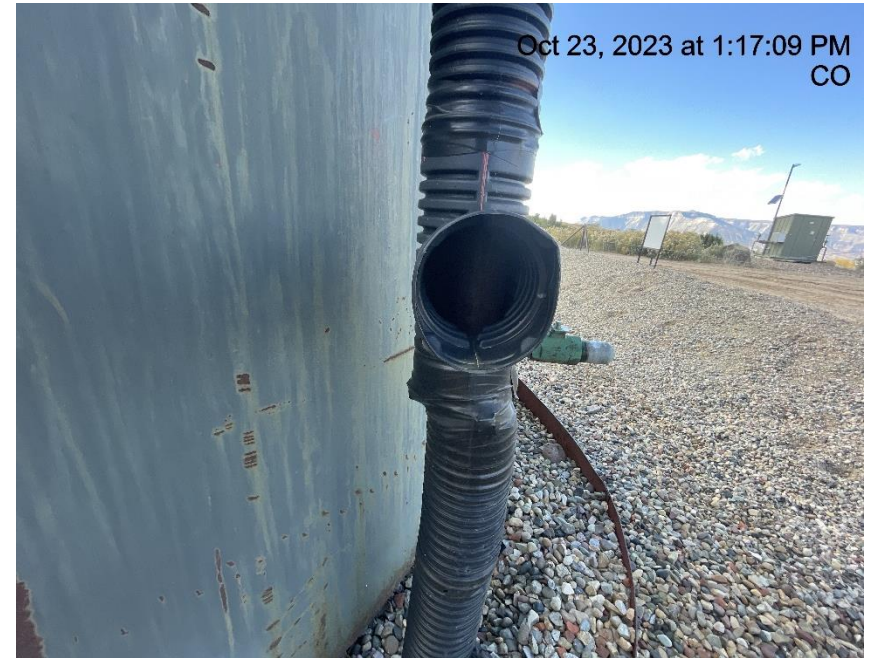
**Photo # 3810 Flowline heating insulation open ended**

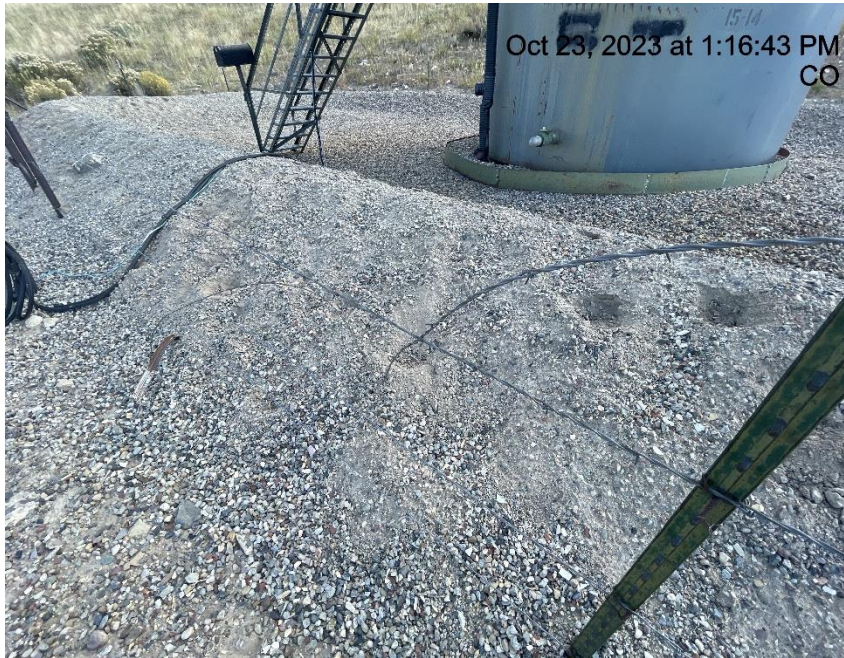
**Photo # 3811 Fence is in disrepair & needs maintenance**
