Storm Water Management and Erosion control
Location Name: CAERUS PICEANCE LLC CLEM 15-24 (PH15) Pad
Location #: 324264

**Location Overview: Location is within High Priority/Black Bear/Density Habitat areas & in close proximity to NSO Habitat area. Location is approximately 384 yards from Battlement Creek. Location is within close proximity to Rule 411a Surface Water External Buffer.
Section/Township/Range: 15 7S95W**

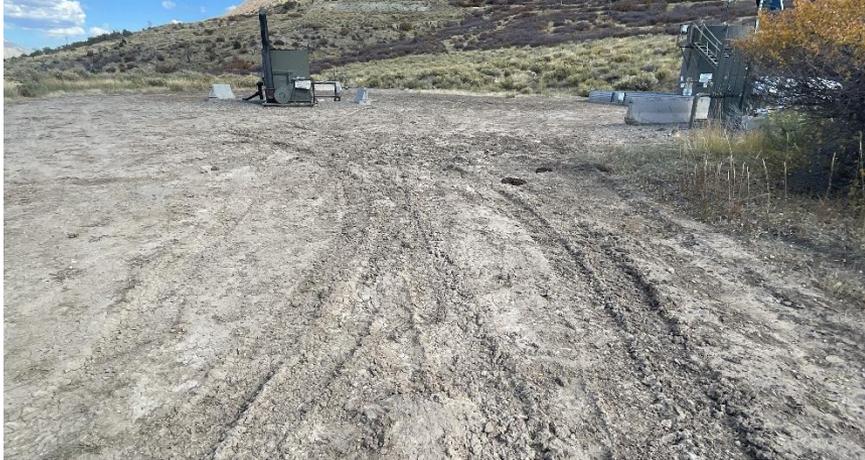
North West corner of location.

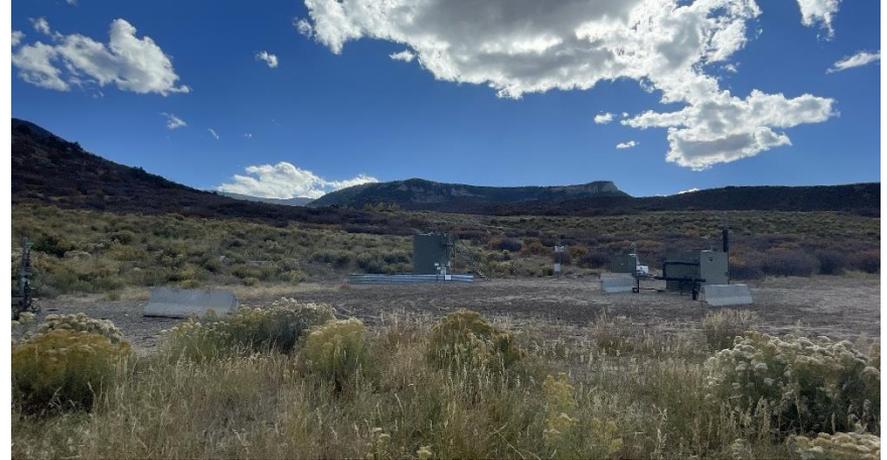
North East corner of location.

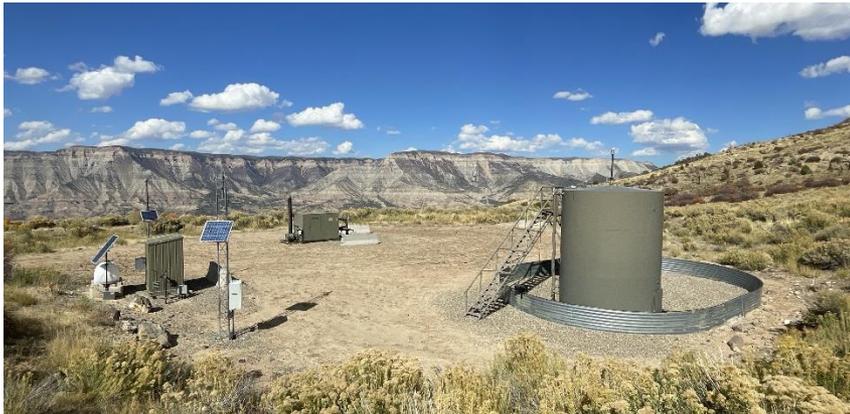
South West corner of location.

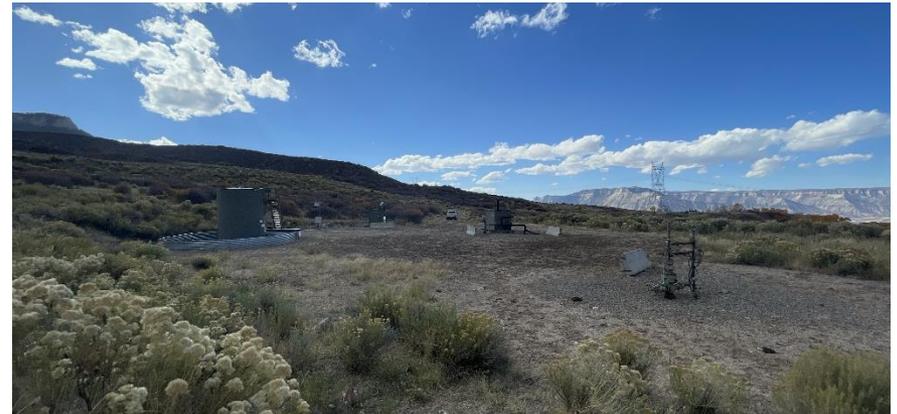
South East corner of location.

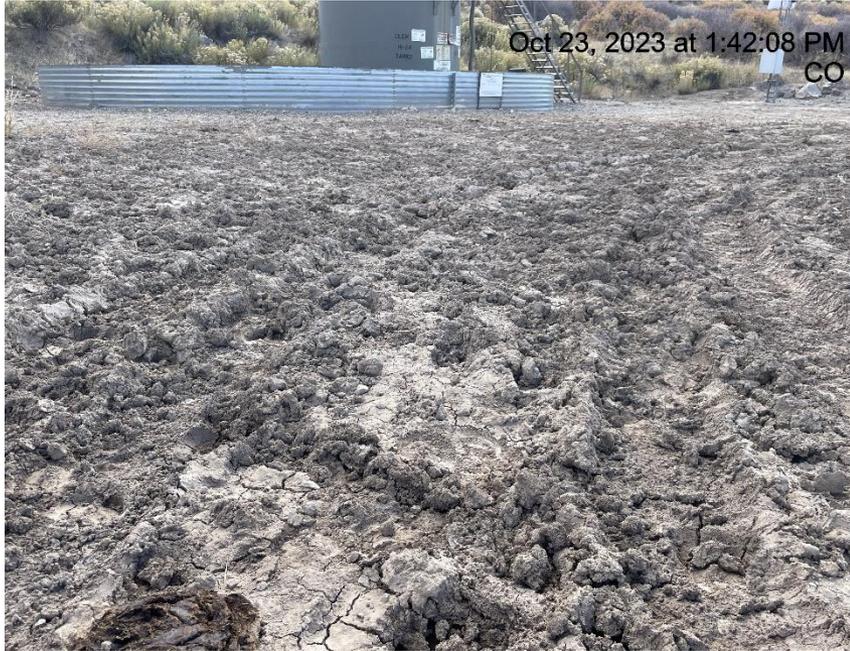
Photo # 3845 Lack of stabilization/compaction/insufficient tracking BMP's

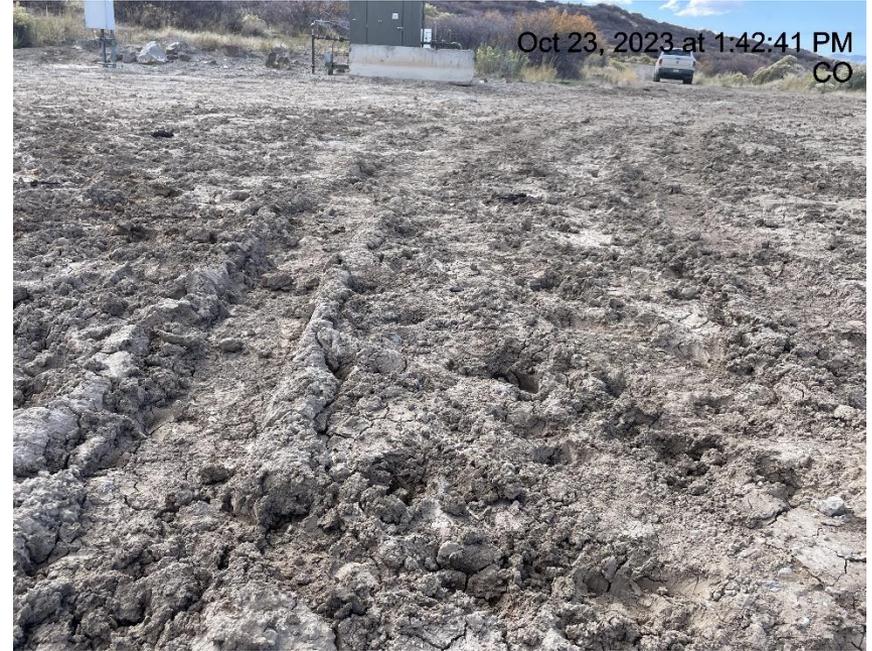
Photo # 3846 Lack of stabilization/compaction/insufficient tracking BMP's

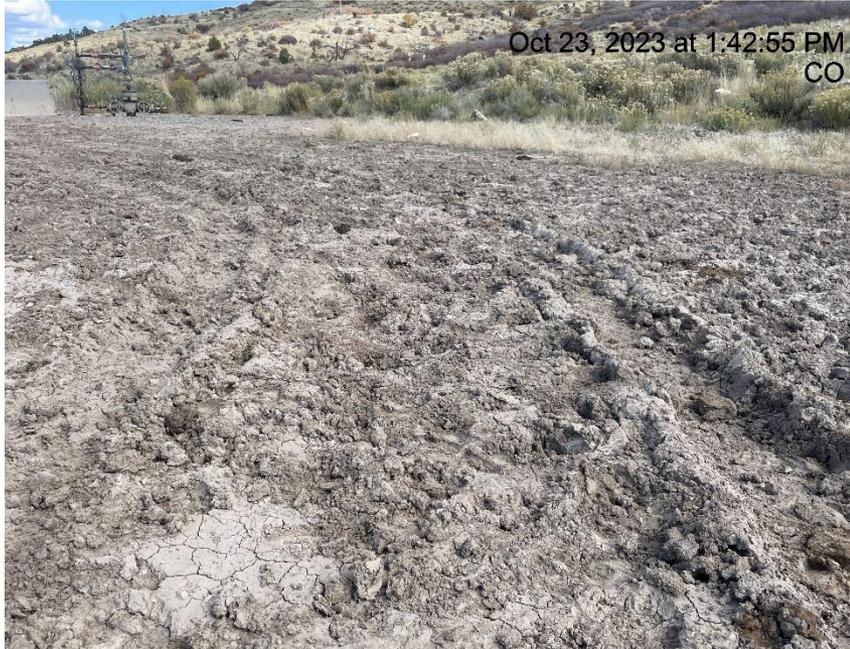
Photo # 3847 Lack of stabilization/compaction/insufficient tracking BMP's

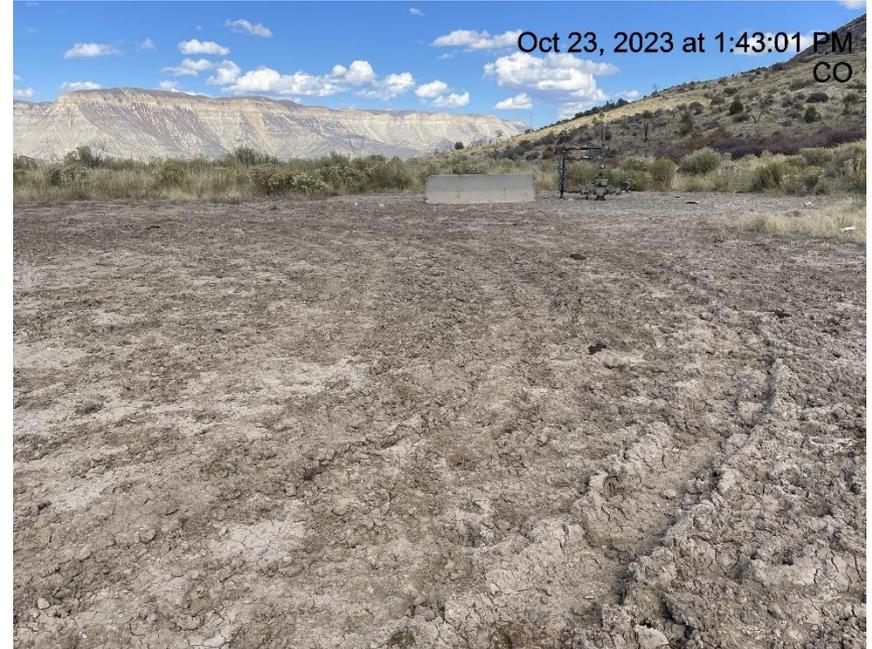
Photo # 3848 Lack of stabilization/compaction/insufficient tracking BMP's

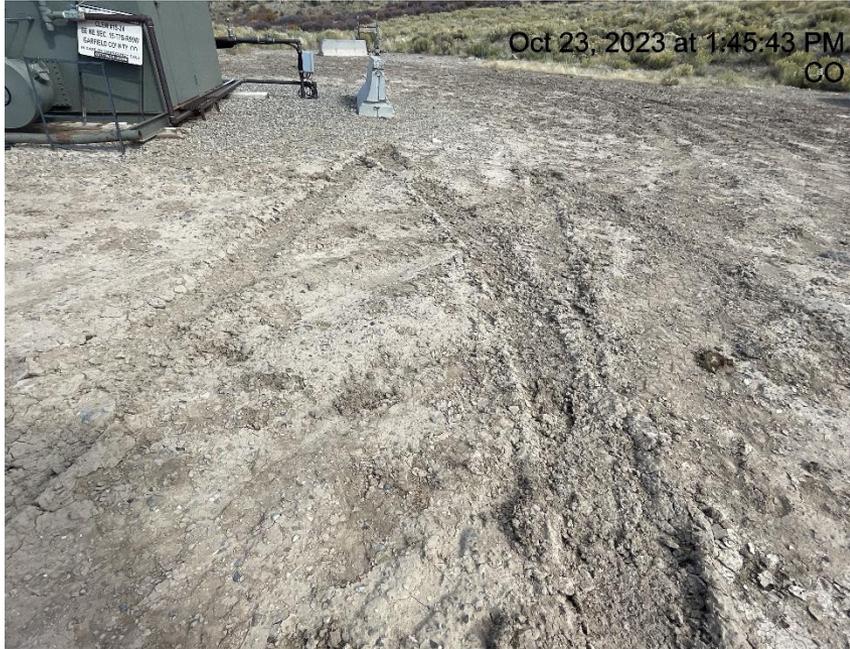
Photo # 3849 Lack of stabilization/compaction/insufficient tracking BMP's

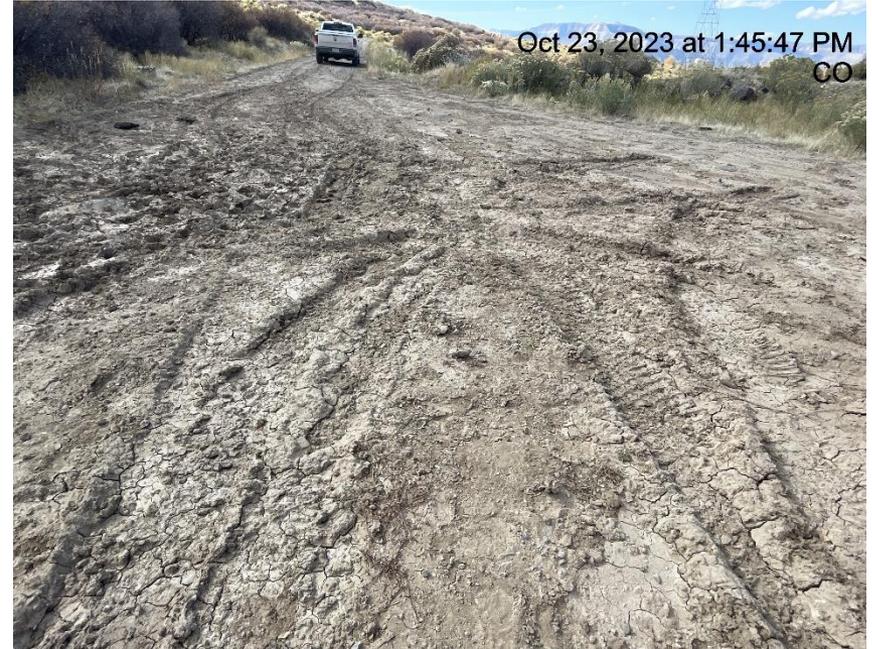
Photo # 3850 Lack of stabilization/compaction/insufficient tracking BMP's

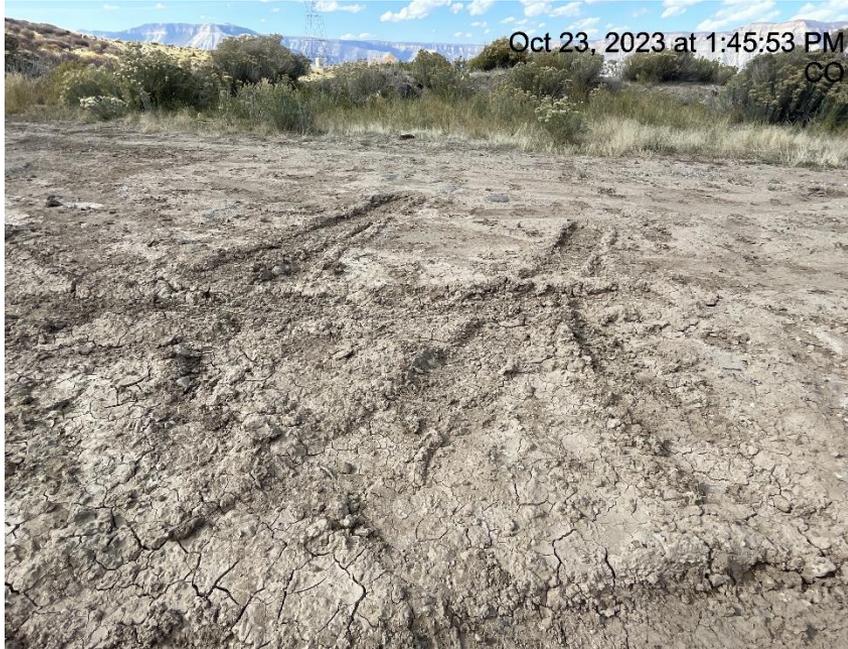
Photo # 3851 Lack of stabilization/compaction/insufficient tracking BMP's

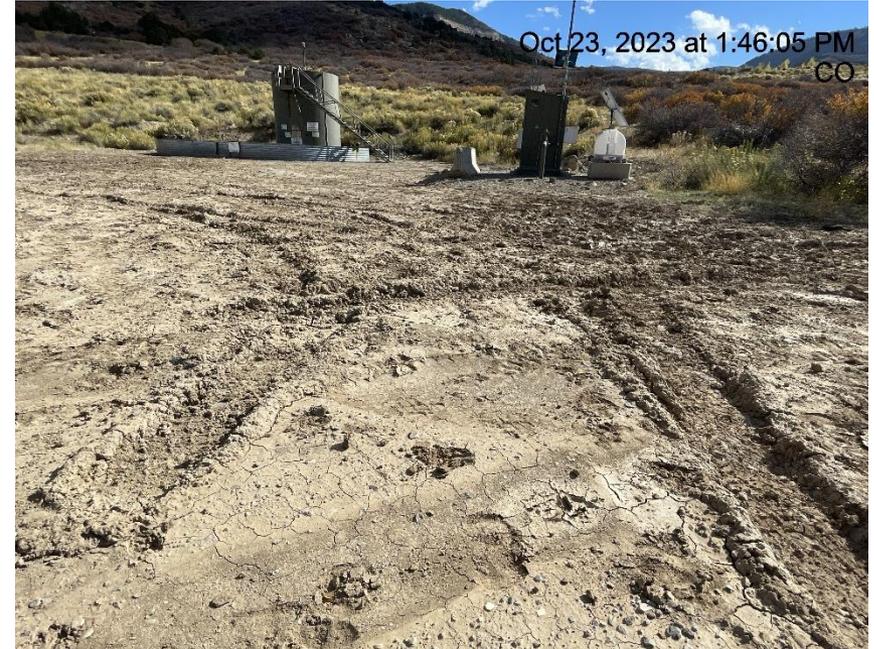
Photo # 3852 Lack of stabilization/compaction/insufficient tracking BMP's

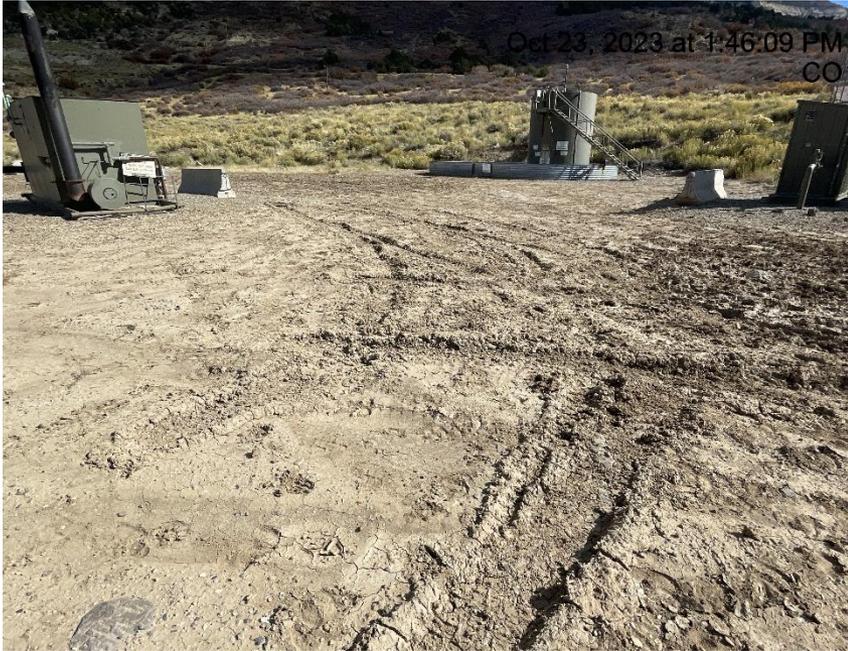
Photo # 3853 Lack of stabilization/compaction/insufficient tracking BMP's

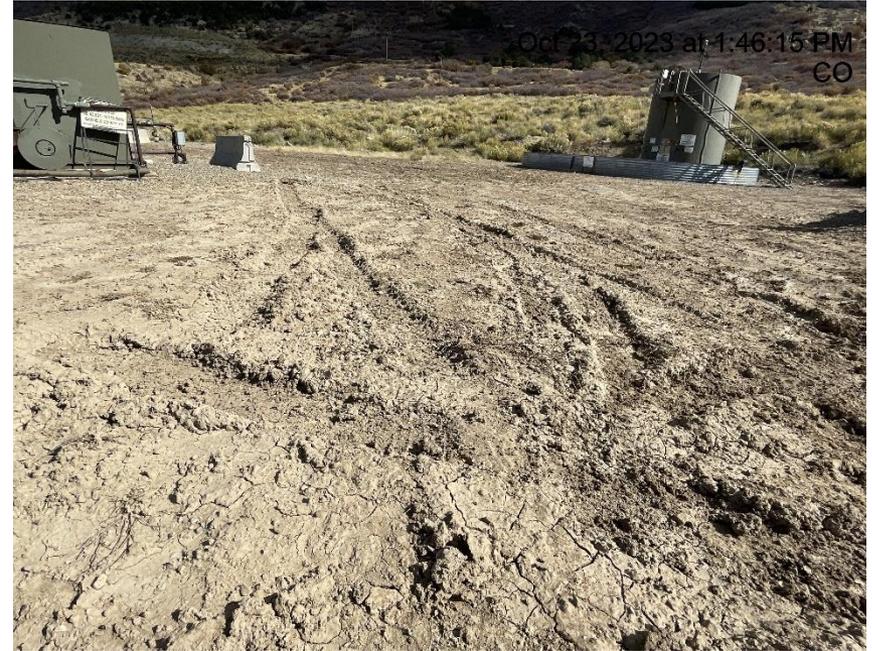
Photo # 3854 Lack of stabilization/compaction/insufficient tracking BMP's

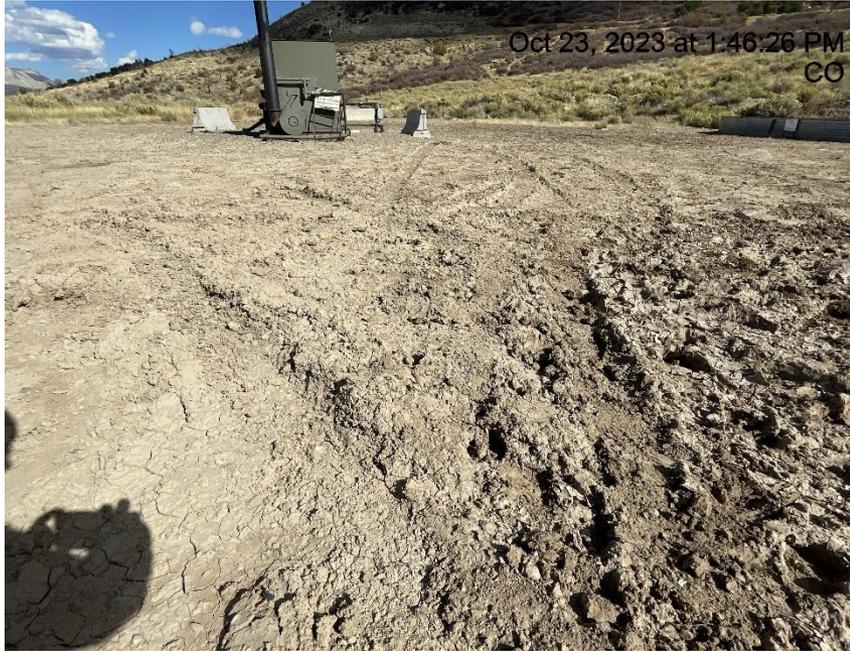
Photo # 3855 Lack of stabilization/compaction/insufficient tracking BMP's

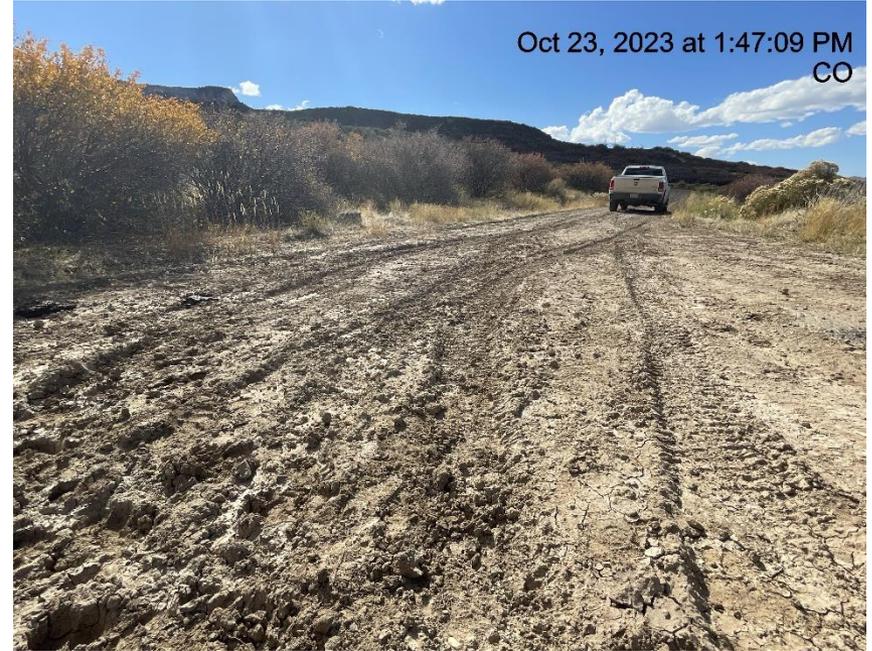
Photo # 3856 Lack of stabilization/compaction/insufficient tracking BMP's

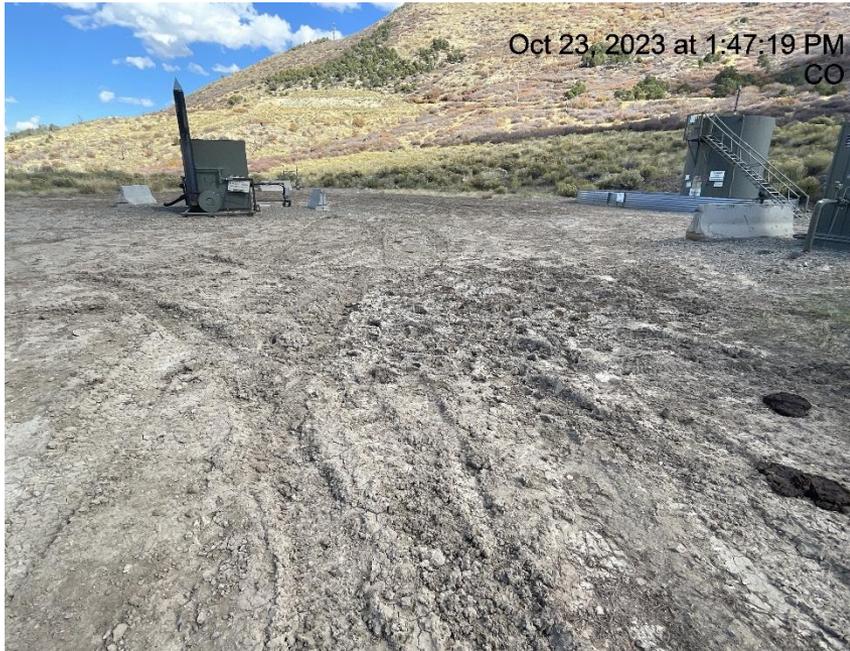
Photo # 3857 Lack of stabilization/compaction/insufficient tracking BMP's

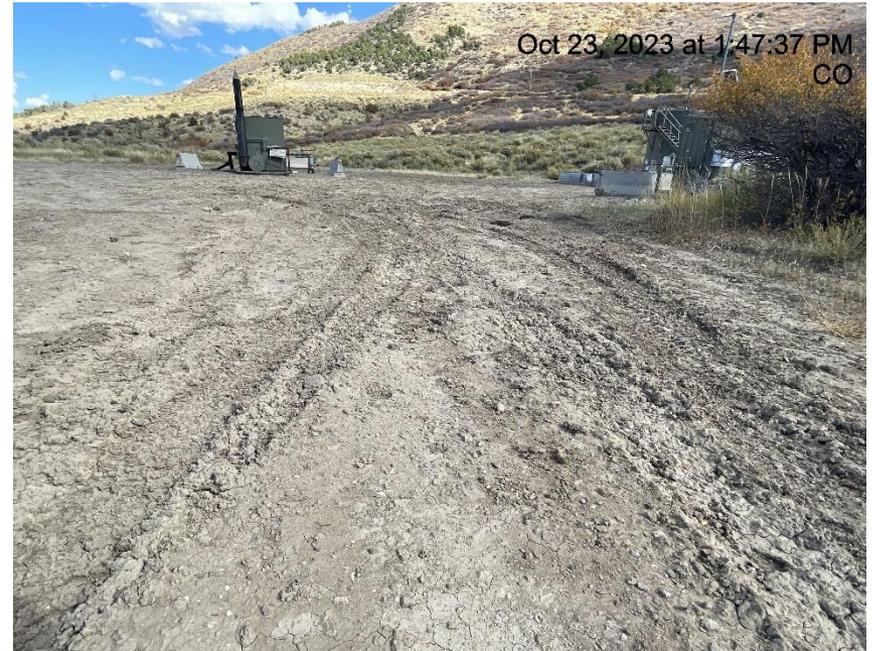
Photo # 3858 Lack of stabilization/compaction/insufficient tracking BMP's

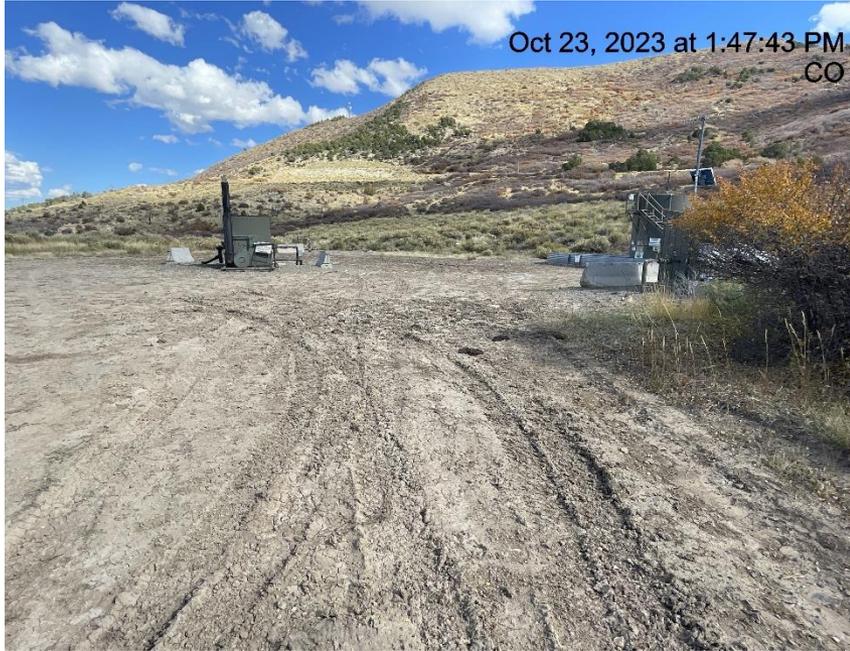
Photo # 3859 Lack of stabilization/compaction/insufficient tracking BMP's

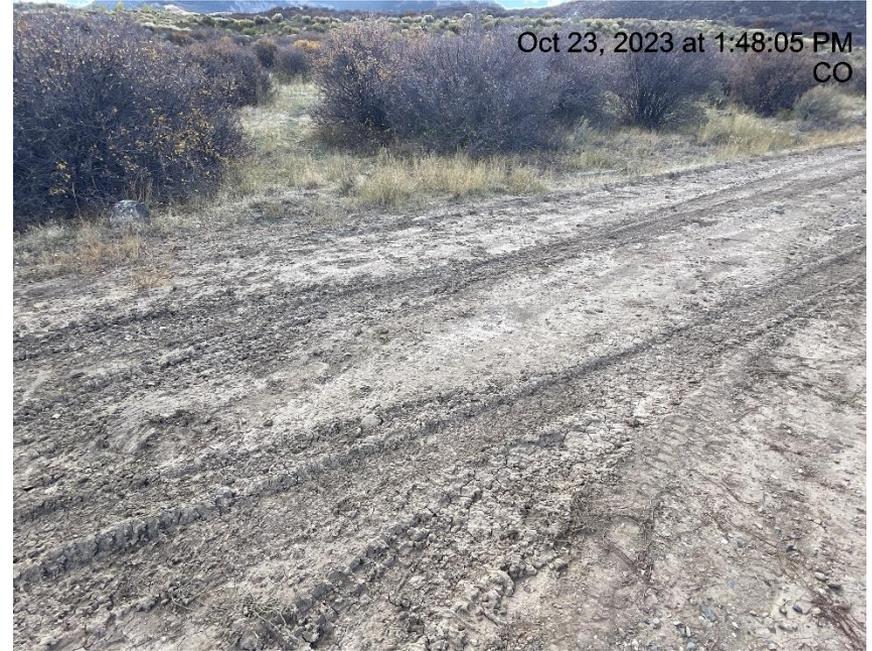
Photo # 3860 Lack of stabilization/compaction/insufficient tracking BMP's

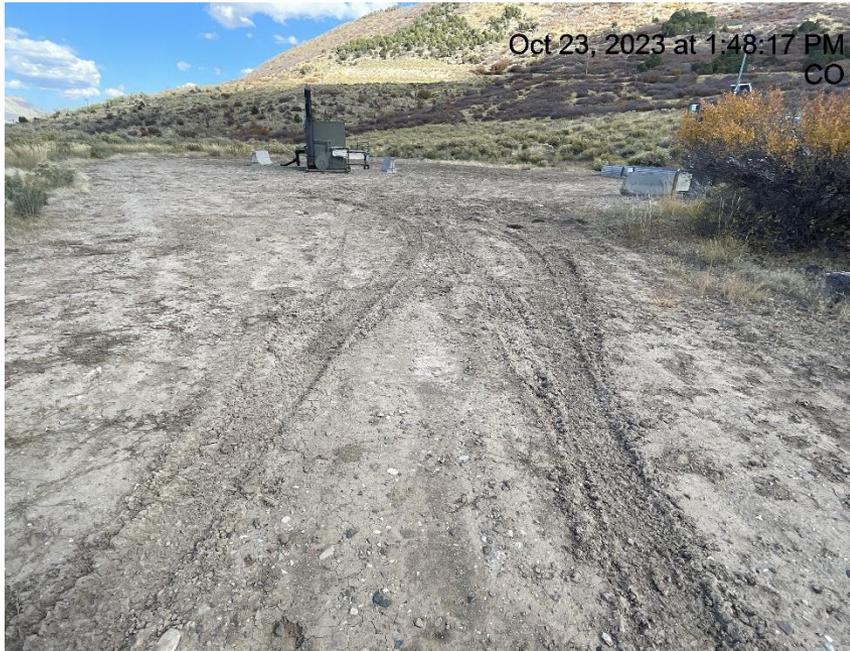
Photo # 3861 Lack of stabilization/compaction/insufficient tracking BMP's

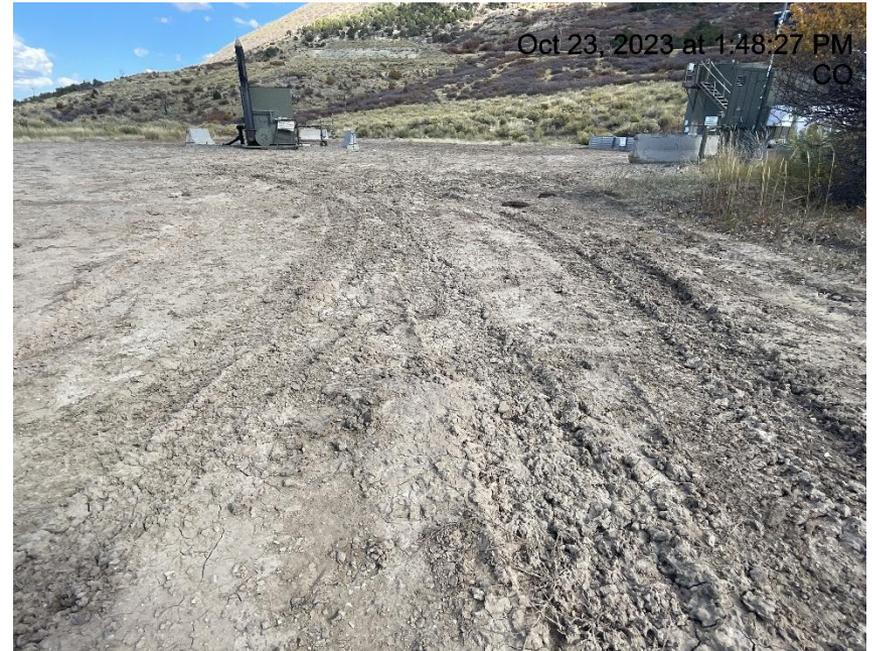
Photo # 3862 Lack of stabilization/compaction/insufficient tracking BMP's
