Interim Reclamation and Stormwater Inspection

Date: 10/20/2023

Operator: SUMMIT OIL & GAS LLC - 10774

Location ID: 465272

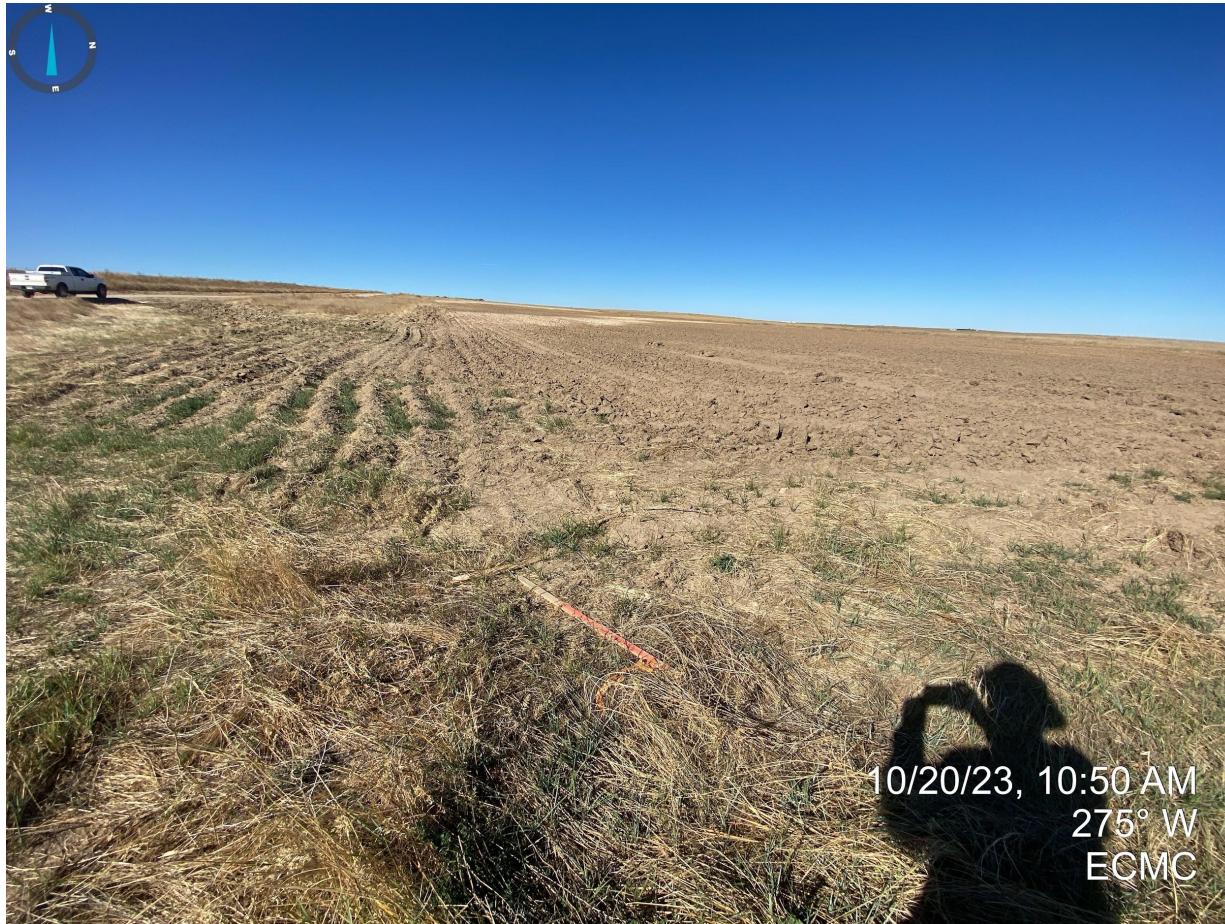
Photo 1. Taken from the southeast corner of the topsoil import/borrow area. The Operator shall ensure that borrow area is reclaimed according to the 1000 Series Rules.

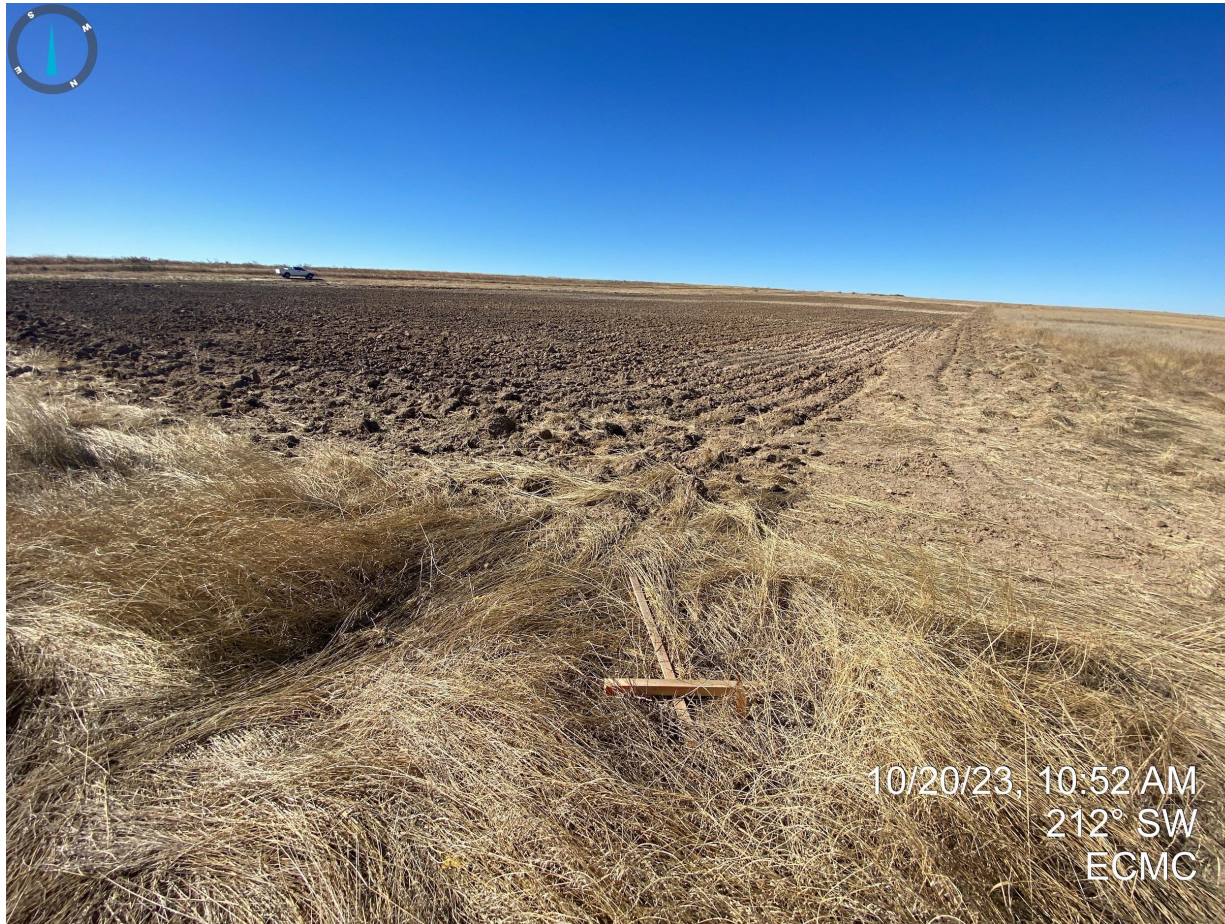
Photo 2. Taken from the northeast corner of the topsoil import/borrow area. See comments in Photo 1.

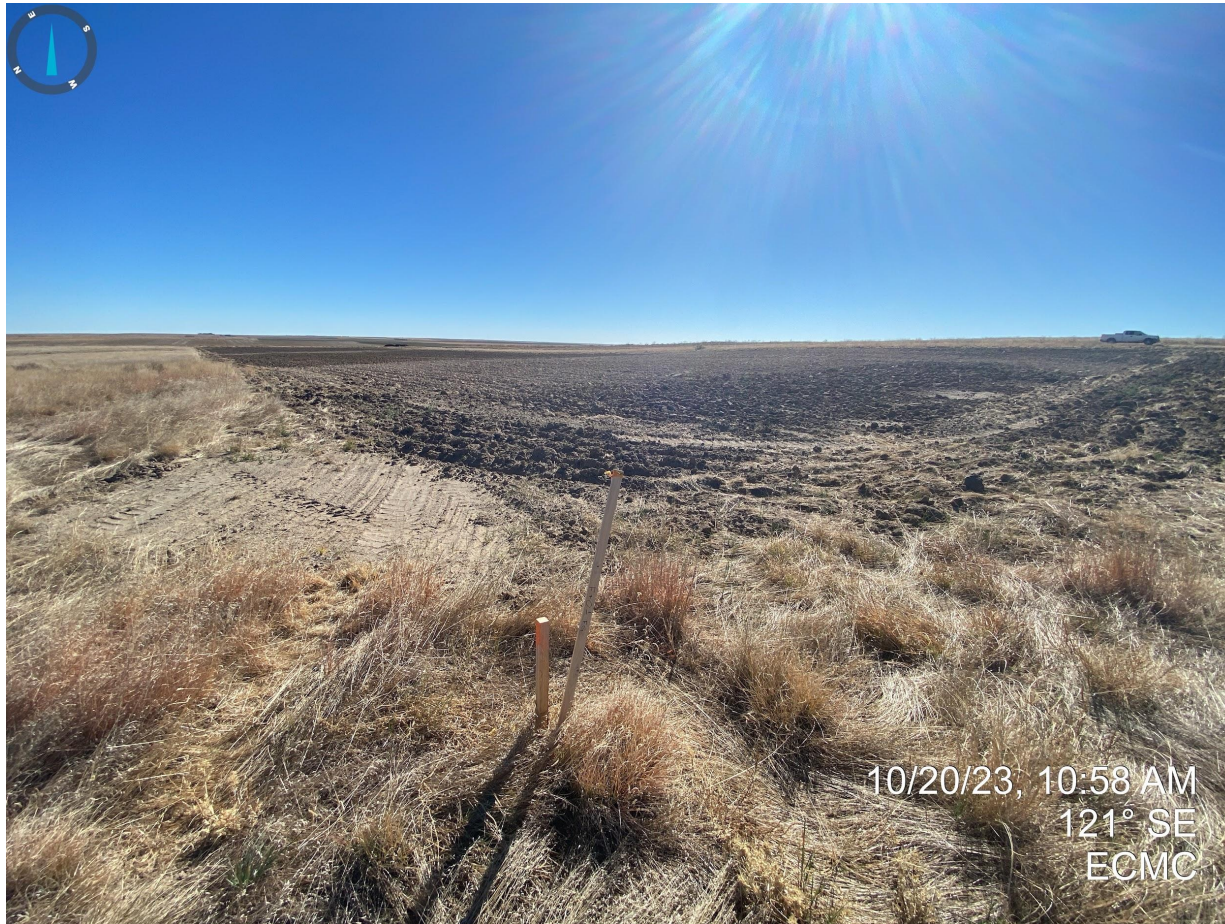
Photo 3. Taken from the northwest corner of the topsoil import/borrow area. See comments in Photo 1.

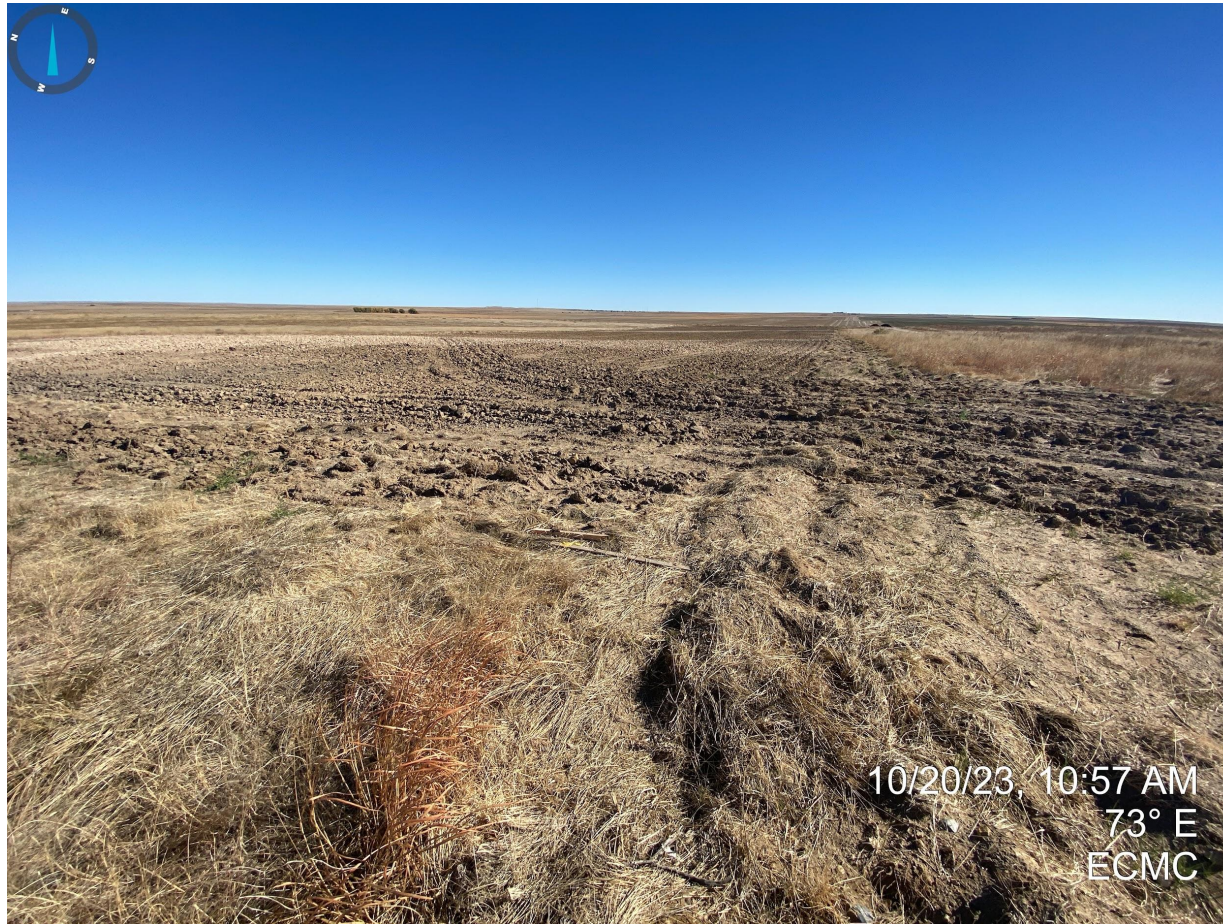
Photo 4. Taken from the southwest corner of the topsoil import/borrow area. See comments in Photo 1.

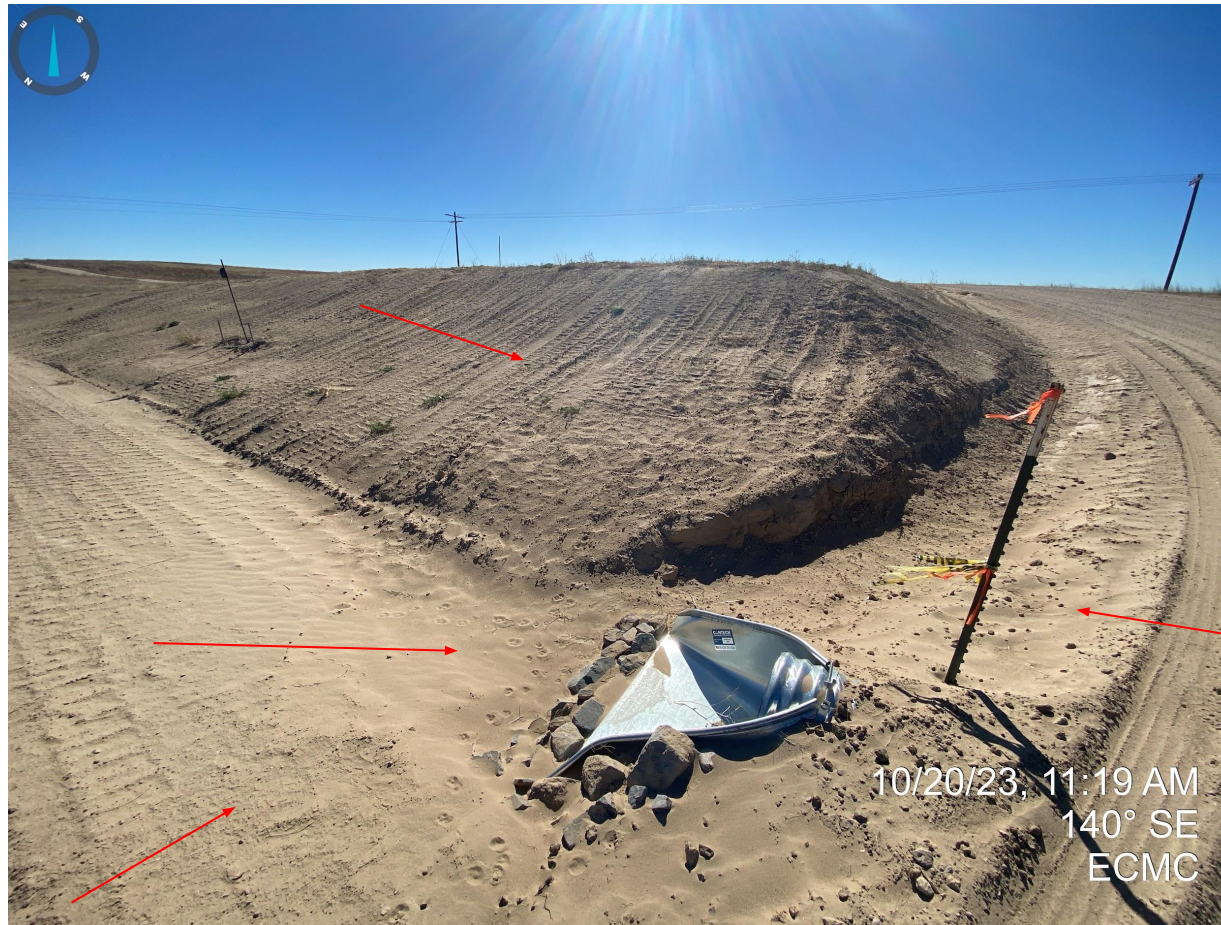
Photo 5. Taken near the location entrance. Photo illustrates that erosion degradation has been repaired, however, blow sand is evident from the unstabilized production areas and cut slopes, and is beginning to fill the stormwater ditches. Additional stabilization techniques are required.

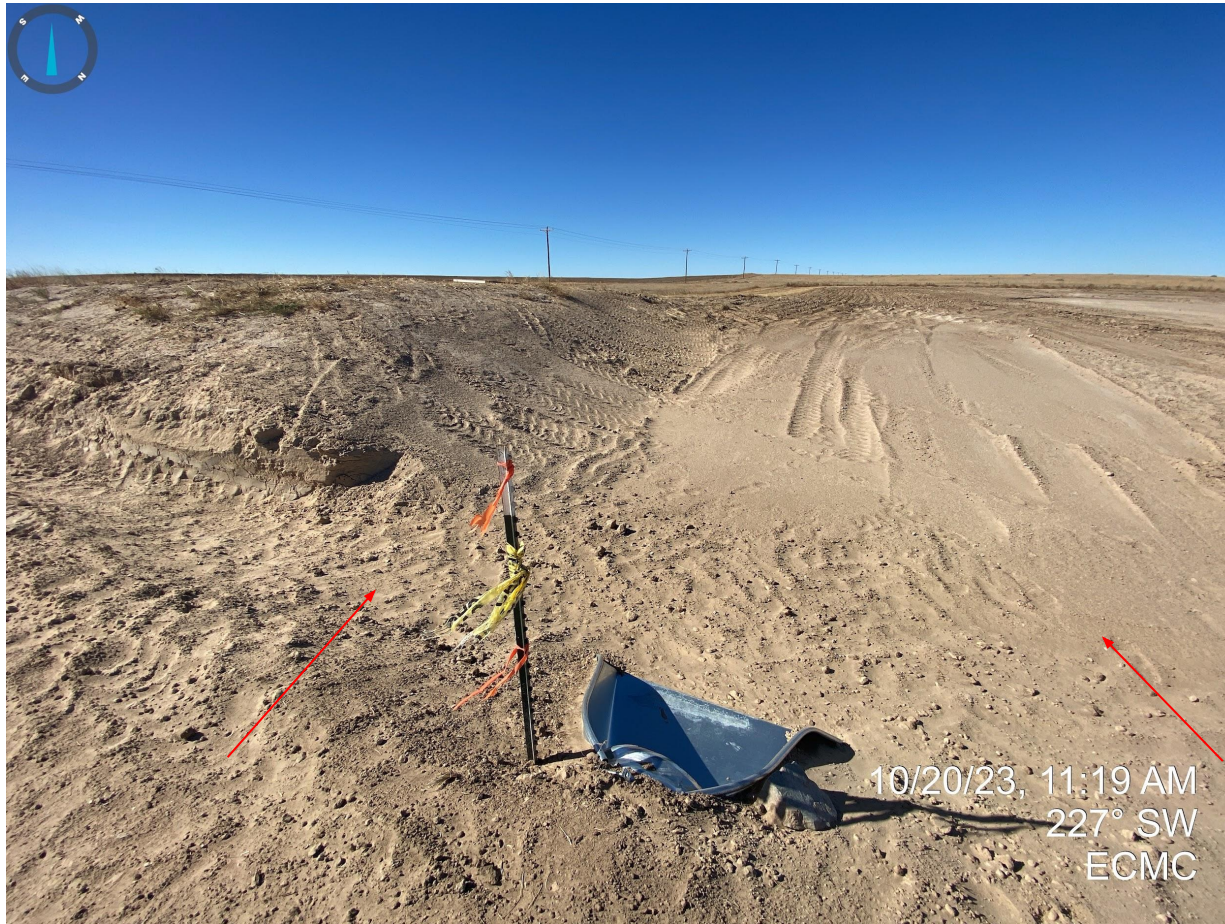
Photo 6. Taken from the location entrance. See comments in Photo 5.

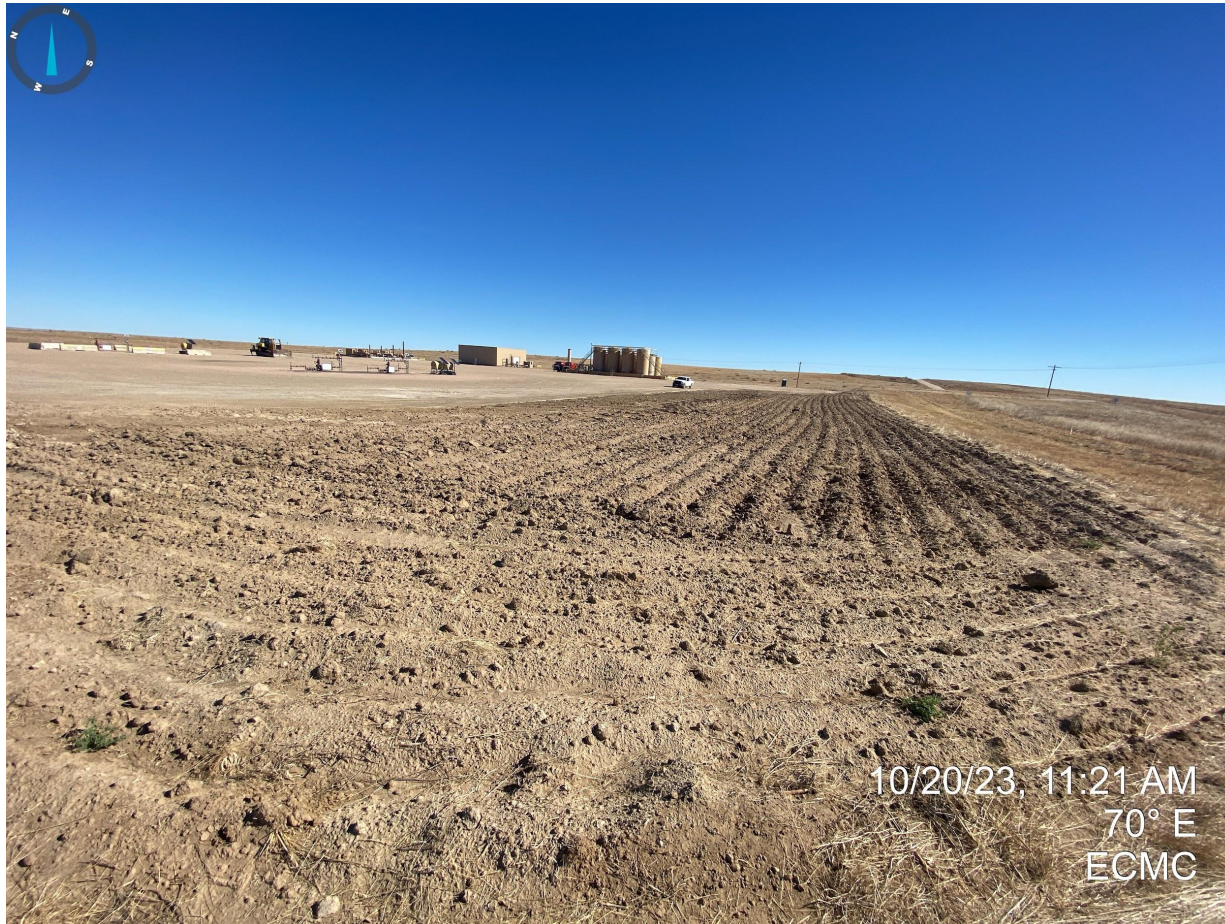
Photo 7. Taken from the southwest corner of the location. Photo illustrates interim reclaimed portions of the location. The Operator indicated that the interim areas would be reseeded at a later date.

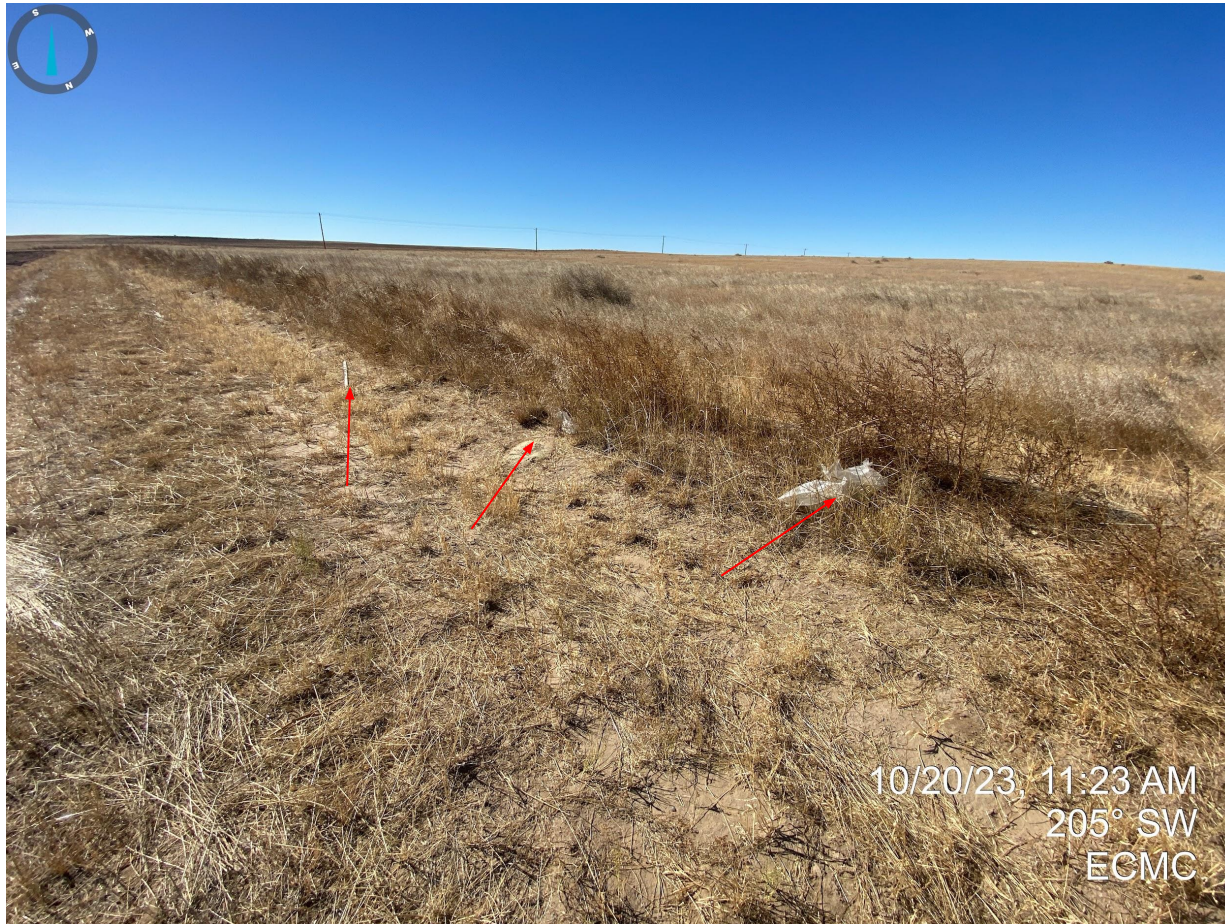
Photo 8. Taken from the western portion of the location. Photo illustrates trash observed on location during this inspection.

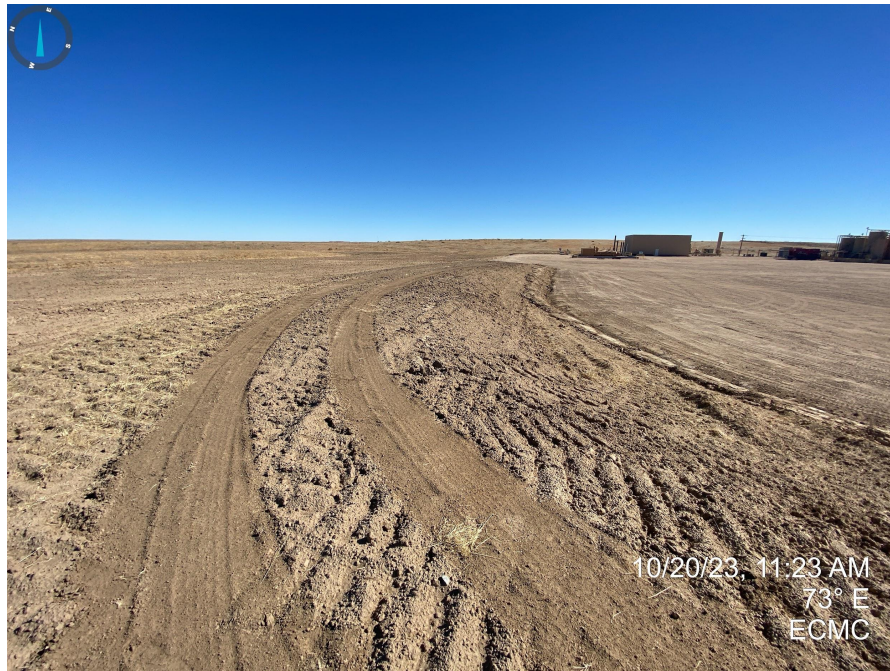
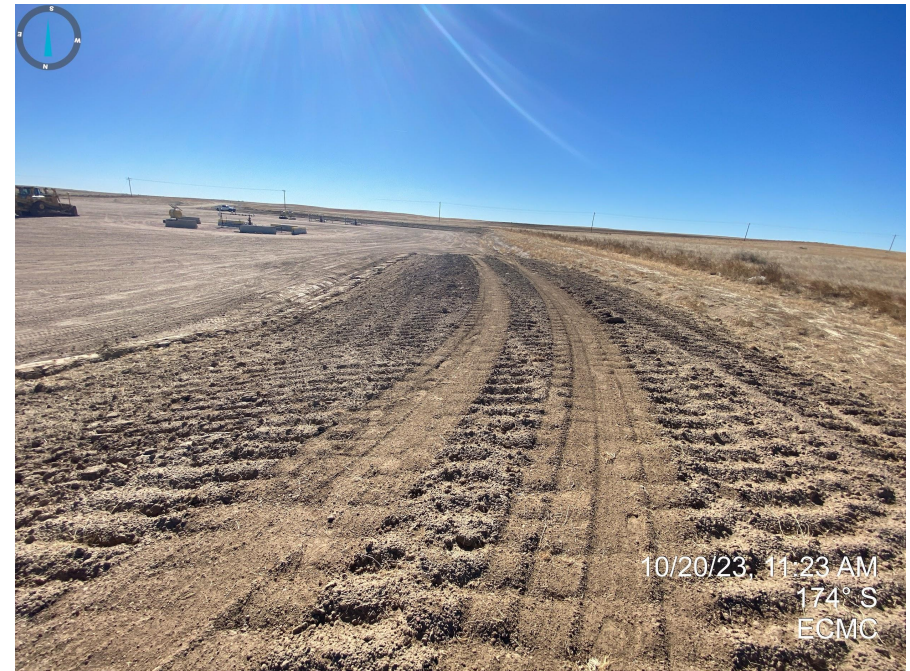
Photos 9 & 10. Taken from the middle portion of the new topsoil stockpile. Photo illustrates that the topsoil stockpile has not been revegetated at the time of this inspection. Also pictured, tire tracks/vehicle traffic on the topsoil stockpile; The Operator shall restrict or prohibit any vehicle traffic on the stockpile.

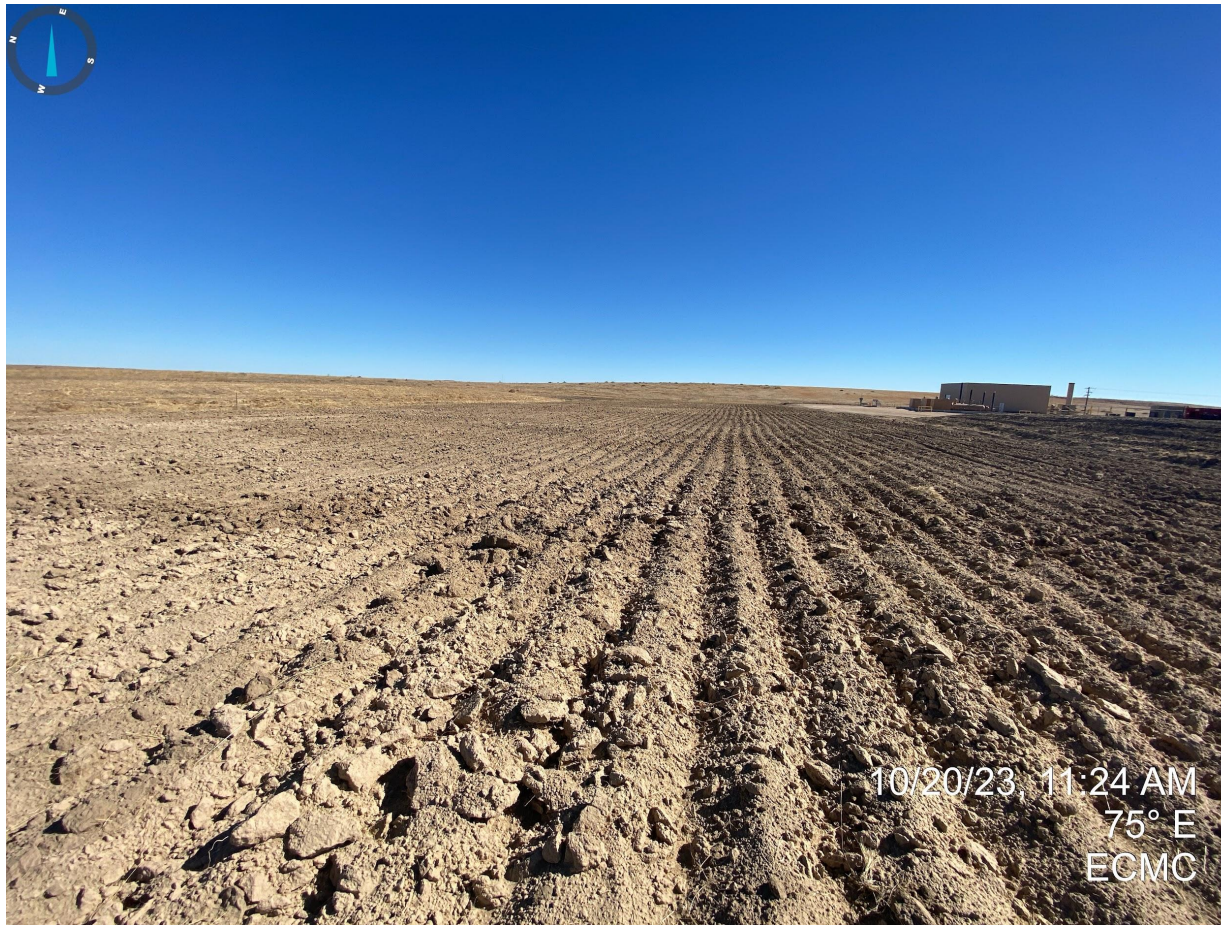
Photo 11. Taken near the northwest corner of the location. Photo illustrates interim reclaimed portions of the location. The Operator indicated that the interim areas would be reseeded at a later date.

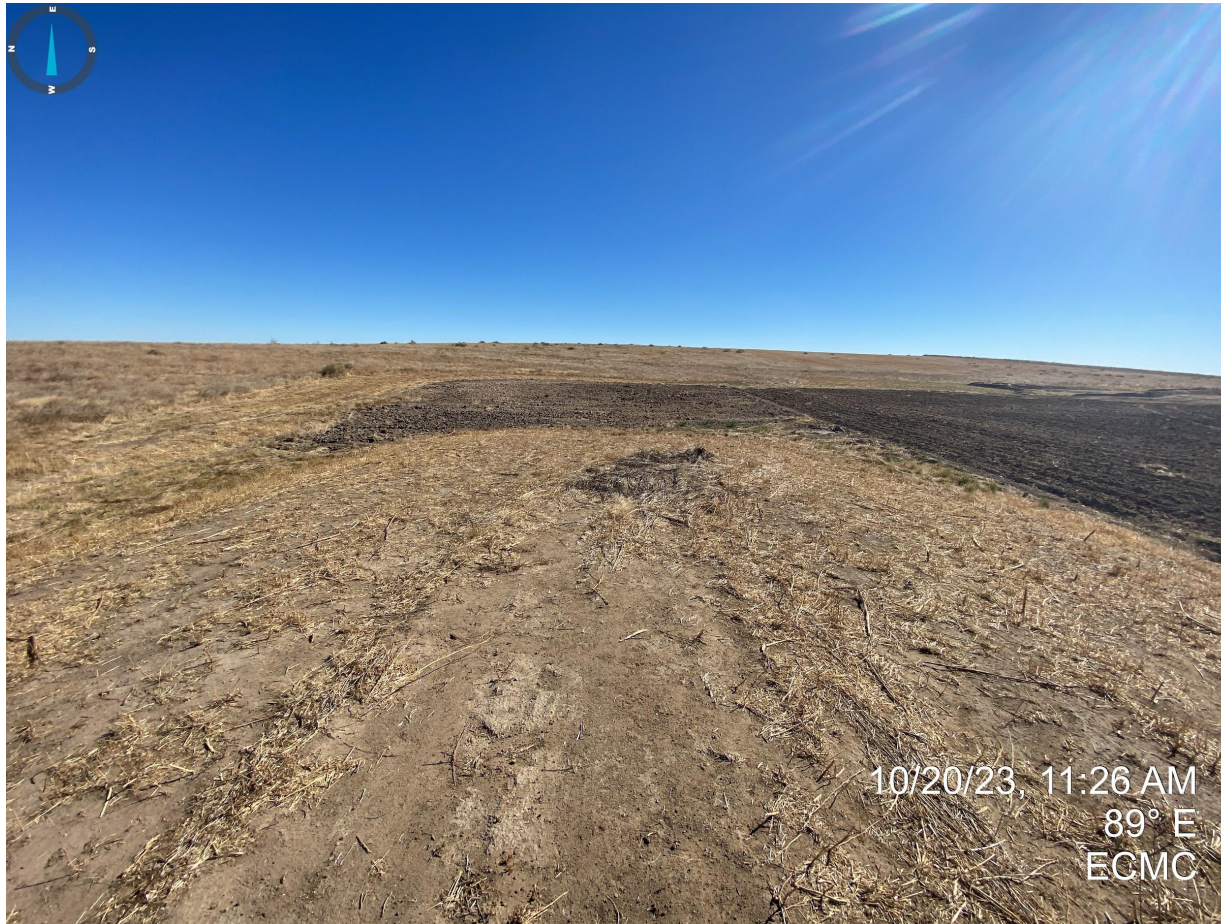
Photo 12. Taken from the existing topsoil stockpile. Photo illustrates that the undesirable vegetation, previously documented, has been managed (e.g. mowed). Additional stabilization (e.g. revegetation) activities are required to protect against wind and water erosion.

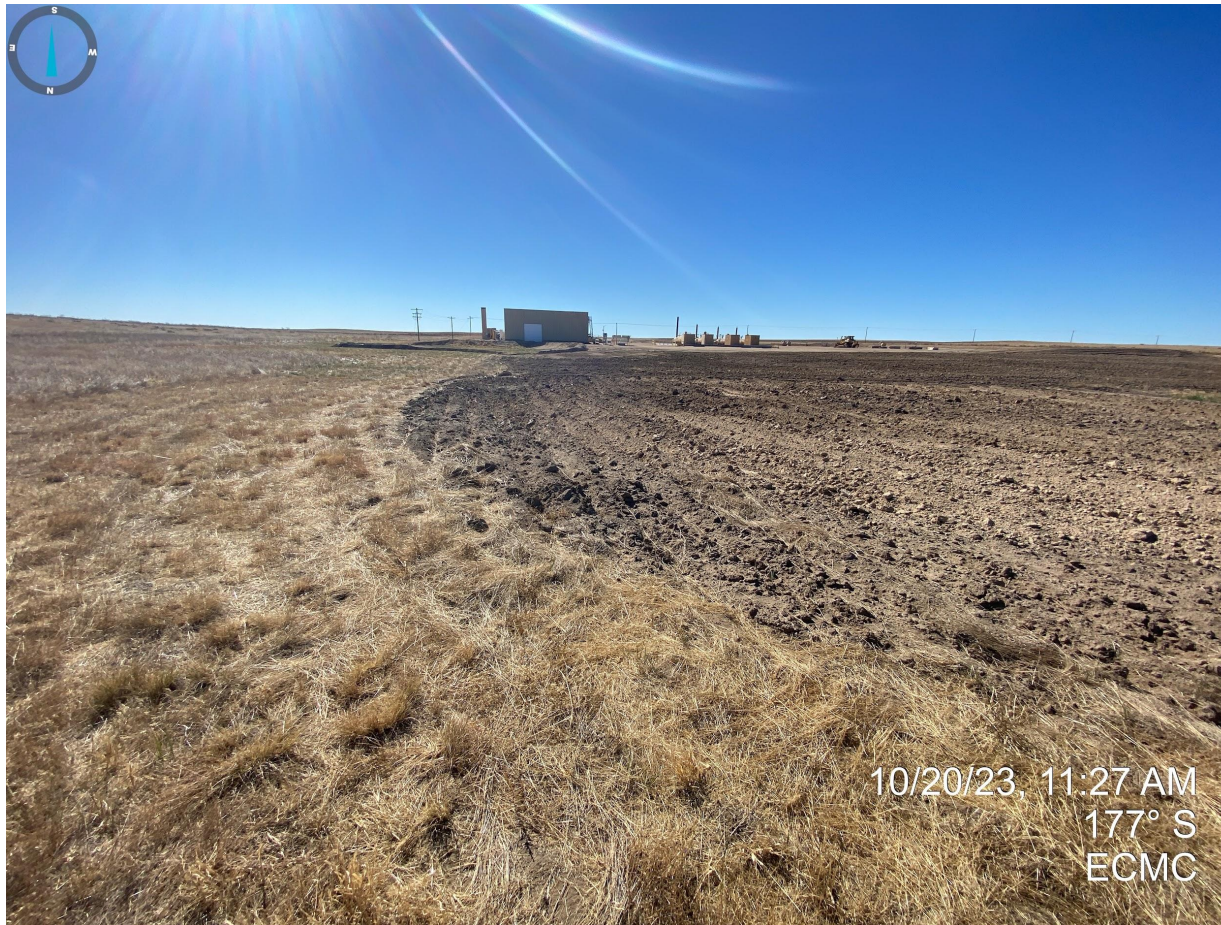
Photo 13. Taken from the northeast corner of the location. Photo illustrates interim reclaimed portions of the location. The Operator indicated that the interim areas would be reseeded at a later date.

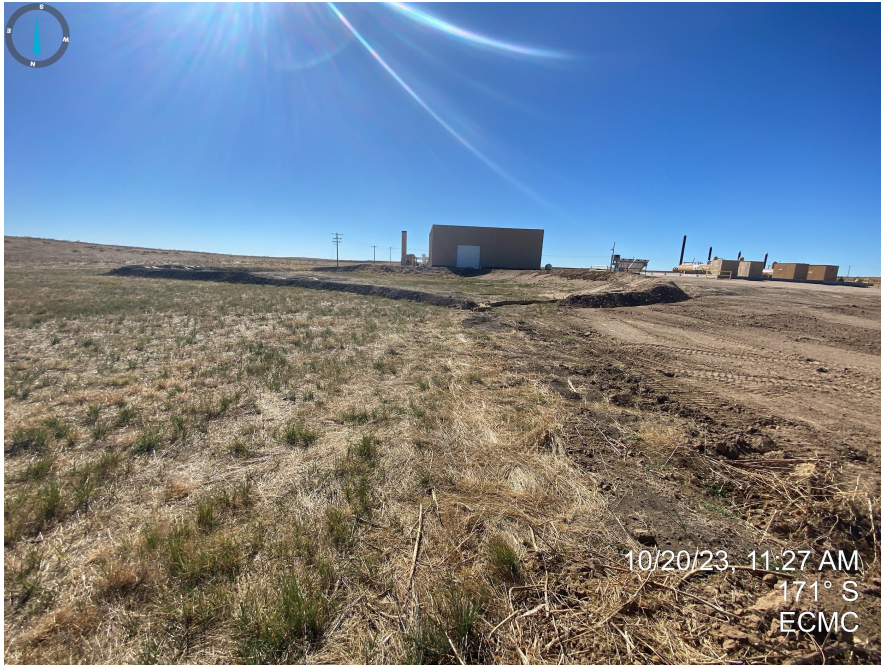
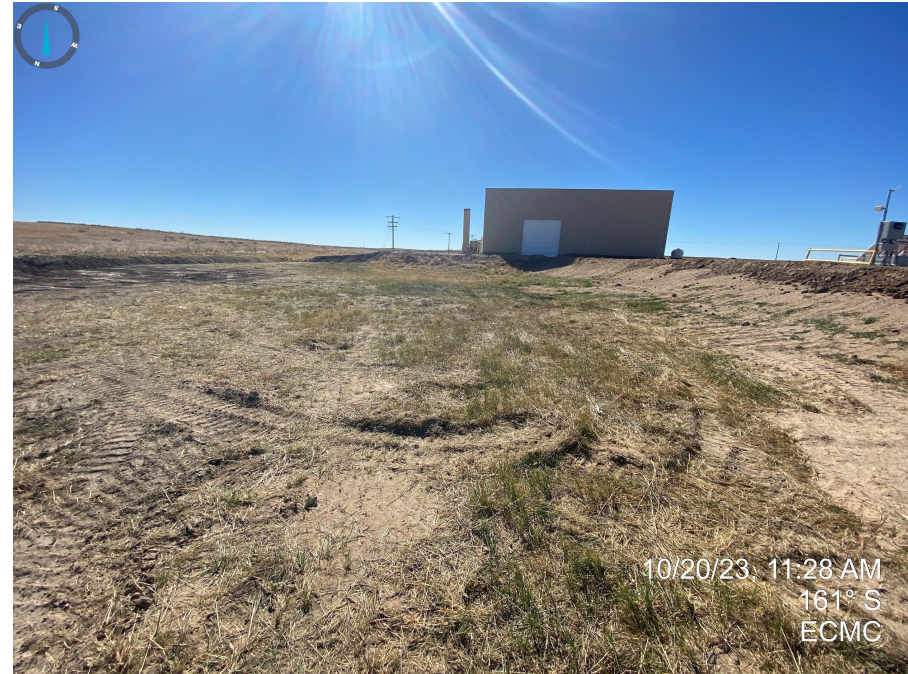
Photos 14 & 15. New sediment basin constructed near the eastern/northeastern portion of the location.

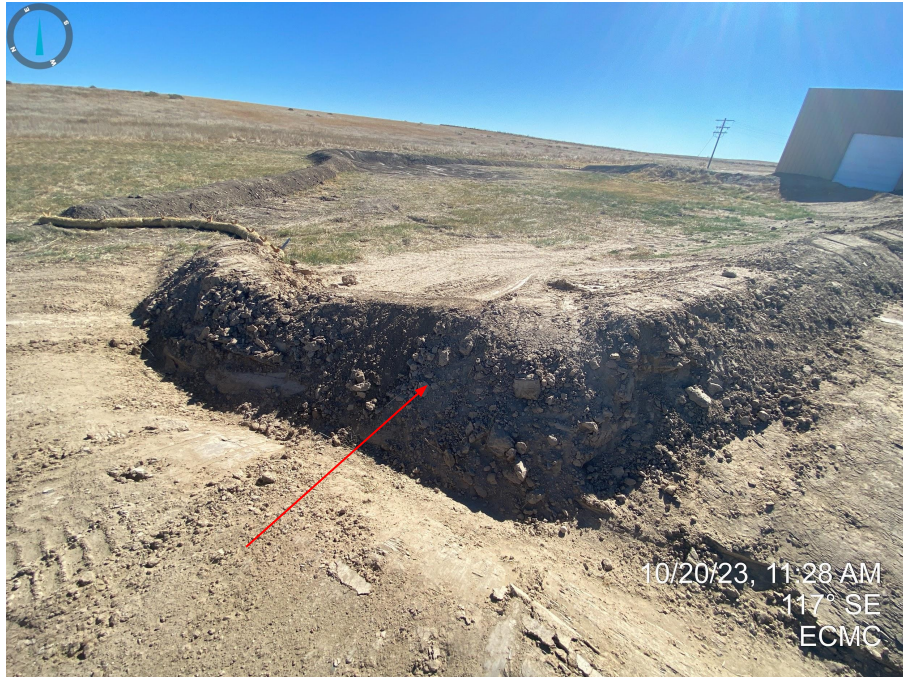
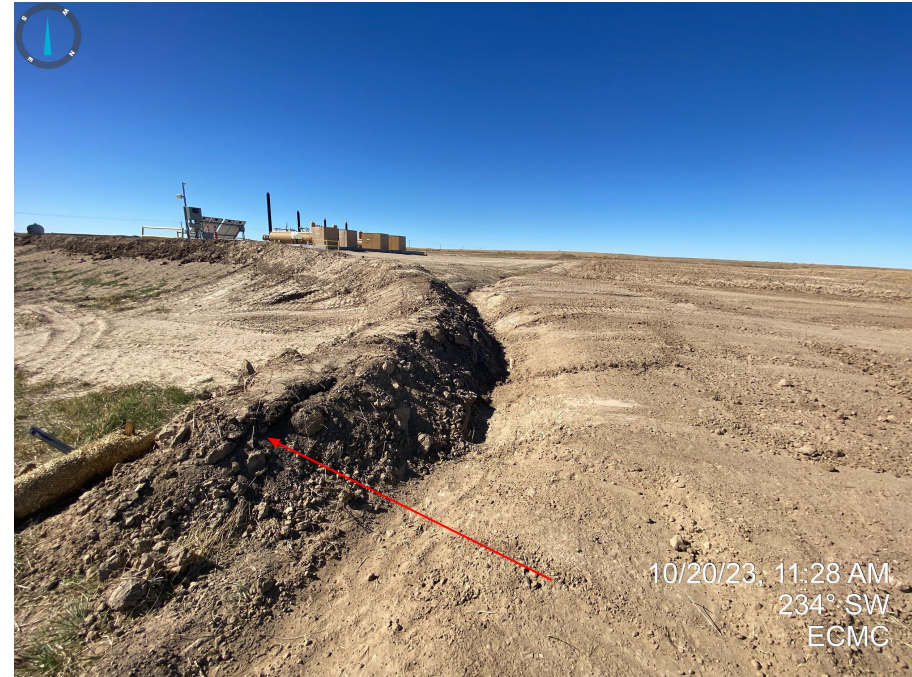
Photo 16 & 17. Taken near the northwest corner of the sediment basin. Photos illustrate that portions of the berms are comprised of unconsolidated material, which can become a potential source of sedimentation/pollution itself. Additional stabilization techniques are required.

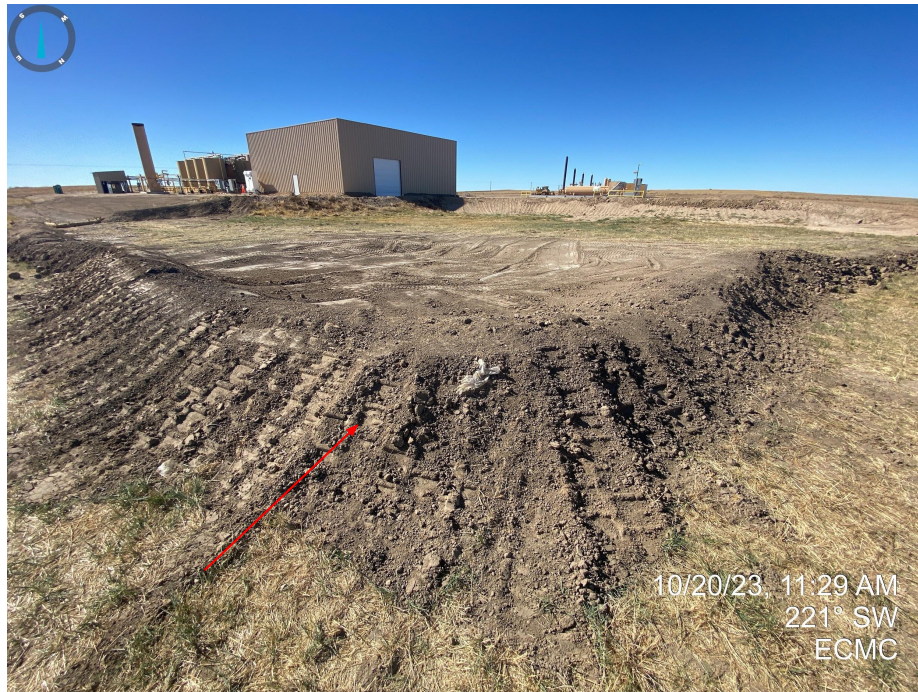
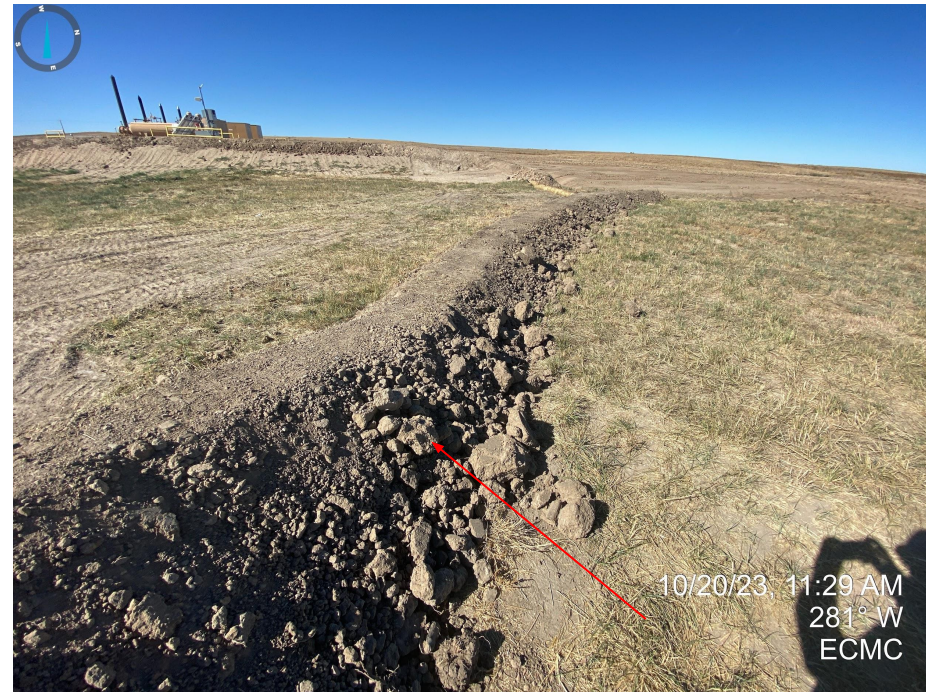
Photos 18 & 19. Taken from the northeast corner of the sediment basin. Photo illustrates that portions of the berm have been temporarily stabilized (e.g. equipment tracking) whereas some portions have been left unconsolidated.

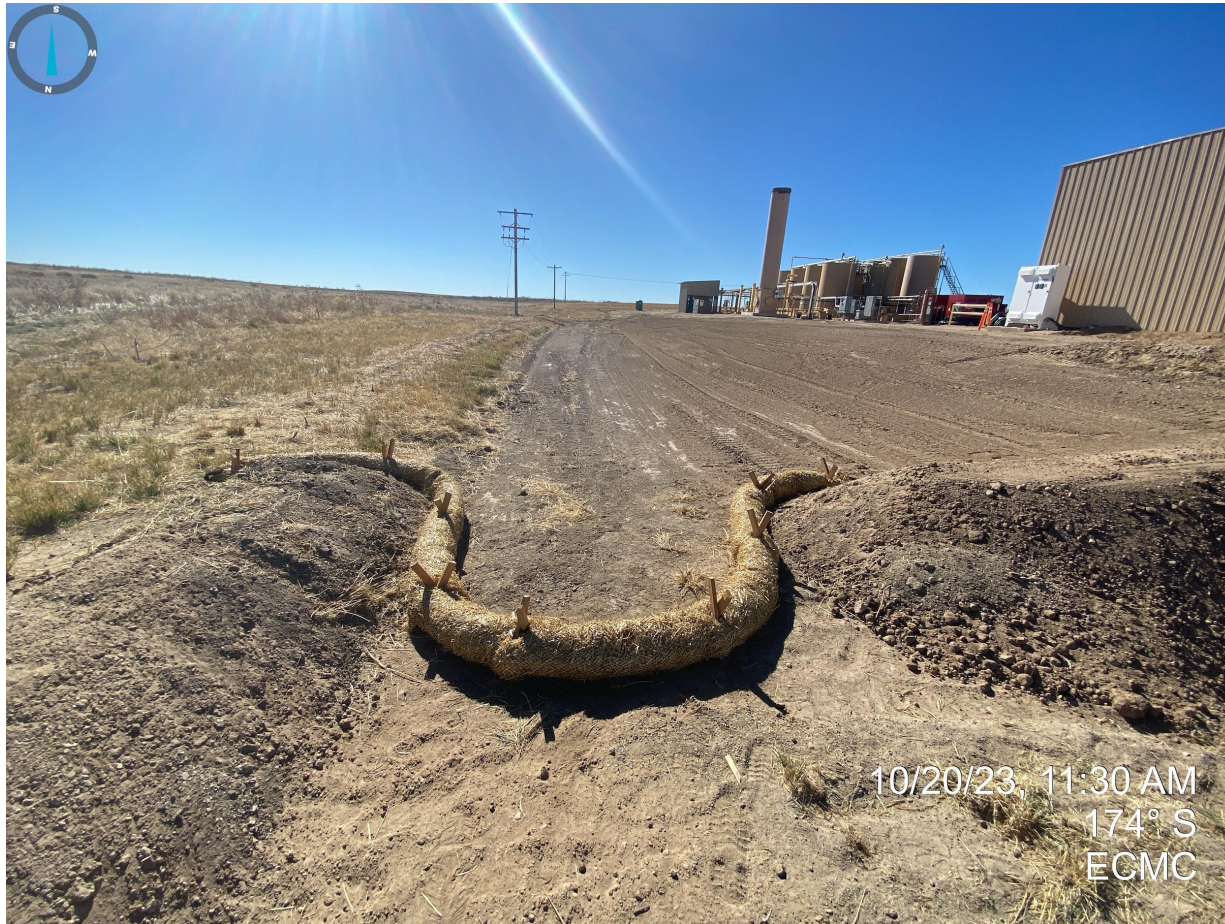
Photo 20. Taken from the southern portion of the sediment basin. Photo illustrates a temporary inlet control measure (e.g. straw wattle). More permanent control measures should be selected to provide long term stabilization.

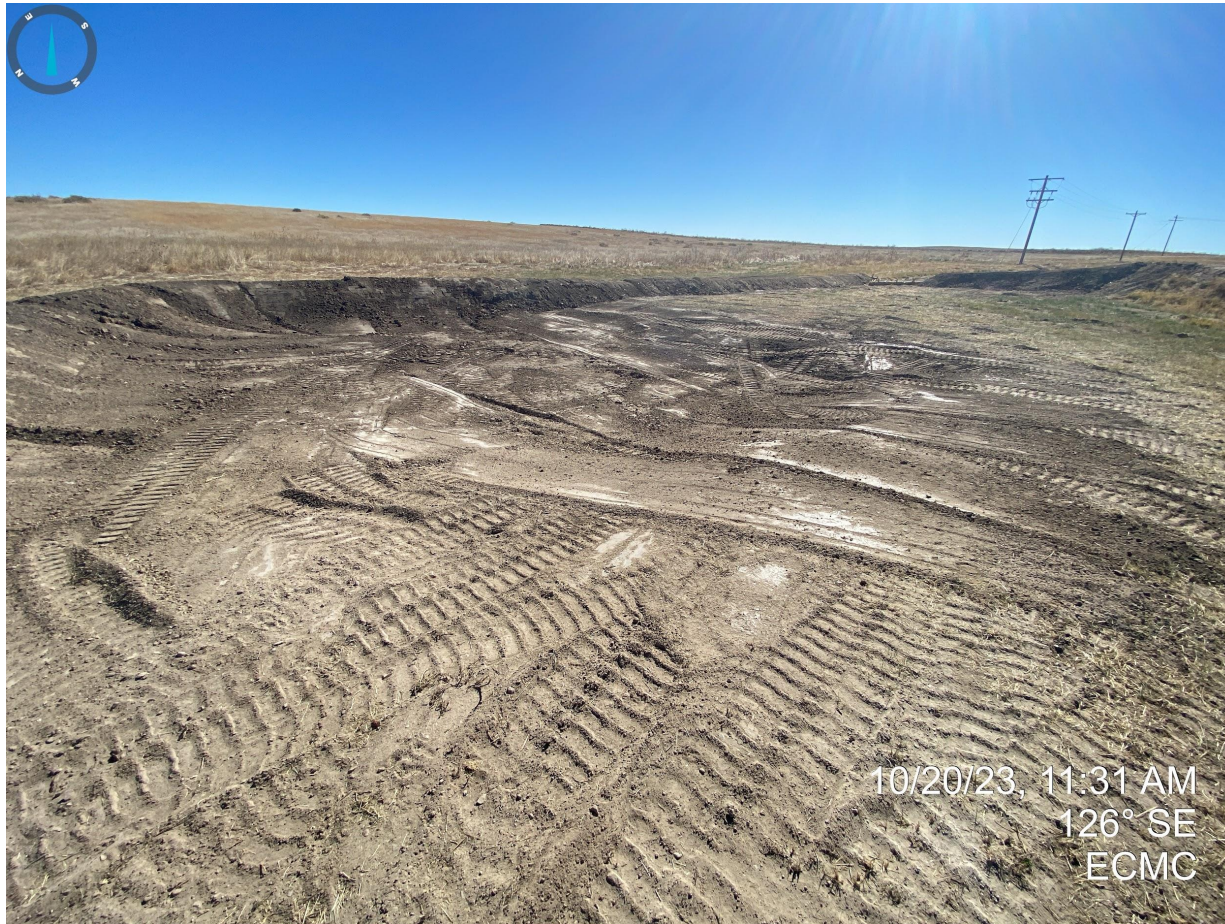
Photo 21. Additional revegetation activities are required to stabilize bare and exposed soils located within the sediment basin.

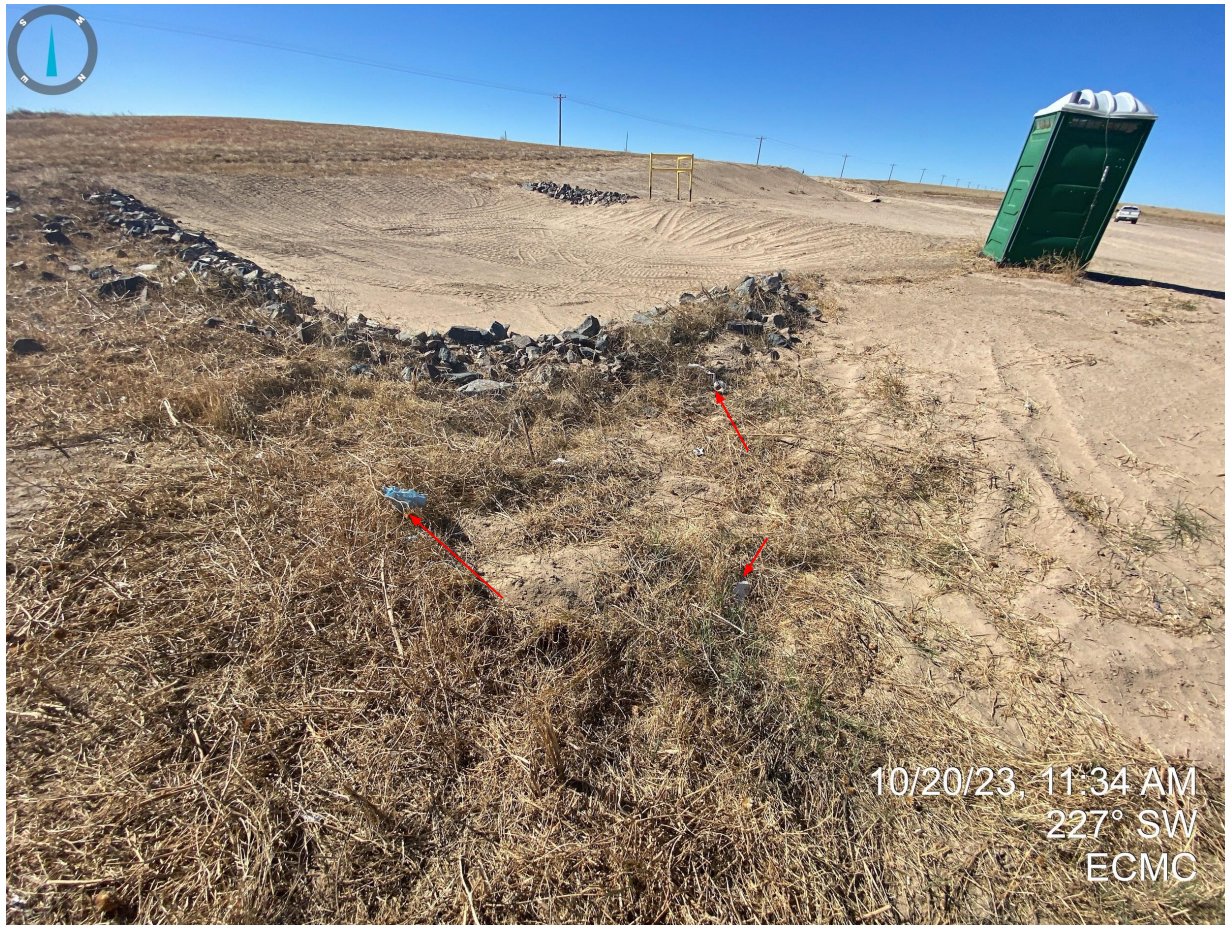
Photo 22. Taken from the southeastern corner of the location. Photo illustrates that undesirable vegetation has been managed (e.g. mowed). Also pictured, trash.

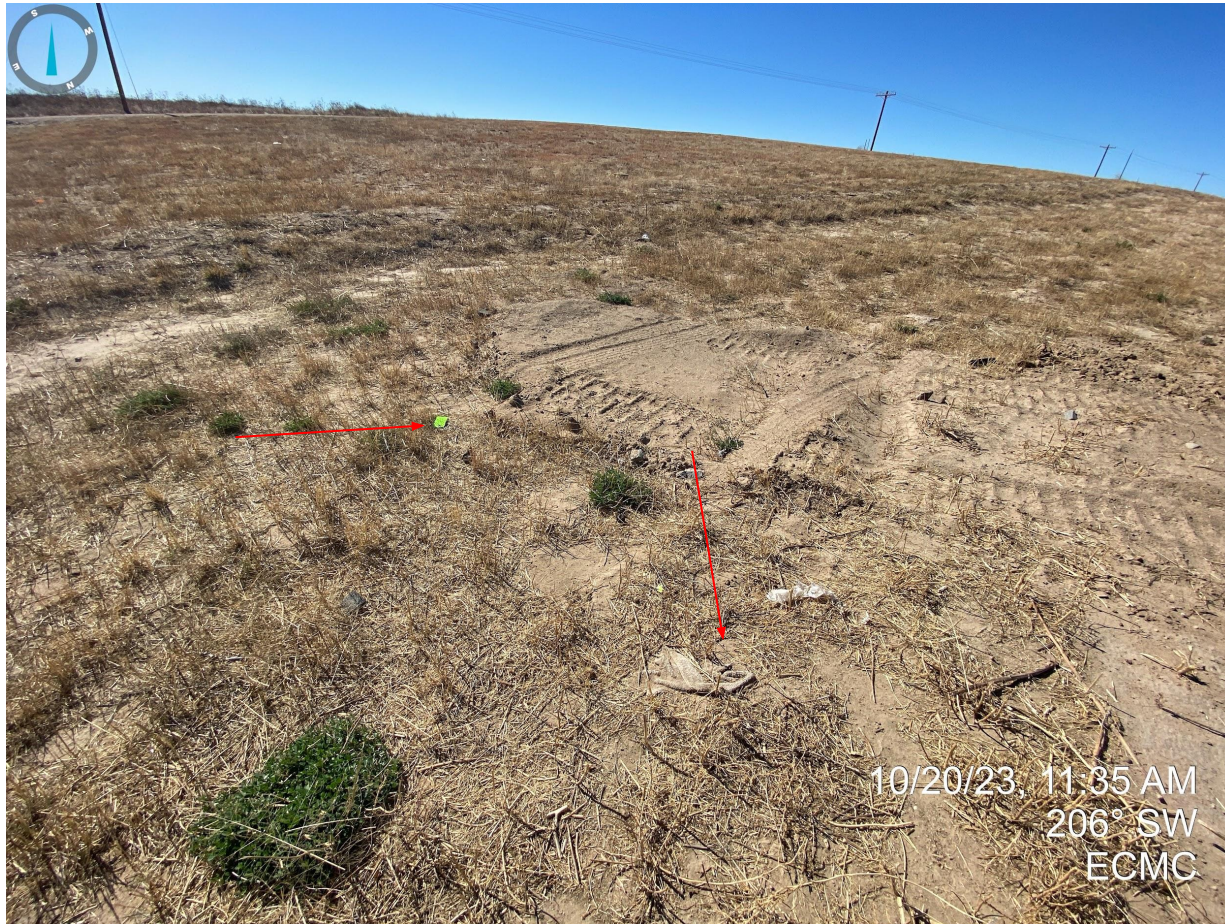
Photo 23. Taken from the southeastern corner of the location. Photo illustrates that undesirable vegetation has been managed (e.g. mowed). Also pictured, trash.
