Interim Reclamation and Stormwater Inspection

Date: 10/20/2023

Operator: SUMMIT OIL & GAS LLC - 10774

Location ID: 465272

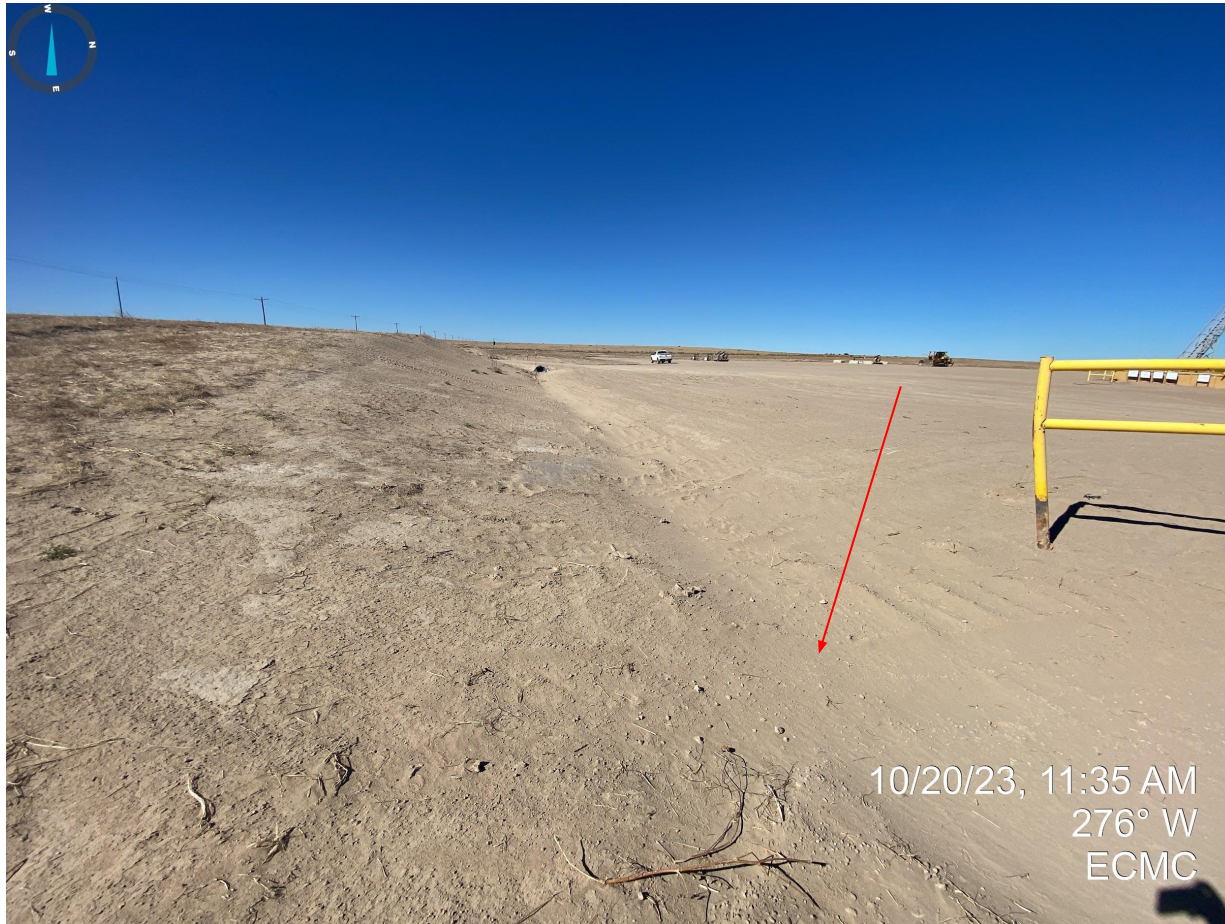
Photo 24. Taken near the southeast corner of the location. Photo illustrates that erosion degradation has been repaired, however, blow sand is evident from the unstabilized production areas and cut slopes and is beginning to fill the stormwater ditches. Additional stabilization techniques are required.

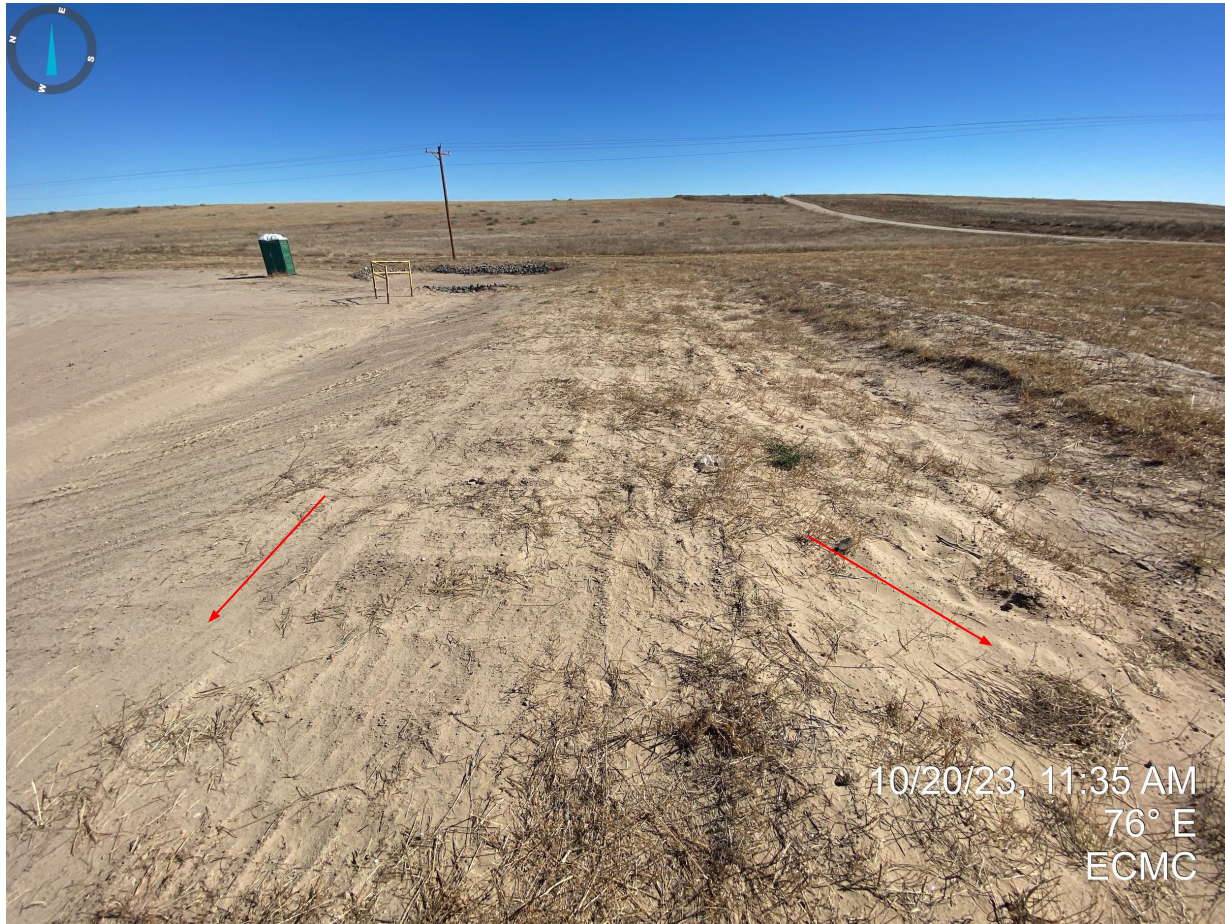
Photo 25. See comments in Photo 24.

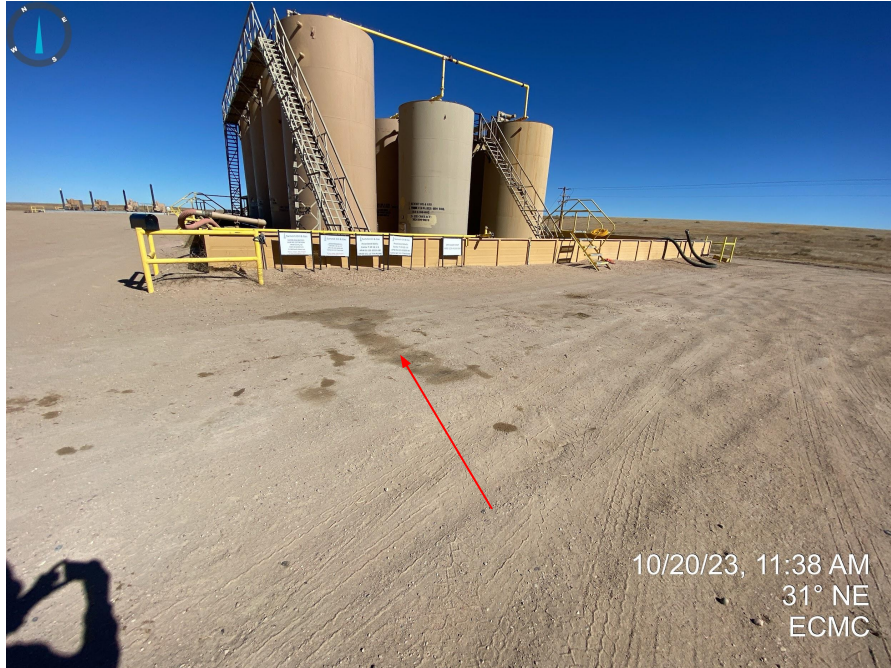
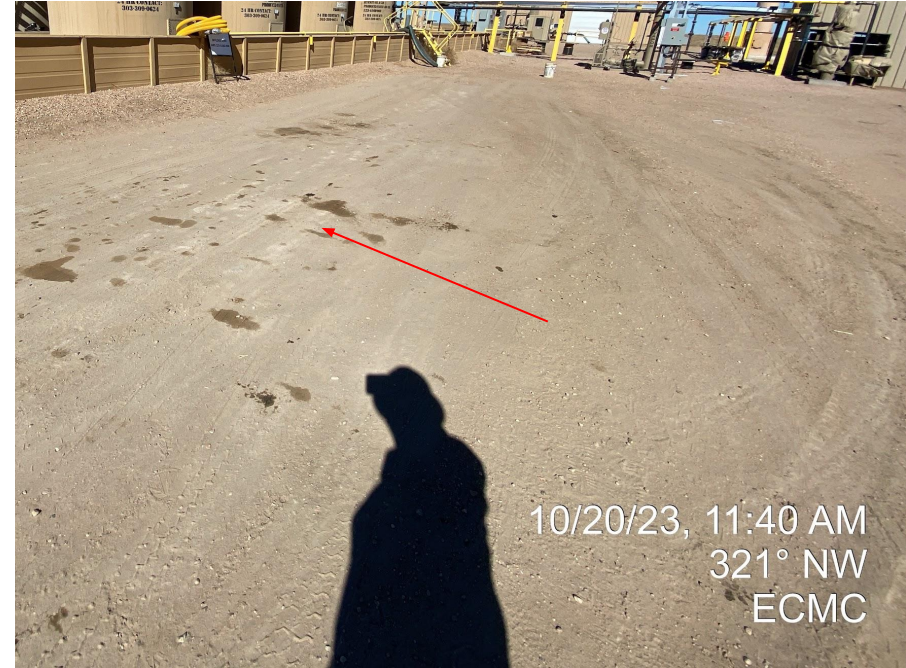
Photos 26 & 27. Stained soils observed around the tank battery facility.

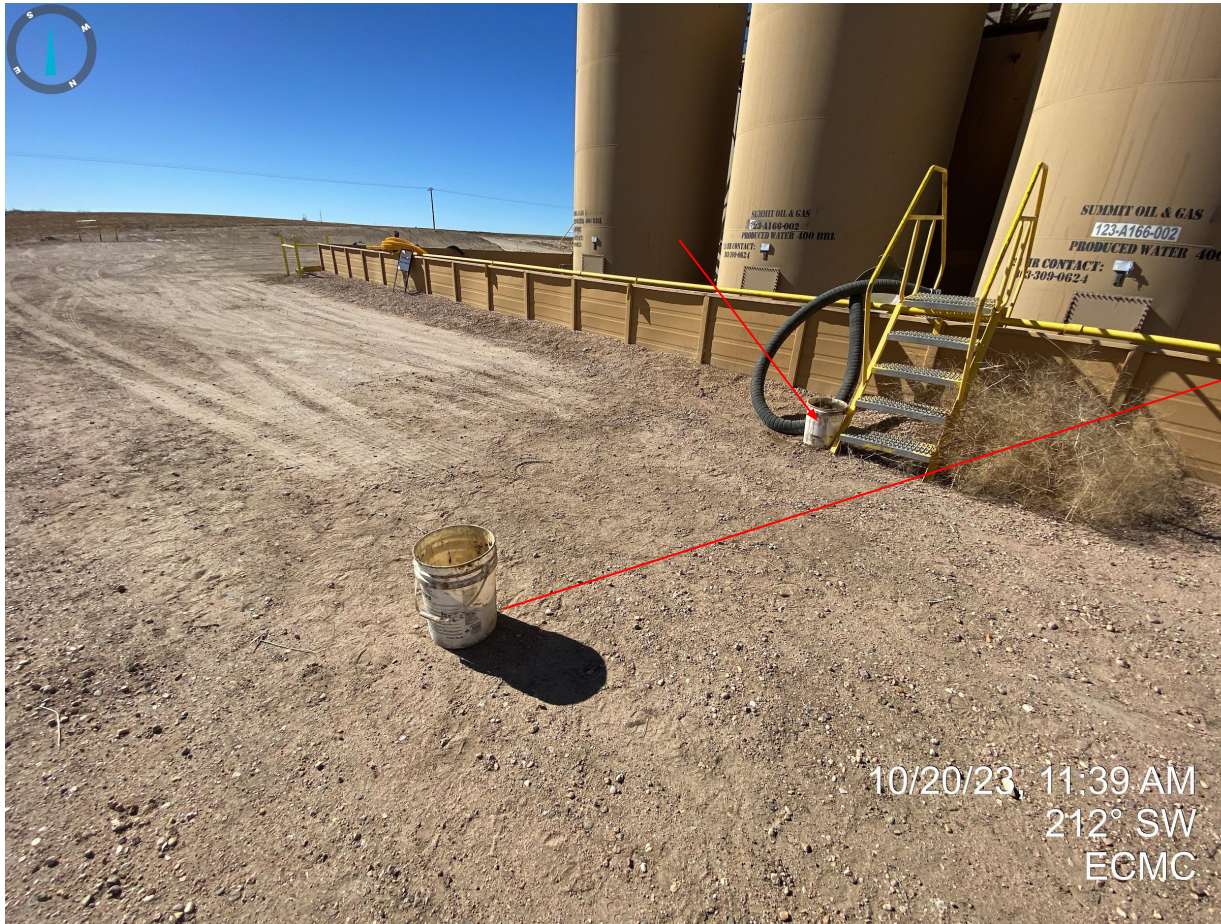
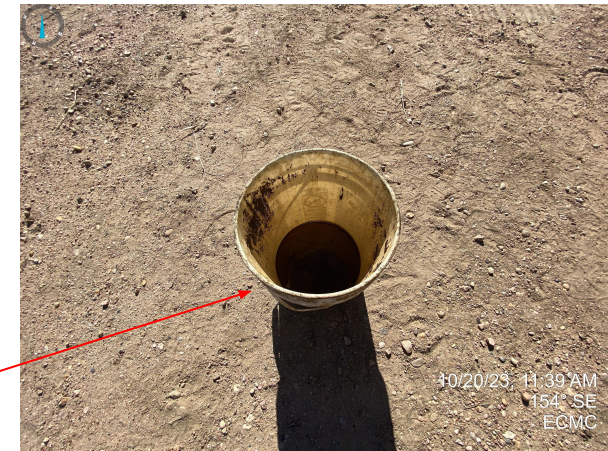
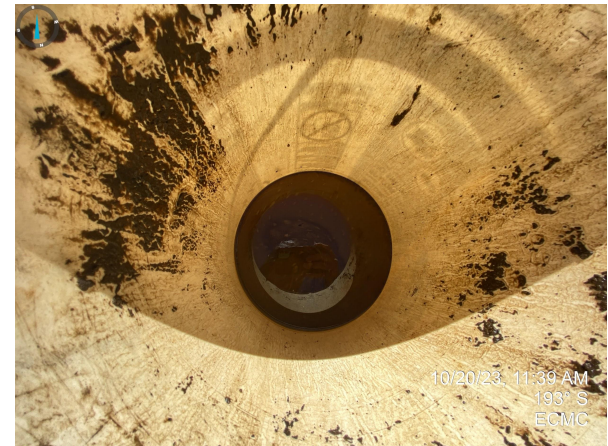
Photos 28-30. Buckets with apparent hydrocarbons observed outside of secondary containment.

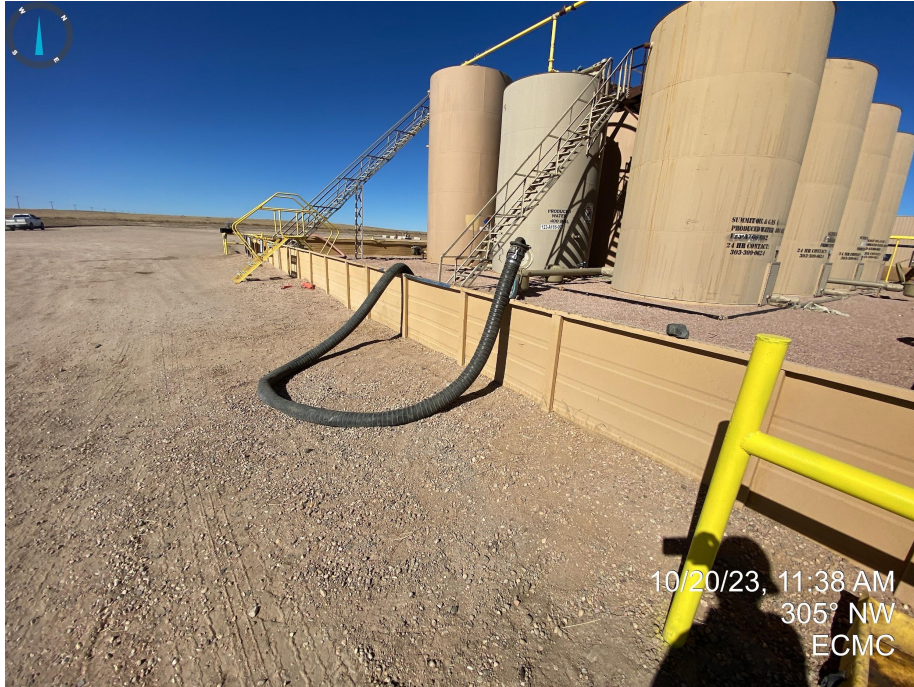
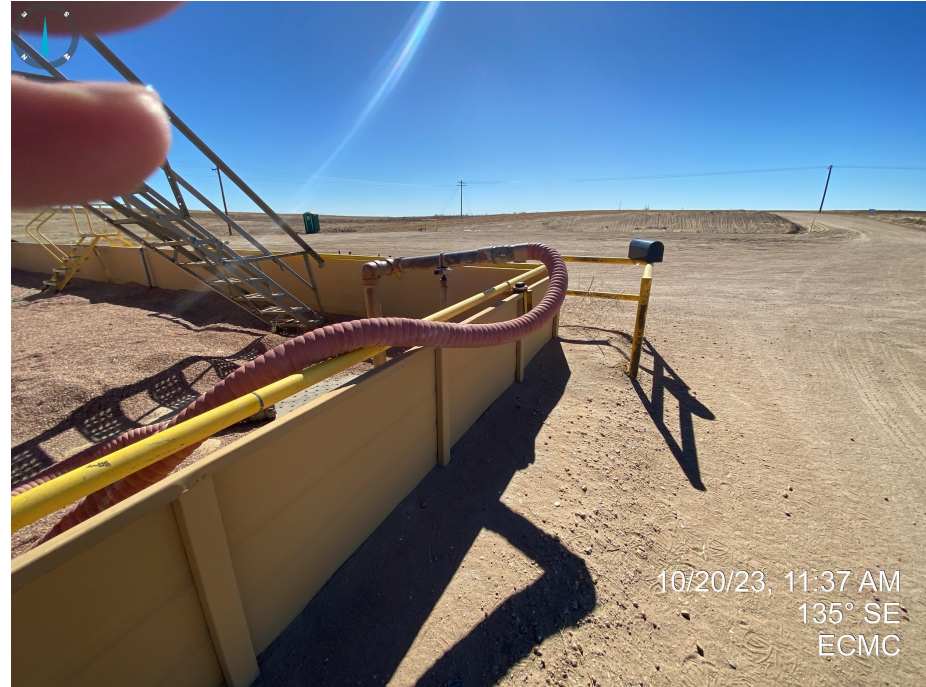
Photos 31 & 32. The Operator was previously advised about loadout lines resting outside of the secondary containment. All loadout lines should be placed within secondary containment in the event failure occurs.
