Inspection Photos
Nuevida Resources Ardourel 33081718 3HL
API 067-10037

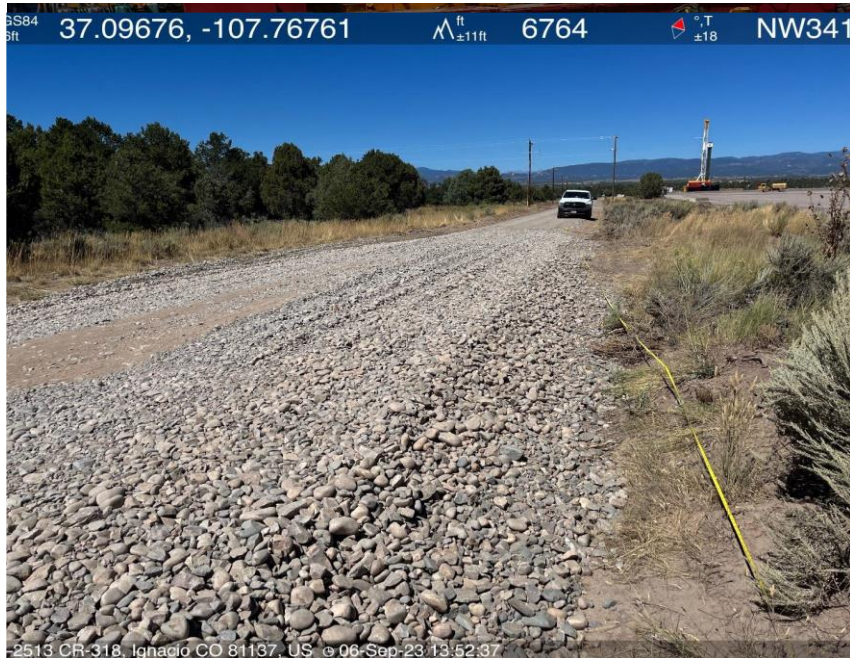
Photo #1 Tracking BMP installed during 9/8/2023 inspection.

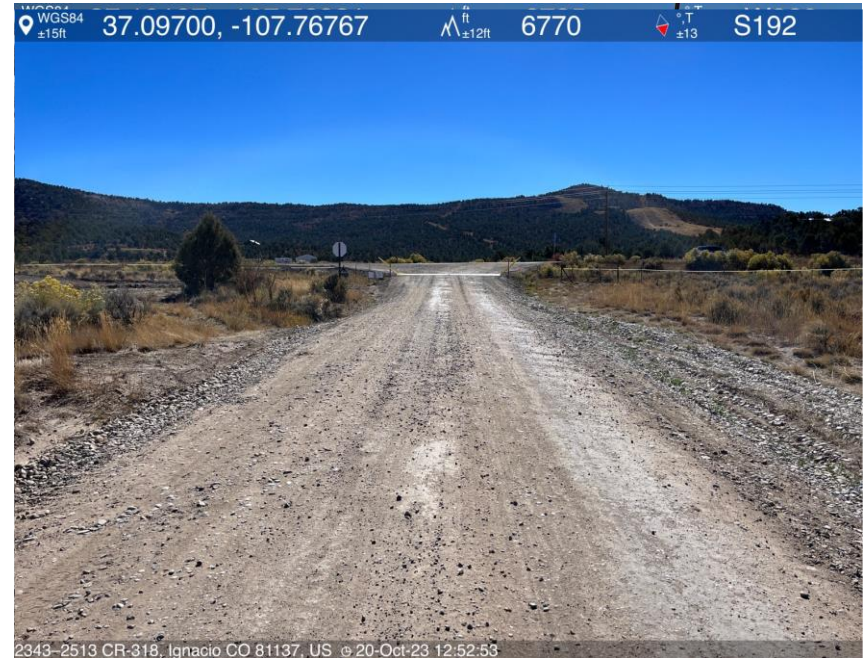
Photo #2 Tracking pad BMPs not maintained.

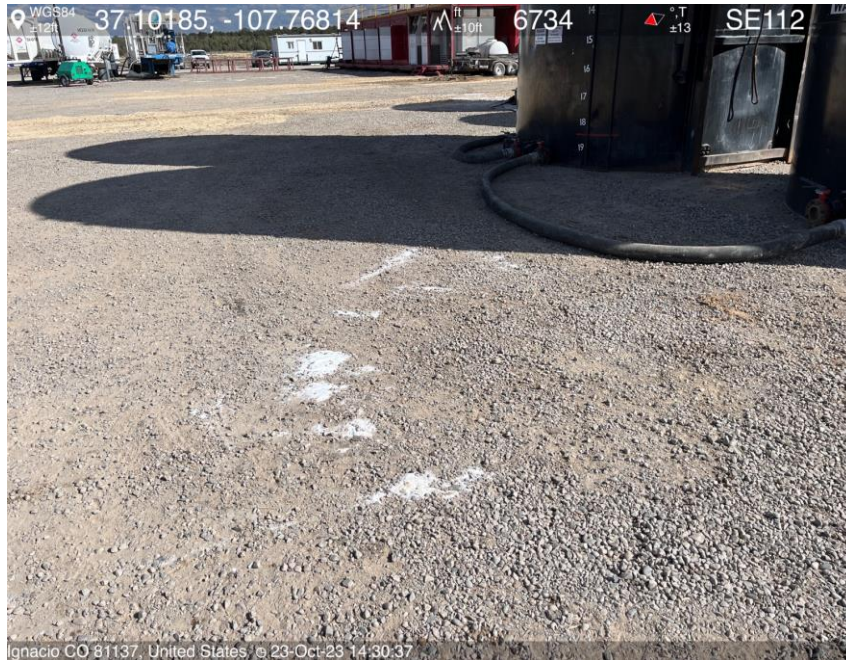
Photo #3 Impacted ground at northwest side of rig.

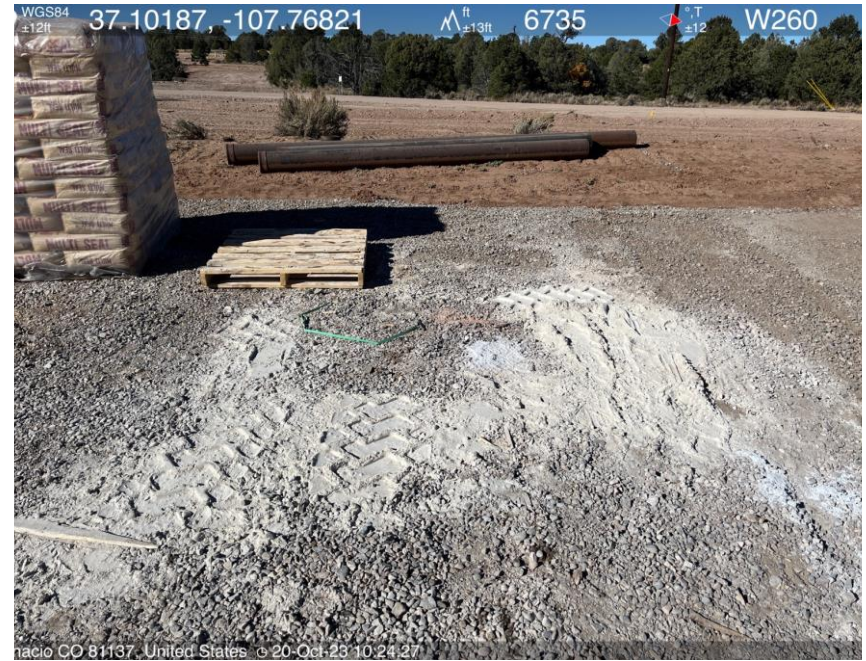
Photo #4 Impacted ground at west side of rig.

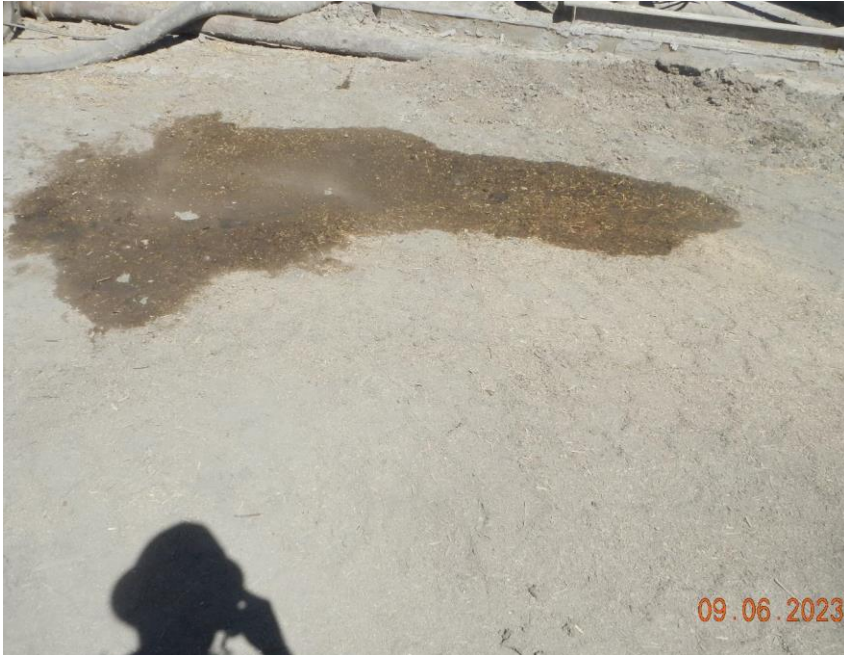
Photo #5 Inspection 9/8/2023. Corrective action completed.
This impact has been cleaned.

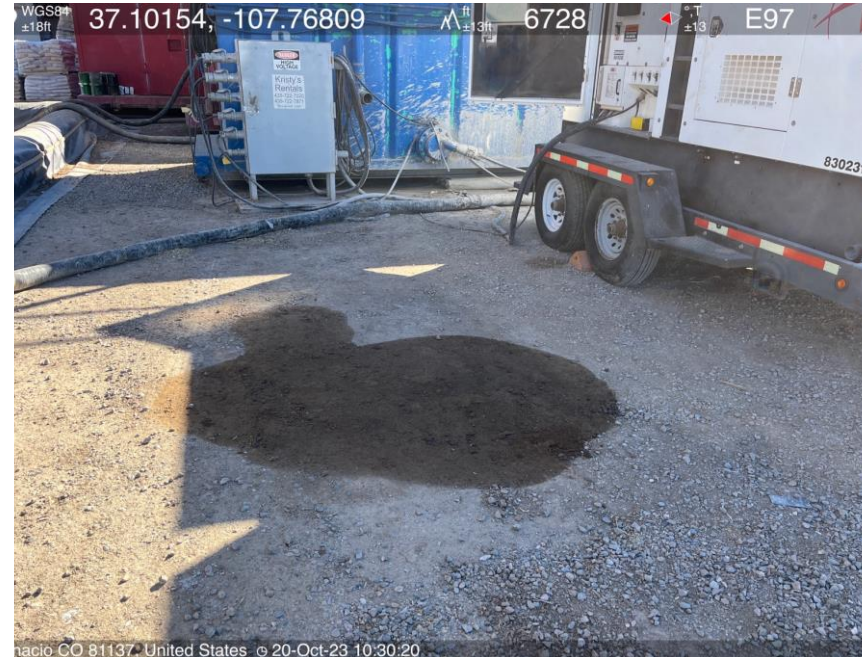
Photo #6 New impact on west side of rig.

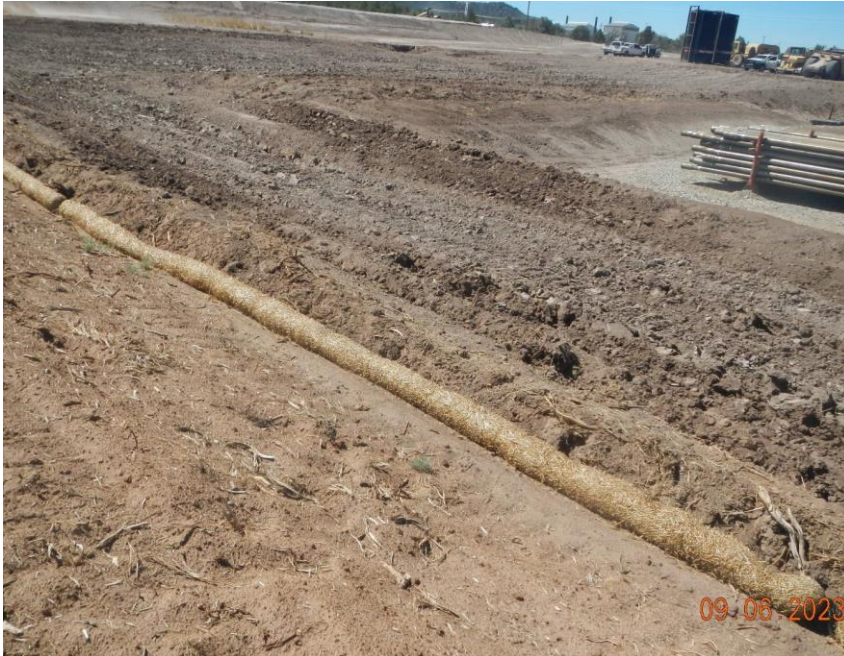
Photo #7 Corrective action identified on 9/8/2023. Stacking of wattles not to accepted specifications.

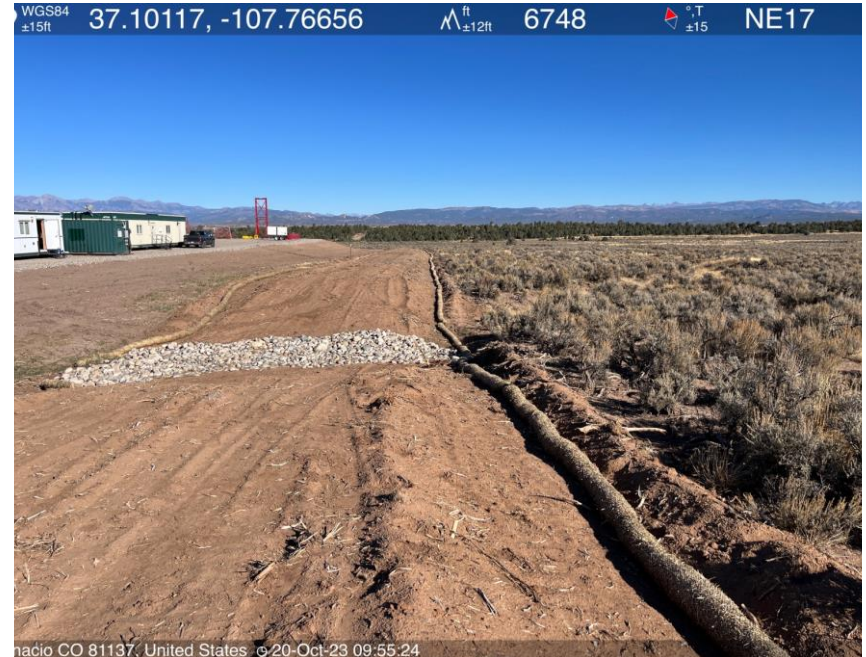
Photo #8 Corrective action not completed. Wattles not installed/staked to accepted specifications.

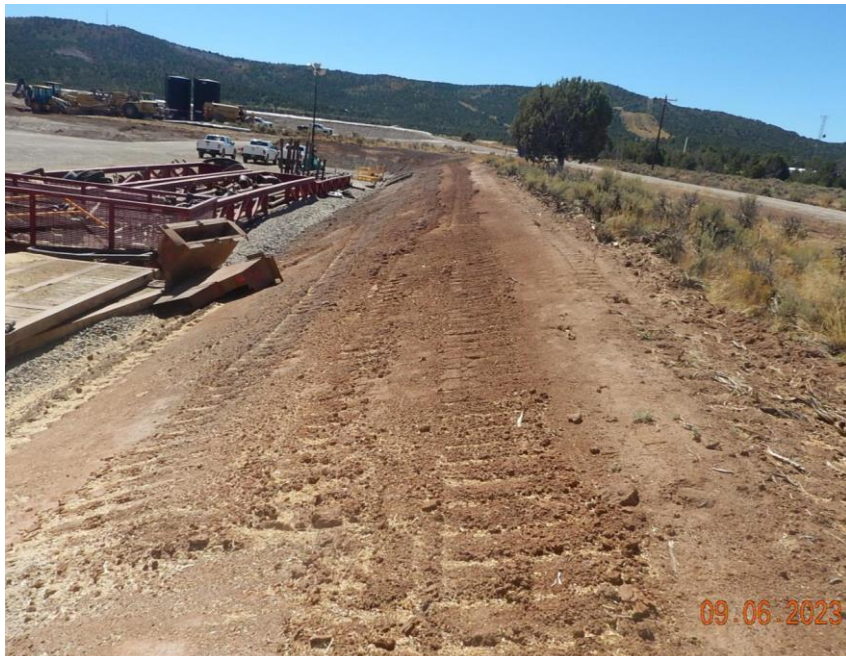
Photo #9 Corrective action identified, 9/8/2023. No perimeter wattle installation.

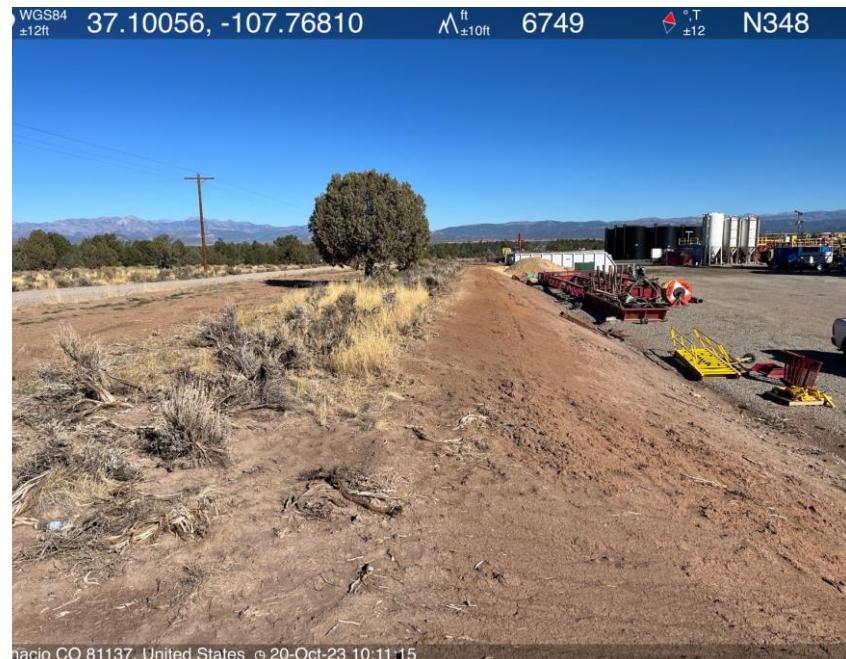
Photo #10 Corrective action not completed. No perimeter wattle installation along west side of well location.

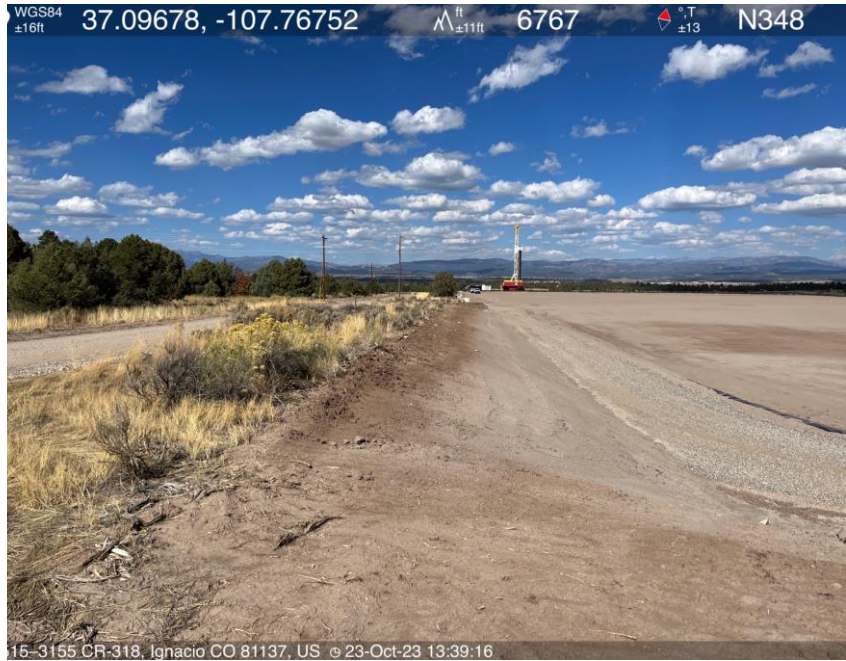
Photo #11 No perimeter wattles along west side of tank pad.

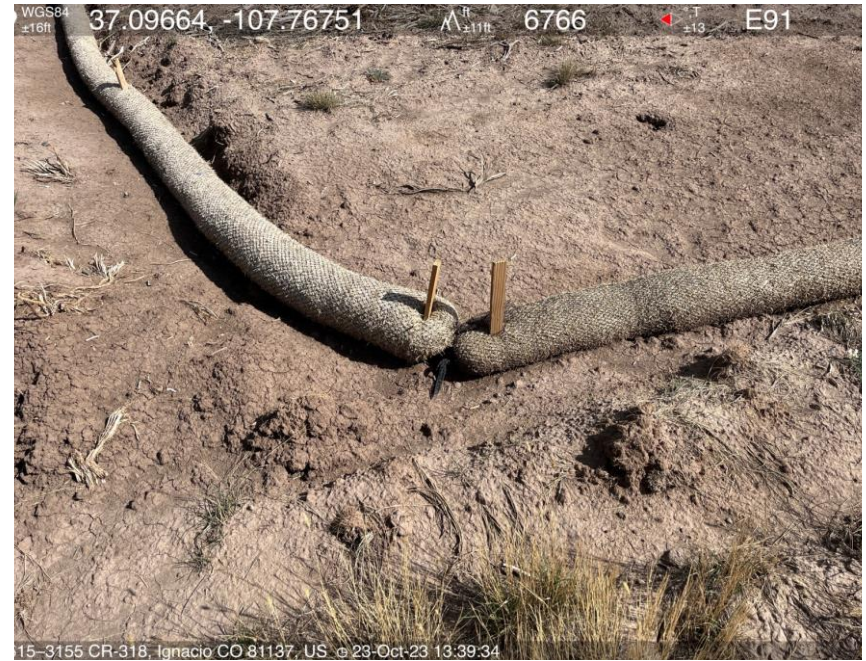
Photo #12 Wattle installation not to accepted specifications.

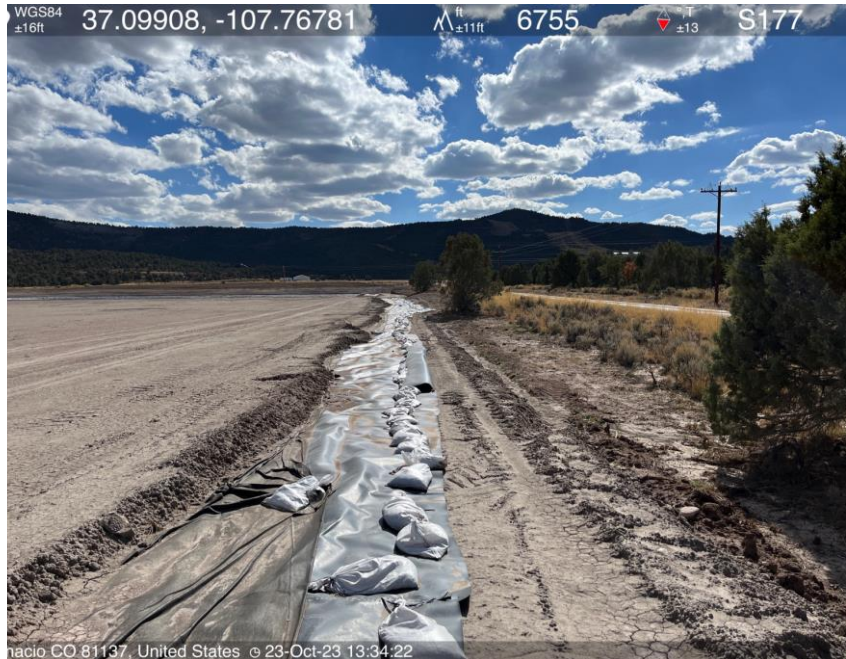
Photo #13 No perimeter wattles along west side of tank pad.

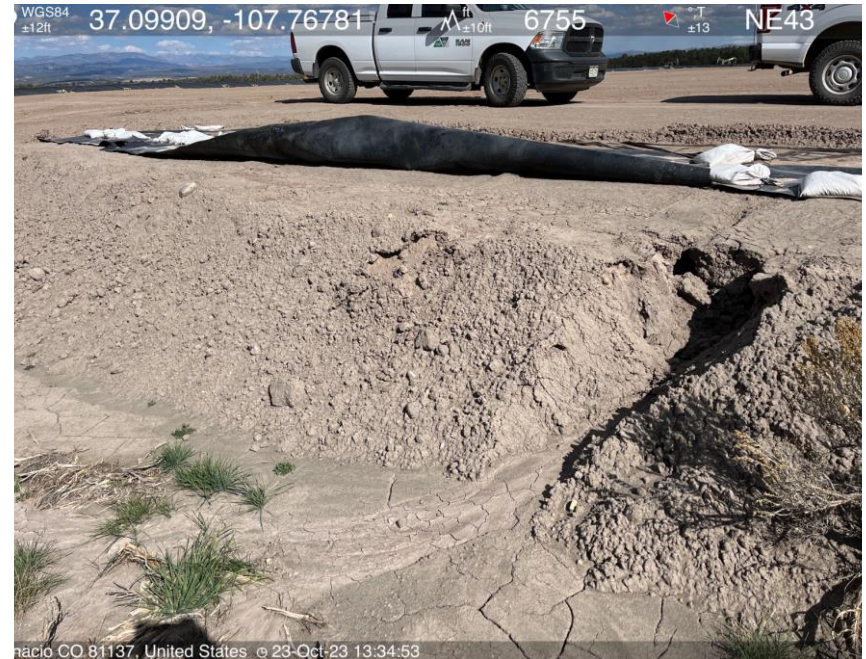
Photo #14 Gulley erosion at northwest entrance to tank pad.

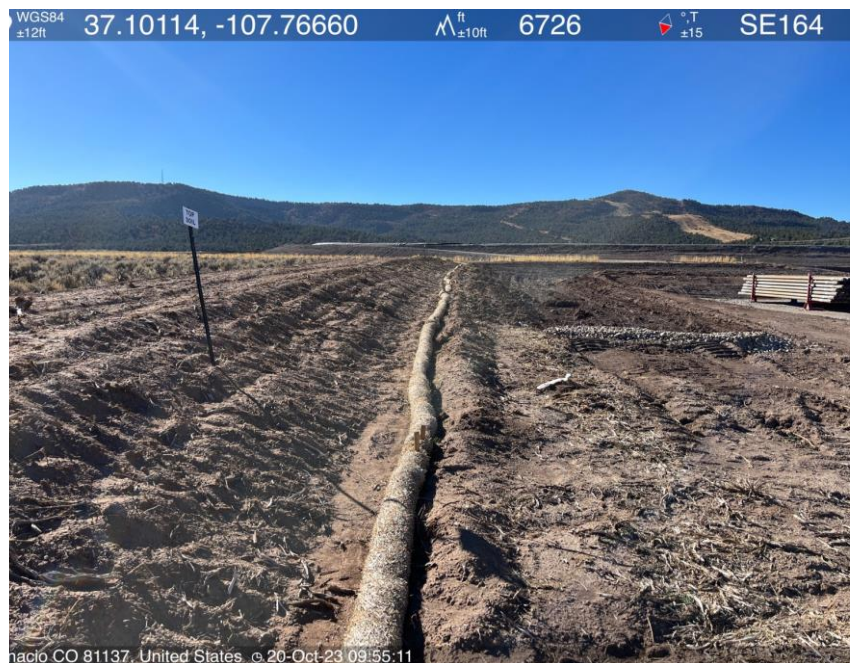
Photo #15 Corrective action identified 9/8/2023. Wattles not installed/stacked to accepted specifications.

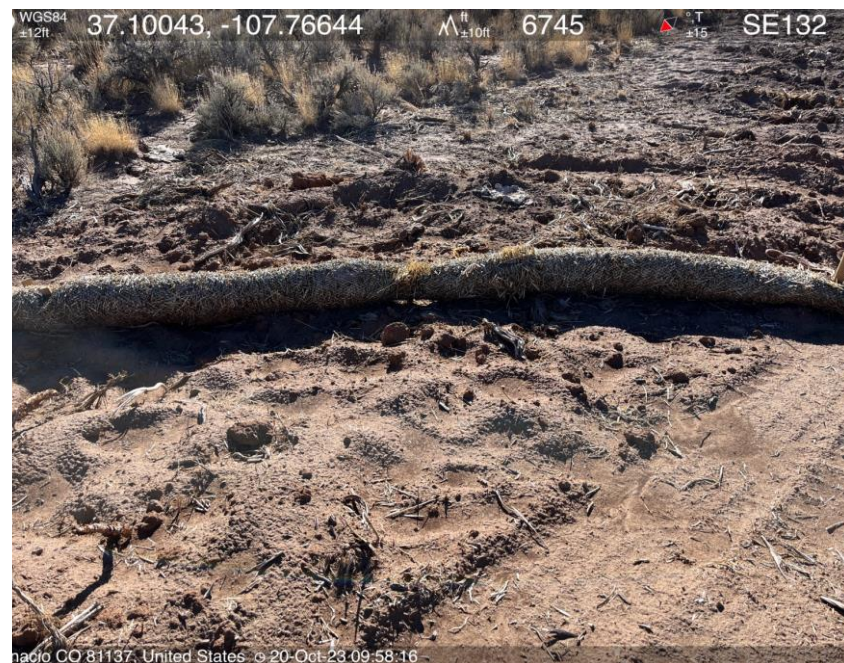
Photo #16 Corrective action not completed. Wattles not installed/stacked to accepted specifications.

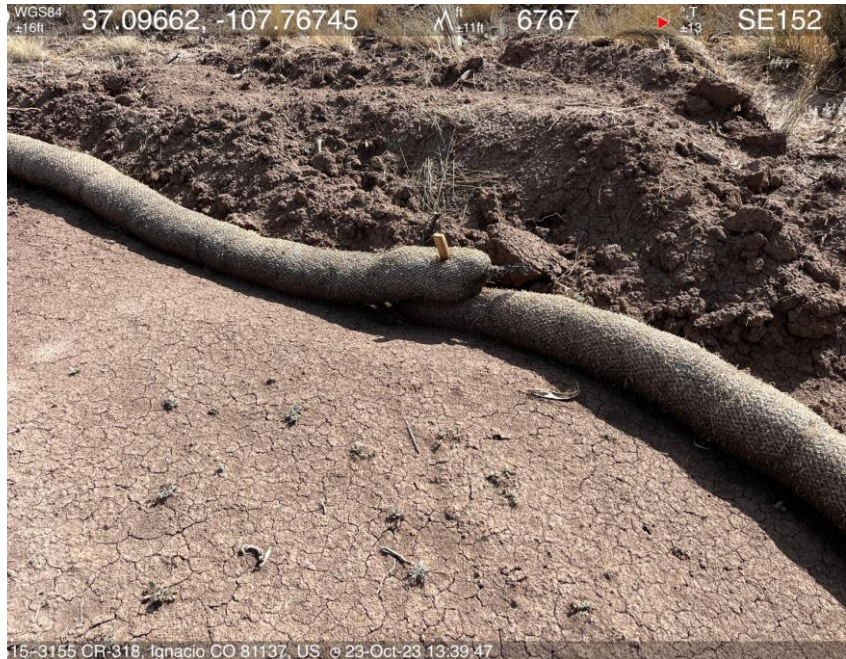
Photo #17 Wattle installation not to accepted specifications.

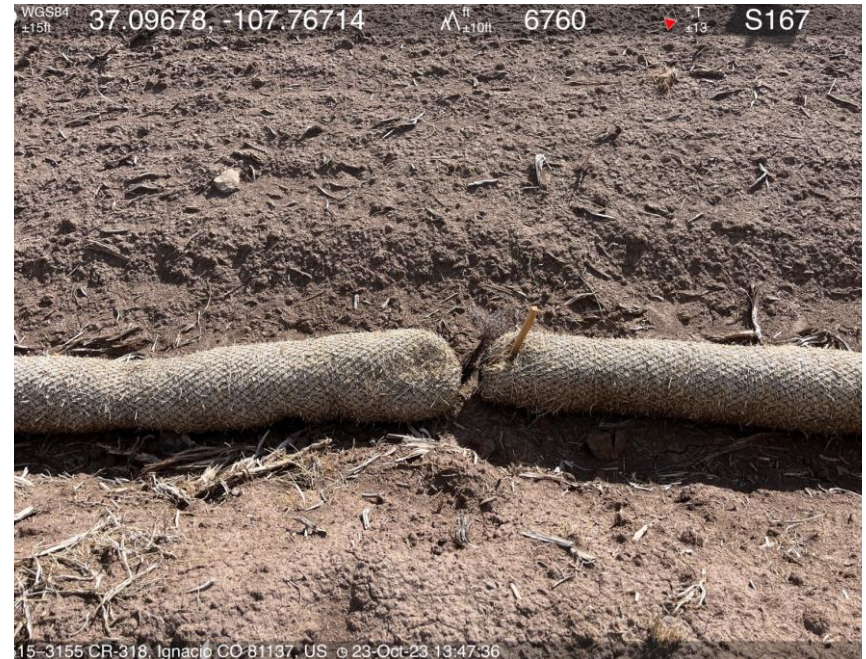
Photo #18 Wattle installation not to accepted specifications.

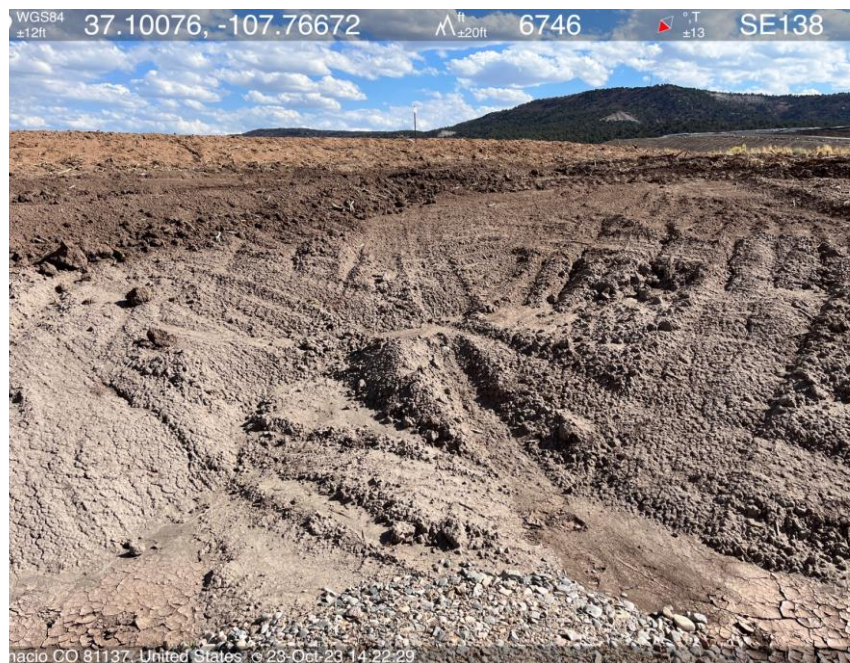
Photo #19 Slope and soils not stabilized, southeast corner of well location.

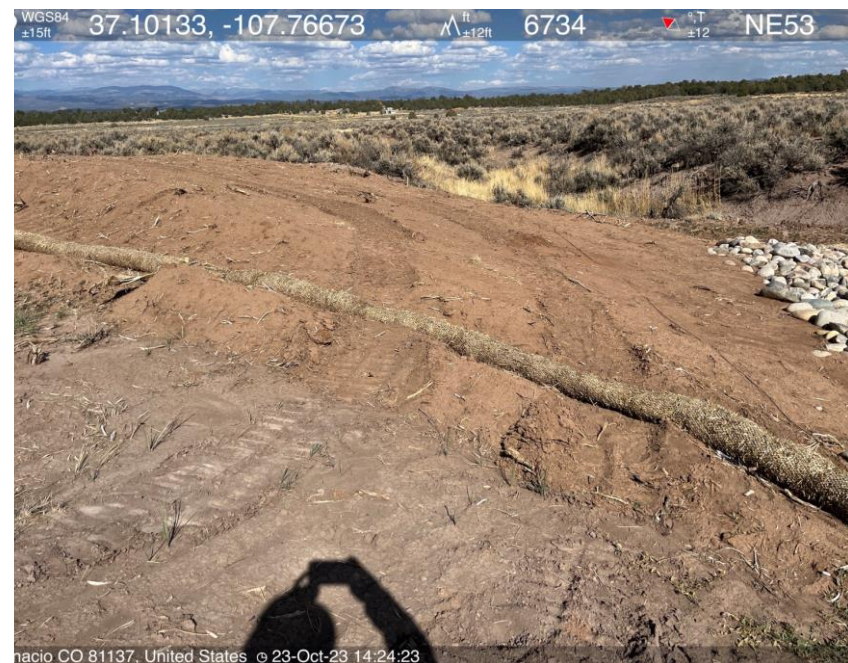
Photo #20 Topsoil stockpile not being protected, equipment tracking atop stockpile and BMPs, no signage in this area.

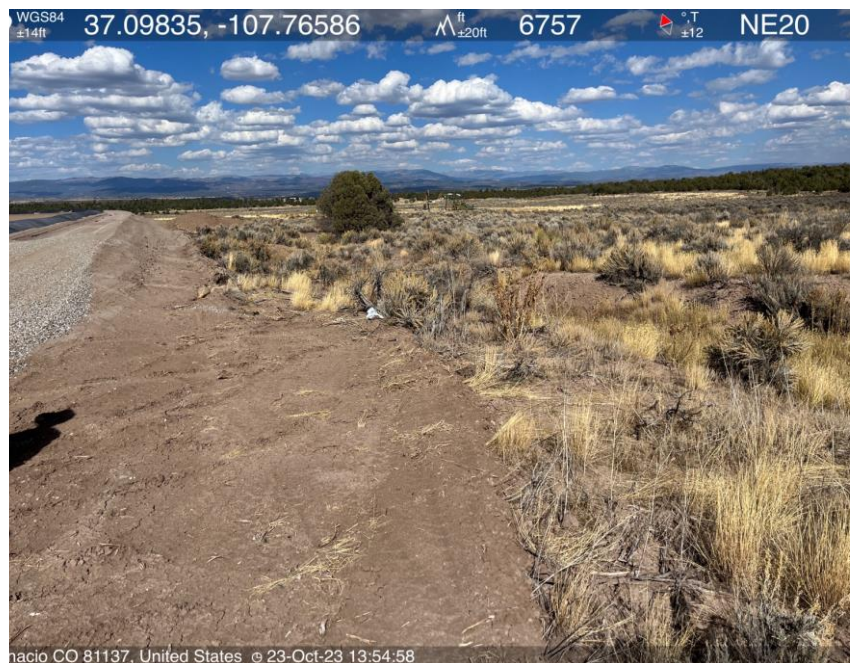
Photo #21 No perimeter wattle installation along east side of tank pad.

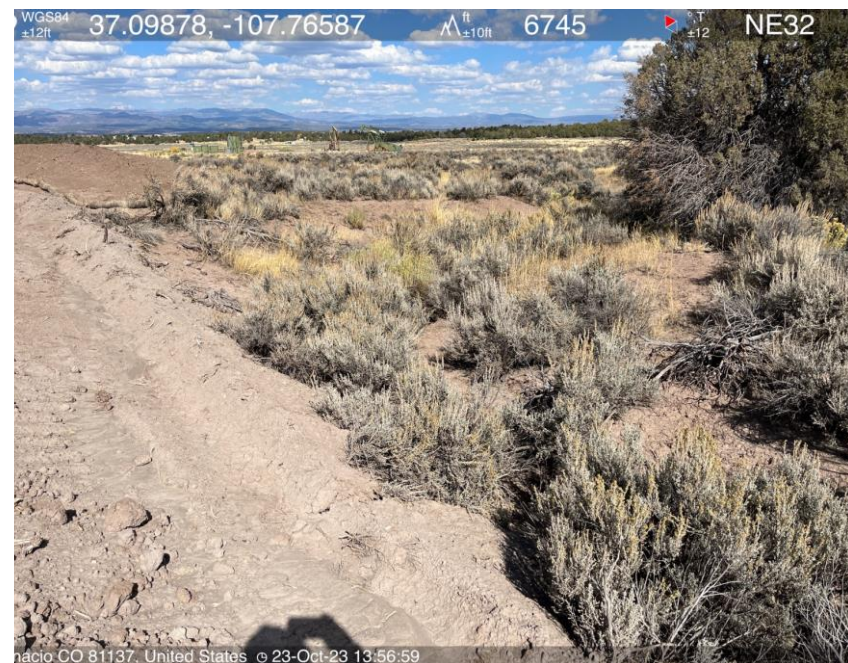
Photo #22 No perimeter wattle installation along east side of tank pad. Non-compacted windrowed soil next to surface drainage.

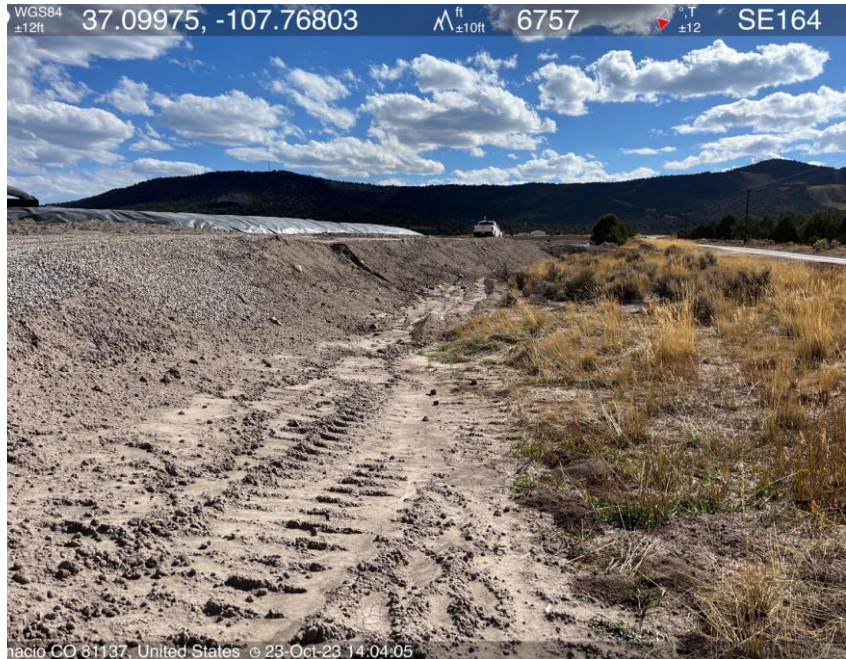
Photo #23 No perimeter wattle installation along northwest side of tank pad.

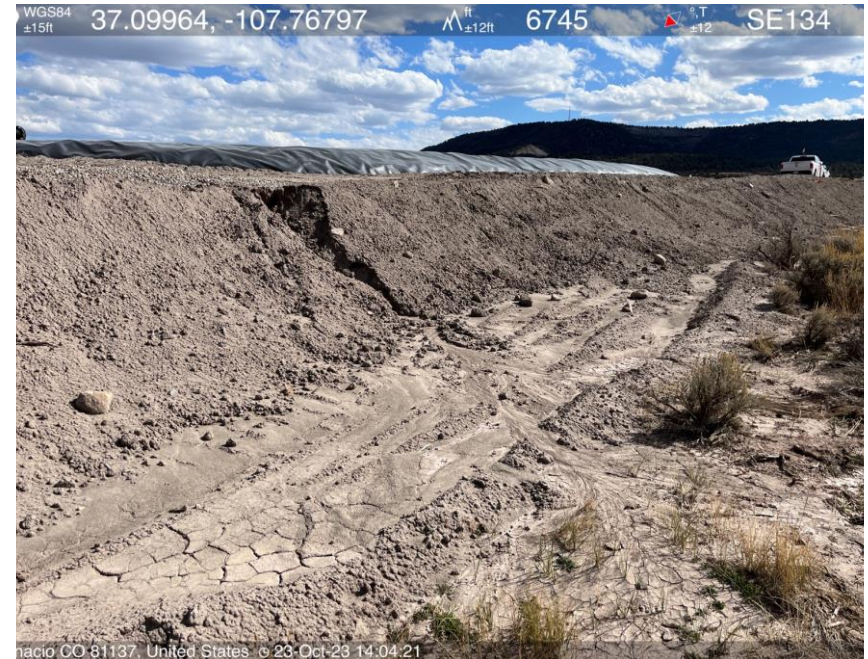
Photo #24 No perimeter wattle installation, active gully erosion along northwest side of tank pad.

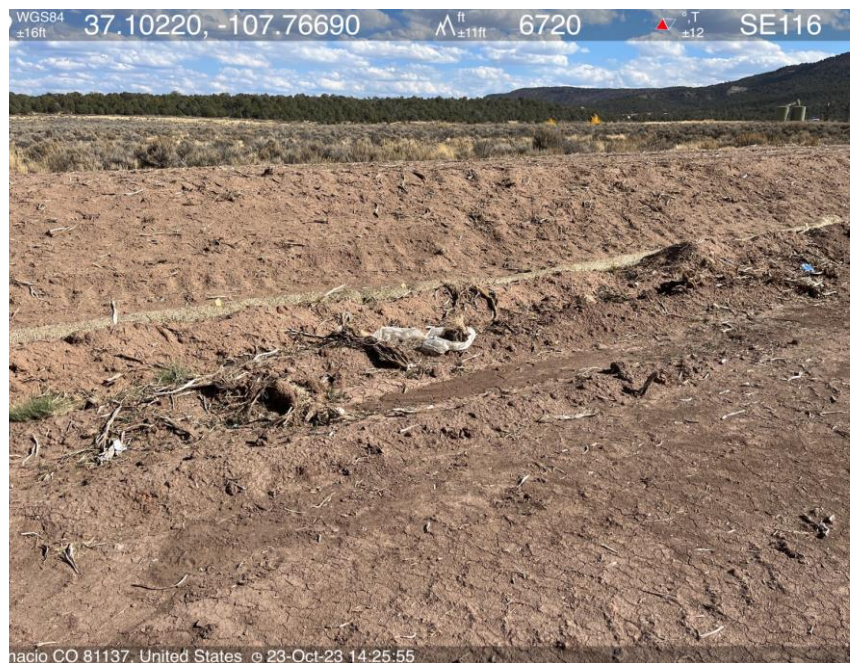
Photo #25 Trash on ground along east side of well location.

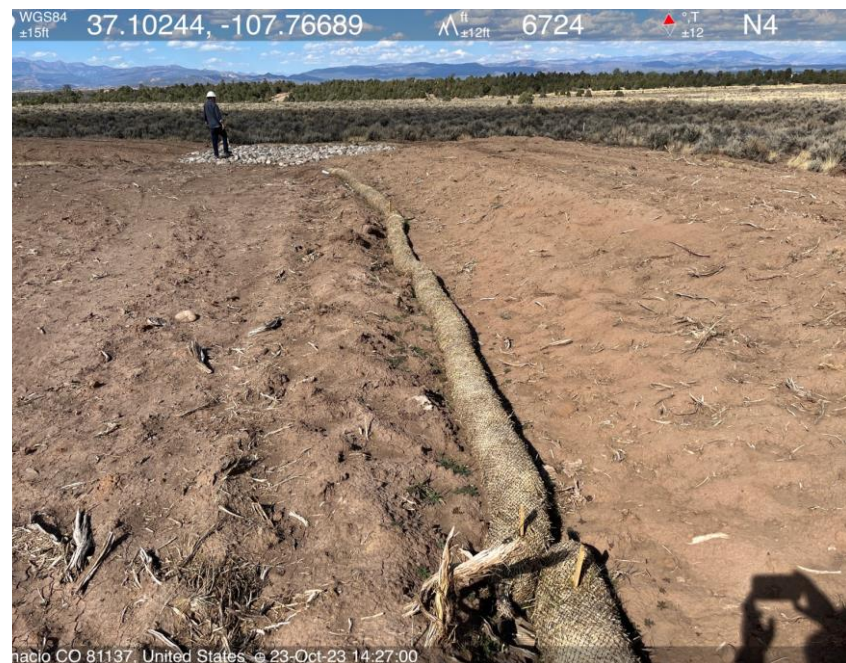
Photo #26 Wattle installation not to accepted specifications, 2 stakes installed in a 50-ft. roll.

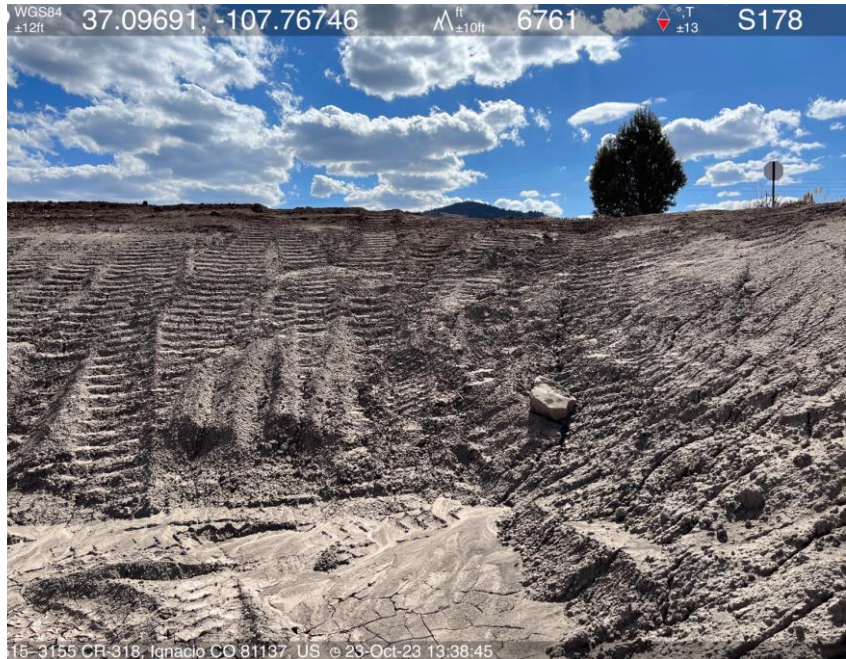
Photo #27 Vertical dozer tracking, however slopes not stabilized.

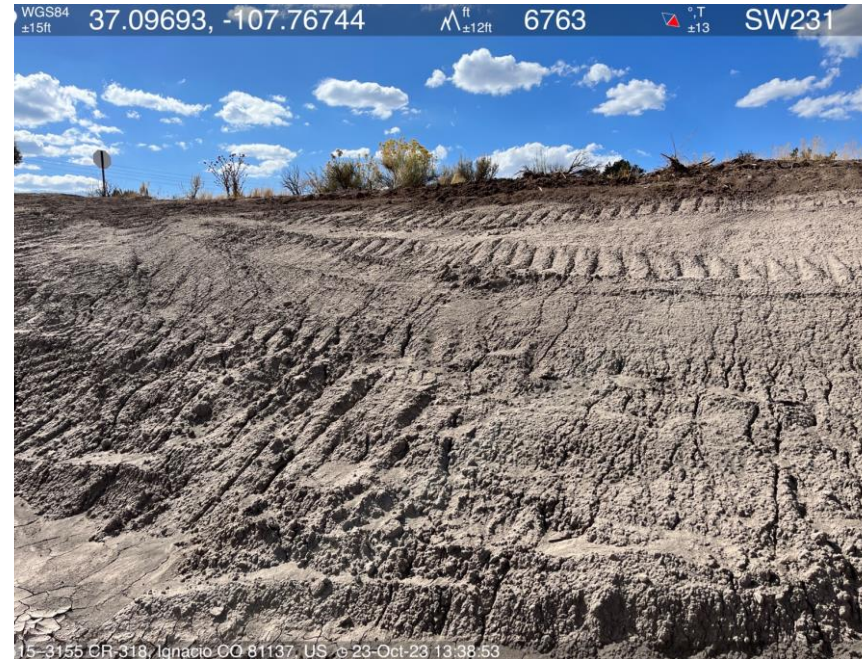
Photo #28 Horizontal dozer tracking, slopes not stabilized.

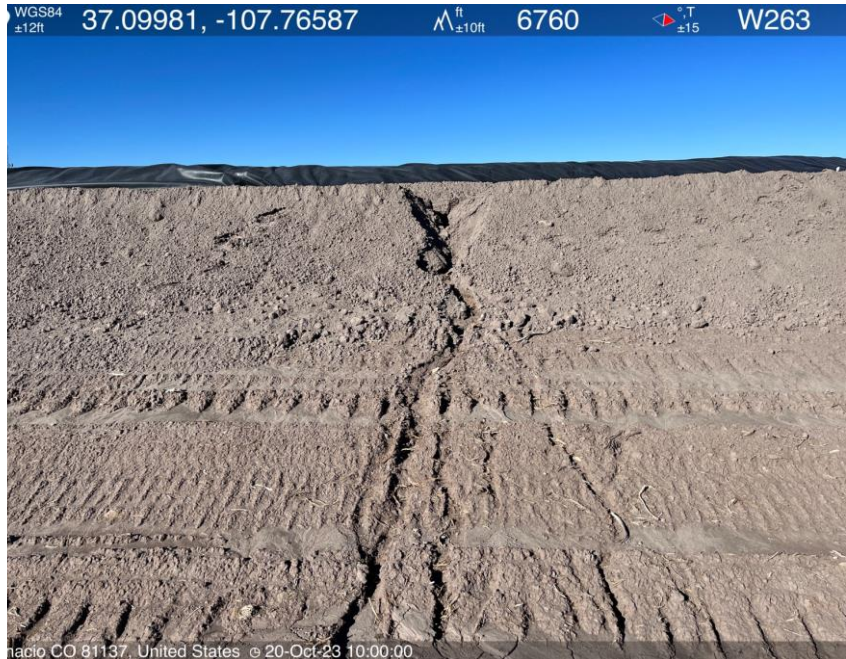
Photo #29 Visible erosion and sediment migration on 9/8/2023. Horizontal dozer tracks.

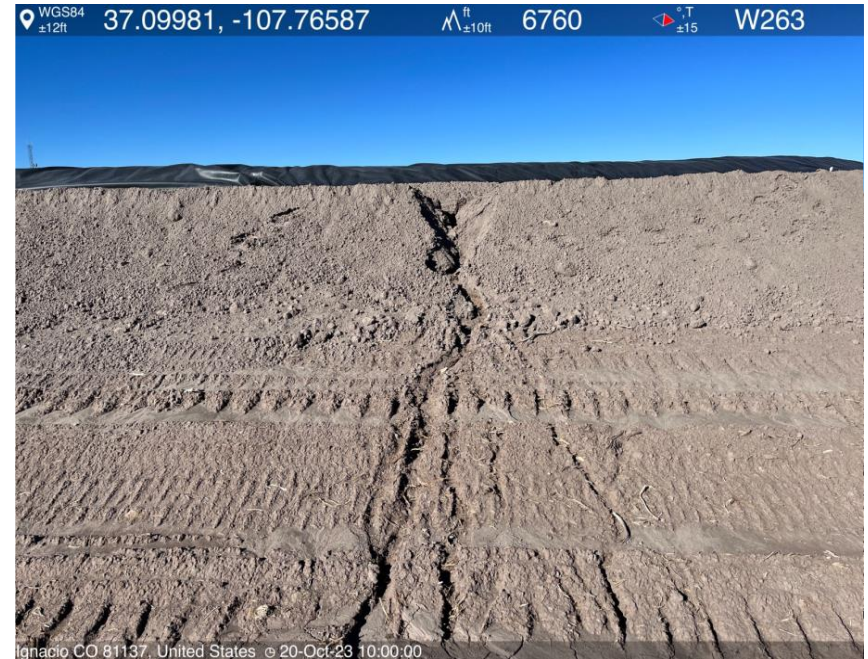
Photo #30 Corrective action not completed. Horizontal dozer tracks.

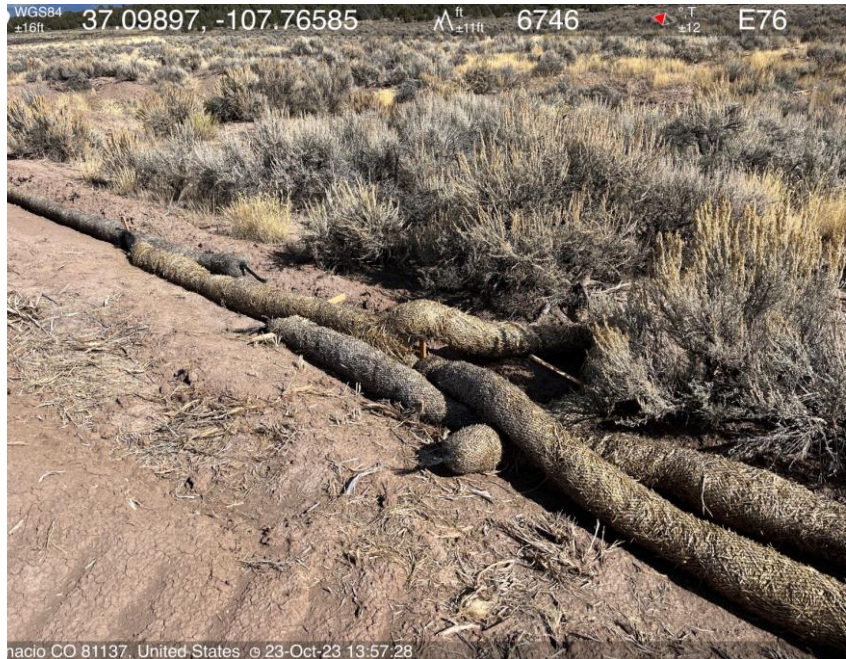
Photo #31 Wattle installation not to accepted specifications, along east side of tank pad.

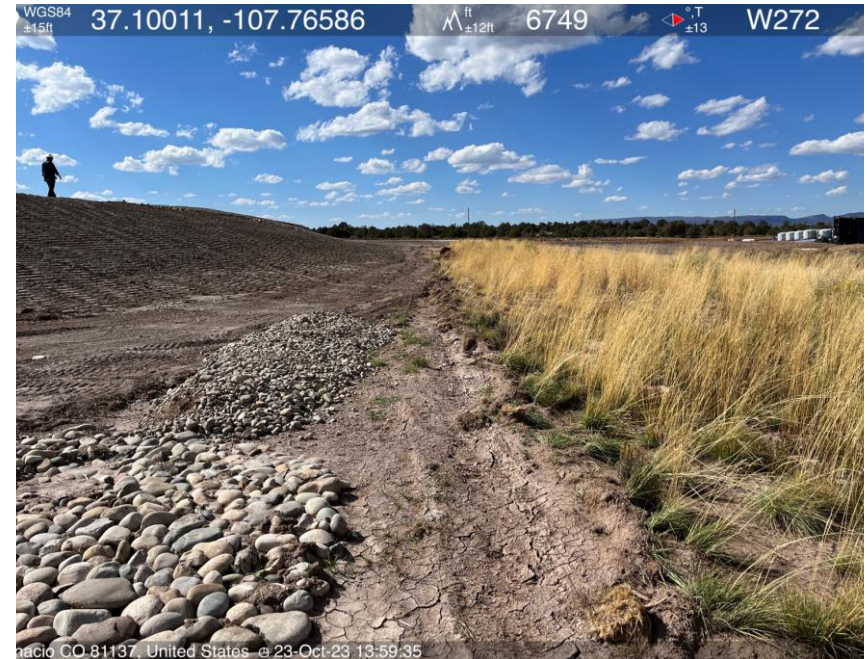
Photo #32 No perimeter wattle installation along north side of tank pad.

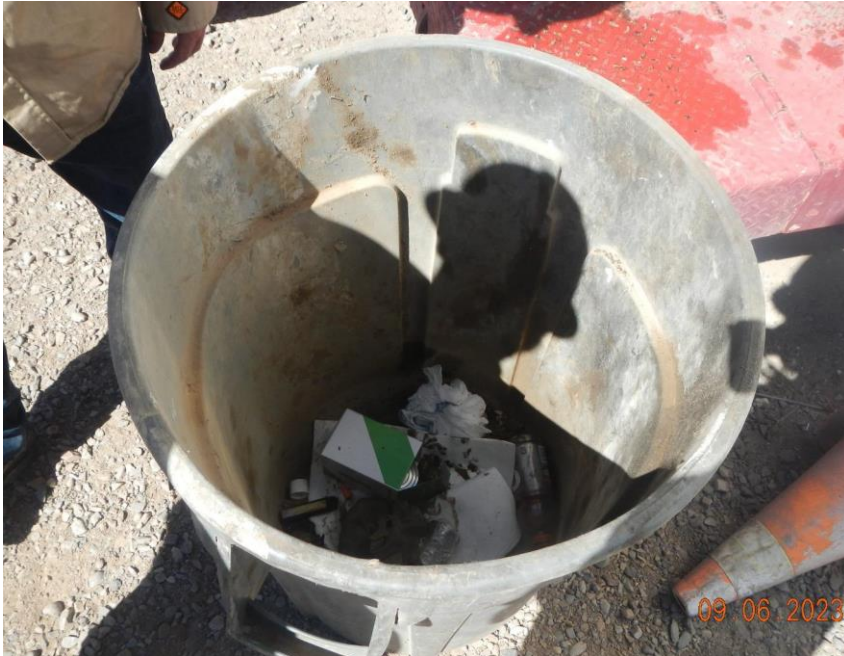
Photo #33 Corrective action identified during 9/8/2023.

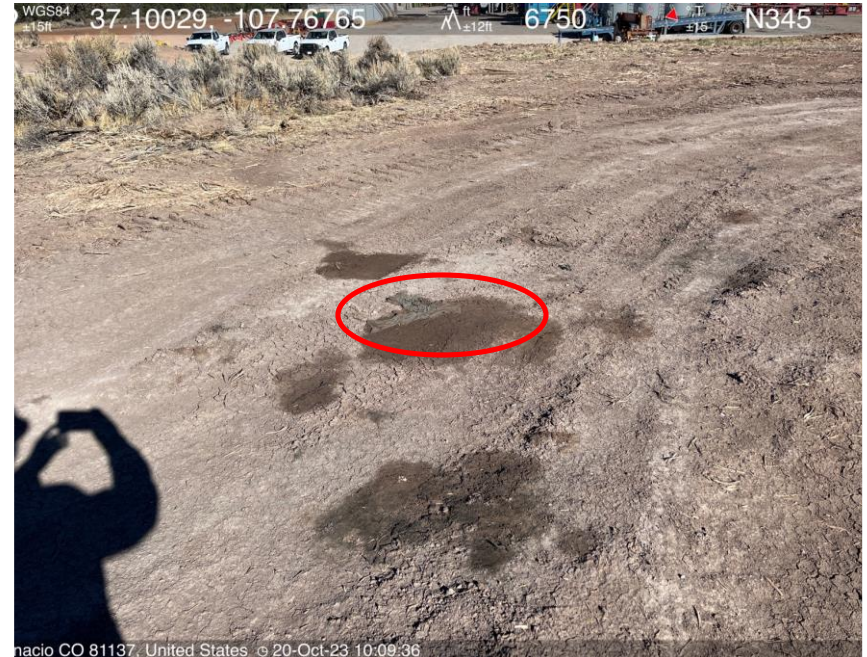
Photo #34 Oily rag within red circle on photo.

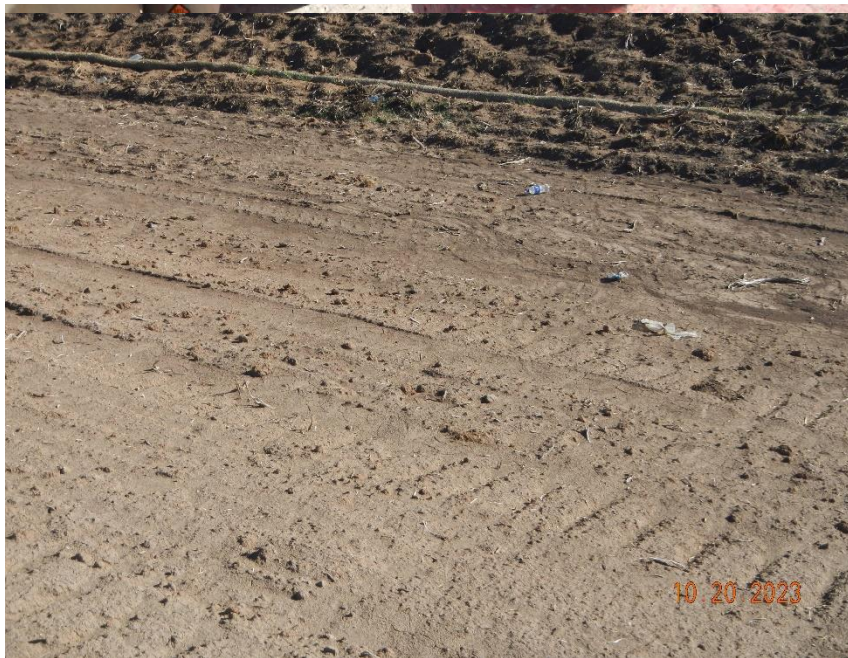
Photo #35 Corrective action on 9/8/2023. Trash observed around the northeast portion of the location.

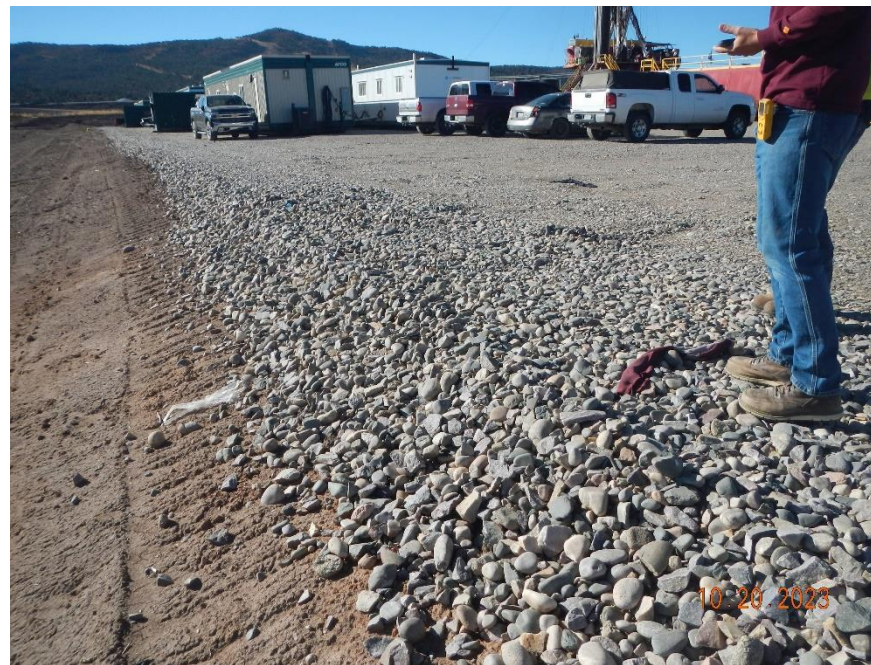
Photo #36 Oily rag at feet of worker, not properly disposed.

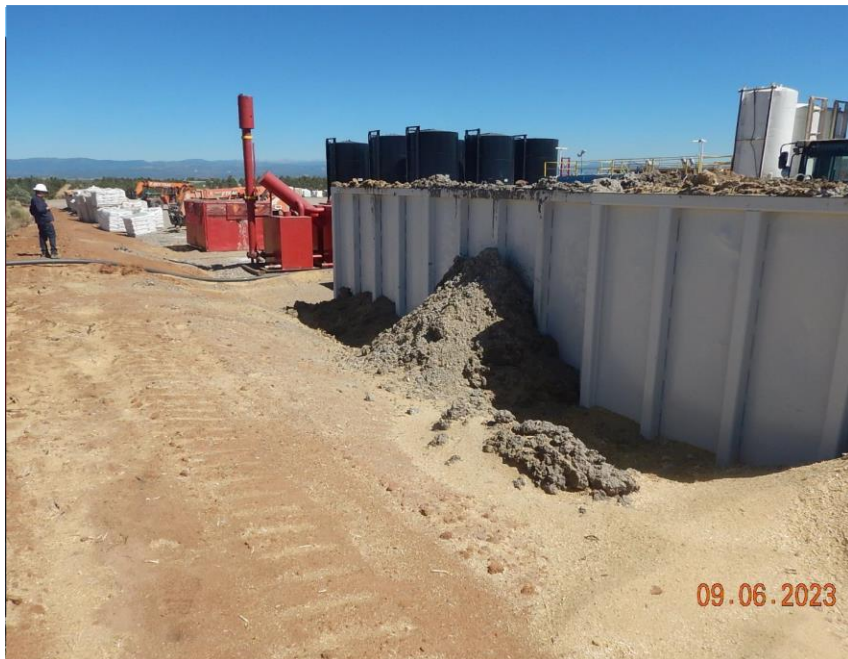
Photo #37 Corrective action identified on 9/8/2023.

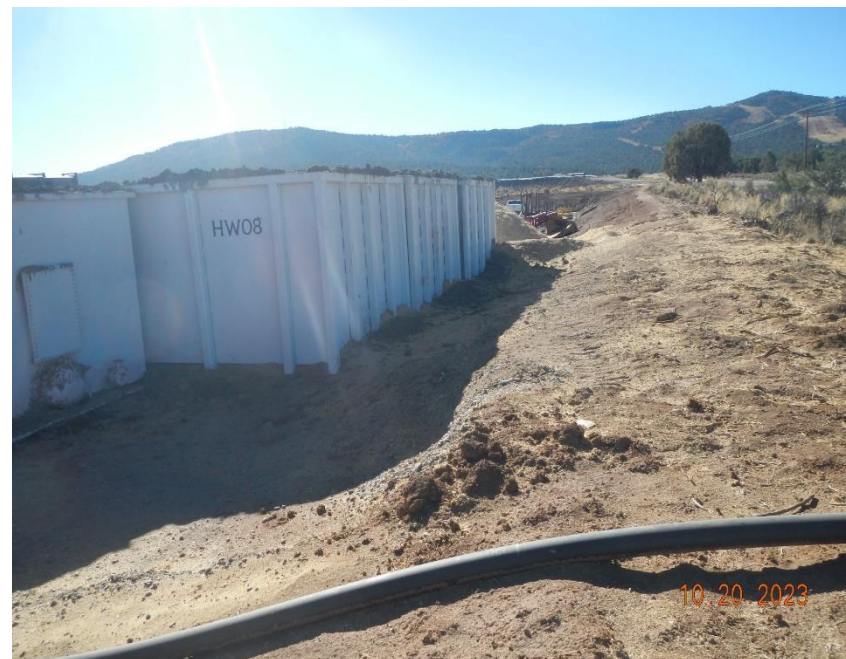
Photo #38 Cuttings removed, increase self-inspection, cuttings continue to escape storage bin.

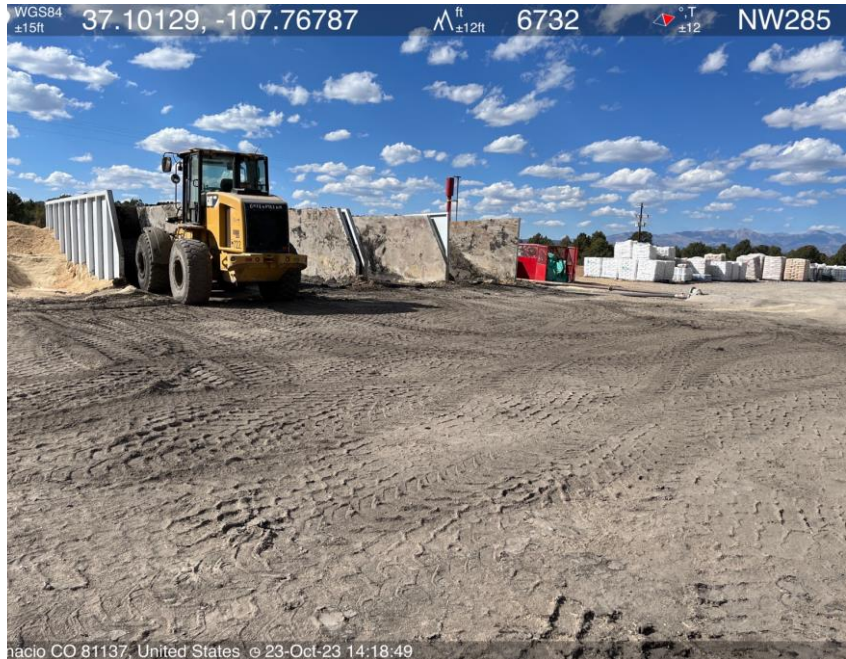
Photo #39 Drill cuttings spread across ground from shaker bin to storage bin.
