Inspection Photos
Nuevida Resources Ardourel 33081718 3HL
API 067-10037

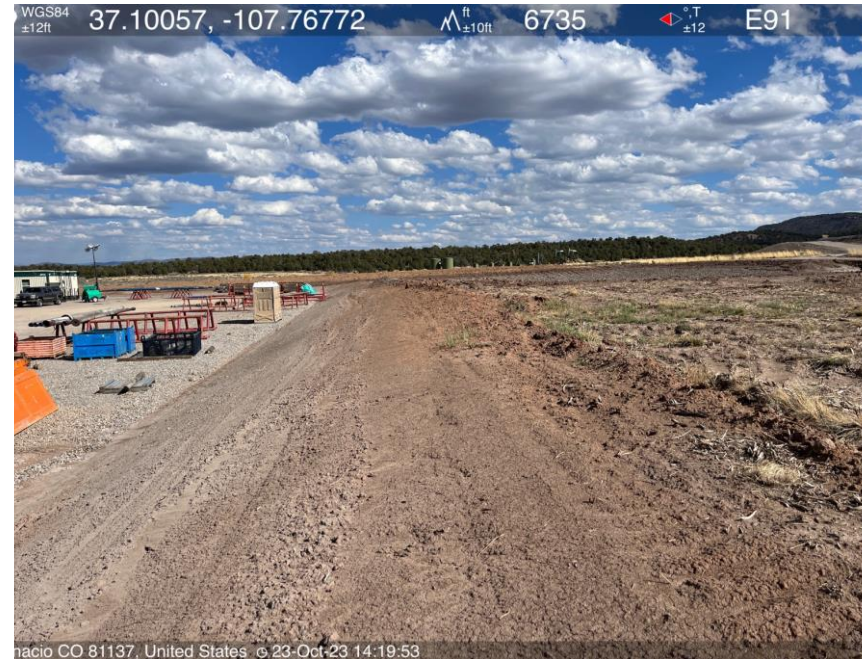
Photo #40 No perimeter wattle installation along south side of well location.

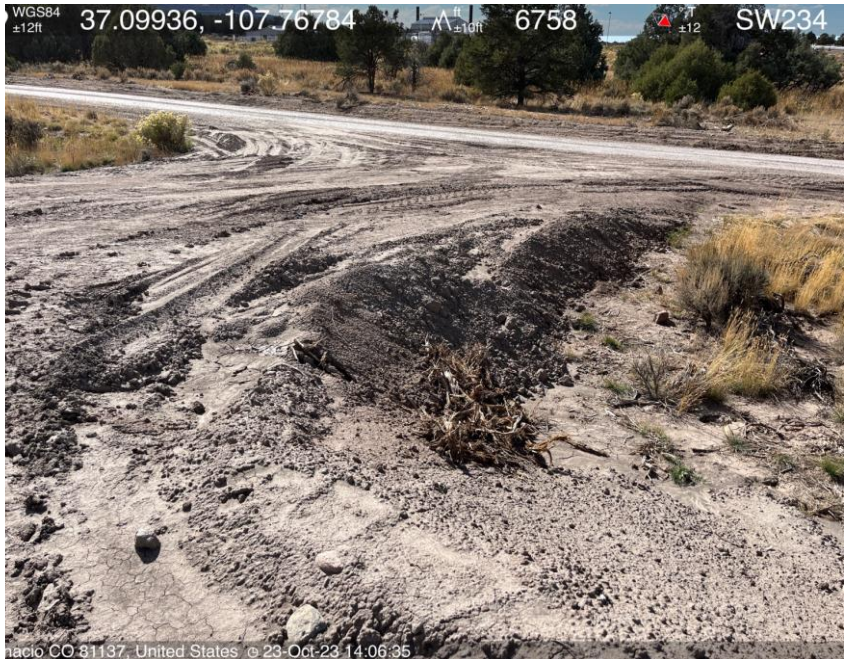
Photo #41 No perimeter wattle installation, unstable fill at entrance to well location.

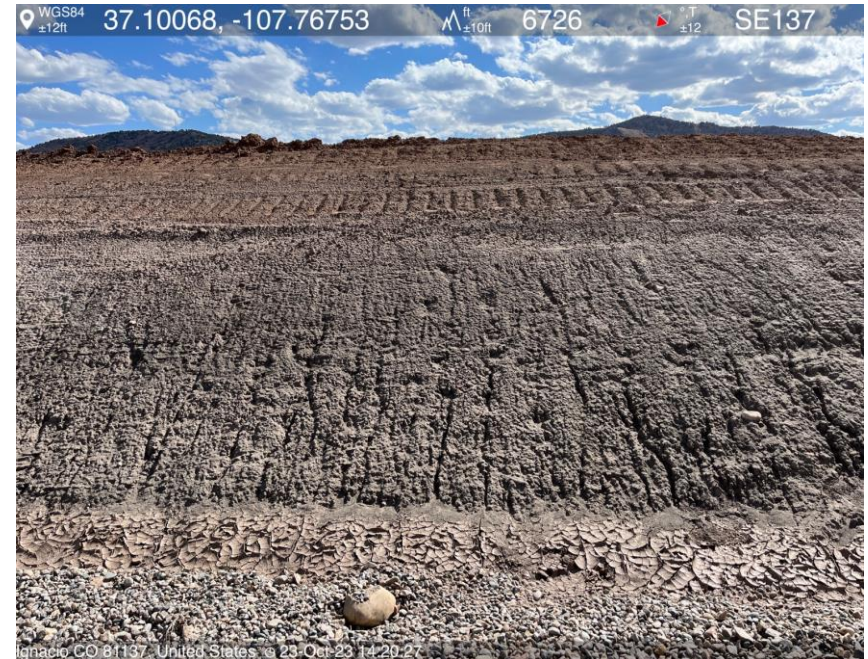
Photo # 42 Rill erosion and sediment migration along north side of well location.

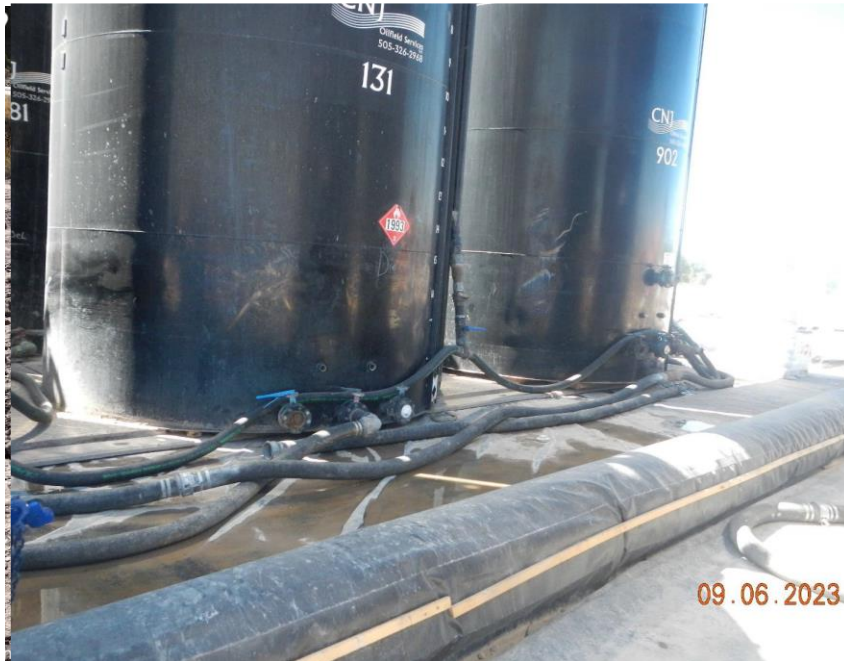
Photo #43 Corrective action identified on 9/8/2023. No contents labeling.

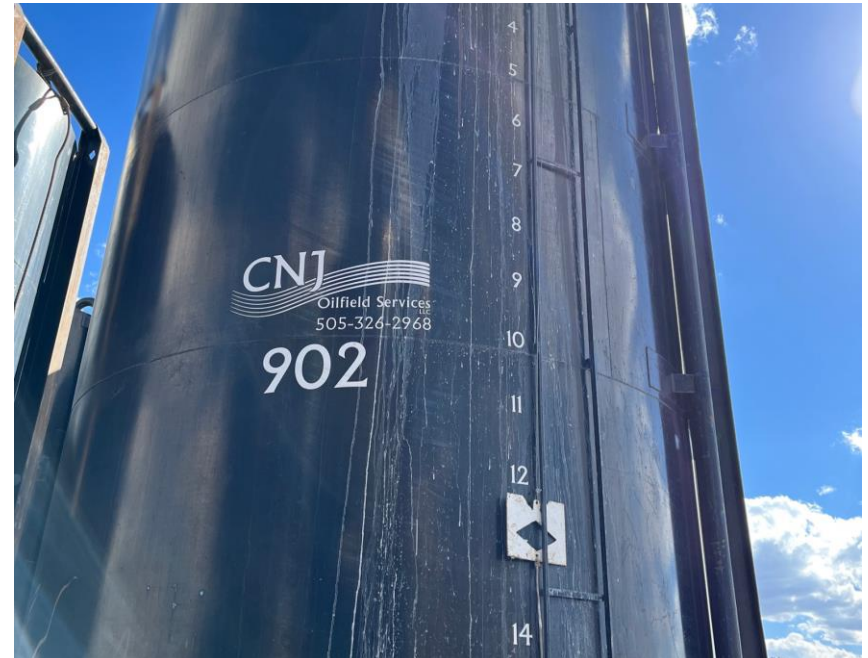
Photo # 44 6-400 bbl tanks in containment on north side of rig, no contents labeling.

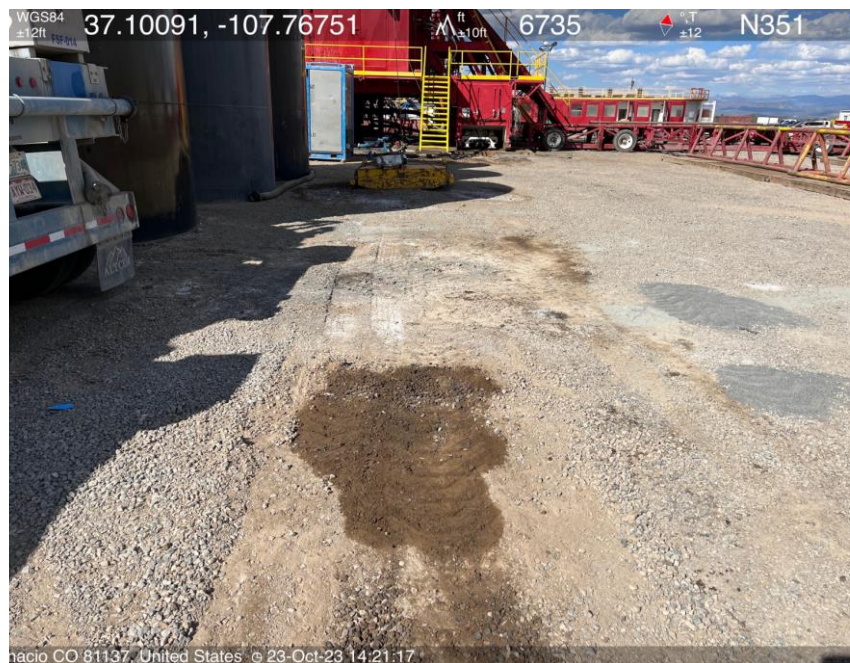
Photo #45 Unsatisfactory spill response, impacted ground at southeast side of rig.

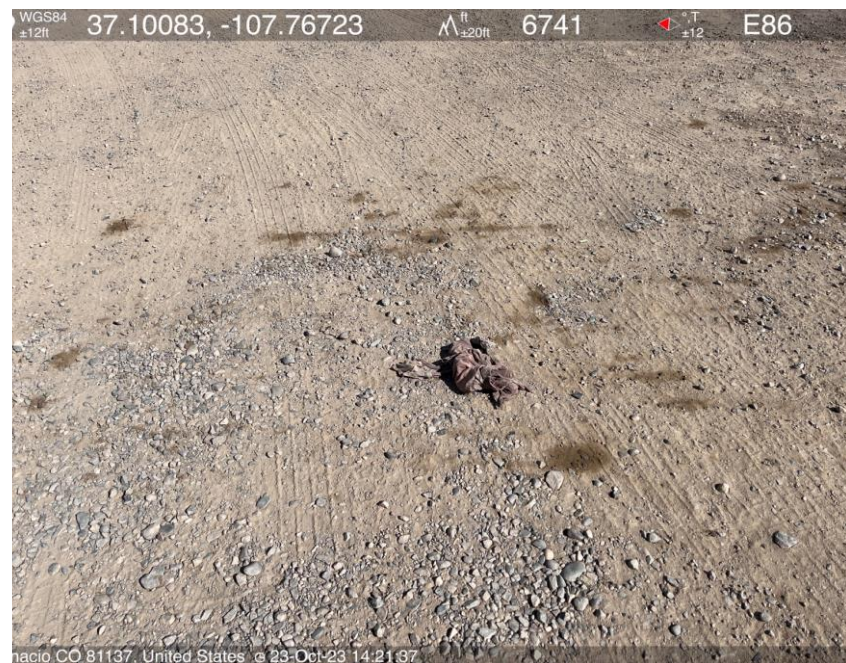
Photo #46 Oily rag not properly disposed.

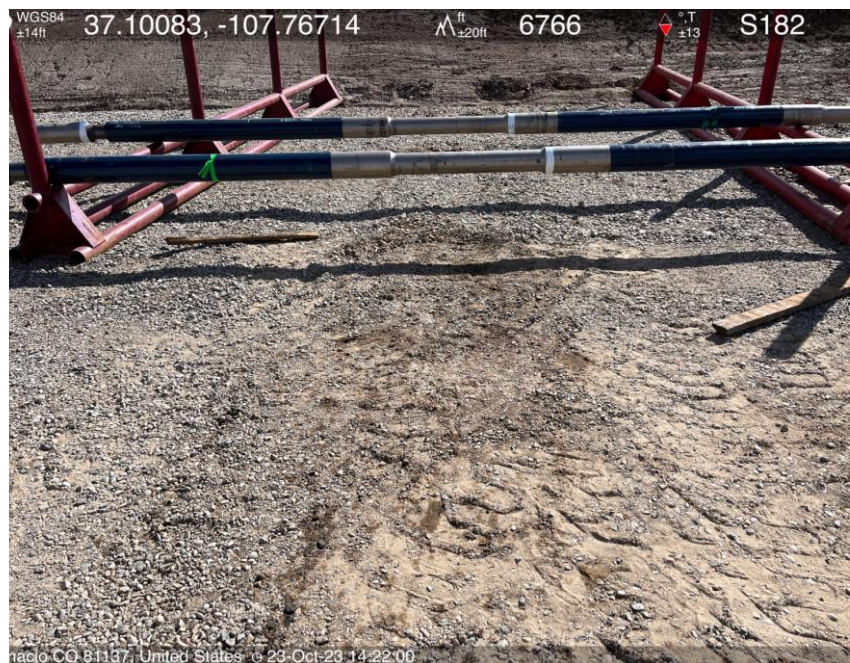
Photo #47 Impacted ground from leaky equipment.

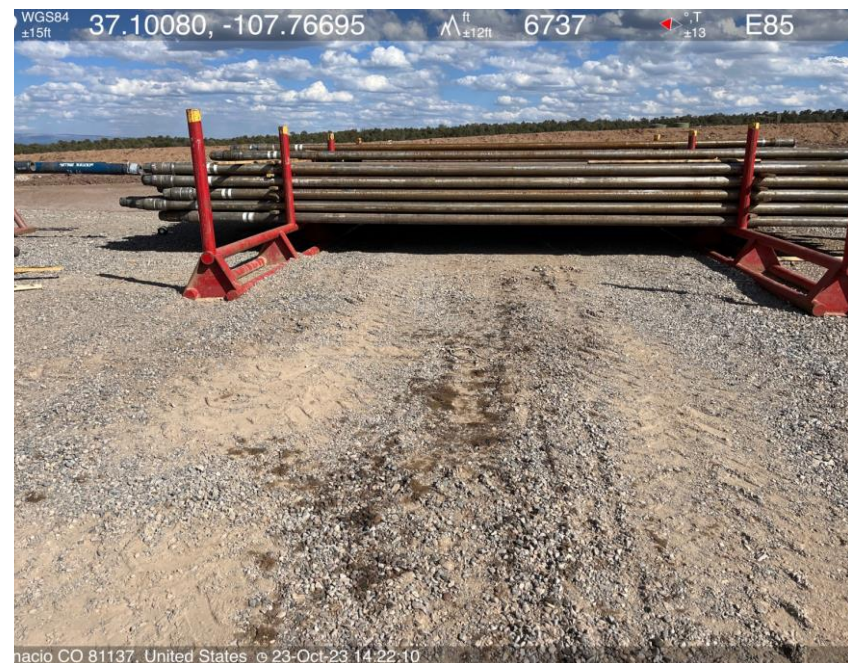
Photo #48 Impacted ground from leaky equipment.

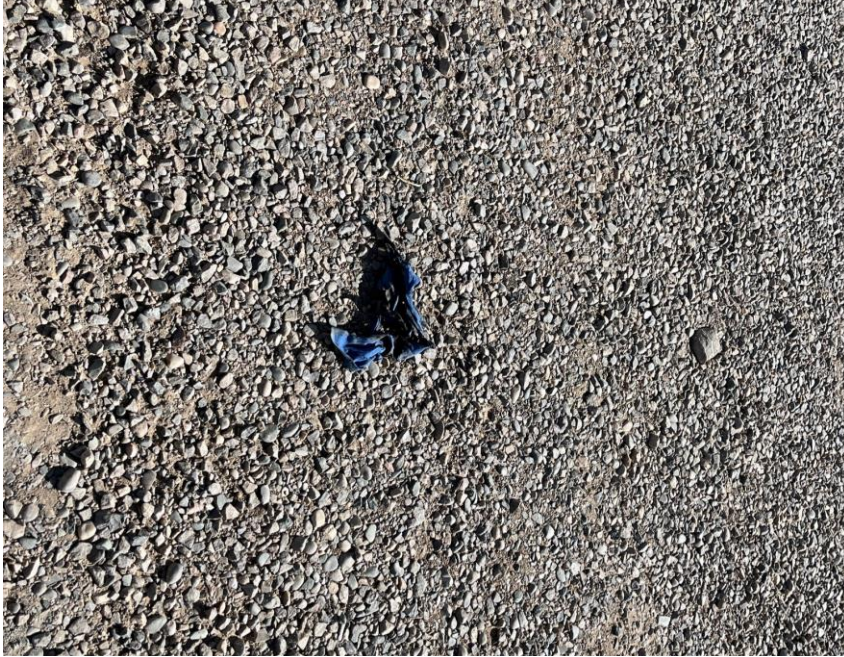
Photo #49 Oily rag not properly disposed, on ground.

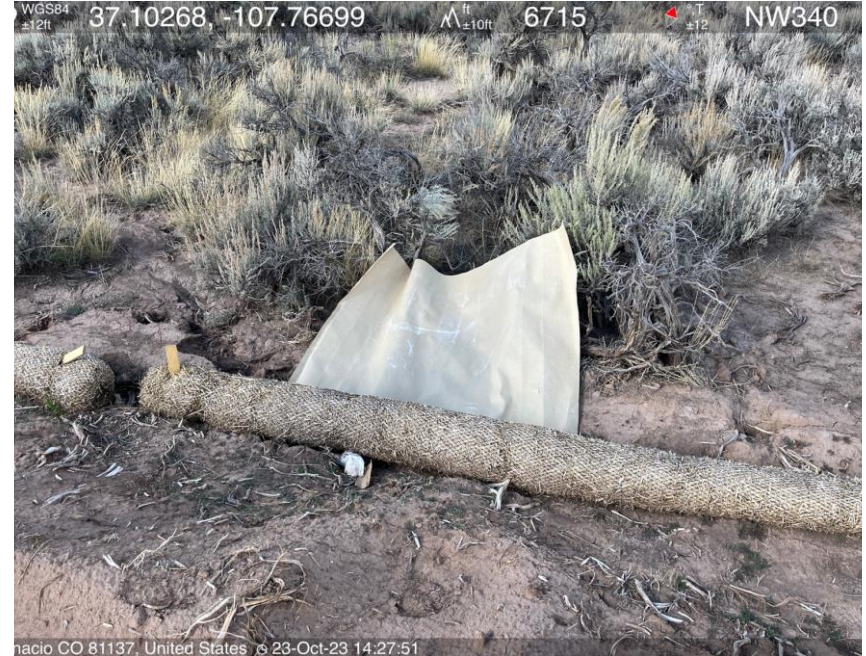
Photo #50 Improper wattle installation, trash on ground along north side of well location.
