Inspection Photos

Location Name: Ant Hill Unit RBC WG #3142

Location ID: #316335

Inspection Date: October 24, 2023

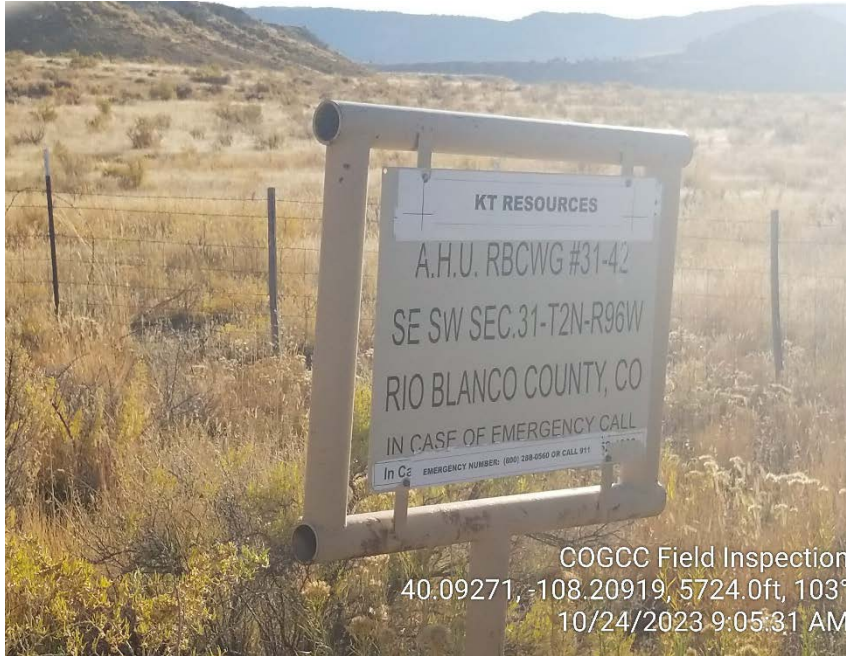
Photo #1 – Sign at entrance to pad.

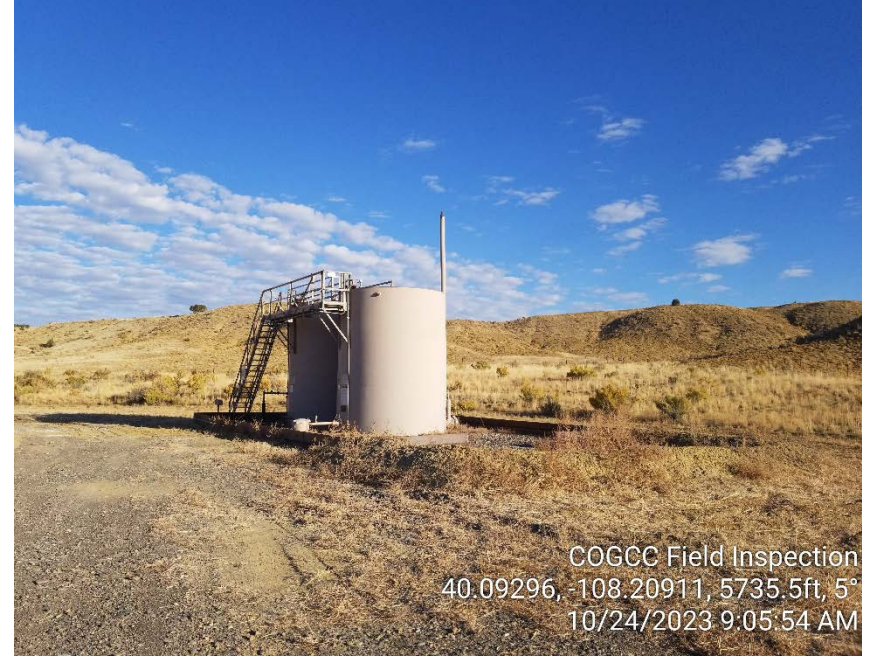
Photo #2 – View of tank battery from SE. Desktop calculation of secondary containment area volume is approximately 250-350 bbls assuming 1800 square feet area and a height of 1-1.5 feet. Vegetative growth along base and berms indicates that the berm is permeable. No liner was observed in secondary containment area during inspection.

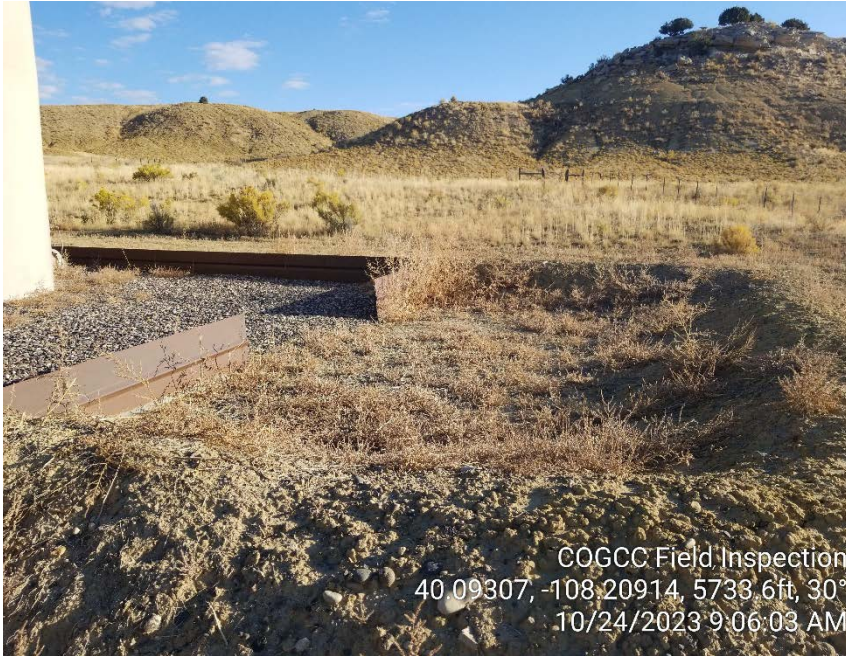
Photo #3 - Earthen berm on SE side of secondary containment area is eroded and overgrown.

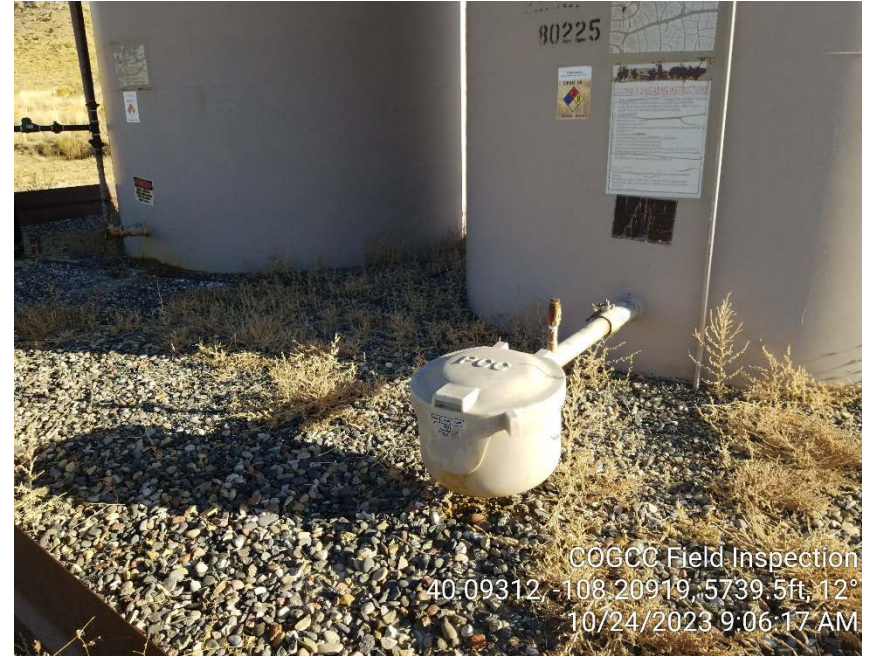
Photo #4 – Uncontrolled vegetation growth inside of tank battery secondary containment area (1).

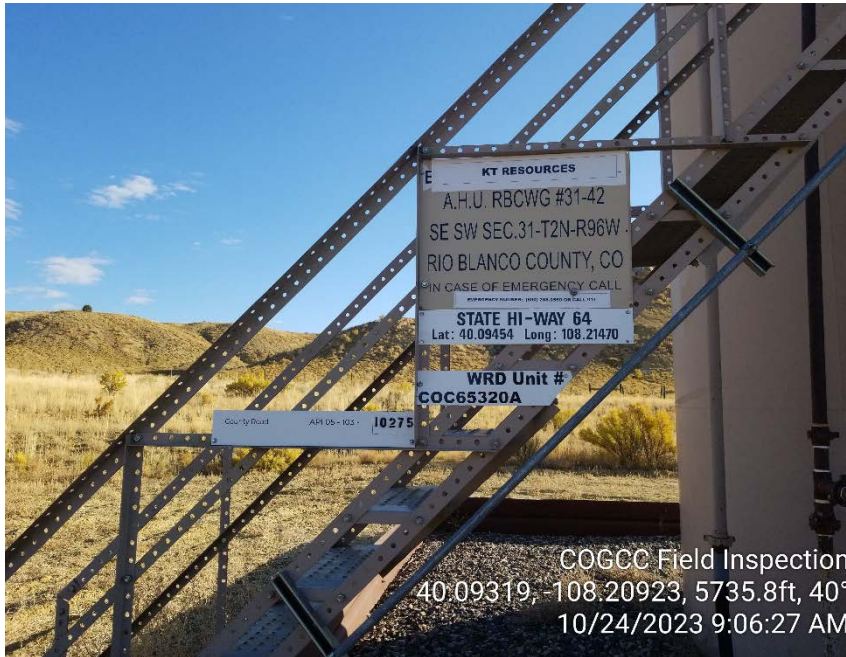
Photo #5 – Tank battery sign.

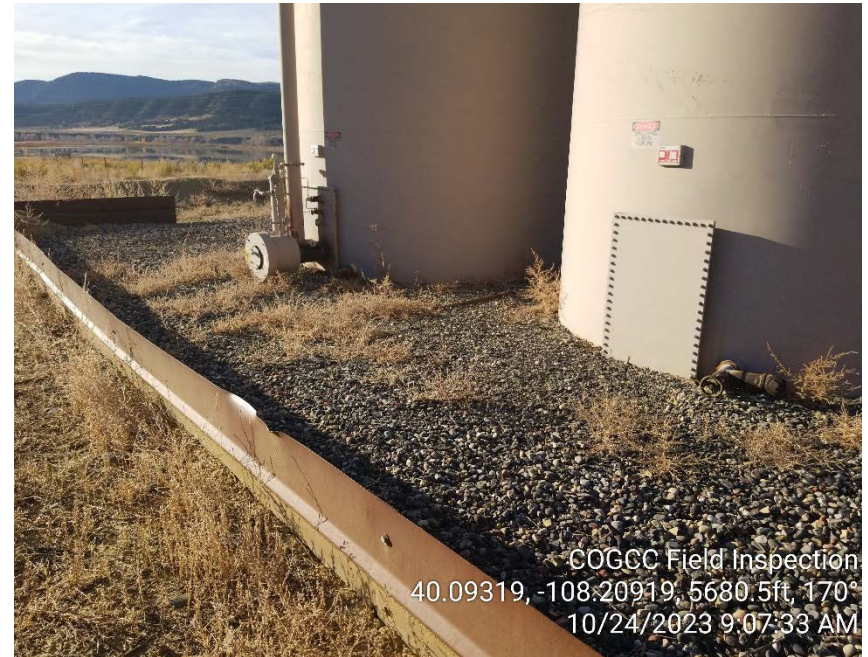
Photo #6 - Uncontrolled vegetation growth inside of tank battery secondary containment area (2).

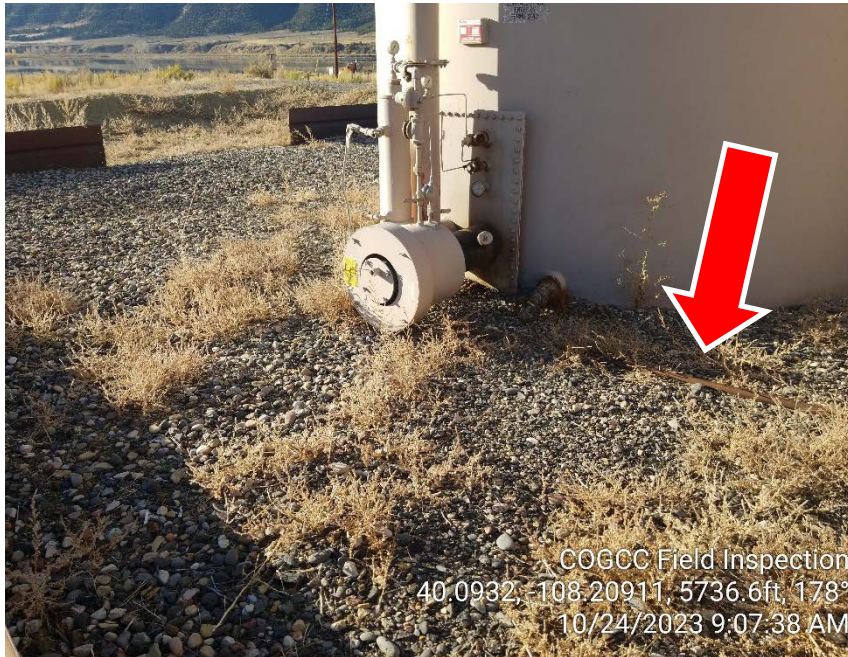
Photo #7 - Uncontrolled vegetation growth inside of tank battery secondary containment area (3). Vegetation growth directly beneath fire tube.

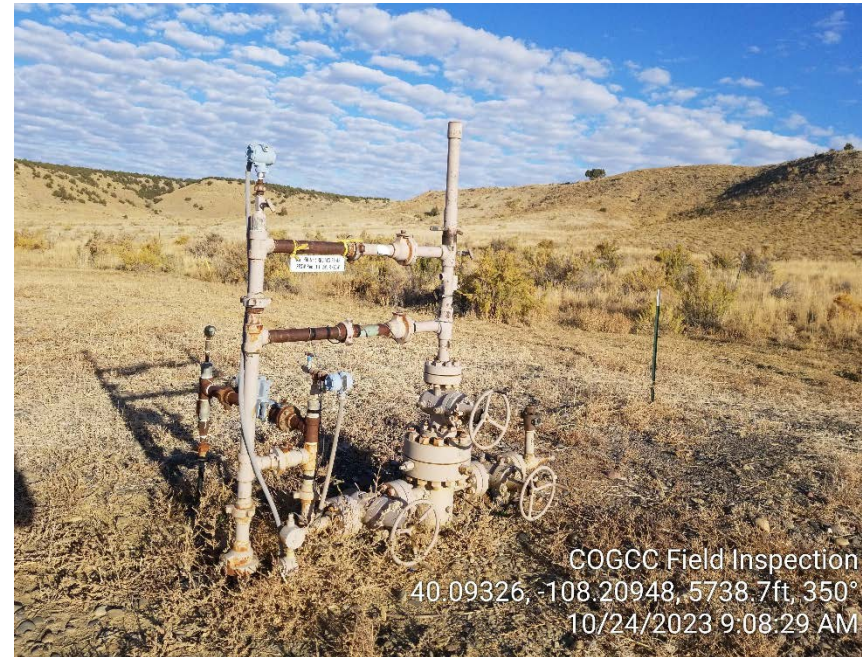
Photo #8 - Uncontrolled vegetation growth at wellhead.

Red arrow denotes location of unused pipe stored inside of secondary containment area.

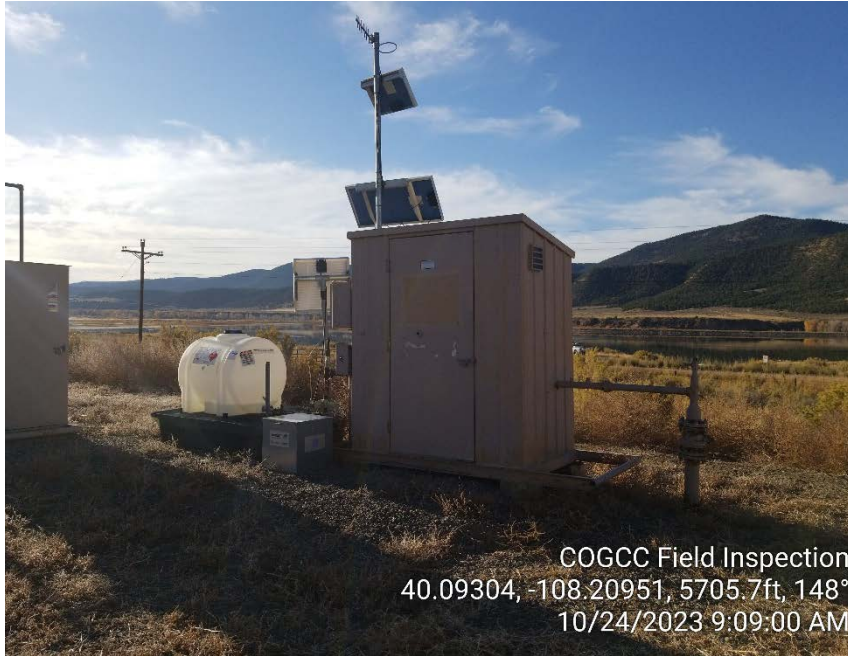
Photo #9 - Uncontrolled vegetation growth at gas meter shed

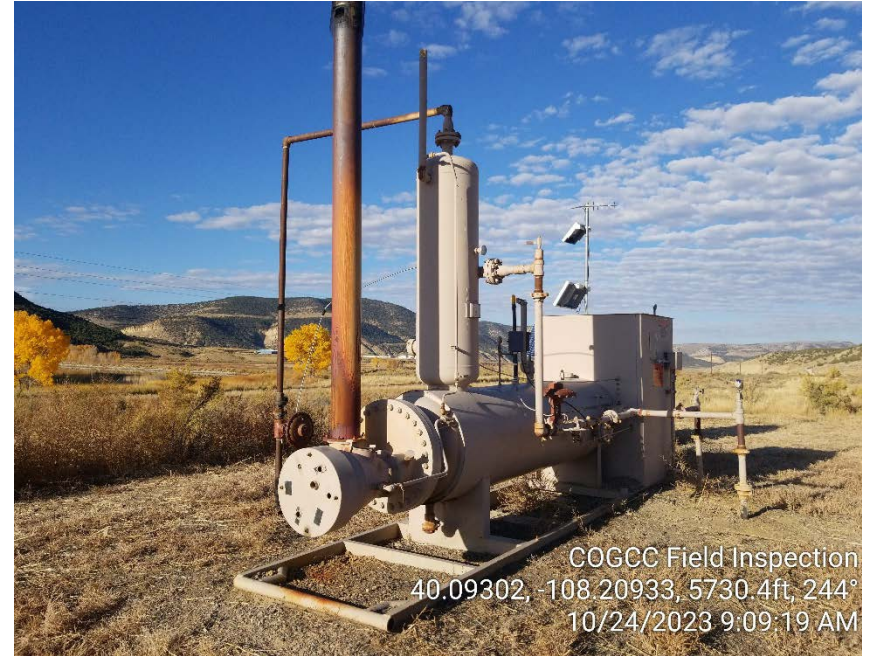
Photo #10 – View of separator from NE.

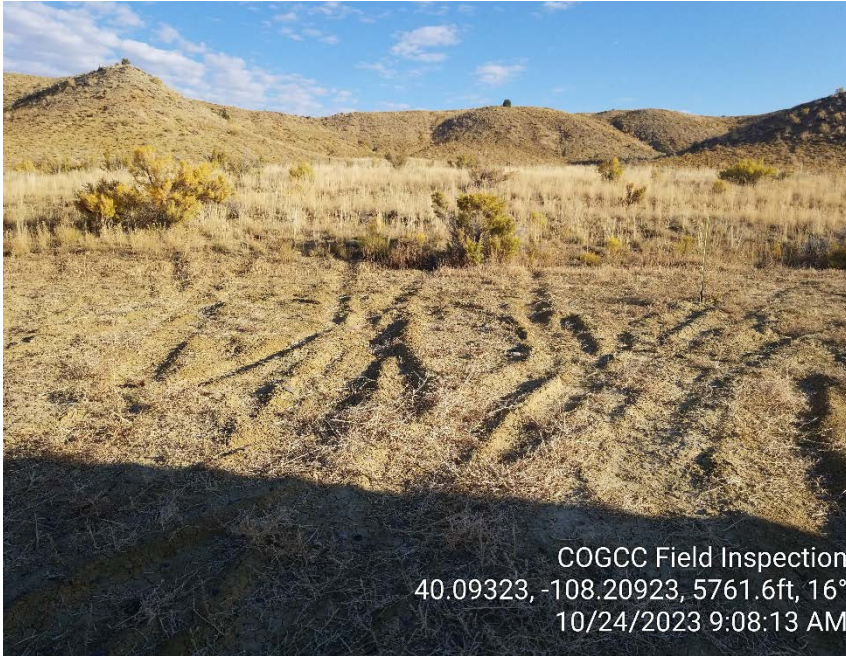
Photo #11 – Pad surface is rutted (1).

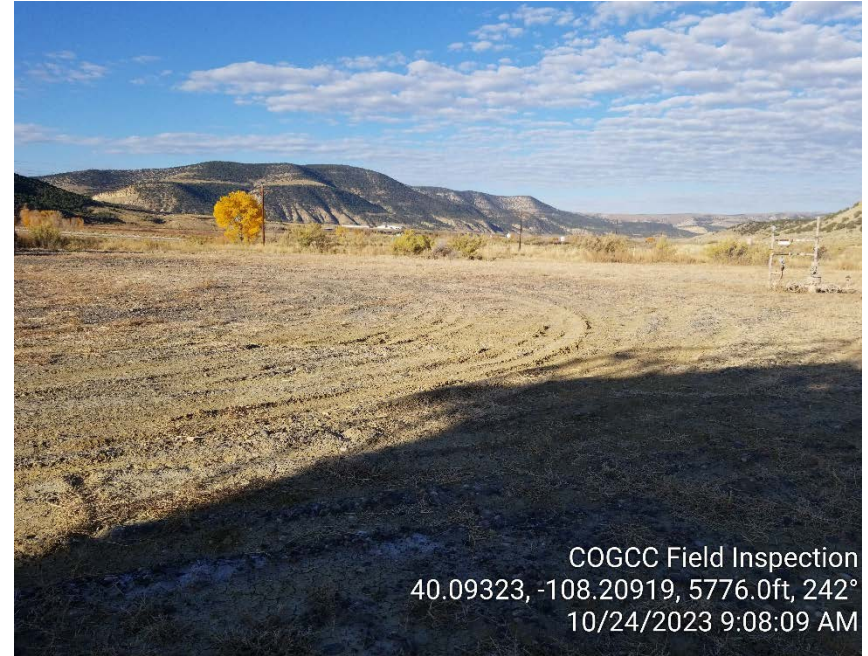
Photo #12 - Pad surface is rutted (2).
