Storm Water Management and Erosion control
Location Name: CAERUS PICEANCE LLC ROLES J13W Pad
Location #: 334558

**Location Overview: Location is within High
Priority/NSO/Black Bear/Density Habitat areas. Location is
approximately 129 yards from West Mamm Creek.
Section/Township/Range: 13 7S93W**

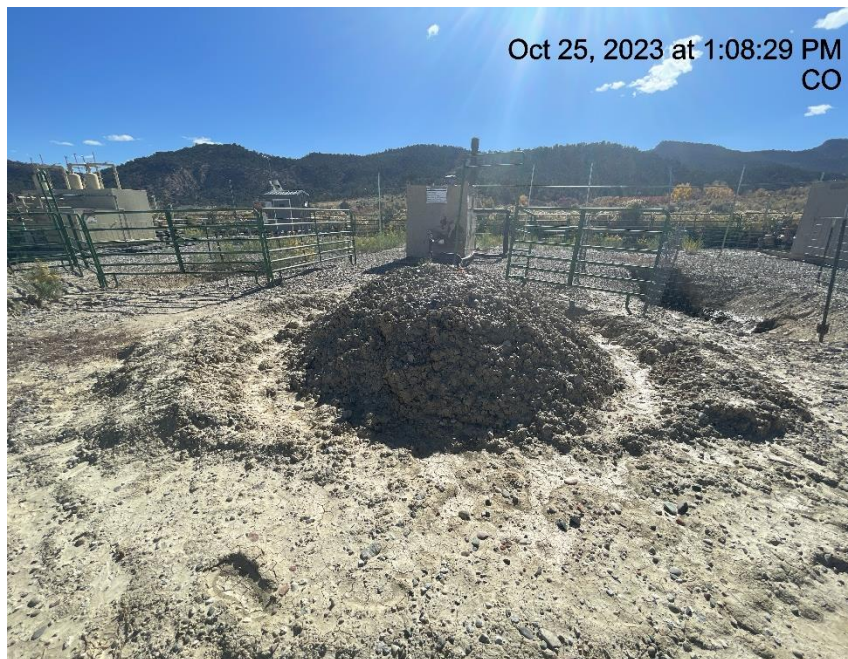
Photo # 4275 Berm around stockpiled soils has eroded/BMP needs maintenance

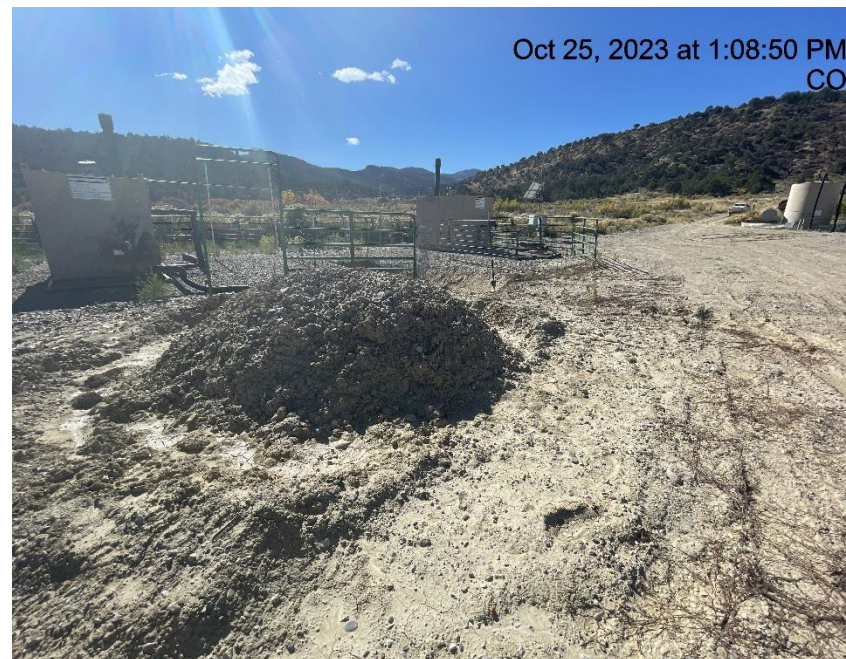
Photo # 4276 Berm around stockpiled soils has eroded/BMP needs maintenance

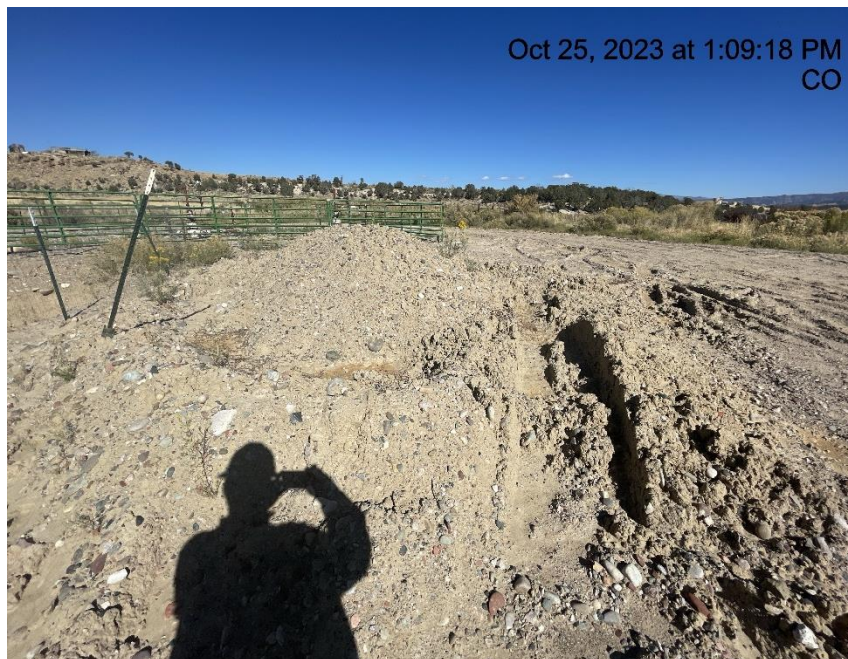
Photo # 4277 Vehicle tracks through berm around stockpiled soils/BMP needs maintenance

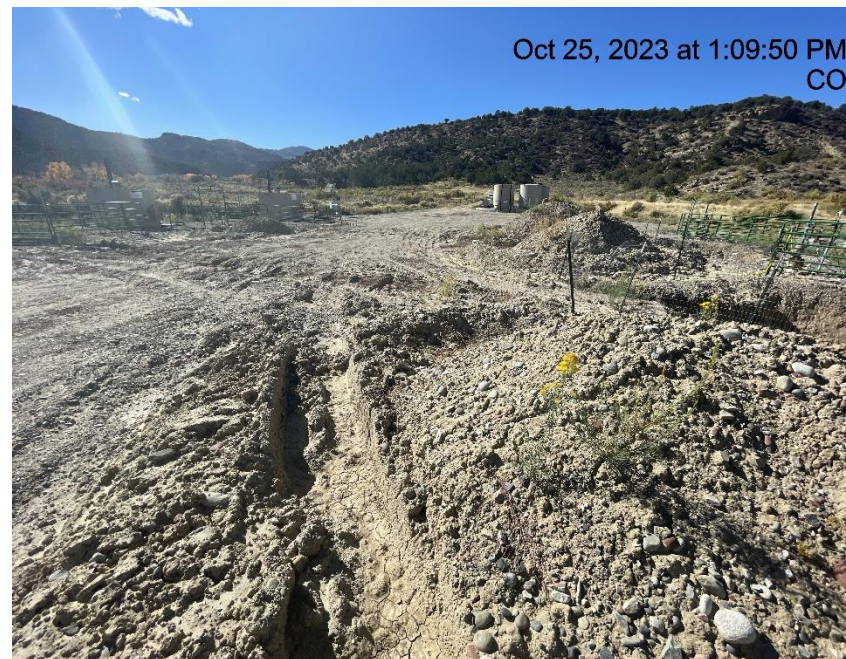
Photo # 4278 Vehicle tracks through berm around stockpiled soils/BMP needs maintenance

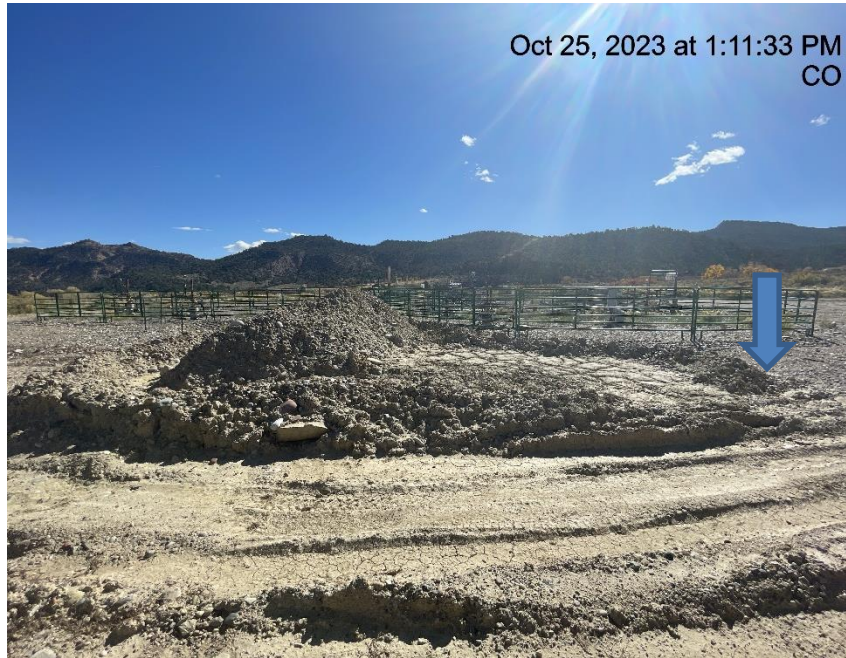
Photo # 4279 Berm around stockpiled soils has partially eroded/BMP needs maintenance

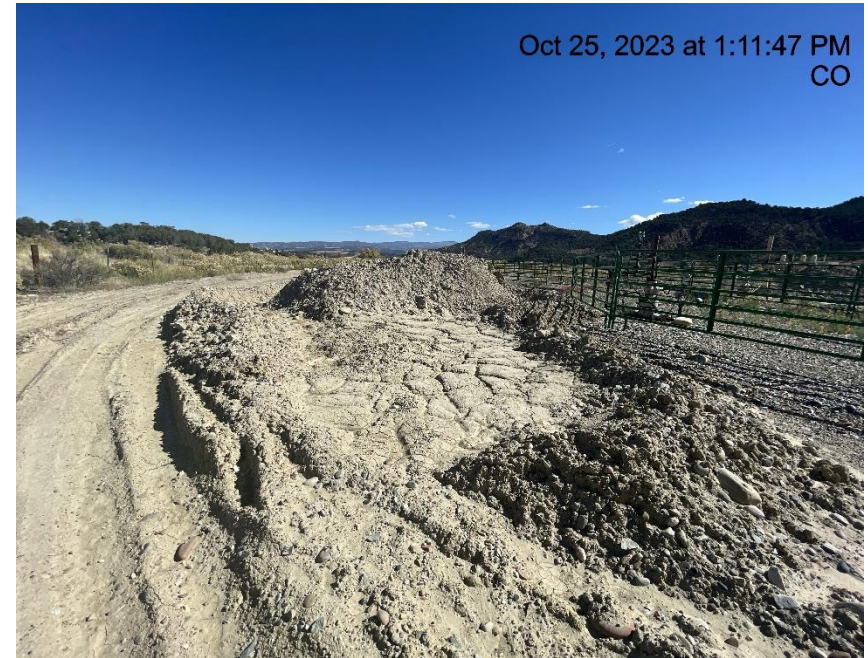
Photo # 4280 Berm around stockpiled soils has partially eroded/BMP needs maintenance

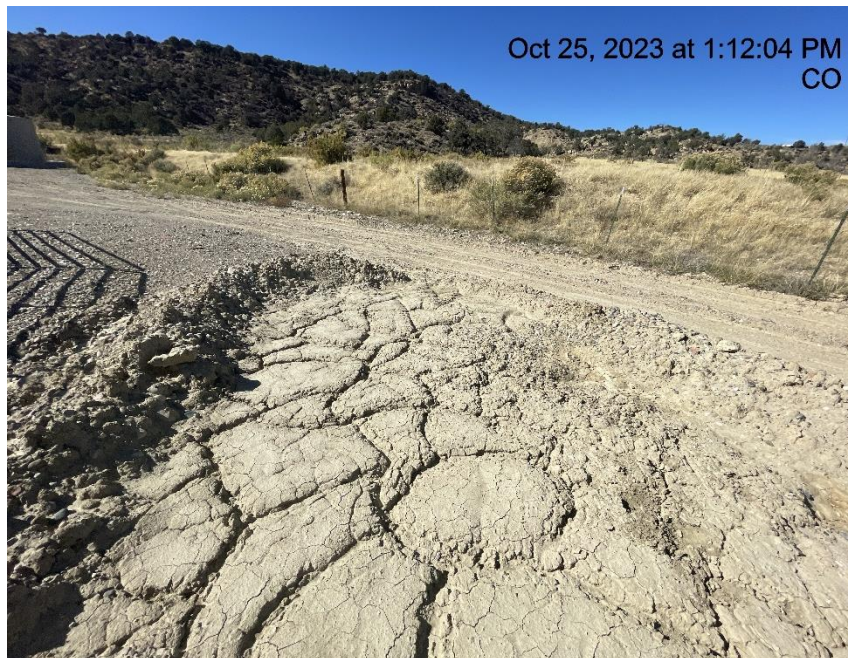
Photo # 4281 Berm around stockpiled soils has partially eroded/BMP needs maintenance

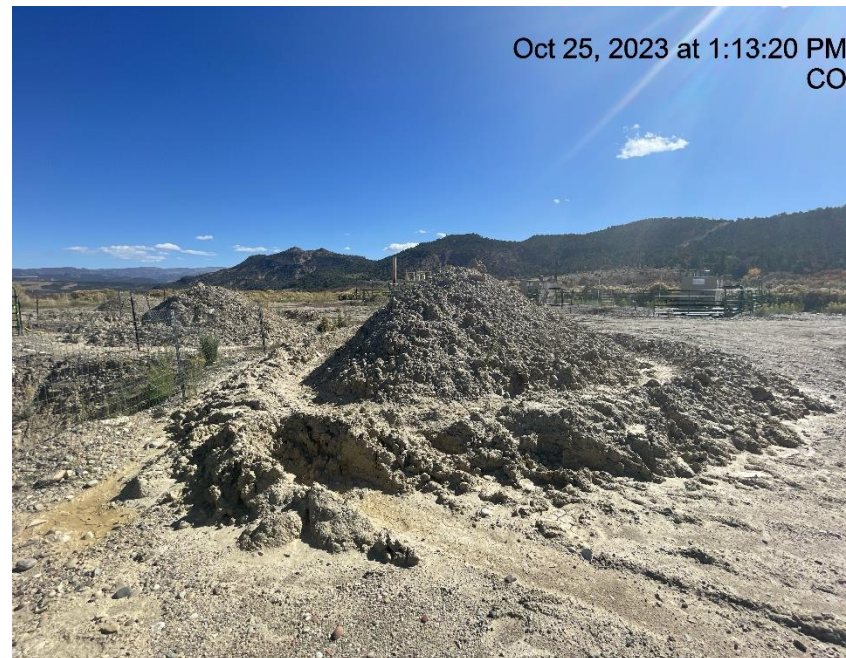
Photo # 4282 Vehicle tracks through berm around stockpiled soils/BMP needs maintenance

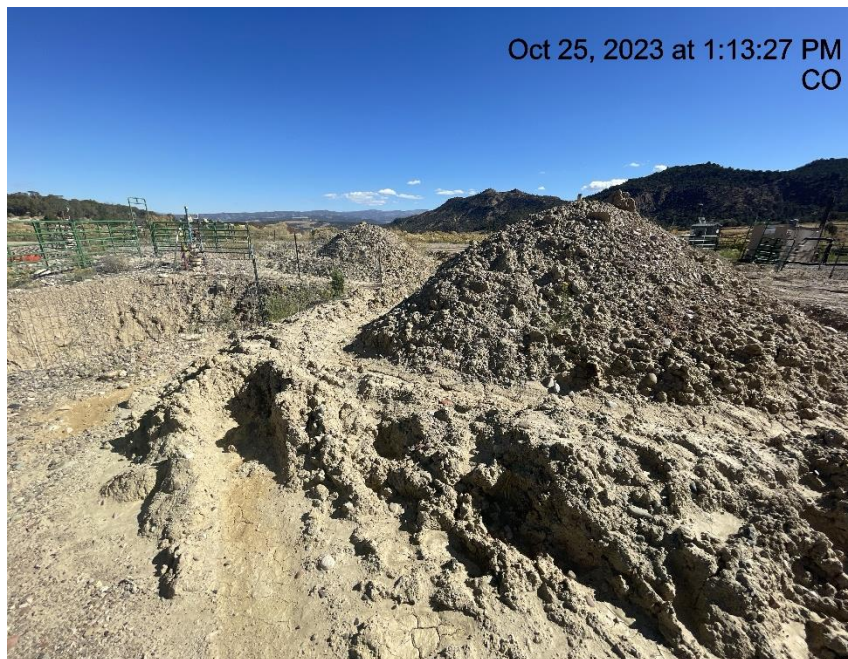
Photo # 4283 Vehicle tracks through berm around stockpiled soils/BMP needs maintenance

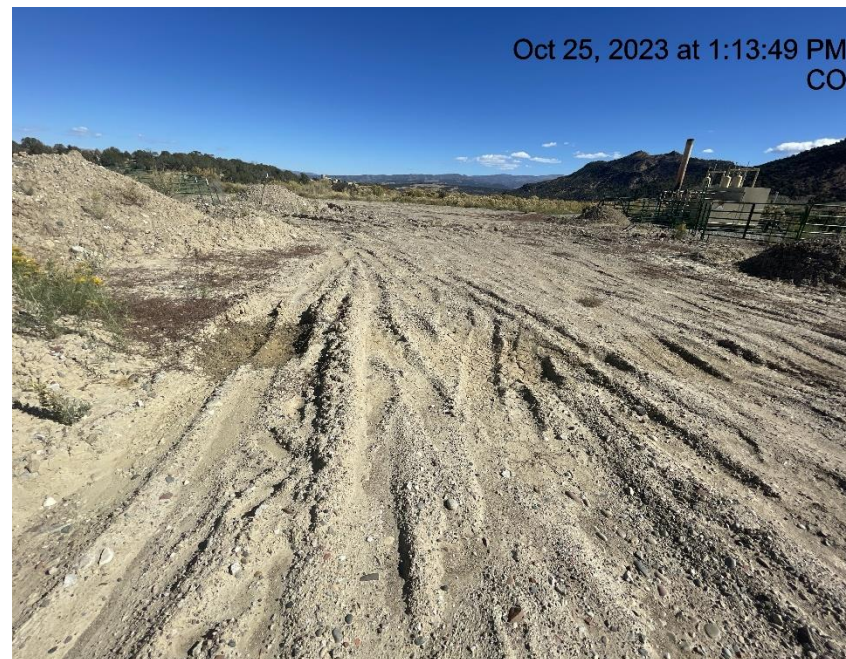
Photo # 4284 Lack of stabilization/compaction on location soils/BMP

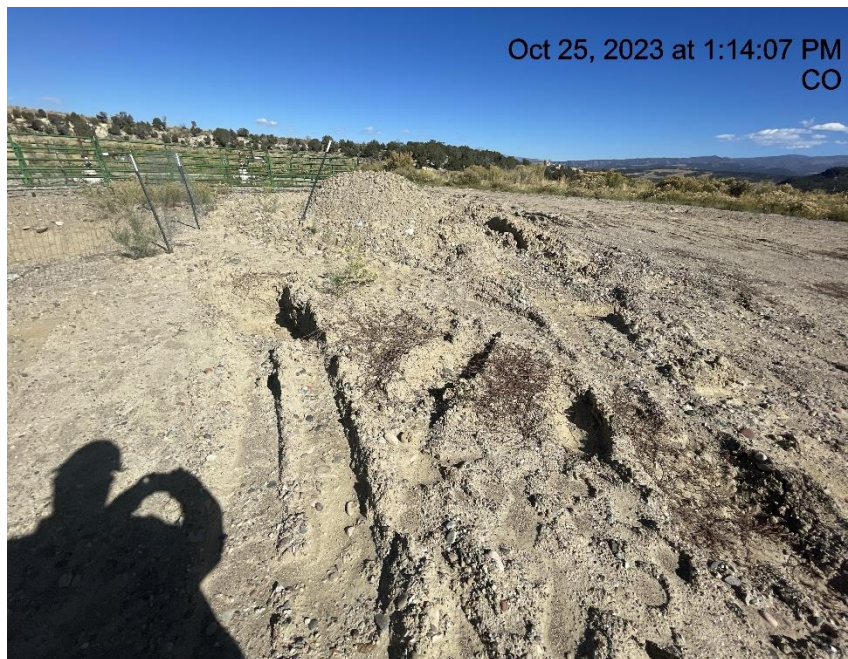
Photo # 4285 Lack of stabilization/compaction on location

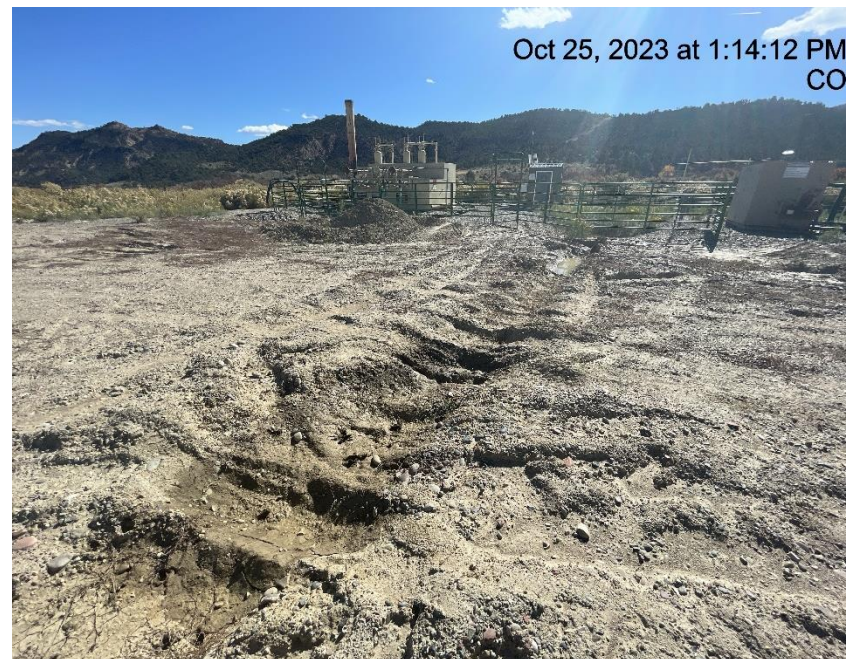
Photo # 4286 Lack of stabilization/compaction on location

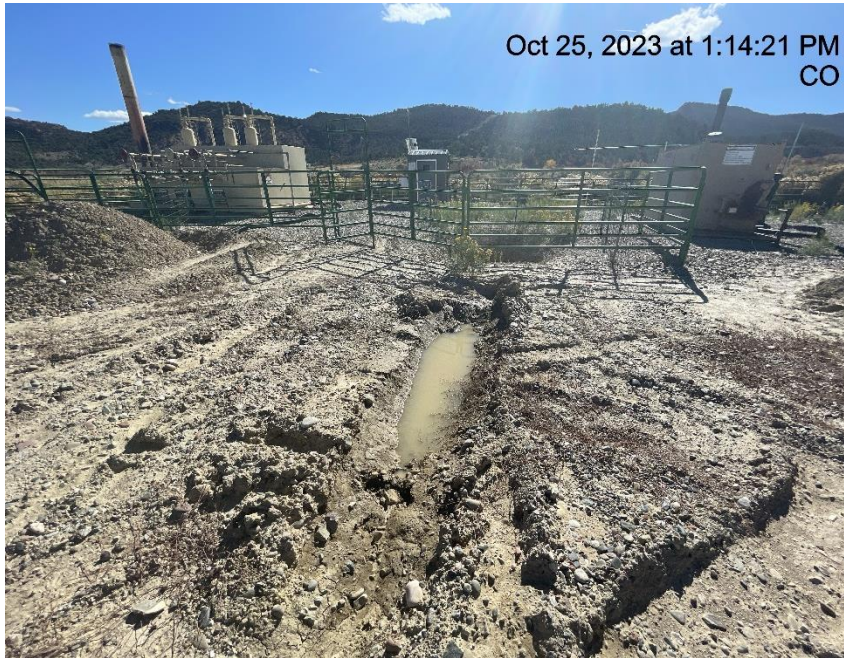
Photo # 4287 Lack of stabilization/compaction on location

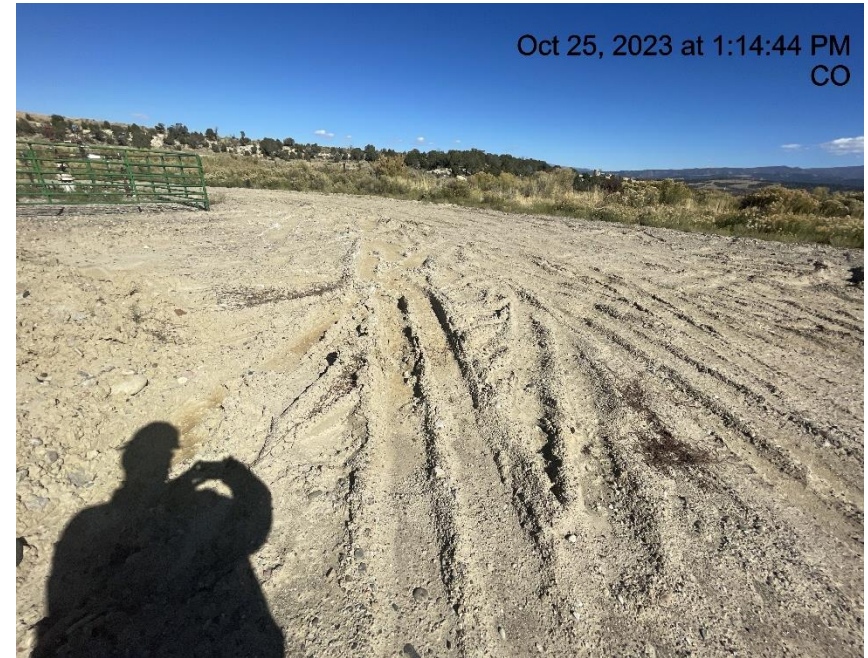
Photo # 4288 Lack of stabilization/compaction on location

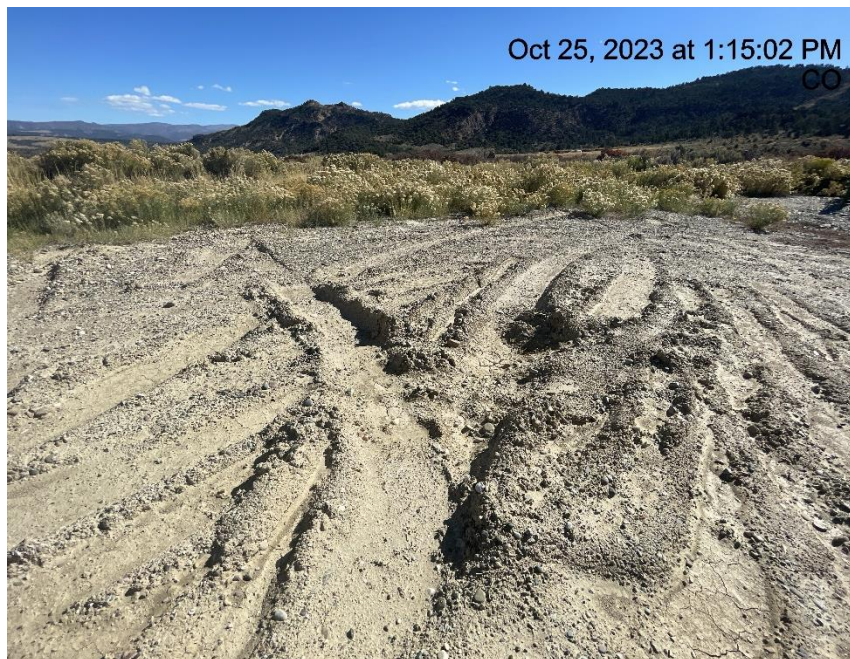
Photo # 4289 Lack of stabilization/compaction on location

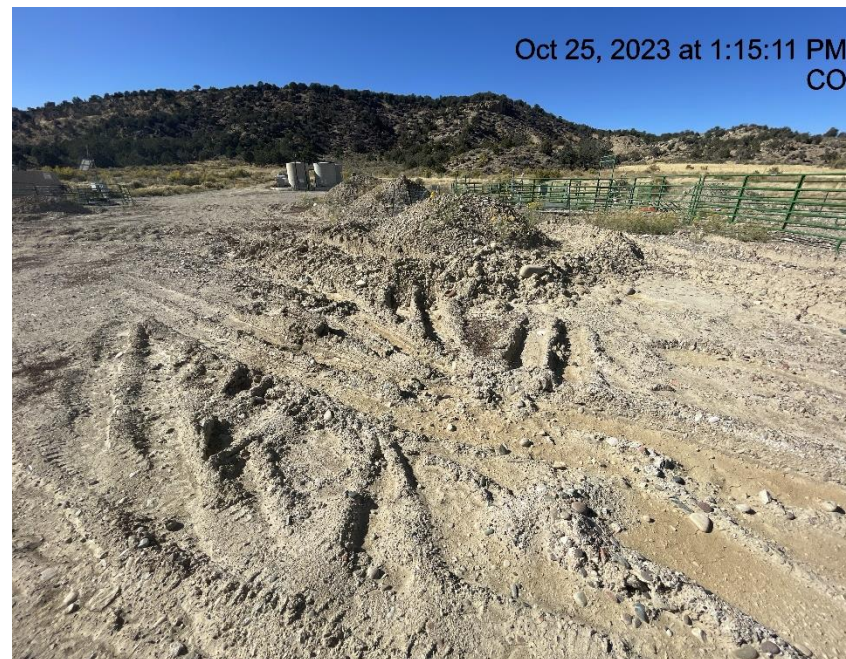
Photo # 4290 Lack of stabilization/compaction on location

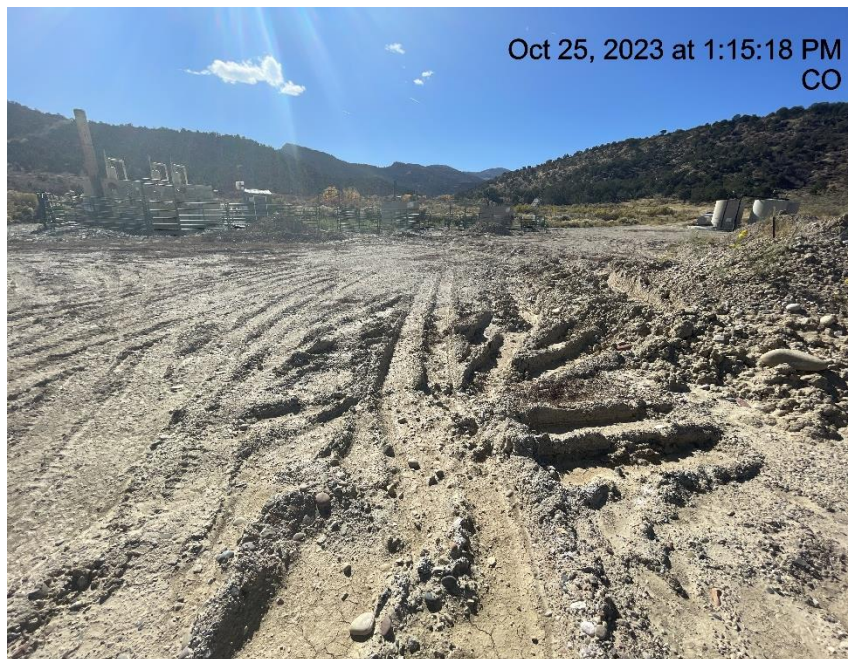
Photo # 4291 Lack of stabilization/compaction on location

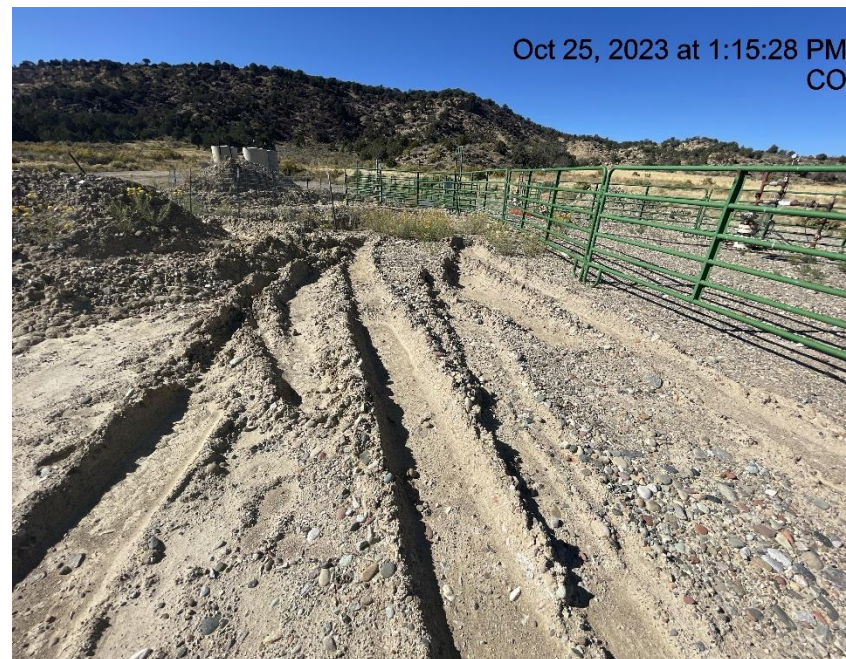
Photo # 4292 Lack of stabilization/compaction on location

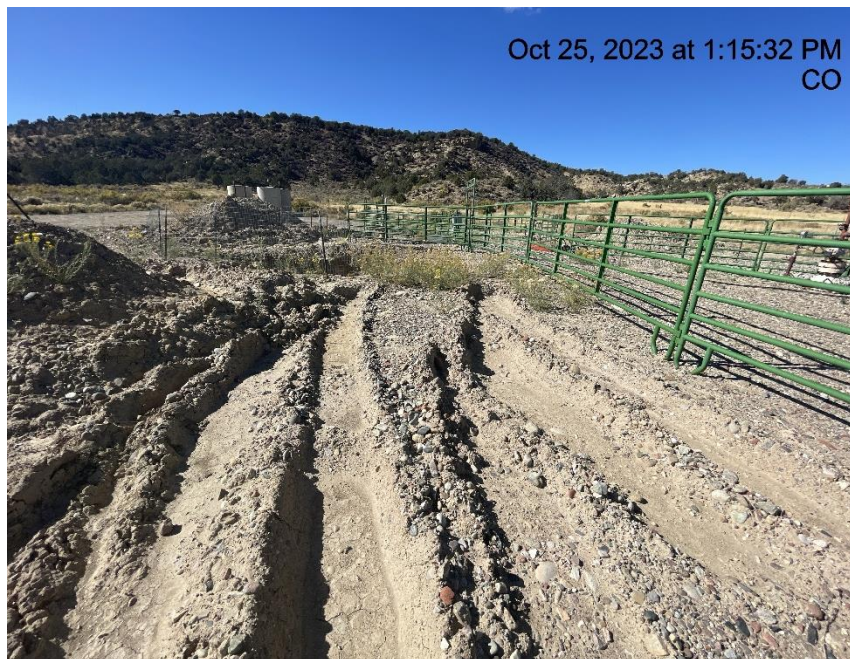
Photo # 4293 Lack of stabilization/compaction on location

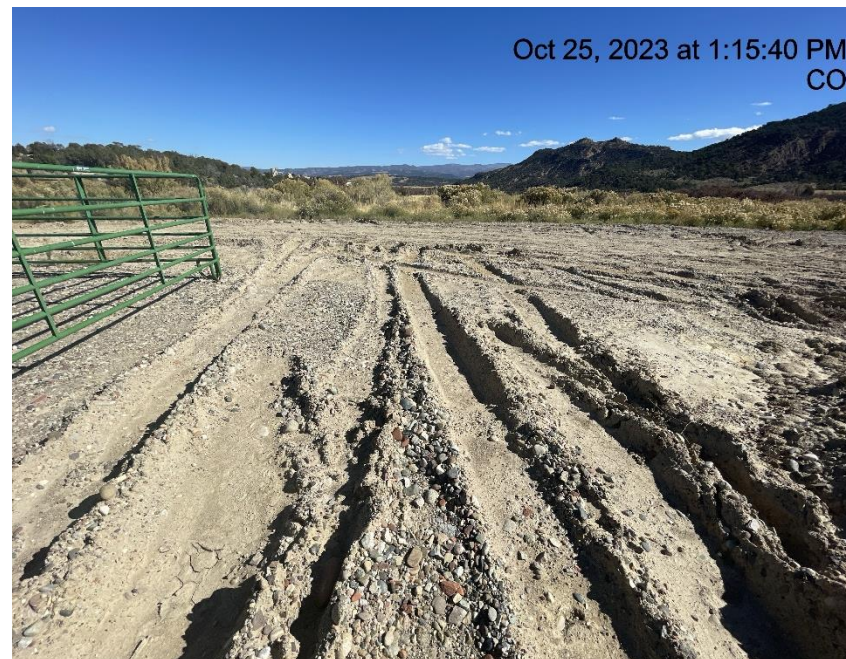
Photo # 4294 Lack of stabilization/compaction on location

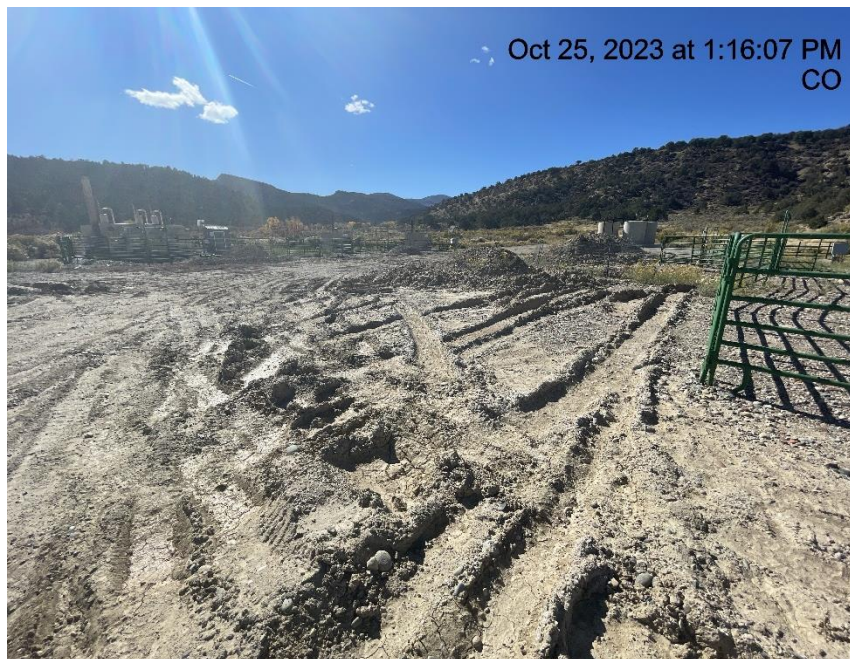
Photo # 4295 Lack of stabilization/compaction on location

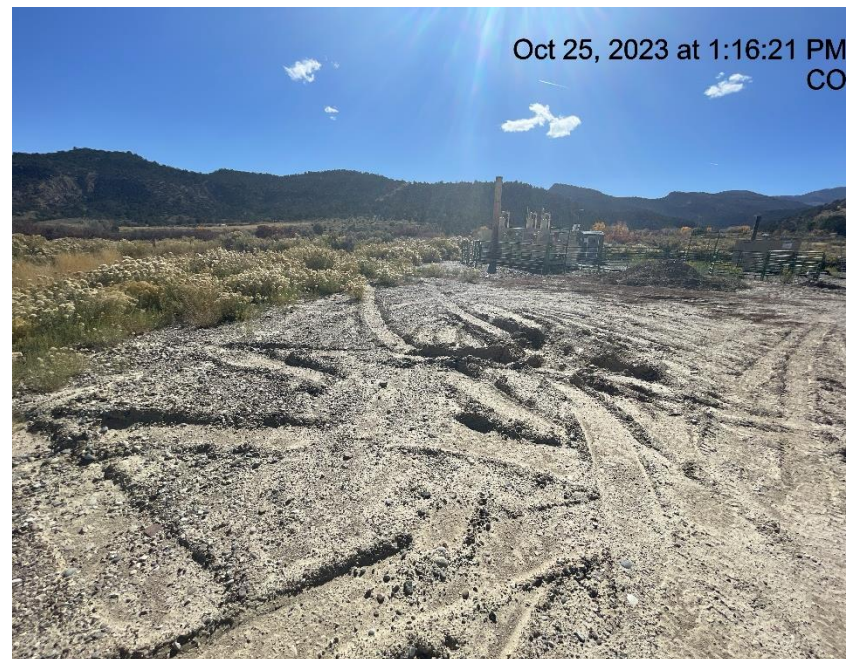
Photo # 4296 Lack of stabilization/compaction on location

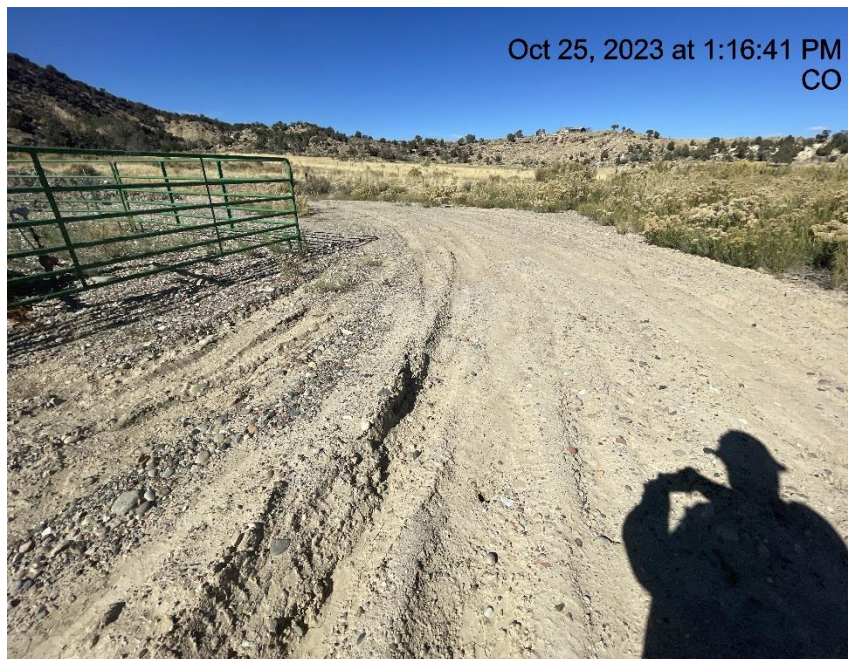
Photo # 4297 Lack of stabilization/compaction on location

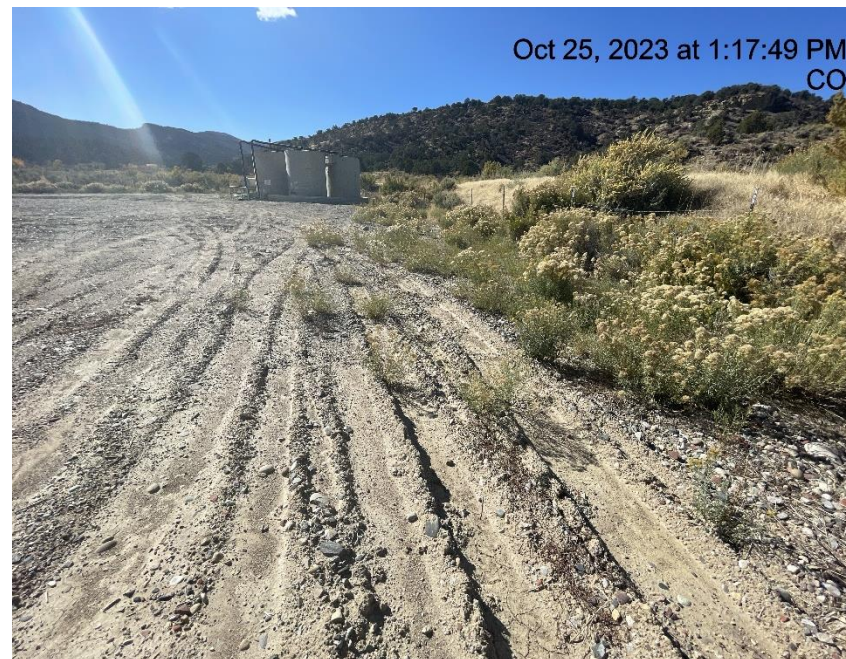
Photo # 4298 Lack of stabilization/compaction on location

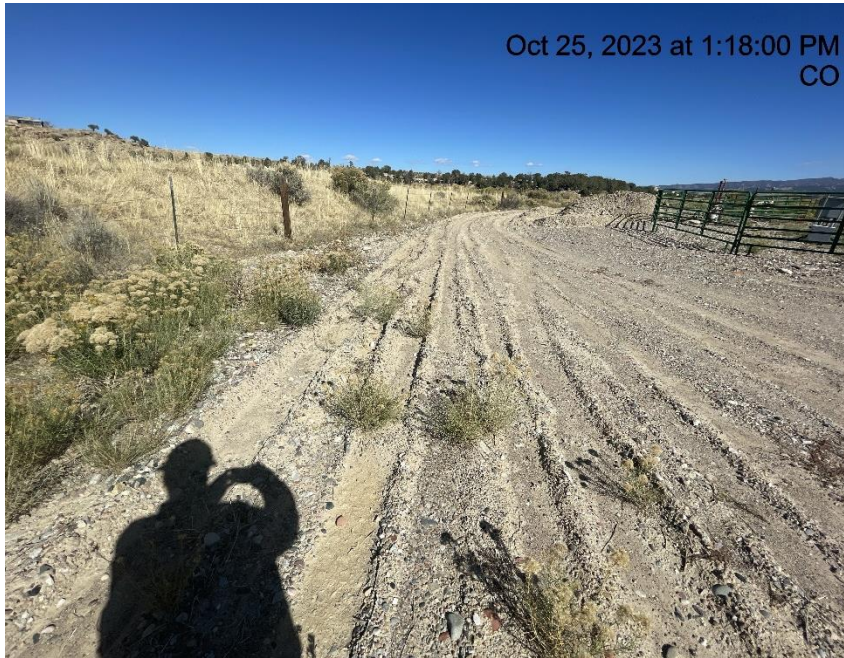
Photo # 4299 Lack of stabilization/compaction on location

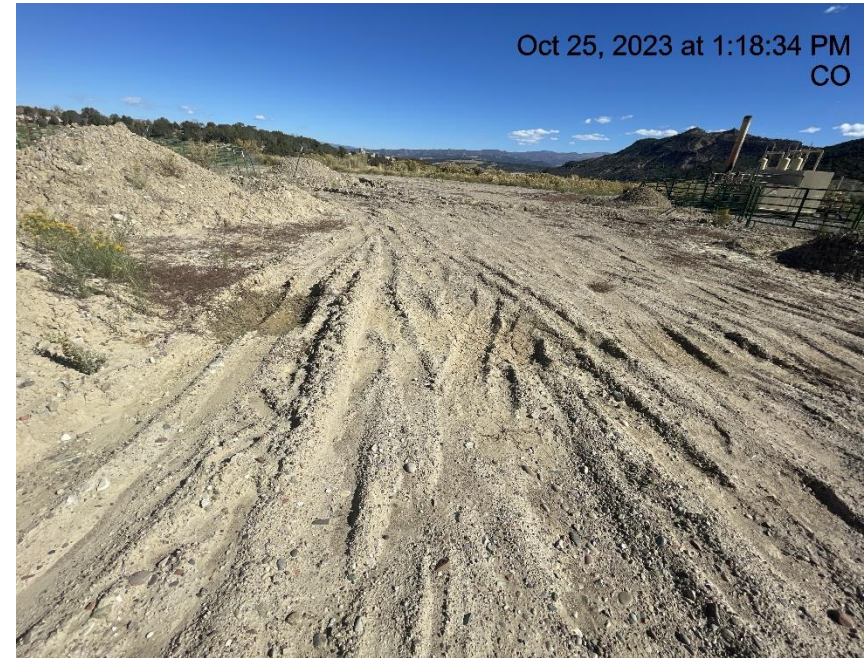
Photo # 4300 Lack of stabilization/compaction on location

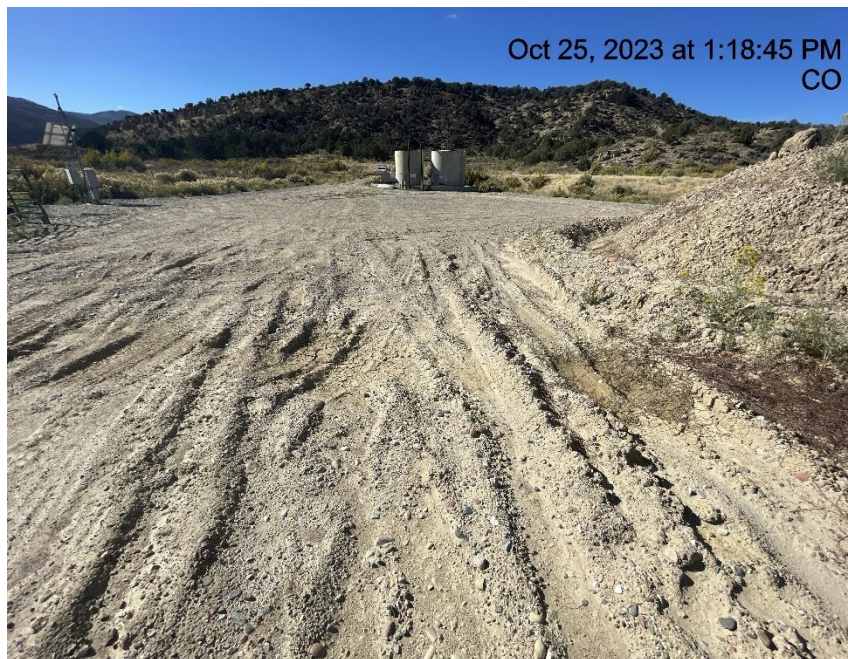
Photo # 4301 Lack of stabilization/compaction on location

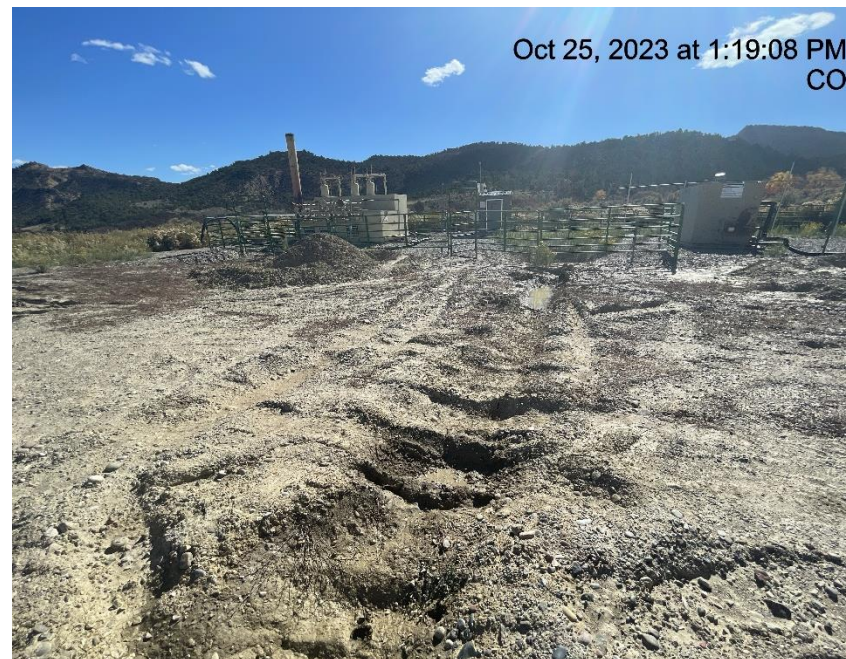
Photo # 4302 Lack of stabilization/compaction on location

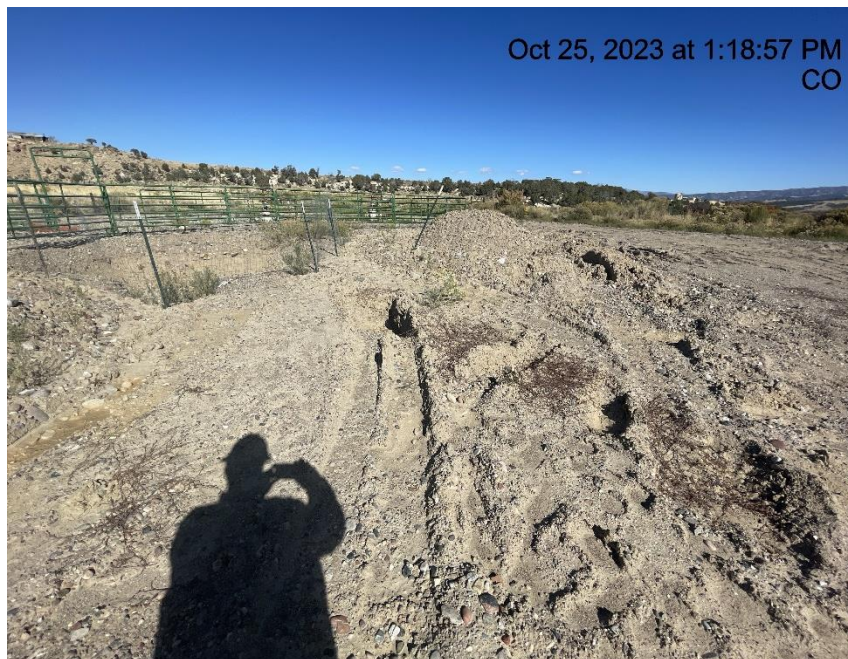
Photo # 4303 Lack of stabilization/compaction on location

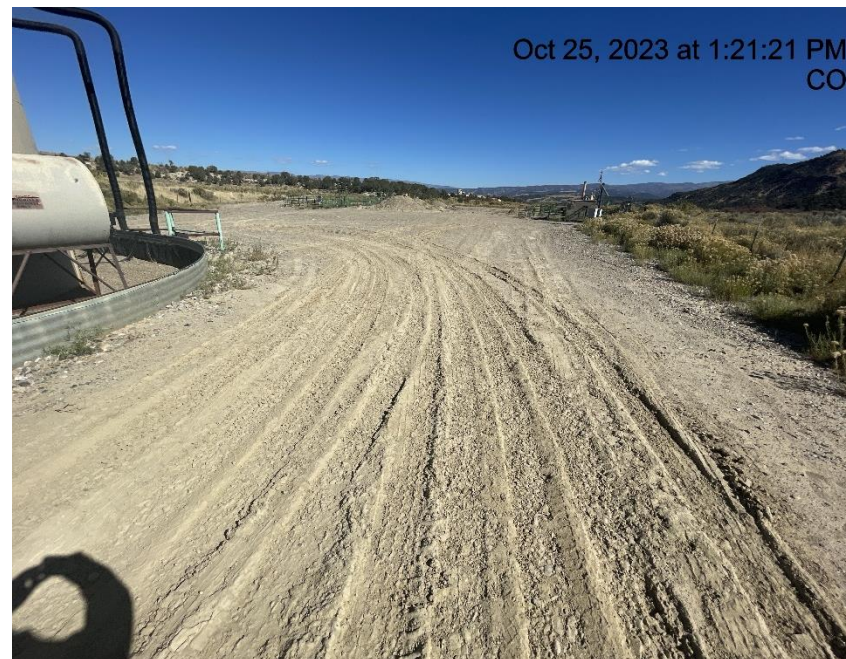
Photo # 4304 Lack of stabilization/compaction near entrance to location

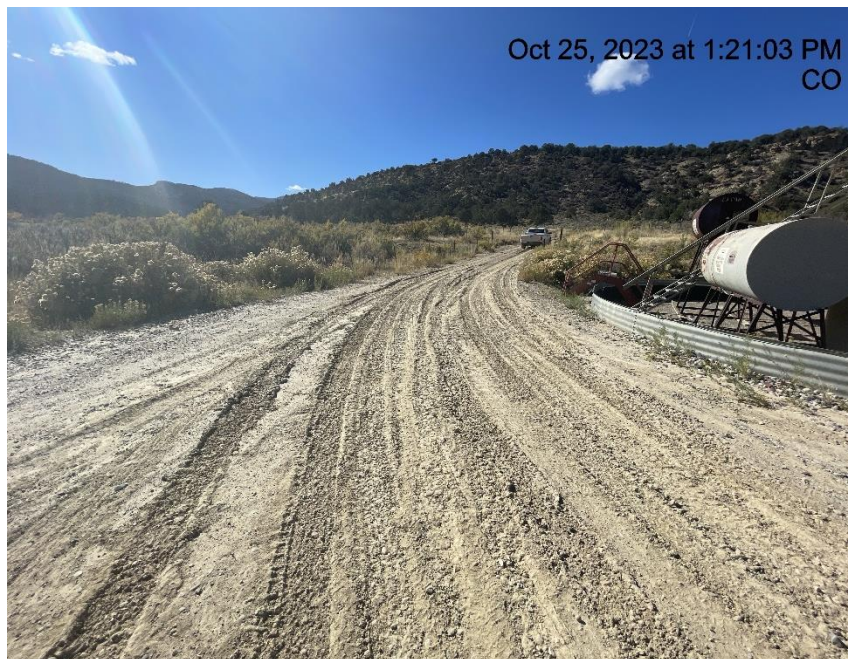
Photo # 4305 Lack of stabilization/compaction near entrance to location

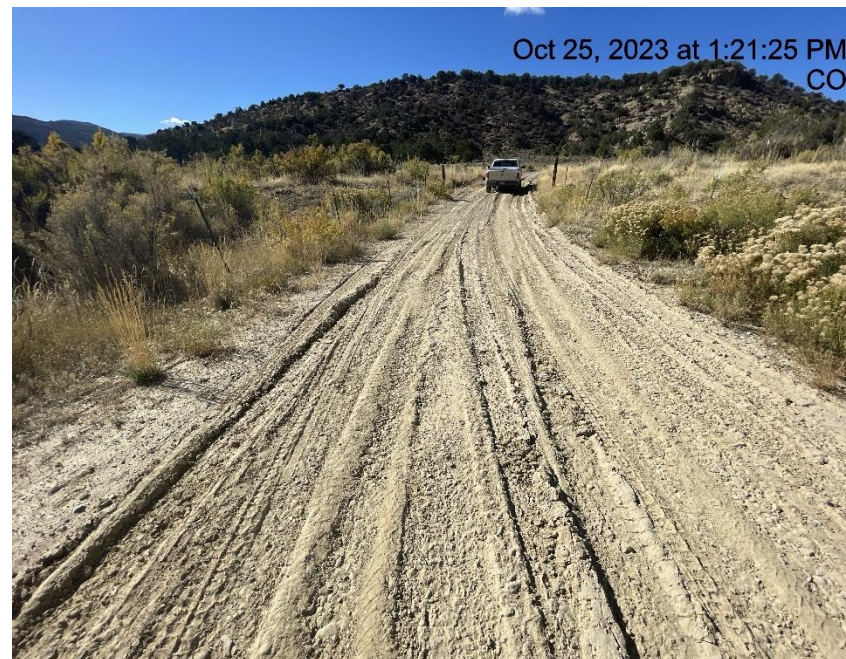
Photo # 4306 Lack of stabilization/compaction near entrance to location

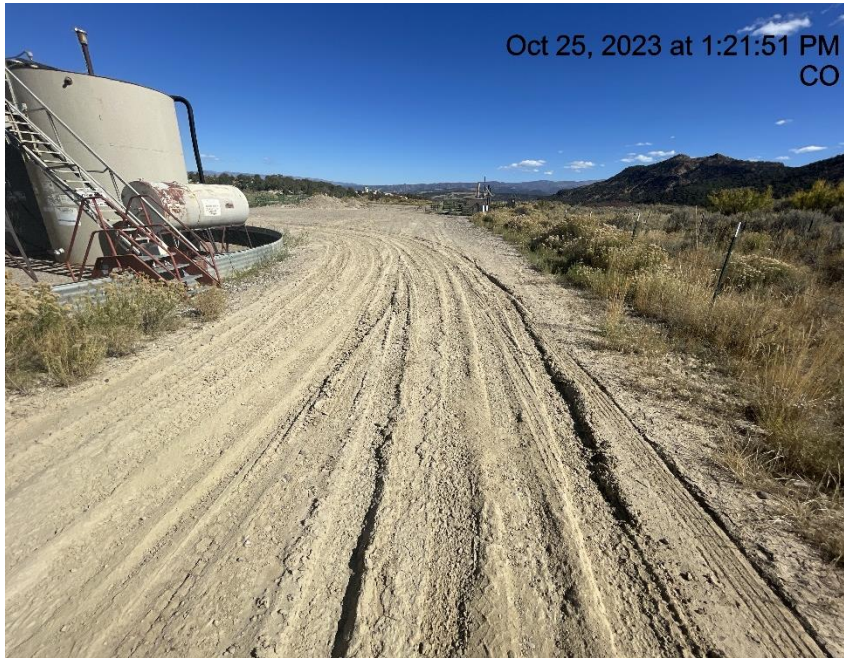
Photo # 4307 Lack of stabilization/compaction at entrance to location

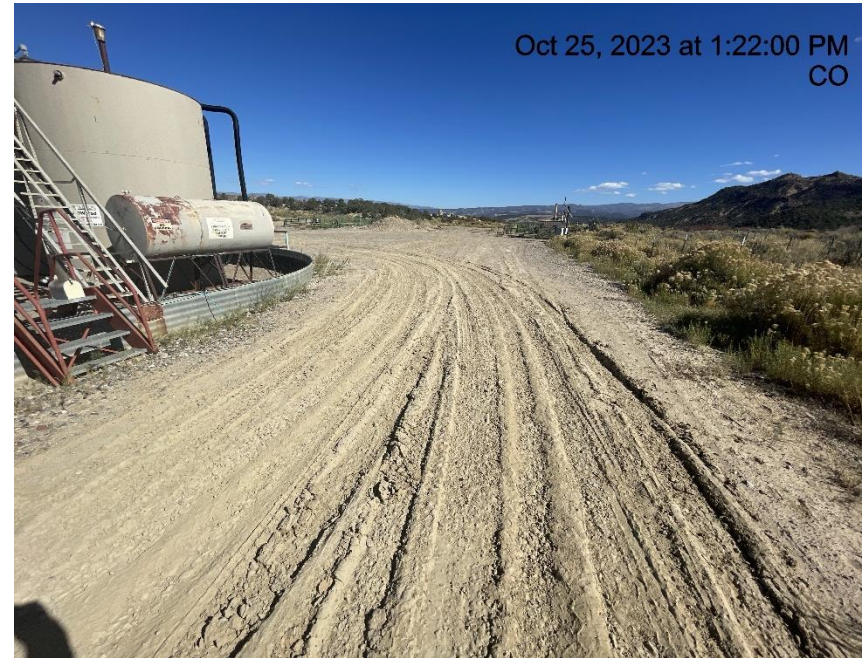
Photo # 4308 Lack of stabilization/compaction at entrance to location

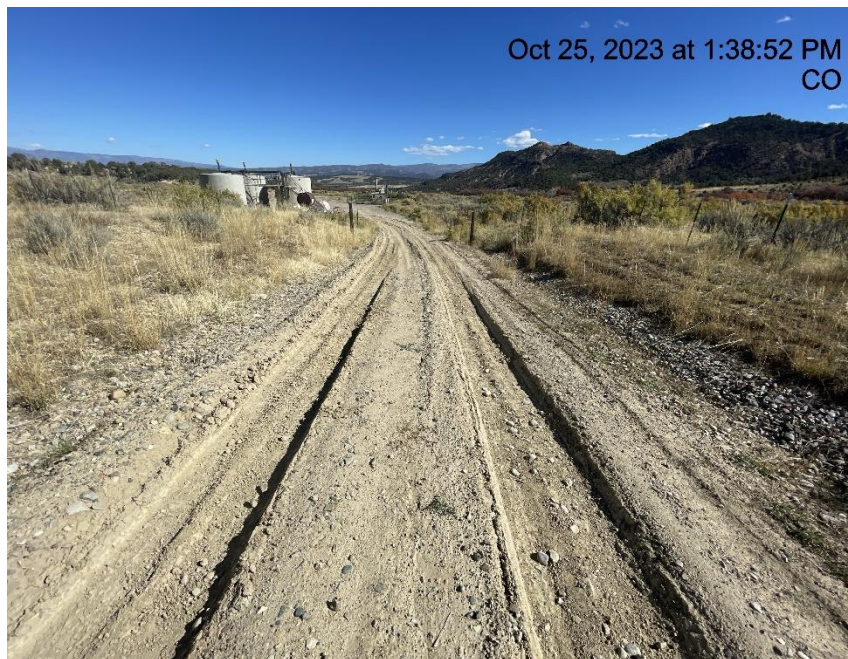
Photo # 4309 Lack of stabilization/compaction on lease road near entrance to location

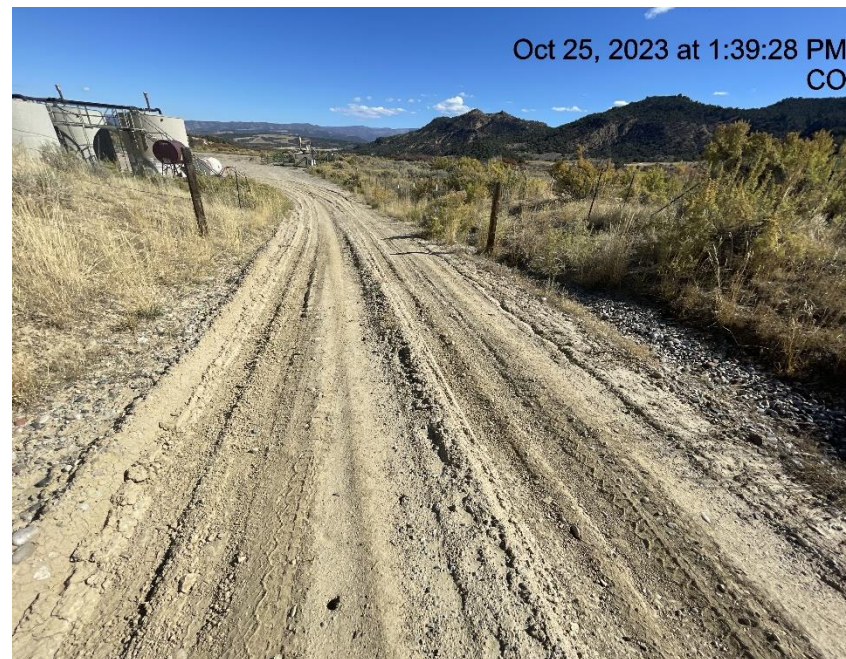
Photo # 4310 Lack of stabilization/compaction on lease road near entrance to location
