Inspection Photos
Operator: SCOUT ENERGY MANAGEMENT LLC - 10779
Location Name: EMERALD #98X
Location ID: 428384 API #: 05-103-11915
Inspection Date: 10/26/2023 Inspection Doc#: 693806504

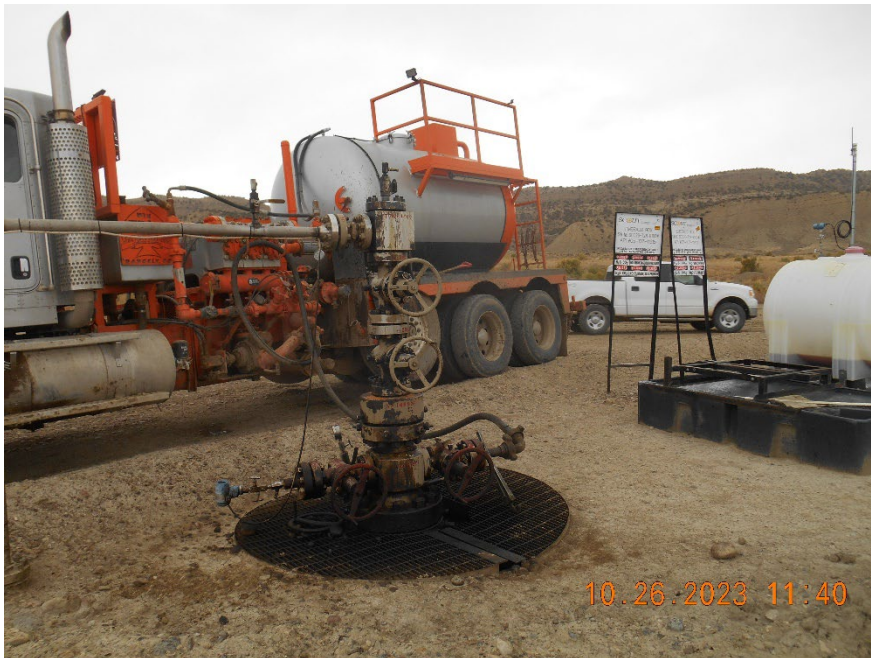
Injection well during MIT
