Inspection Photos

Loc: 309022

Operator: EVERGREEN NATURAL
RESOURCES LLC

Inspection Date: 10/26/2023

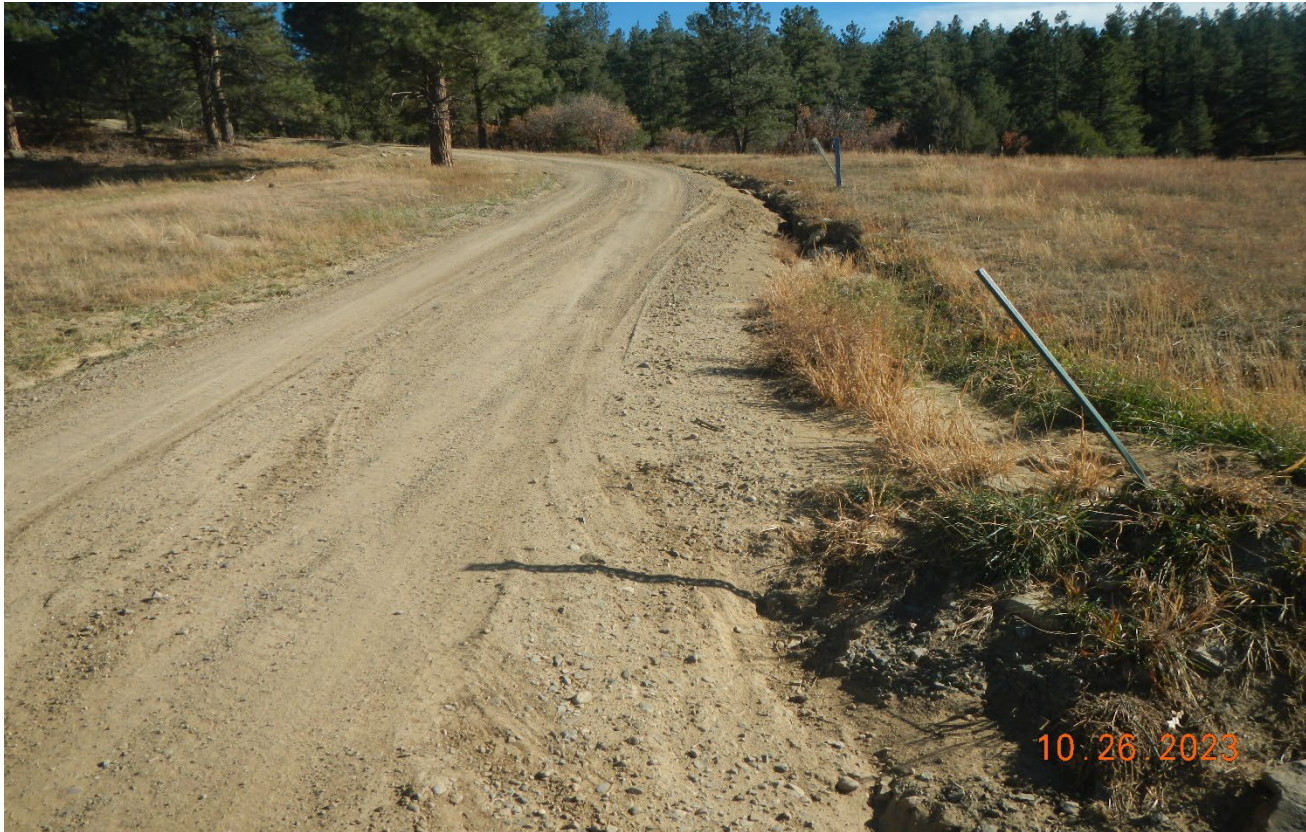
Photo 1. This culvert along the main access road is filled in with sediment at Lat/Long:37.302109, -104.78223 .

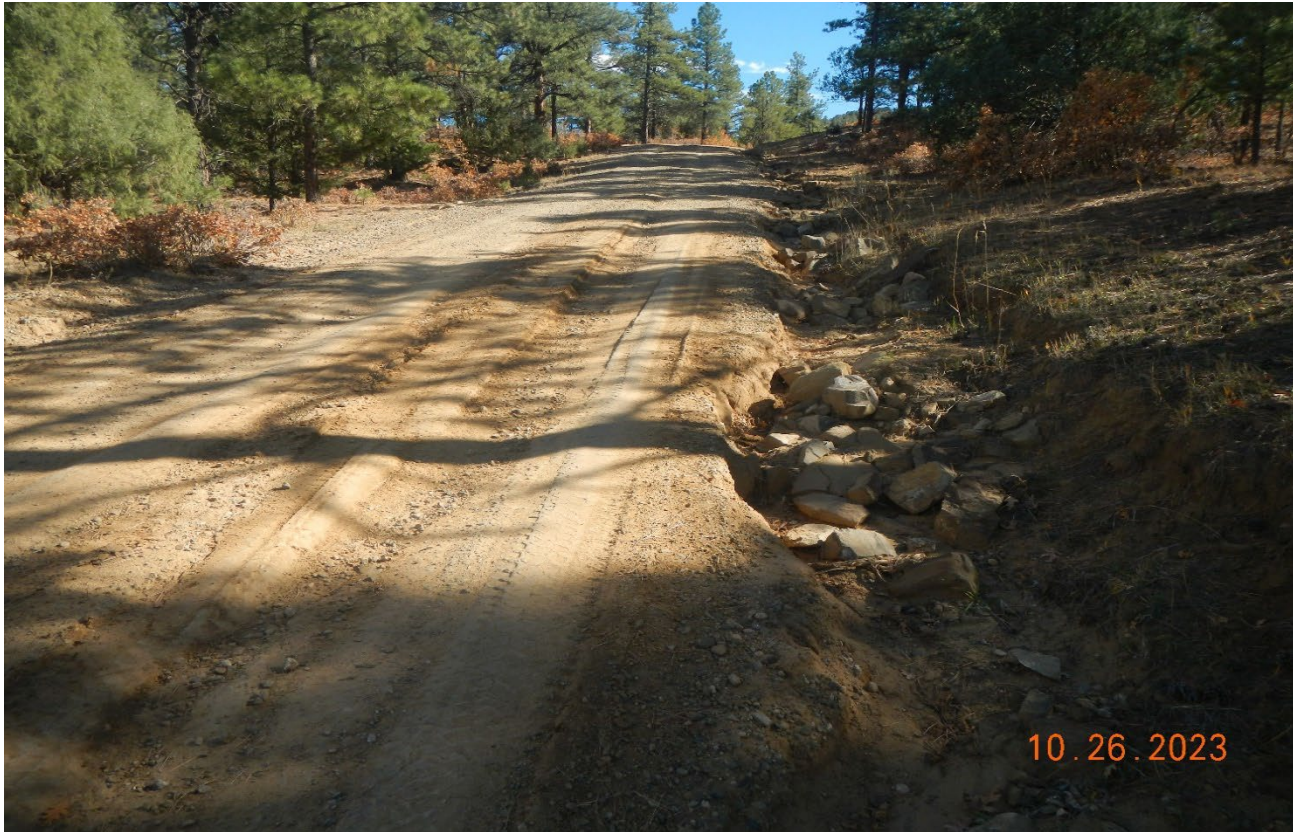
Photo 2. There is erosion along the roadside near the Rampart 43-33 well site.

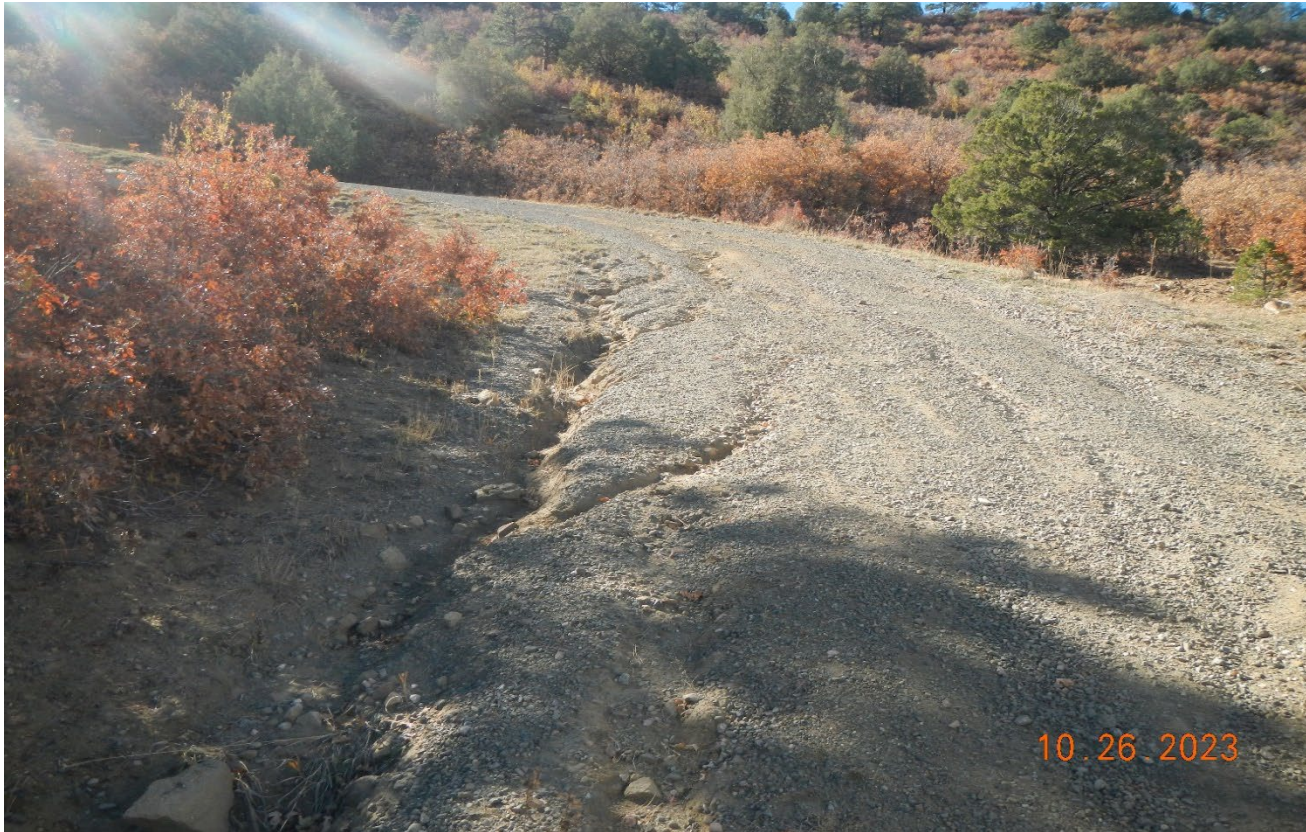
Photo 3. Facing southwest along the switch back of the access road which has erosion issues.

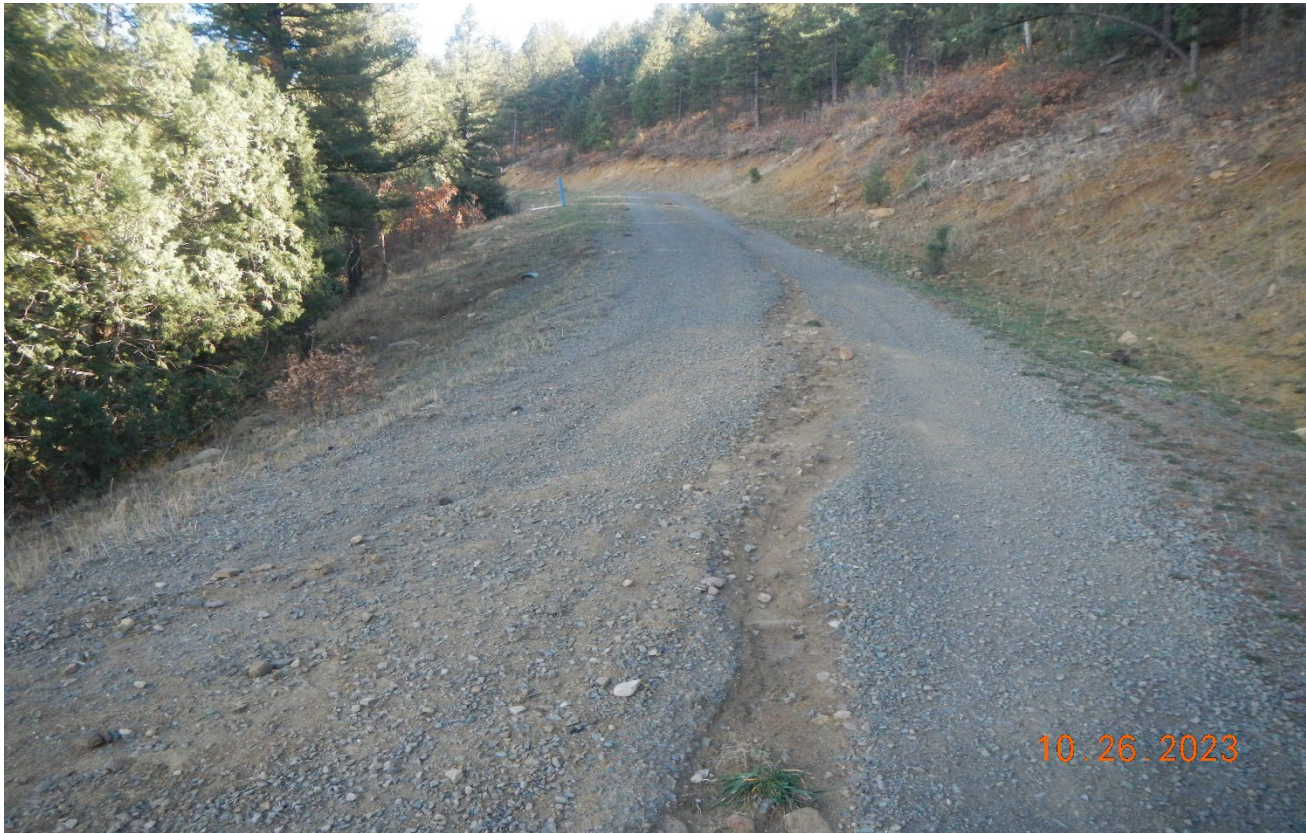
Photo 4. Facing southeast along the access road. There is erosion occurring down the center of the road.

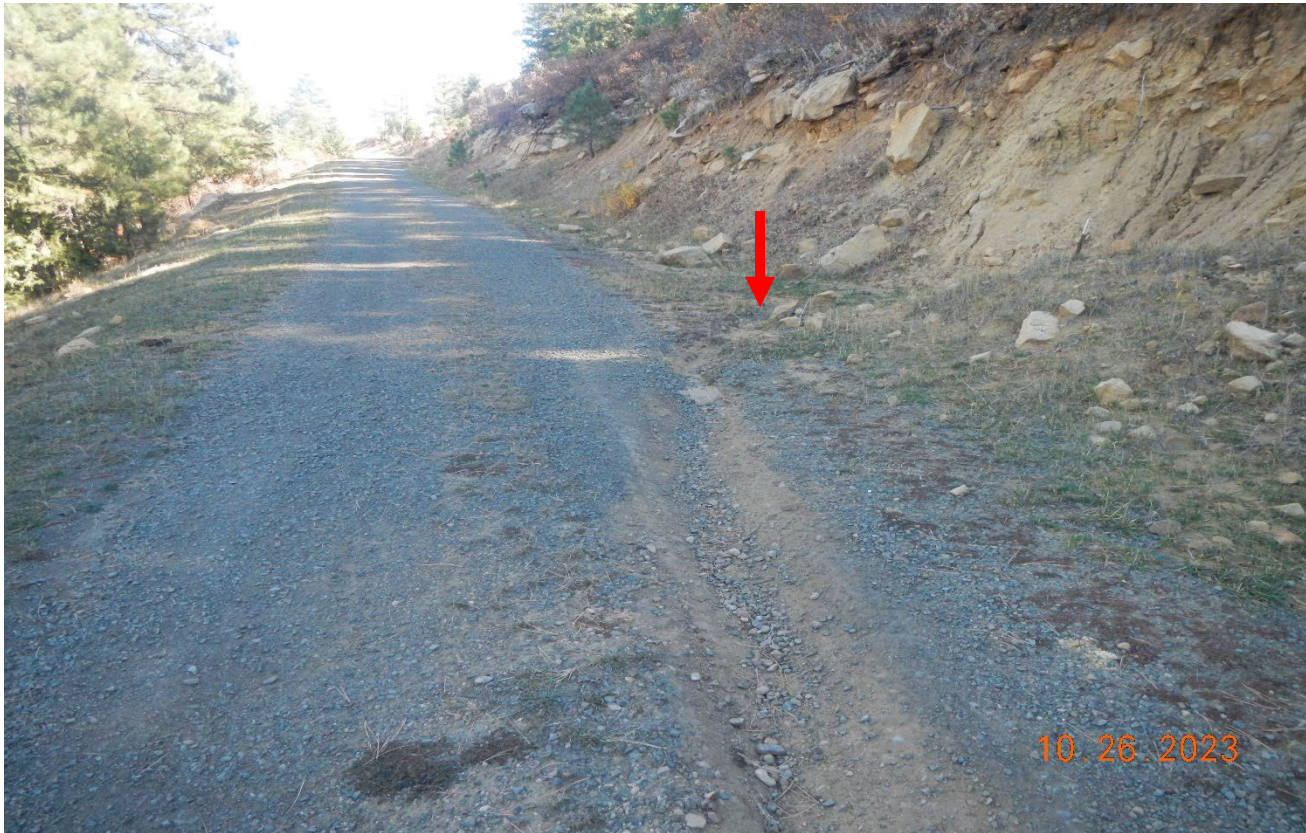
Photo 5. Facing southeast along the access road. The culvert at the red arrow is filled in with sediment and which is causing stormwater to flow down the road.
