Inspection Photos

Location Name: TEP ROCKY MOUNTAIN LLC, OXY USA INC-67S96W/4SESW

Location ID: 334843

Date: 10/30/2023

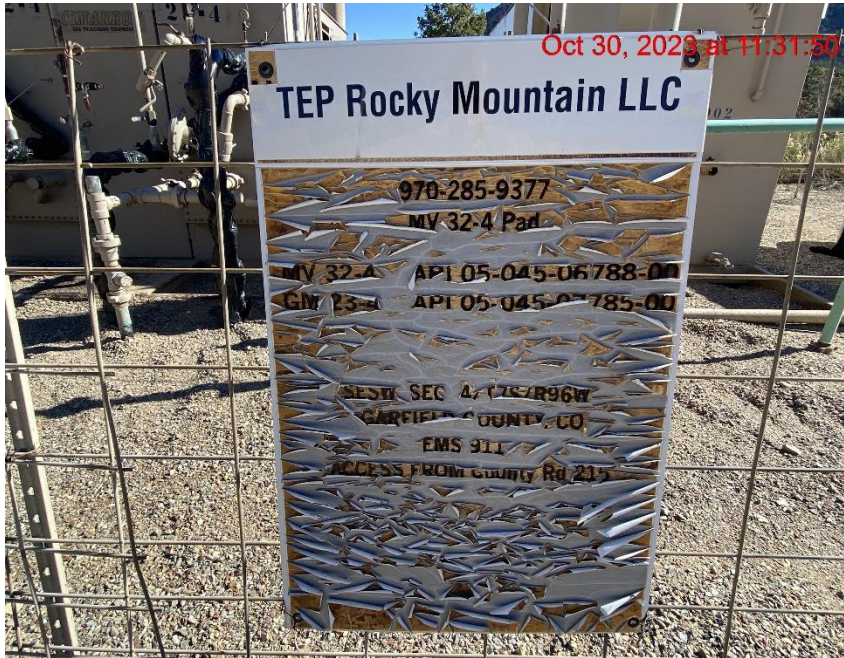
Battery Sign Weathered and Needs Replaced – Photo #07209

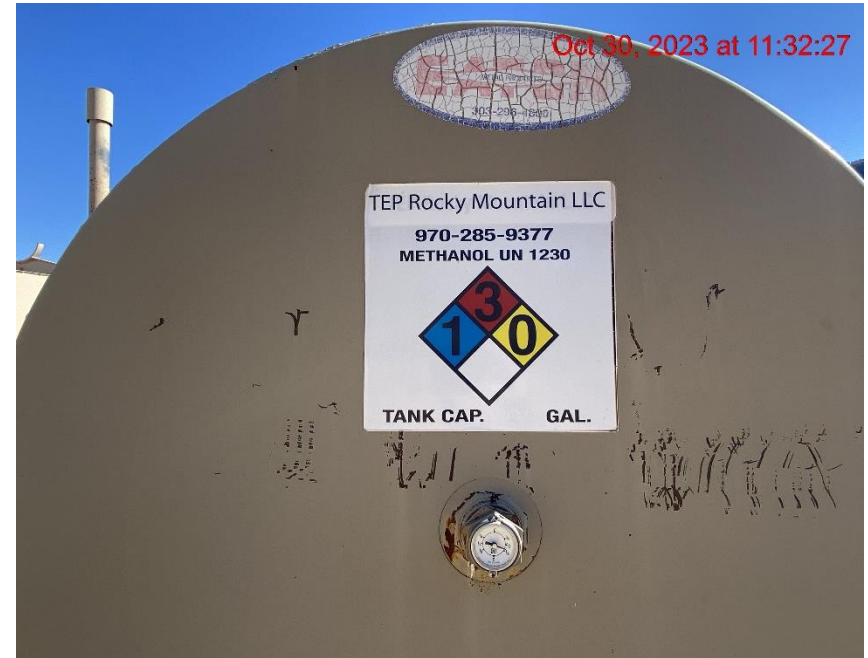
Methanol Tank Capacity Not Posted – Photo #07211

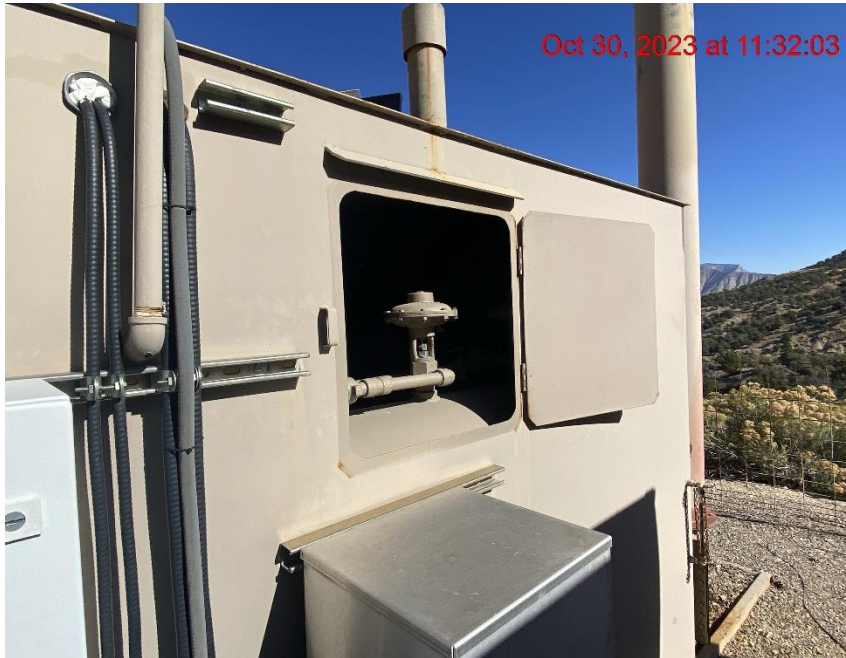
Unsecured Hatch on Separator – Photo #07210

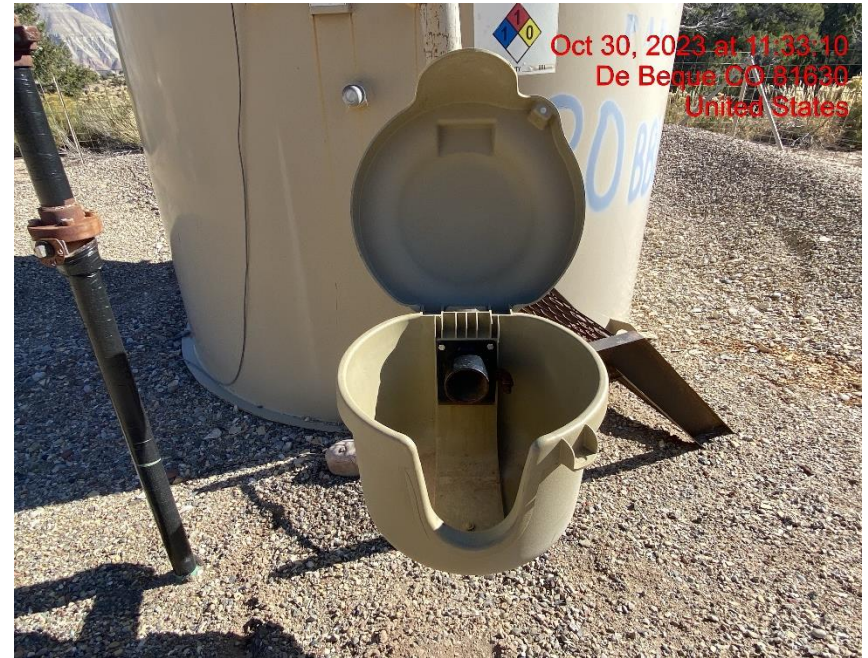
Open-Ended Load Line – Photo #07214

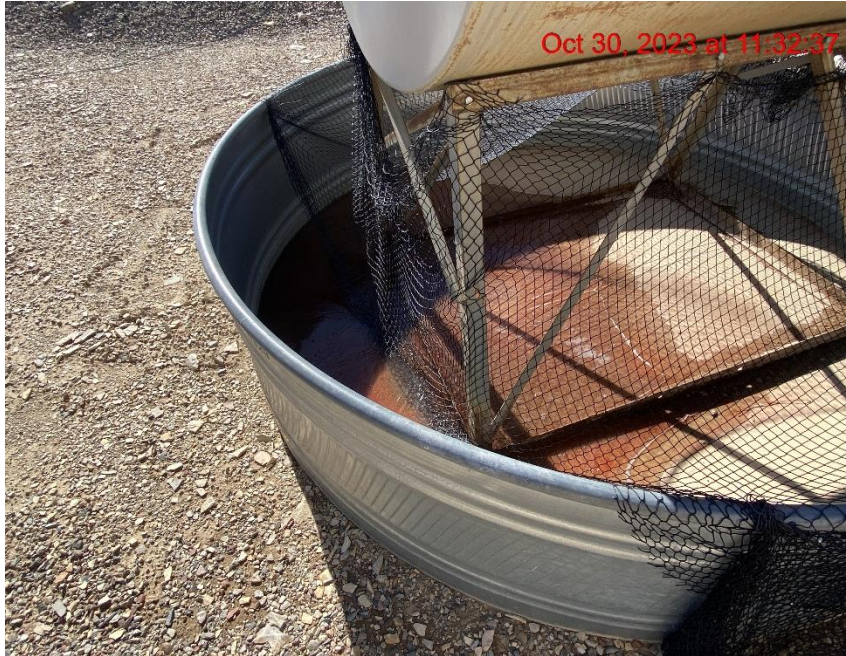
Wildlife Protective Netting Needs Repair – Photo #07212

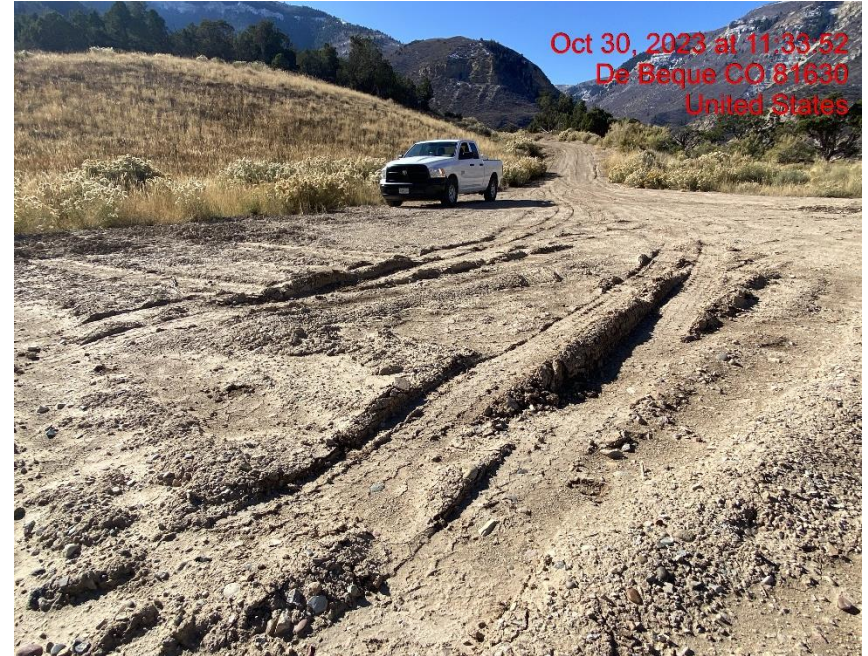
Lack of Stabilization – Photo #07216

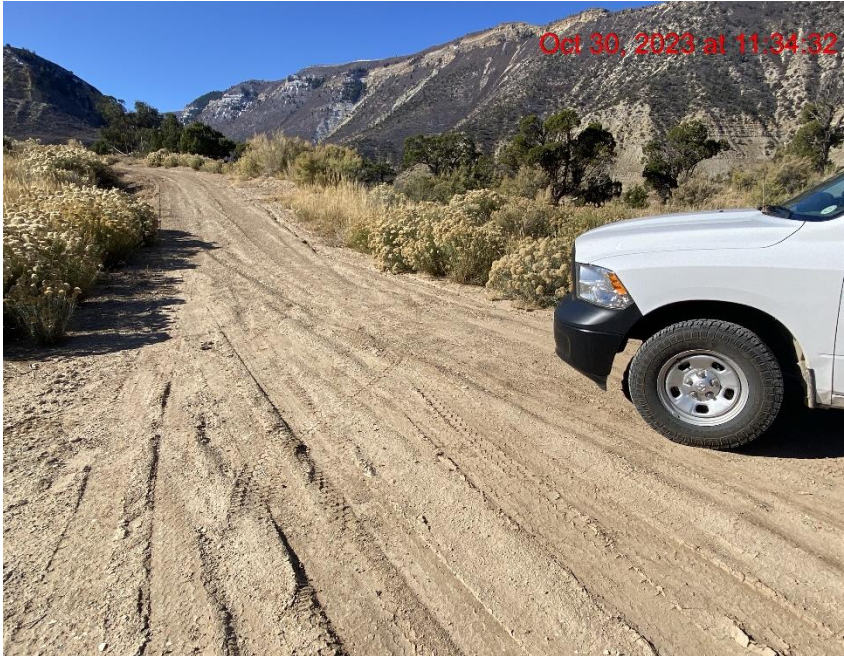
**Insufficient Vehicle Tracking BMPs at Location Entrance/Exit
– Photo #07217**

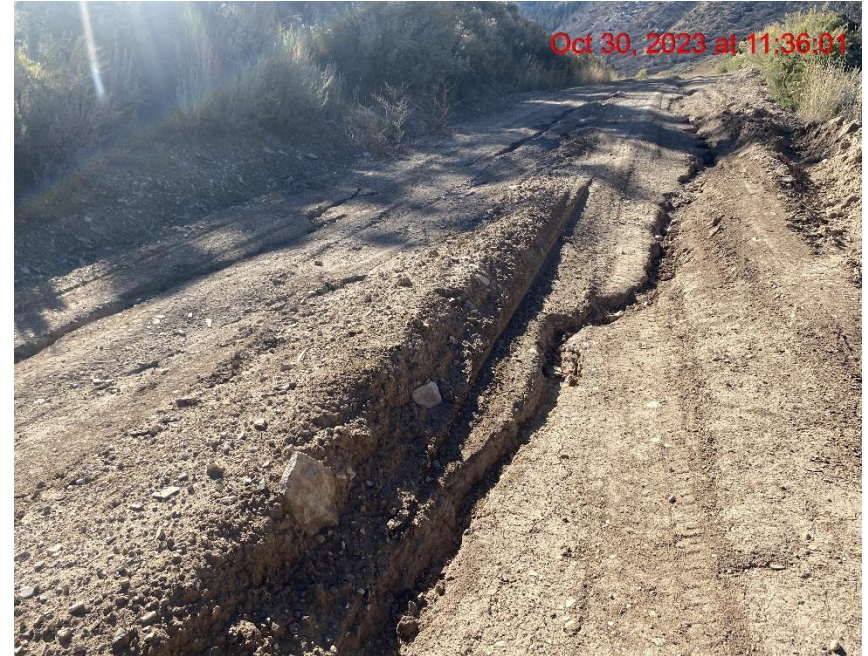
Insufficient Erosion Controls on Lease Road – Photo #07218
