Logos Ignacio 33-8 5: Location ID/API #:067-05476

COLORADO
Oil & Gas Conservation
Commission
Department of Natural Resources

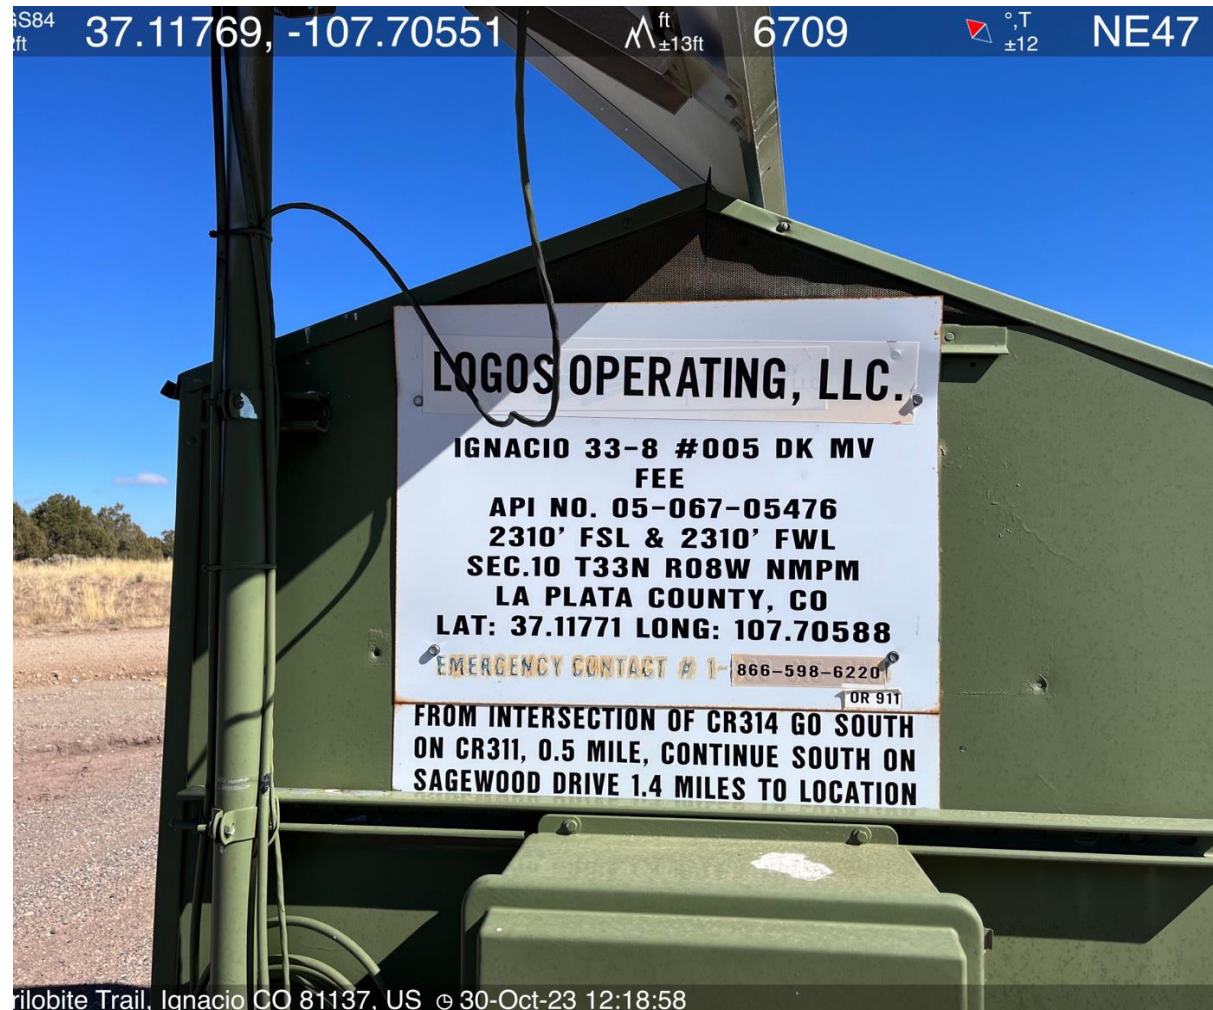
Photo #1 View of the posted well location signage.

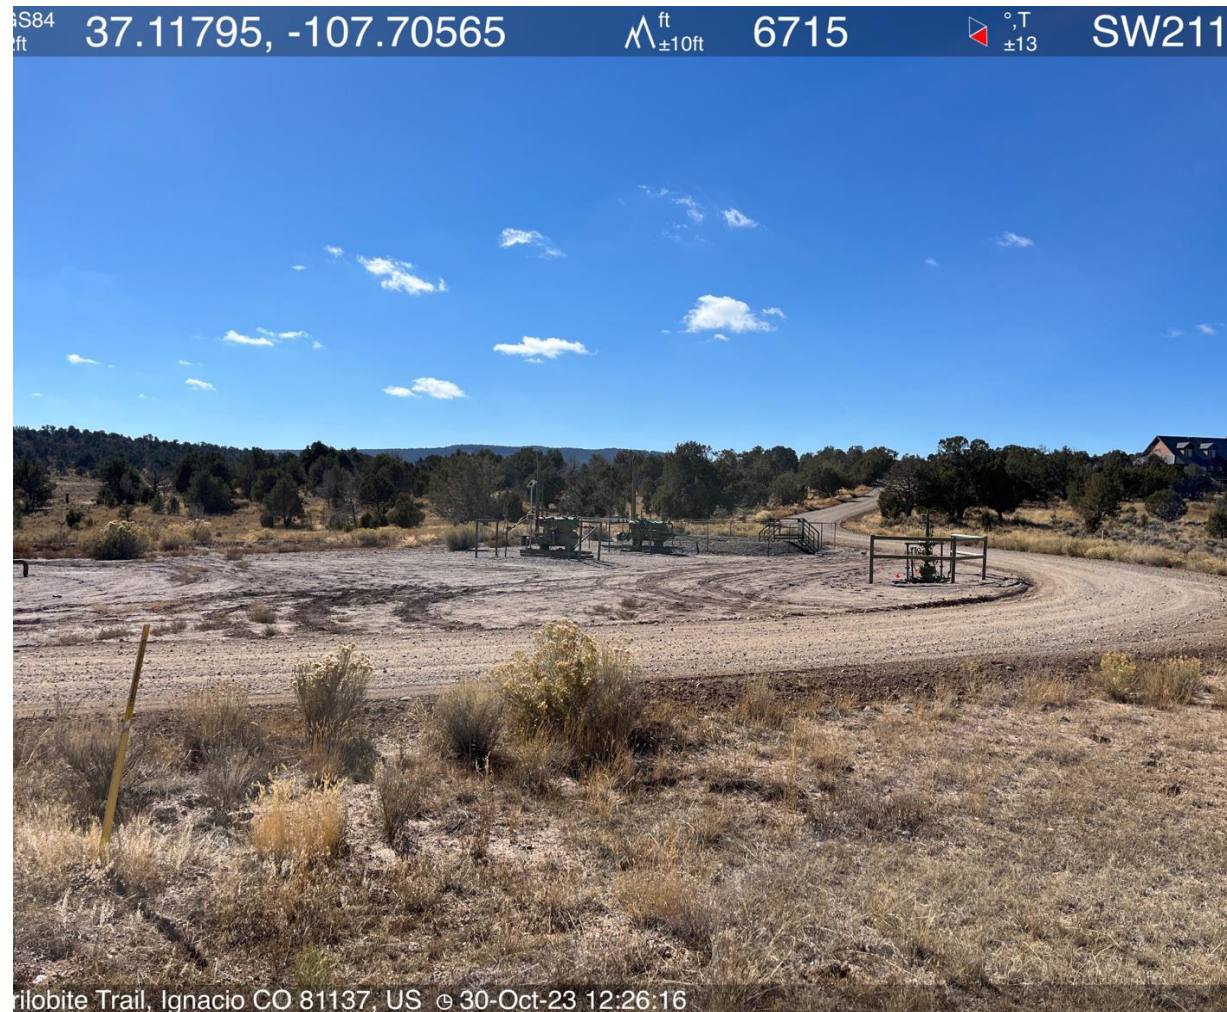
Photo #3 Overview of the well location, west side.

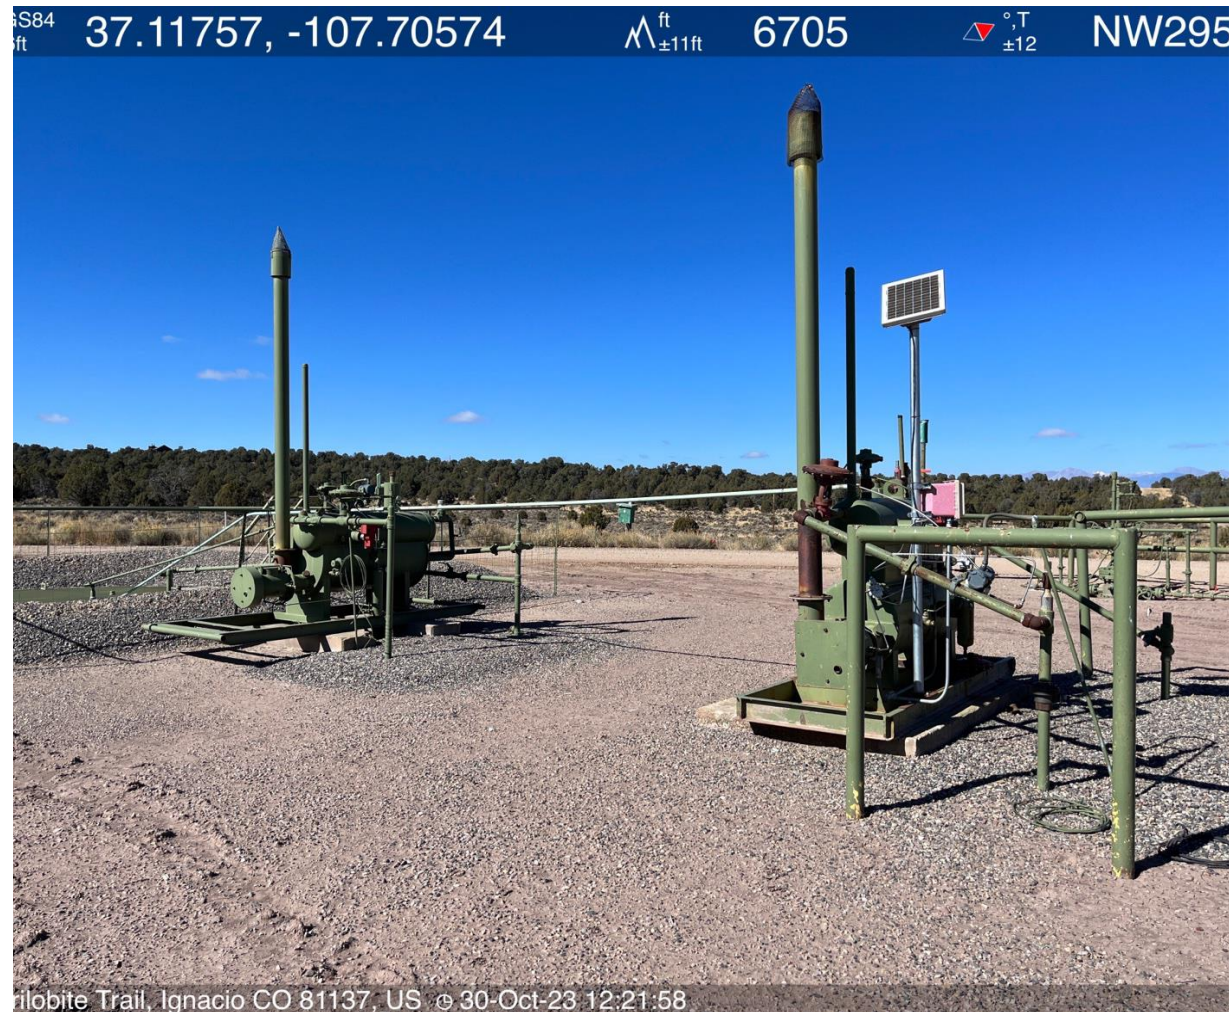
Photo #4 View of the separation equipment.

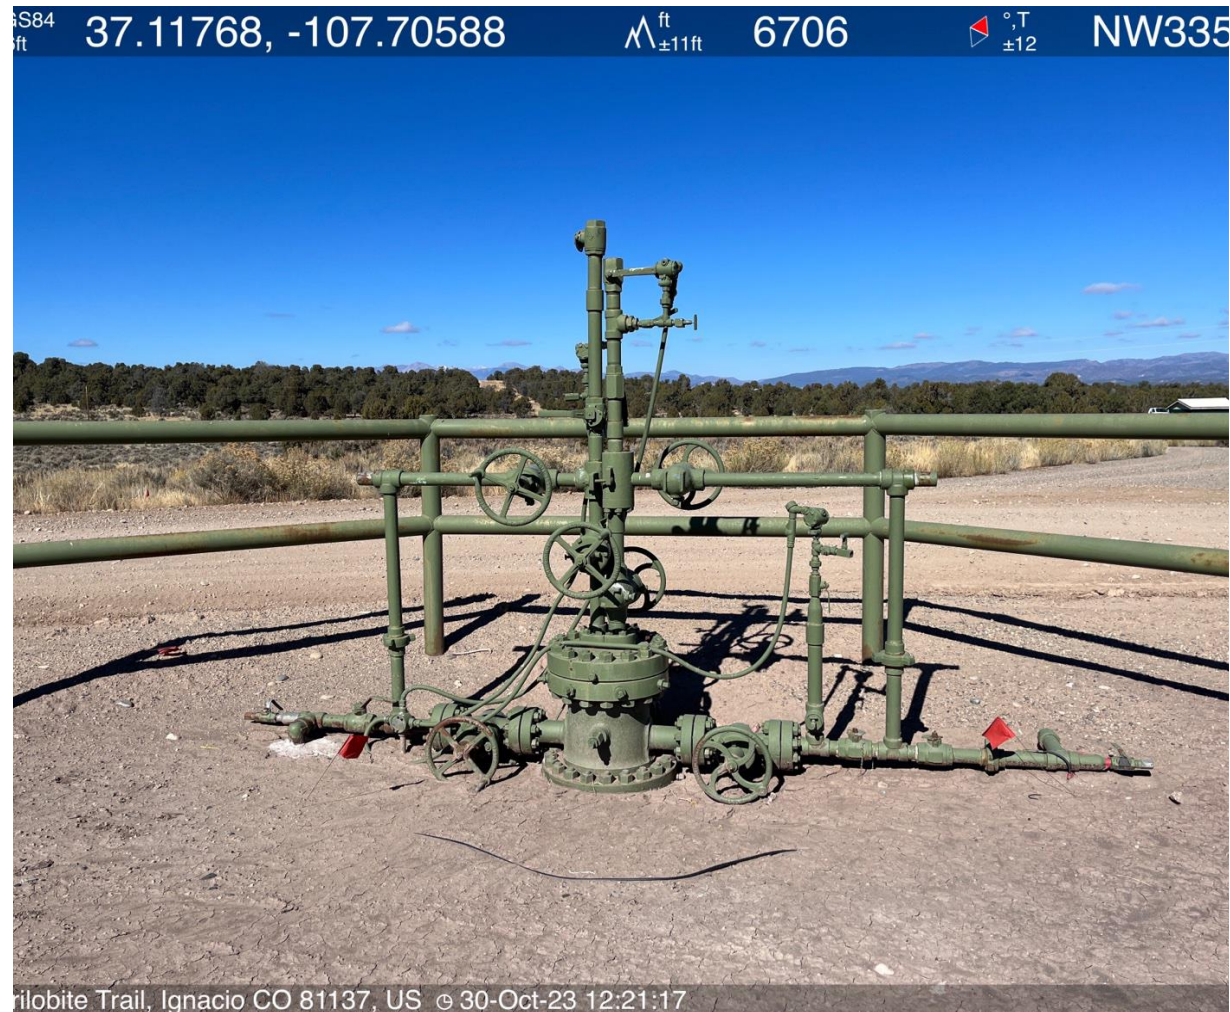
Photo #5 View of the wellhead assembly.

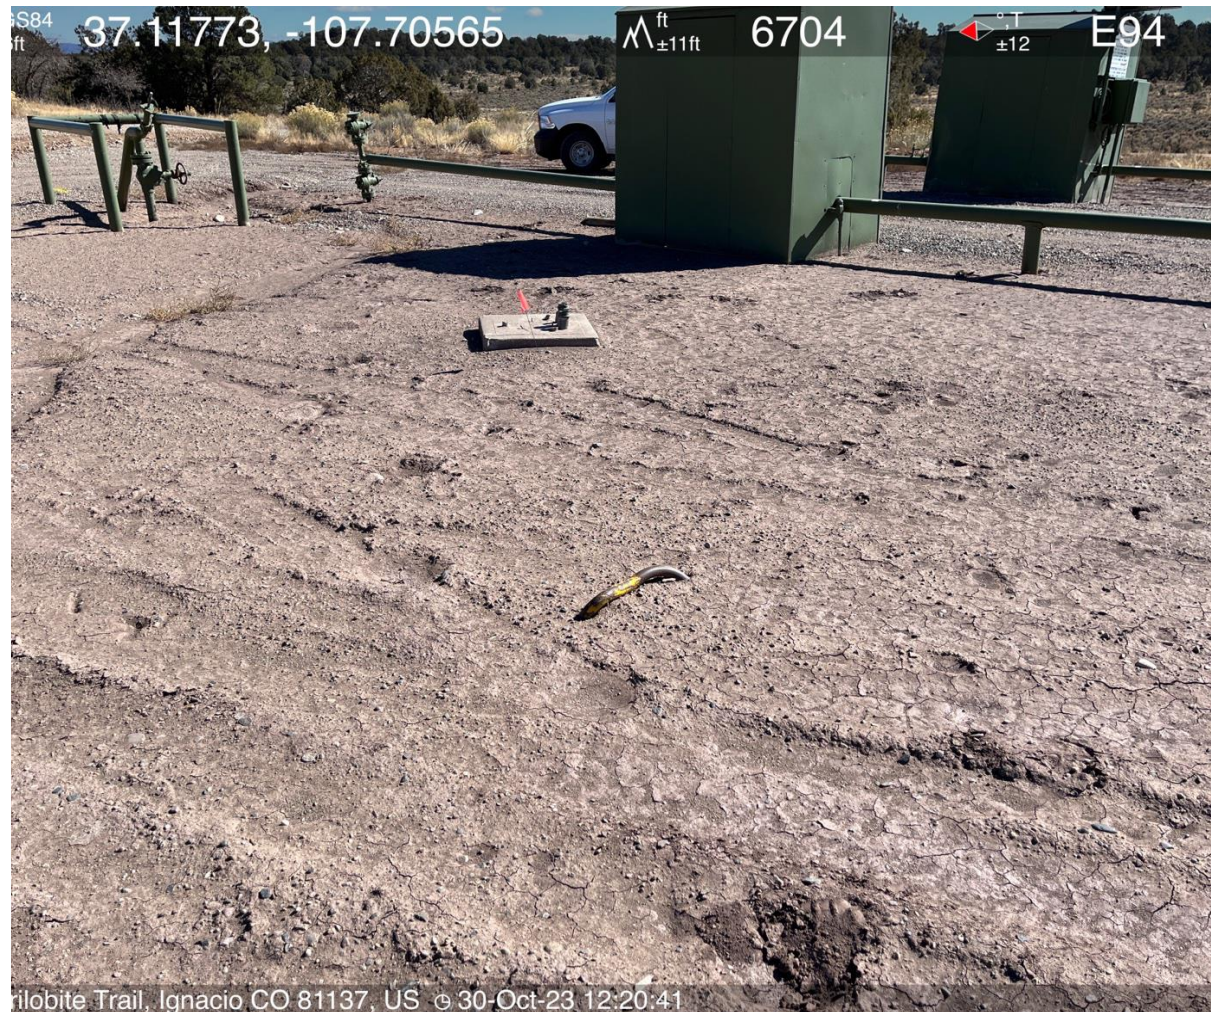
Photo #6 View of unmarked guy anchor.

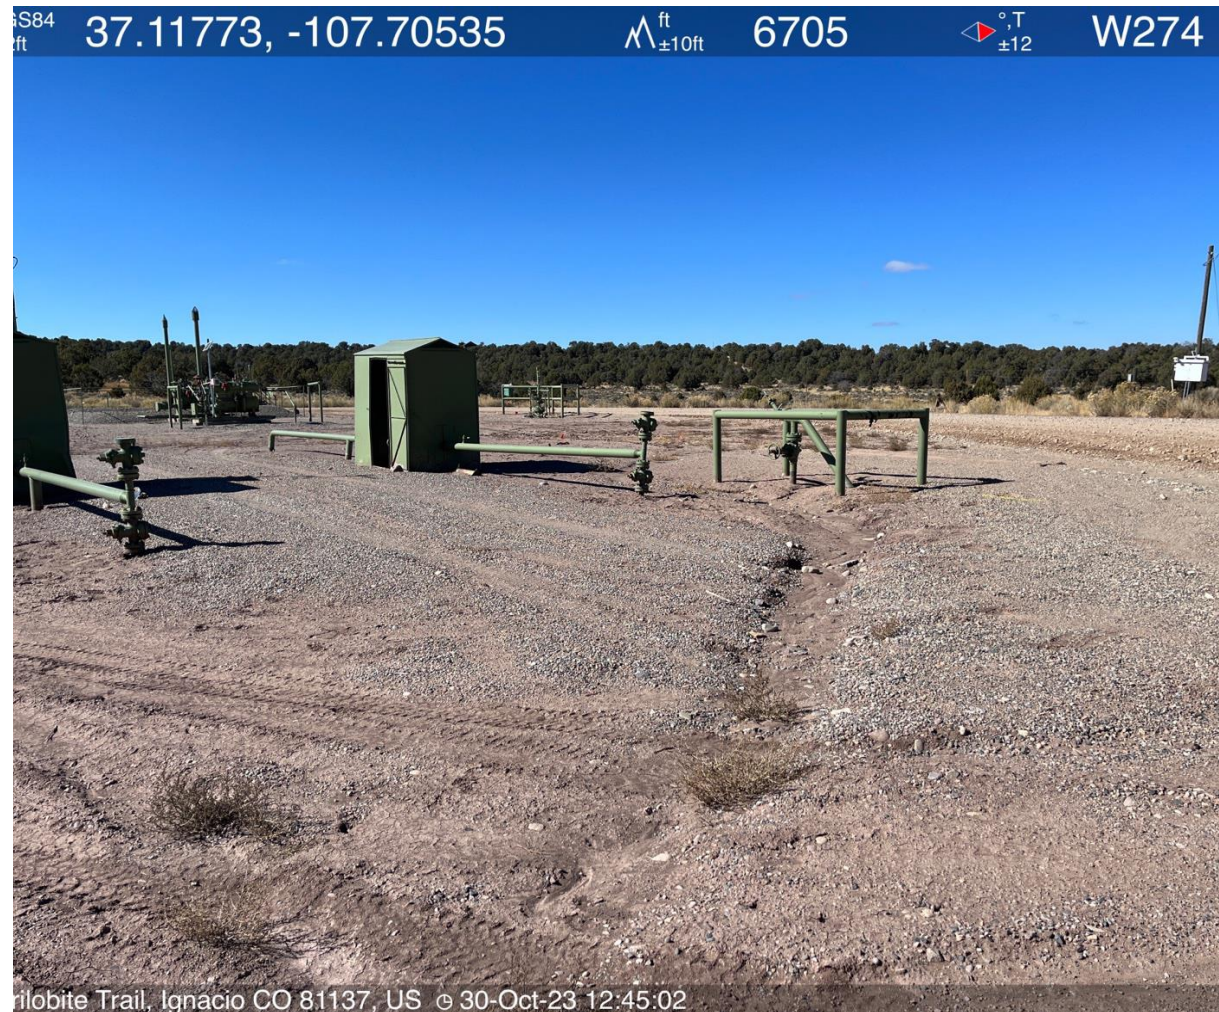
Photo #7 View of gulley erosion on east side of location.
