Inspection Photos

Location Name: TEP ROCKY MOUNTAIN LLC LAST DANCE 43C-3 Pad

Location ID: 334990

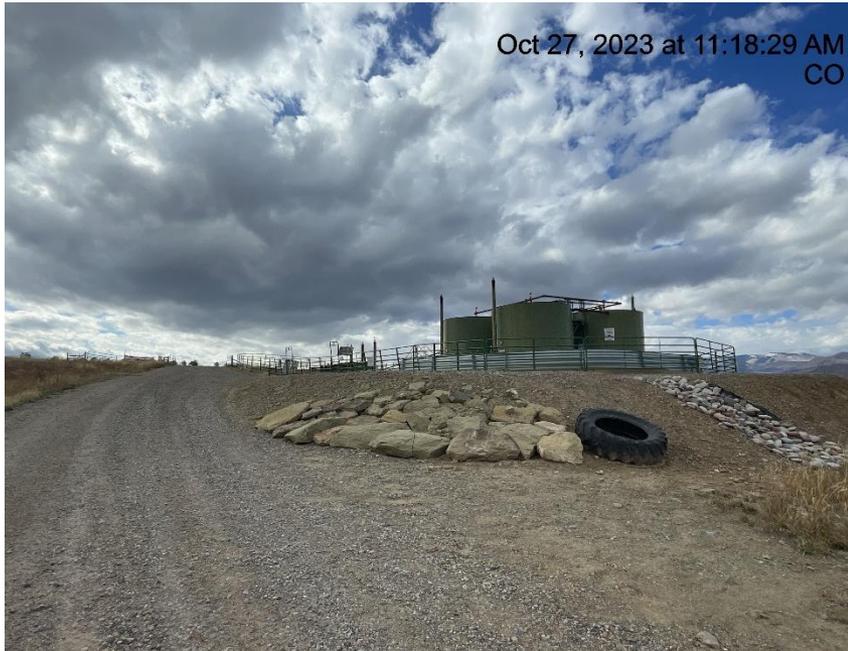
Photo # 4507 From entrance to location

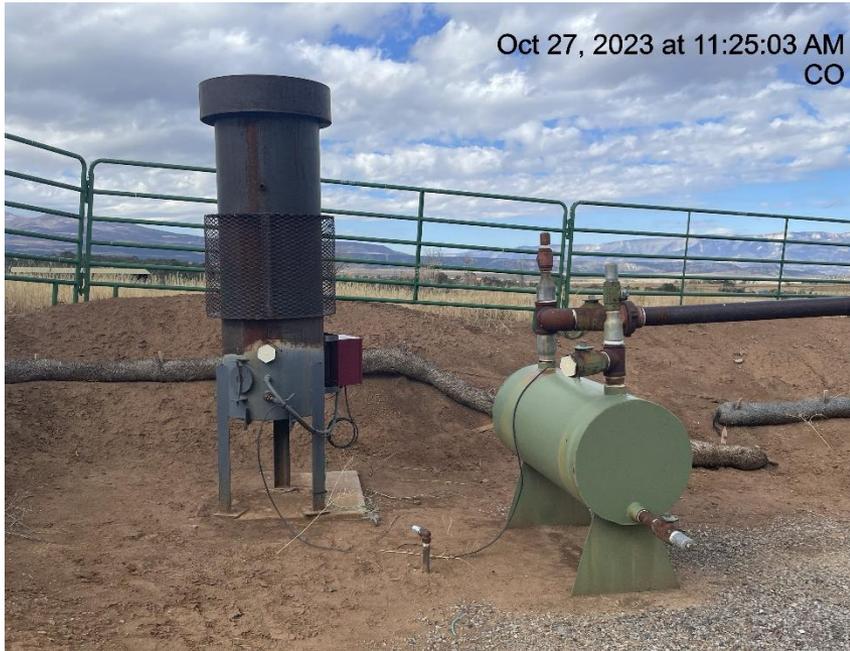
Photo # 4515 Unused equipment/ECD is disconnected

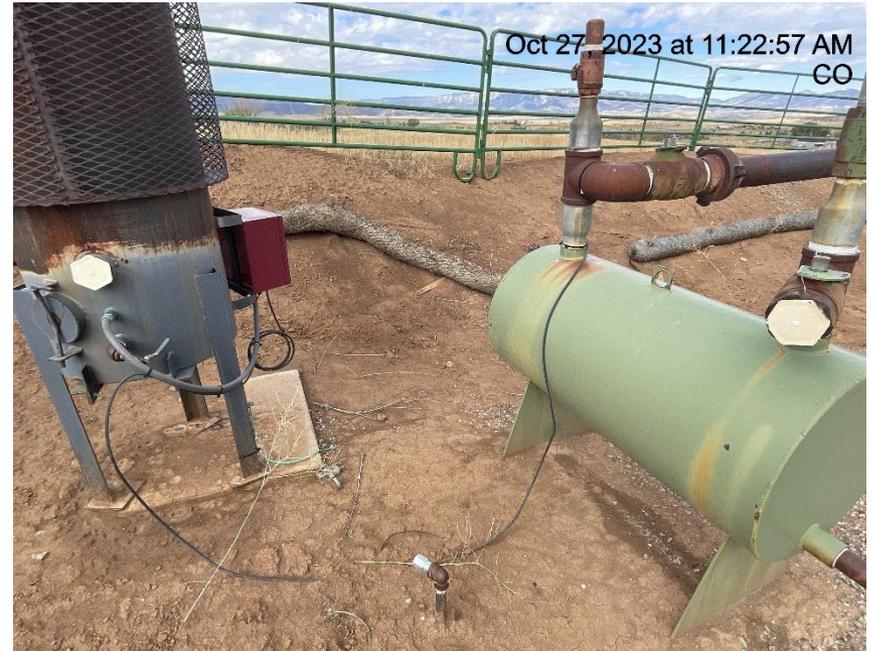
Photo # 4516 Unused equipment/ECD is disconnected

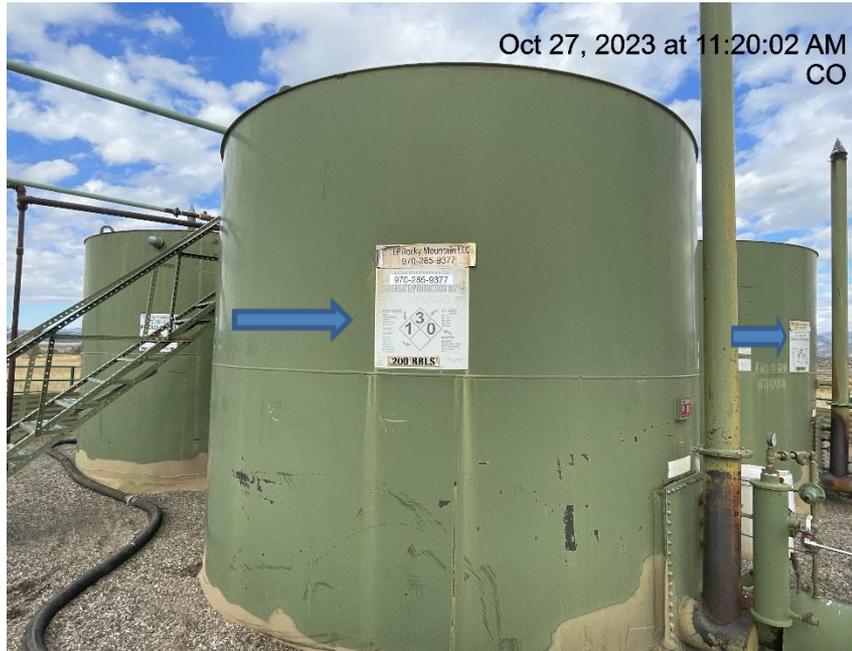
Photo # 4517 Multiple tank labels are weathered & fading

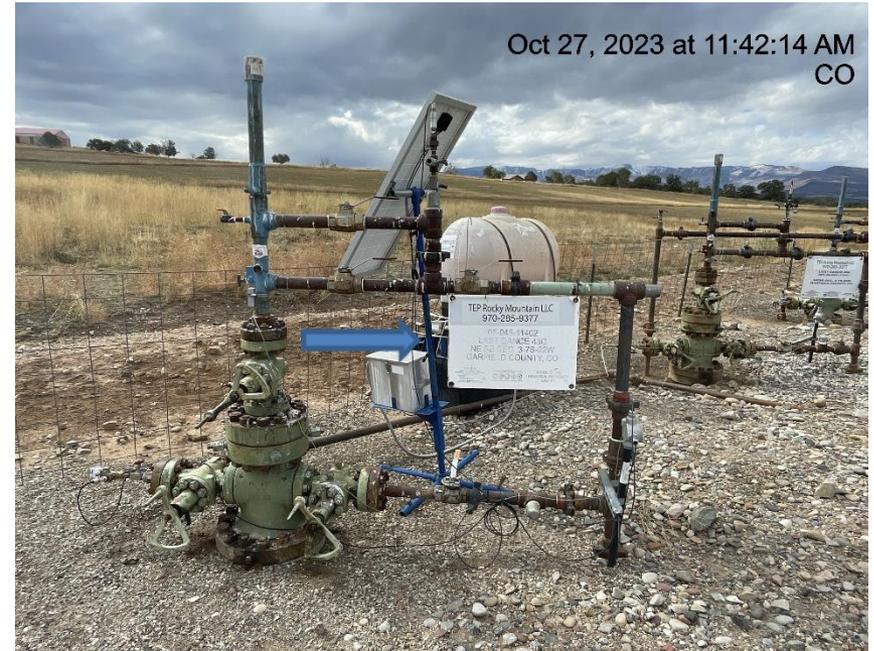
Photo # 4518 Last Dance 43C wellhead sign weathered & some info illegible

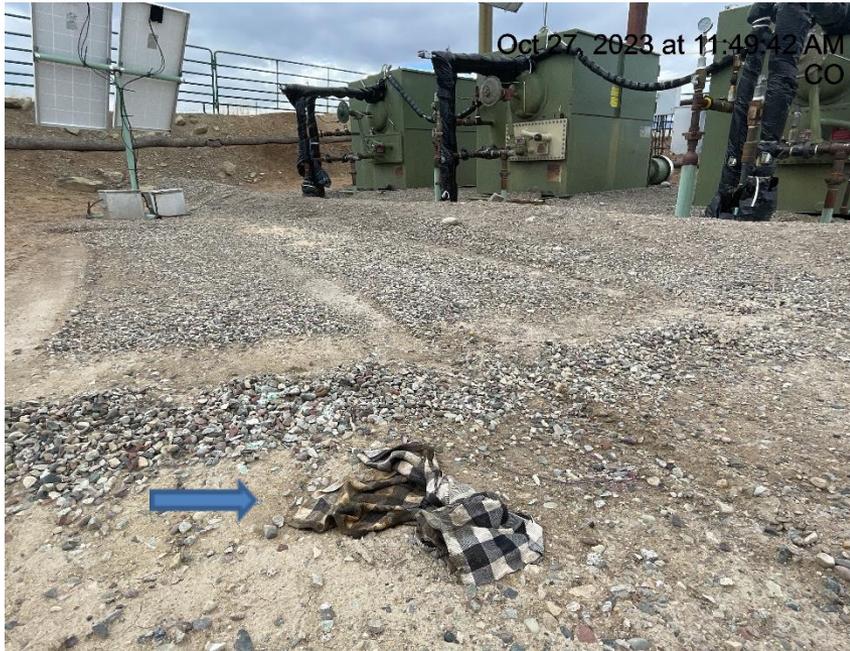
Photo # 4519 Debris

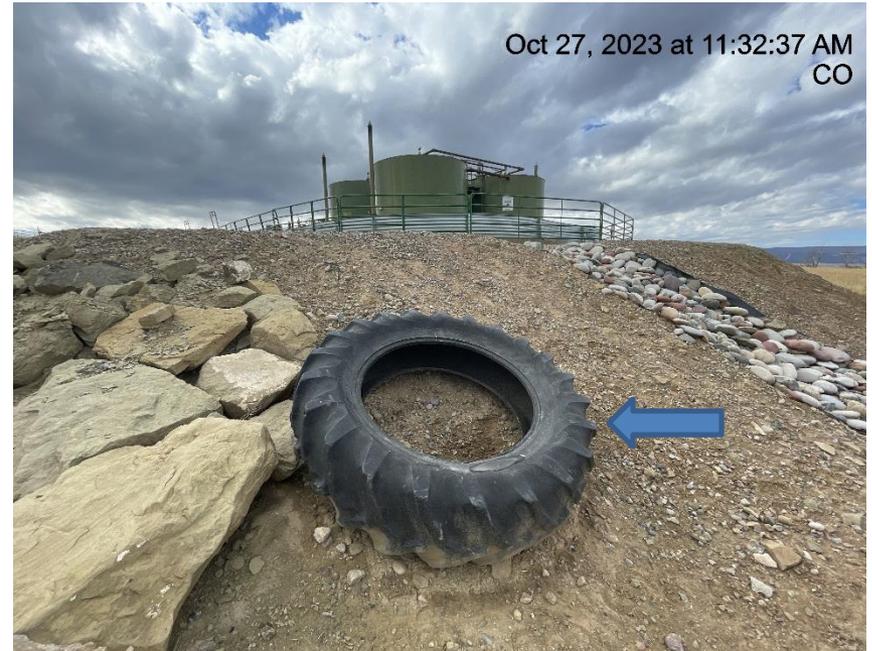
Photo # 4520 Debris
