## Inspection Photos

Location Name: Prospect Energy MSSU Injection Line Release

Spill ID: 485394

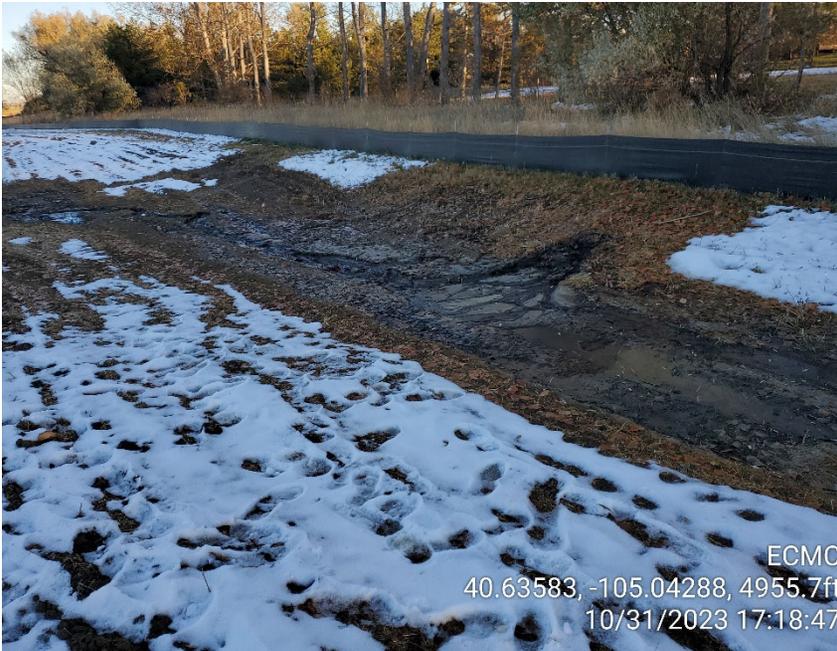
**Photo 1: Injection line apparent release point**

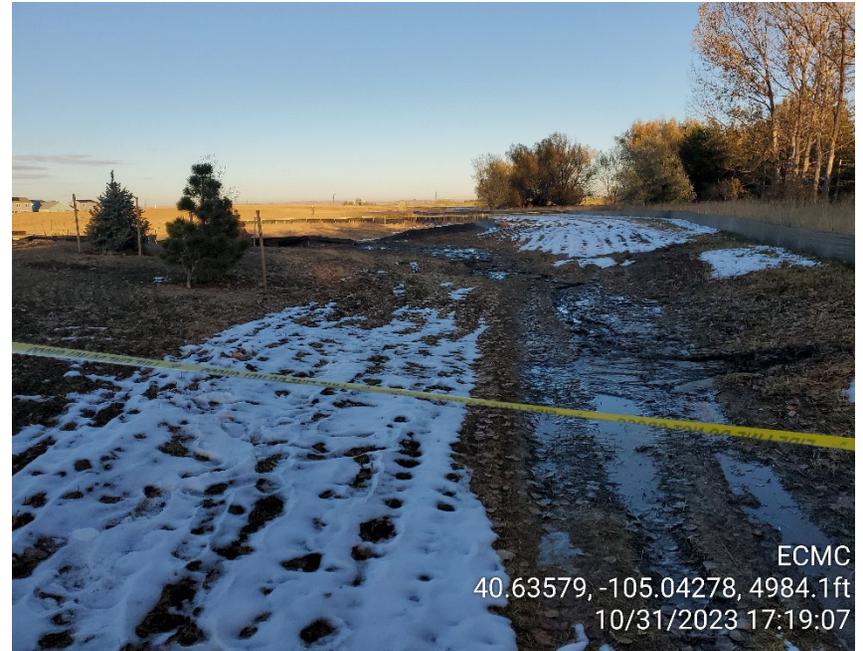
**Photo 2: Injection line release point looking east toward rain garden**

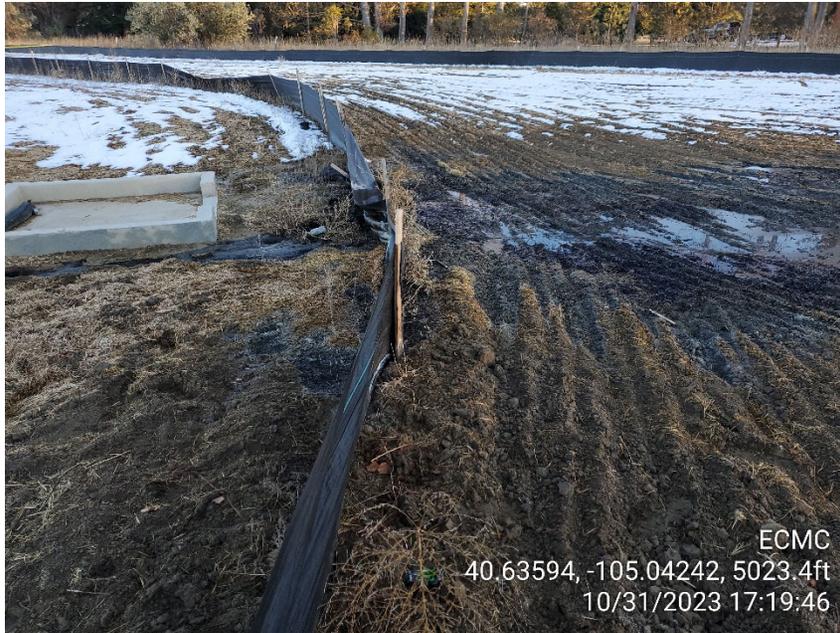
**Photo 3: Looking at inlet to rain garden with oil/produced water visible impacts**

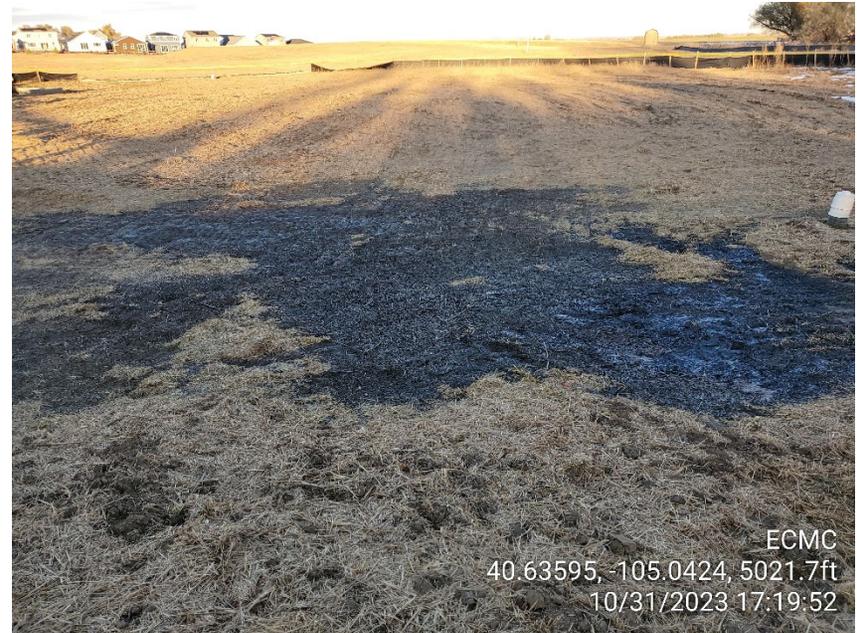
**Photo 4: Visible oil/produced water impacts to surface in rain garden**

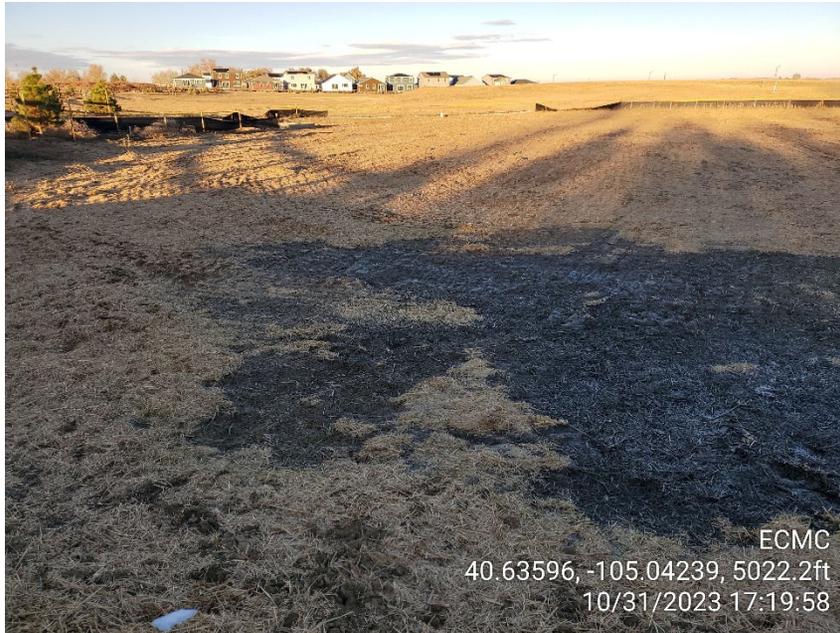
**Photo 5: Visible oil/produced water impacts in rain garden.  
Looking north.**

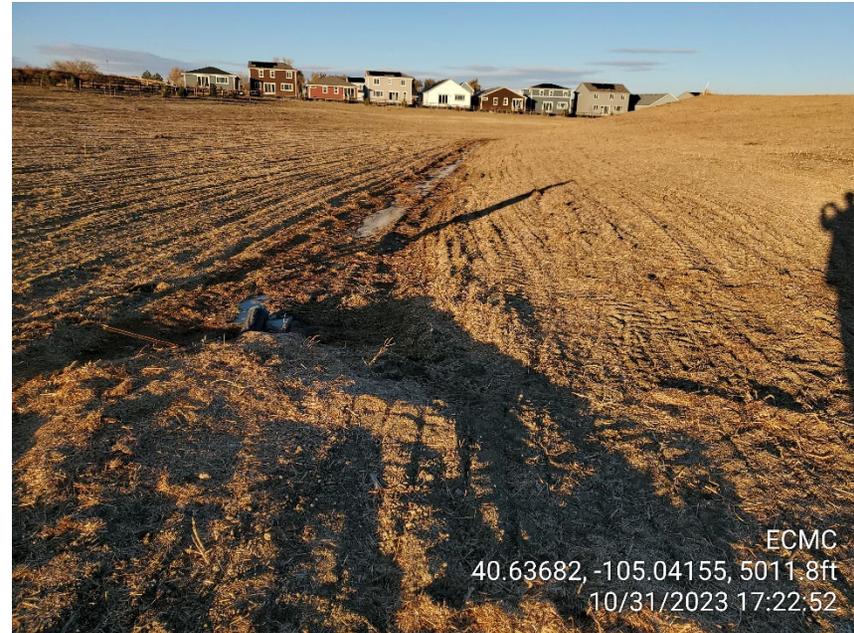
**Photo 6: Discharge overflow pipe from rain garden, looking  
north**

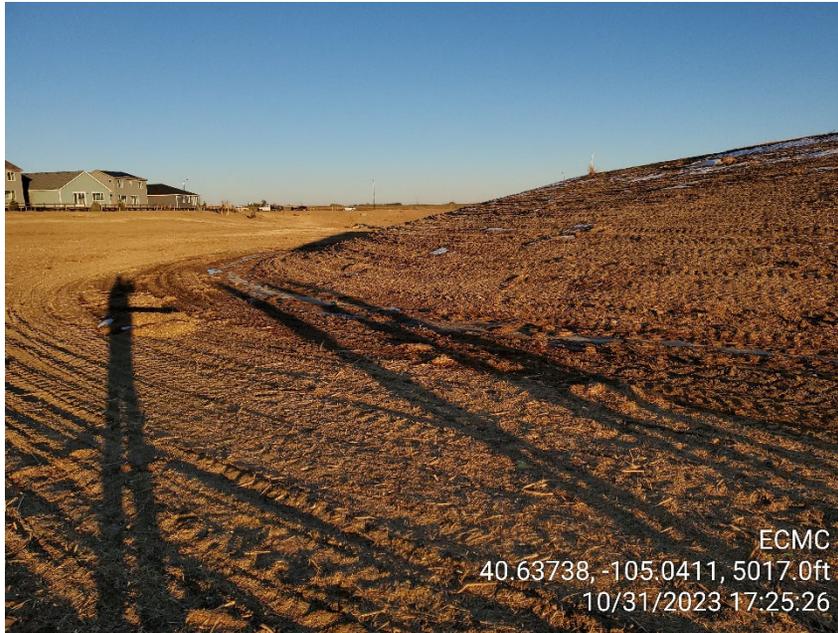
**Photo 7: Stormwater drain downgradient of rain garden outfall/overflow pipe, looking northeast**

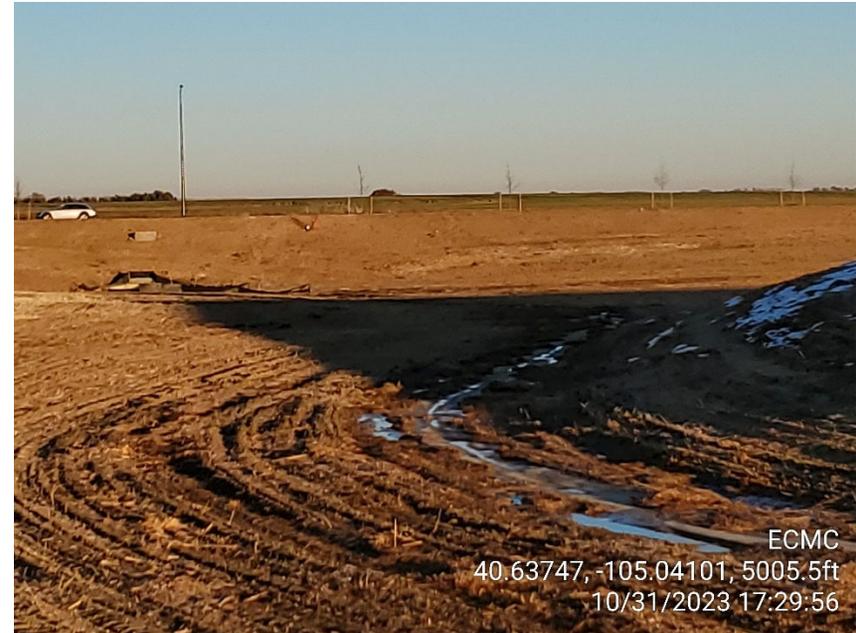
**Photo 8: Stormwater drain downgradient of rain garden outfall/overflow pipe, looking east toward Turnburry Road**

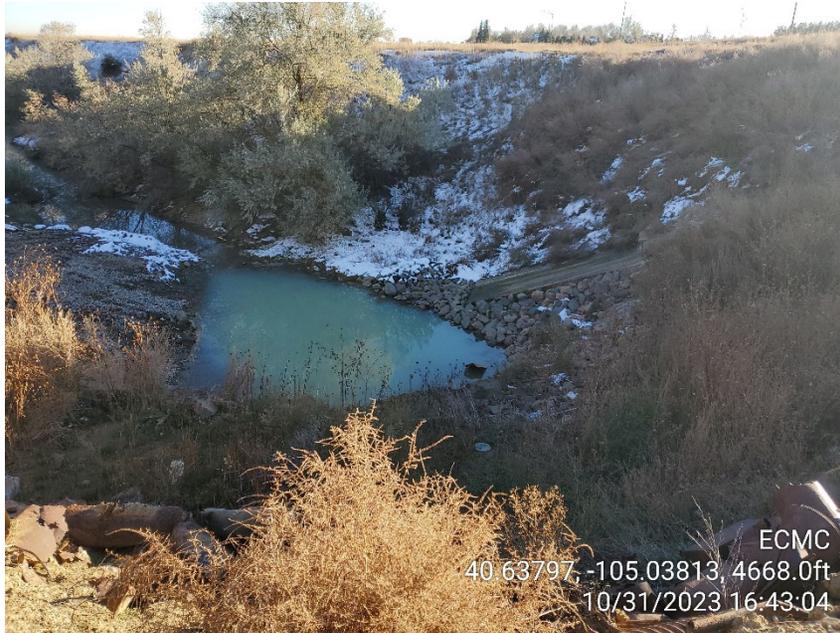
**Photo 9: Discharge of culvert on east side of Turnberry Road into settling pond, looking south**

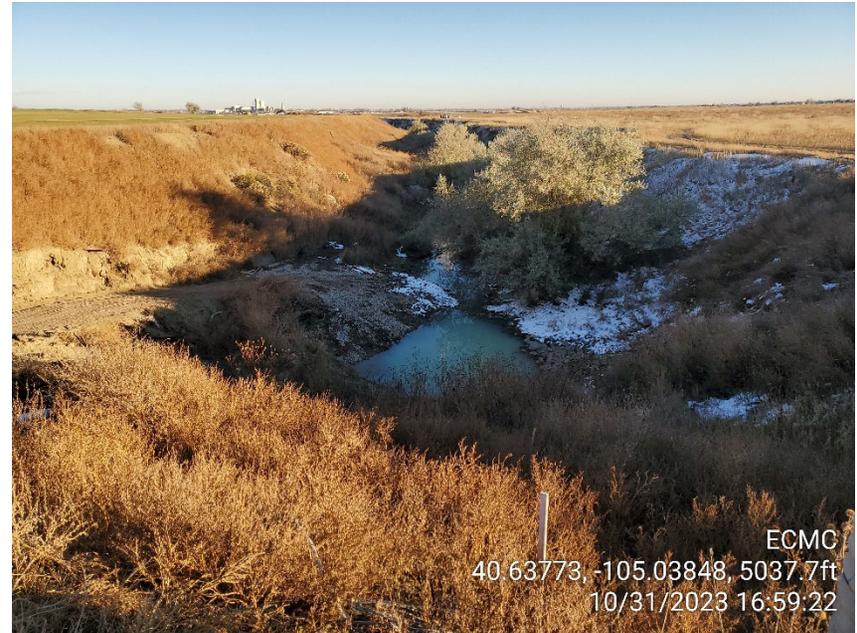
**Photo 10: Looking south/southeast along Number 8 Outfall Ditch.**

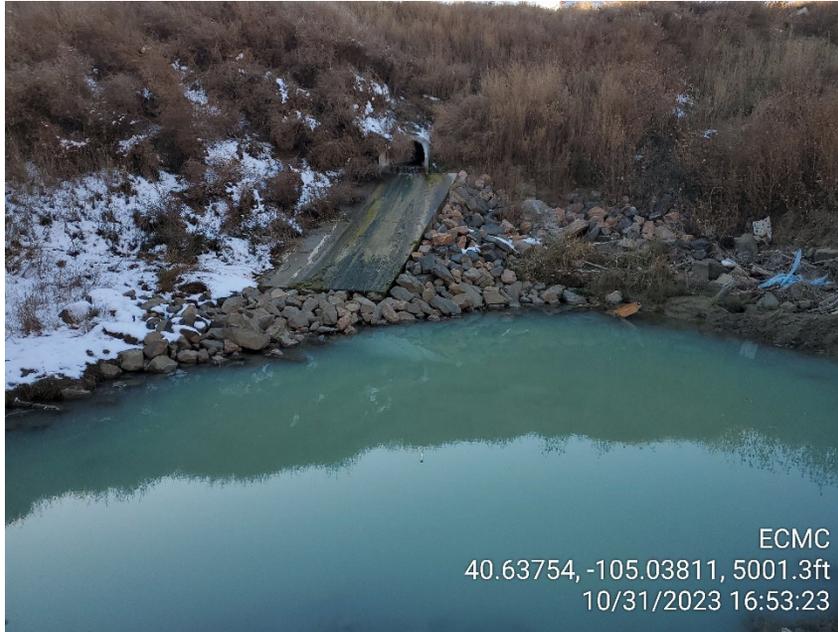
**Photo 11: View of outfall from culvert beneath Turnberry Road and settling pond in Number 8 Outlet ditch. Also ECMC sample location "Outfall Basin"**

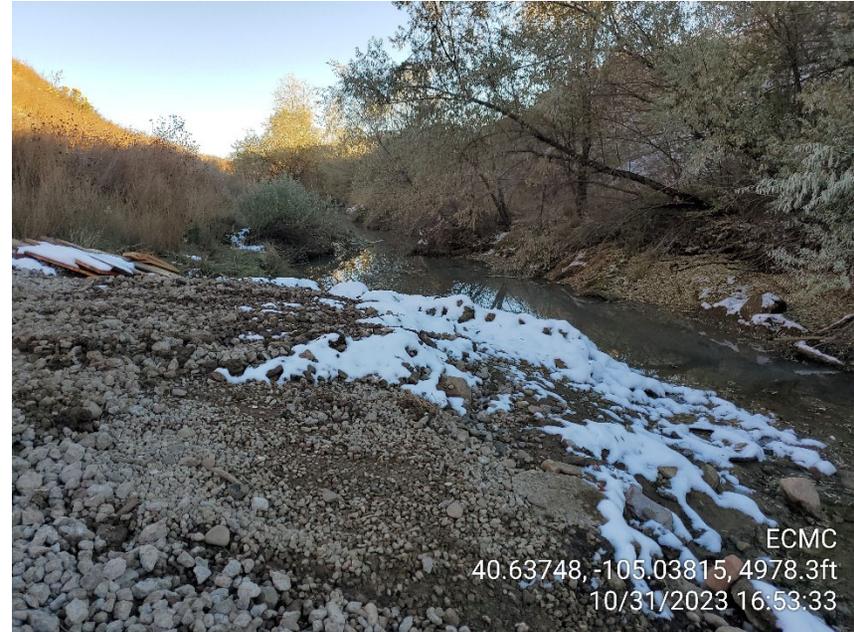
**Photo 12: View from settling pond looking southeast downstream in ditch.**

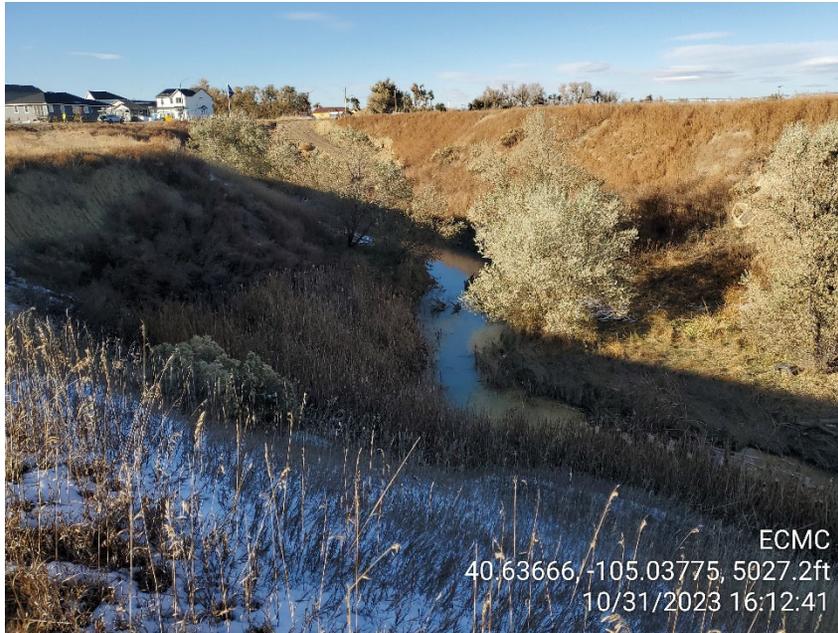
**Photo 13: View from downstream along Number 8 Outlet ditch, looking northwest.**

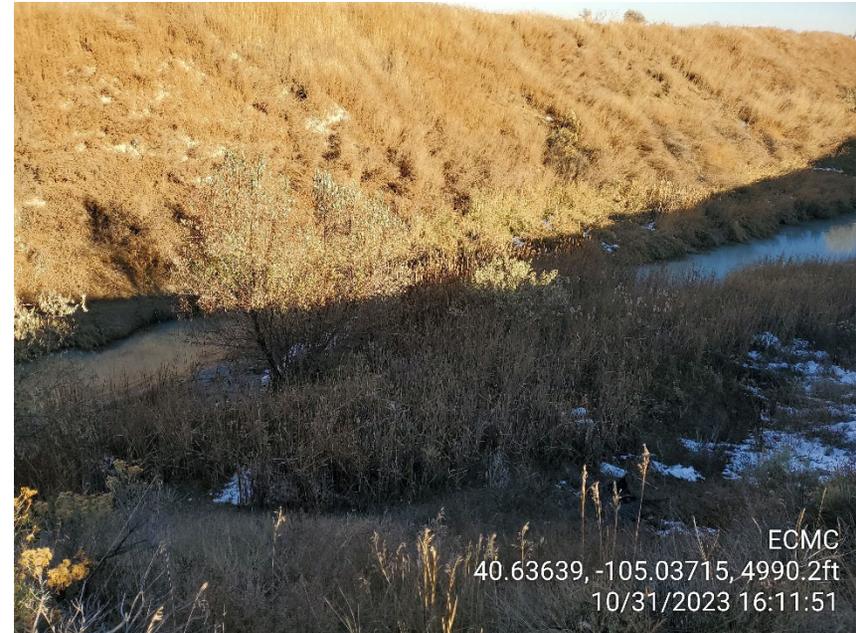
**Photo 14: View from downstream along Number 8 Outlet ditch, looking into ditch.**

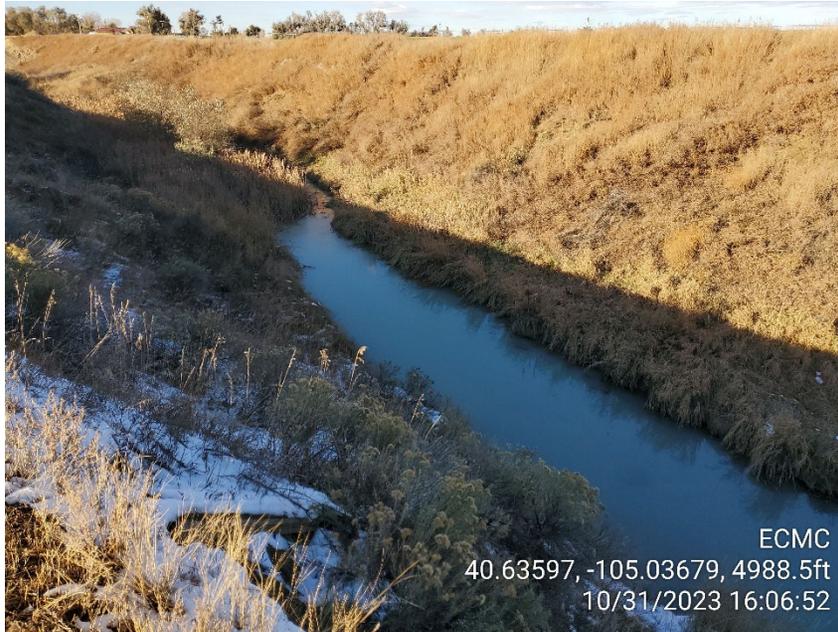
**Photo 15: View into Number 8 Outlet ditch, at approximate terminus of visible impacts in water downstream from culvert outfall, looking northwest.**

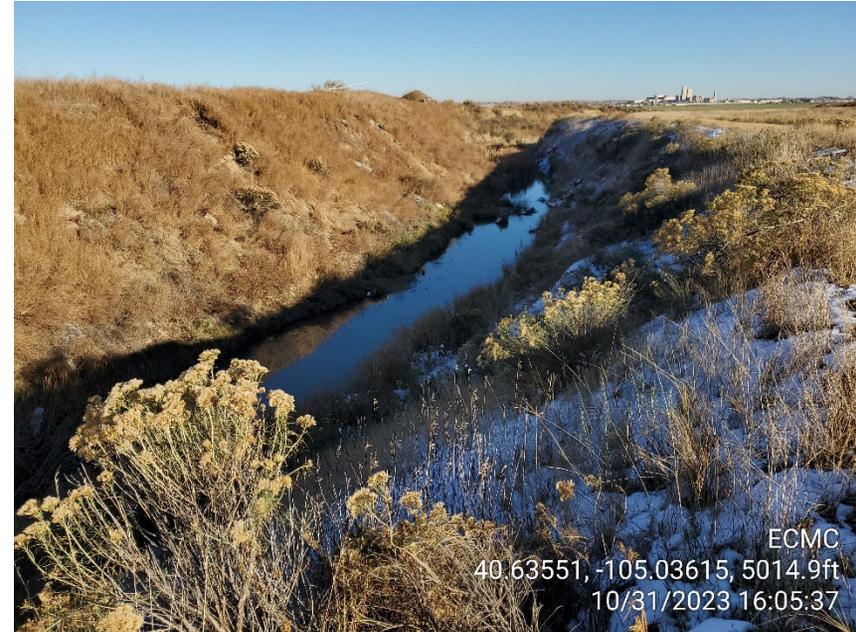
**Photo 16: View into Number 8 Outlet ditch, at approximate terminus of visible impacts in water downstream from culvert outfall, looking southeast.**

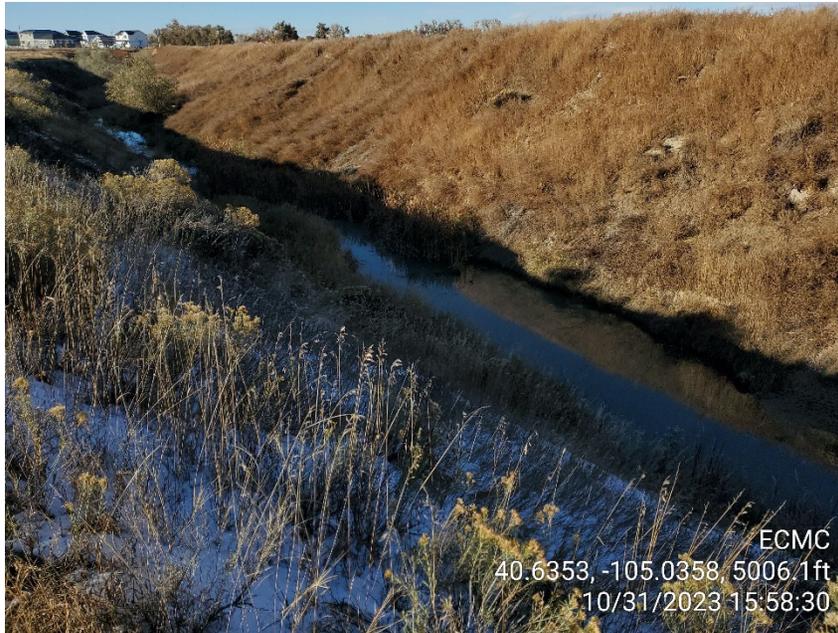
**Photo 17: View into Number 8 Outlet ditch, at approximate terminus of visible impacts in water downstream from culvert outfall, looking northwest.**

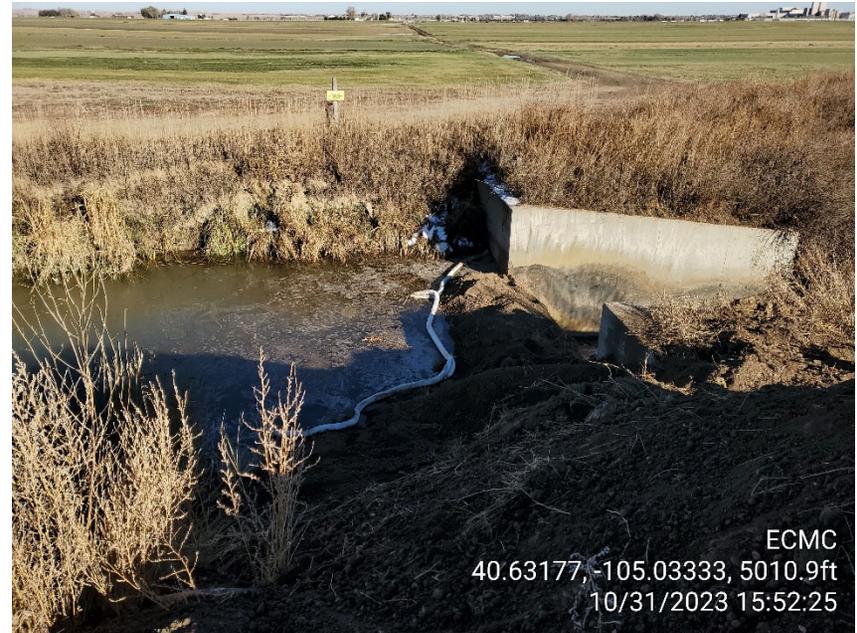
**Photo 18: View of temporary berm constructed downstream in Number 8 Outlet ditch.**

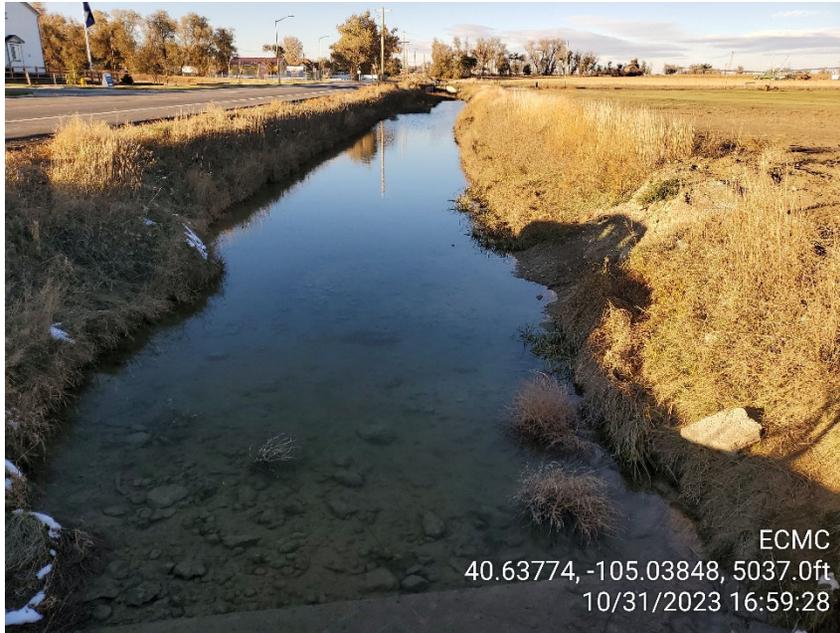
**Photo 19: View of Number 8 Outfall ditch, looking north, upstream of Produced Water impacts.**

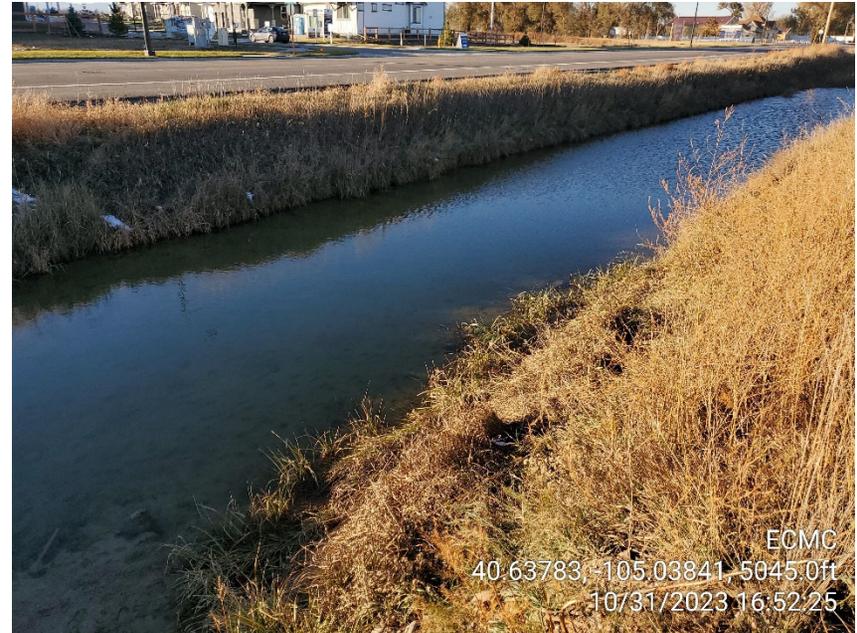
**Photo 20: View of ECMC sample point "Upstream" in Number 8 Outfall ditch, upstream of Produced Water impacts.**
