Inspection Photos
Location Name: HSR Stroh 11-35
Location ID: 326834

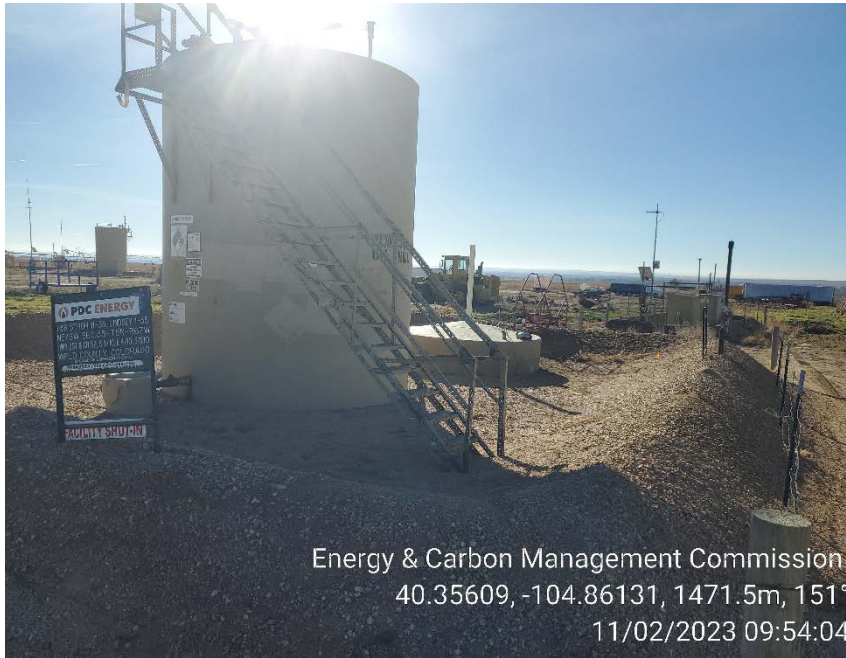
Production facility

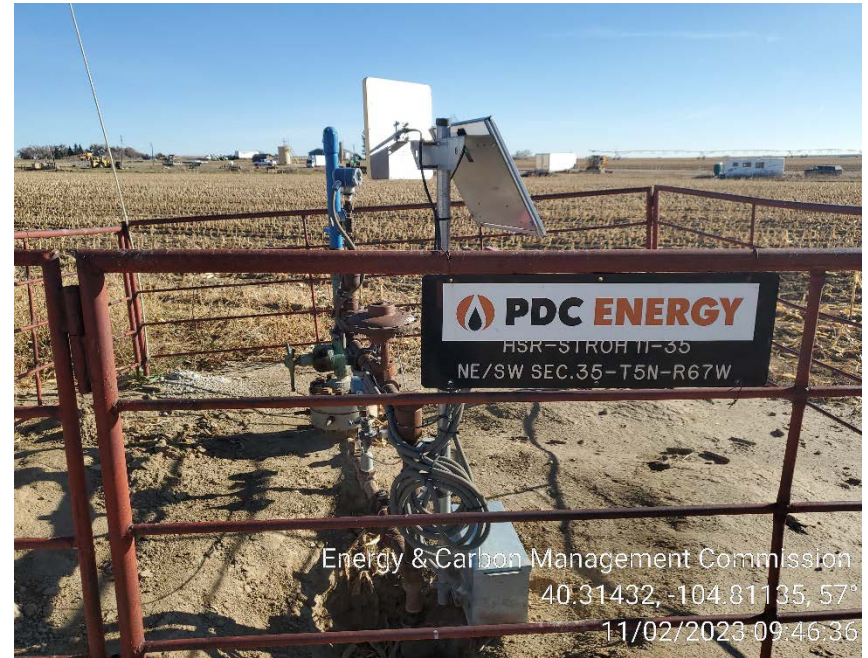
Wellhead sign

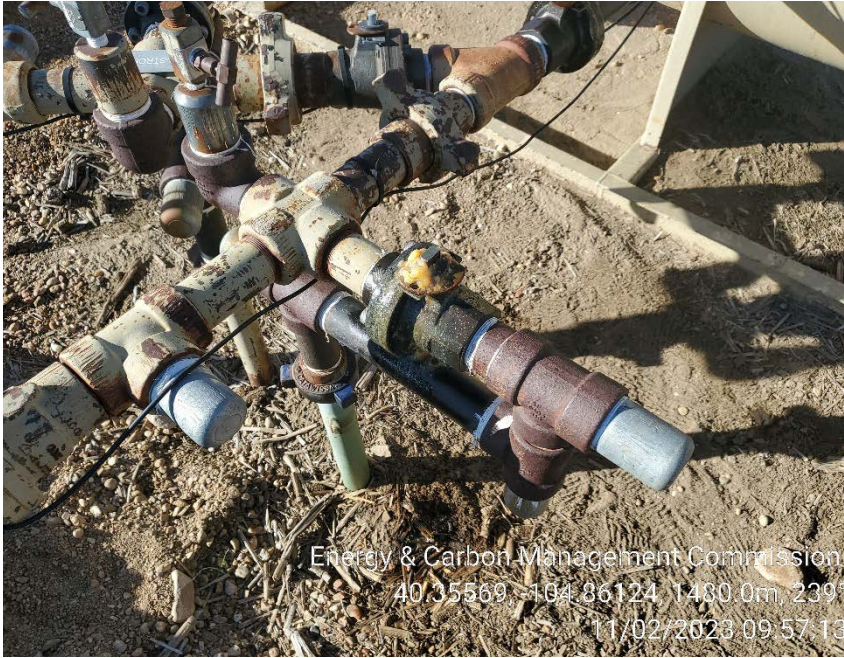
Valve leak

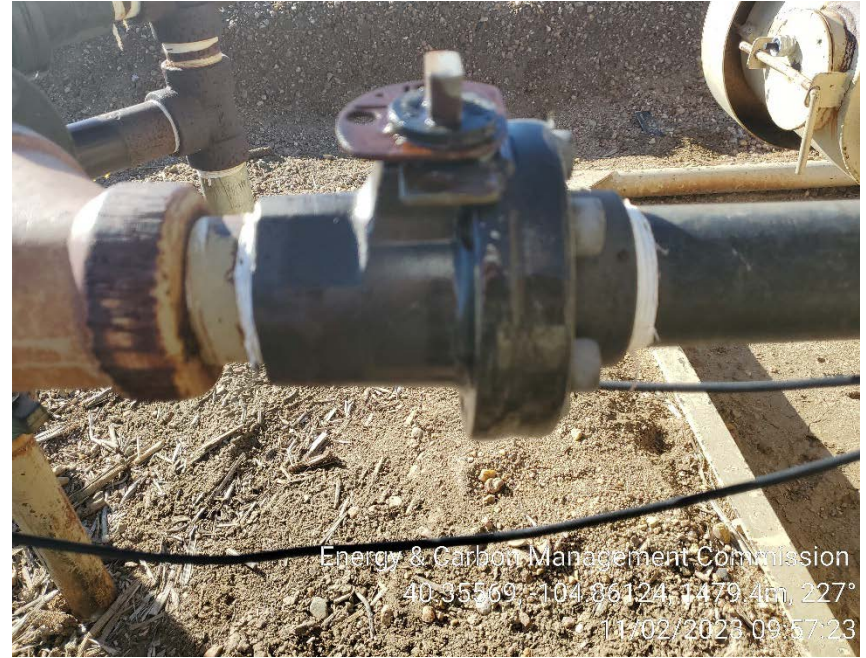
Valve leak

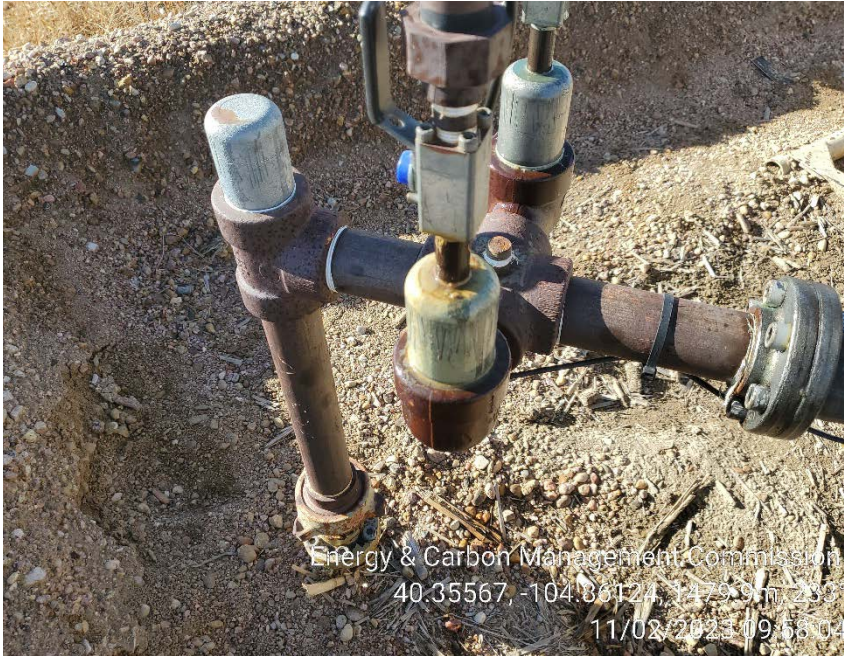
Valve leak

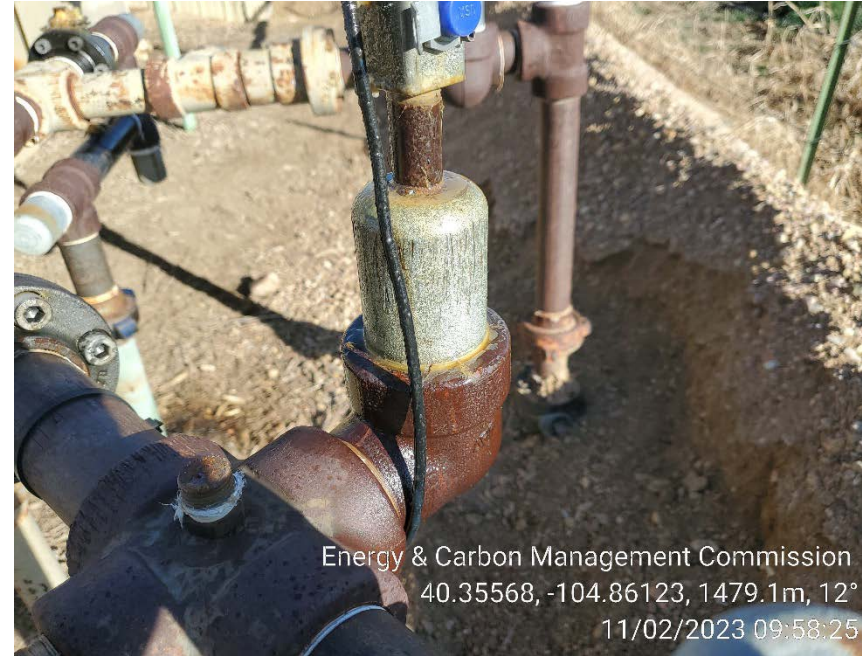
Valve leak

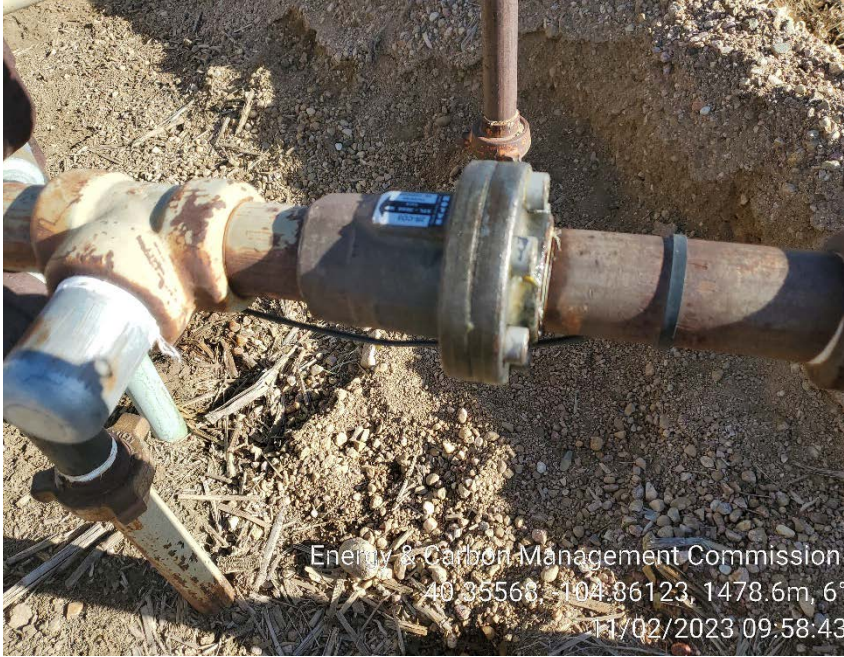
Check valve leak

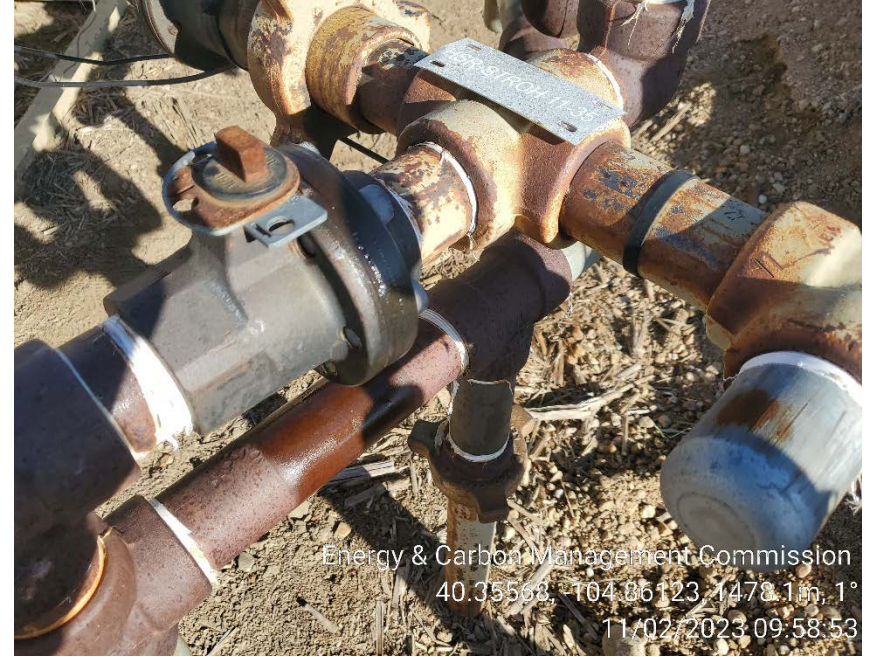
Valve leak
