**Inspection Photos 11/1/23**  
**Location Name: Dent 1-16**  
**API: 05-099-06211**

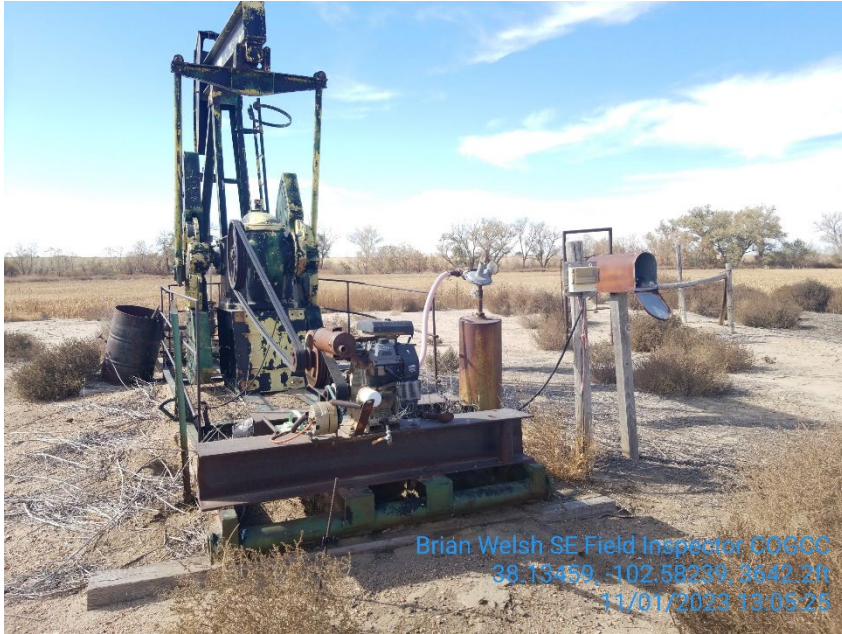
**Prime mover and ancillary equipment**

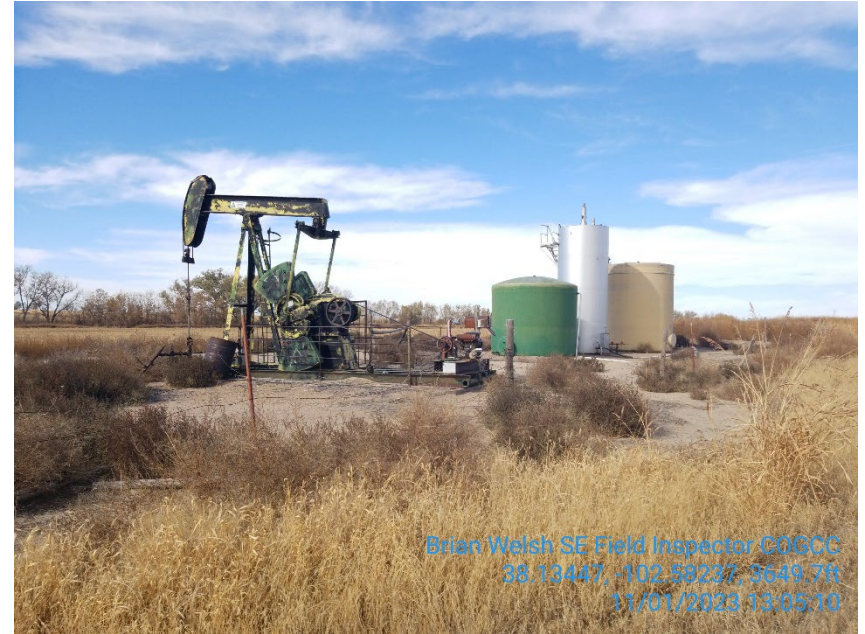
**Location photo of unit and tanks**

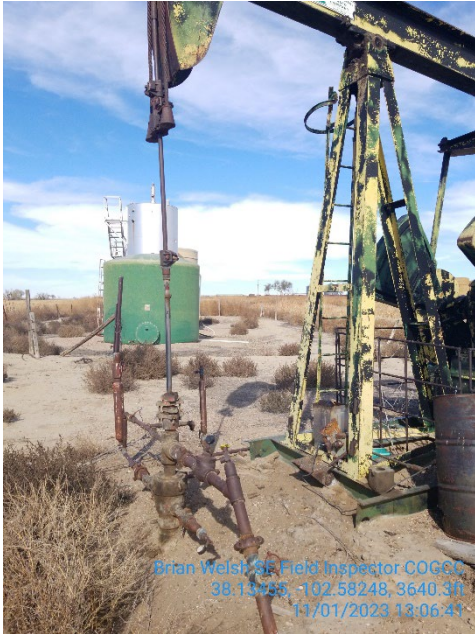
**Bridle still connected to polished rod and downhole equipment in wellbore**

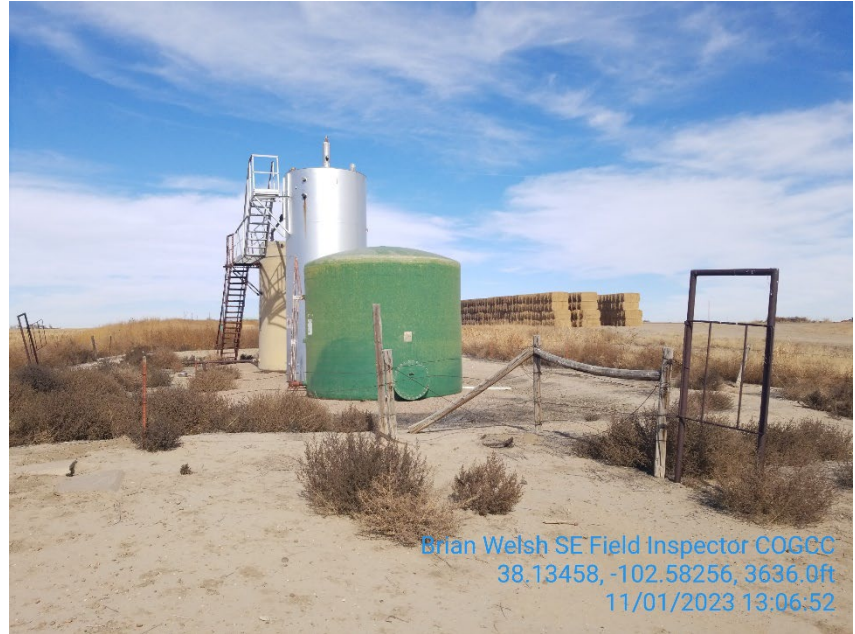
**South side of tank battery looking north**

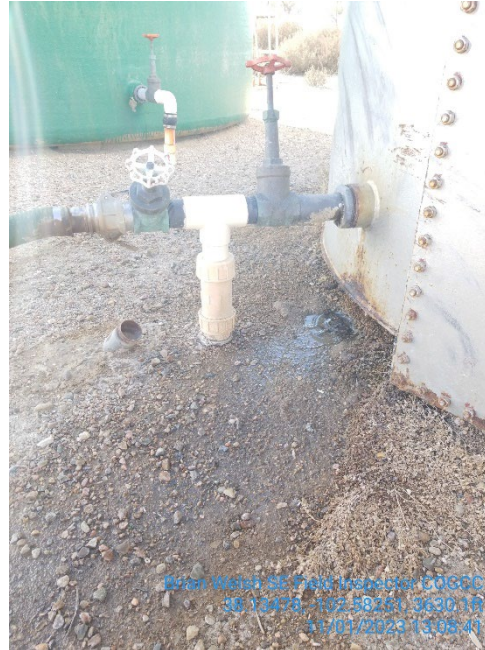
**Active water leak found at time of inspection. Notified OWP manager. Water seems to be high H<sub>2</sub>S content**
