Location  
: 446527

**COLORADO**  
Energy & Carbon Management  
Commission  
Department of Natural Resources

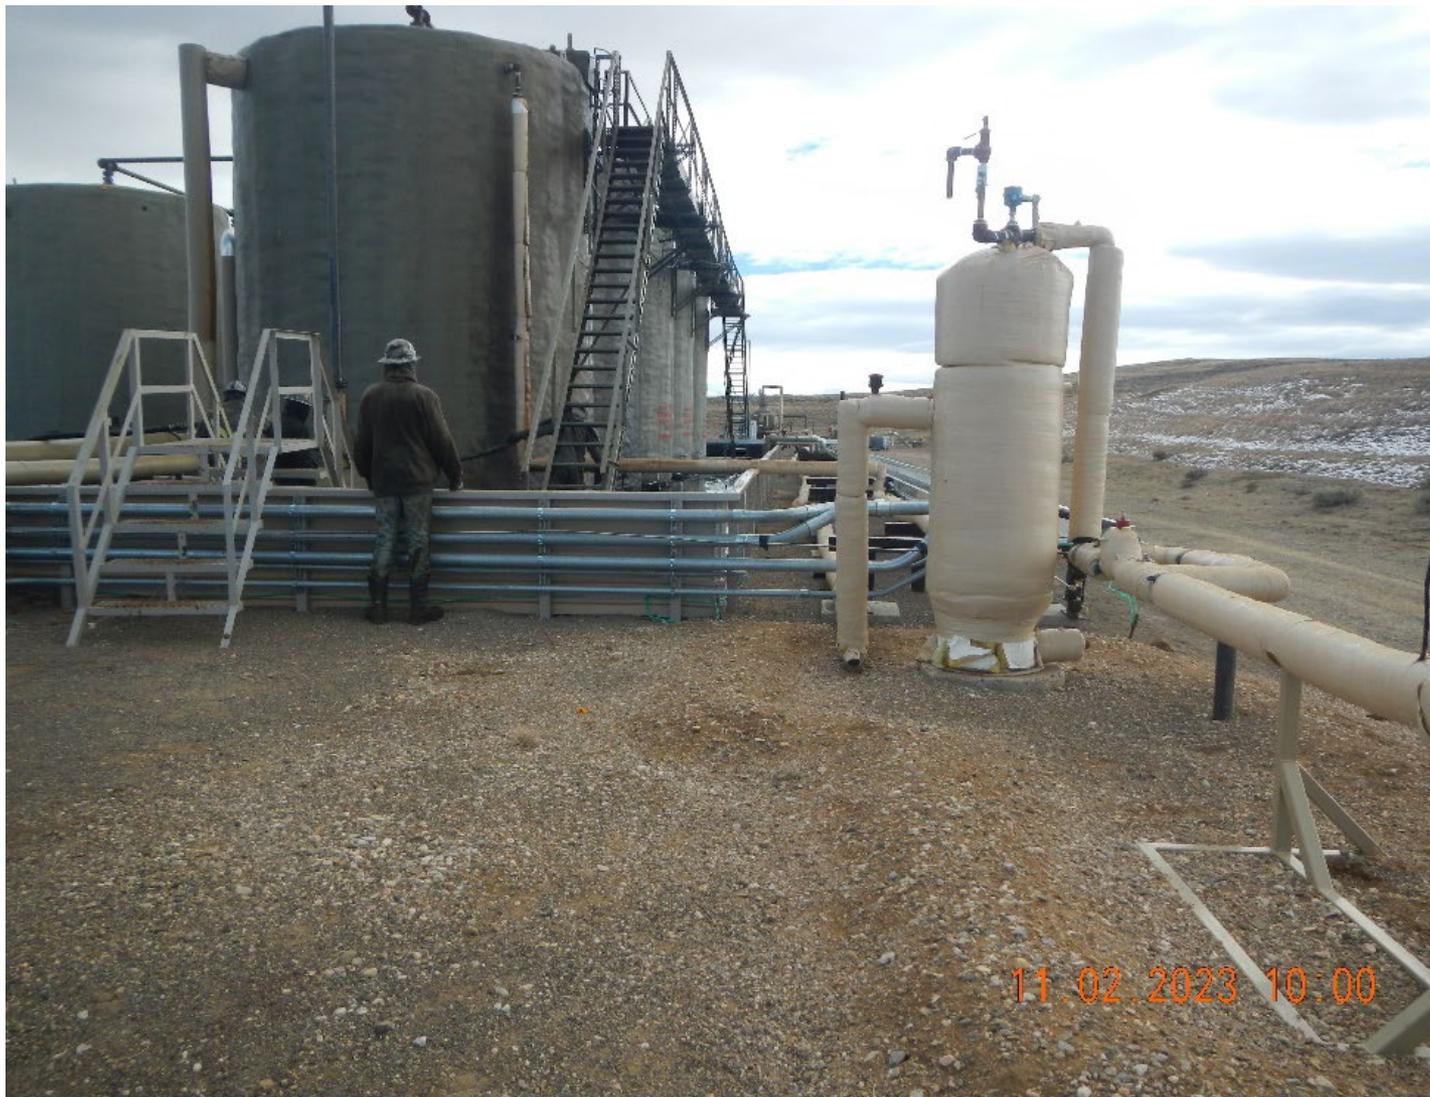
Photo #1 looking at containment where spill occurred.

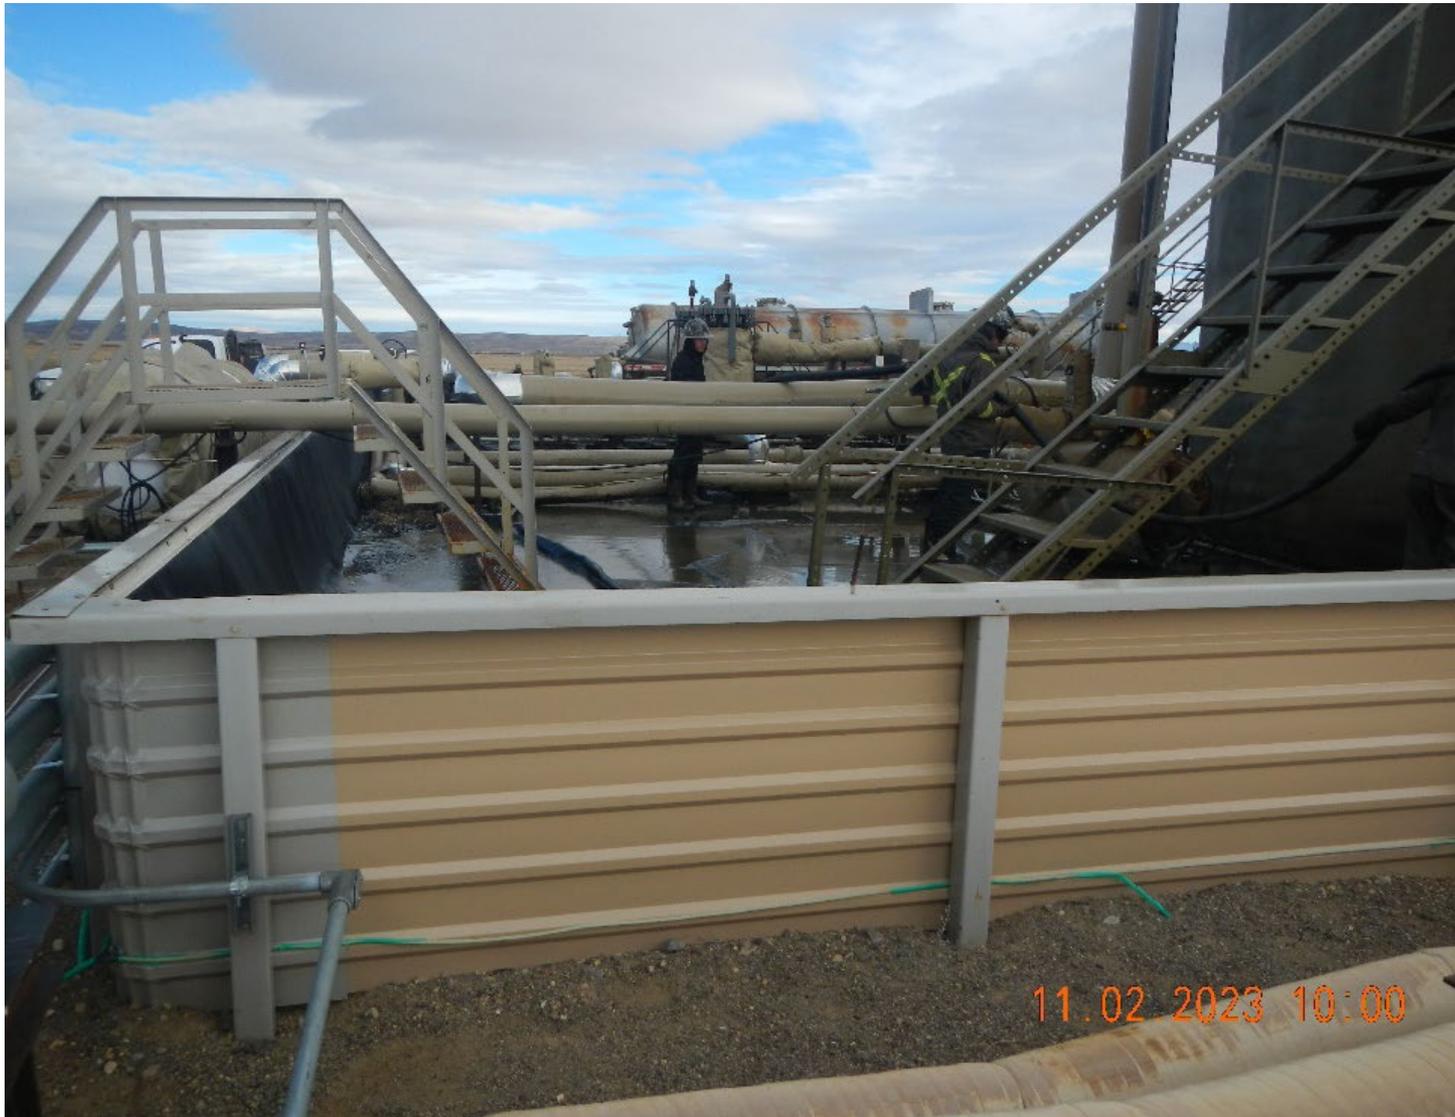
**Photo #2 Crews were vacing up fluid inside secondary  
containment.**

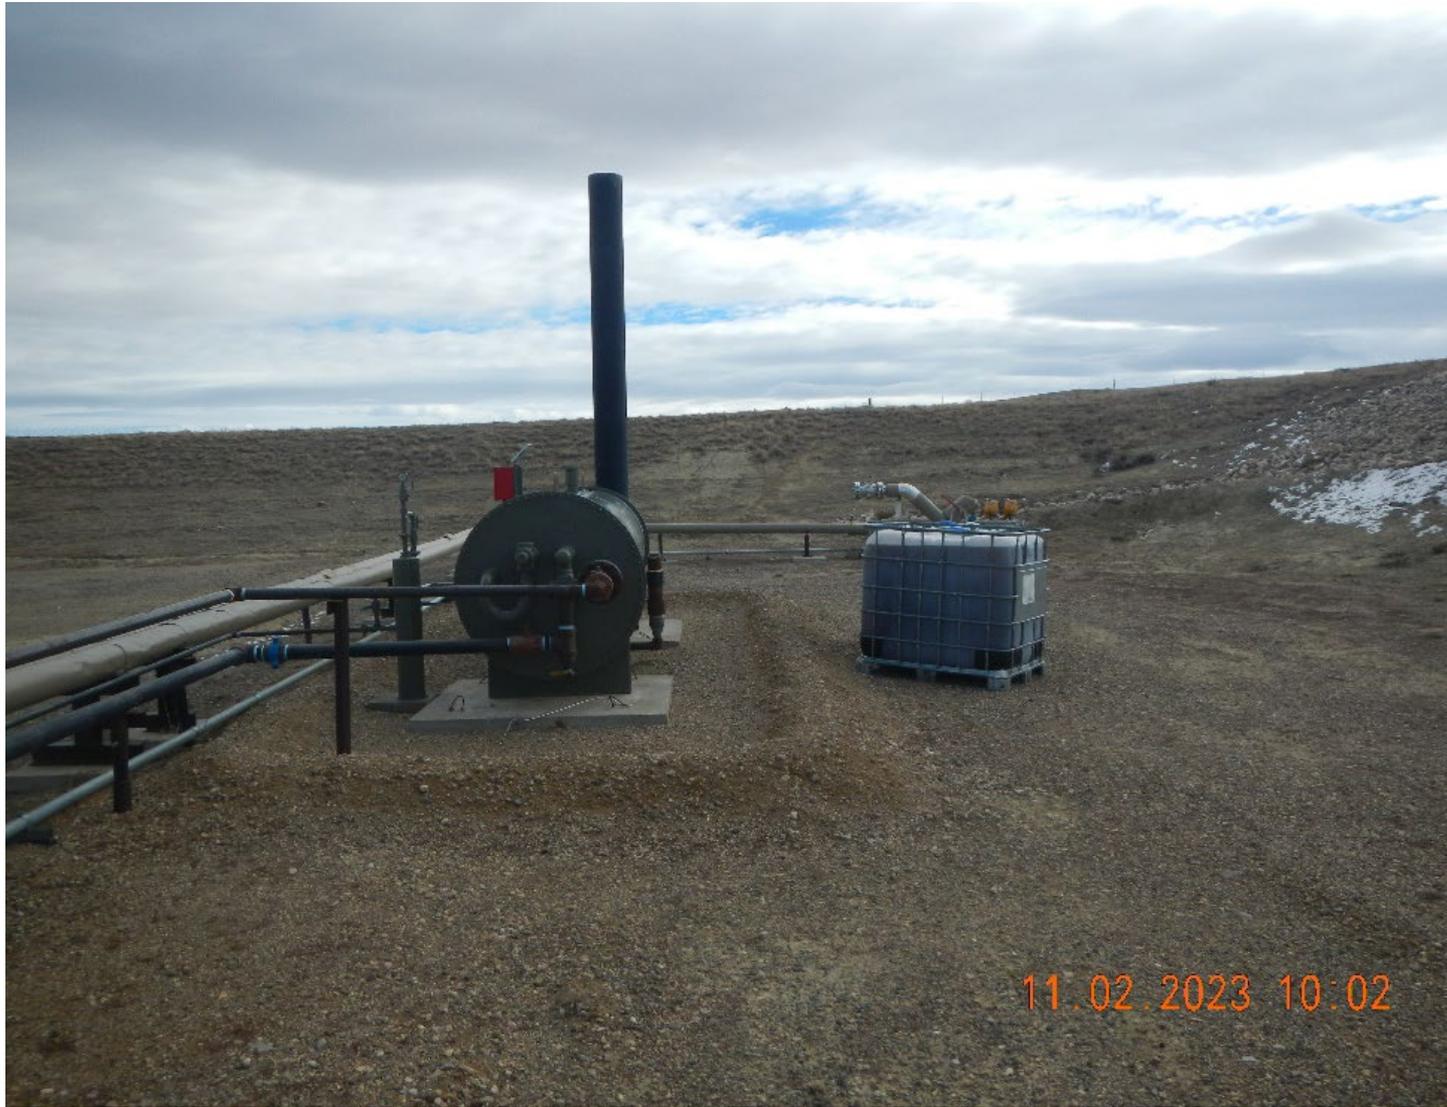
Photo #3 fired heater and stored totes. The totes were labeled as Ethylene Glycol, it was obvious that there is a fluid other than Glycol contained in these totes.

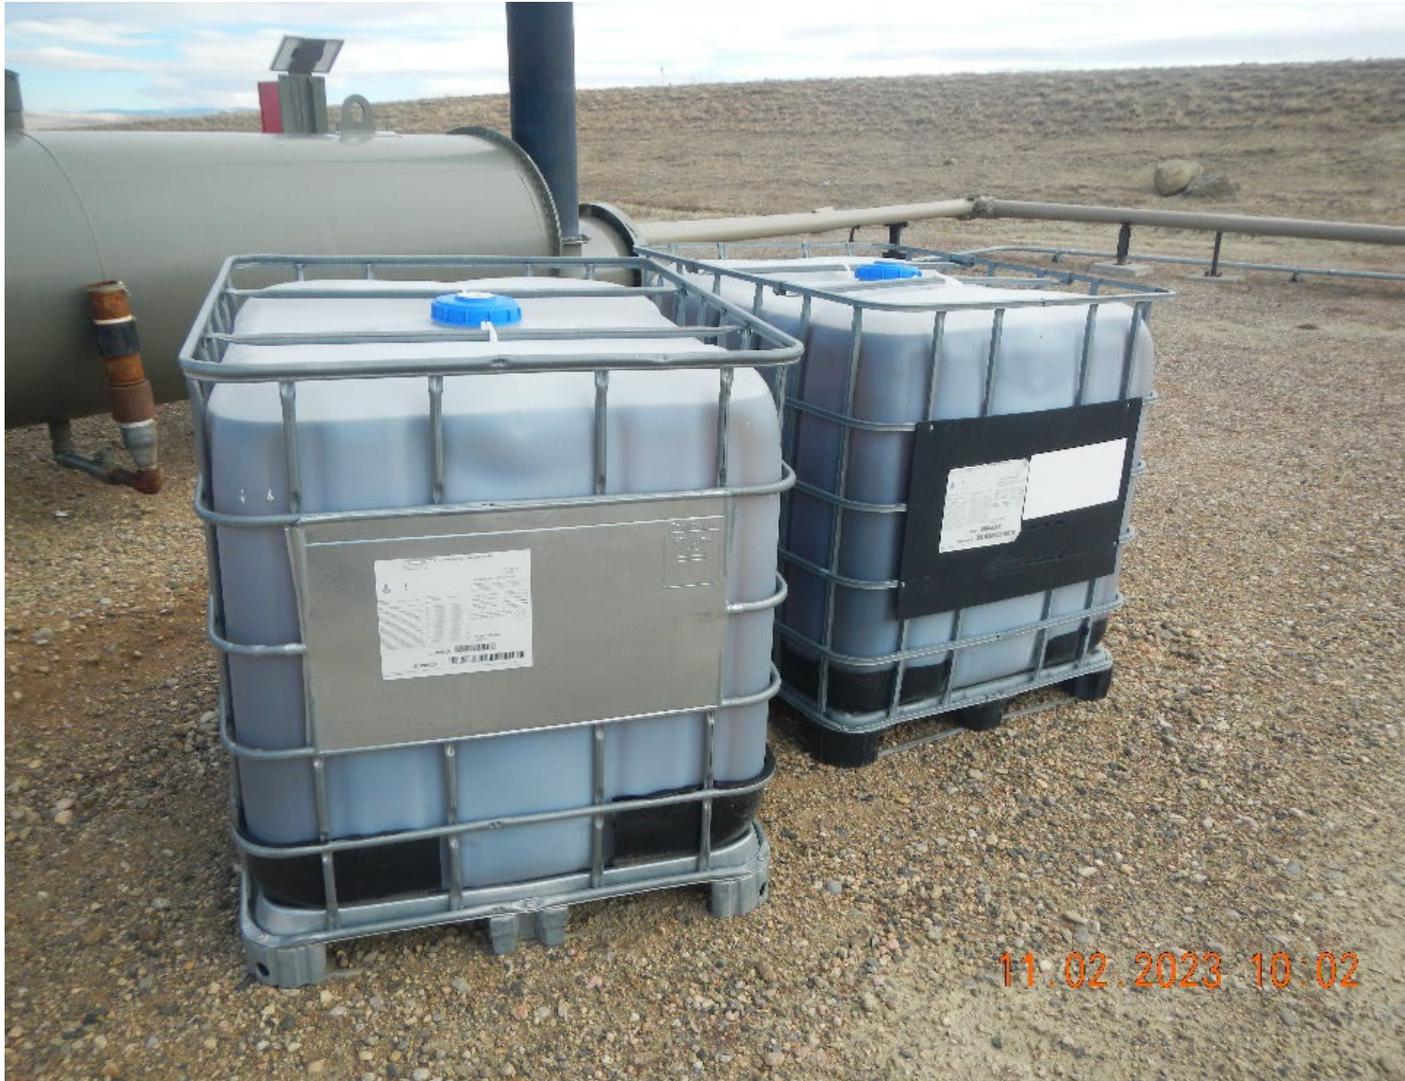
**Photo #4** The totes were labeled as Ethylene Glycol, it was obvious that there is a fluid other than Glycol contained in these totes.

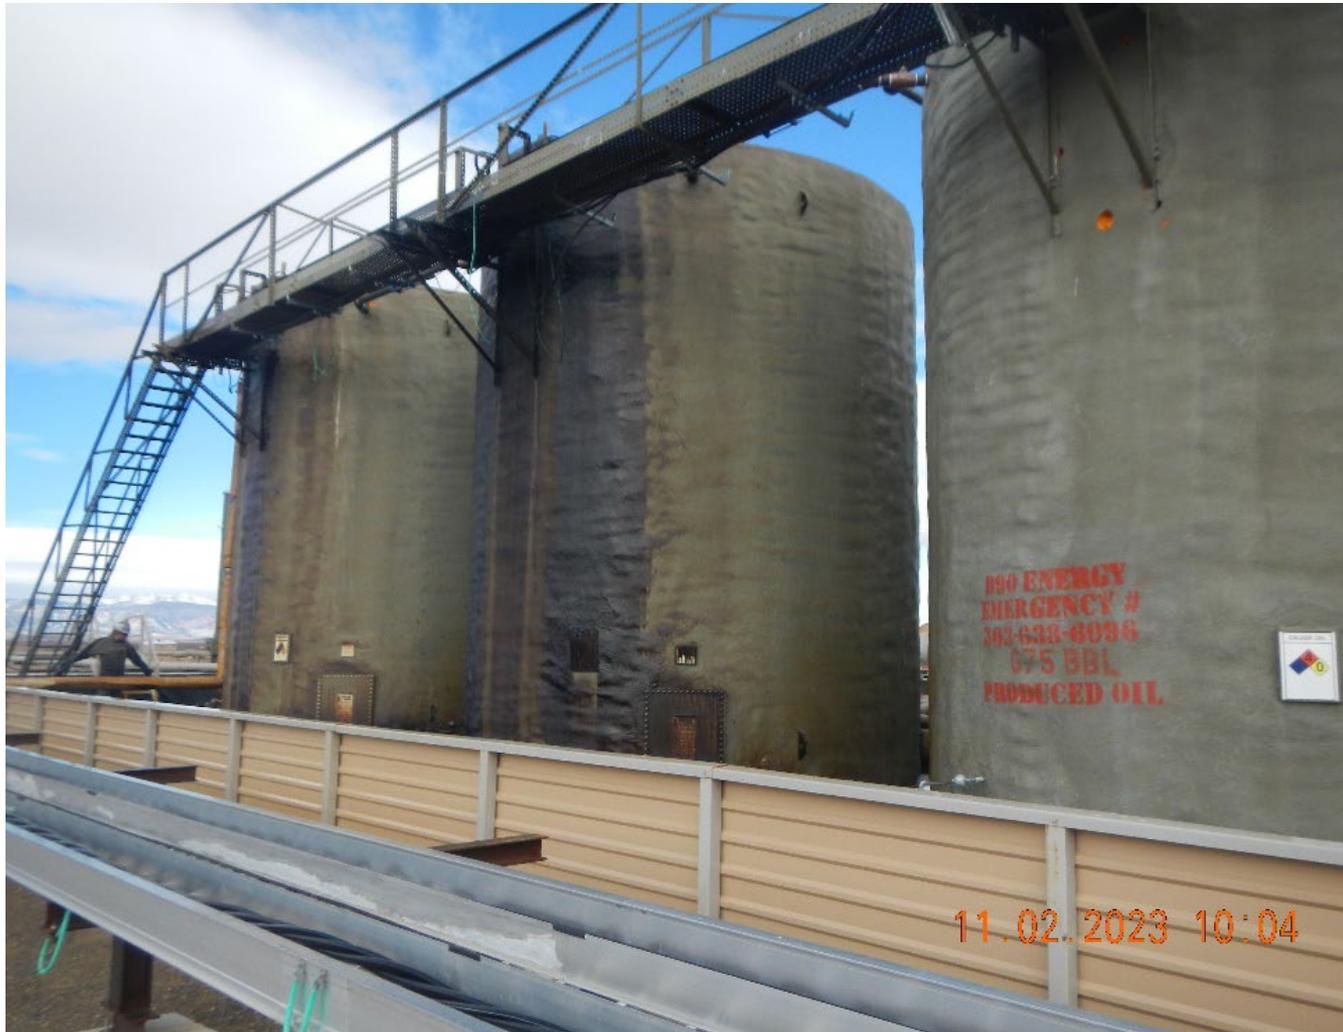
**Photo #6 Two tanks on left of photo show evidence of being over filled.**

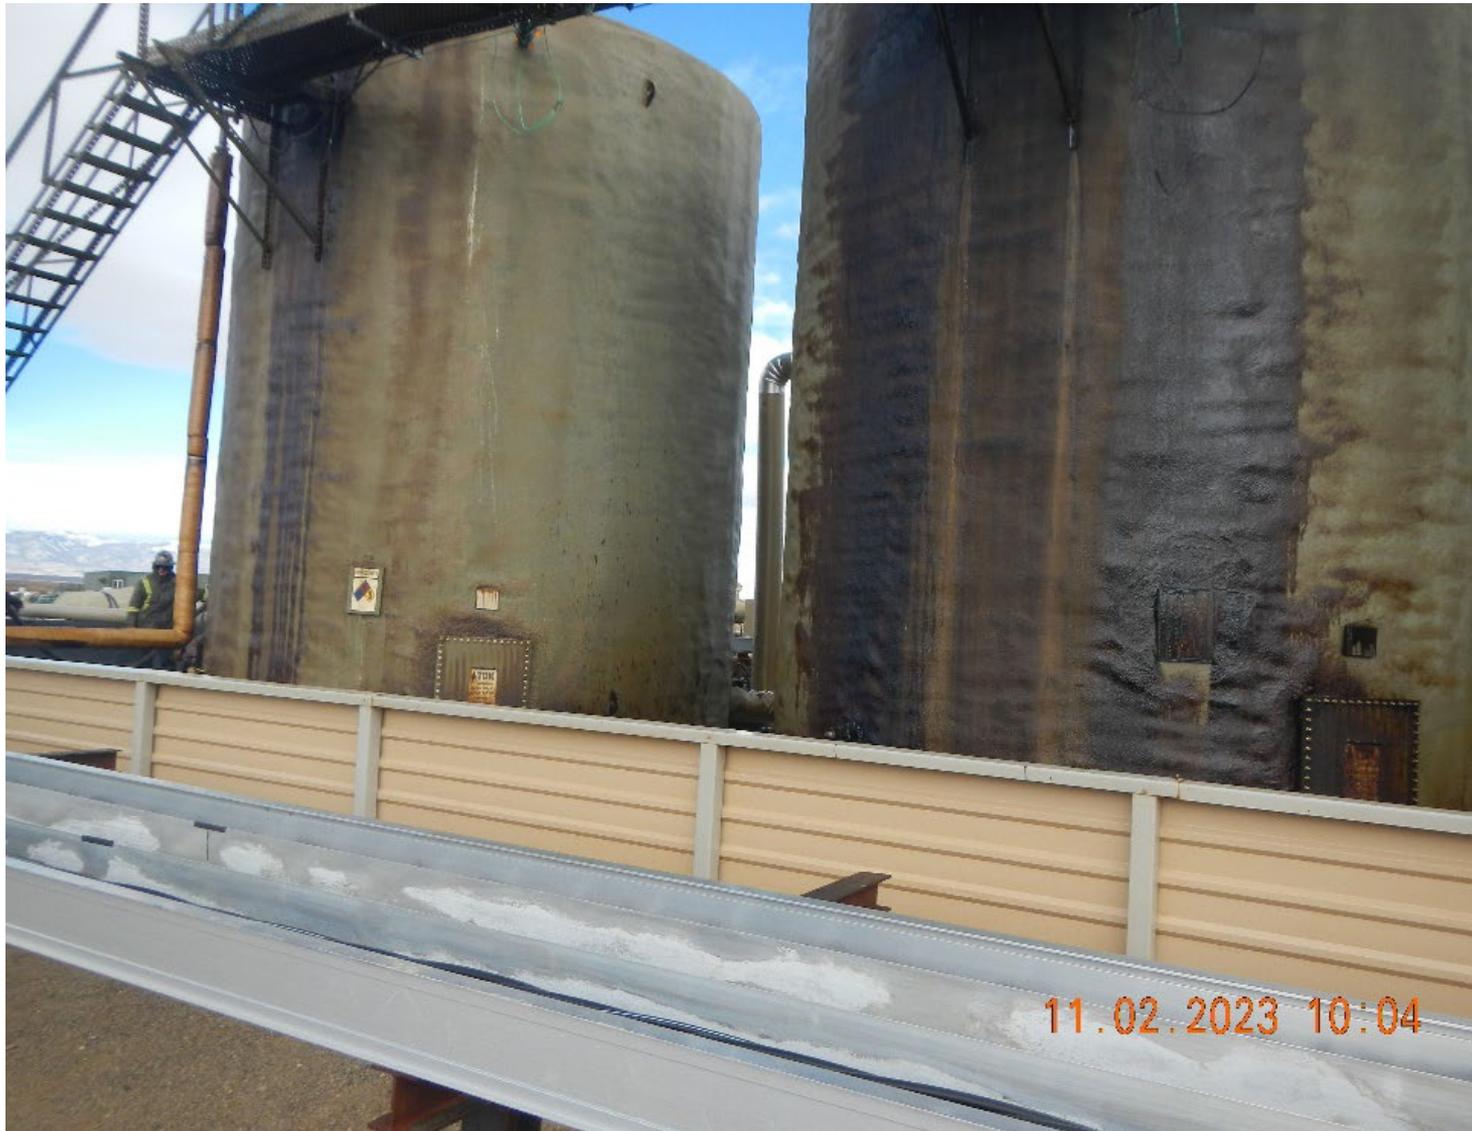
Photo #7 over topped tanks.

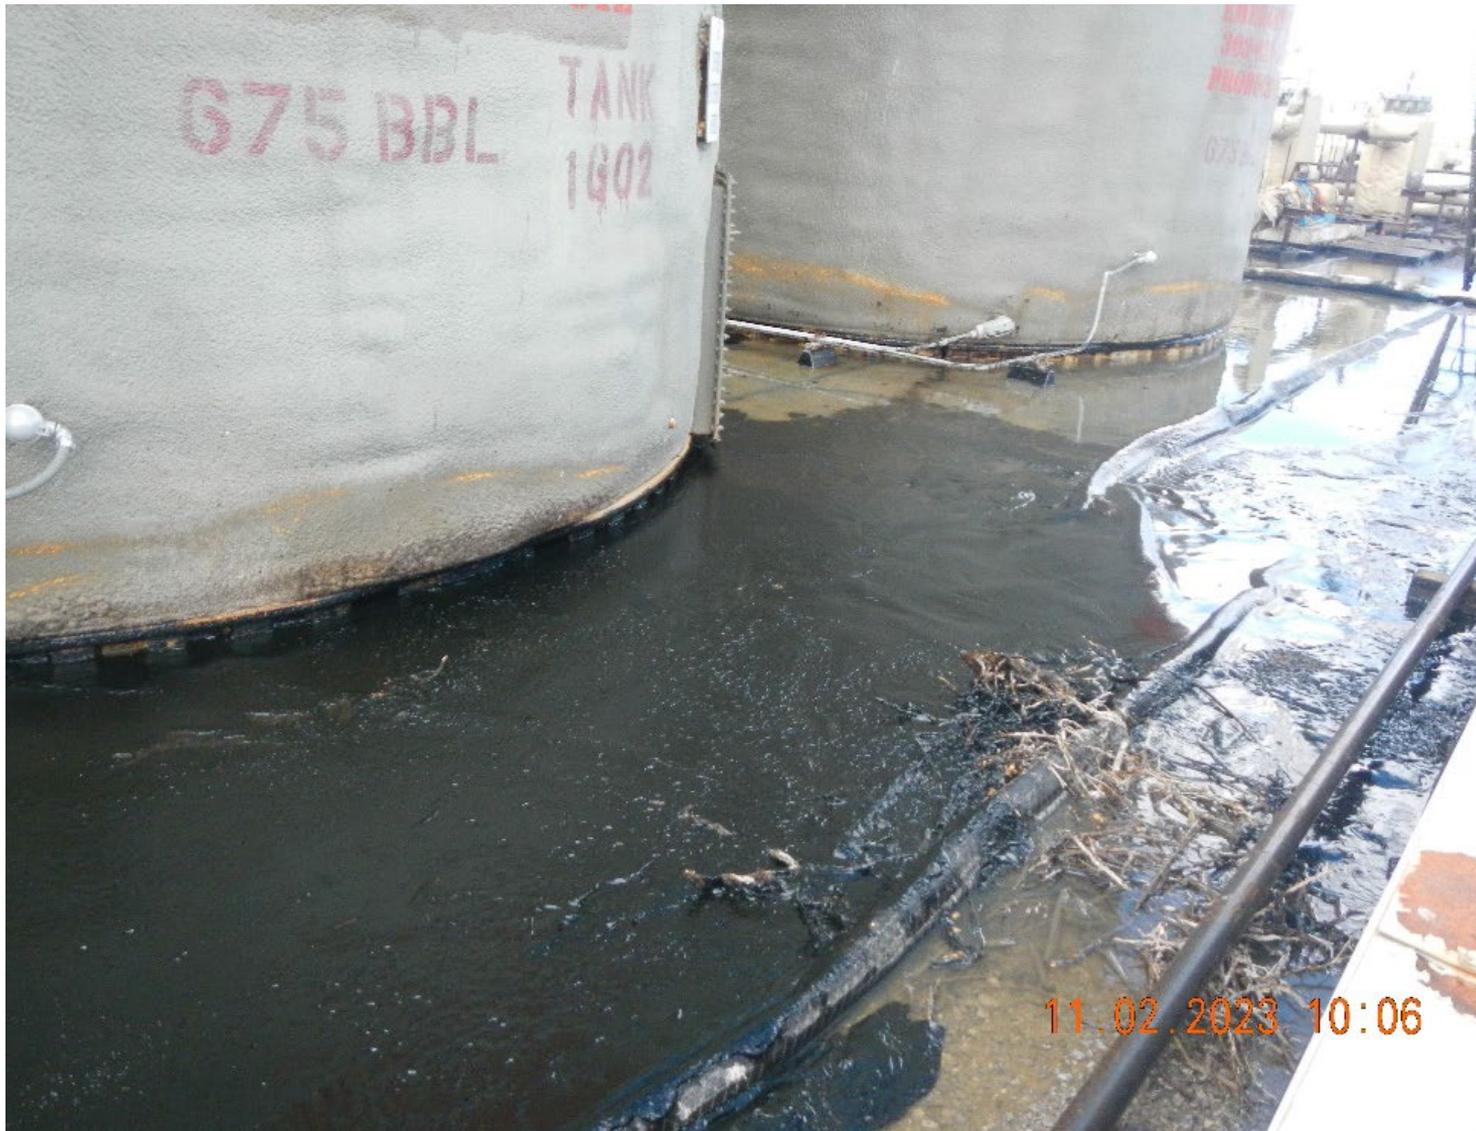
**Photo #8 Spilled fluid was observable in 98% of engineered  
secondary containment.**

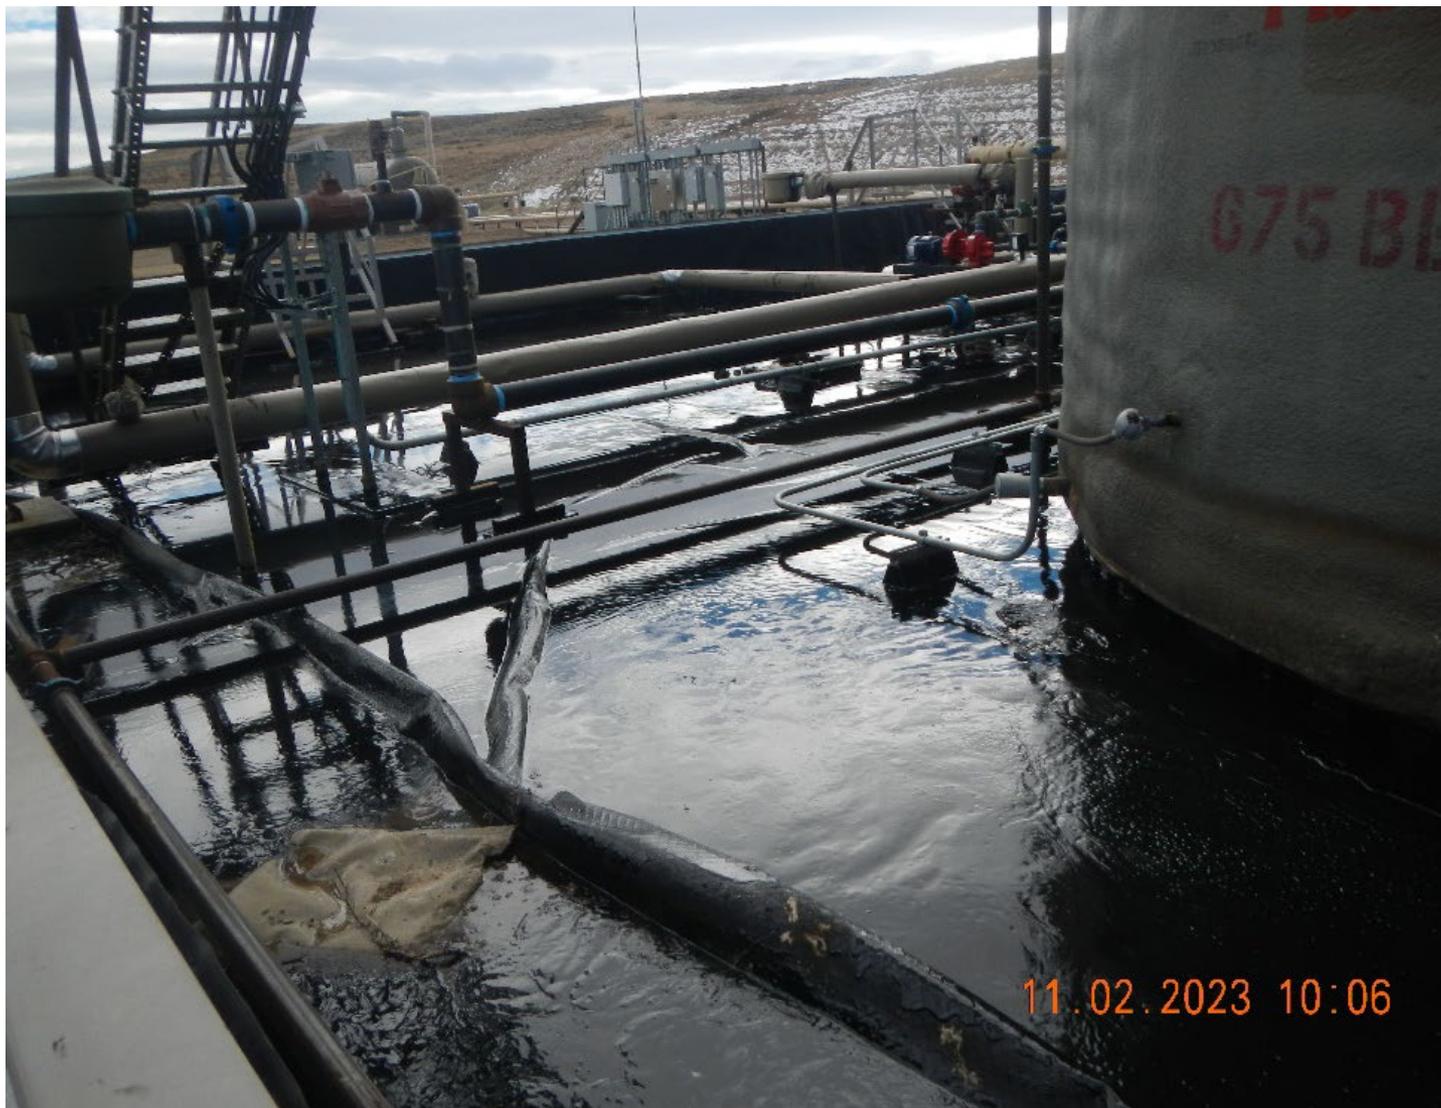
Photo #9 Spilled fluid was observable in nearly all of the surface of the engineered secondary containment.

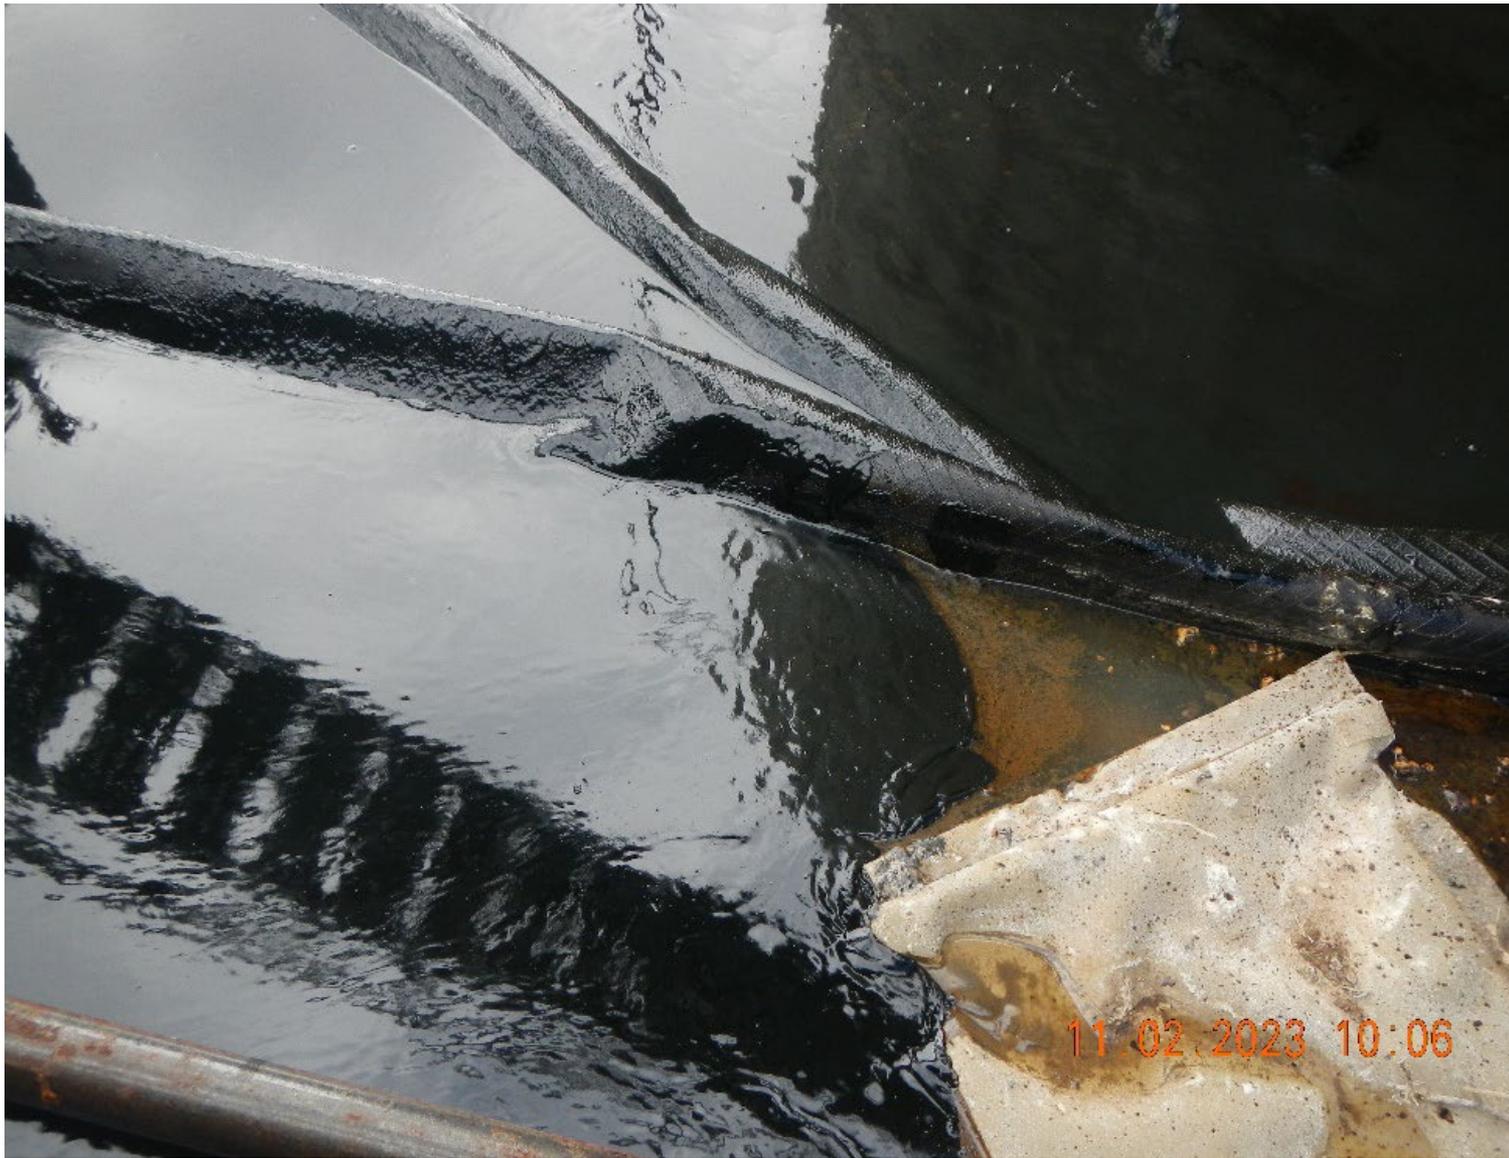
**Photo #10 close up of liner and spilled fluid and perhaps water  
that was inside of secondary containment. All fluid should be  
handled as E&P waste.**

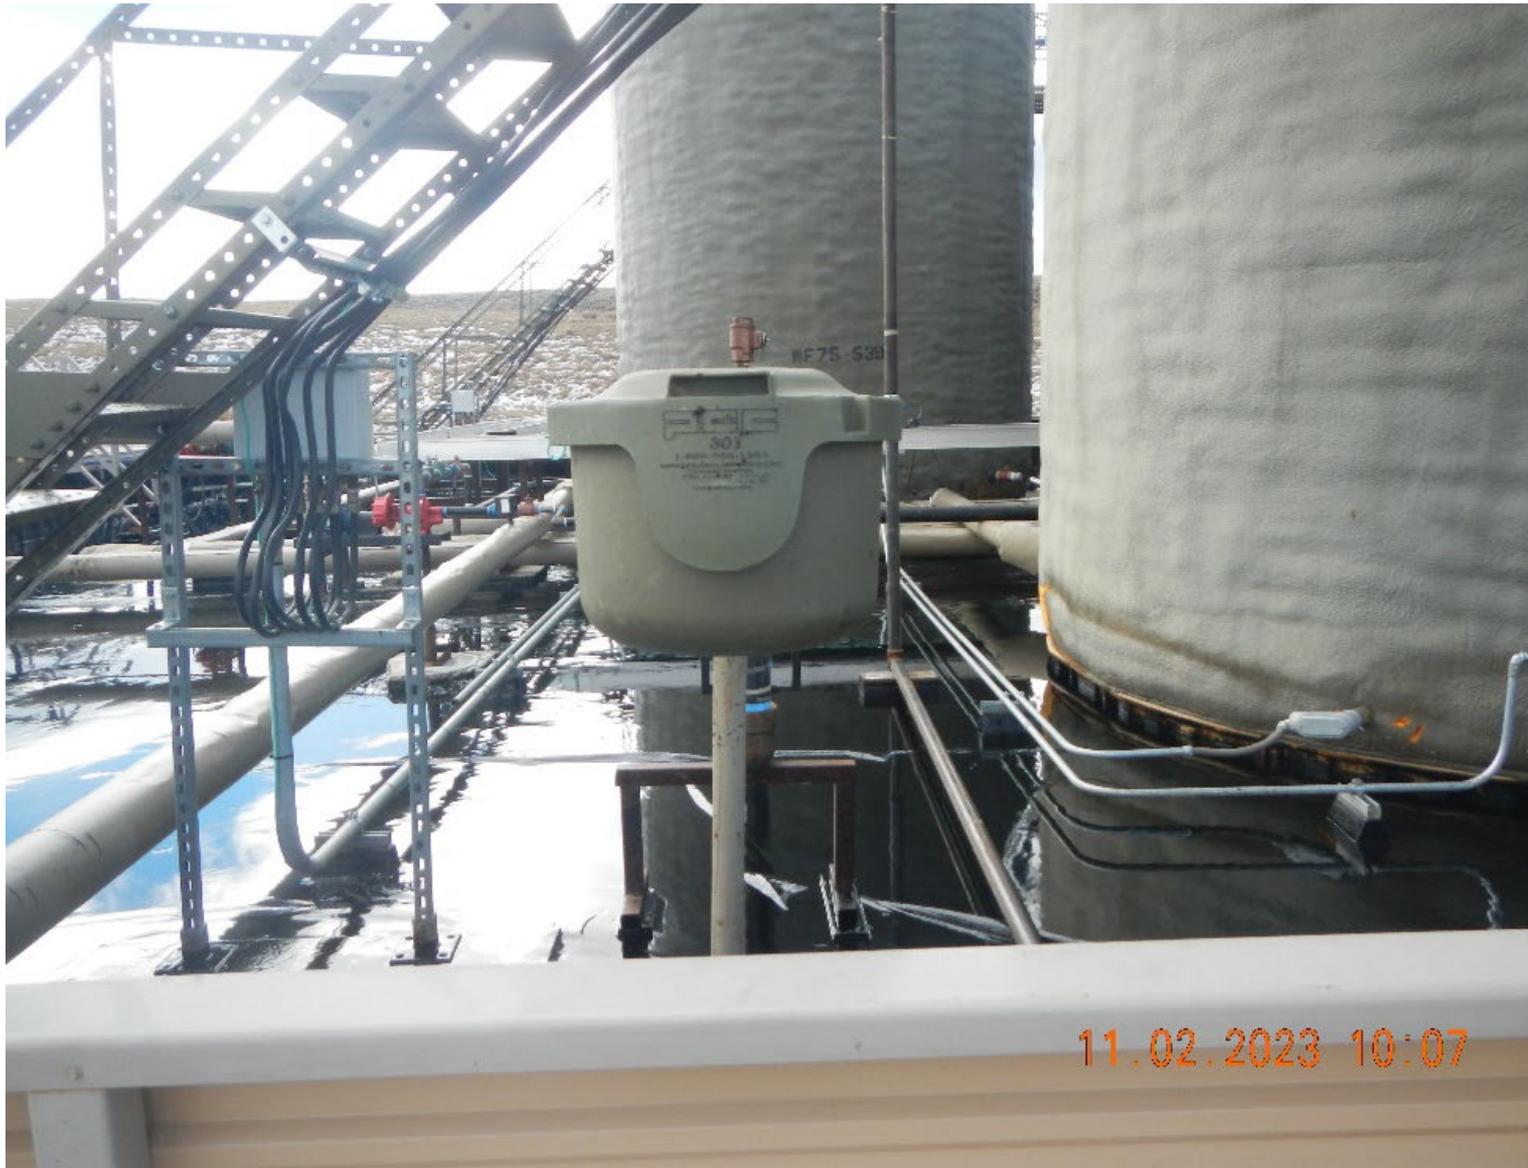
Photo #12 some load outs are “inside” of secondary  
containment perimeter.
