TEP Rocky Mountain LLC
Diamond Elk-67S95W 12NWNW
Location ID: 334712

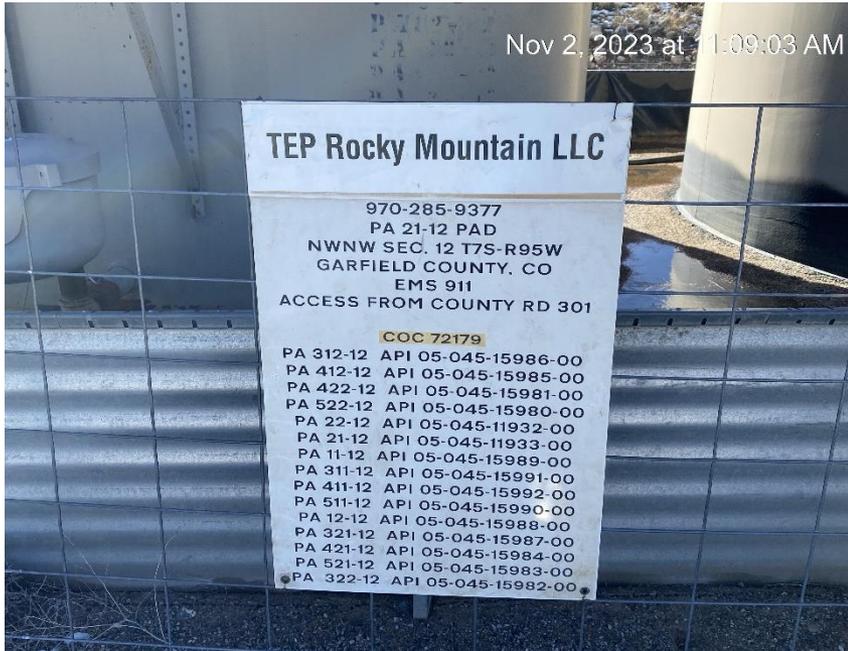
Sign at tank battery

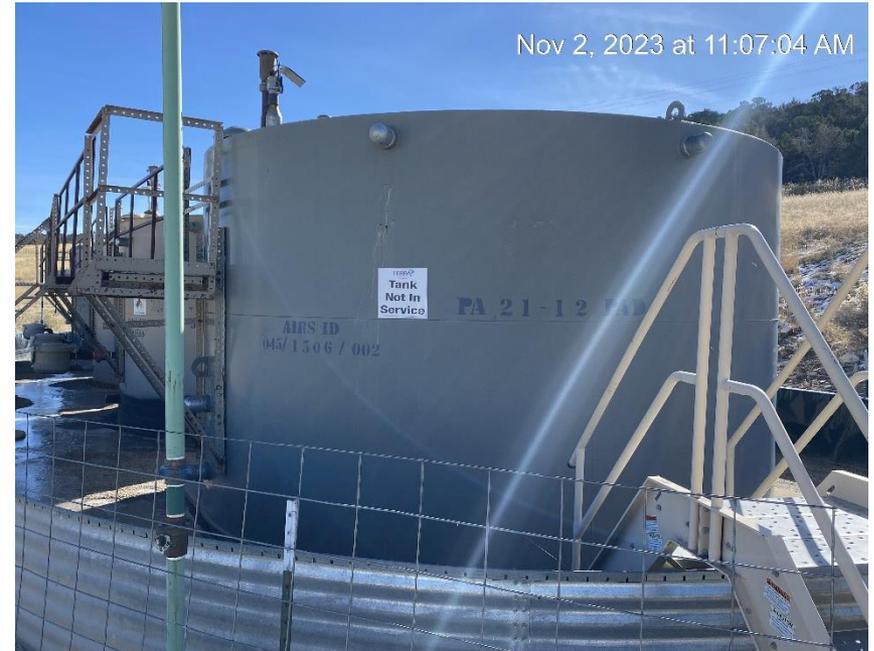
Unused equipment on location

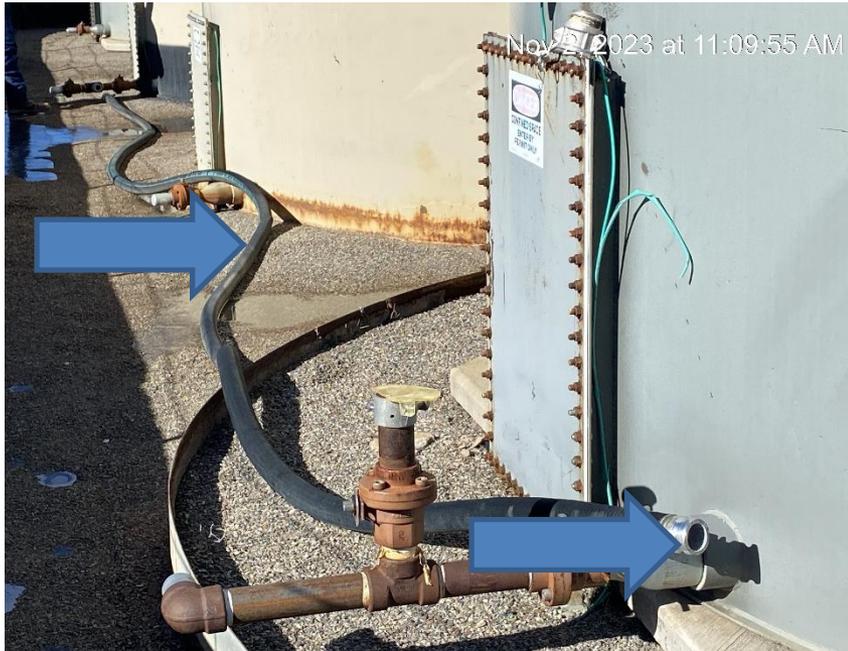
Debris. Open to wildlife.

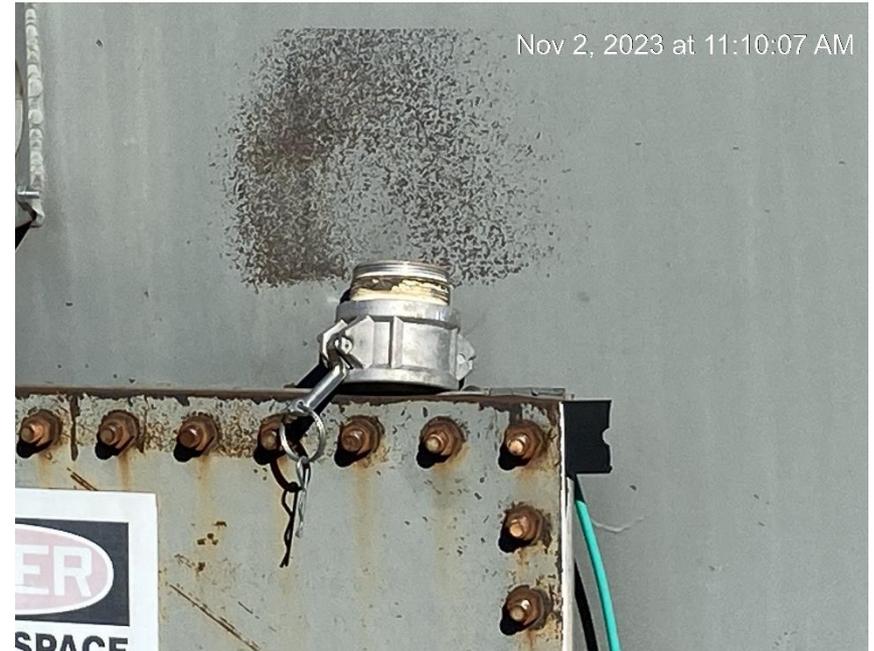
Debris

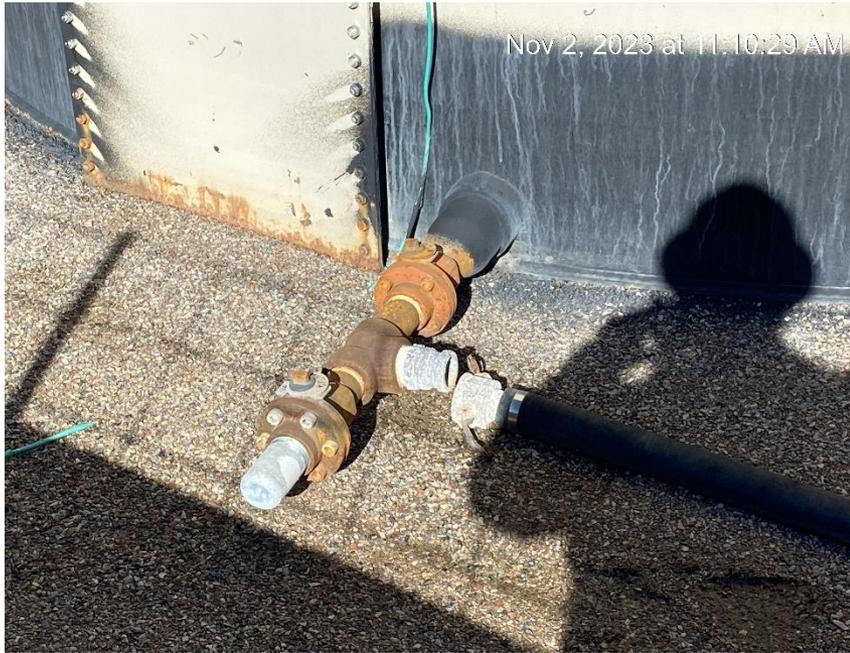
Open end loadline

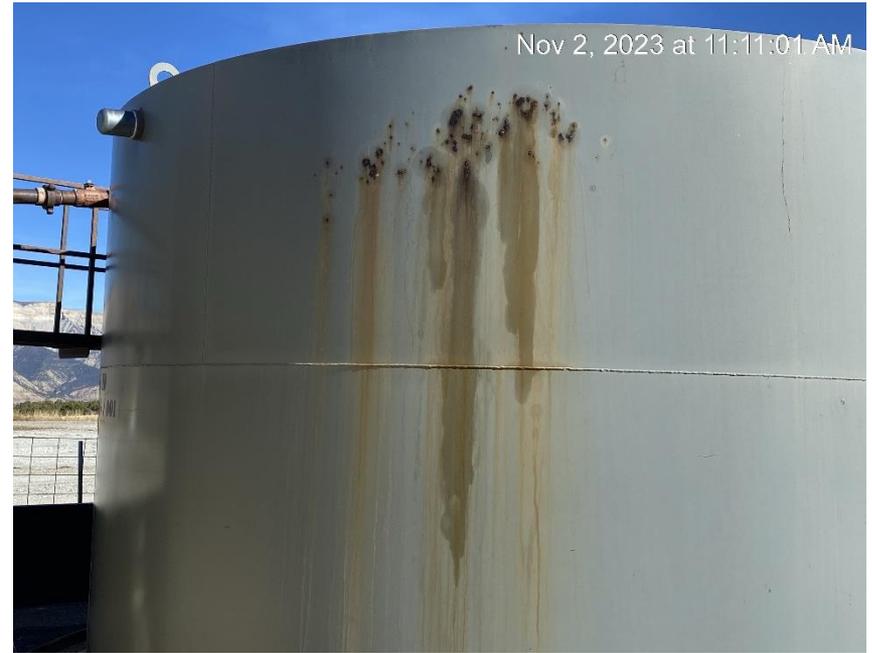
Condensate tank leaking.

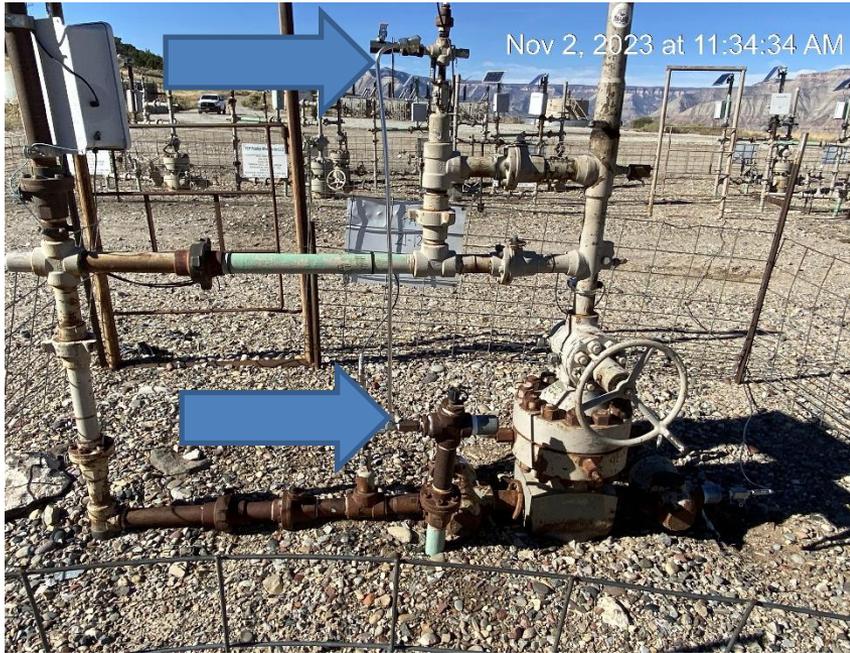
Bradenhead connected to flowline

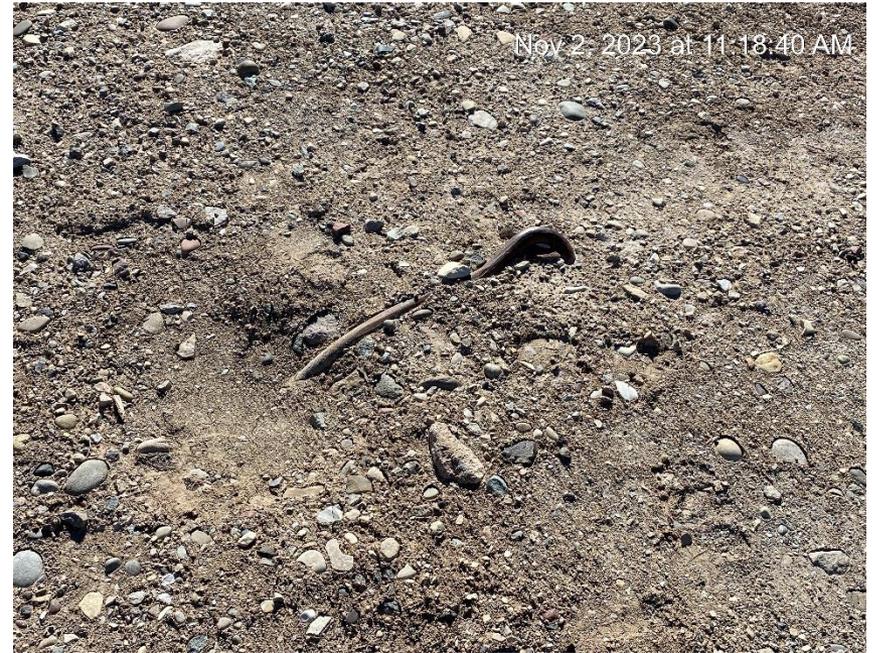
Unmarked anchor

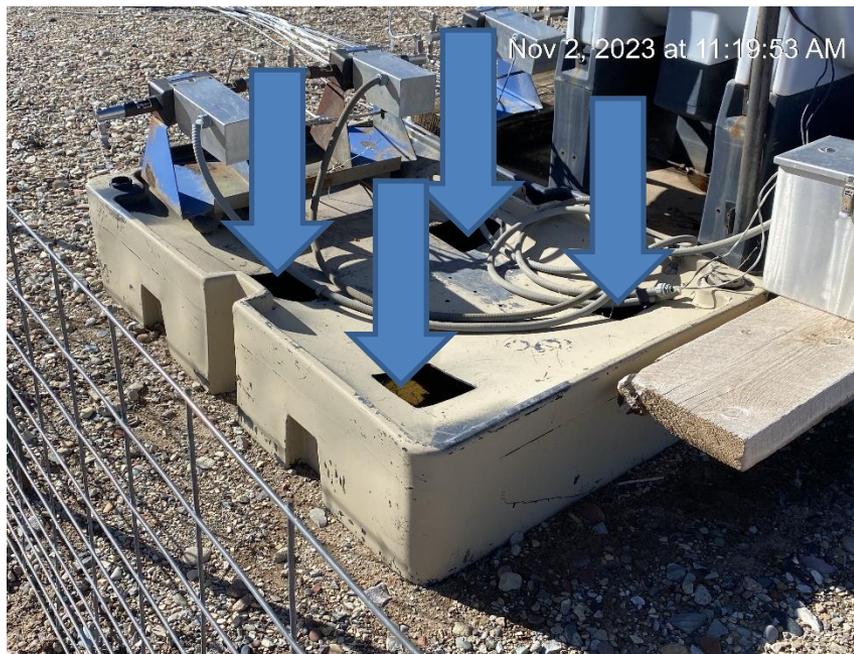
Open to wildlife

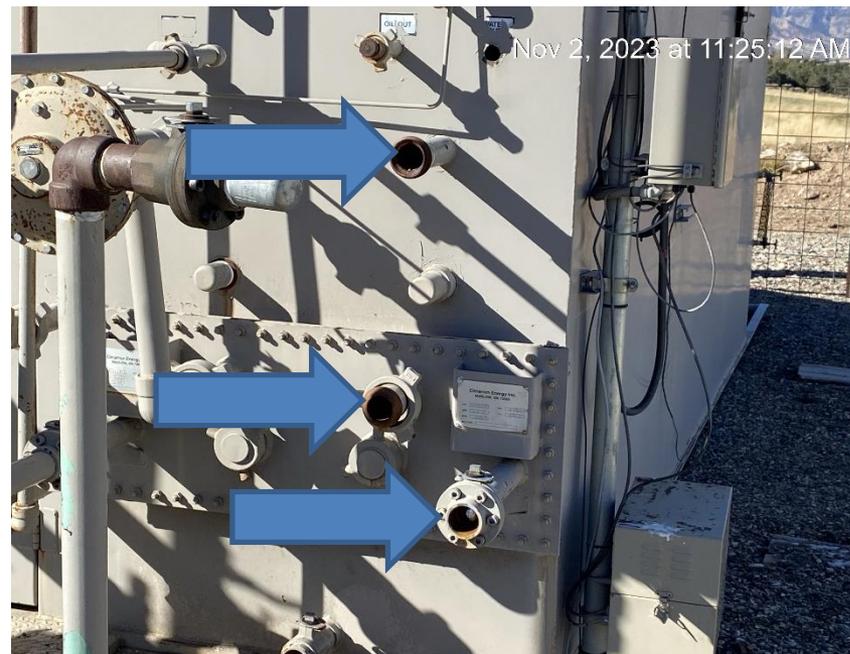
Open to wildlife

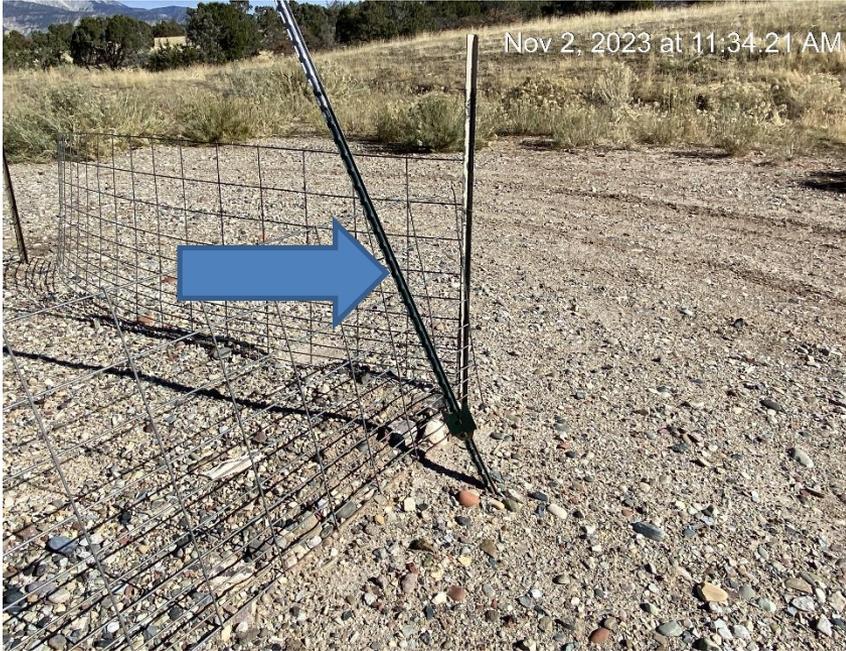
Debris

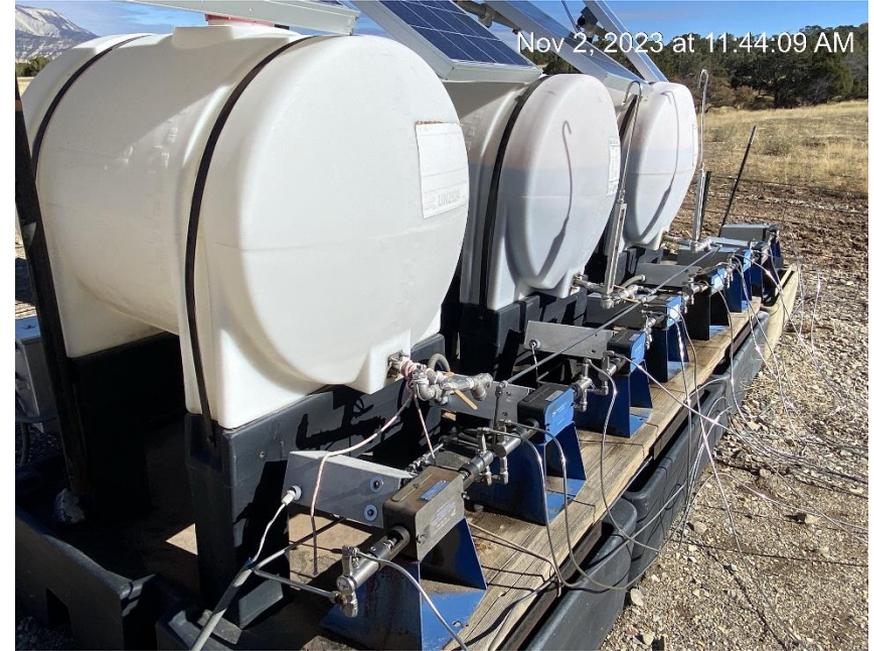
Tank disconnected and label illegible

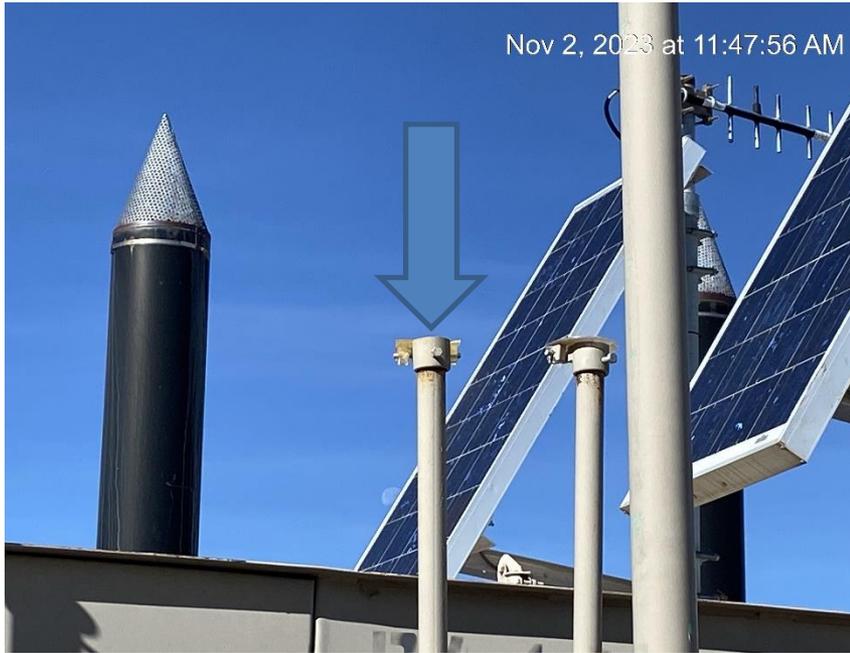
Damaged rain cap

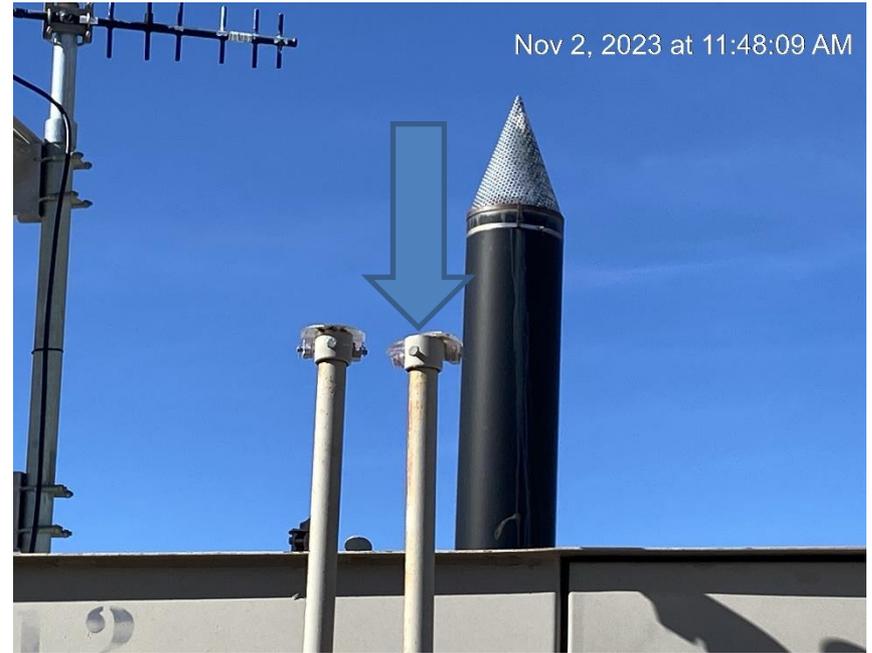
Damaged rain cap
