Inspection Photos

Location Name: CAERUS PICEANCE LLC GMR 9-14B (N9B) Pad

Location #: 334678

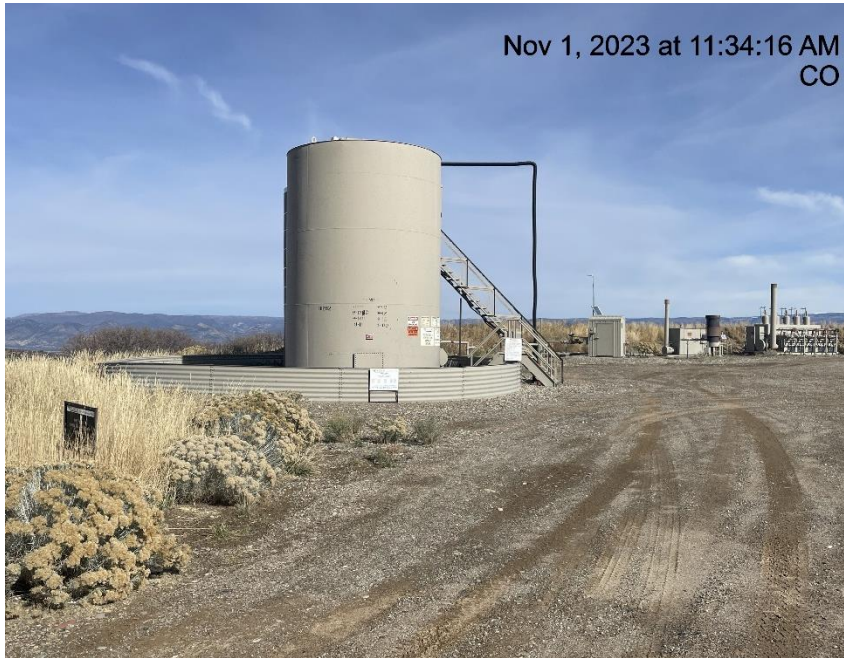
Photo # 4929 From entrance to location

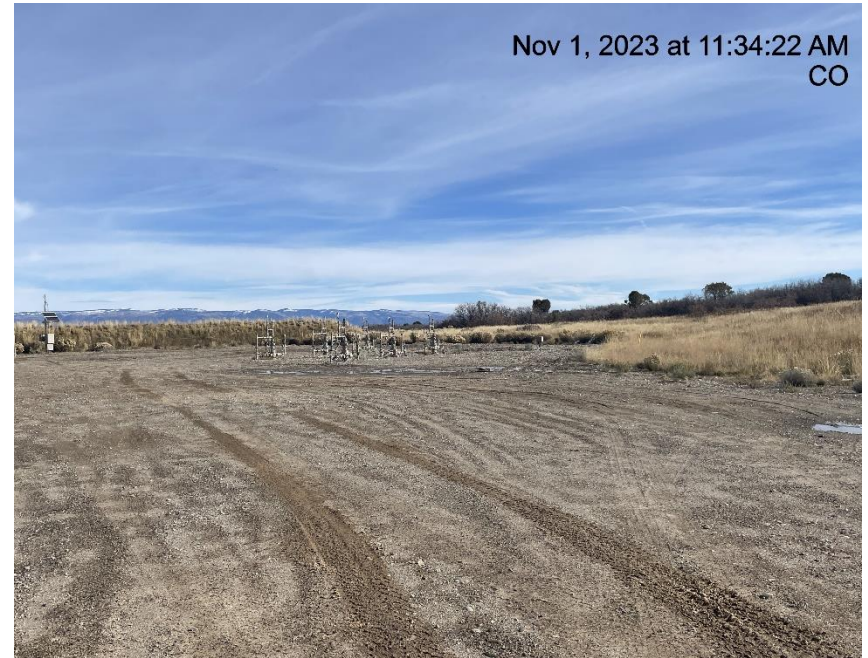
Photo # 4930 From entrance to location

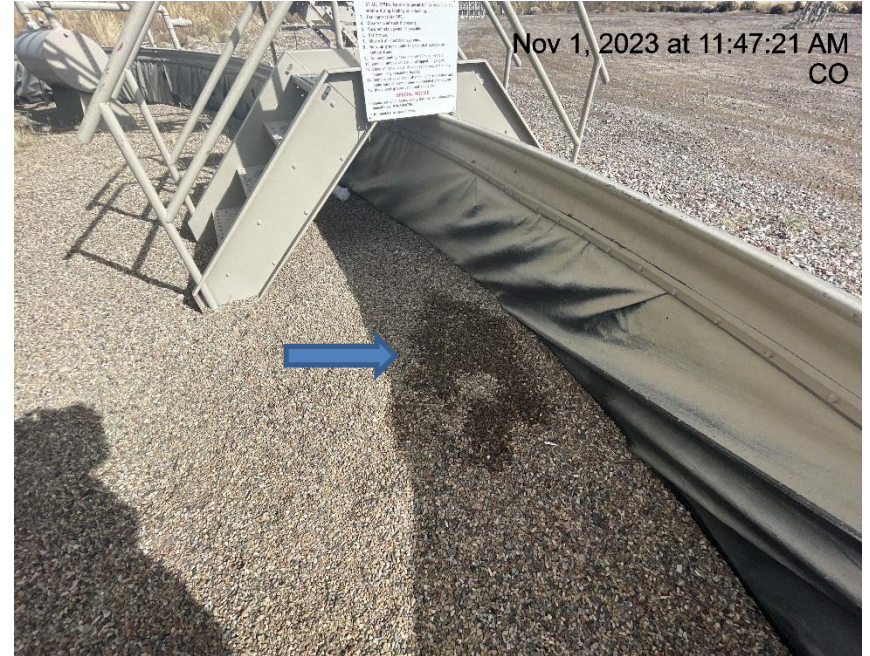
Photo # 4938 Stained gravel

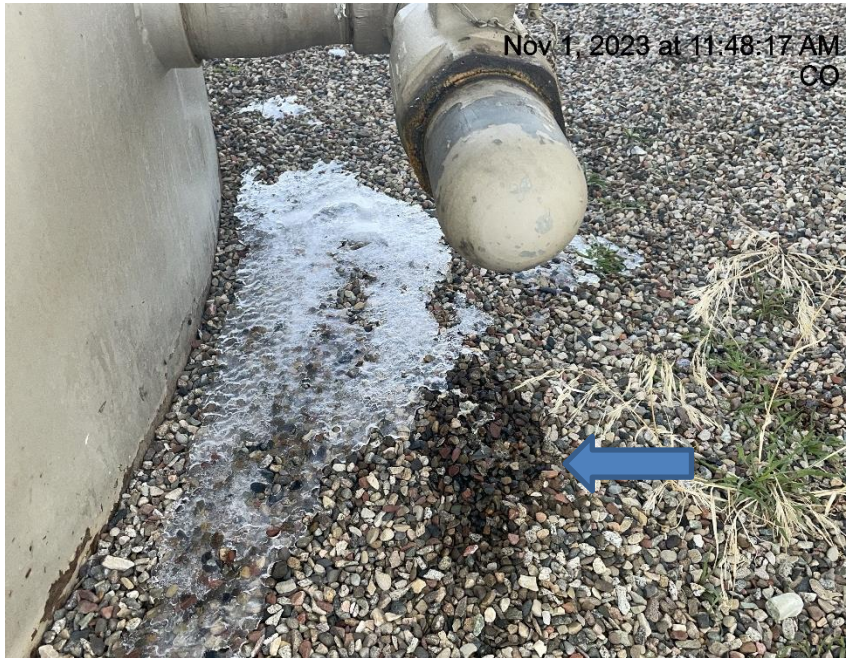
Photo # 4939 Stained gravel
