Inspection Photos

Location Name: CAERUS PICEANCE LLC HMU 9-5 (E9W) Pad

Location #: 334584

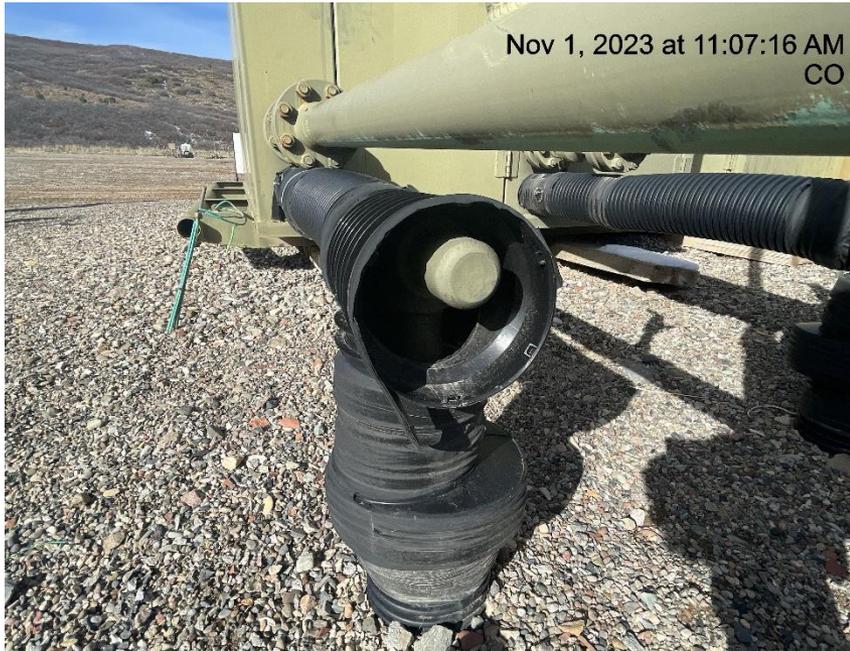
Photo # 4867 Flowline heating insulation open ended

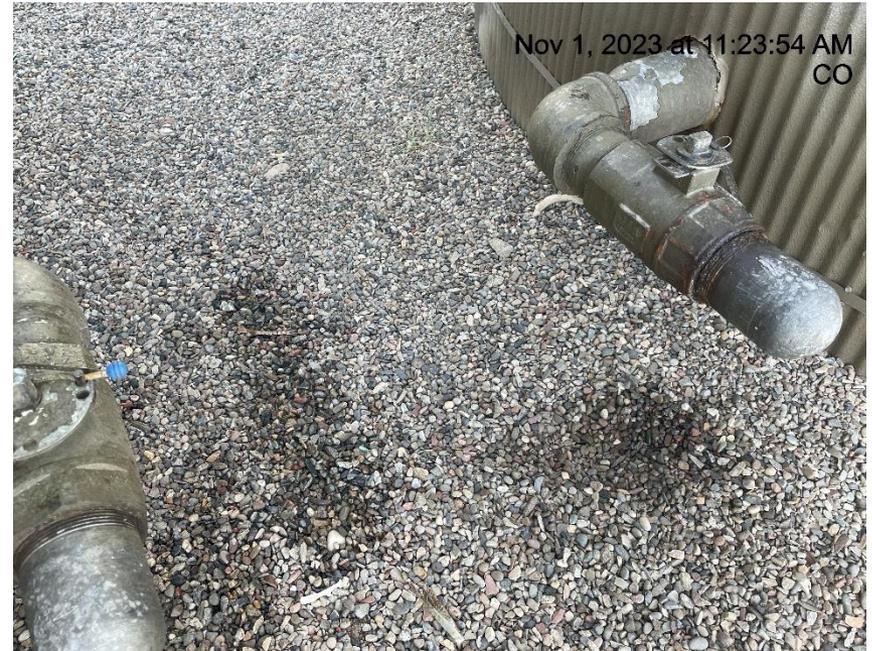
Photo # 4868 Stained gravel

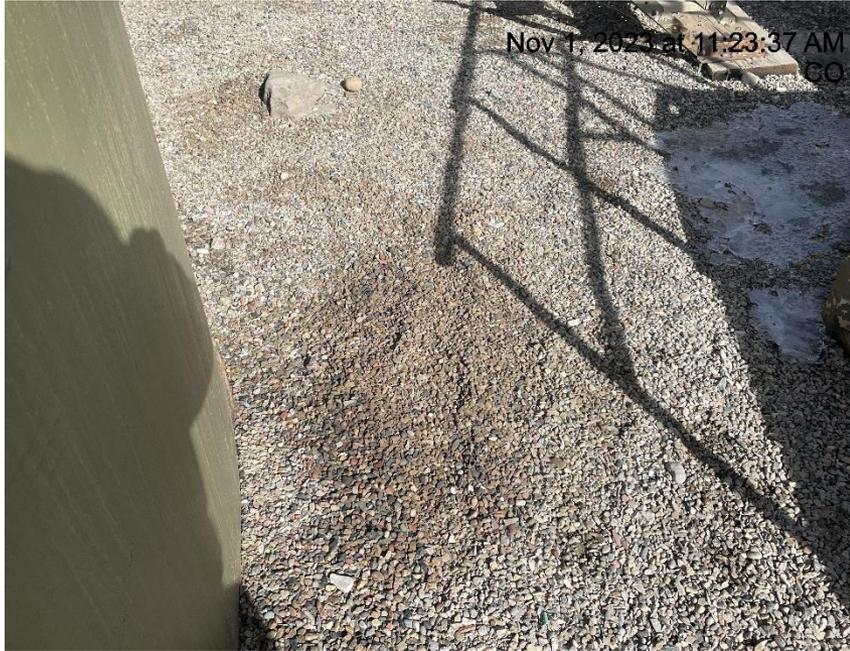
Photo # 4869 Stained gravel
